Gatwick Airport Northern Runway Project

Environmental Statement

Appendix 9.9.2: Biodiversity Net Gain Statement – Clean Version

River Mole and Gatwick Stream Condition Assessment

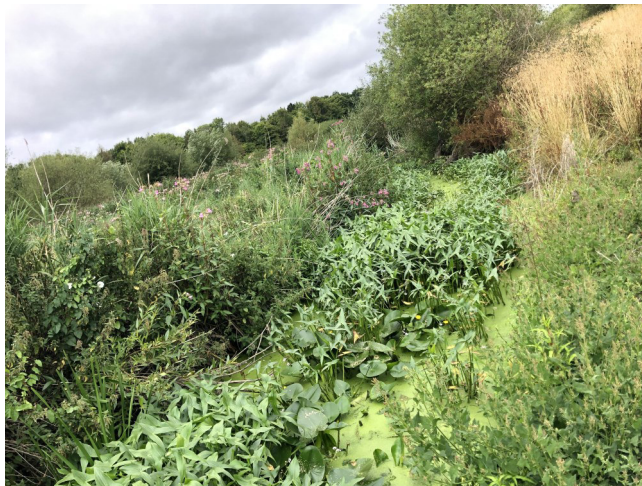
Client	RPS Consulting Services Ltd		Drawing Ref	RPS001-022-001/003/1	
Figure Number	Figure 3b		Drawn	LG	Checked
Figure Title	Photographs of River Mole		Date	27/06/2022

Photograph 1:
Module 1

Photograph 2:
Module 2

Photograph 3:
Module 3

Photograph 4:
Module 4

Photograph 5:
Module 5
