Gatwick Airport Northern Runway Project

Environmental Statement

Appendix 9.9.2: Biodiversity Net Gain Statement – Tracked Version

Application Document Ref: 5.3

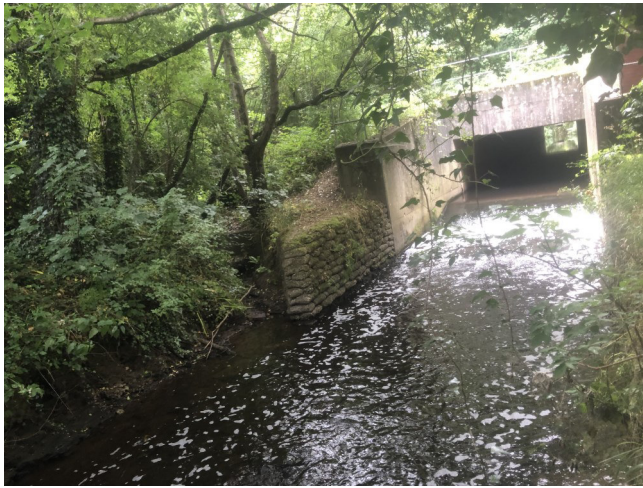
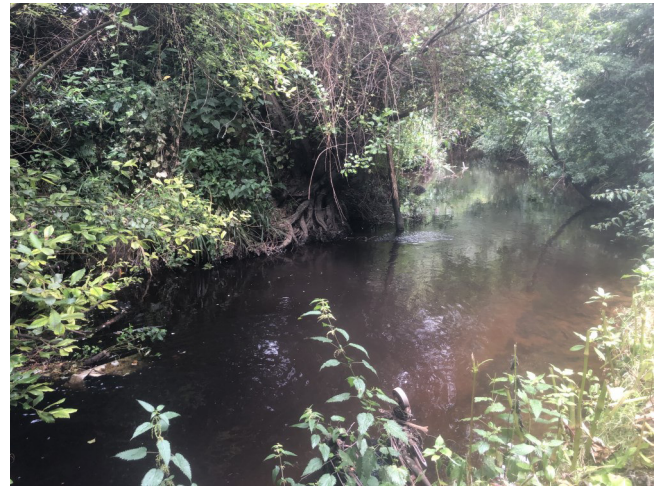
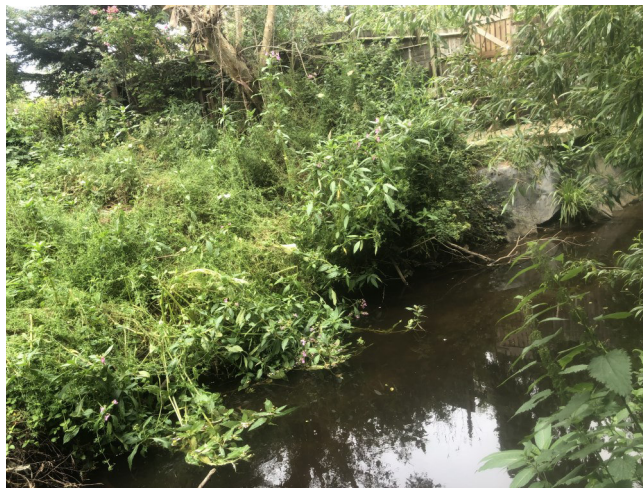
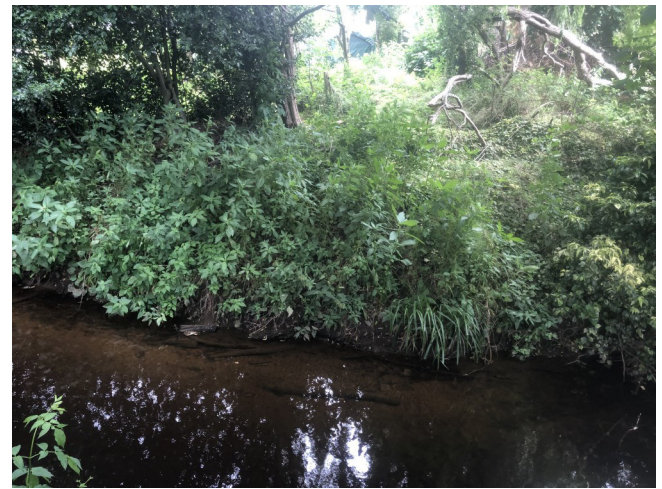
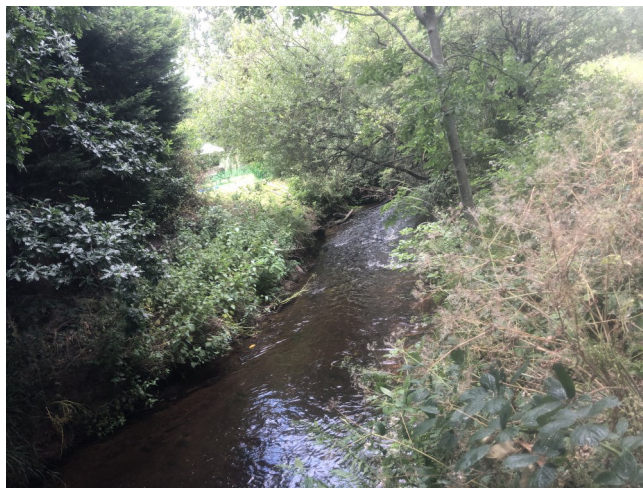
Client	RPS Consulting Services Ltd		Drawing Ref	RPS001-022-001/003/1	
Figure Number	Figure 3a		Drawn	LG	Checked
Figure Title	Photographs of Gatwick Stream				JS
			Date	27/06/2022

Photograph 1:
Module 1

Photograph 2:
Module 2

Photograph 3:
Module 3

Photograph 4:
Module 4

Photograph 5:
Module 5

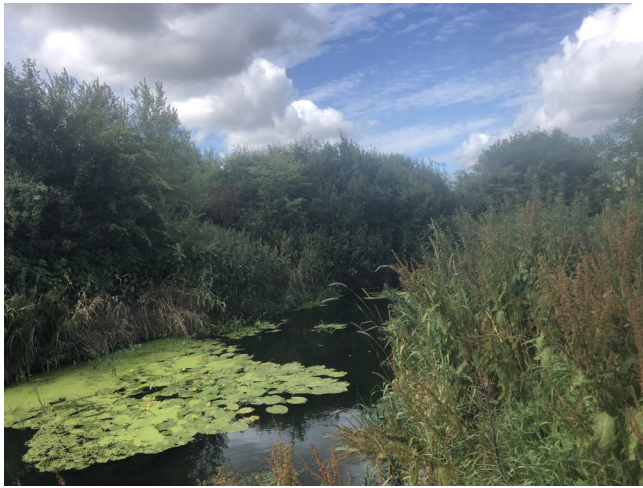
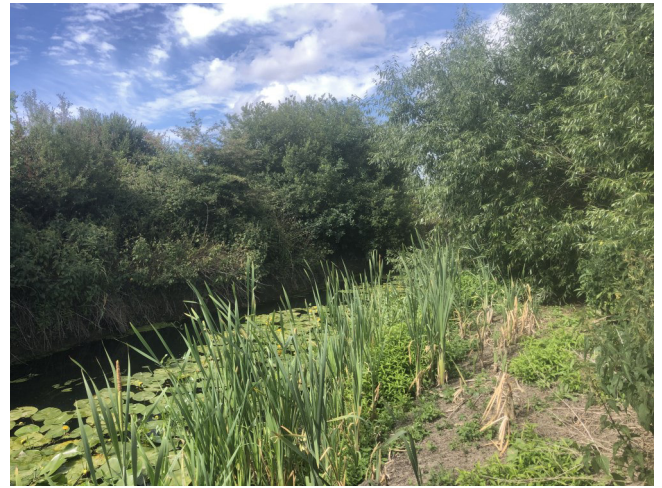
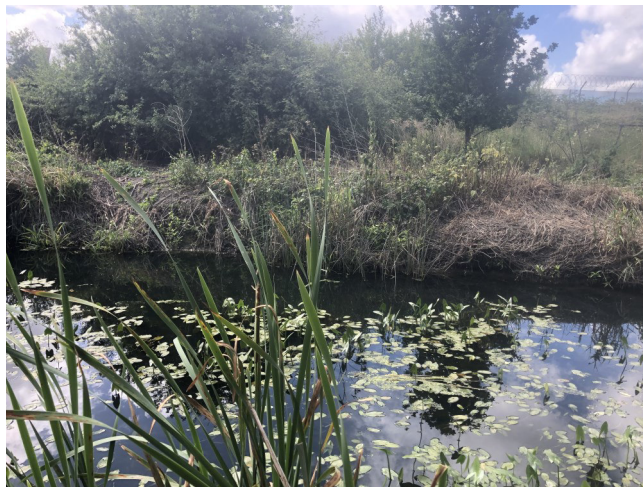
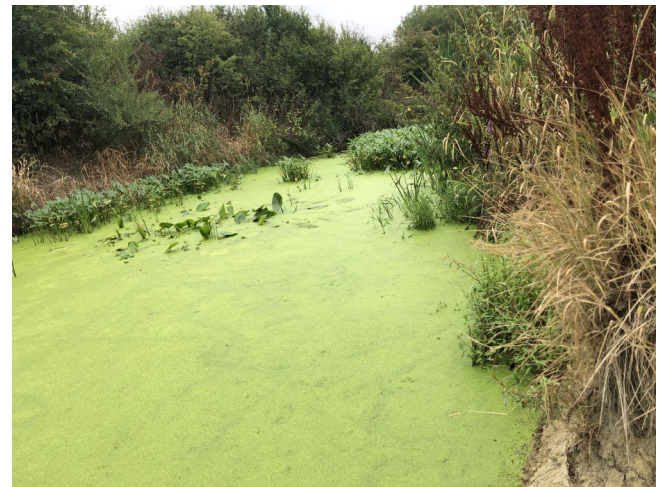
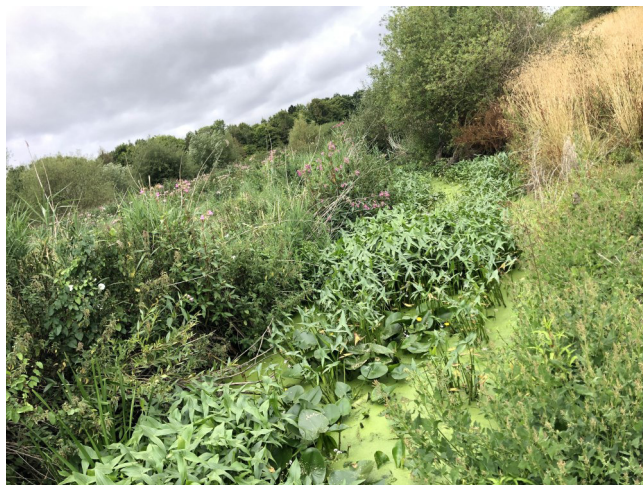
Client	RPS Consulting Services Ltd	Drawing Ref	RPS001-022-001/003/1

Photograph 1:
Module 1

Photograph 2:
Module 2

Photograph 3:
Module 3

Photograph 4:
Module 4

Photograph 5:
Module 5
