Cherry Cobb Sands
Compensation Land
Saltmarsh Survey Report

Cherry Cobb Sands Compensation Land

Saltmarsh Survey Report

January 2011

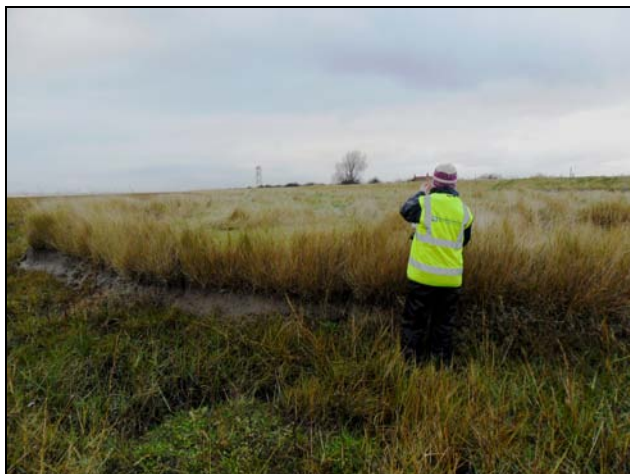
3.2.2 From Stone Creek (TA 235 188) to just south of the Outstray (TA 214 211), the upper saltmarsh forms a band approximately 5 to 10 metres wide which extends from the bottom of the seaward side of the flood embankment, to the edge of the mid saltmarsh. The width of the upper saltmarsh zone is greater (up to 50 metres) where freshwater drains into the saltmarsh, at TA 219 205 and TA 222 201. In the northern part of the frontage, from TA 214 211 to TA 212 217, this zone is markedly wider and at its widest extent, where the flood embankment is set further back compared to the south, the upper saltmarsh zone is approximately 330m wide. A distinct boundary was observed between the upper and mid saltmarsh and in some places a ledge had developed between the zones (Appendix B, Photo 1).

Photo 1. Ledge that has formed between upper and mid saltmarsh zones in some places.

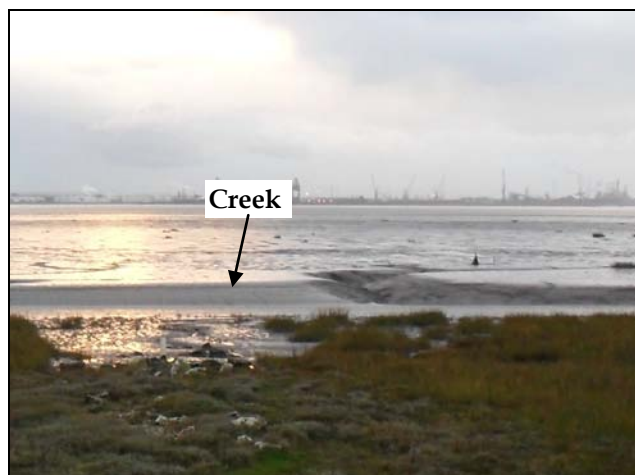
3.2.4 A major drainage creek, approximately 2m deep and 3m wide, runs parallel to the existing flood defence, forming a boundary between the lower and mid saltmarsh zones, creating a clear distinction between these zones (Appendix B, Photo 2). It was not possible to cross this creek and therefore the extent of the lower saltmarsh was not recorded using GPS. From observations made from the edge of the mid saltmarsh zone, and from aerial photographs (Google Inc., 2010), it appears that the lower saltmarsh zone is quite extensive and stretches up to the edge of the main channel of the Humber estuary, between 600 and 800m from the boundary of the mid saltmarsh zone, being wider in the southern part of the frontage where the mid and upper saltmarsh zones are narrower.

Photo 2. Major drainage creek running north-west to south-east between mid and lower saltmarsh.

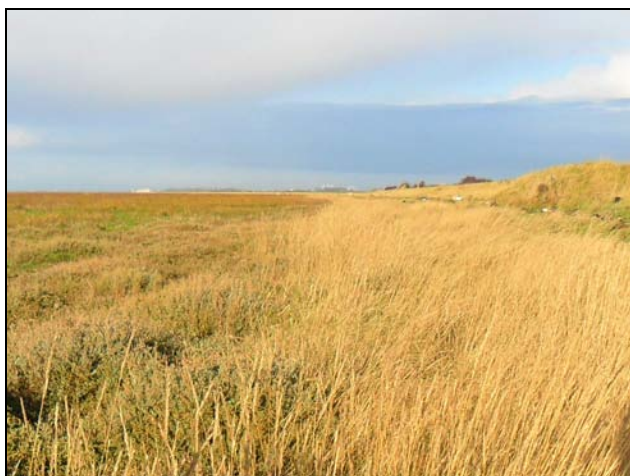
- 3.3.1 Throughout the study area, Sea couch grass *Elytrigia atherica* (*Elymus pycnanthus*) saltmarsh community is dominant in the upper saltmarsh. Other species of note in this zone include Sea plantain *Plantago maritima*, Red fescue *Festuca rubra* and *Orache atriplex* sp. (Appendix B, Photo 3). The quality of the upper saltmarsh is good, with high plant coverage and very few bare patches. Whilst the vegetation is of good quality, there is a large amount of rubbish and flotsam, comprising both natural and anthropogenic debris along the whole of the frontage, which may have contributed to the 'unfavourable recovering' status of SSSI units 77 and 78 (Natural England, 2010) (Appendix B, Photo 4).

Photo 3. Upper saltmarsh.

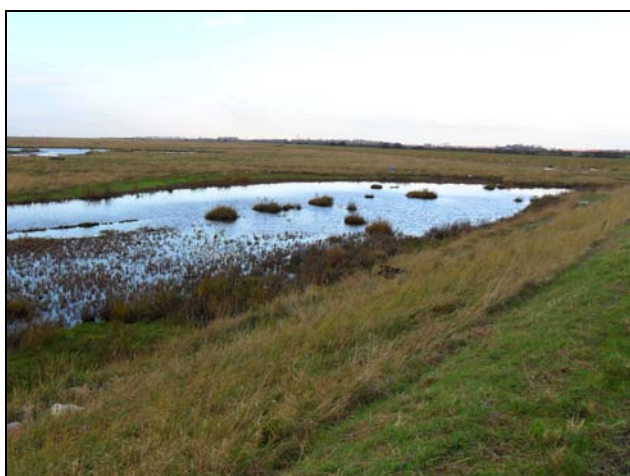
- 3.3.2 The upper saltmarsh has a network of saltmarsh creeks running through it as well as areas of standing water (Appendix B, Photo 5). The saltmarsh creeks feed into either the major drainage creek running between the mid and lower saltmarsh to the south, or directly into the Humber via the lower saltmarsh zone. Saltmarsh creeks vary in size, with some being as deep as 2-3 metres and other around 0.5 metres (Appendix B, Photo 6).

Photo 5. Standing water in upper saltmarsh in the north of the Cherry Cobb Sands frontage.

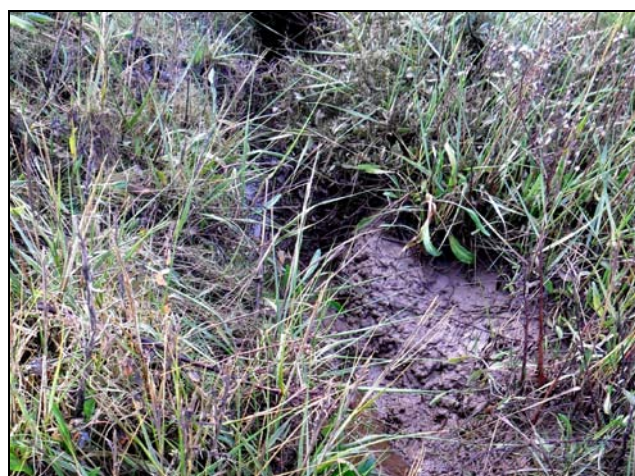
Photo 6. Saltmarsh creek.

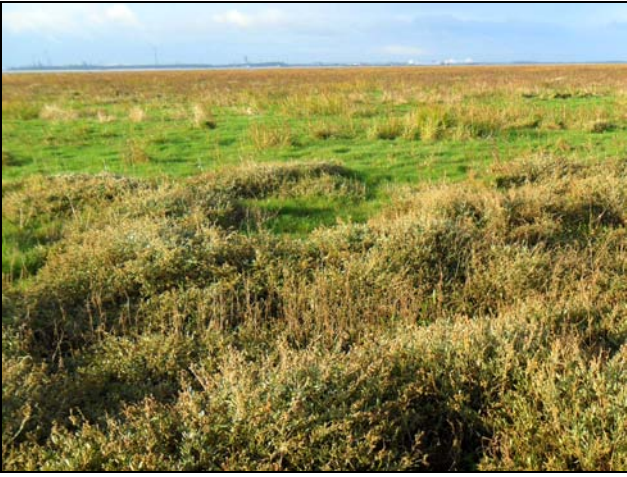
- 3.3.3 The majority of the mid saltmarsh is also dominated by Sea couch grass, although some small patches of mid saltmarsh are colonised instead by Sea purslane *Atriplex portulacoides* (Appendix B, Photo 7). Other species identified in this zone include Sea aster *Aster tripolium*, Common scurvy grass *Cochlearia officinalis* and English scurvy grass *Cochlearia anglica*. The quality of the mid saltmarsh is generally good, with the exception of a small number of locations where bare patches were noted (Appendix A, Figure 1 and Appendix B, Photo 8). These patches may be due to a die-off of annual species, which would be expected at this time of year, or it may be where mud has been washed up onto the saltmarsh causing smothering (see target note 5 in Appendix A, Figure 1). There are also a number of places where freshwater drains from the landward side of the embankment out into the estuary. In some places these drains have cut creeks in the saltmarsh (see target notes 6 in Appendix A, Figure 1; Appendix B, Photo 9).

Photo 7. Sea purslane (foreground).

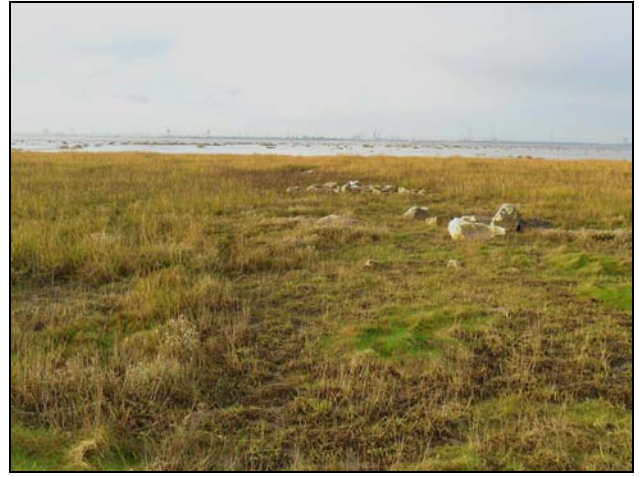
Photo 8. Area of die-back within mid saltmarsh.

- 5.1.3 It is likely that the saltmarsh along the frontage would regenerate relatively quickly following any disturbance, given that there are no signs of erosion and that die-off appears to be constrained to the annual species which is expected at this time of year.

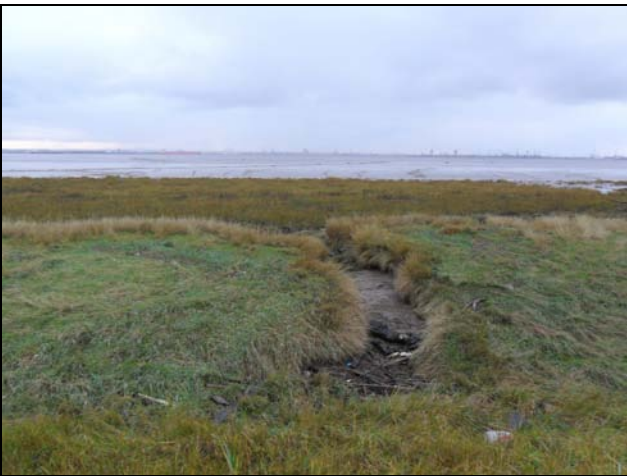
Photo 9. A creek that has been cut into the saltmarsh where freshwater drains out from behind the embankment.

- 5.1.2 The extent of saltmarsh is greatest in the north of the Cherry Cobb Sands frontage and if possible cutting of a channel across this part of the saltmarsh should be avoided, given that this would lead to disturbance and loss of a significant area of saltmarsh. From south of the Outstray to Stone Creek the saltmarsh band is narrower than in the north and is relatively uniform in width and therefore breaches could be located at any point along this length. Use of existing saltmarsh creeks or freshwater drains to drain the compensation land should be considered.

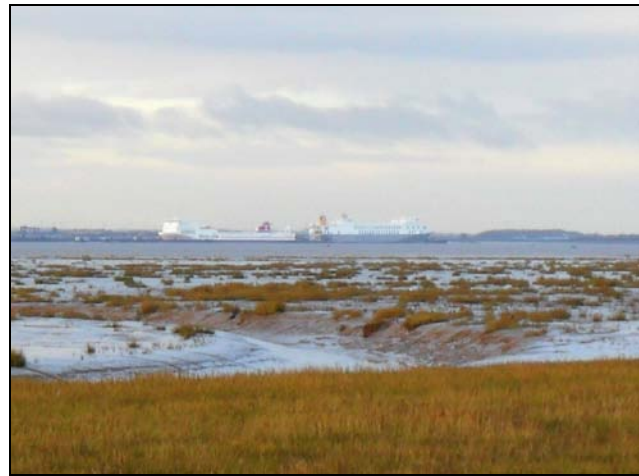
- 3.3.4 The major drainage creek that runs parallel along the edge of the mid saltmarsh creates a distinctive divide between the mid and lower zones of saltmarsh. It was not possible to cross this creek and therefore the lower saltmarsh was only observed from the edge of the mid saltmarsh. The lower saltmarsh zone is defined by 'clumps' of saltmarsh vegetation interspersed by bare mud, with plant coverage far

less than the mid and upper saltmarsh zones (Appendix B, Photo 10). The plant species likely to be present in this area are 'pioneer' species including annual glasswort *Salicornia europea* agg. and common cord grass *Spartina anglica* (Natural England, 2010).

Photo 10. Lower saltmarsh characterised by patches of vegetation interspersed by bare mud.

- 4.1.3 Although the extent of the lower saltmarsh was not mapped precisely, it is thought likely that this zone is gradually accreting as substantially more vegetation was observed on site compared to aerial photographs from 2007, although without a time-series of aerial photographs it is difficult to have certainty in this conclusion.
