Phase 1 Habitat Survey
**Intertidal Habitat, Tilbury2 Port
Terminal, Tilbury**

Port of Tilbury London Limited

Project No.: AUNI123/002/001/003

October 2017

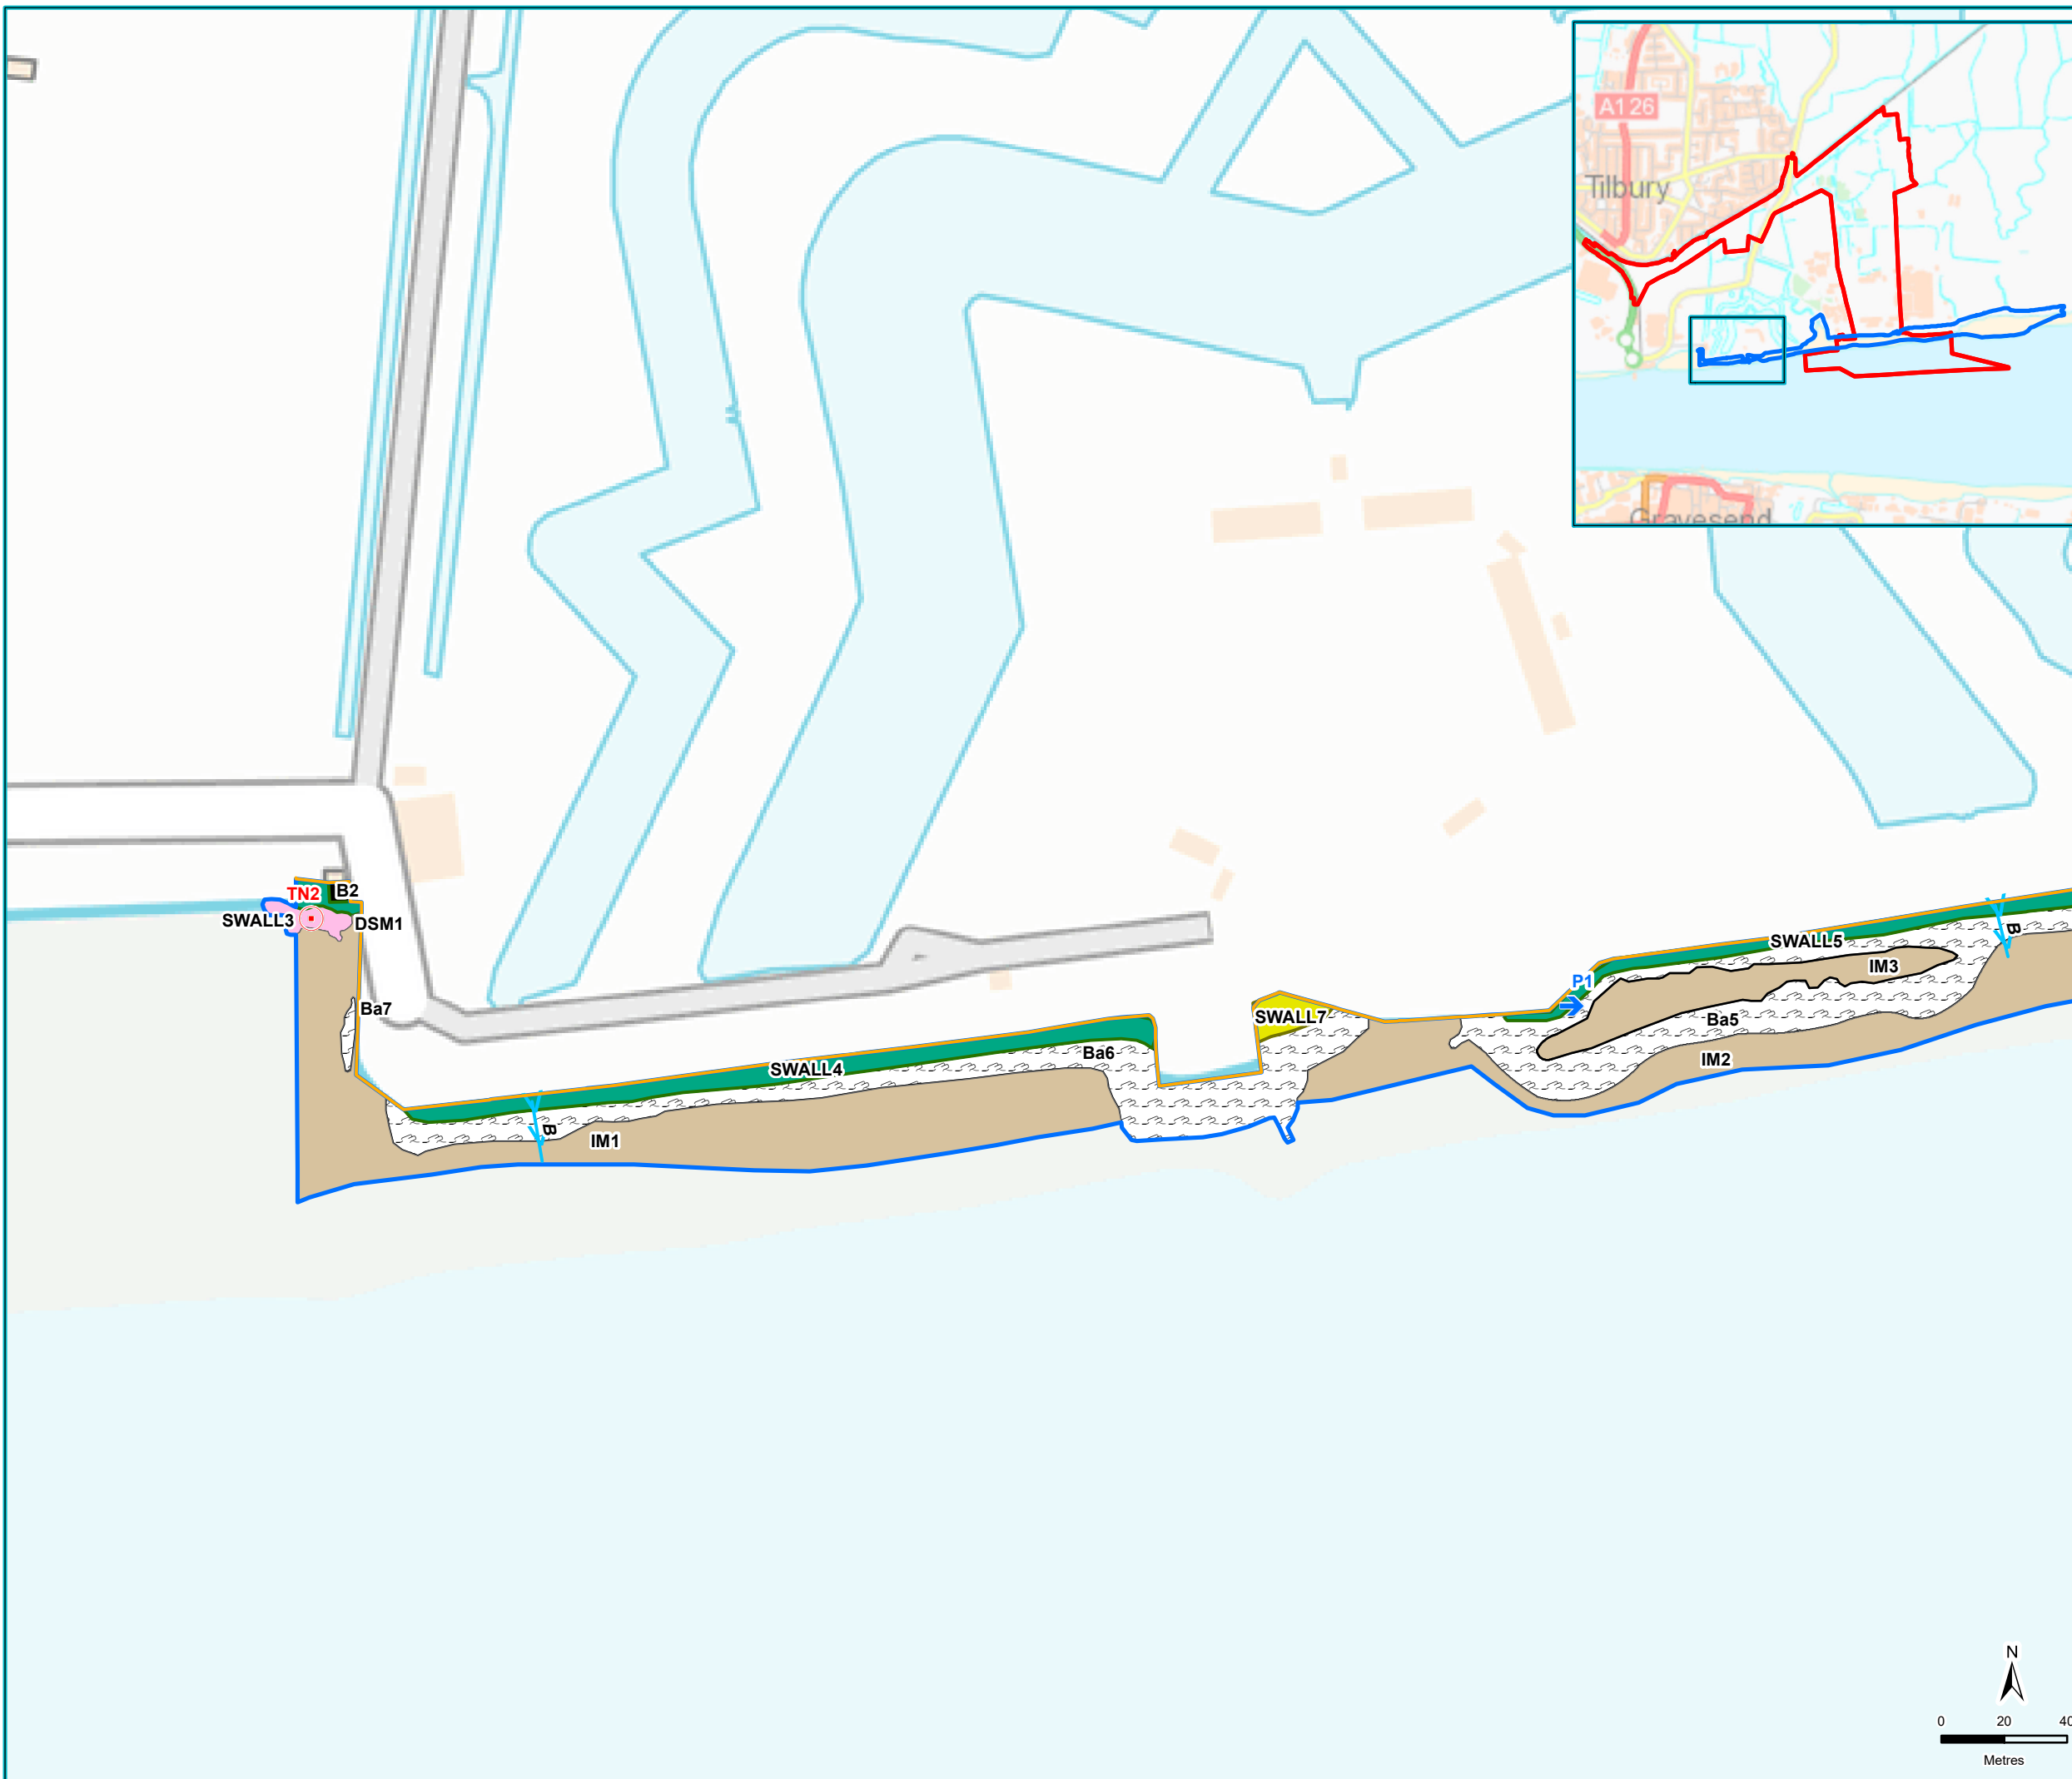
Figure Number
2a

Figure Title
**Extended Phase 1
Habitat Survey Results**

4.2.2 These habitats are described below and their distribution is given on Figures 2a to 2d. Their distribution is shaped by the presence along most of the survey area of a coastal defence system

built on the north bank of the river Thames. This system comprises a continuous vertical concrete wall inland and a discontinuous rock armour of varying width and slope at the toe of the vertical wall.

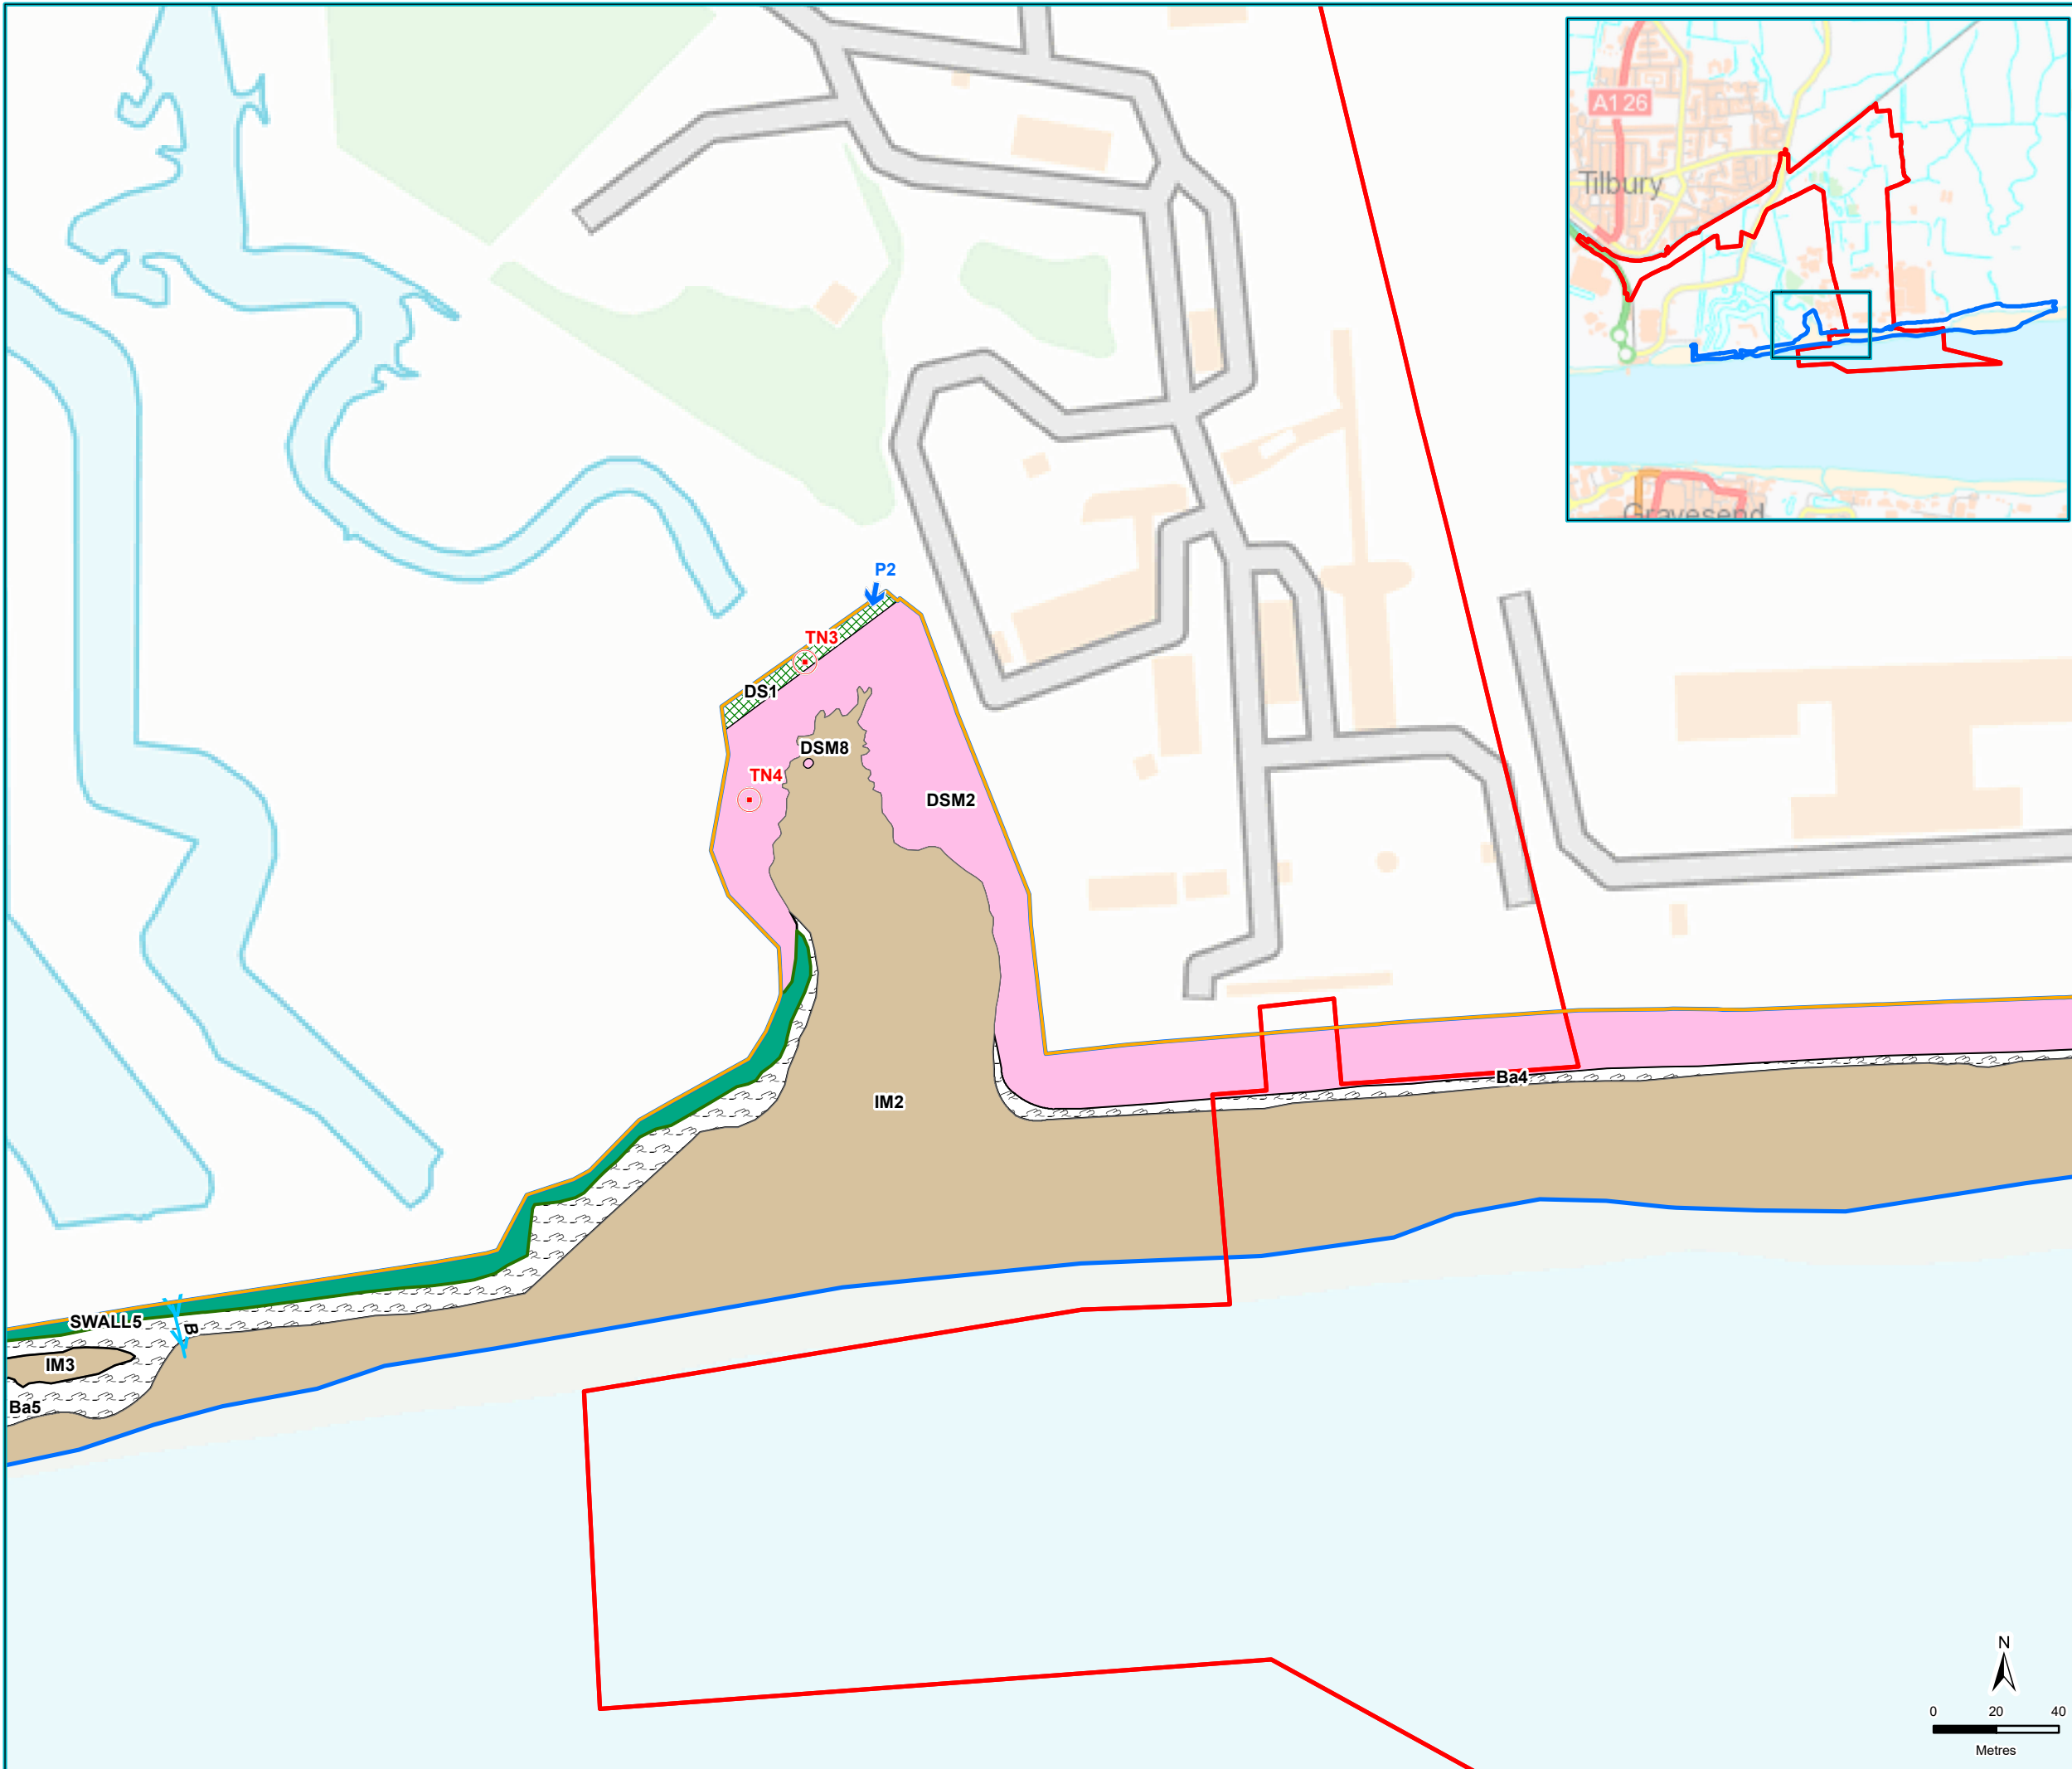
Figure Number
2b

Figure Title
**Extended Phase 1
Habitat Survey Results**

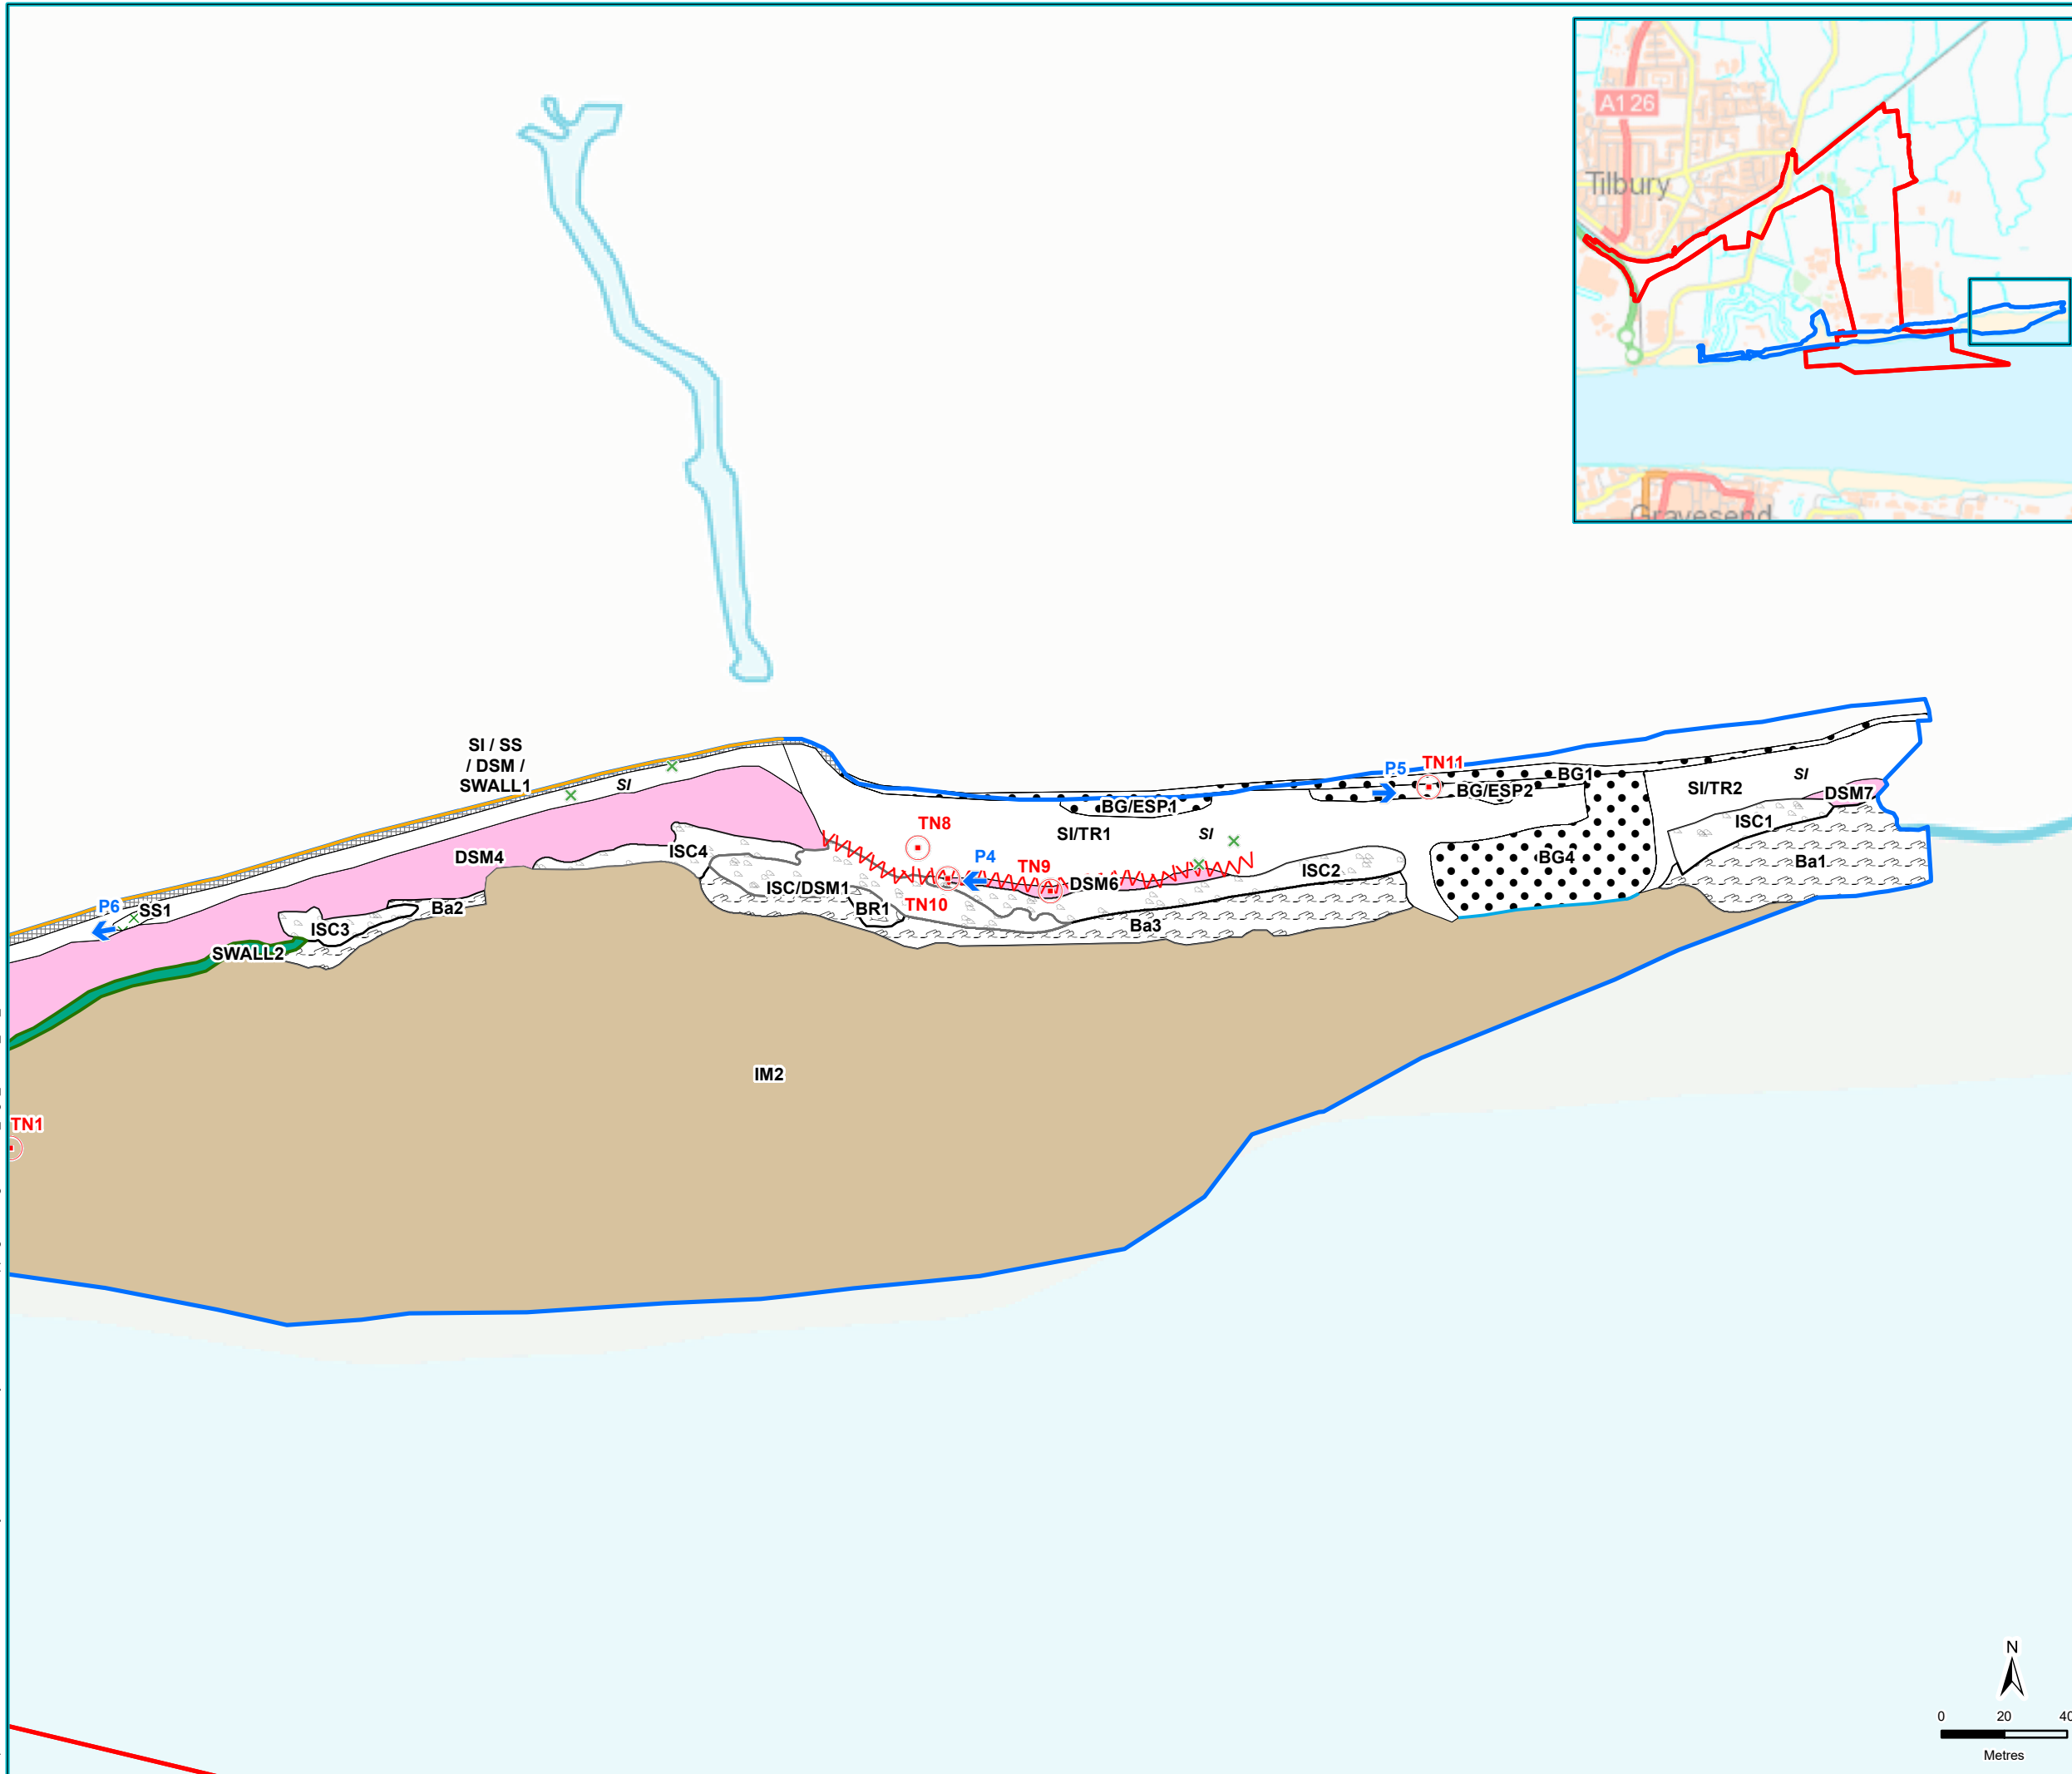
Figure Number
2d

Figure Title
**Extended Phase 1
Habitat Survey Results**

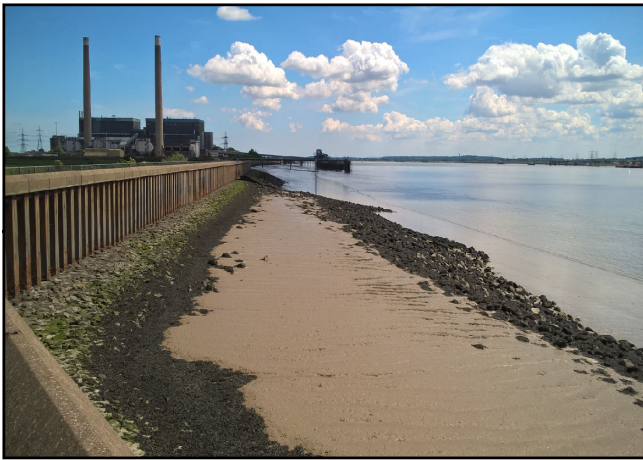
Photograph 1:
From left to right: sea wall (wall and rock armour), brown algal beds on intertidal boulders/rocks, and intertidal mudflats.

- 4.2.12** This habitat (Ba1 to Ba8 on Figure 2, Photographs 1 and 3 on Figure 3), which covers a combined area of 1.9ha, corresponds to the lowest lying part of the rock armour that was built at the toe of the sea wall or in front of saltmarshes. The width of this rock armour that is within the intertidal range has been colonised by brown algae, mainly bladder wrack (*Fucus vesiculosus*). This width is very variable along the survey area, ranging from 0 to 45m.

- 4.2.21** A flood defence structure is present continuously along most of the northern boundary of the survey area, over a distance of 2.3km from the World's End Pub to the east of the ash field. It is made of several components (Photographs 1 and 3 on):

- A vertical wall, 2-3m in height;
 - A rock armour with a shallow slope at the toe of the vertical wall, in which gaps between boulders have been filled with asphalt or concrete;

- A rock armour with free boulders or rocks further into the sea, directly in front of the other sea defences south of Tilbury Fort or defending saltmarshes south of the power station and the ash field.

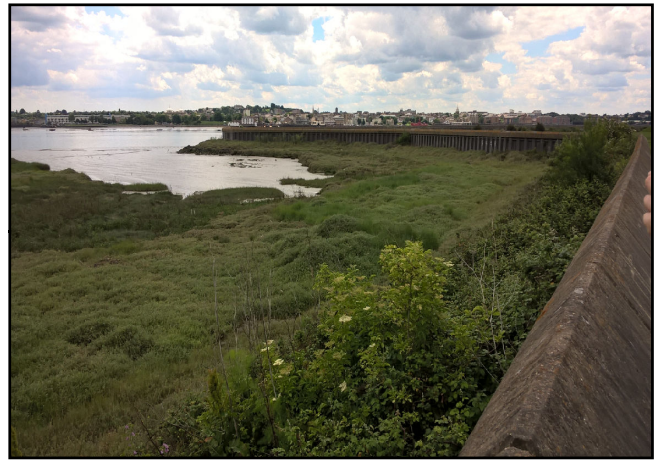
Photograph 2:
From right to left: Sea wall, dense scrub, dense/continuous saltmarsh, and intertidal mudflats.

4.2.5 A small area of dense scrub (DS1 on , Photograph 2 on Figure 3) occurs at the bottom of the sea wall immediately west of the sewage works. It covers 388m². Bramble (*Rubus fruticosus* agg.) dominates the shrub layer, with frequent hawthorn (*Crataegus monogyna*), blackthorn (*Prunus spinosa*) and dog-rose (*Rosa canina* agg.) and rare elder (*Sambucus nigra*).

- 4.2.15** Further east, DSM2 and DSM3 covers 1.2ha between the creek west of the sewage works and the main pontoon of the power station (Photographs 2 and 3 on). Sea-purslane is dominant, sea couch abundant, sea aster, sea plantain and sea arrowgrass frequent, saltmarsh rush (*Juncus gerardii*), common saltmarsh-grass (*Puccinellia maritima*), cord-grass and greater sea-spurrey occasional, and English scurvygrass, sea-milkwort (*Glaux maritima*), dittander (*Lepidium latifolium*) and common sea-lavender (*Limonium vulgare*) are rare. DSM8 is a small patch of cord-grass that has started to colonise the mudflat.

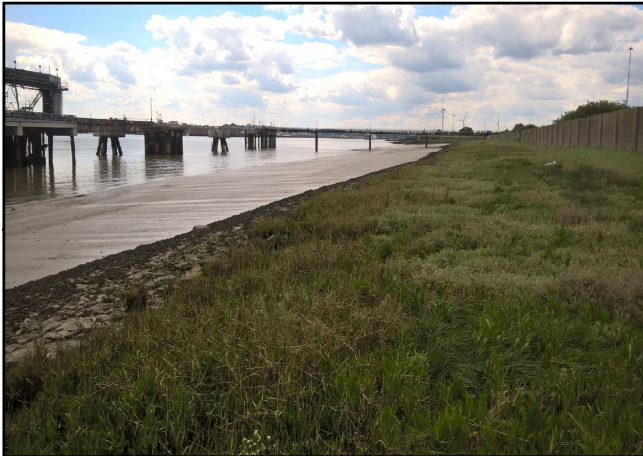
Photograph 3:
From right to left: Sea wall, dense/continuous saltmarsh (with sea couch facies, sea-purslane and sea plantain facies, and common cord-grass facies), sea wall (rock armour), brown algal beds on intertidal boulders/rocks, and intertidal mudflats.

4.2.9 Intertidal mud forms a continuous habitat all along the survey area in the lower part of the intertidal range (IM1 and IM2 on Figure 2, Photograph 3 on Figure 3). No vegetation was present. In the absence of detailed bathymetric data that could be used to delineate the Mean Low Water Springs isobath, the seaward boundary of intertidal mudflats was estimated using aerial photography. Smaller secondary mudflats have formed at a slightly higher level in flat areas within the rock armour at the toe of the sea wall (IM3 to IM7 on Figure 2, Photograph 1 on Figure 3). The total area covered by intertidal mudflats within the survey area was estimated to be around 10.8ha.

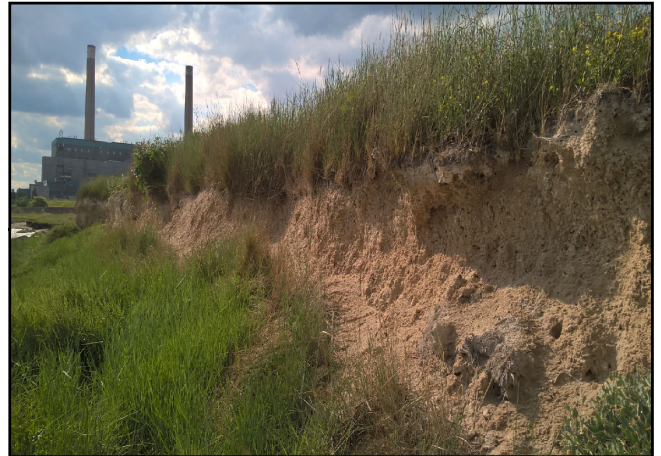
Photograph 4:
Soft maritime cliff with mosaic of poor semi-improved grassland and tall ruderal at the top of the cliff and dense/continuous saltmarsh (sea couch and sea beet facies) at the bottom.

- 4.2.17** At the foot of the soft cliff in the eastern part of the site, there is a narrow strip of species-poor vegetation (DSM6 on Figure 2, Photograph 4 on Figure 3) related to saltmarsh communities, and dominated by sea beet (*Beta vulgaris* subsp. *maritima*) and sea couch.
- 4.2.18** Finally, DSM7 is a small patch of relic saltmarsh vegetation within disturbed ground in the eastern end of the site.

- 4.2.20** The eastern part of the survey area is being actively eroded by the sea, and a small vertical soft cliff, about 1.0 to 1.5 metre high, has formed in clayey and chalky deposits over a length of approximately 145m (Photograph 4 on). It forms a boundary between intertidal shingles (IS2) and eroding saltmarsh with intertidal shingles (IS/DSM1) and the vegetation growing on the upper terrace out of reach of sea water. Material falling from the cliff has been colonised by a strip of saltmarsh vegetation (DSM6, see above).

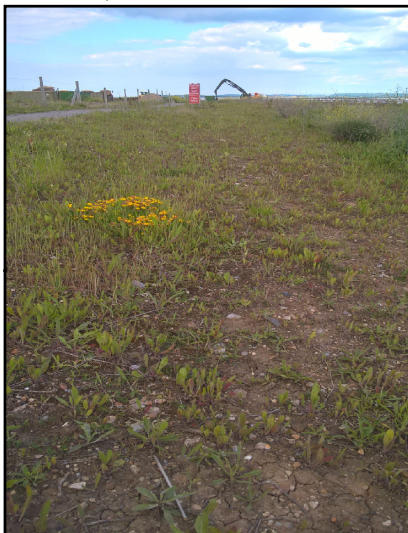
Photograph 5:
Mosaic of bare ground and ephemeral/short perennial vegetation.

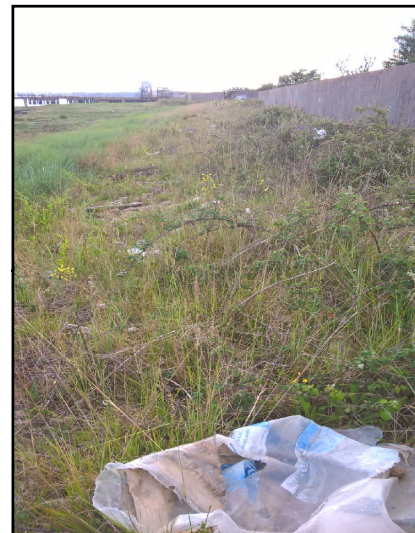
Photograph 6:
Mosaic of scattered scrub, poor semi-improved grassland, saltmarsh and sea wall (rock armour).
