PROPOSED PORT TERMINAL AT FORMER TILBURY POWER STATION

TILBURY2

ES APPENDIX 15.E: DETAILED UXO RISK ASSESSMENT

Project Name	Port of Tilbury		
Client	Port of Tilbury London Limited		
Site Address	Tilbury, Essex		
Report Reference	DA3222-01	Revision	00
Date	4 th May 2016		
Originator	SM

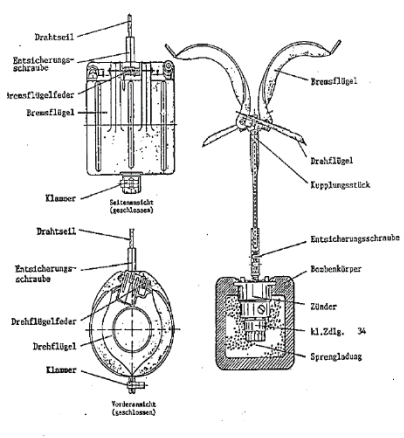
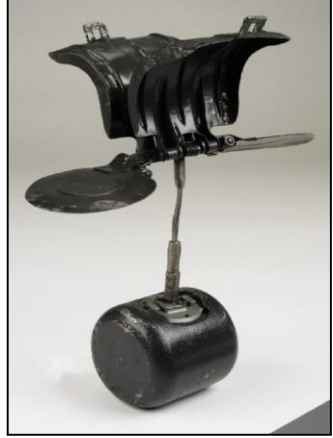
SD2 Butterfly Bomb	
Bomb Weight	2kg (4.41lb)
Explosive Weight	7.5oz (225 grams) of TNT surrounded by a layer of bituminous composition.
Fuze Type	41 fuze (time) , 67 fuze (clockwork time delay) or 70 fuze (anti-handling device)
Bomb Dimensions	Length 240 mm Width 140 mm Height 310 mm
Body Diameter	3in (7.62 cm) diameter, 3.1in (7.874) long
Use	It was designed as an anti-personnel/fragmentation weapon. They were delivered by air, being dropped in containers that opened at a predetermined height, thus scattering the bombs.
Remarks	The smallest and most common conventional German bomb. Nearly 70% of bombs dropped on the UK were 50kg.

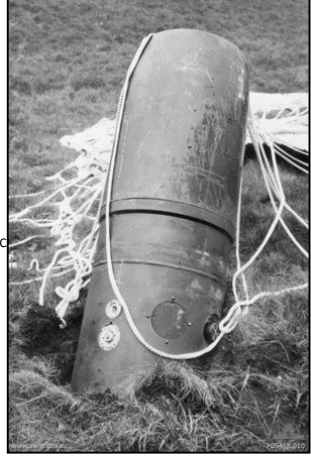
Parachute Mine (Luftmine B / LMB)	
Bomb Weight	987.017kg (2176lb)
Explosive Weight	125-130kg (276-287lb)
Fuze Type	Impact/ Time delay / hydrostatic pressure fuze
Bomb Dimensions	1640 x 512mm (64.57 x 20.16in)
Body Diameter	368mm (14.5in)
Use	Against civilian, military and industrial targets. Designed to detonate above ground level to maximise damage to a wider area.
Remarks	Parachute Mines were normally carried by HE 115 (Naval operations), HE 111 and JU 88 aircraft types. Deployed a parachute when dropped in order to control its descent.

Description	The Luftmines (LMA-500kg and LMB-1000kg) were magnetic sea mines which were thin walled, cylindrical in shape with a hemispherical nose and were deployed under a green artificial silk parachute about 8m in diameter. They were fitted with magnetic and later with acoustic or magnetic/acoustic firing. When the mine hit the water and sank to more than 8ft, hydrostatic pressure and the dissolution of a soluble plug actuated the magnetic device and the mine became operational against shipping. The mine was also armed with a clockwork bomb fuze which caused the bomb to explode when used against land targets, and this was started by the impact of hitting the ground. The Bombenmine (BM 1000, Monika, or G Mine) was also used. This was fitted with a tail made from Bakelite which broke up on impact. It had a photoelectric cell beneath a cover which detonated the bomb if exposed to light to counteract the work of bomb disposal units.

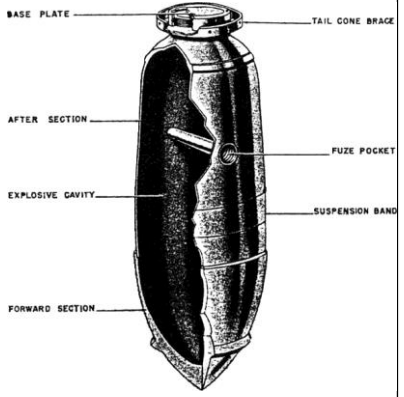
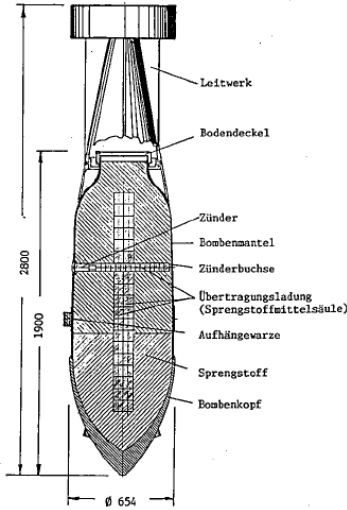
SC 1000kg	
Bomb Weight	996-1061kg (1,058-1,146lb)
Explosive Weight	530-620kg (551-573lb)
Fuze Type	Electrical impact/mechanical time delay fuze.
Filling	Mixture of 40% amatol and 60% TNT, but when used as an anti-shipping bomb it was filled with Trialen 105, a mixture of 15% RDX, 70% TNT and 15% aluminium powder.
Bomb Dimensions	2800 x 654mm (77 x 25.2in)
Body Diameter	654mm (18.5in)
Use	SC type bombs are General Purpose Bombs used primarily for general demolition work. Constructed of parallel walls with comparatively heavy noses. They are usually of three piece welded construction

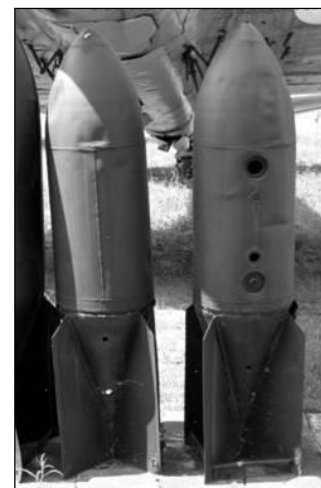
Flam C-250 Oil Bomb

Bomb Weight	125kg (276lb)
Explosive Weight	1kg (2.2lb)
Fuze Type	Super-fast electrical impact fuze
Filling	Mixture of 30% petrol and 70% crude oil
Bomb Dimensions	1,650 x 512.2mm (65 x 20.2in)
Body Diameter	368mm (14.5in)
Use	Often used for surprise attacks on living targets, against troop barracks and industrial installations. Thin casing – not designed for ground penetration

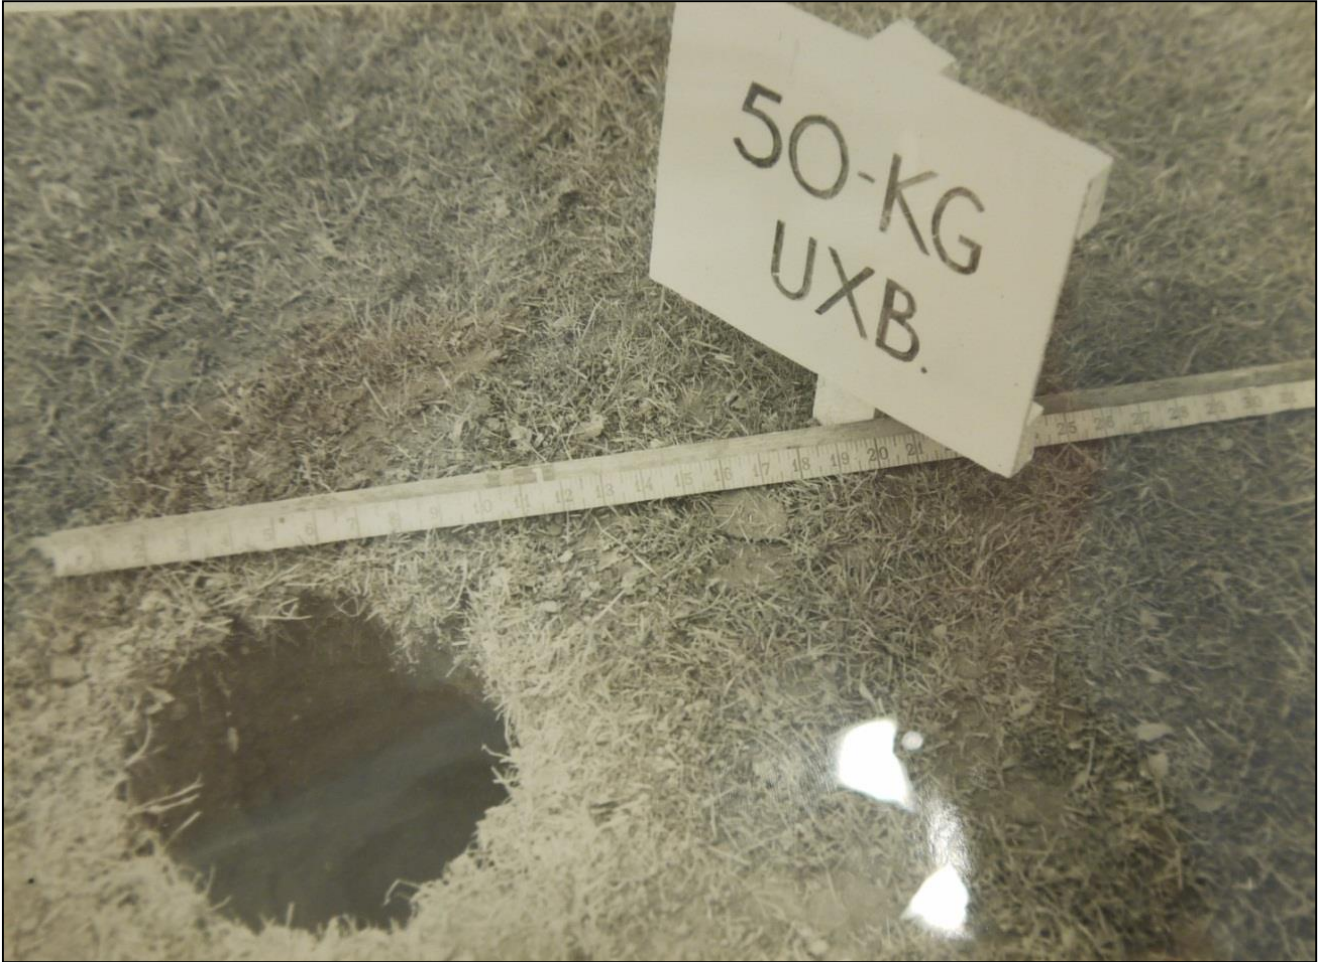
German 50kg HE Bomb Entry Hole

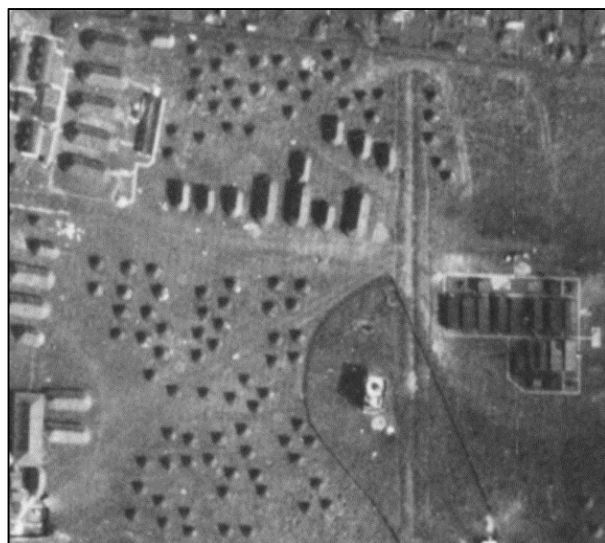
Tented army camp. Approximately 35m from site boundary to the north on other side of railway line (boundary shown above)

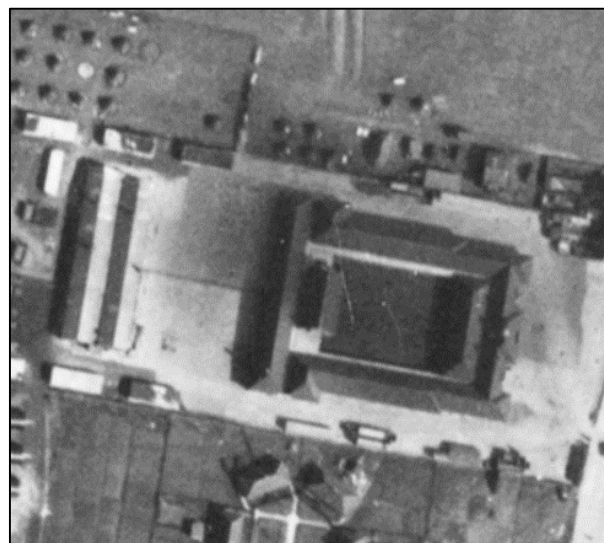
Tented army camps and additional facilities. Approximately 800m from the site to the north.

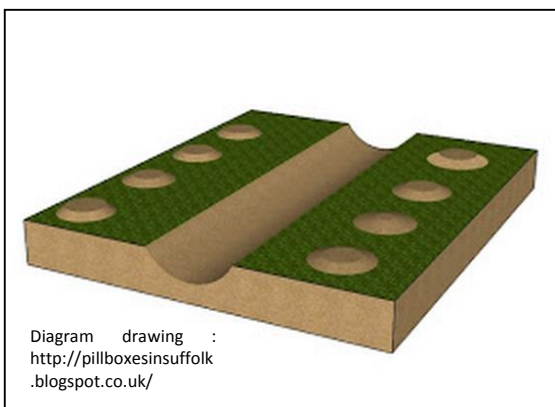
Layout 1: spoil piles would be formed into mounds at a slight distance away from the trench line.

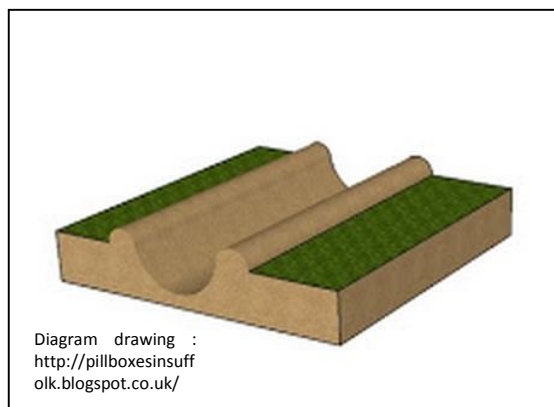
Layout 2: spoil piles would be formed into a 'lip' by the trench line.

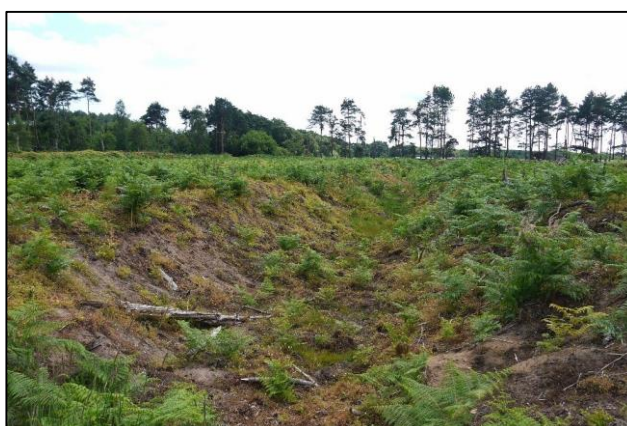
Image of anti-glider ditch on the ground

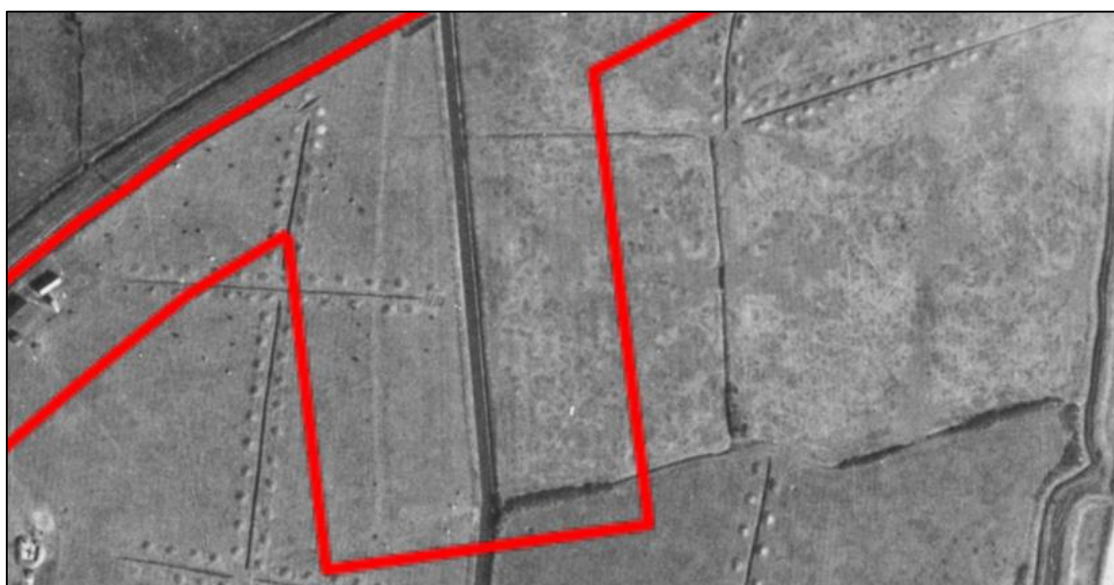
Anti-glider obstacles in central section of site

- Large sections of this area were dug with anti-glider defences, and access and checks are likely to have been minimal, possibly for the most part non-existent. The soft, scrubby nature of the groundcover would also not have been conducive to the observation of UXO entry holes even if the area had been subject to checks. The entry hole of a 50kg UXB could be as little as 20cm in diameter (and even smaller for anti-aircraft artillery projectiles) and could even close up in marshy conditions. For these reasons, no one section of the marsh can be considered a 'low' risk from having been contaminated with unexploded ordnance. It should be noted that of significant concern is the open stretch of water at the southern end of the site. Had bombs fallen within this area, there is effectively negligible chance of them being either observed or recovered.

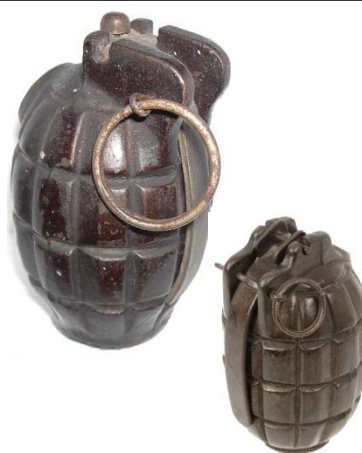
No. 69 Grenade

Weight	383g (0.81lb)
Explosive Weight	93g (3.25 oz) of either Amatol, Baratol or Lyddite
Fuze Type	'All-ways' Fuze. Compromised of a safety cap, a weighted streamer attached to a steel ball bearing and a safety bolt designed to detonate from any point of impact.
Dimensions	114 x 60mm (4.5 x 2.4 in)
Use	A blast grenade for use as an offensive weapon.
Remarks	Introduced December 1940 and made from the plastic Bakelite as opposed to conventional metals. Detection is difficult due to this low metal content.

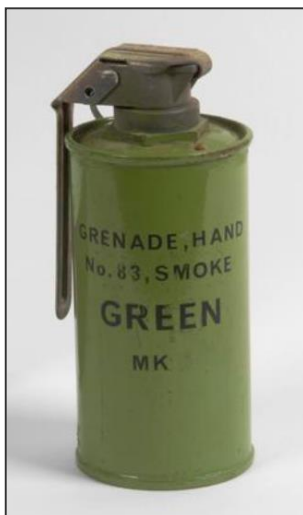
No. 83 Smoke Grenade

Weight	Approx. 680g (1.5lb)
Explosive Weight	Approx. 170-200g. (6-7 oz)
Fuze Type	Originally used a friction system using a match head composition. Later developed to a striker lever ignition system.
Dimensions	Approx. 65 x 115mm (2.5 x 4.4 in)
Use	Use as a target or landing zone marking device and as a screening method for troop / unit movement.
Remarks	This basic design stayed relatively unchanged up to the 1980's. The letters CCC were often etched into the body of the grenade in the colour of the smoke.

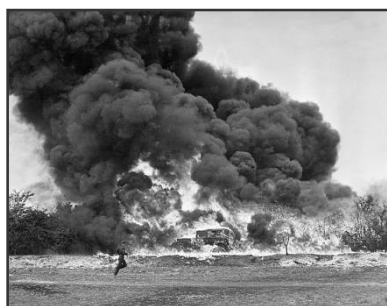
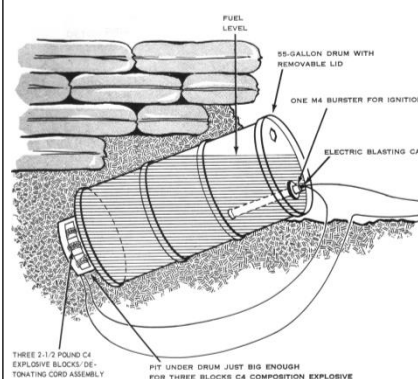
Figure 21. Flame fougasse (55-gallon drum).

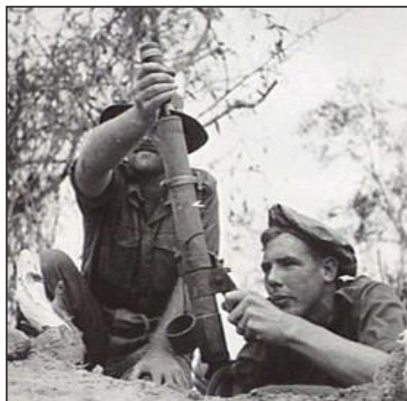
Typical 2 Inch High Explosive Mortar

Weight	1.02kg (2.25lb)
Maximum Range	460m (500yards)
Filling	200g RDX/TNT
Dimensions	51 x 290mm (2in x 11.4 in)
Fuze Type	An impact fuze which detonates the fuze booster charge and in turn the high explosive charge.
Use	A small, portable mortar introduced into the British army in 1938. It had greater range and firepower over hand and rifle grenades, and was used to attack targets behind cover with high explosive rounds.
Remarks	Detonation causes the mortars bomb body to shatter producing optimum fragmentation and blast effect at the target.

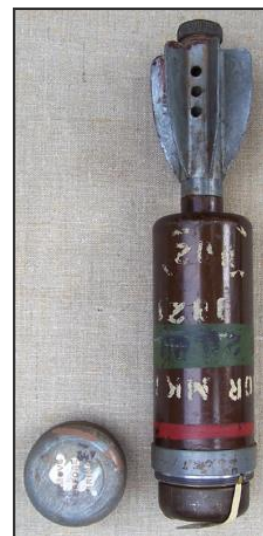
Typical 2/3 inch Smoke Mortar

Weight	4.5kg (9lb 14oz)
Maximum Range	2515m (2,750 yards)
Filling	White phosphorus & smoke fill (also came in Explosive & Illuminating models)
Bomb Dimensions	490 x 76mm (19.3in x 3in)
Fuze Type	An impact fuze which initiates a bursting charge. This ruptures the mortar bomb 's body and disperses the phosphorus filler
Use	As a screening devices for unit movement or to impair enemy field of vision.
Remarks	This mortars long cylindrical body and tail sometimes causes it to be misrecognised as a German incendiary bomb.

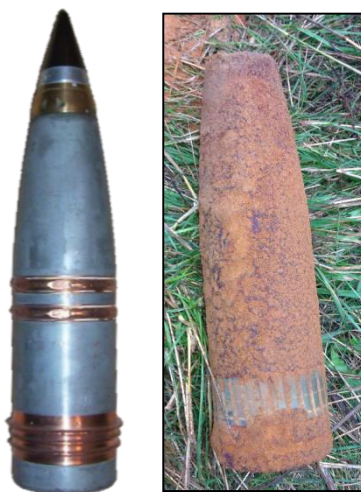
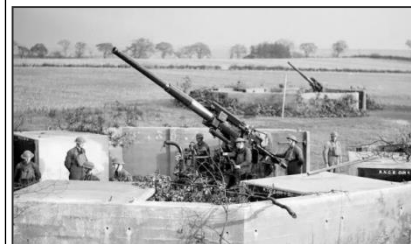
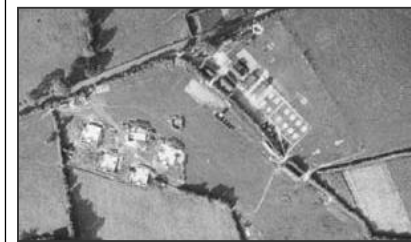
QF 3.7 Inch WWII Anti-Aircraft Projectile

Projectile Weight	28lb (12.6 kg)
Explosive Weight	2.52lbs
Fuze Type	Mechanical Time Fuze
Dimensions	3.7in x 14.7in (94mm x 360mm)
Rate of Fire	10 to 20 rounds per minute
Use	High Explosive Anti-Aircraft projectile. 4.5in projectiles were also used in this role.
Ceiling	30,000ft to 59,000ft

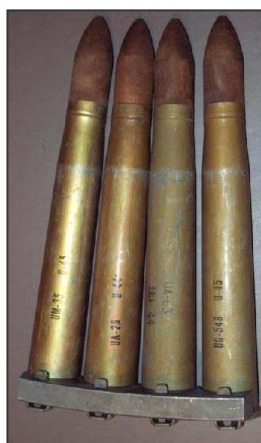
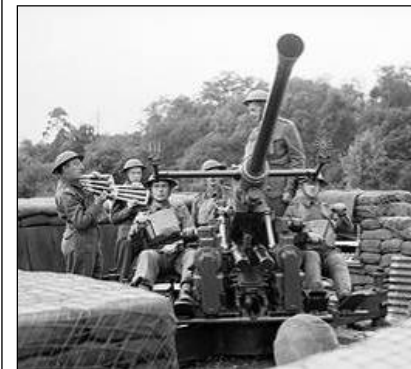
40mm Bofors Projectile

Projectile Weight	1.96lb (0.86kg)
Explosive Weight	300g (0.6lb)
Fuze Type	Proximity and Mechanical Time Fuze
Rate of Fire	120 rounds per minute
Projectile Dimensions	40mm x 310mm (1.6in x 12.2in)
Ceiling	23,000ft (7000m)

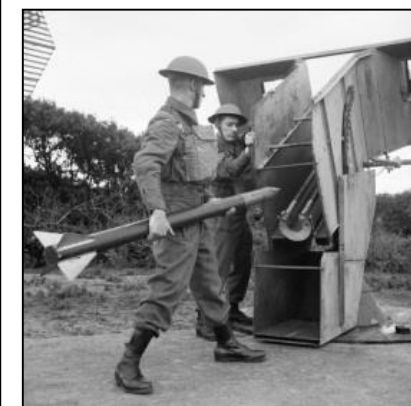
Unrotated Projectile (UP) – Z Battery

Projectile Weight	84lb (24.5kg)
Warhead Weight	4.28lb (1.94kg)
Warhead	Aerial Mine with a No. 700 / 720 fuze
Filling	High Explosive
Dimensions	1930mm x 82.6mm (76 x 3.25in)
Use	As a short range rocket-firing anti-aircraft weapon developed for the Royal Navy. It was used extensively by British ships during the early days of World War II. The UP was also used in ground-based single and 128-round launchers known as Z Batteries.

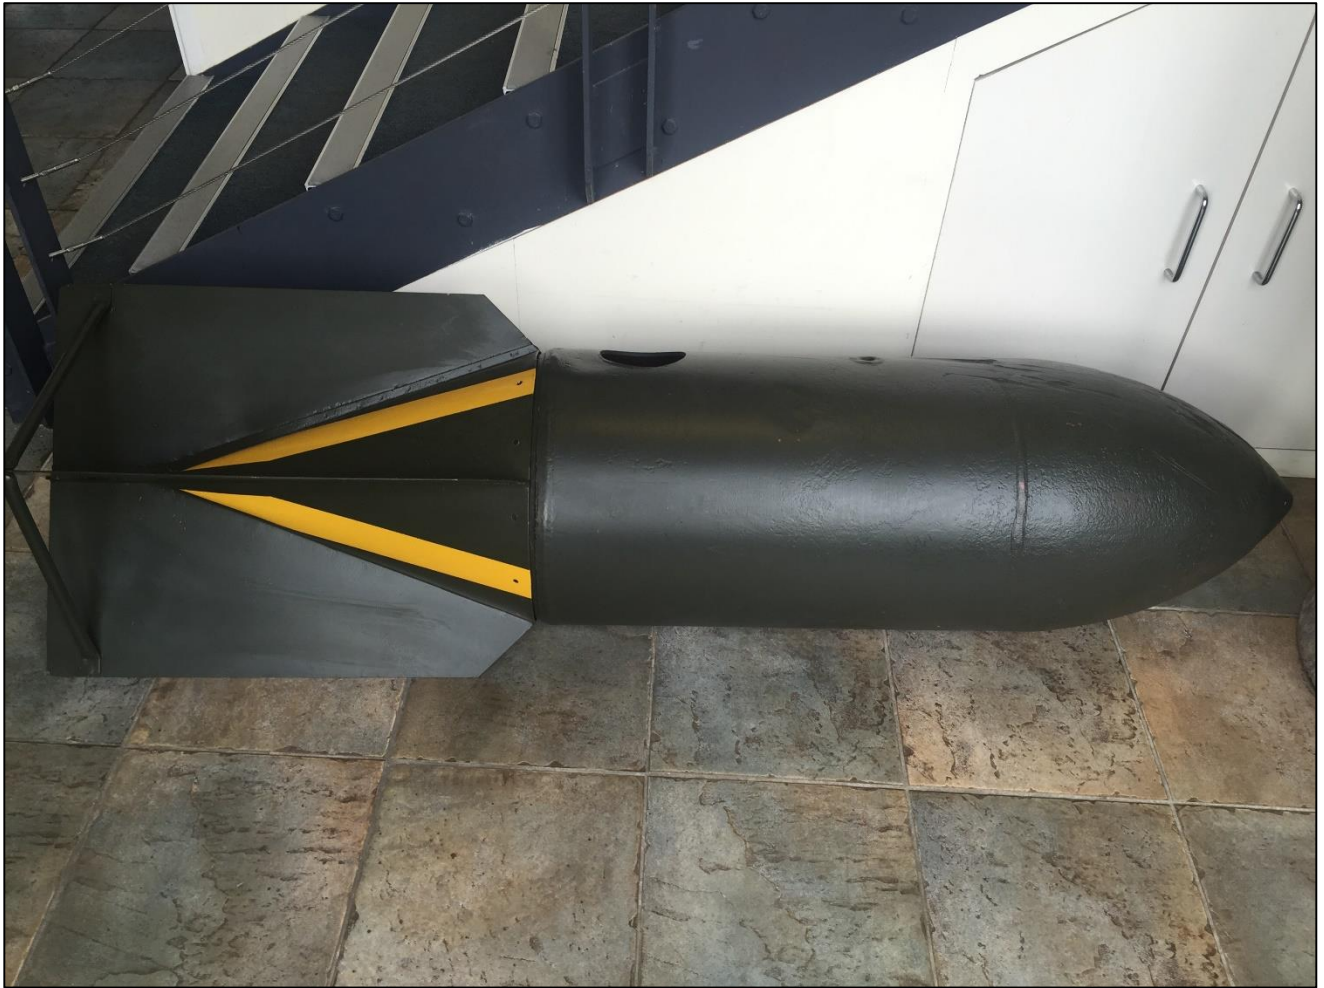
250kg HE bomb found in Tilbury, 1991
