IMMINGHAM EASTERN RO-RO TERMINAL

Environmental Statement: Volume 3 Appendix 12.1: Phase 1 Desk Study -

Part 4

Document Reference: 8.4.12 (a)

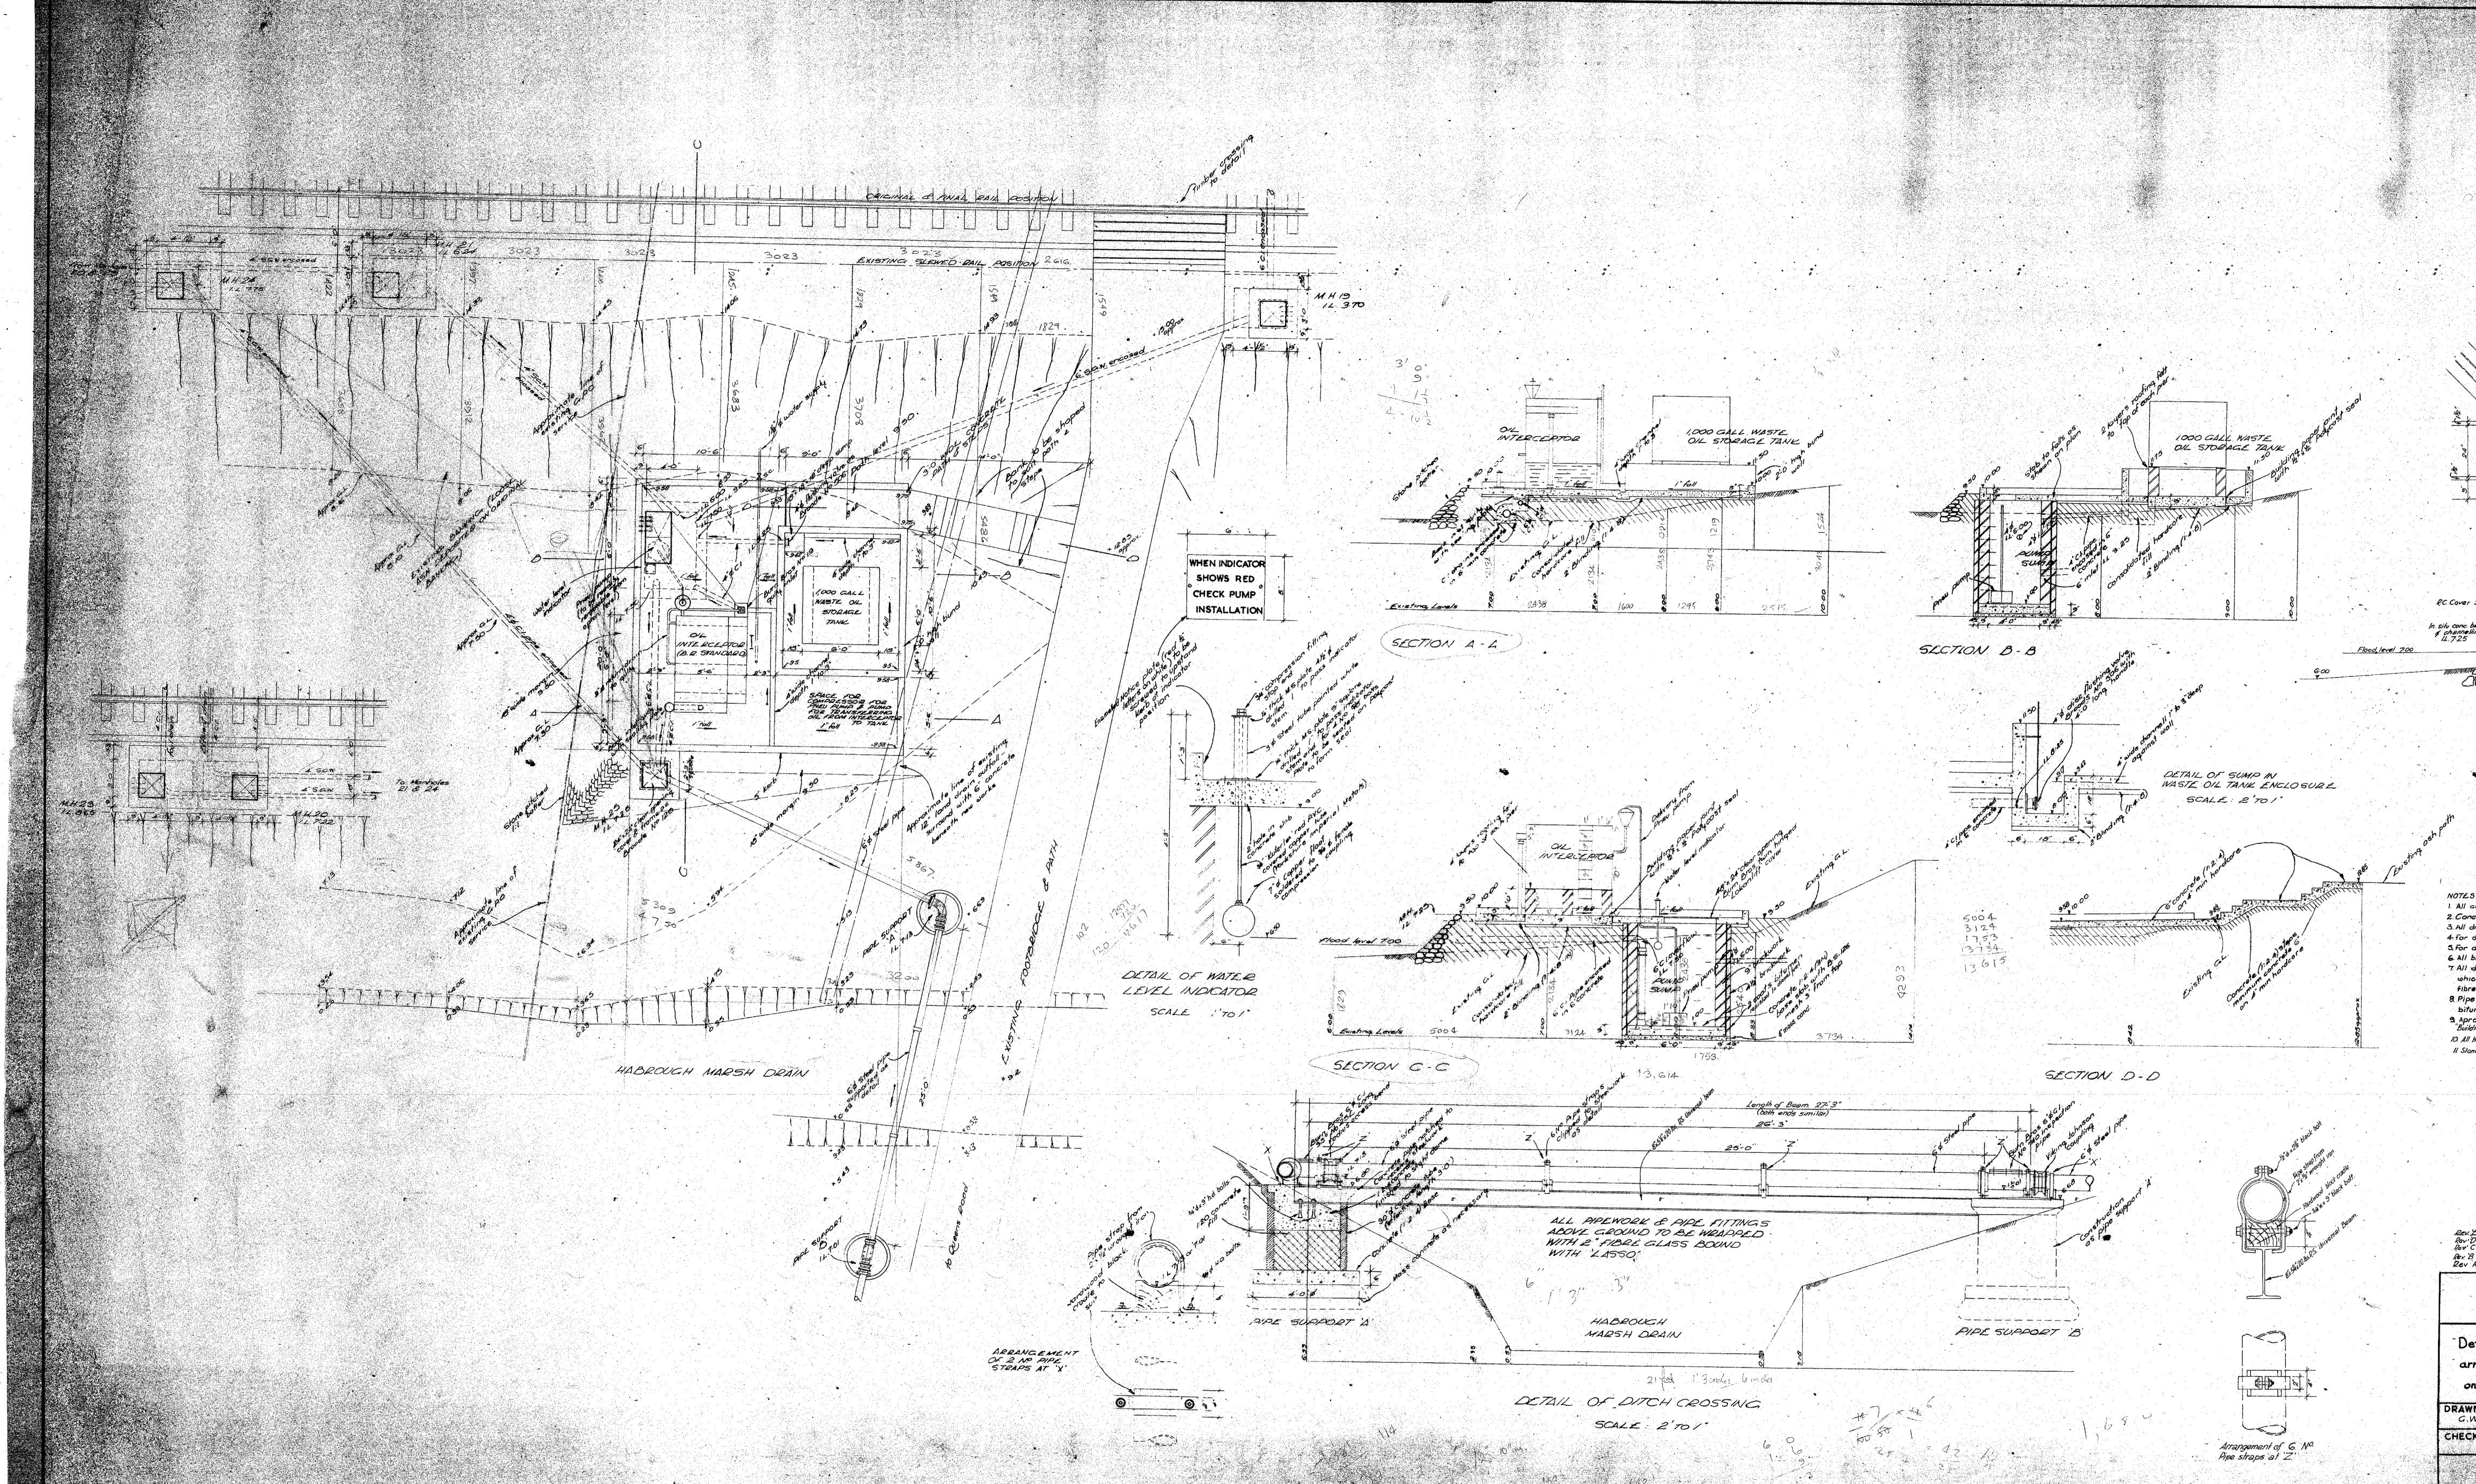
Detail of Outfall Drain and General arrangments of waste oil installation on outfall drain.

1 All concrete to be 1:2:4 (3v) mix unless noted. 2. Concrete blinding to be 1:4:8 (I.N.) mix.
3. All drains cased in 6" thick concrete 1:24:6 (2.N.) mix

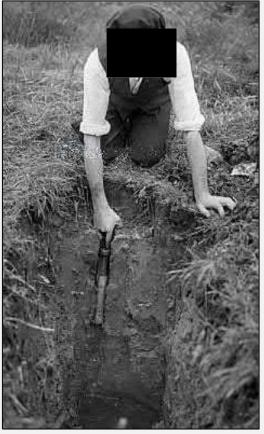
- 1. Ordinary scaffold pipe
- 2. 1kg incendiary bomb
- 3. Incendiary bomb recently found on site in $\ensuremath{\mathsf{UK}}$

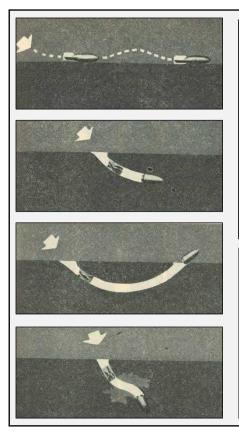
The location of the bomb is thus "offset" from the hole of entry. This "offset" from vertical is generally understood to be about one third of the penetration depth but can reach up to (and have been found at) 15m/50 ft from point of entry, dependent on ground conditions and the bomb's angle of impact. The figure below depicts the various paths of UXB through homogenous ground, showing how the J-curve effect can lead to a UXB coming to rest beneath undamaged buildings.

A UXB can come to rest beneath undamaged buildings due to the J-Curve effect if it lands in nearby soft ground.

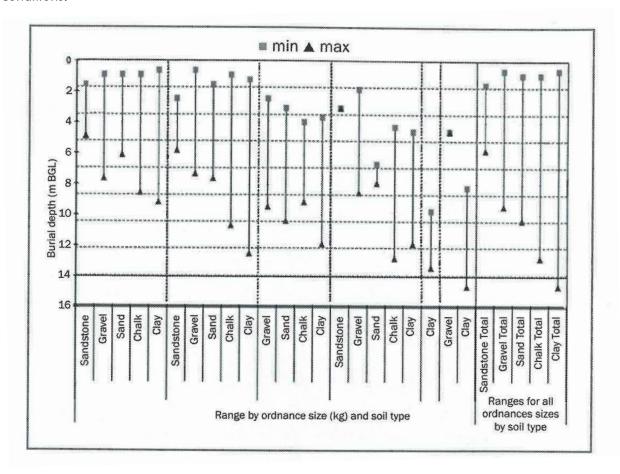
As stated within C681, the ground conditions at any individual site are likely to be highly variable and this results in a large range of burial depths for each different size bomb. The below chart shows the observed variation in burial depths of various sizes of air-delivered UXO for different ground conditions.

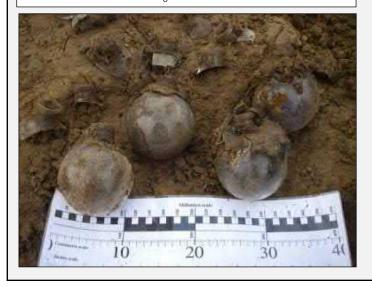
No 74 Grenade (Sticky Bomb)

Designed as an anti-tank grenade and used by the Home Guard. The grenade consisted of a glass ball on the end of a Bakelite (plastic) handle. Inside the glass ball was an explosive filling whilst on the outside was a very sticky adhesive covering. Until used, this adhesive covering was encased in a metal outer casing.

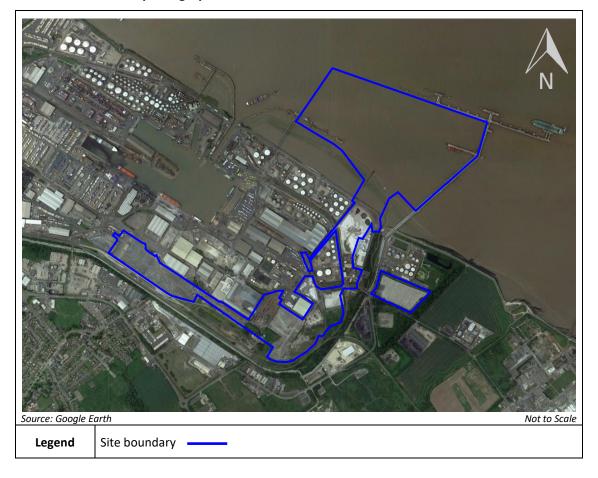
Plate 1 Recent aerial photograph of the Site

Figure 1 is a Site location map and Plate 1 is a recent aerial photograph of the Site.

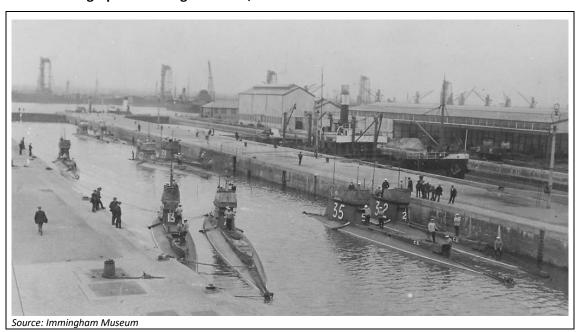
Plate 2 is a photograph of Immingham Dock, dating from circa 1916. This shows several Royal Navy (RN) C-class submarines moored at Immingham's entrance lock, approximately 0.3km west of the Site.

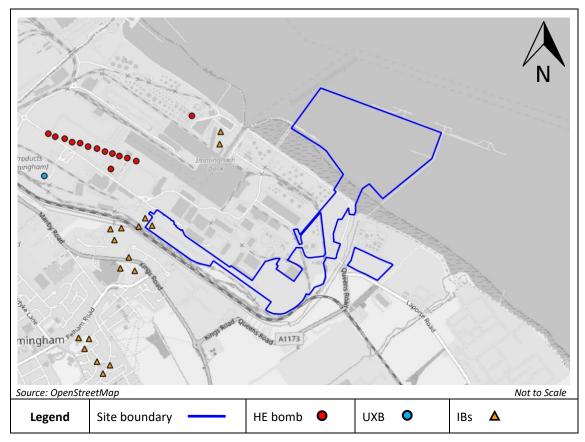
Figure 5 Compiled bomb impact map for the vicinity of the Site

The bomb map is also given in the accompanying P11479-22-R1-MAP01-A.

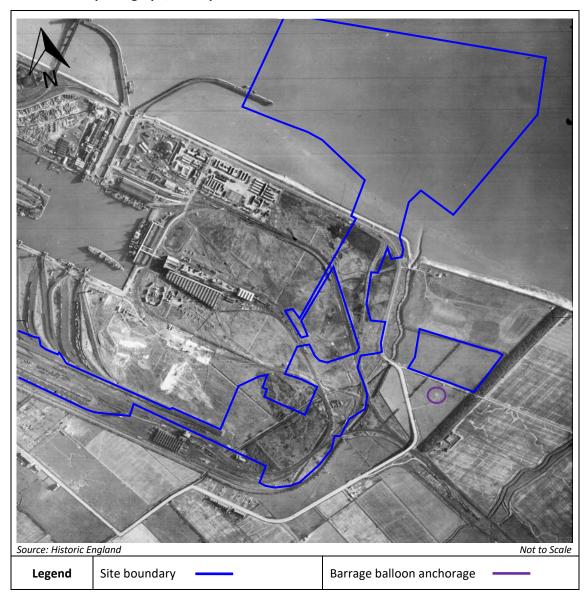
Plate 4 Aerial photograph, 29th April 1947

Plate 4 is an aerial photograph dated the 29th April 1947. No bomb damage or cratering has been identified on or in close proximity to the Site.

Barrage balloon anchorage No. 27 has been identified adjacent to the Site (see Section 3.2.4).

No records have been found indicating that the Site was bombed and no bomb damage or cratering has been identified on the Site on historical aerial photography.

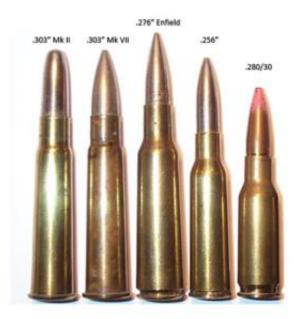
Category Small Arms Ammunition Type Various

Description: Small Arms Ammunition (SAA) is one of the more recognisable categories of ordnance which is primarily designed for anti-personnel use. SAA include items such as bullets, generally up to a calibre (diameter) of 20mm.

Generally small arms ordnance has a relatively low risk as UXO, although the larger calibre categories may have the same detonation risk as larger high explosive ordnance.

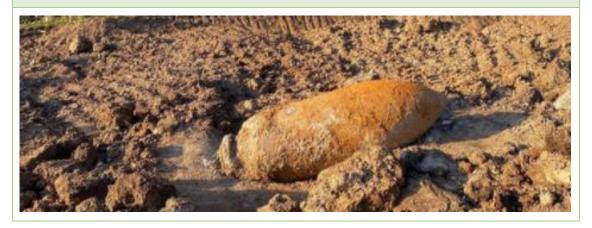
On the 26th February 2021, a 1,000kg German "Hermann" UXB was discovered by builders at Exeter University campus (see plate below). It was investigated and detonated in-situ following the evacuation of nearby properties and University halls of residence.
