IMMINGHAM EASTERN RO-RO TERMINAL

Environmental Statement: Volume 3
Appendix 14.1: Sound Monitoring Survey
Document Reference: 8.4.14 (a)

Appendix 14.1

Sound Monitoring Surveys Information

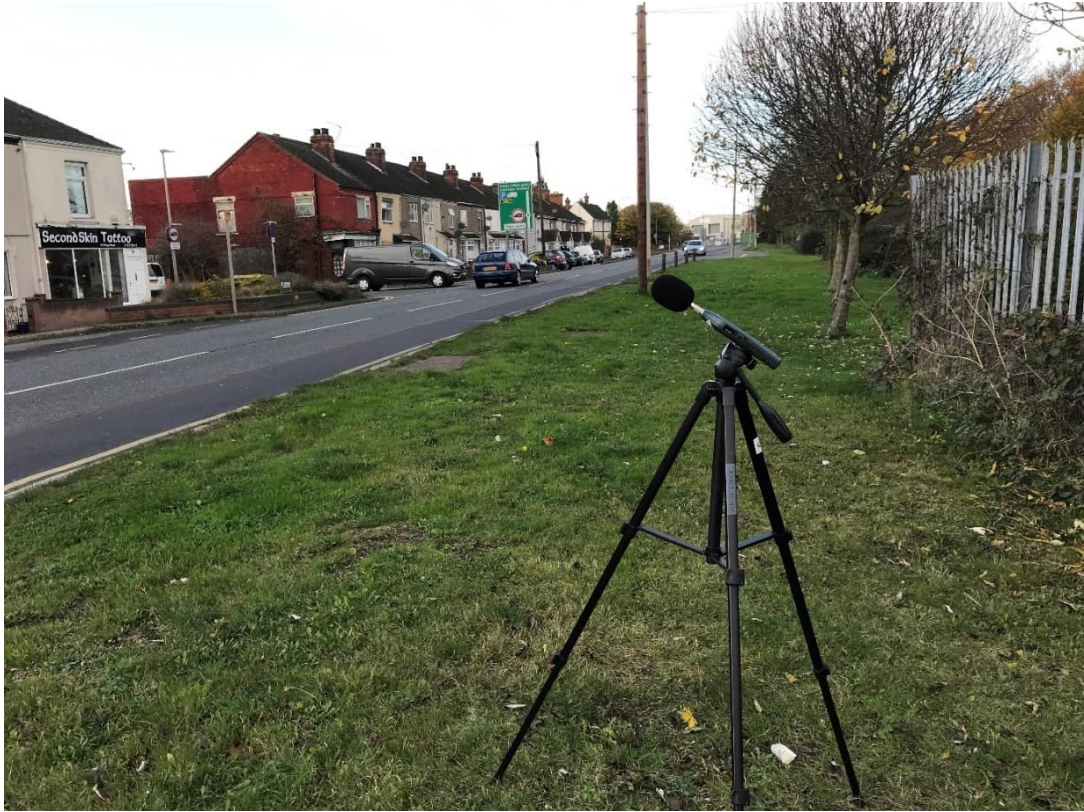
Figure 1: Location M1 on Kings Road looking towards the North West (Day).

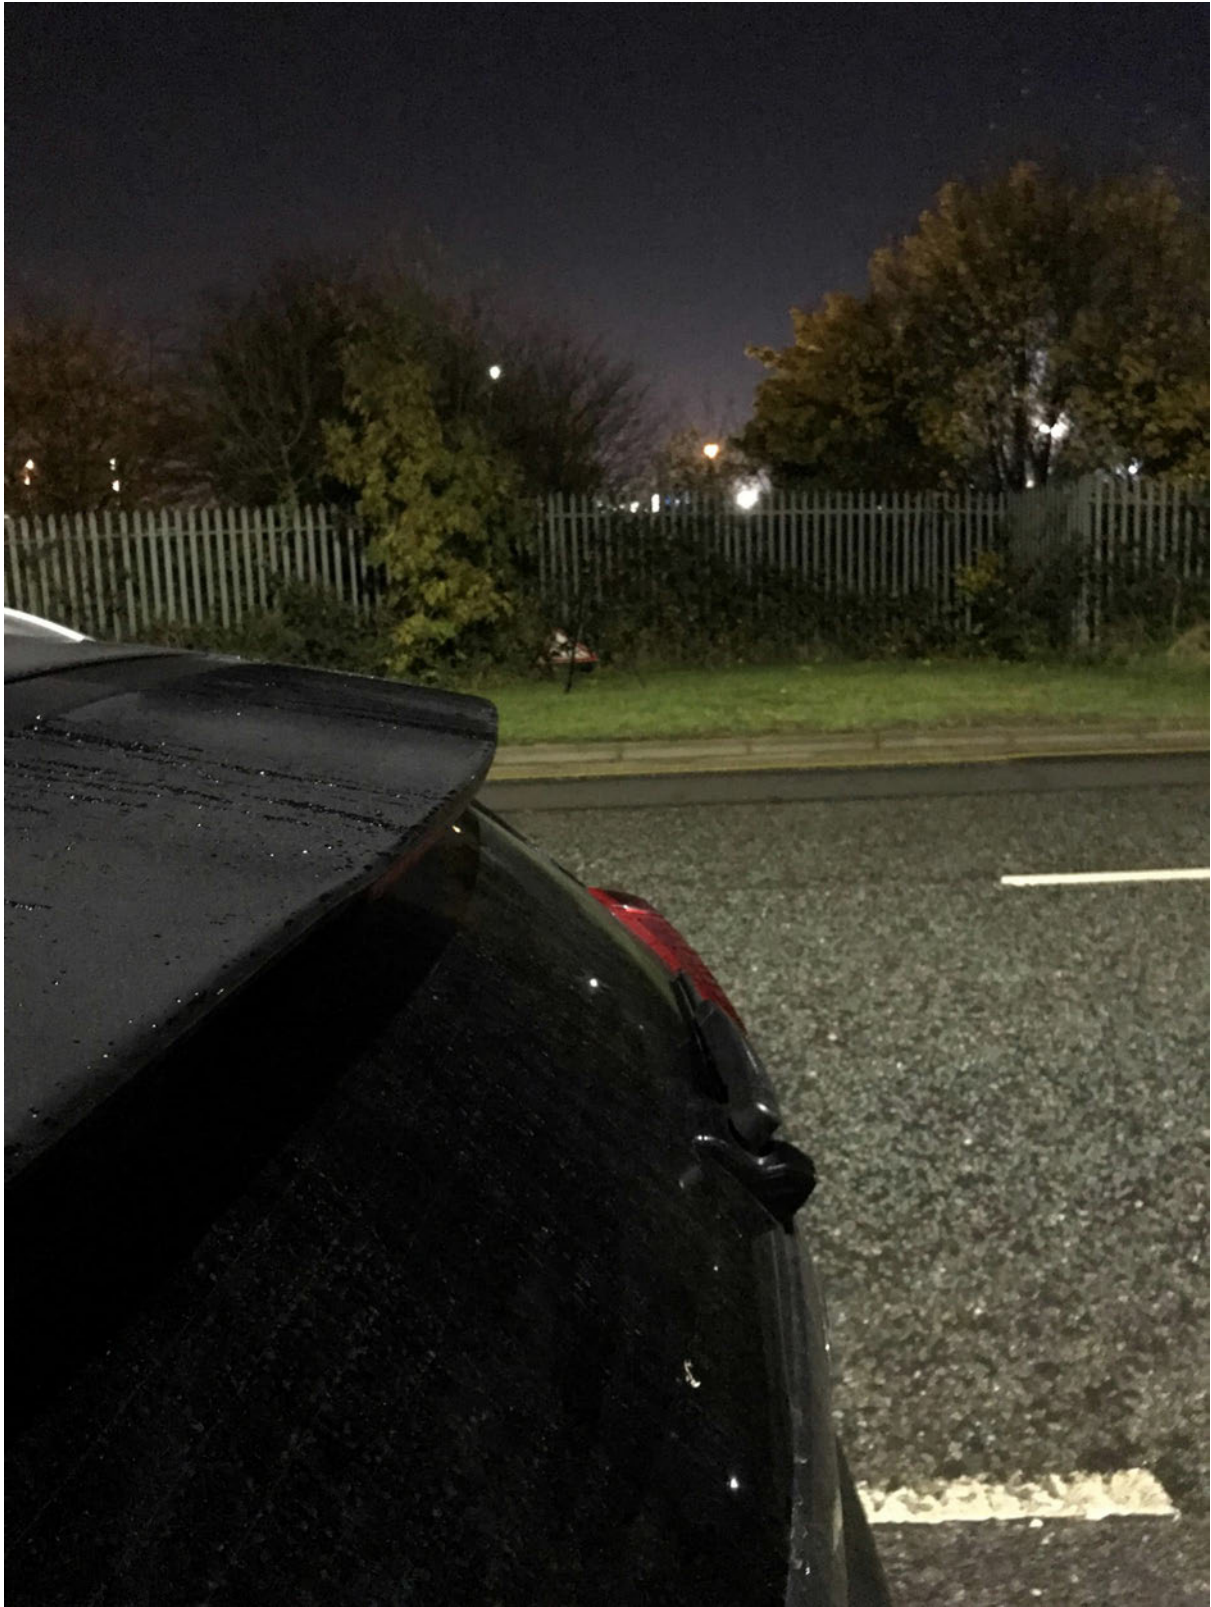
Figure 2: Location M1 on Kings Road (Night).

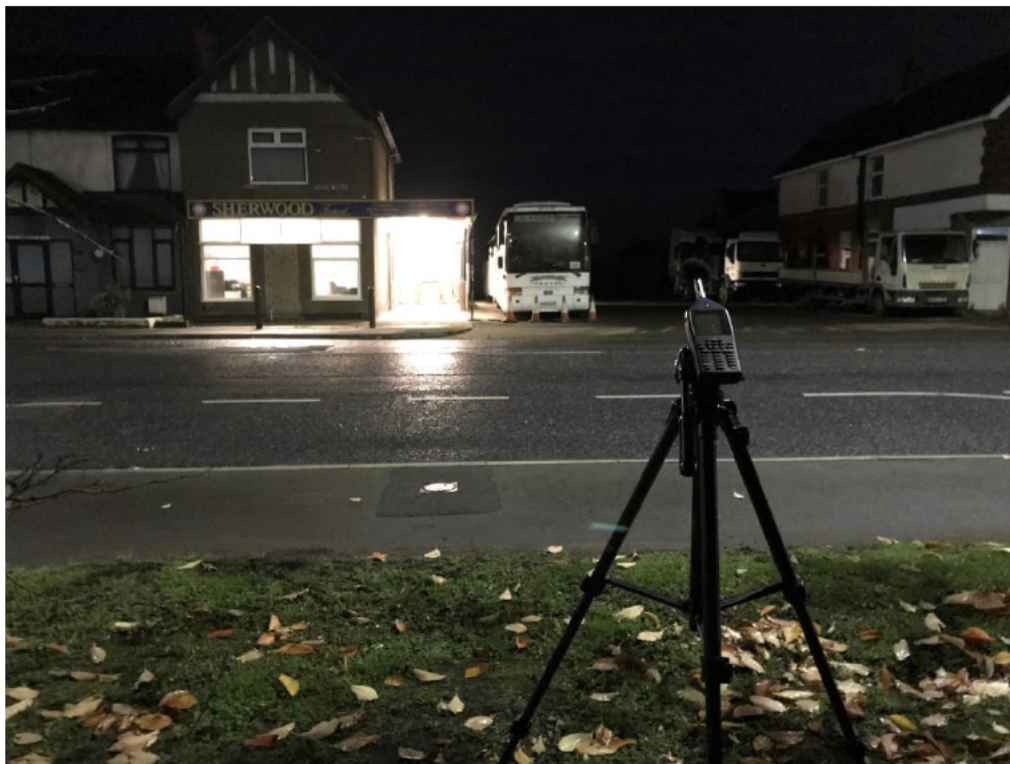
Figure 3: Location M2 Queens Road looking towards the South-West (Night).

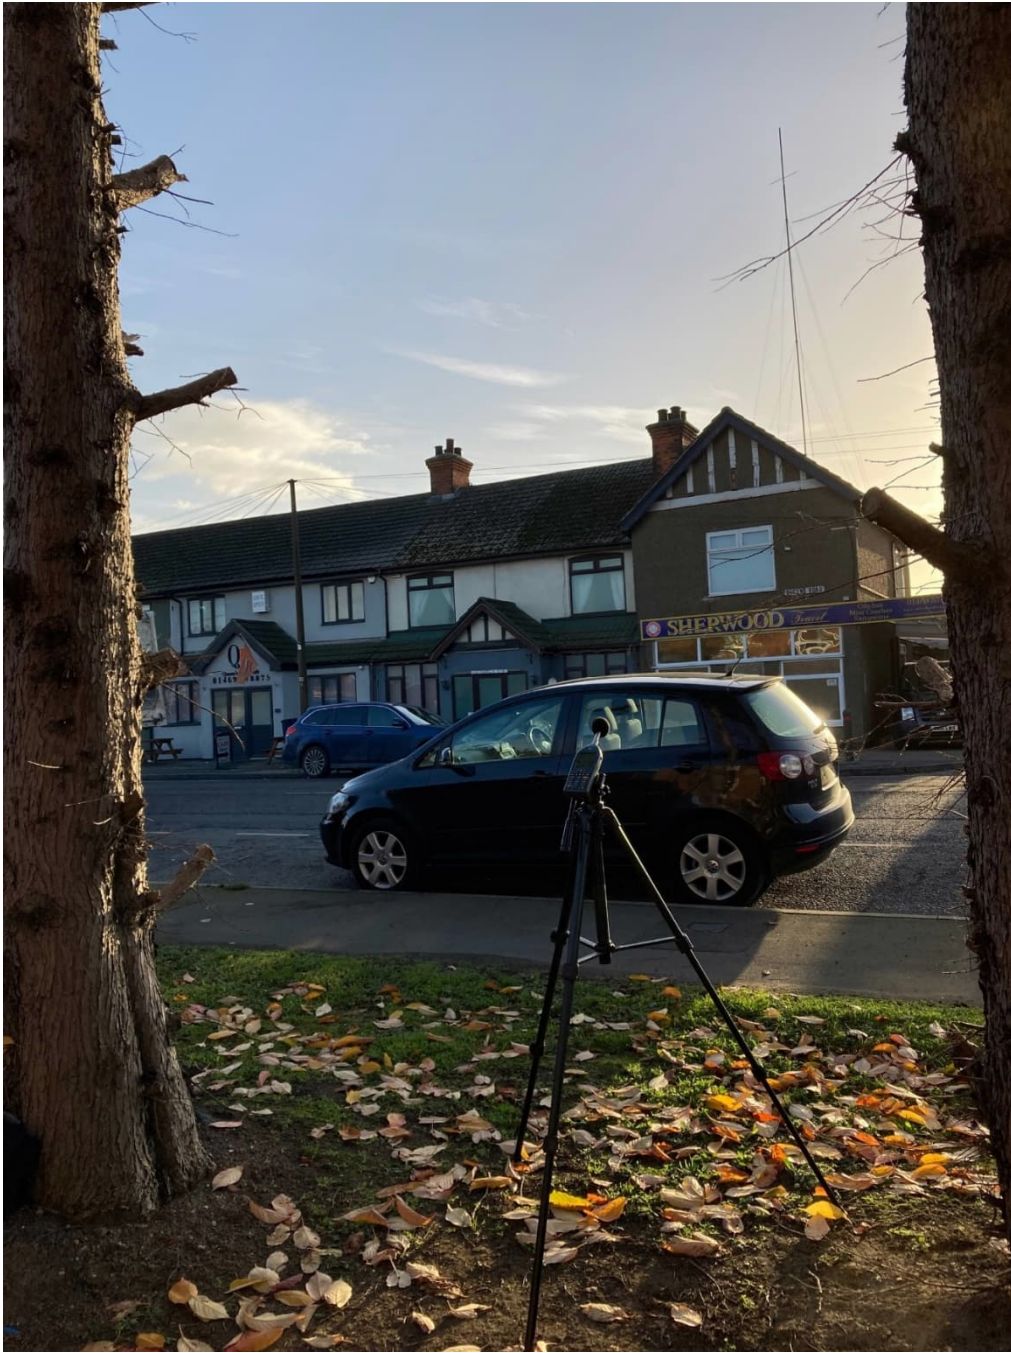
Figure 4: Location M2 Queens Road looking towards the South West (Day).

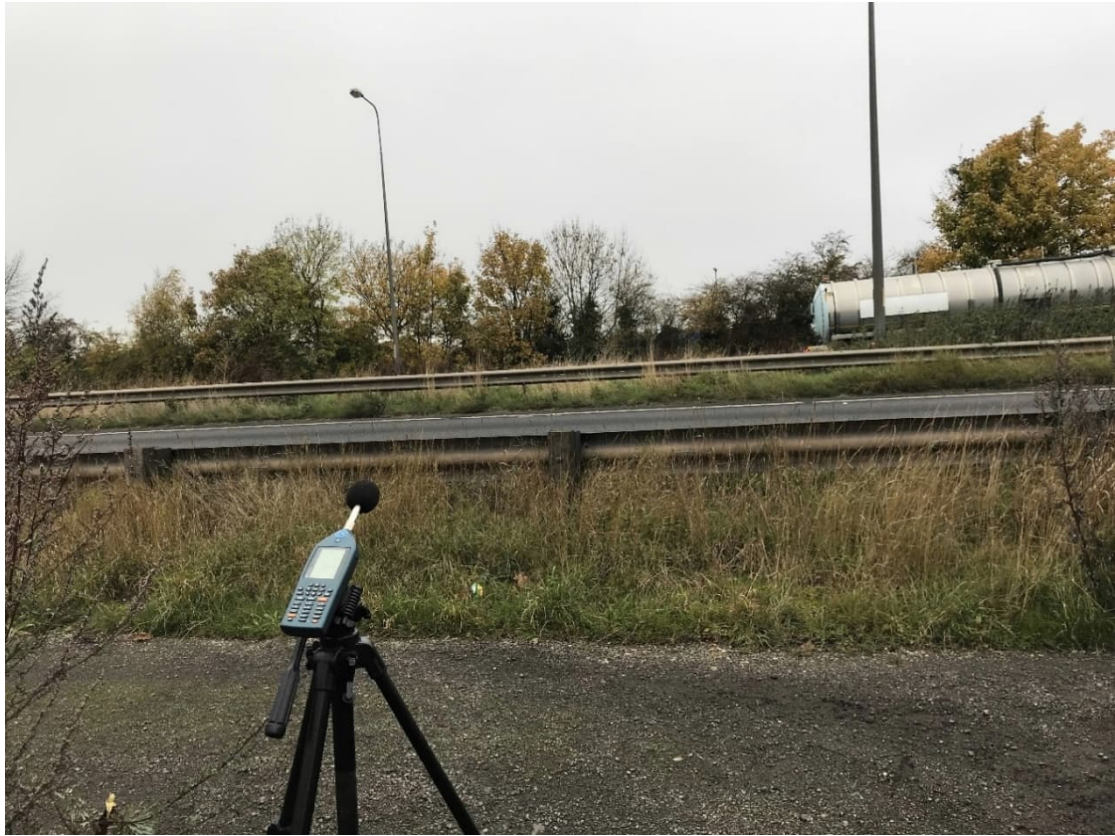
Figure 5: Location M3 looking towards A160, South Killingholme (Day)

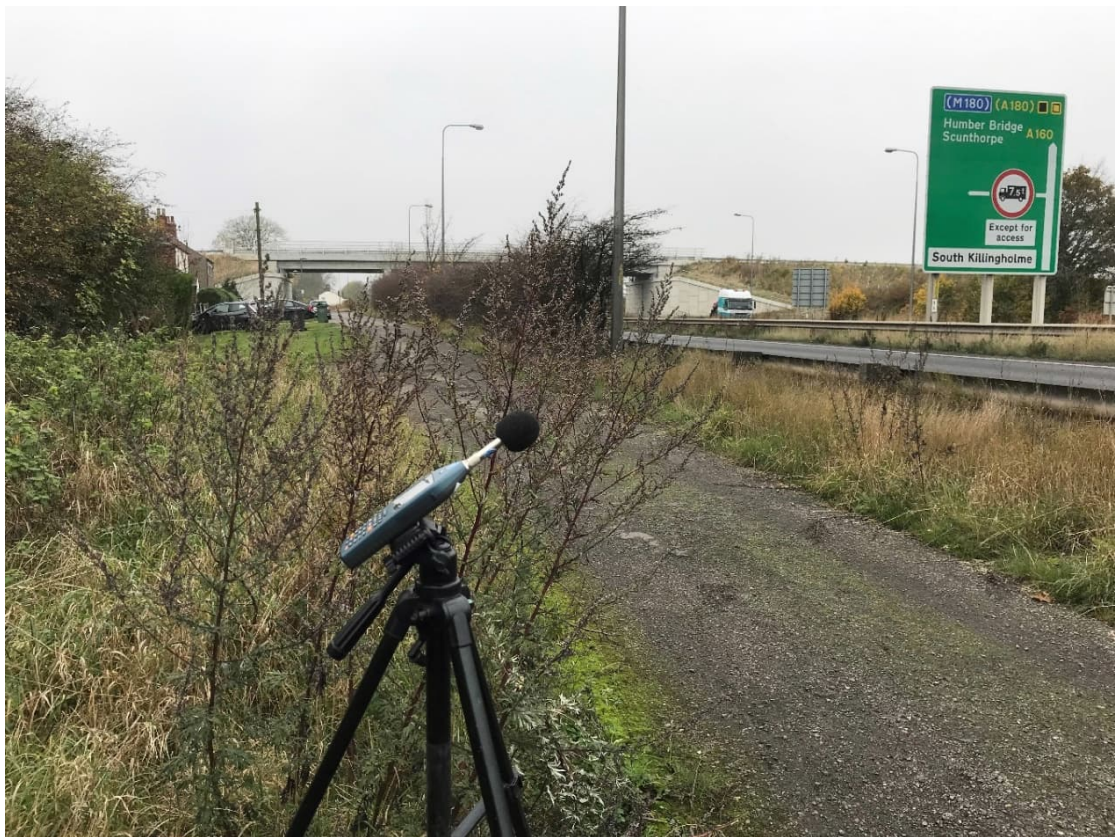
Figure 6: Location M3 looking towards A160, South Killingholme (Day)

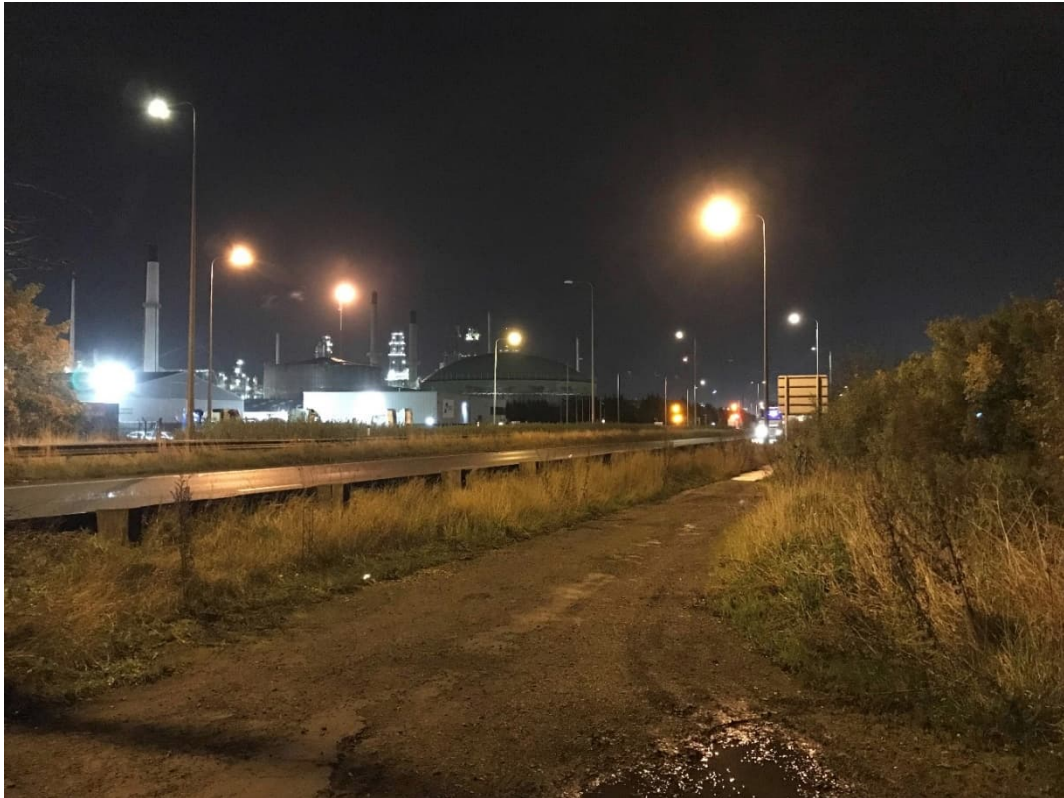
Figure 7: Location M3 South Killingholme looking toward chimney flaring (middle left light source) (Night)

Location M3	Description	
	Day	Night
Location description and OS grid reference (Easting/Northing)	Number 2, Humber Road South Killingholme ///expiring.wiggly.crumble 515546,416147	
Monitoring date and time	16/11/2021 at 11:15-14:15	17/11/2021 at 02:20-02:50
Monitoring height above ground	1.4 m	
Distance to nearest building facade	Greater than 3.5 m	
Average wind speeds (m/s)	No wind perceived	No wind perceived
Wind direction	No wind perceived	No wind perceived
Temperature (°C)	16	8
Cloud coverage	8/8	2/8
Sound Level Meter and Serial No.	Norsonic Nor140 s/n 1403909	
Field Calibrator and Serial No.	Norsonic Type 1251 s/n 34393	
Description of the sound climate	Dominated by road traffic noise from A160, contribution by the flaming from the chimney nearby.	Dominated by the road traffic noise from A160, contribution by the flaming from the chimney becomes more noticeable.

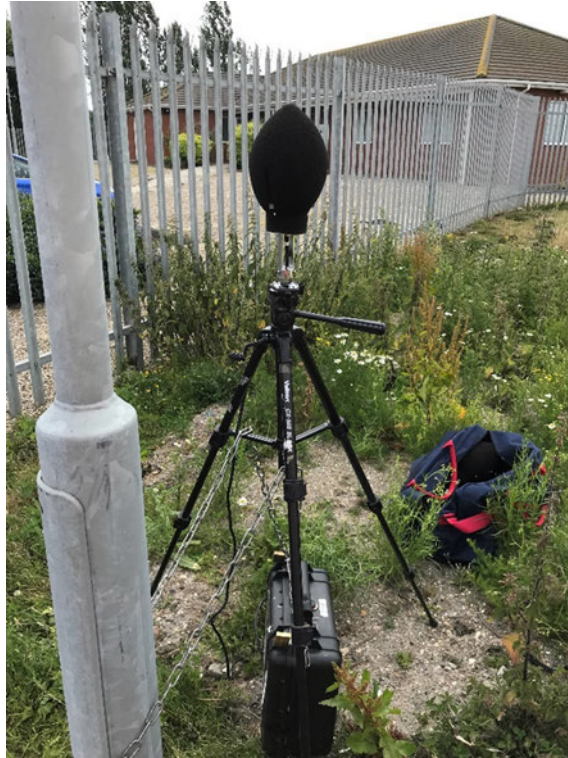
Figure 8: Location M4 looking towards the PAM Building

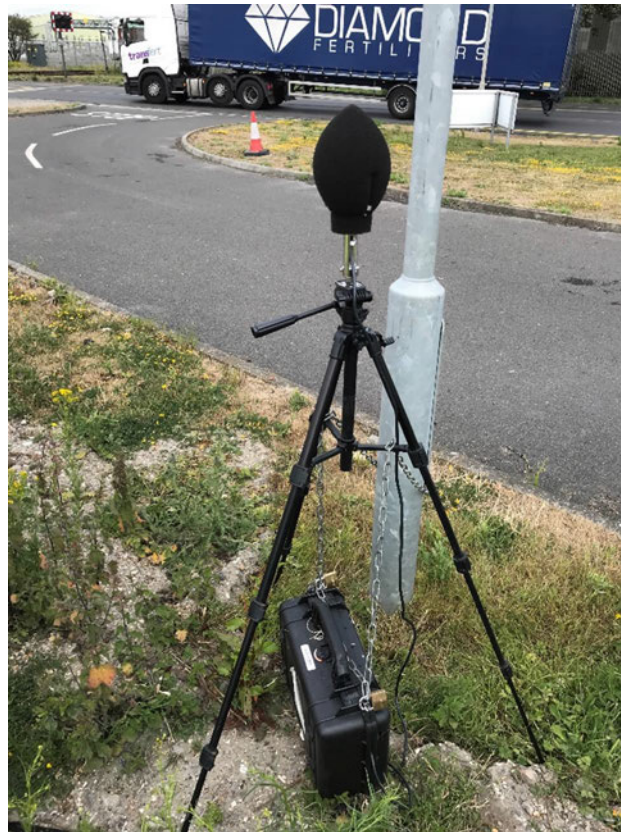
Figure 9: Location M4 looking towards Robinson Road

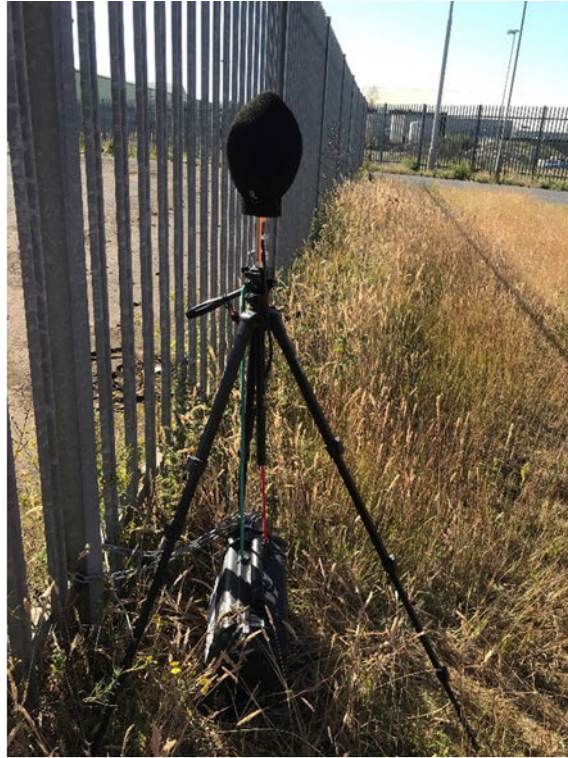
Figure 10: Location M5 looking towards Gresley Way.

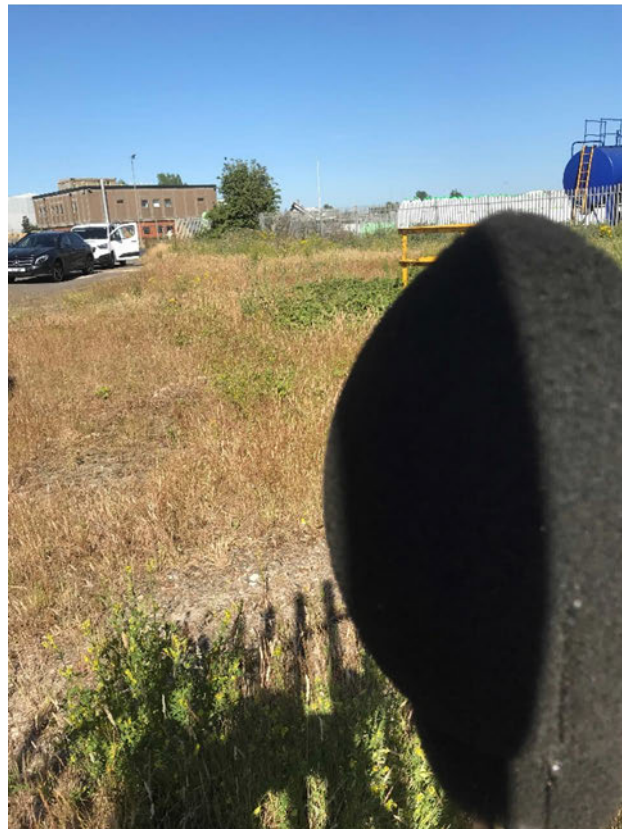
Figure 11: Location M5 looking towards Nippon Gases offices.

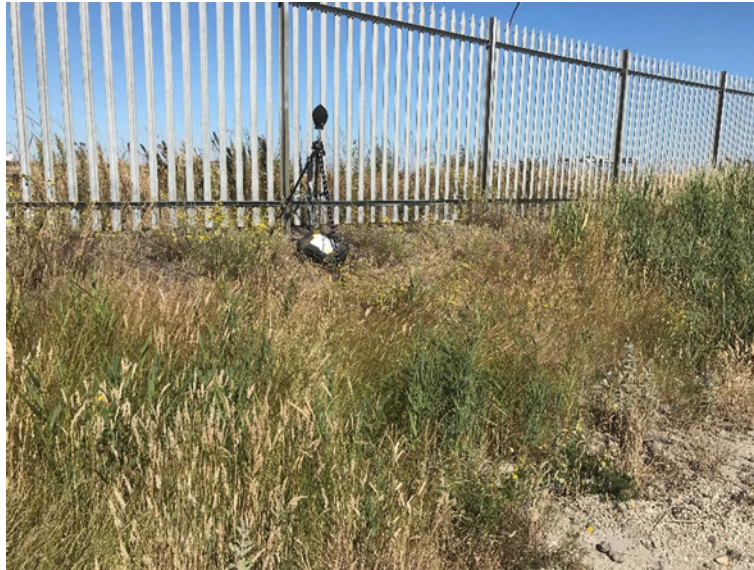
Figure 12: Location M6 looking towards the IERRT project.

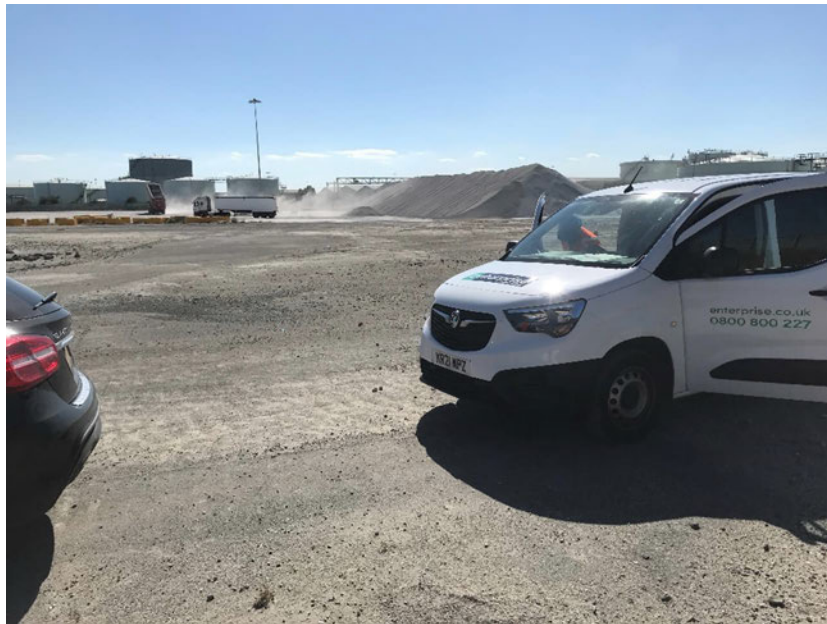
Figure 13: Location M6 looking towards nearby stockpiling, storage and distribution of gravel.

Location M6	Description	
	On Start	At End
Location description and OS grid reference (Easting/Northing)	On northern boundary of IERRT site, representative of the ecological receptors on the mudflats on the Humber Estuary ///agreeing.sideboard.torso 520715,415853	
Monitoring date and time	07/07/2022 at 16:15	13/07/2022 at 14:30
Monitoring height above ground	1.5 m	
Distance to nearest building facade	Greater than 3.5 m	
Wind speeds (m/s)	1.0	1.6
Wind direction	SE	NE
Temperature (°C)	24	27
Cloud coverage	0/8	0/8
Sound Level Meter and Serial No.	Rion NL-52 s/n: 01021278	
Field Calibrator and Serial No.	Brüel & Kjær Model 4231 s/n: 2217877	
Description of the sound climate	Dominated by stockpiling, storage and distribution of gravel. Other sources include road pass-bys and forklift manoeuvres.	Dominated by stockpiling, storage and distribution of gravel. Other sources include squeal from vehicle hydraulic systems, continuous hum from berthed vessels.
