IMMINGHAM EASTERN RO-RO TERMINAL

Applicant's Response to ISH5 Action Point 5 – Part 2

Document 10.2.73

A replay of the VTS traffic monitoring system

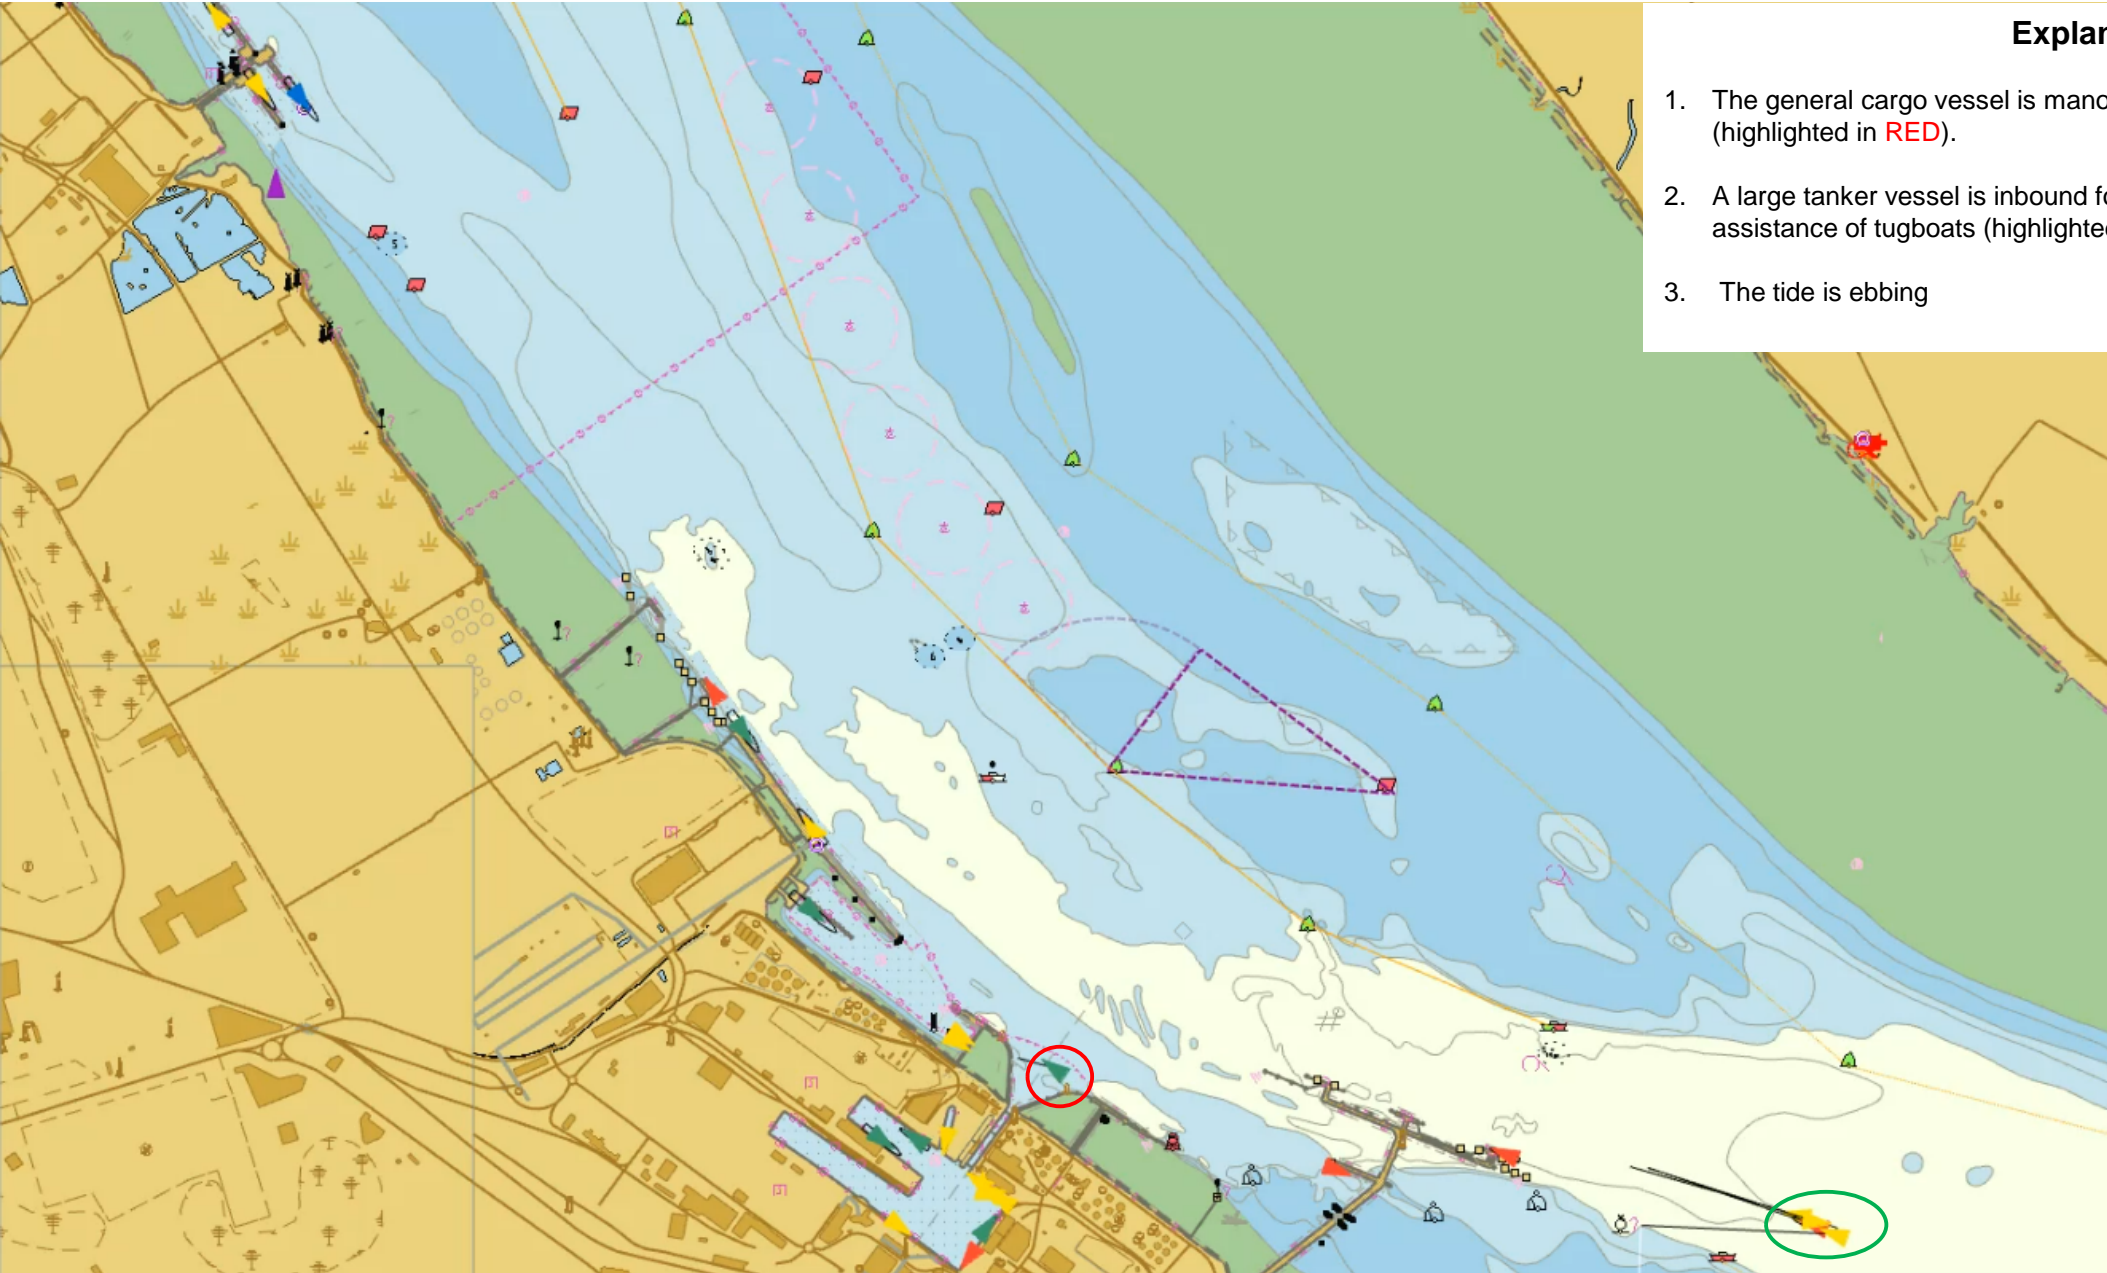
PM HW -6.75Hrs

1. The general cargo vessel is manoeuvring for Immingham lock (highlighted in RED).
2. A large tanker vessel is inbound for Immingham Oil Terminal with the assistance of tugboats (highlighted in GREEN).
3. The tide is ebbing

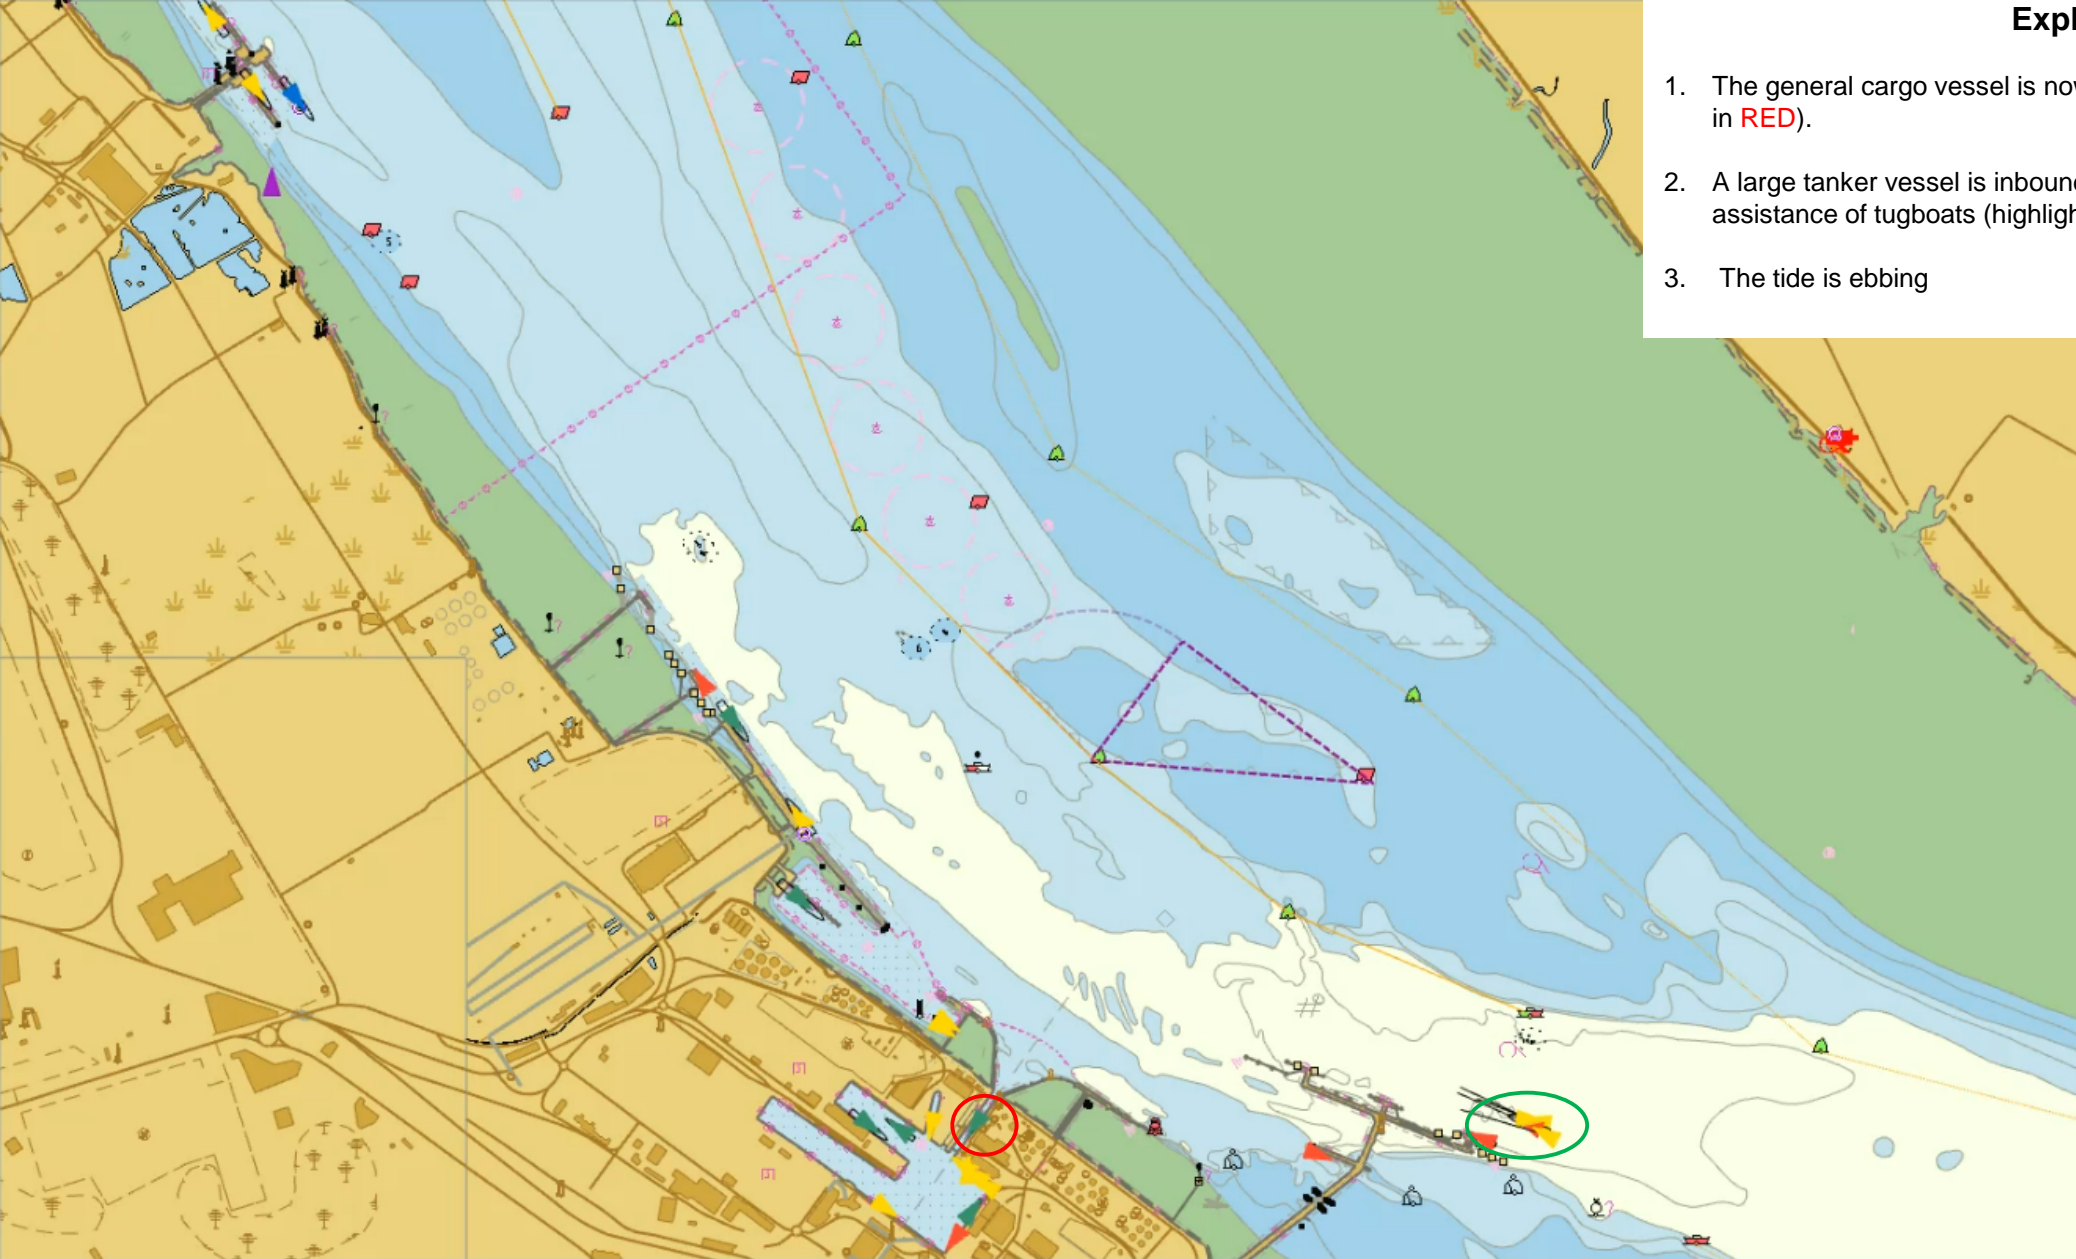
PM HW -6.5Hrs

1. The general cargo vessel is now inside Immingham lock (highlighted in **RED**).
2. A large tanker vessel is inbound for Immingham Oil Terminal with the assistance of tugboats (highlighted in **GREEN**).
3. The tide is ebbing

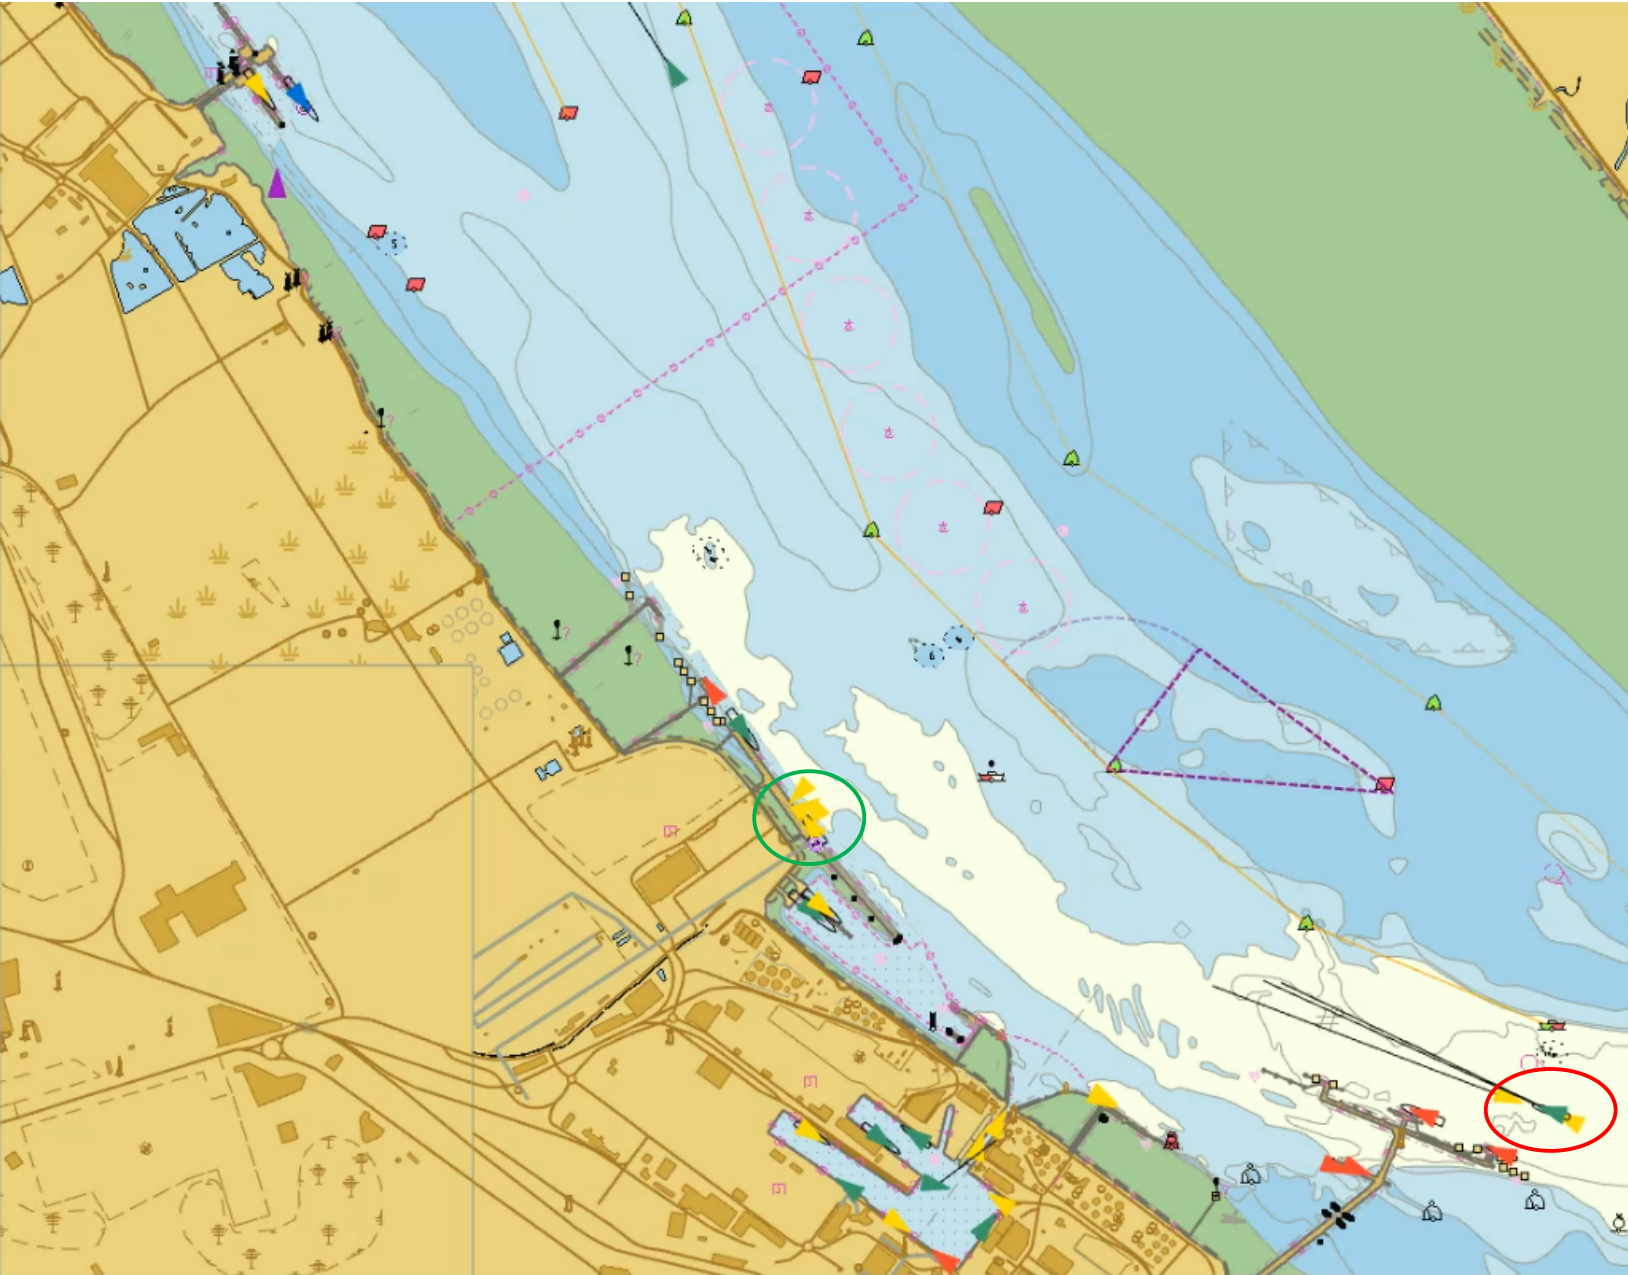
PM HW -1.75Hrs

1. A large bulk carrier is inbound for Immingham Dock with the assistance of tugs passing the IOT using the main navigational channel (highlighted in RED)
2. Another large bulk carrier is preparing to depart from Immingham HIT 1 (highlighted in GREEN)
3. The tide is flooding

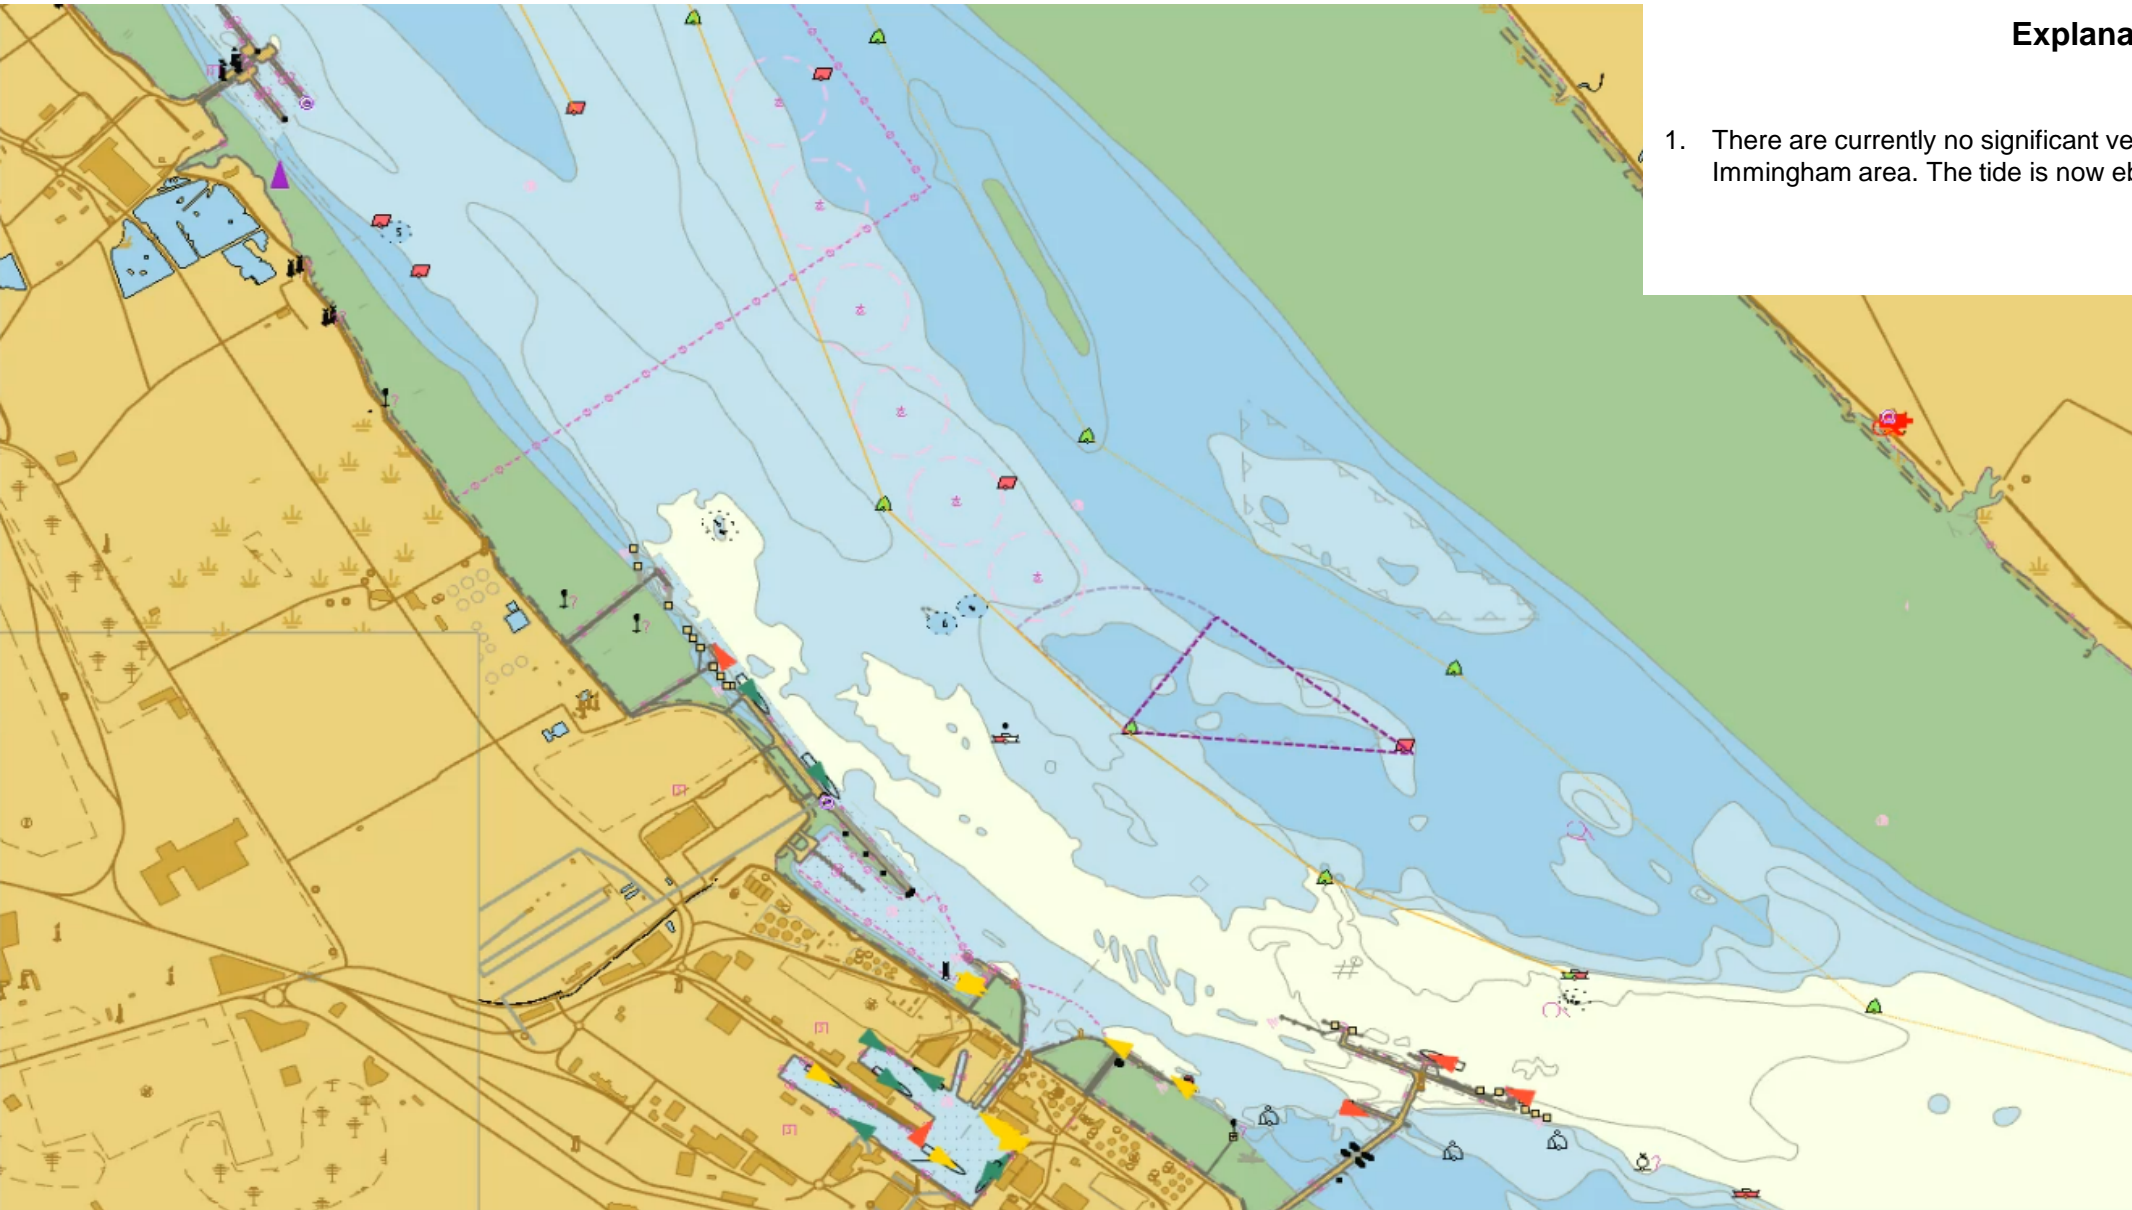
PM HW +1Hr

1. There are currently no significant vessel movements within the Immingham area. The tide is now ebbing
