# Immingham Green Energy Terminal

Appendix 8.D: Otter and Water vole Survey Report

#### Appendix 8.D: Otter and Water Vole Survey Report

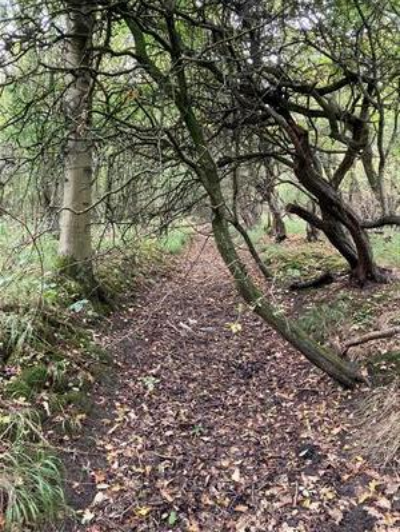
| Ditch ref | Description | Location relative to site boundary | Water vole field signs | Otter field signs | Photograph |
|---|--|--|---|---|--|
| 1 | <p>A shallow dry ditch approximately 1m wide running on the northern edge of Long Strip woodland. There was leaf litter in the ditch and no evidence of any marginal or aquatic plant species to indicate it regularly holds water. The ditch channel is heavily shaded by mature trees and scrub present on both banks. Connected to Ditch 3 via culvert beneath Laporte Road.</p> <p>Adjacent land: mature woodland and scrub.</p> | <p>Outside Site Boundary.</p> <p>Adjacent to East Site – Hydrogen Production Unit Site</p> | x | x | |

- 4.2.5. No water vole evidence was identified on the ditch that runs along the northern boundary of Long Strip Woodland (within the Pipe Rack and Jetty Access Road site). This ditch is predominantly dry along the majority of its length, and is culverted beneath Laporte Road (separated into Ditch 3 and Ditch 4 for the purposes of the survey). Only the northernmost few metres of the ditch regularly hold water, and this section is stagnant and largely anoxic, and lacks sufficient aquatic or marginal vegetation to support water vole. Despite its connectivity with Ditch 7 on which water vole field signs were recorded, it is concluded to be unsuitable for the species.

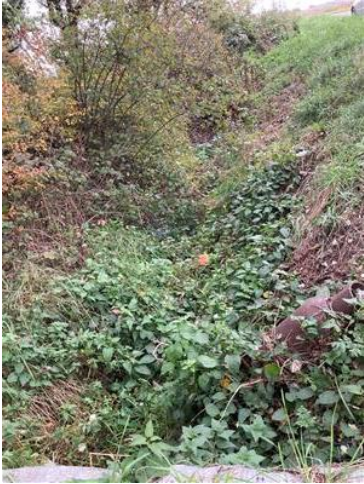
| Ditch ref | Description | Location relative to site boundary | Water vole field signs | Otter field signs | Photograph |
|---|---|--|---|---|--|
| 2 | <p>A steep sided dry ditch approximately 0.4m wide running along the northern side of Laporte Road. No aquatic or marginal vegetation. May hold water in winter months.</p> <p>Adjacent land: mature woodland, arable farmland, road.</p> | <p>Outside Site Boundary.</p> <p>Adjacent to Temporary Construction Area</p> | x | x | |

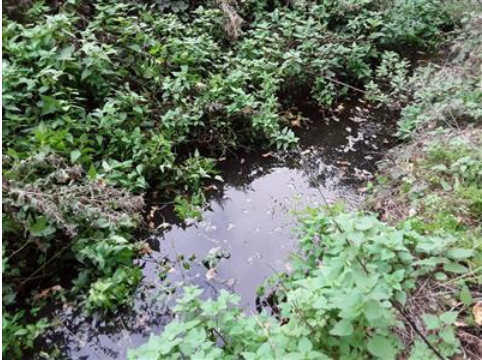
| Ditch ref | Description | Location relative to site boundary | Water vole field signs | Otter field signs | Photograph |
|---|---|--|---|---|--|
| 3 | <p>A shallow, seasonally dry ditch approximately 1m wide running on the northern edge of Long Strip woodland. The ditch is heavily shaded by overhanging scrub and trees from the adjacent woodland, and supports no marginal/ aquatic vegetation. Standing water present in October 2022 appears to have no flow and is generally stagnant and anoxic.</p> <p>Connected to Ditch 1 via culvert beneath Laporte Road.</p> | <p>Within Pipe Rack and Jetty Access Road site</p> | x | x | |

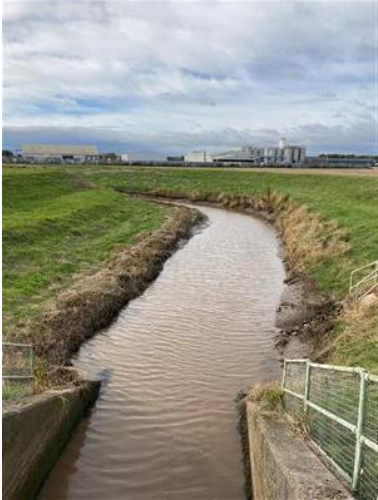
| Ditch ref | Description | Location relative to site boundary | Water vole field signs | Otter field signs | Photograph |
|---|--|---|---|---|--|
| 4 | <p>North Beck Drain.</p> <p>Substantial main drain with tidal influence and tidal flap outfall to the estuary at its northernmost extent.</p> <p>Watercourse is approximately 4m wide with steep sided banks, and supports no aquatic/marginal vegetation.</p> <p>Adjacent land: arable farmland</p> | <p>Outside Site Boundary.</p> <p>Adjacent to Temporary Construction Area.</p> | x | x | |

3.3.2. Ditch 4 (North Beck Drain) was only surveyed from the top of the banks using binoculars, due to it being a wide, deep tidal drain with no safe access to the riparian habitat zone for field sign inspections. However, given there are numerous desk study records of the species on North Beck Drain, despite the lack of field signs observed during the survey visit in October 2022 it was assumed for the purposes of the ecological impact assessment that the species was present at this location, and thus a second survey was not undertaken.

- 5.2.2. Although no evidence of water vole was observed on North Beck Drain (Ditch 4), given that there are numerous desk study records of water vole on Ditch 4 and it is connected to the ditches referred to above, it is reasonable to conclude for the purposes of the ecological impact assessment that it also supports this species.

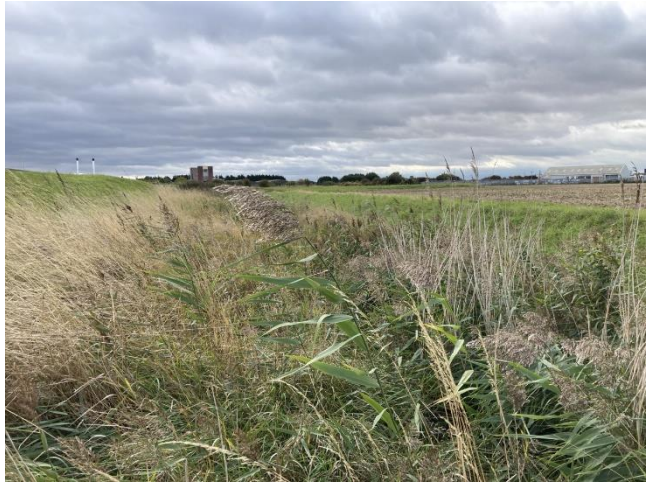
| Ditch ref | Description | Location relative to site boundary | Water vole field signs | Otter field signs | Photograph |
|---|--|---|---|---|---|
| 6 | <p>Drainage ditch running along landward toe of flood embankment.</p> <p>The ditch was dry at the time of the survey, although likely to hold water in the winter months. The channel is entirely choked with common reed and there is some shading from scattered bankside scrub. The grassed banks of the flood embankment are regularly mown short.</p> <p>Connected to Ditch 7 and North Beck Drain (Ditch 4).</p> <p>Adjacent land: arable farmland, mown flood embankment.</p> | <p>Crossed by Pipe Rack and Jetty Access Road.</p> <p>Adjacent to Temporary Construction Area</p> | ✓ | x | |

- 4.2.3. Water vole field signs were recorded on both Ditch 6 and Ditch 7, which are both connected sections of the drainage ditch at the landward toe of the flood embankment. This ditch is crossed by the Pipe Rack and Jetty Access Road, and runs along the northern boundary of the Temporary Construction Area. Water vole are also assumed present on North Beck Drain (Ditch 4), which was not accessible for survey, but on which there have been several historical records of the species, and which is connected to Ditch 6 and Ditch 7.

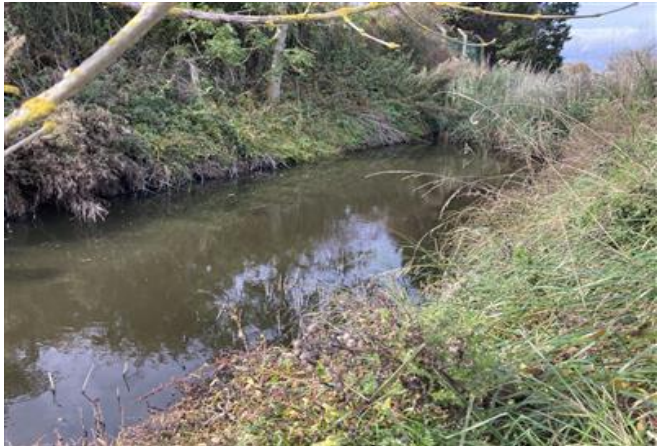
| Ditch ref | Description | Location relative to site boundary | Water vole field signs | Otter field signs | Photograph |
|---|--|--|---|---|--|
| 7 | <p>Wide drainage ditch running along landward toe of flood embankment.</p> <p>Abundant common reed and some shading from scattered bankside scrub. The grassed banks of the flood embankment are regularly mown short.</p> <p>Connected to Ditch 6 and North Beck Drain (Ditch 4).</p> <p>Adjacent land: industrial land (Associated Petroleum Terminal site), mown flood embankment, mature woodland.</p> | Crossed by Pipe Rack and Jetty Access Road | ✓ | x | |

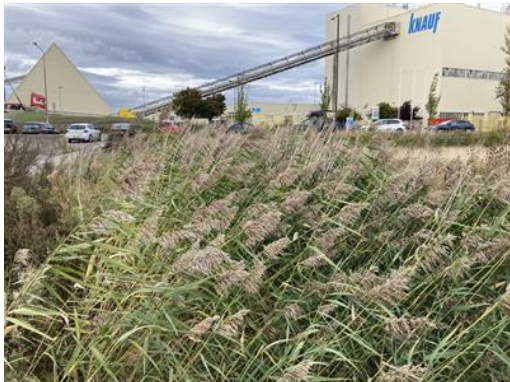
| Ditch ref | Description | Location relative to site boundary | Water vole field signs | Otter field signs | Photograph |
|---|--|--|---|---|--|
| 8 | <p>Man-made ditch created as part of site access to West Site for previous planning application.</p> <p>Ditch is approximately 1.5m wide and was dry along the majority of its length at the time of the survey. The ditch is choked with common reed, and has no connectivity with any other ditches.</p> <p>Adjacent land: neutral grassland</p> | Within West Site | x | x | |

- 4.2.4. No water vole evidence was found on any of the ditches within West Site (Ditch 8 and Ditch 9), despite their proximity to known water vole populations in the landfill site to the south. This is due to the lack of permanent water in the ditches, which is sub-optimal for the species. Furthermore, none of the ditches within West Site have any connectivity to ditches/watercourses or waterbodies within the adjacent landfill site that support water vole. The water vole population within the landfill site may also use the high-quality habitat associated with North Beck Drain, which is immediately south of the landfill site.
