## Portishead Branch Line (MetroWest Phase 1)

### 8.8 Level Crossing Narrative Risk Assessment – Ashton Containers Footpath Level Crossing

**Ashton Containers Footpath Level Crossing**

**POD 121m 05c**

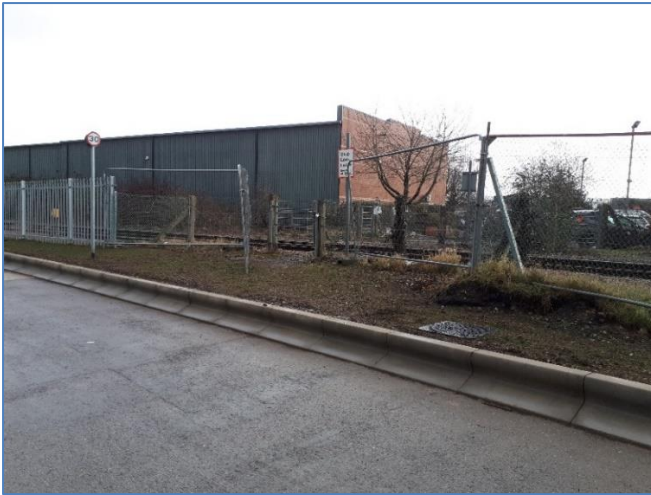
13. The approach from the western side along the footpath, which follows Colliter's Brook through scrub tree and hedgerow growth, now also crosses the newly constructed Ashton Vale-Temple Meads MetroBus busway, which has not yet opened. As the busway turns northwards to cross over the POD, a new skew bridge has been constructed over the Ashton Junction Level Crossing (Ashton Vale Road). The busway (which is a kerb guided busway) has a tall kerb on both sides. As it is now necessary for pedestrians to cross the busway and the Ashton Containers level crossing, negotiating these tall kerbs is likely to impeded some people and raises safety concerns. The approach either side of Ashton Containers pedestrian crossing is a public right of way. A plan of the current public rights of way and proposed alterations to public rights of way is shown in appendix i). For clarification appendix ii) shows the alignment of the Metrobus busway as it passes alongside and over the railway. The photographs below show the busway, busway kerb and the Ashton Containers level crossing.

Photo 1. Approaching Ashton Containers Level Crossing from the busway looking northeast

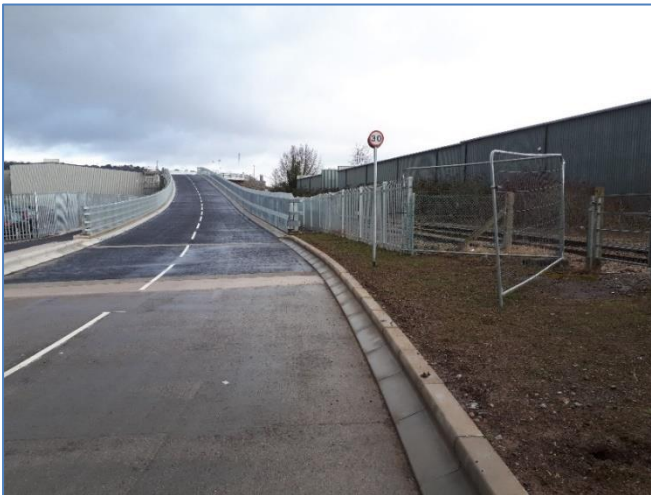
Photo 2. At Ashton Containers Level Crossing looking north to busway

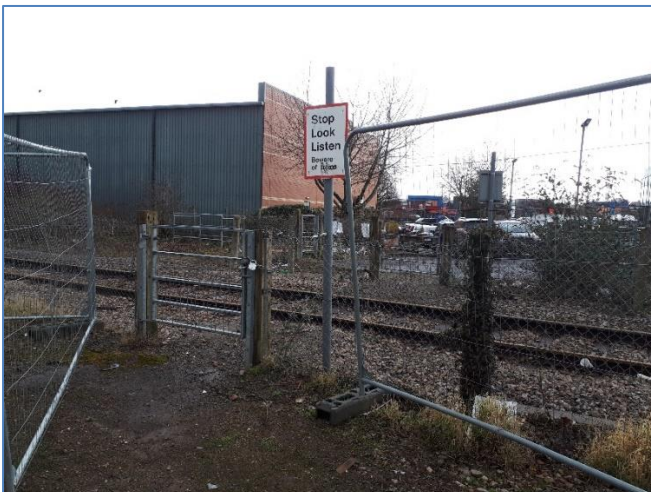
Photo 3. Ashton Containers Level Crossing Gate looking northeast (Gate Padlocked)

14. The level crossing has typical public footpath pedestrian gates in both railway boundary fences and Stop, Look, Listen signs (rail signs reference CC03z) at the pedestrian decision points on both sides. The crossing deck was removed some time ago when the crossing was locked out of use. The crossing remains locked out of use.

42. The preferred option is to close the level crossing permanently. This can be achieved through the diversion of the public right of way from its current alignment to the alignment of the new permissive pedestrian path/cycleway that runs directly from Colliter's Brook (opposite Ashton Containers level crossing) under the skew bridge and terminates near Ashton Junction MCB CCTV level crossing. It is understood that the diversion of the public footpath, by creating a new public right of way on the currently permissive pedestrian/cycle path is within the scope of the powers that can be sought in a Development Consent Order. The footpath diversion can be included in the relevant schedule of the Order such that the closure of the level crossing could be achieved.

43. When closed, Network Rail will securely fence-off the crossing with palisade fencing (the current track workers access point on the eastern side of the crossing will have a lockable palisade gate) and erect and maintain public notices regarding the diversion of the footpath on site for a reasonable time.
