## Portishead Branch Line (MetroWest Phase 1)

**Applicant: North Somerset District Council**  
**8.12, Avon Gorge Vegetation Management Plan**  
**The Infrastructure Planning (Applications: Prescribed Forms and Procedure)**  
**Regulations 2009, Regulation 5(2)(q)**  
**Planning Act 2008**

**Author: CH2M**  
**Revision: Version 2**  
**Date: October 2020**

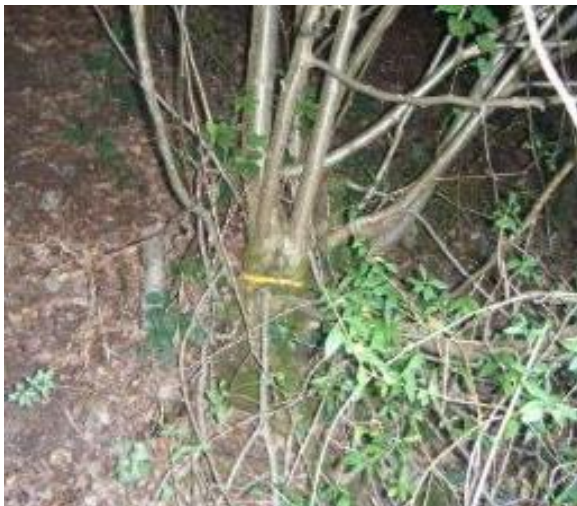
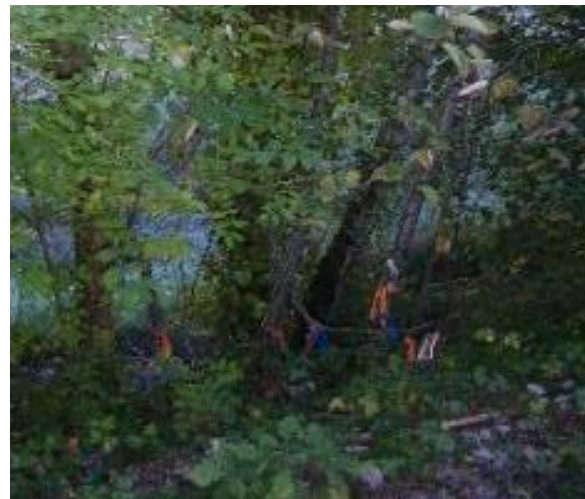
*Plastic yellow collars installed to facilitate the identification of sensitive species during works along the freight line. A number of these collars are now constricting the plant which they demarcate and should be removed to prevent growth restriction and death of the tree.*

- 2.1.27 A number of techniques including spray paint, coloured tape and plastic collars have been used to demarcate sensitive Whitebeam plants in the Avon Gorge, as shown in the photographs below. The number of methods employed have the potential to cause confusion to those undertaking works, alert the public to sensitive species and also distract from the natural setting of the woodland. As such the mechanism of demarcation needs to be consolidated, as discussed in Section 5.3.

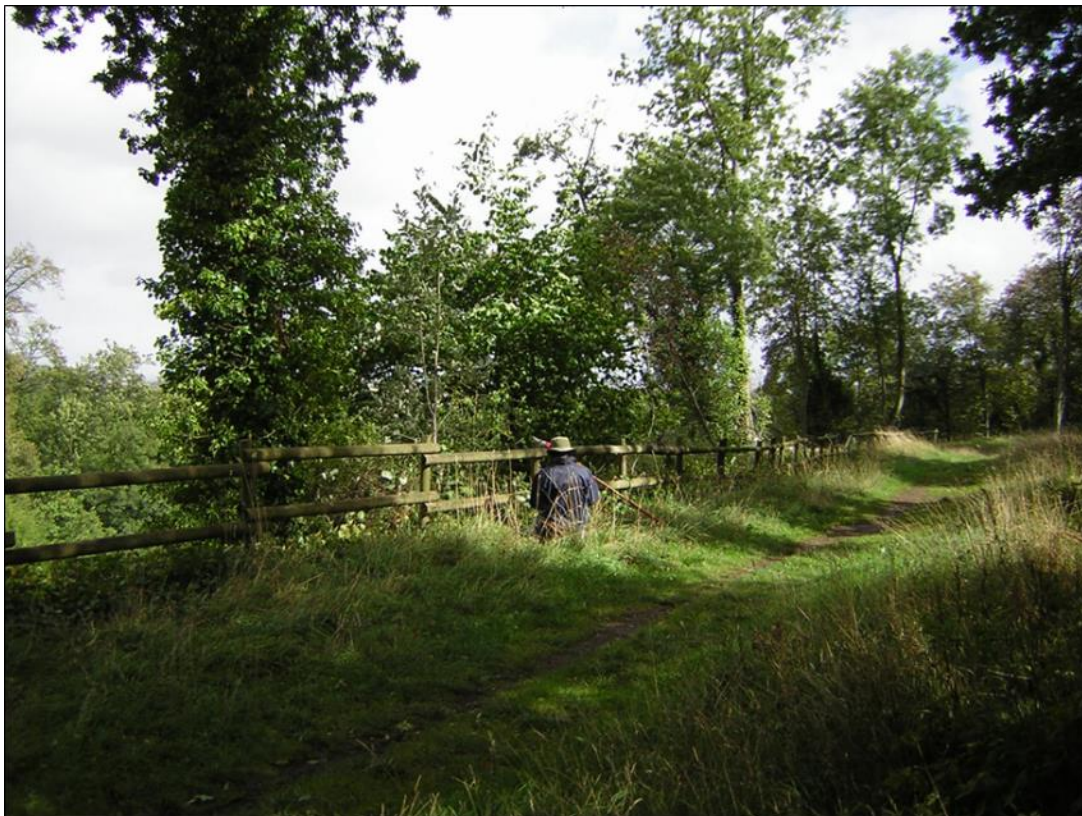
**Photograph 1. Grey-leaved whitebeams planted on far side of fence, Leigh Woods Camp, 2004.**

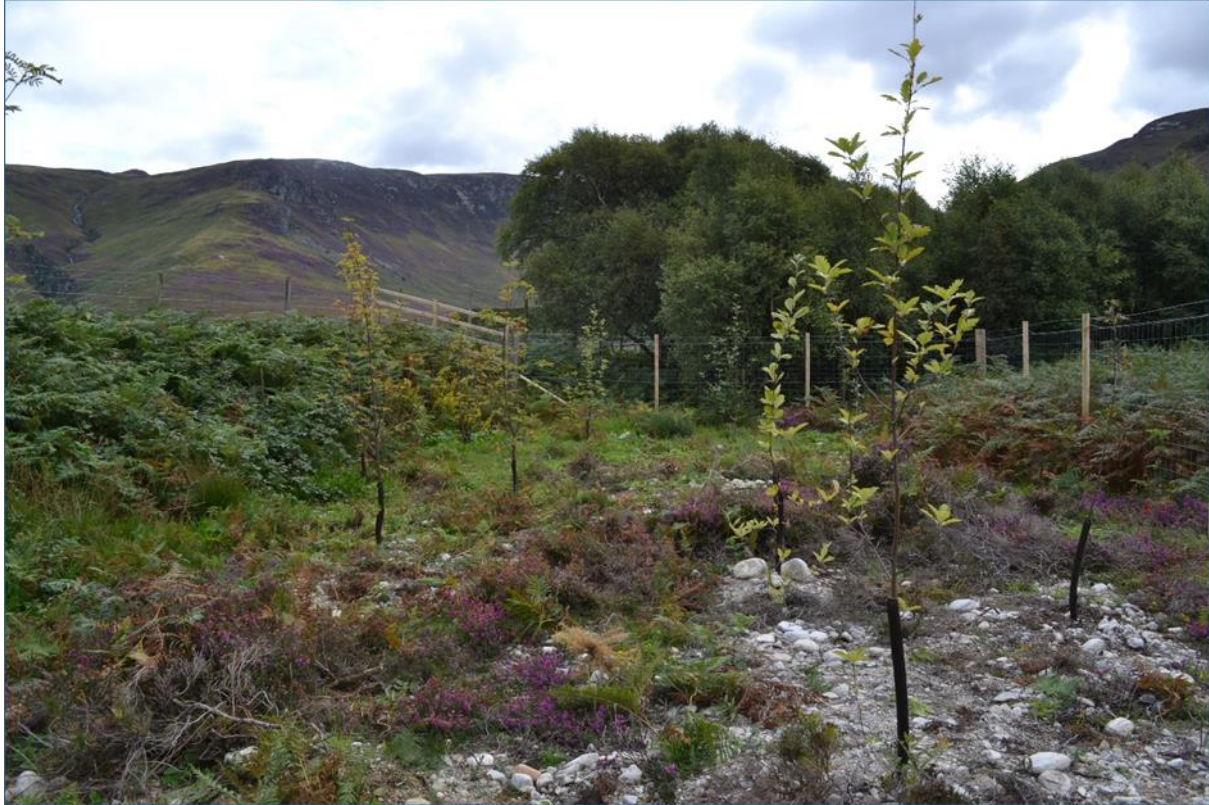
**Photograph 7. Arran Sorbus planting enclosure at mouth of Glen Catacol. September 2014.**
