# MetroWest+

## Portishead Branch Line (MetroWest Phase 1)

**Planning Inspectorate Reference: TR040011**

### 9.3.5 ExA.SoCG-HE.D1.V1 – Statement of Common Ground

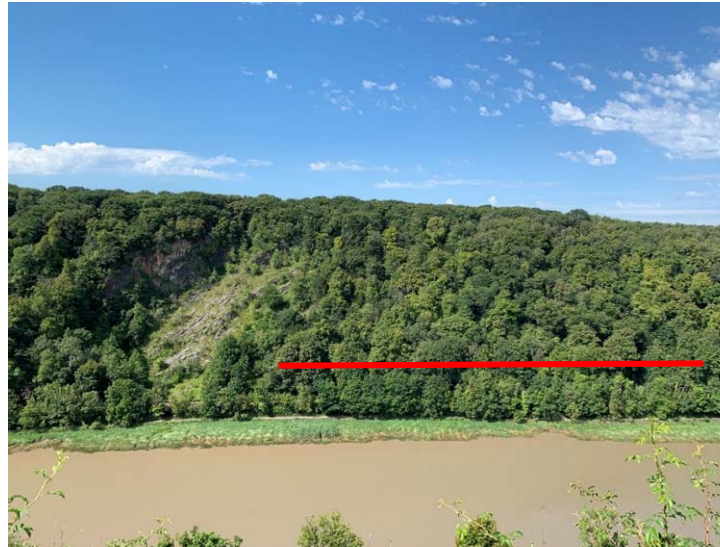
Photograph 1 – Rockfall barrier 1 location (147m long)

The three photographs show the location of the rockfall barriers. Note the locations of the barriers are shown close to scale, but please refer to the engineering drawings in the Network Rail Technical Note 'Metro West Phase I: Avon Gorge Rock Fall Barrier, 26th May 2020' at Appendix A for the exact dimensions.

It can be seen from the photographs that the rockfall barriers would be located within the existing woodland and therefore well screened from view by the planting. There would be some localised vegetation removal to allow their installation, primarily for working space and access, but this

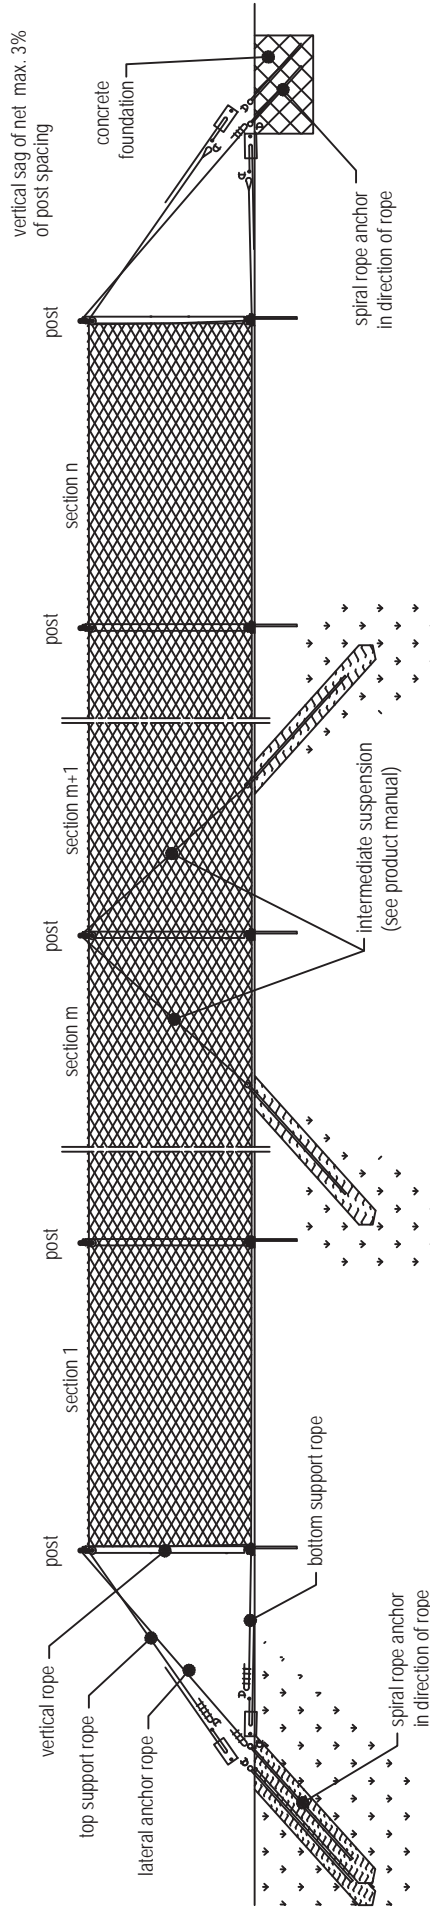
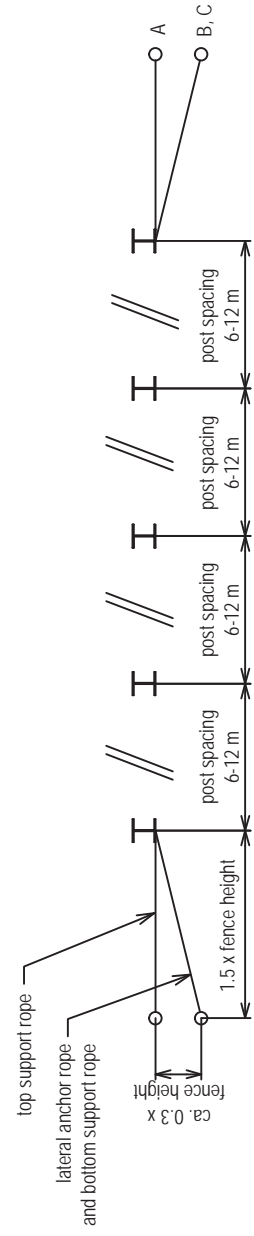
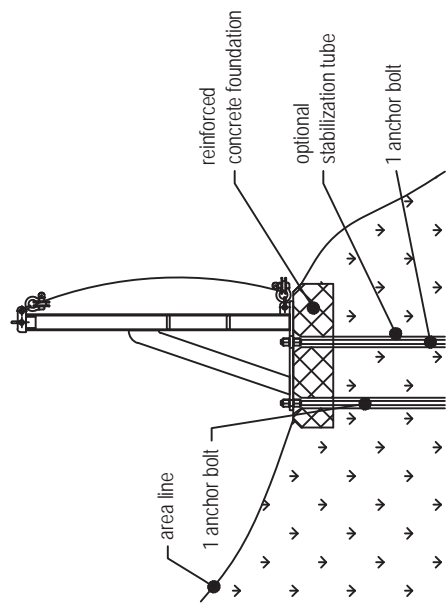
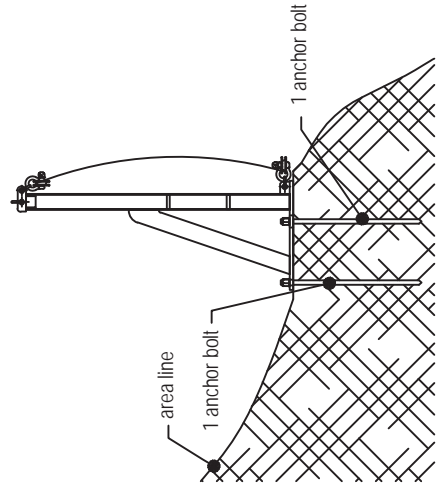
layout of anchor points  
(details see product manual GBE-500A-R)

- anchoring in loose soil: with 2 anchor bolts vertical

- anchoring concrete foundation: for all types of soil

- anchoring in bedrock: with 2 anchor bolts vertical

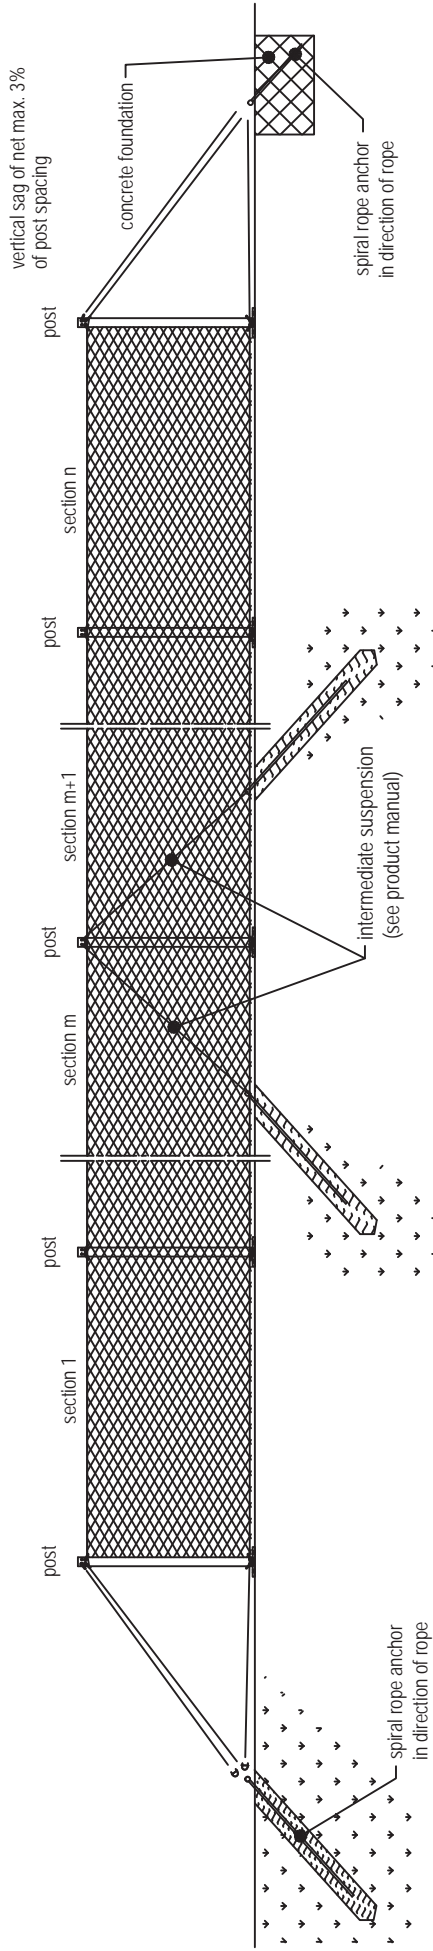
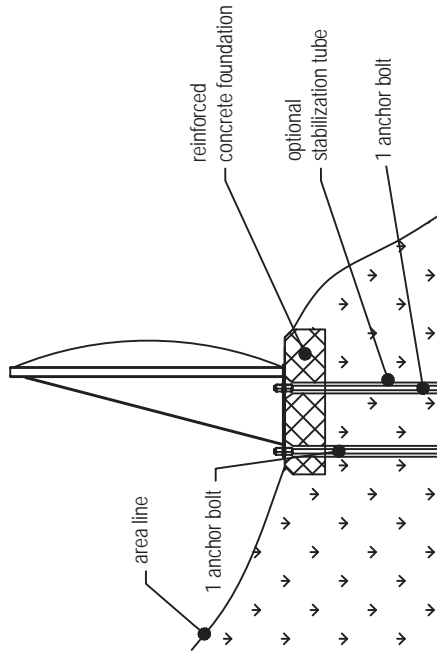
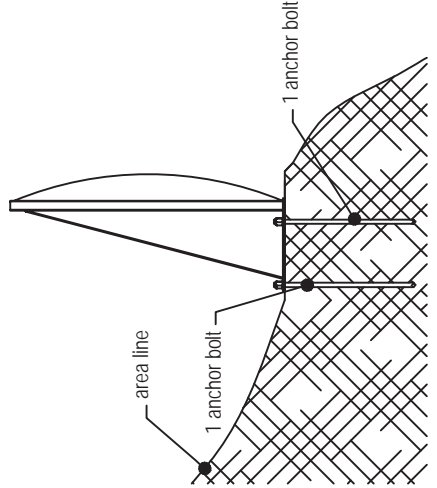
layout of anchor points  
(details see product manual GBE-100A-R)

- anchoring in loose soil: with 2 anchor bolts vertical

- anchoring concrete foundation: for all types of soil

- anchoring in bedrock: with 2 anchor bolts vertical

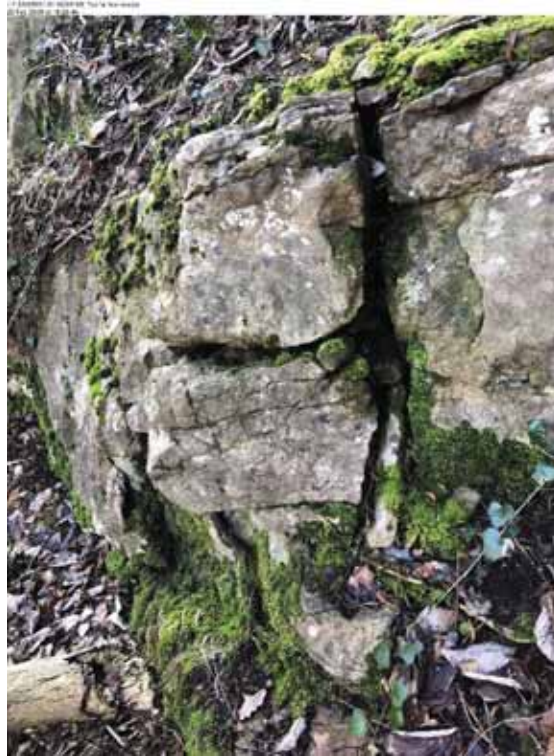
**Photo 1:** Loose rock on face of outcrop at Rockfall Barrier No. 1.

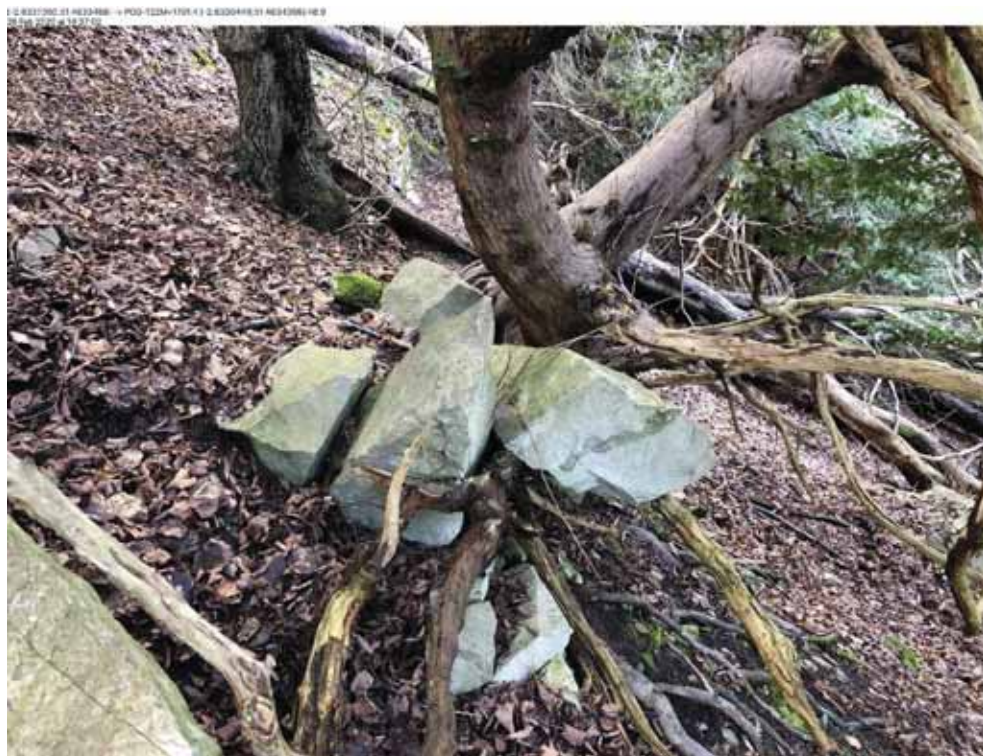
**Photo 2:** Rockfall below outcrops at Rockfall Barrier No. 1.

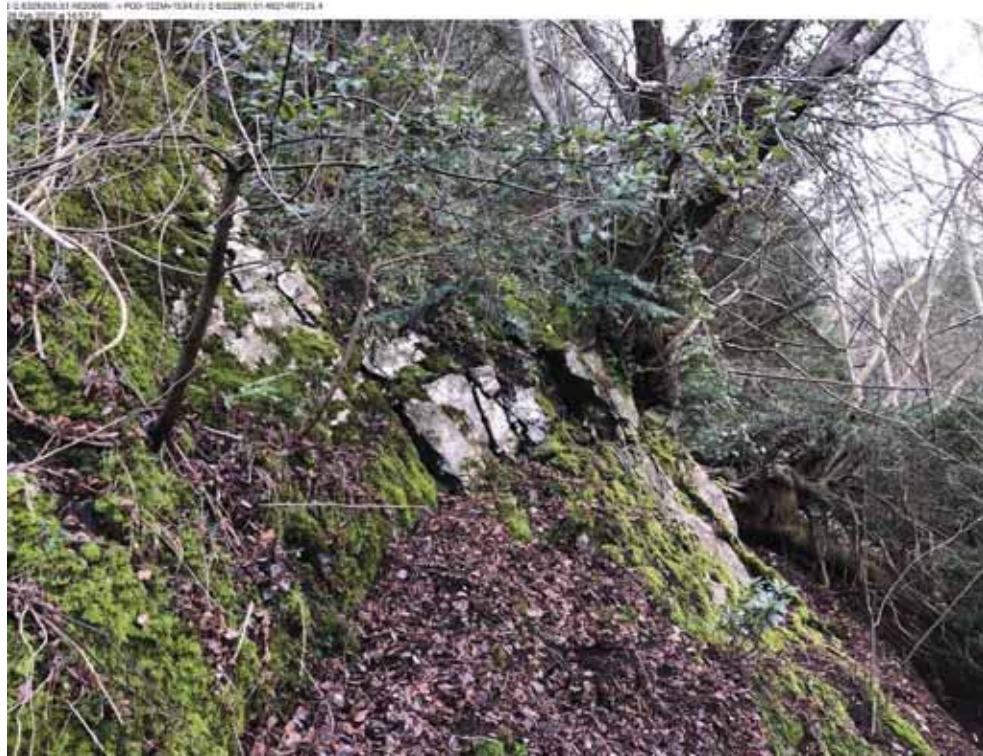
**Photo 3:** Loose rock on face of outcrop at Rockfall Barrier No. 2.

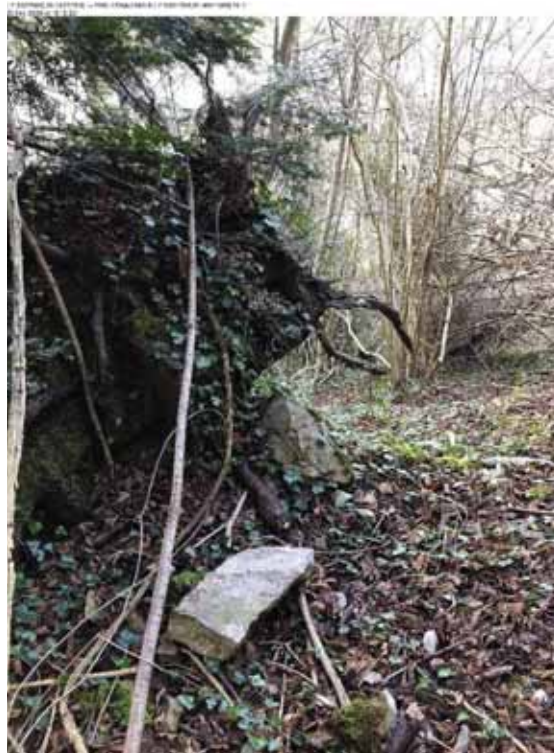
**Photo 4:** Rockfall below outcrops at Rockfall Barrier No. 2.

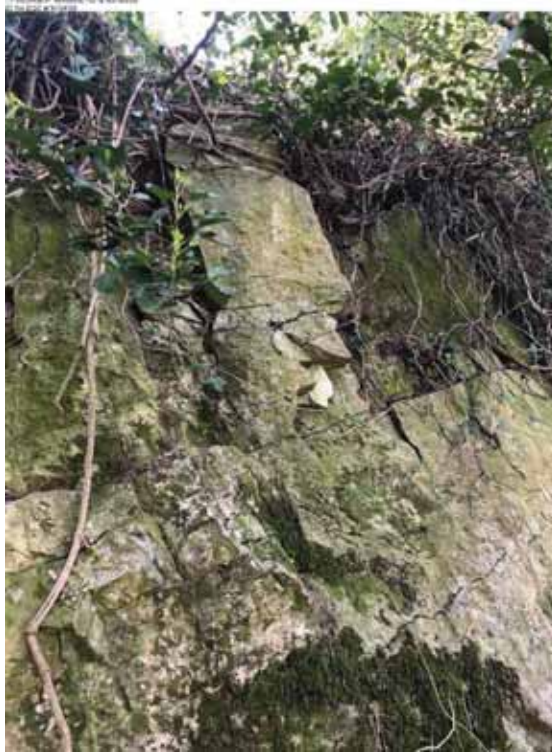
**Photo 5:** Loose rock on face of outcrop at Rockfall Barrier No. 3.

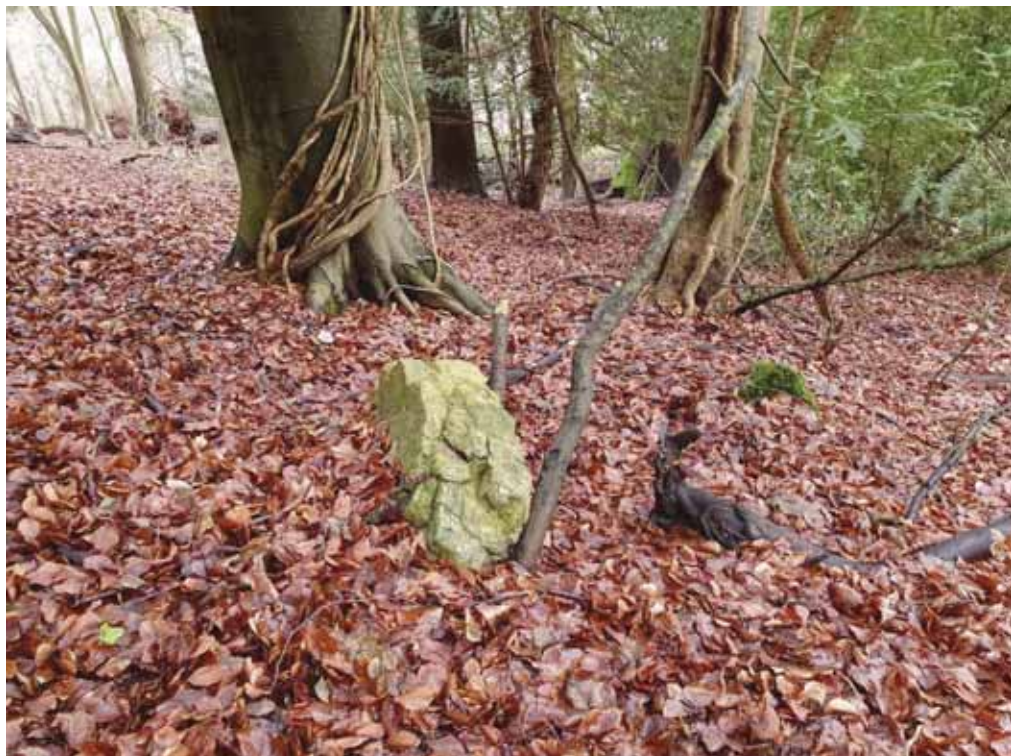
**Photo 6:** Rockfall below outcrops at Rockfall Barrier No. 3.

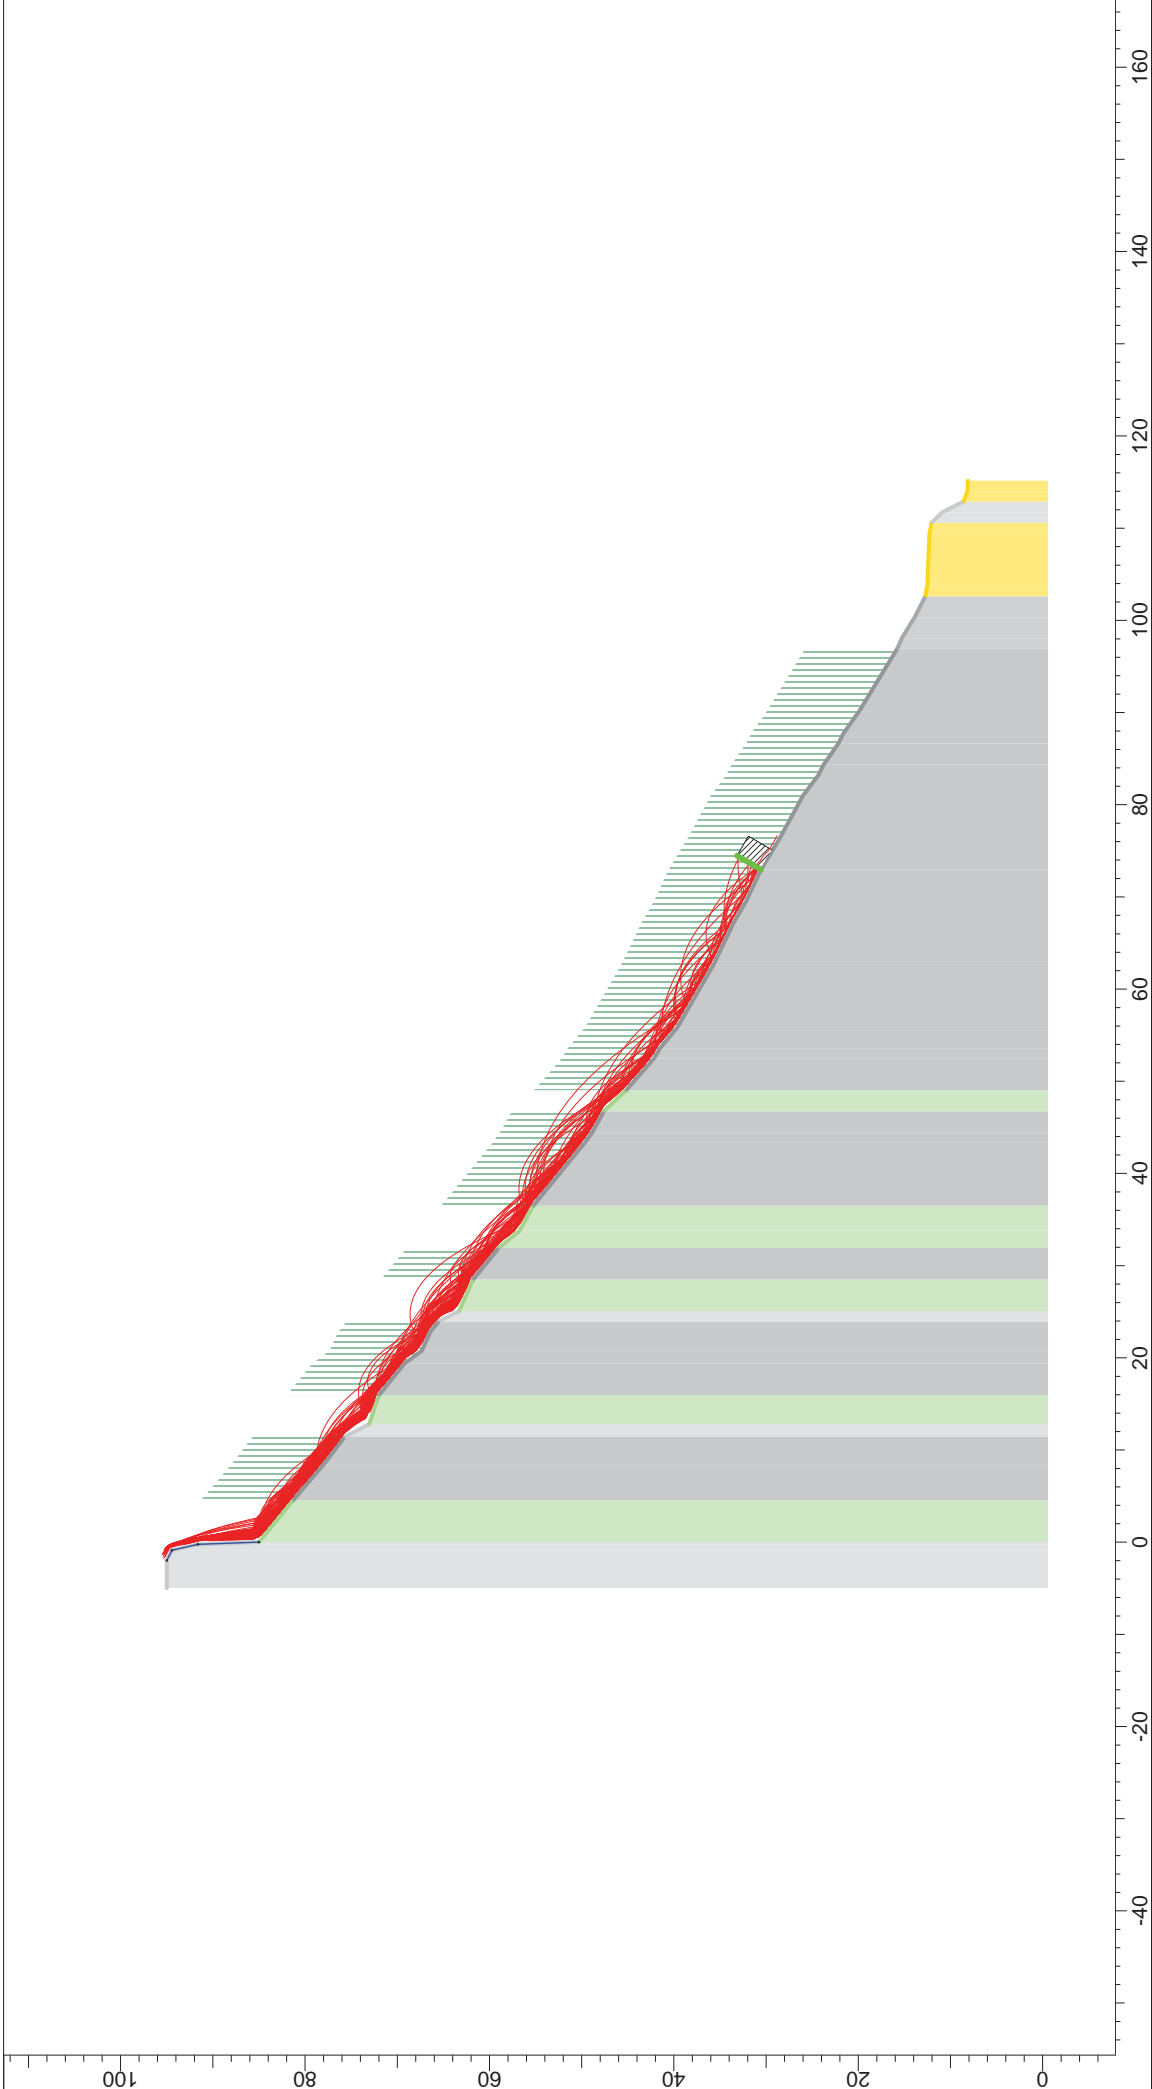
Project		MetroWest Phase I	
Analysis Description		Rockfall Barrier No. 1	
Drawn By		PS	NR
Date		27/02/2020, 12:07:02	Catch Fence No. 1.fal7

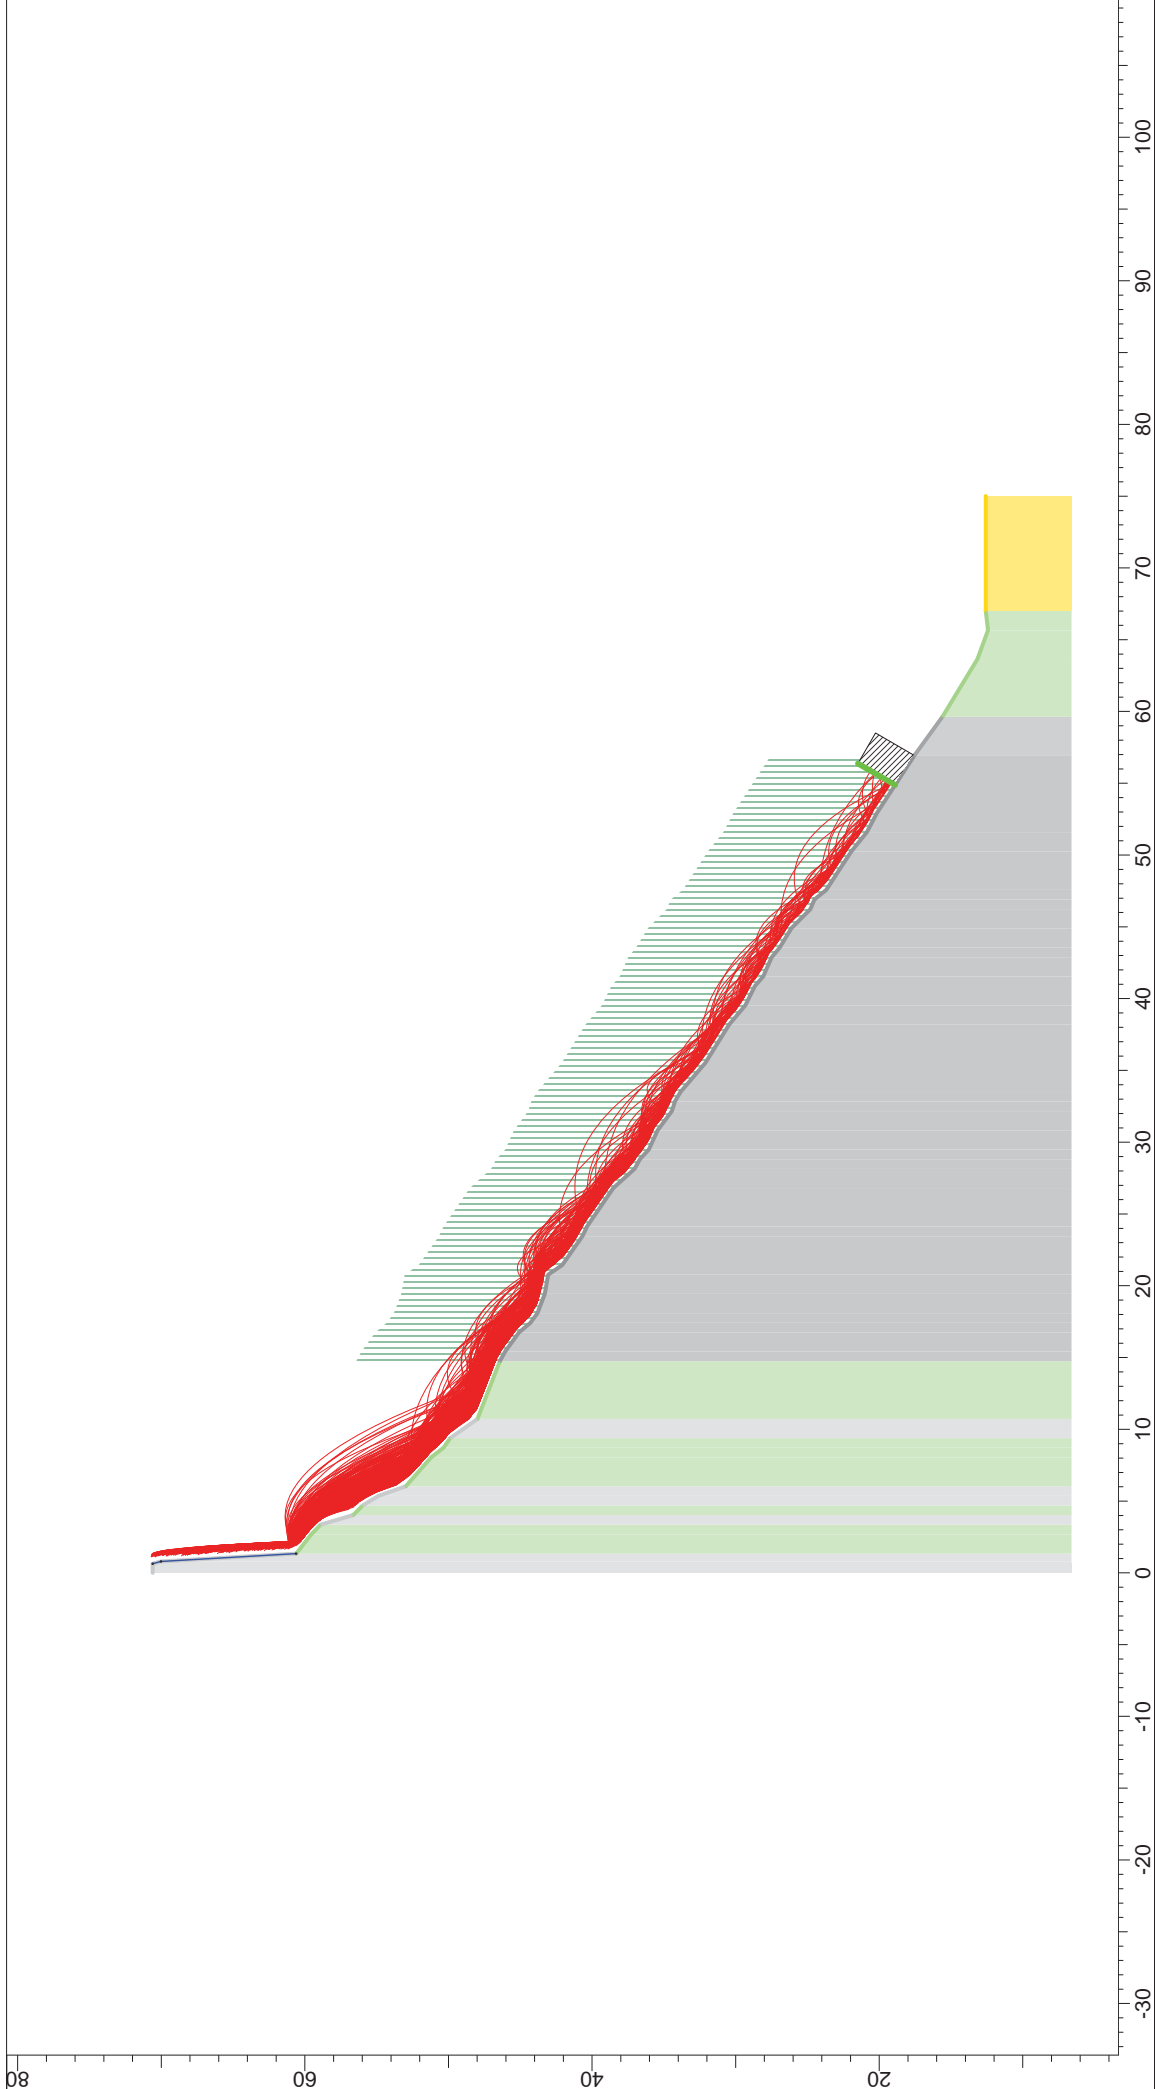
Project		MetroWest Phase I	
Analysis Description		Rockfall Barrier No. 2	
Drawn By		PS	NR
Date		27/02/2020, 12:07:02	Catch Fence No. 2.fal7

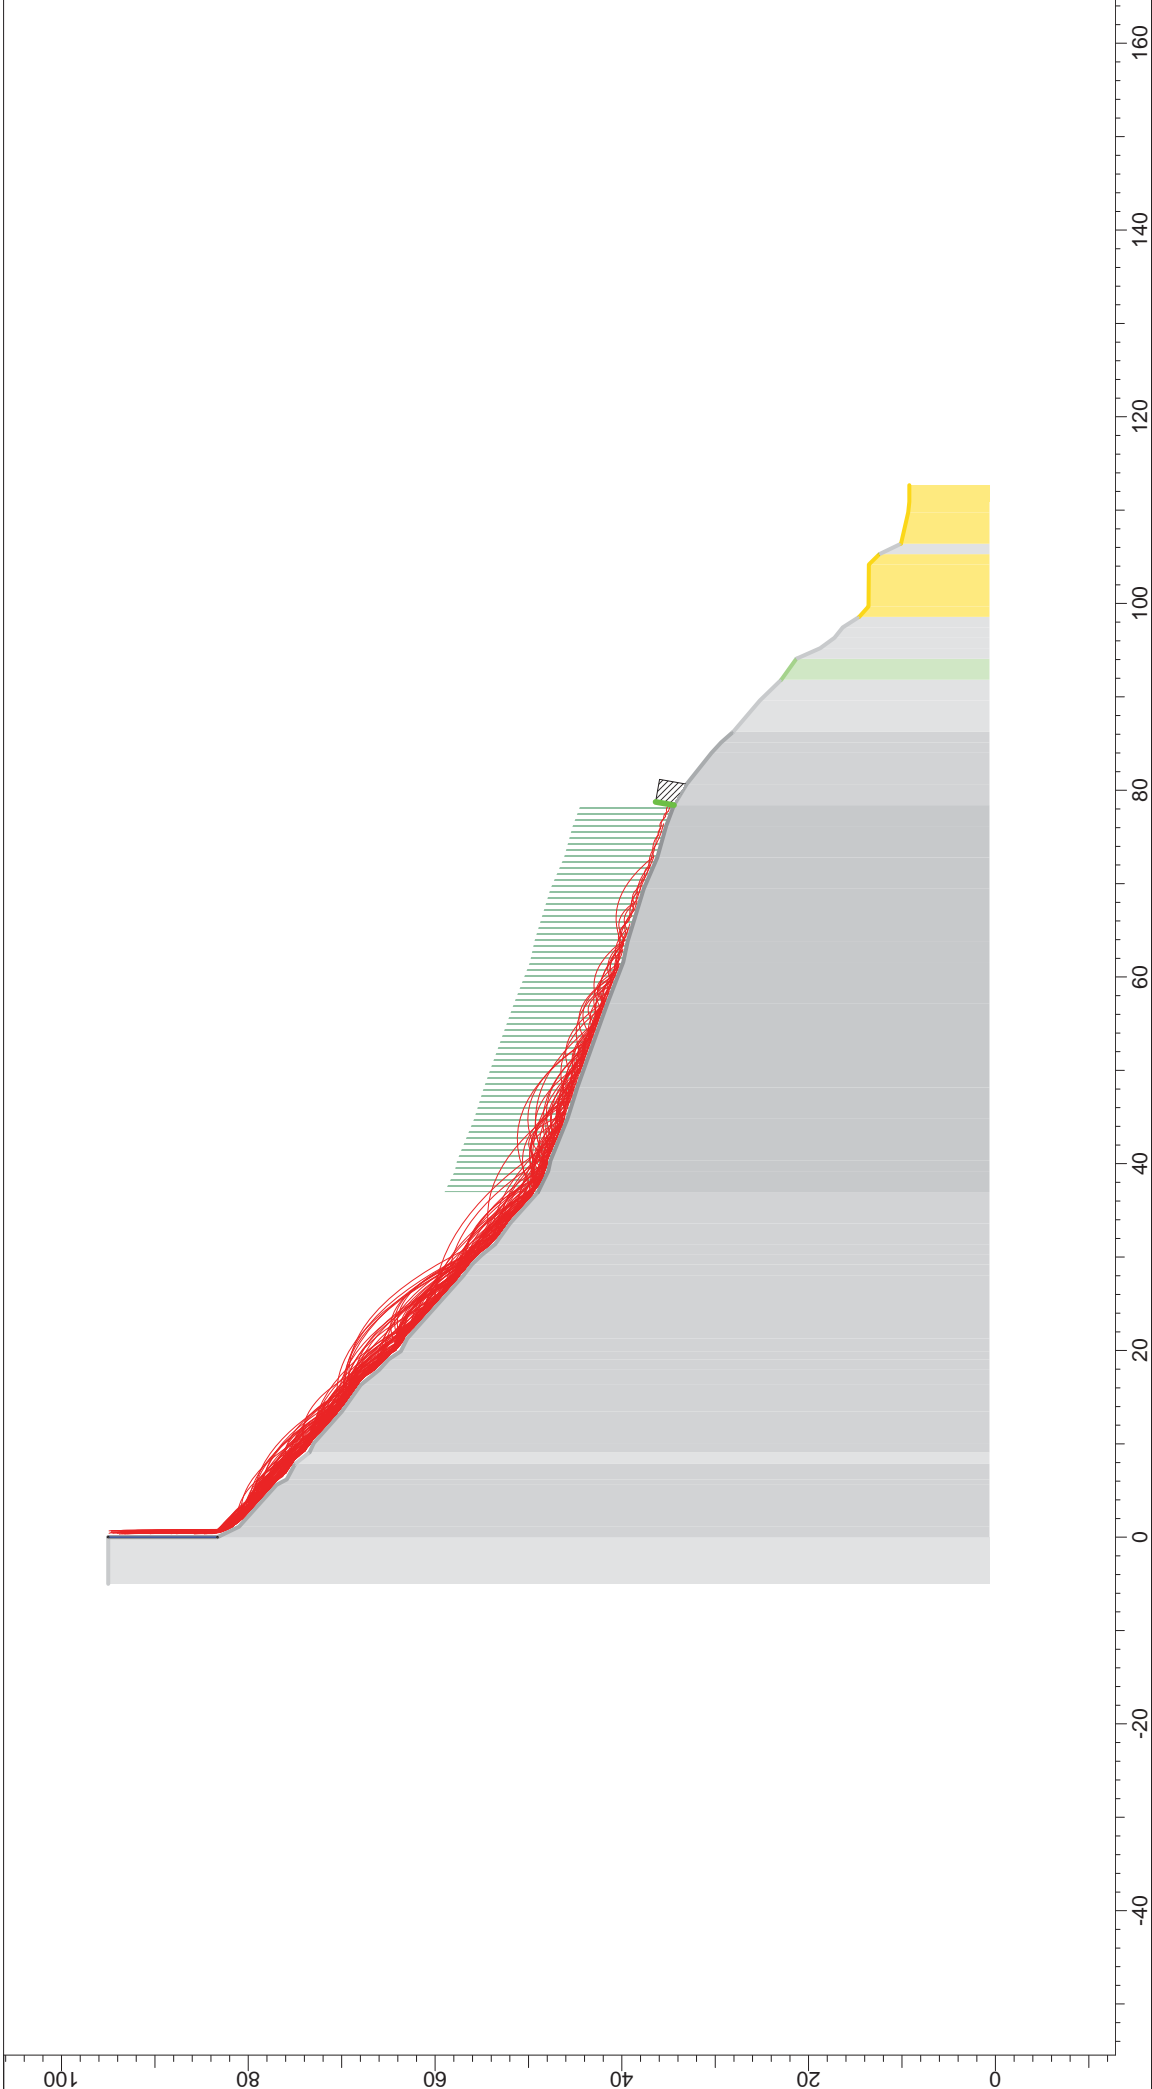
Project		MetroWest Phase I	
Analysis Description		Rockfall Barrier No. 3	
Drawn By		PS	NR
Date		27/02/2020, 12:07:02	Catch Fence No. 3 Worse Credible.fal7

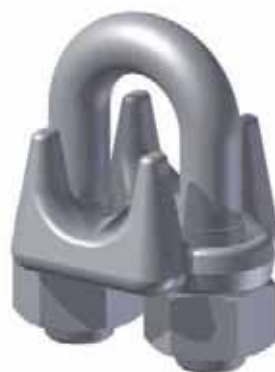
The distance  $e$  between the wire rope clips should be at least  $1 \times t$  but not exceed  $2 \times t$ , where  $t$  is the width of the clamping jaws. The loose rope end has to be  $3 \times e$  at a minimum. Geobrugg recommends looping up the remaining free section and fixing it directly behind the last wire rope clip on the tightened rope.

If you are using a thimble in the loop structure, the first wire rope clip must be attached directly next to the thimble. For loops without a thimble the length  $h$  between the first wire rope clip and the point of load incidence must minimally be 15-time the nominal diameter of the rope. In unloaded condition the length  $h$  of the loop should be not less than the double of the loop width  $h/2$ .

The clamping brackets (U-brackets) must always be fitted to the unstressed end of the rope, the clamping jaws (saddle) must always be fitted to the strained rope („never saddle a dead horse“).

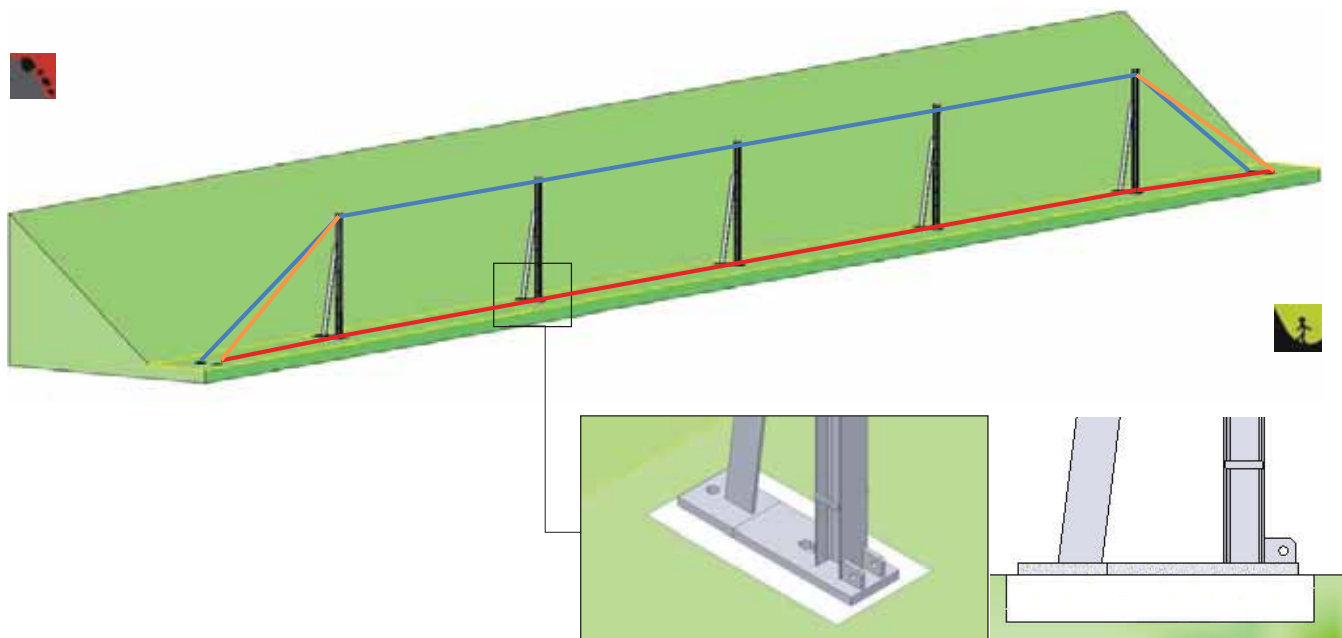
#### Barrier line

It is important to design the barrier line in a way that ensures it is as straight as possible and runs horizontally. Irregular lines as well as depressions and cambers in the terrain between the posts must be avoided or corrected wherever possible.

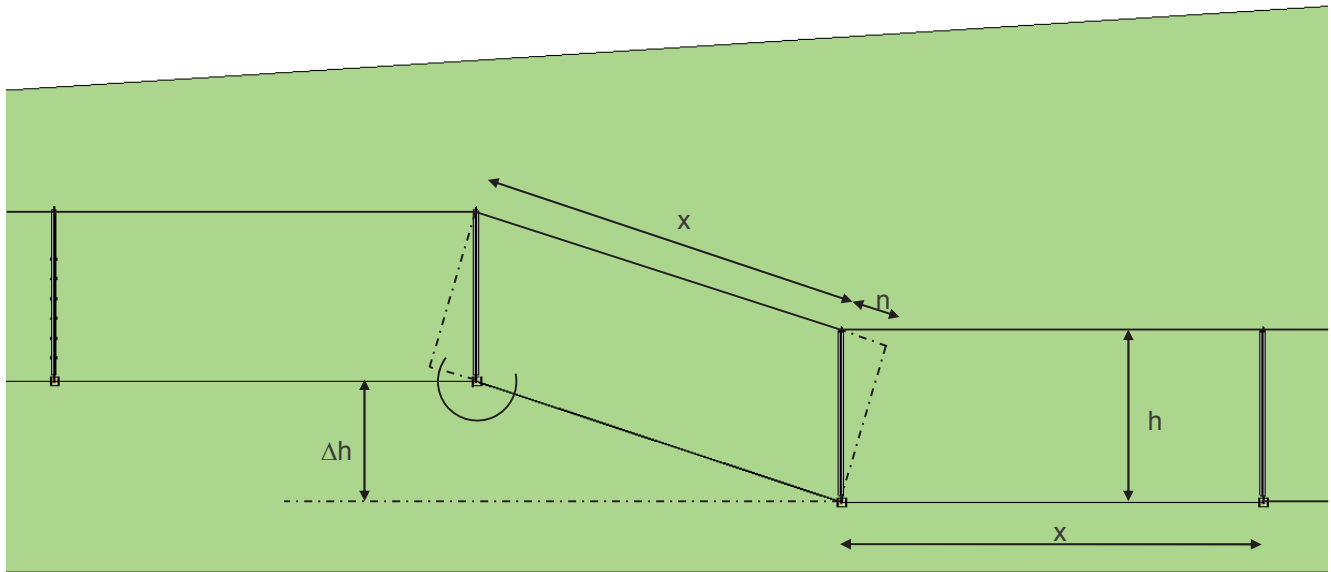
## Height differences in the barrier line

**h:** Barrier height

**x:** Distance between posts

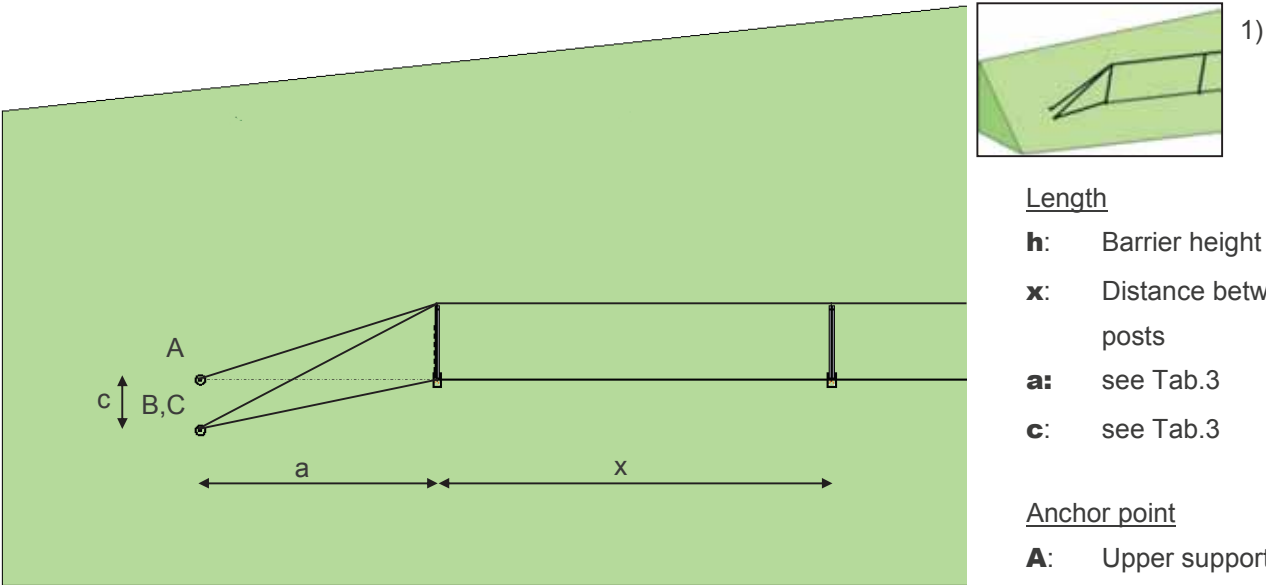
STANDARD STAKING-OUT PARAMETERS FOR A STRAIGHT BARRIER LINE

The table below is valid for slopes of 30° - 90°.  
Dimensions in m; Dimensional tolerance ± 0.20 m

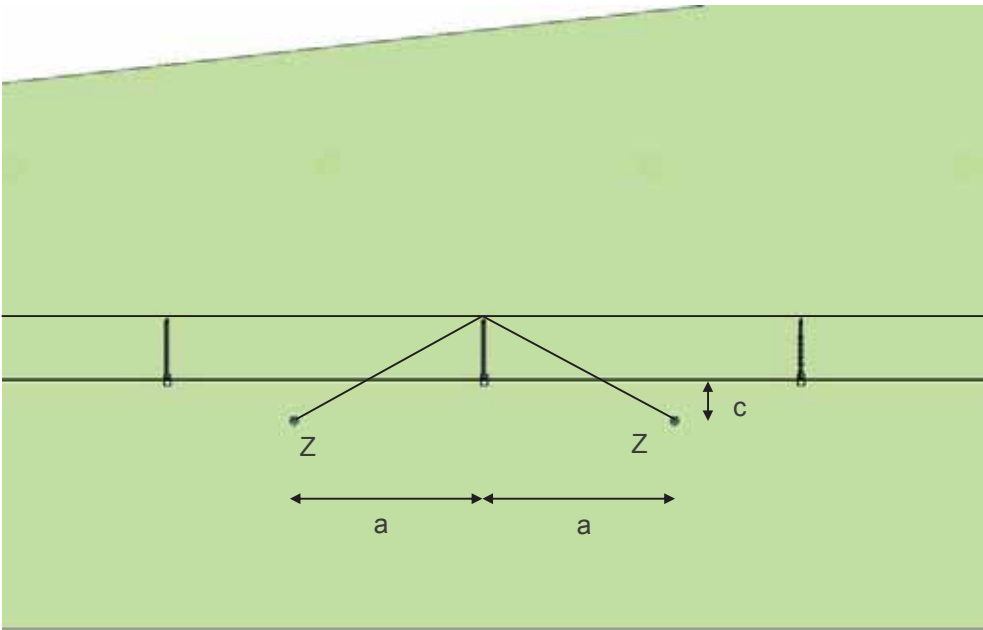
ANCHOR POINT FOR INTERMEDIATE ANCHOR ROPE

- a:** see Tab.3
- c:** see Tab.3

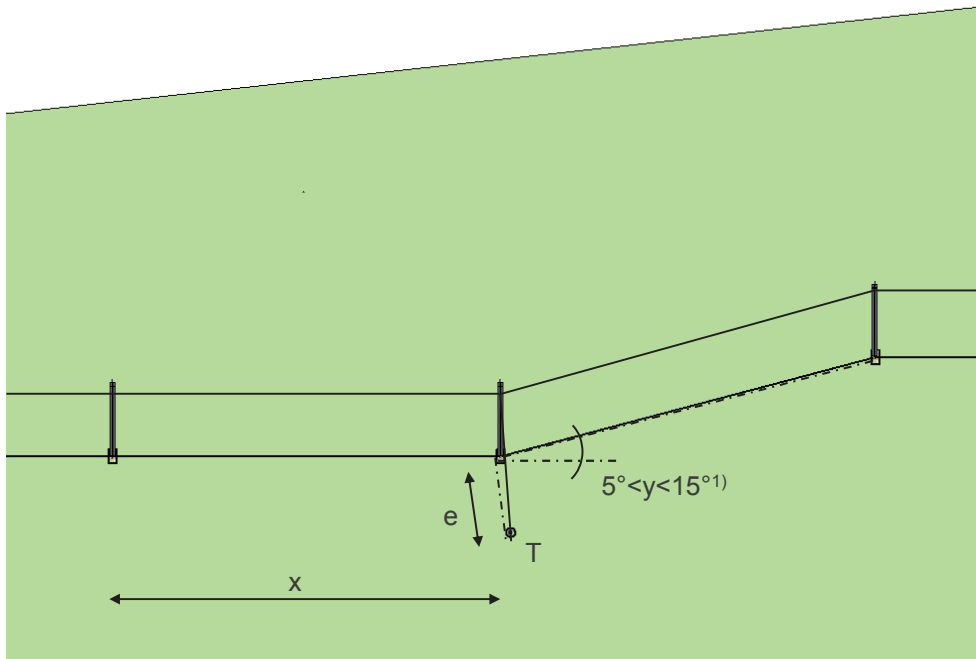
## CHANGE IN DIRECTION TOWARDS THE MOUNTAIN

- e:** See Tab. 2
- x:** Distance between posts
- y:** Angle of change in direction

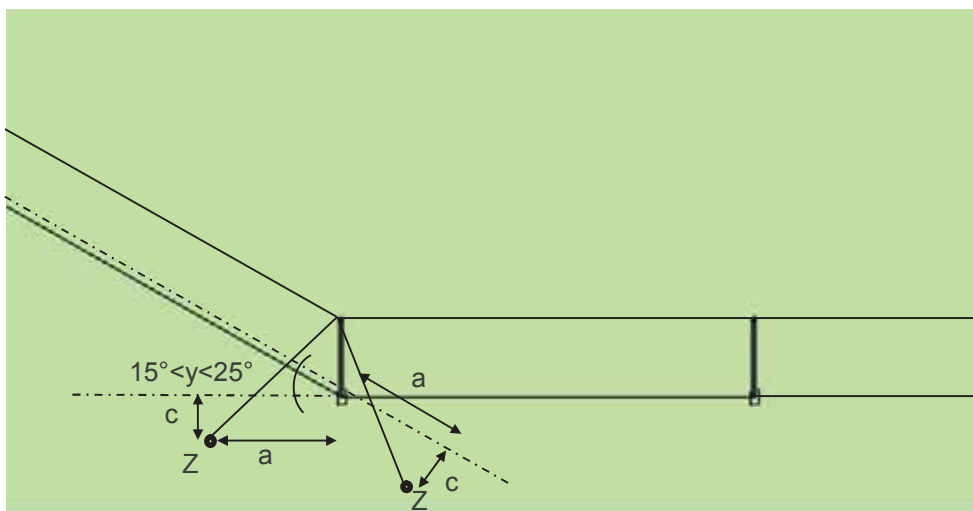
## INTERMEDIATE ANCHOR ROPE

- a:** see Tab.3
- c:** see Tab.3
- y:** angle of change in direction

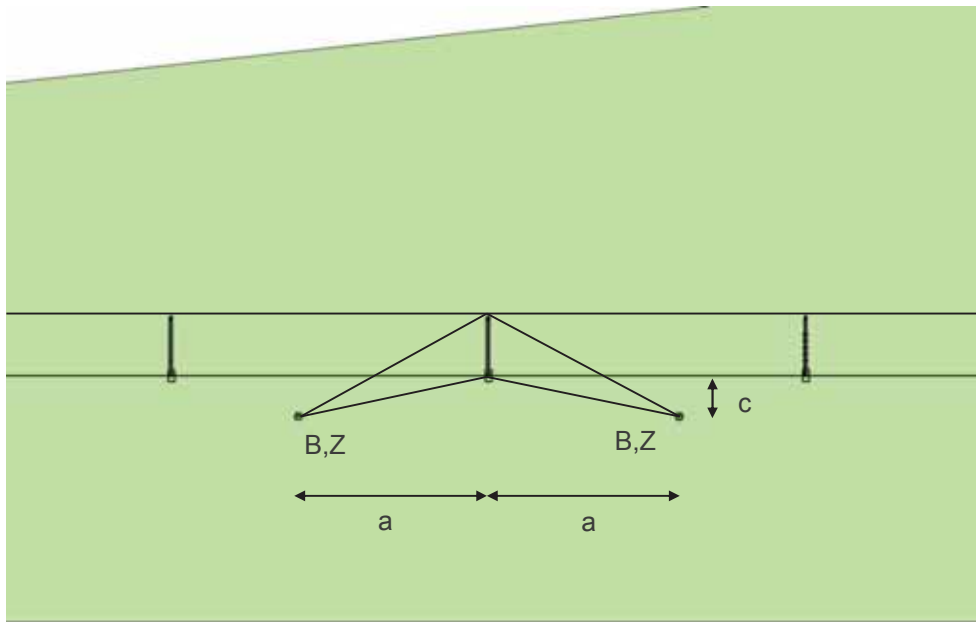
## ROPE ANCHORS FOR SUPPORT ROPE SEPARATION WITH INTERMEDIATE ANCHOR ROPE

A support rope separation also contains an intermediate anchor rope. In straightforward terrain conditions and when using appropriate equipment, we recommend positioning a support rope separation after approx. 60 m – 100 m.

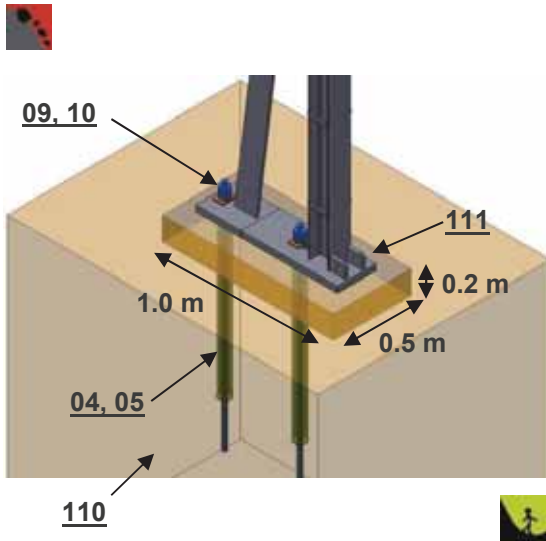
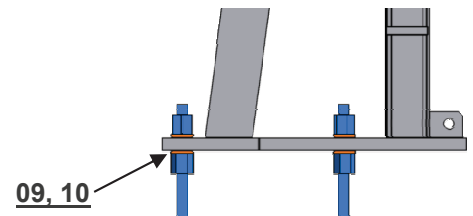
### LOOSE GROUND:

- Drill holes for anchors
- Prepare the concrete foundations 111; the concrete foundations are measured and reinforced in accordance with the specifications of the project engineer
- Insert the anchors 05, spacers 09, and fastening nuts 10; the project engineer calculates the anchor length
- Optional: Stabilization tube 04
- Using grout, fix the anchors 05 in place in loose ground 110
- Fill in the concrete foundation 111
- Tighten the fastening nuts 10 to a preload force of approx. 30 kN

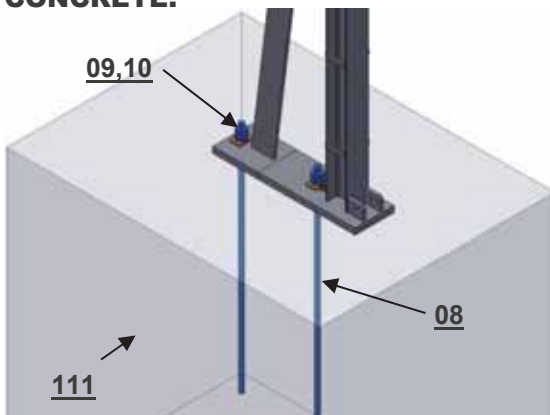
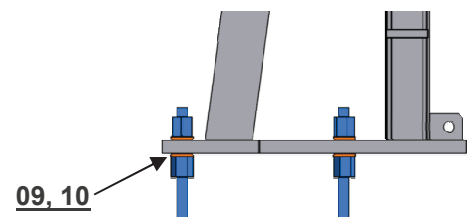
### CONCRETE:

- **Applicable to all ground and rock types**
- Dig a hole for the concrete foundation 111  
The reinforcement of the concrete foundation is measured in accordance with the specifications of the project engineer
- Install both anchors 08 (using a template), **spacers 09 and fastening nuts 10 must be attached on both sides of the base plate**
- Fill in the concrete foundation 111
- Tighten the fastening nuts 10 to a preload force of approx. 30 kN

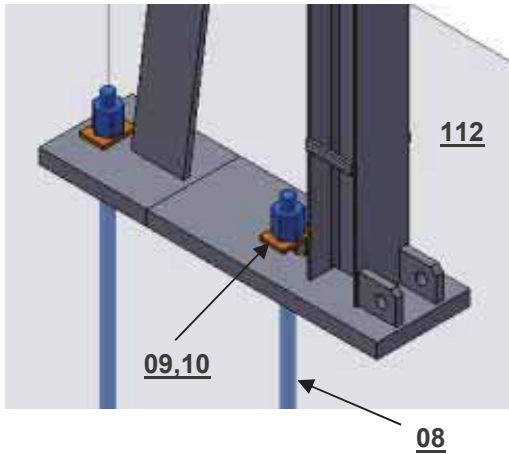
## ROCK:

- Drill holes for anchors **08** into the rock **112** at a right angle to the base plate
- Using grout, fix the anchors **08** in place; the project engineer calculates the anchor lengths
- A thin grout levelling layer is intended to guarantee that the base plate has a sturdy seat
- Position the post in grout levelling layer
- Tighten the fastening nuts **10** with spacers **09** to a preload force of approx. 30 kN once the grout has completely hardened

Use grout that is resistant to frost and de-icing salts.  
Reinforcement: 12 mm steel diameter at 150 mm intervals

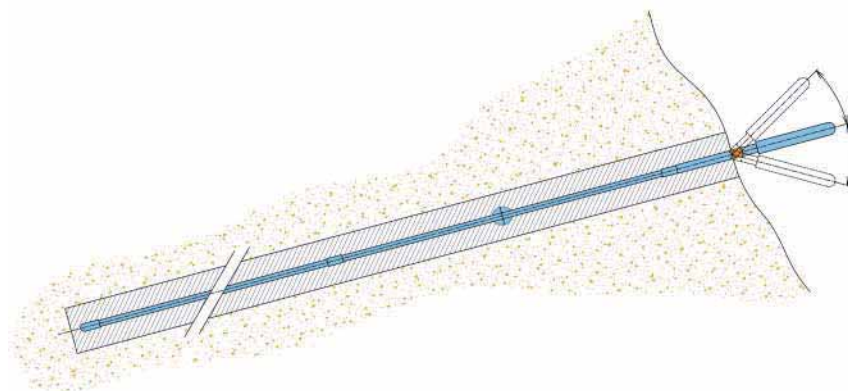
Depending on the terrain conditions but in any case, if terrain slope angle  $\beta > 45^\circ$  it is recommended to use "gap filling nets" (additional mesh between the terrain and bottom part of the mesh).

The anchor holes are drilled in the pulling direction, with a minimum angle of  $> 15^\circ$  to the horizontal.

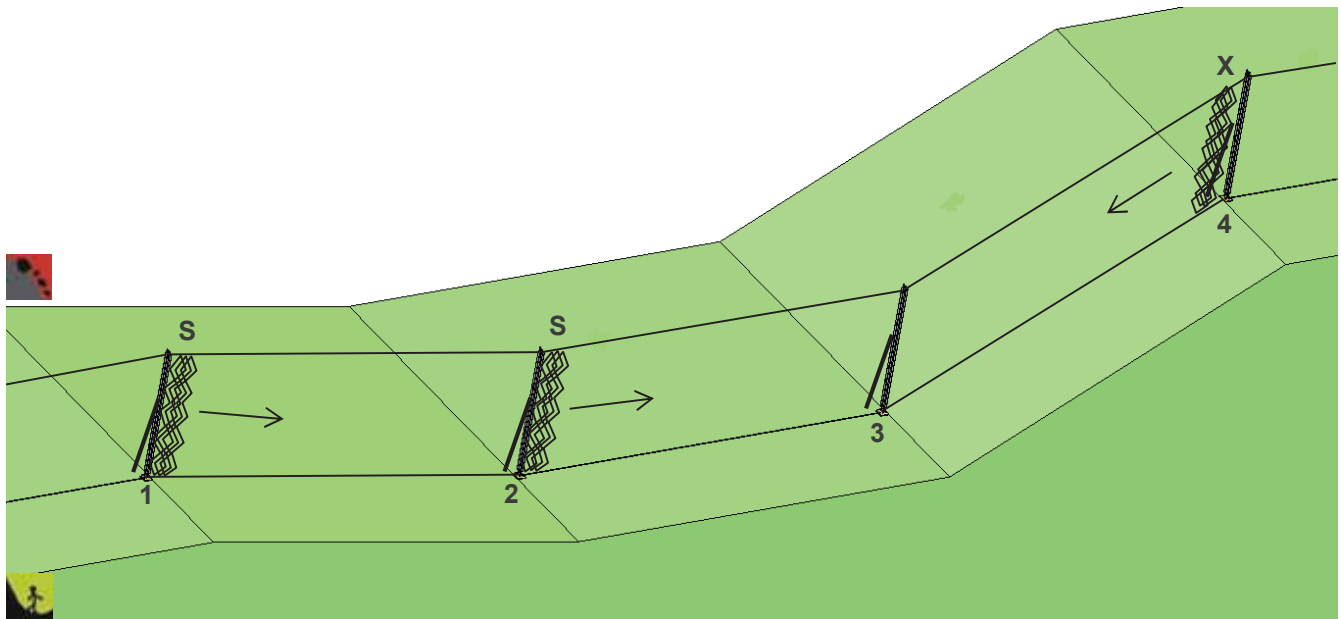
### THE CORRECT SIDE OF THE NET BUNDLE

The posts are numbered from left to right (from the downslope)
