# MetroWest+

## Portishead Branch Line (MetroWest Phase 1)

**Planning Inspectorate Reference: TR040011**

### 9.3.5 ExA.SoCG-HE.D1.V1 – Statement of Common Ground

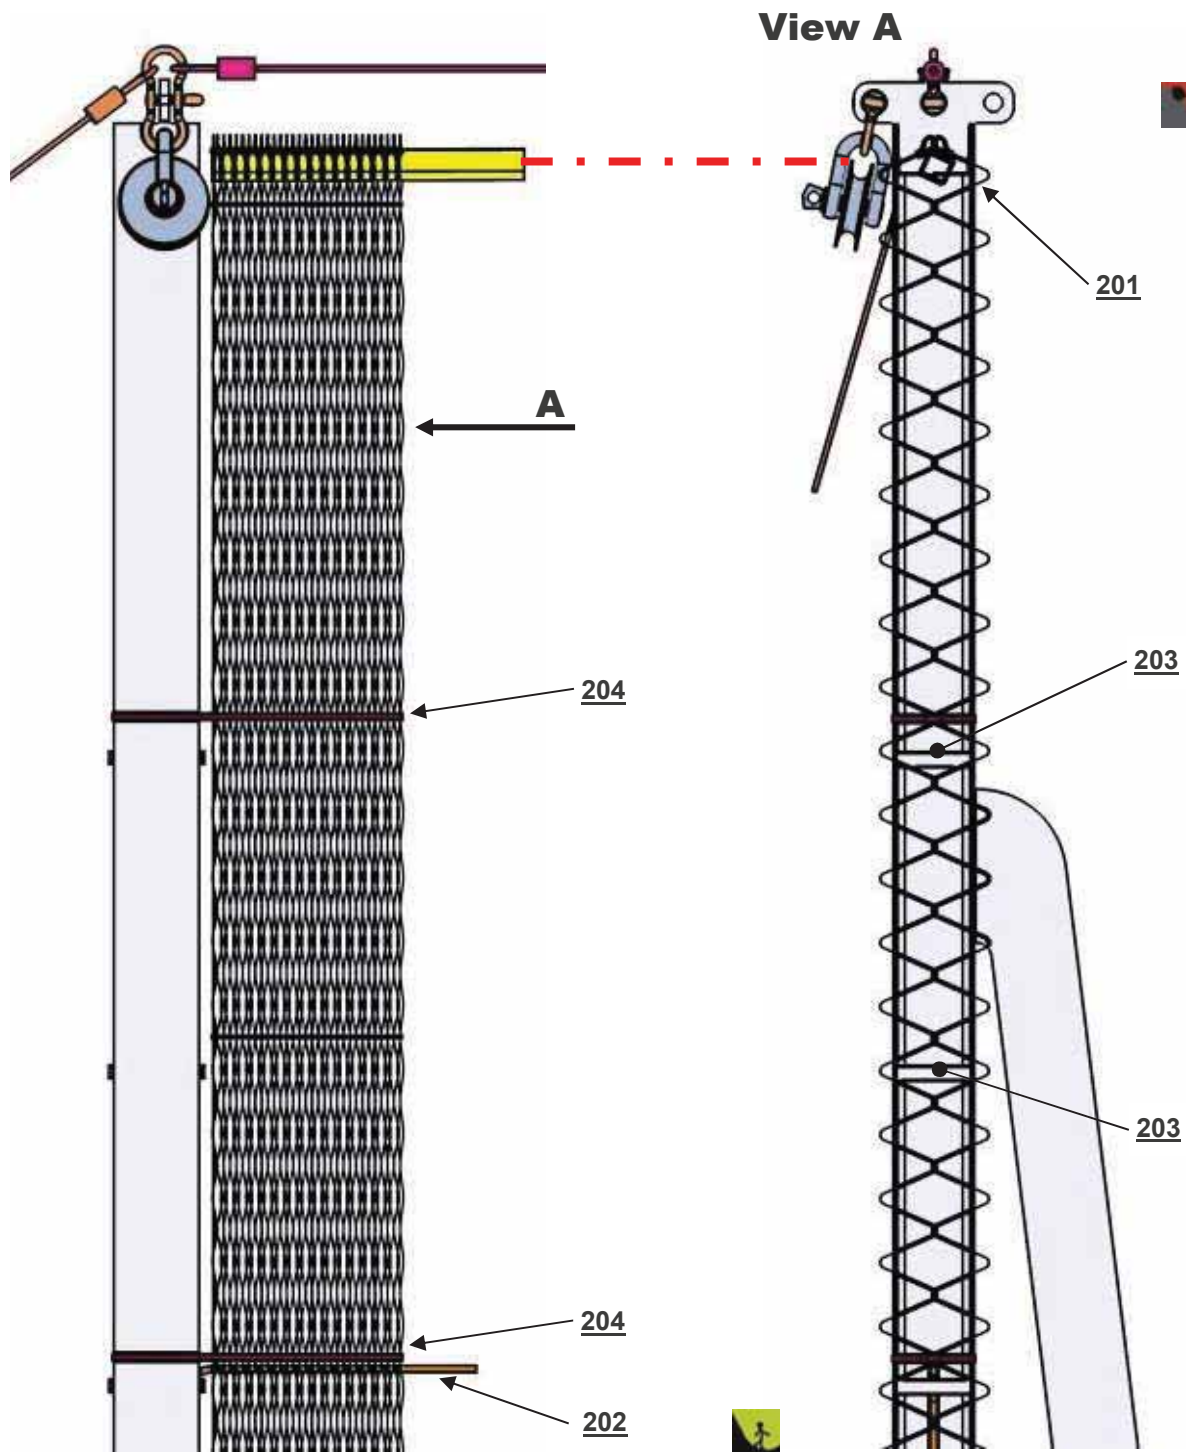
## THE CORRECT HEIGHT OF THE NE BUNDLE

The height of the uppermost row of mesh 201 is somewhat above the height of the preinstalled running wheels. The mounting bracket 202 is placed at the correct height between the rungs 203 and the post wall.

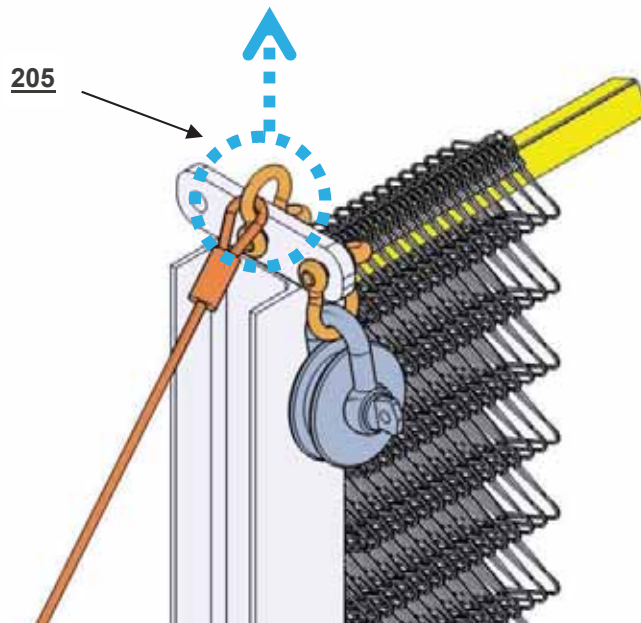
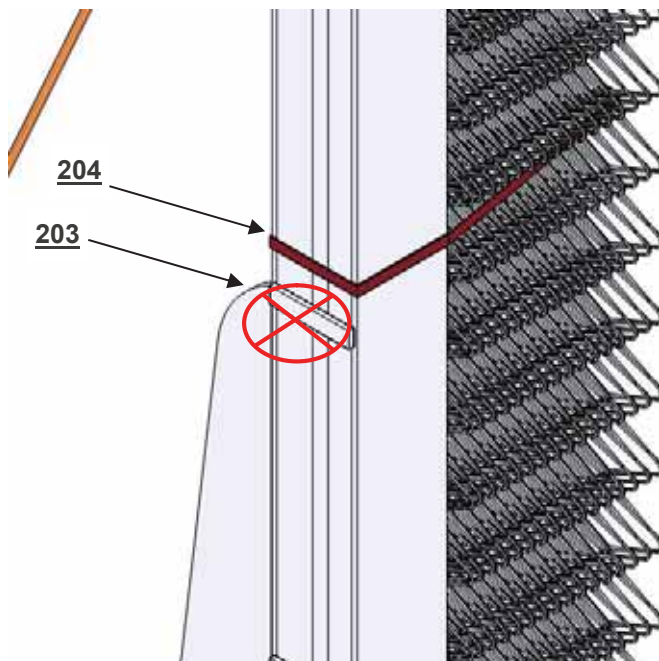
The net bundle is placed on the mounting bracket and securely fastened with 204 bands.

Fasten the mesh bundle using bands 204 and the mounting bracket so that it cannot fly away.

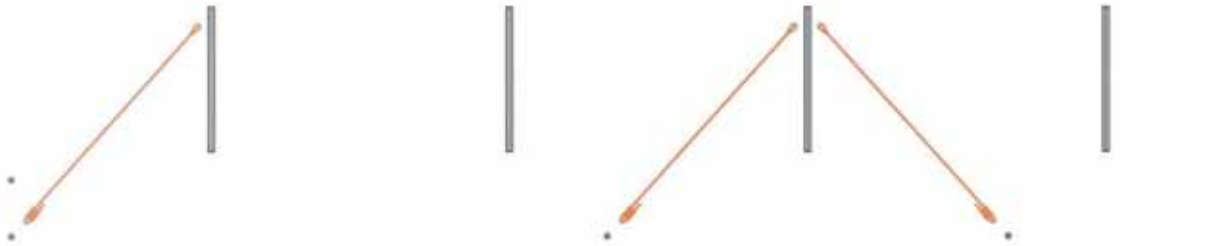
- Install the lateral ropes and intermediate anchor ropes.

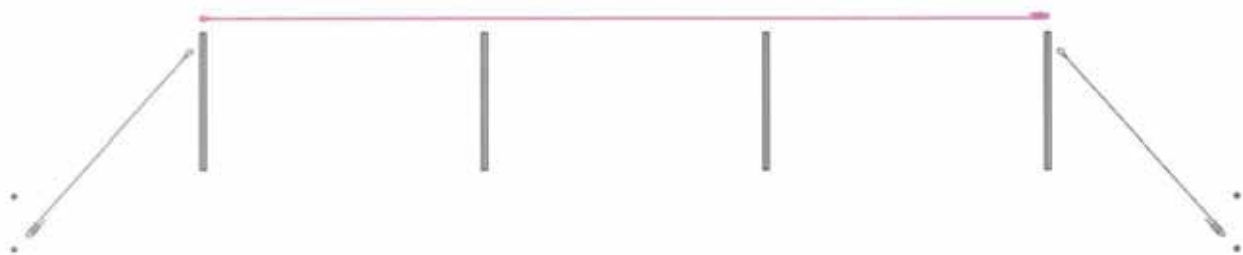
- Install the post head rope on the two outermost posts.

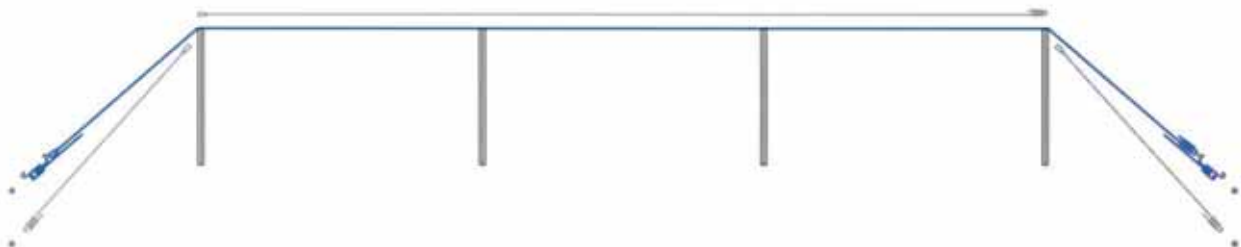
- Install the U-Brake for the top support rope on the anchors. Fasten the top support rope to the tops of the posts and tension the top support rope.

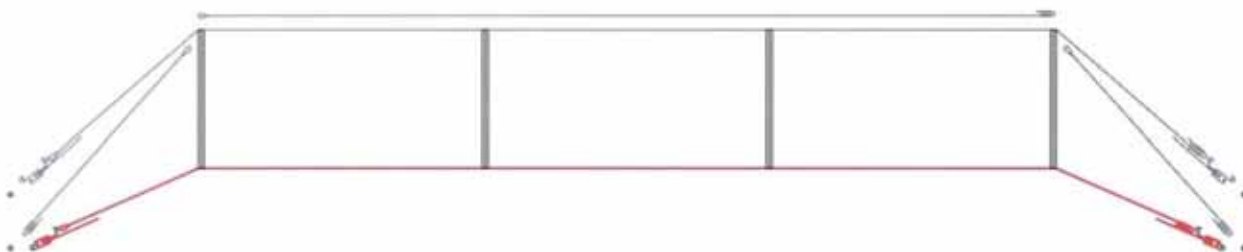
- Install the U-Brakes on the anchors, fasten the bottom support rope to the baseplates, and then tension the lower support rope.

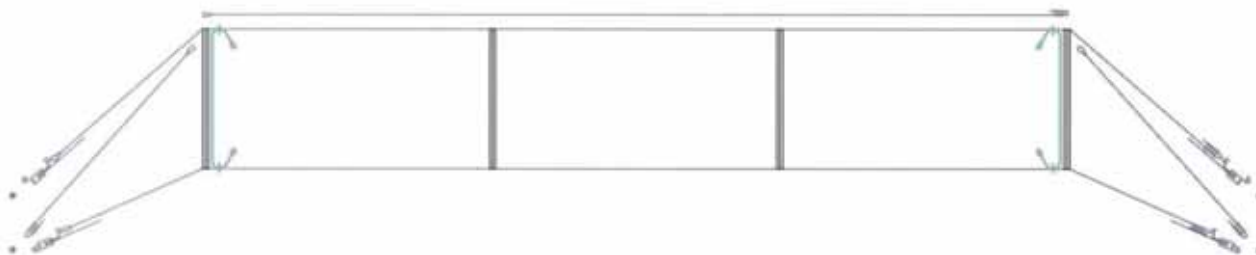
- Install the vertical ropes close to the two outermost posts.

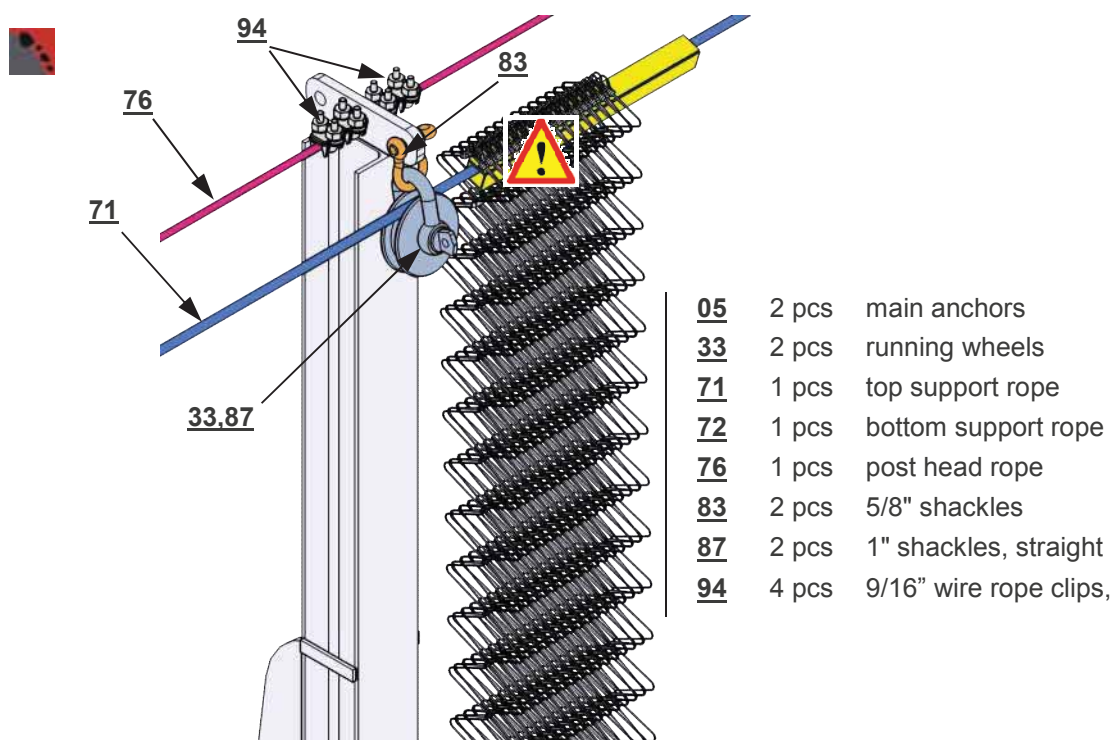
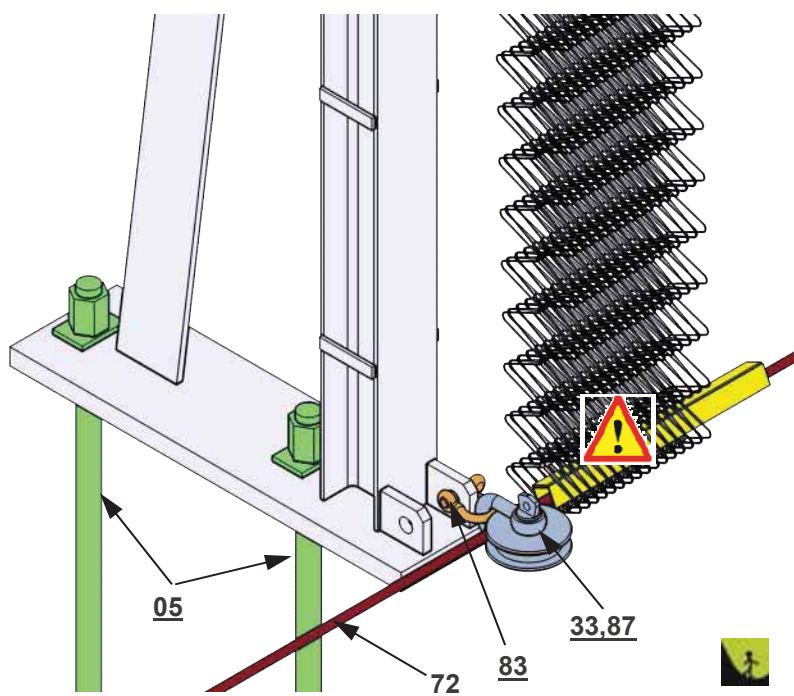
## MIDDLE POST

It is a schematic illustration of the net bundle, make sure that the right number of meshes rest free.

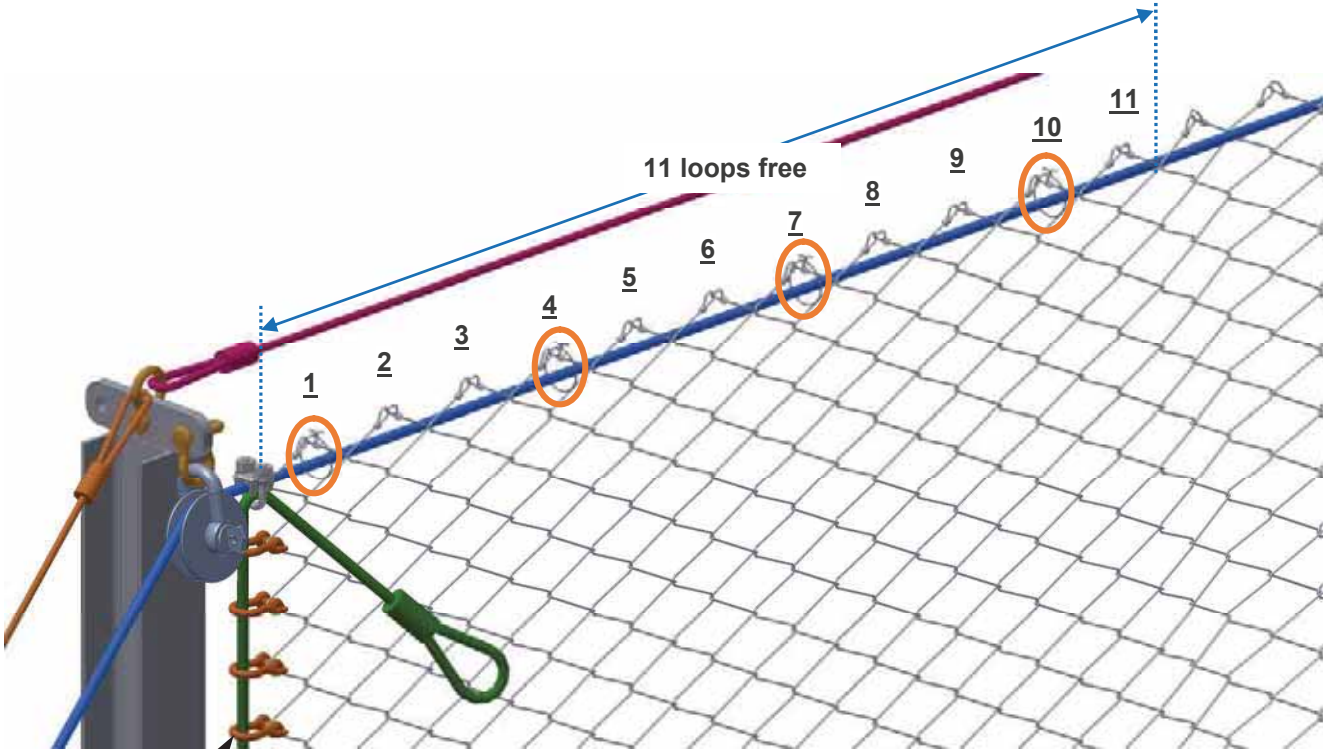
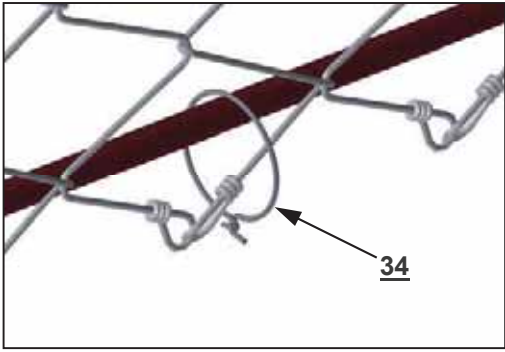
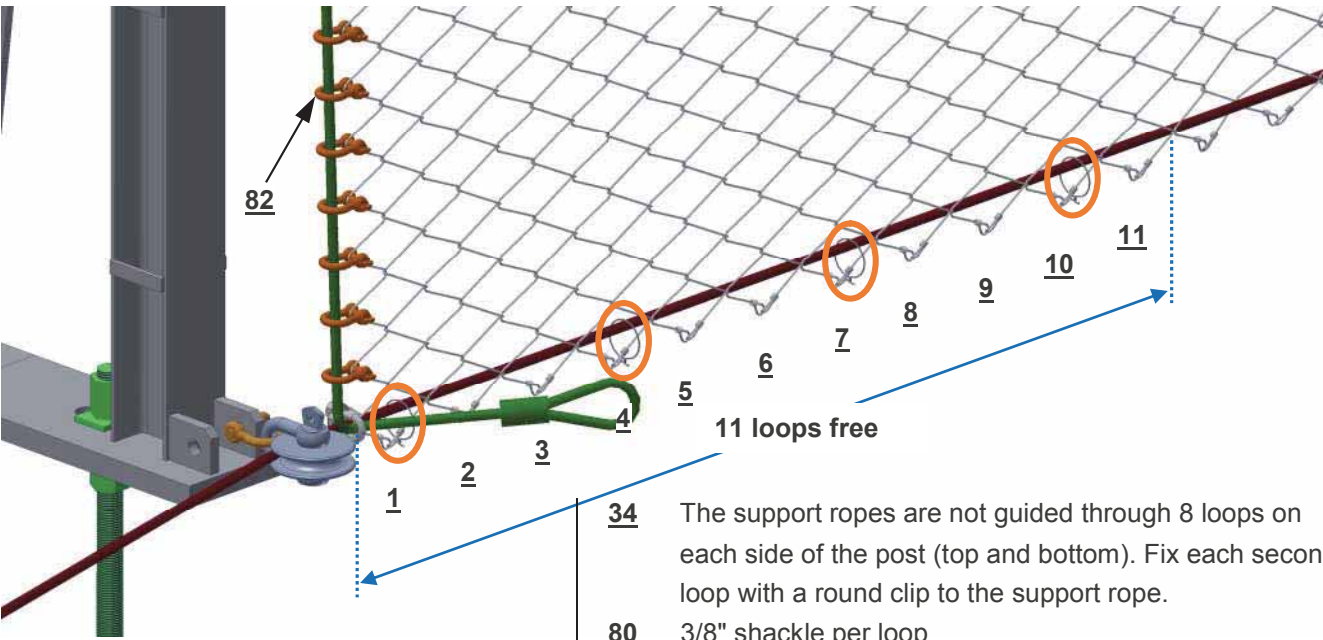
**TECCO® G80/4 ON THE SUPPORT ROPES (BORDER POST)**

- 34** The support ropes are not guided through 8 loops on each side of the post (top and bottom). Fix each second loop with a round clip to the support rope.
- 80** 3/8" shackle per loop
- 82** 1/2" shackle per loop on vertical rope

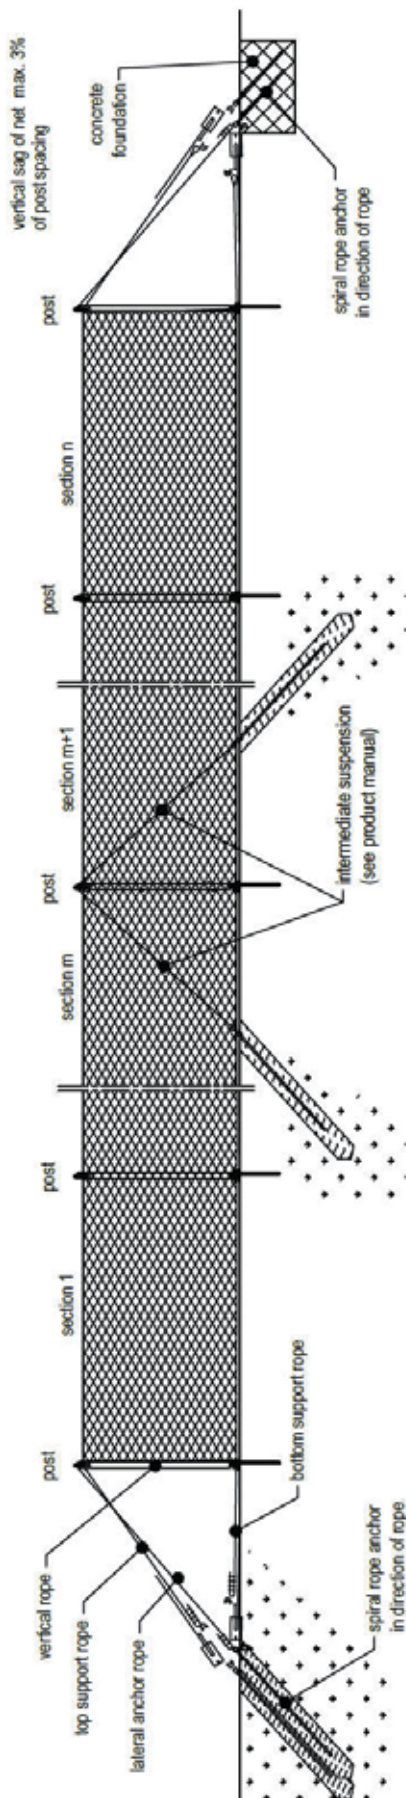
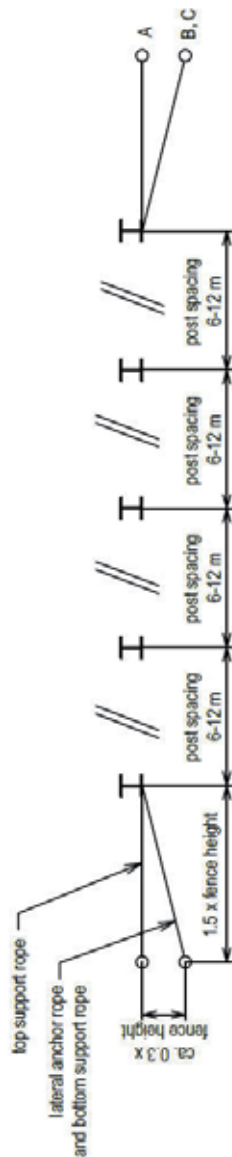
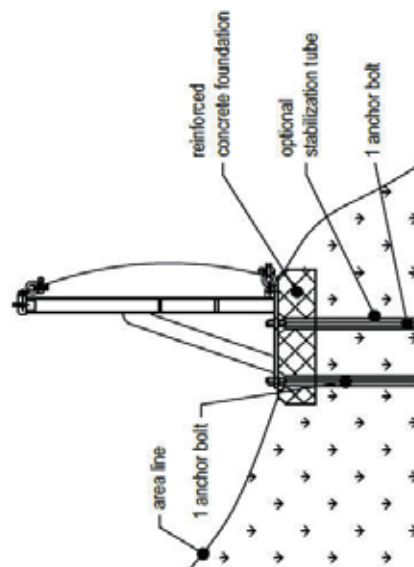
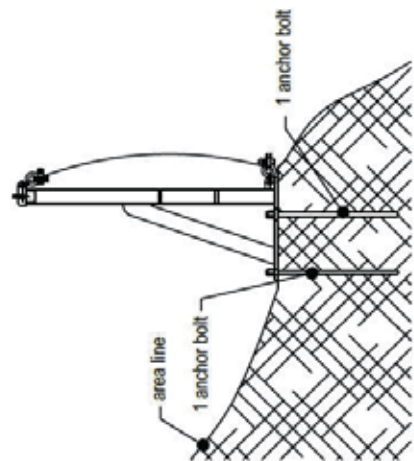
layout of anchor points  
(details see product manual GBE-500A-R)

- anchoring in loose soil: with 2 anchor bolts vertical

- anchoring concrete foundation: for all types of soil

- anchoring in bedrock: with 2 anchor bolts vertical
