Portishead Branch Line (MetroWest Phase 1)

Applicant: North Somerset District Council
8.12, Avon Gorge Vegetation Management Plan
The Infrastructure Planning (Applications: Prescribed Forms and Procedure)
Regulations 2009, Regulation 5(2)(q)
Planning Act 2008

Author: CH2M
Revision: Version 3
Date: March 2021

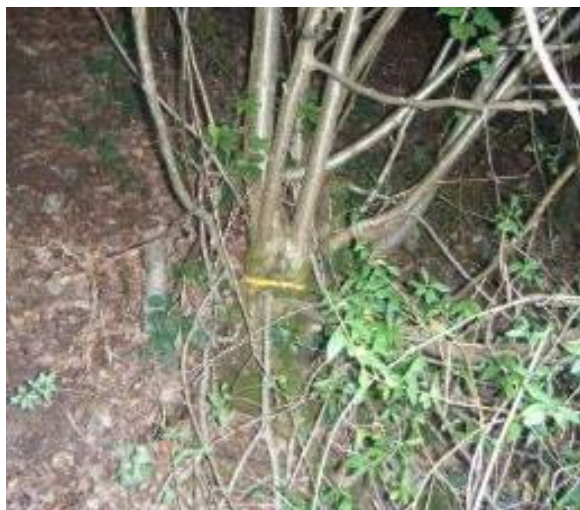
Plastic yellow collars installed to facilitate the identification of sensitive species during works along the freight line. A number of these collars are now constricting the plant which they demarcate and should be removed to prevent growth restriction and death of the tree.

- 2.1.27 A number of techniques including spray paint, coloured tape and plastic collars have been used to demarcate sensitive Whitebeam plants in the Avon Gorge, as shown in the photographs below. The number of methods employed have the potential to cause confusion to those undertaking works, alert the public to sensitive species and also distract from the natural setting of the woodland. As such the mechanism of demarcation needs to be consolidated, as discussed in Section 5.3.

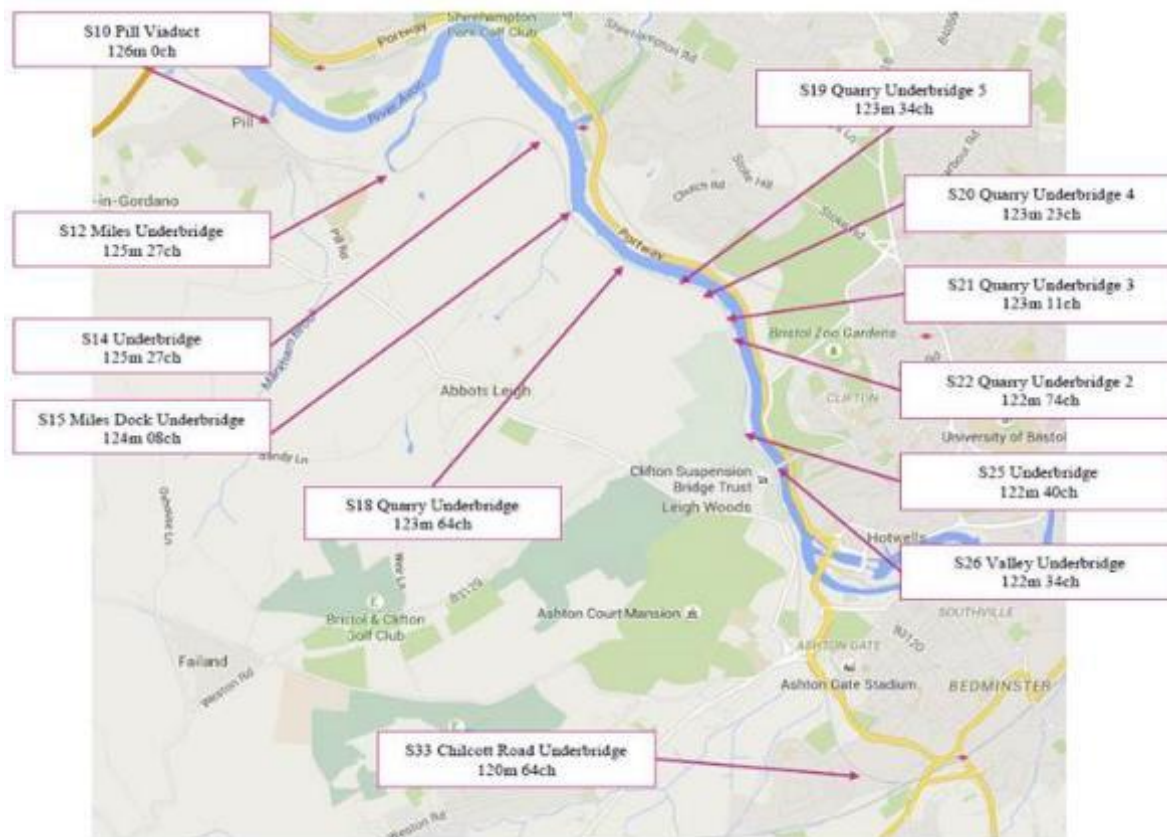
Figure 1: Location of bridges in the Avon Gorge

Structures within the Avon Gorge SAC/SSSI are S15, S18, S19, S20, S21, S22, S25 and S26

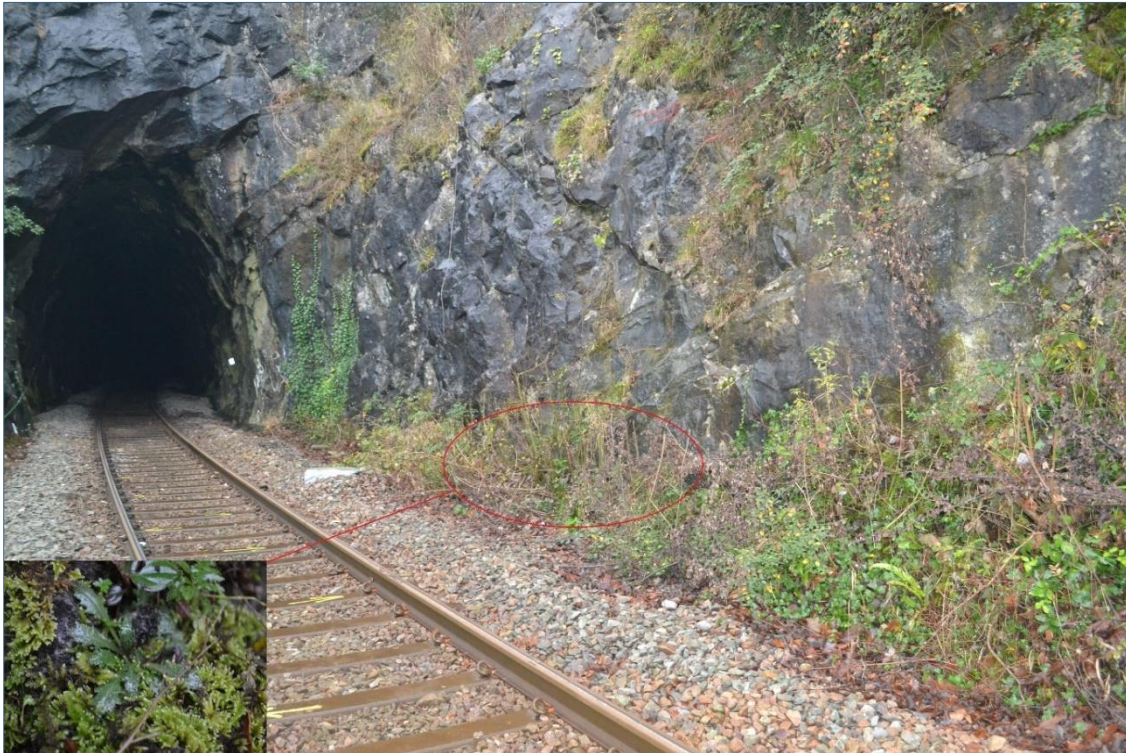
Figure 2. Approximate location of Bristol rockcress on ledge just outside the Portishead portal of Clifton Bridge Tunnel 2. Inset bottom left: the Bristol rockcress plant in moss.
