# WEST MIDLANDS INTERCHANGE

## Transport Technical Note 46 – A449 / A5 Link Road Signalised Crossing

| <b>Subject</b> | A449 / A5 Link Road Signalised Crossing (Final) | | |

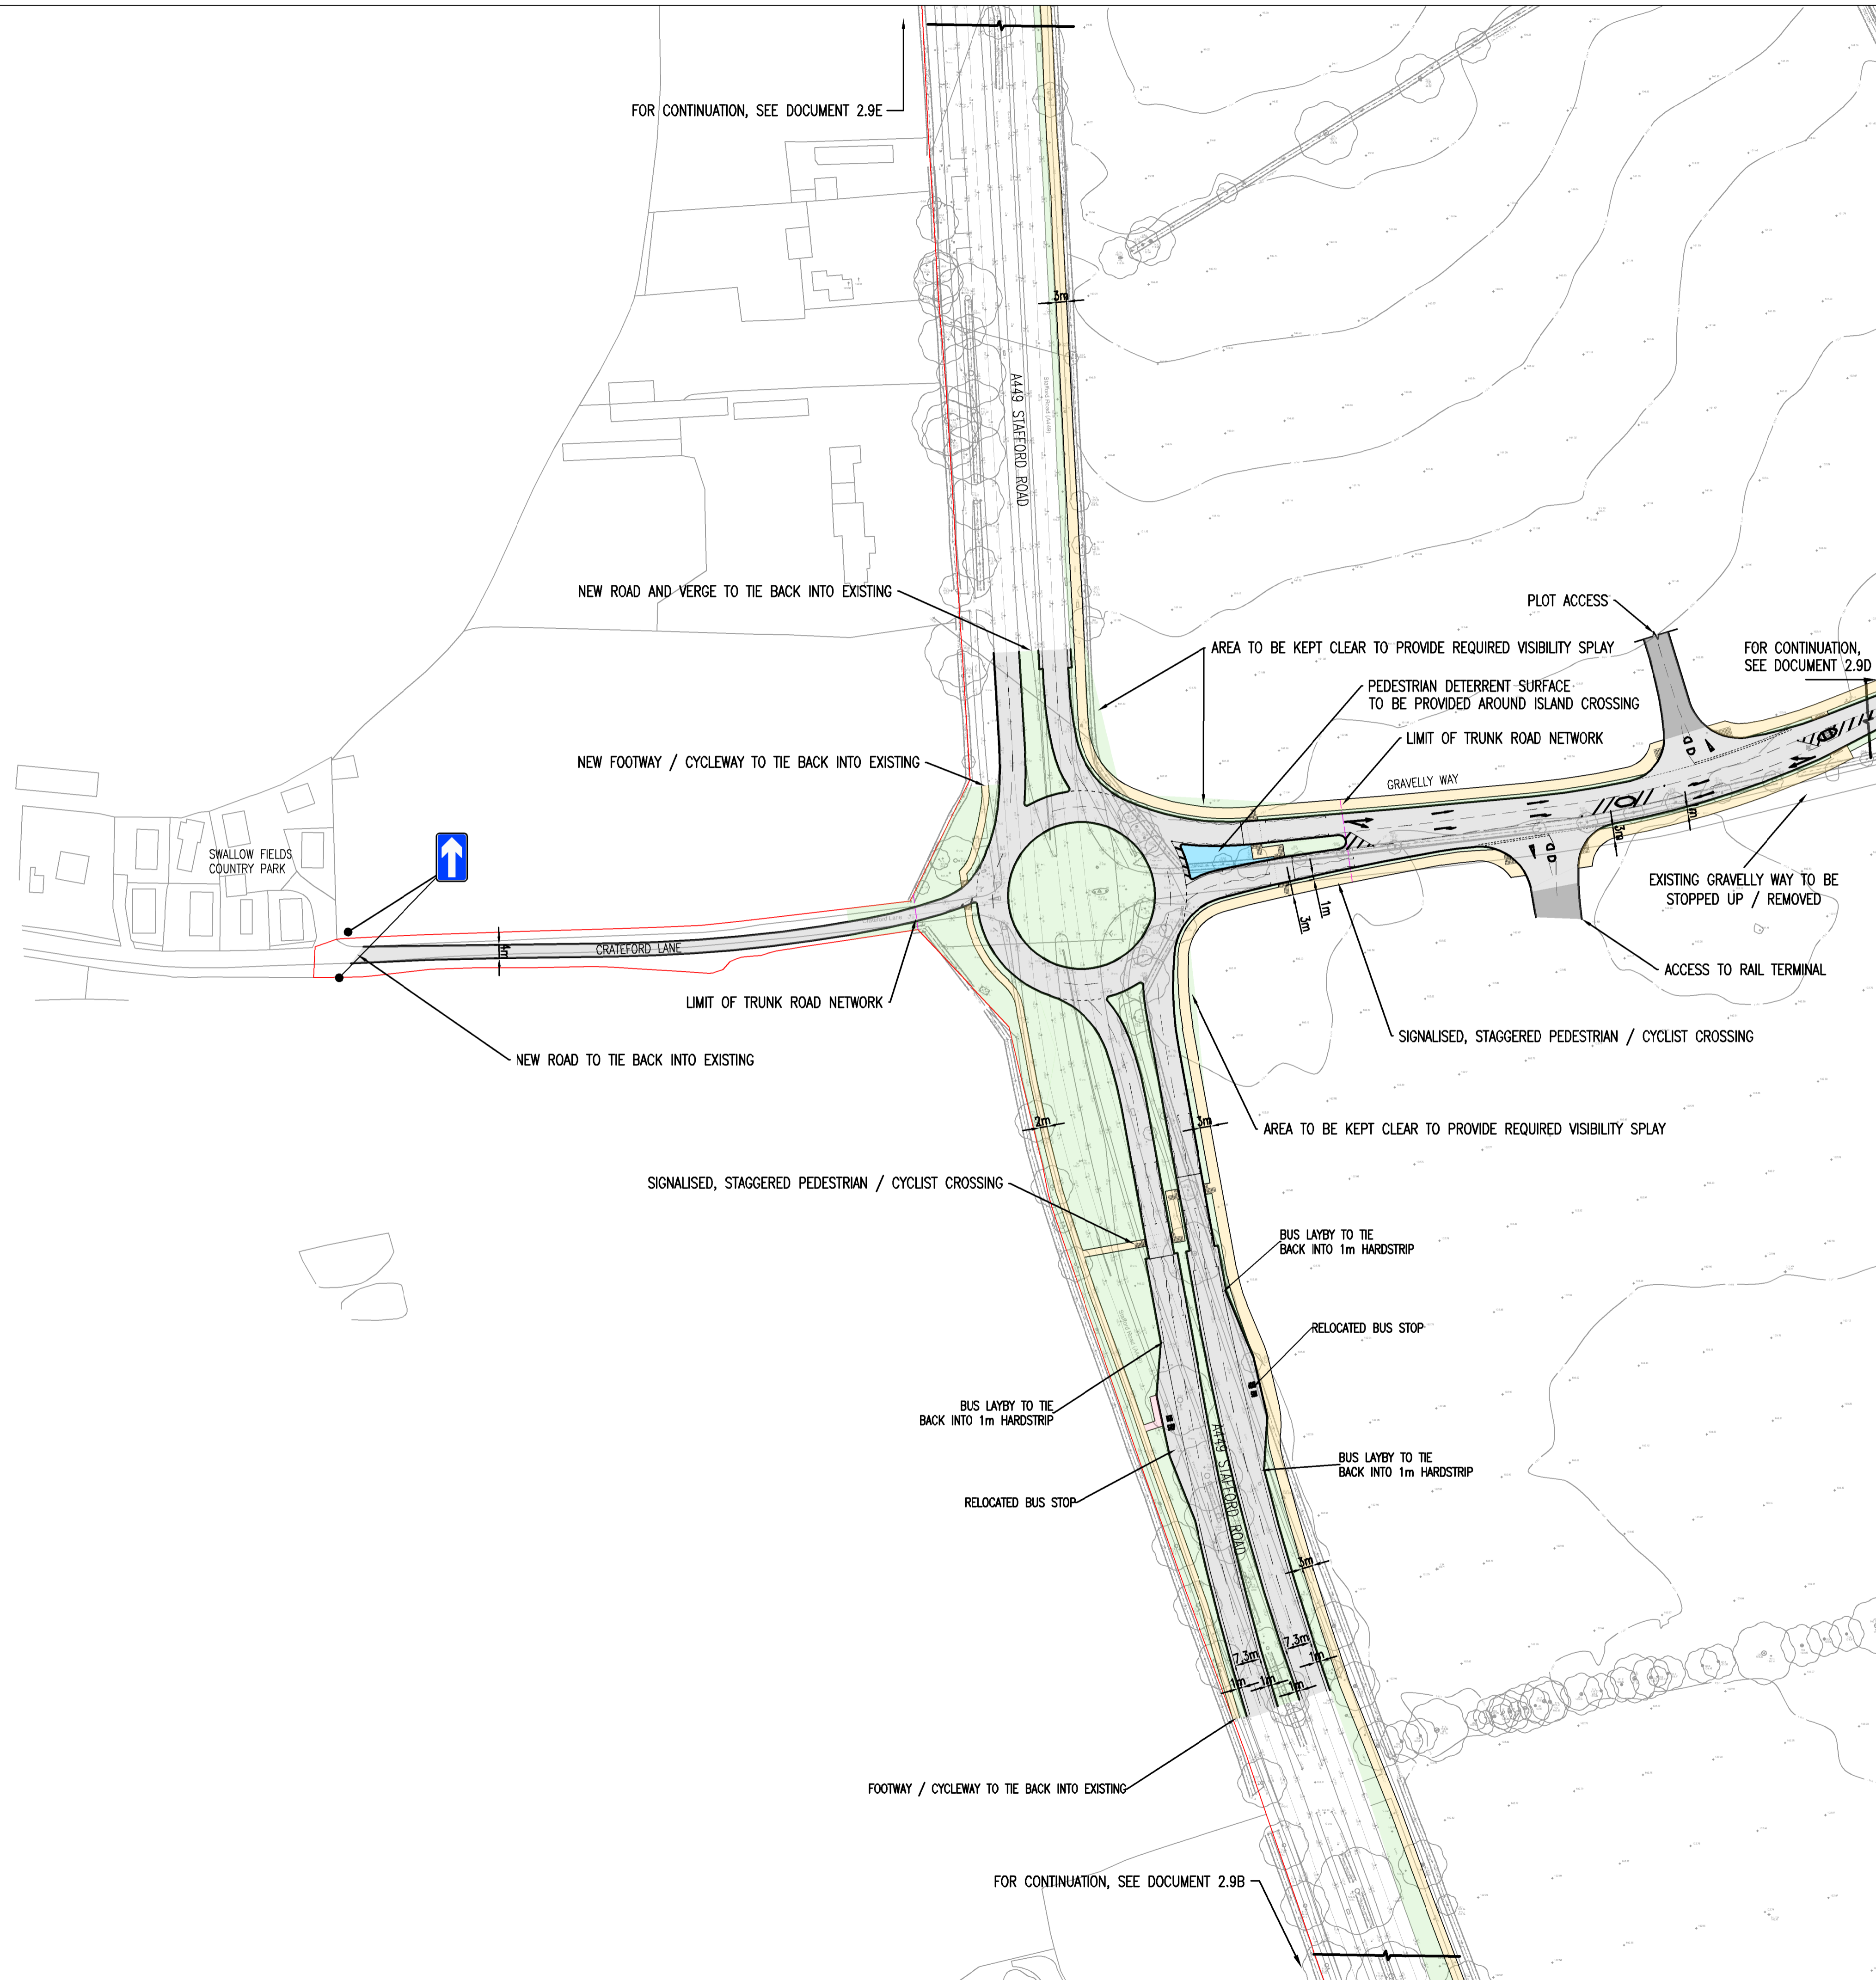
| Drawing No.<br><b>WSP-70001979-GA-103</b> | |

- MAY 2019**
- PEDESTRIAN CROSSING ON THE A449 SIGNALISED AND RELOCATED FURTHER SOUTH OF THE ROUNDABOUT, IN RESPONSE TO COMMENTS FROM HIGHWAYS ENGLAND IN THE RSA.

- PEDESTRIAN CROSSING ON GRAVELLY WAY MOVED EAST, STAGGERED AND SIGNALISED IN RESPONSE TO HIGHWAYS ENGLAND COMMENTS IN THE RSA AND AS A RESULT THE ACCESS TO THE RAIL TERMINAL HAS BEEN MOVED EAST. THE TOTAL WIDTH OF THE GRAVELLY WAY ARM HAS BEEN INCREASED TO PROVIDE SUFFICIENT WIDTH FOR THE CROSSING AND VEHICLE MOVEMENTS.

- THE EXTENT OF THE TRUNK ROAD NETWORK HAS BEEN RELOCATED EAST, TO THE BACK OF THE REDESIGNED SPLITTER ISLAND.
  - ADDITIONAL VERGE ON THE EASTERN SIDE OF THE A449 HAS BEEN ALLOCATED TO ENSURE VISIBILITY TO THE PEDESTRIAN CROSSINGS IS PROTECTED.

- JULY 2019**
- AMENDMENT TO CROSSING OF LINK ROAD IN RESPONSE TO COMMENTS FROM HIGHWAYS ENGLAND AND RSA.
  - CROSSING AREA AS CENTRAL ISLAND OF GRAVELLY WAY REVISED.

- PEDESTRIAN DETERRENT SURFACING ADDED TO CENTRAL ISLAND ON GRAVELLY WAY.
- AUGUST 2019**
- AMENDMENT TO CROSSING ON LINK ROAD IN RESPONSE TO COMMENTS FROM RSA AND GG104 SAFETY RISK ASSESSMENT.

- 1.6 The further RSA1 had considered the proposal of the Applicant to relocate the signal controlled crossing so that it sits 20m to the east of the exit from the A449 roundabout. The reason for this was to provide the crossing on the desire line for Non Motorised Users (NMUs), but not trigger a departure from design standard which would have been the case if it were located further to the west. Previous proposals for the crossing were considered to be provided in a location that did not reflect anticipated desire lines and would give rise to NMU’s attempting to cross the link road in locations where crossings were not present. This issue had been raised by a previous Safety Audit, dated June 2019 (Rev F) and had been responded to by the Applicant by way of drawing 70001979-GA-103 Rev I.

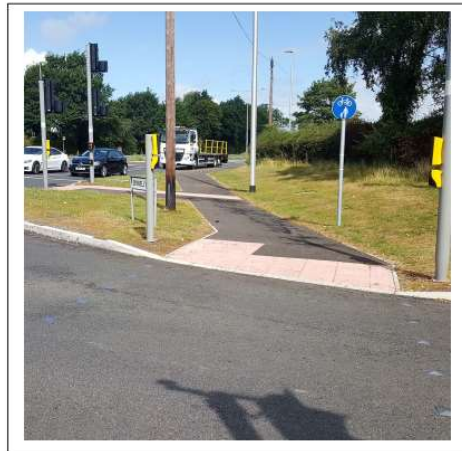
**Photo 5** – Existing controlled pedestrian/cycle facility over Gravelly Way

**Detail:** The existing layout of the A449/Gravelly Way junction includes controlled crossing facilities over the A449 and Gravelly Way (see Photo 5). The proposed roundabout layout removes the controlled crossing facilities and provides uncontrolled crossing facilities for cyclists and pedestrians over Gravelly Way and for pedestrians only over the A449. The risk of a pedestrian/cyclist crossing into the path of an approaching vehicle is therefore increased. Also, once the West Midlands Rail Freight Interchange is completed, traffic flows are likely to increase therefore reducing the potential gaps in traffic to allow pedestrians and cyclists to safely cross A449/Gravelly way. Should a collision occur between a cyclist or pedestrian and a vehicle, the severity of any injuries suffered is likely to be high.

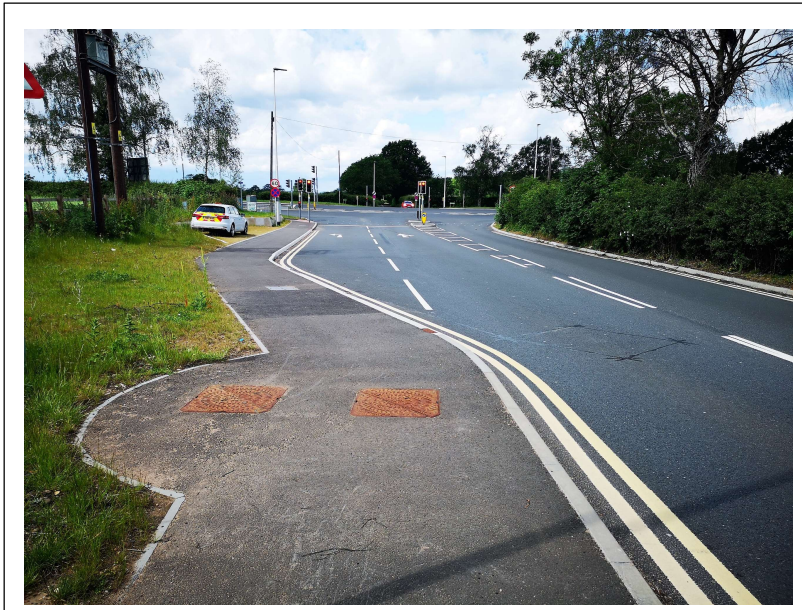
**Photo 1** – View from Gravelly Way at the proposed location of the new NMU crossing.

August 2019 Road Safety Audit review: Given the new location of the controlled crossing, the risk of NMUs choosing to not use the controlled signalised and instead choosing to cross at places where there is no crossing facility has been reduced, along with the risk of an NMU being struck by a vehicle whilst attempting such a crossing.

It is recommended that the proposed signalised crossing on Gravelly Way be located on the desire line for north-south (and vice versa) NMUs. If this is not possible then NMUs should be discouraged from crossing at any likely informal crossing locations.
