## **HINCKLEY NATIONAL RAIL FREIGHT INTERCHANGE**

### **Appendix 13.6 - Evaluation Report (Phase 2)**

**AN ARCHAEOLOGICAL EVALUATION**

## **An Archaeological Evaluation on Land at Hinckley National Freight Interchange, Leicestershire**

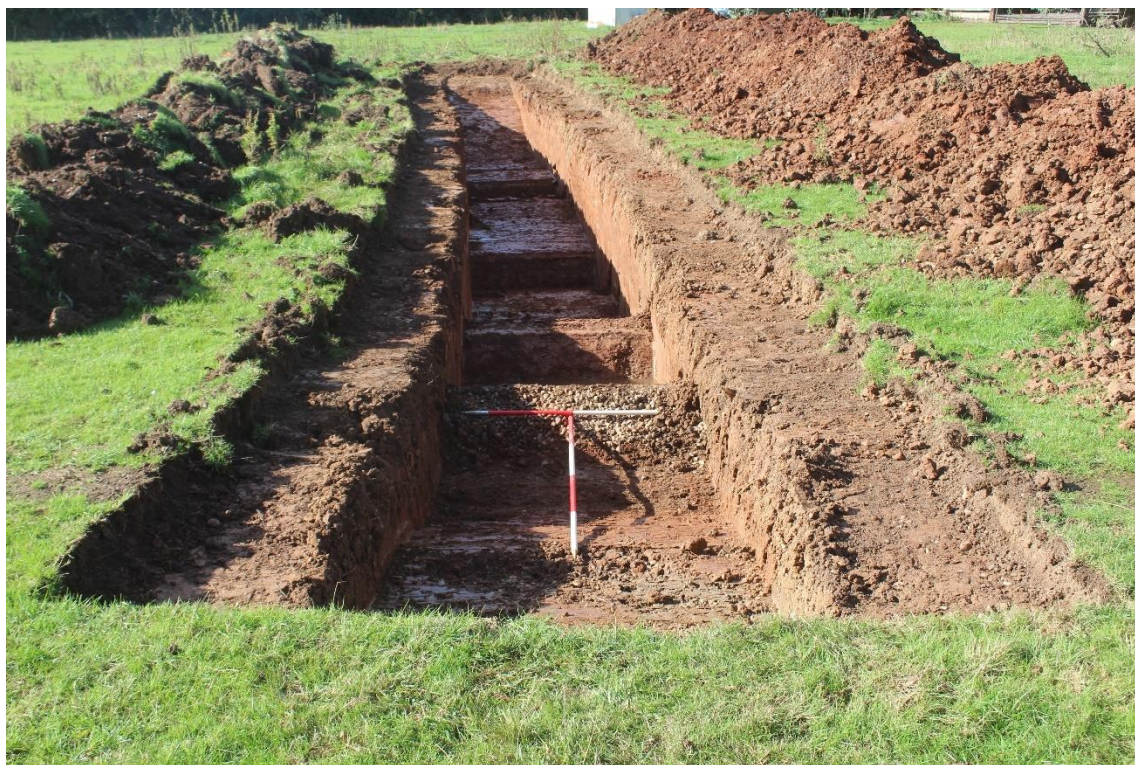
SW facing shot of Trench 1, showing full extent of channel [1004]

- 5.1.3 Trench 1 was situated in the far north-western corner of site, closest to B4668 Leicester Road, and was aligned northeast to southwest. At each end of the trench the mid reddish brown compact silty clay natural substrate **(1003)** was recorded at 93.31m AOD. This deposit was consistent throughout Trenches 1-5.
- 5.1.4 Within Trench 1 the full extent of the river channel **[1004]** was exposed cutting **(1003)**, with a width of 22.76m. The fill of the channel **(1005)** was an apparently homogenous mid reddish brown soft silty clay with occasional lenses of light greyish blue silty clay. Despite the deposit likely being formed over an extended period of time, it was not possible to distinguish different episodes of accumulation, and so a single context was ascribed to the fill. Within this section of the channel the lowest depth reached was 91.55m AOD, 1.96m

BPGL. At the depth, however, the base of the channel was not evident. In fact, it was only within Trench 5 that the probable base of the feature was recorded. No archaeological finds were recovered, and no organic content was noted.

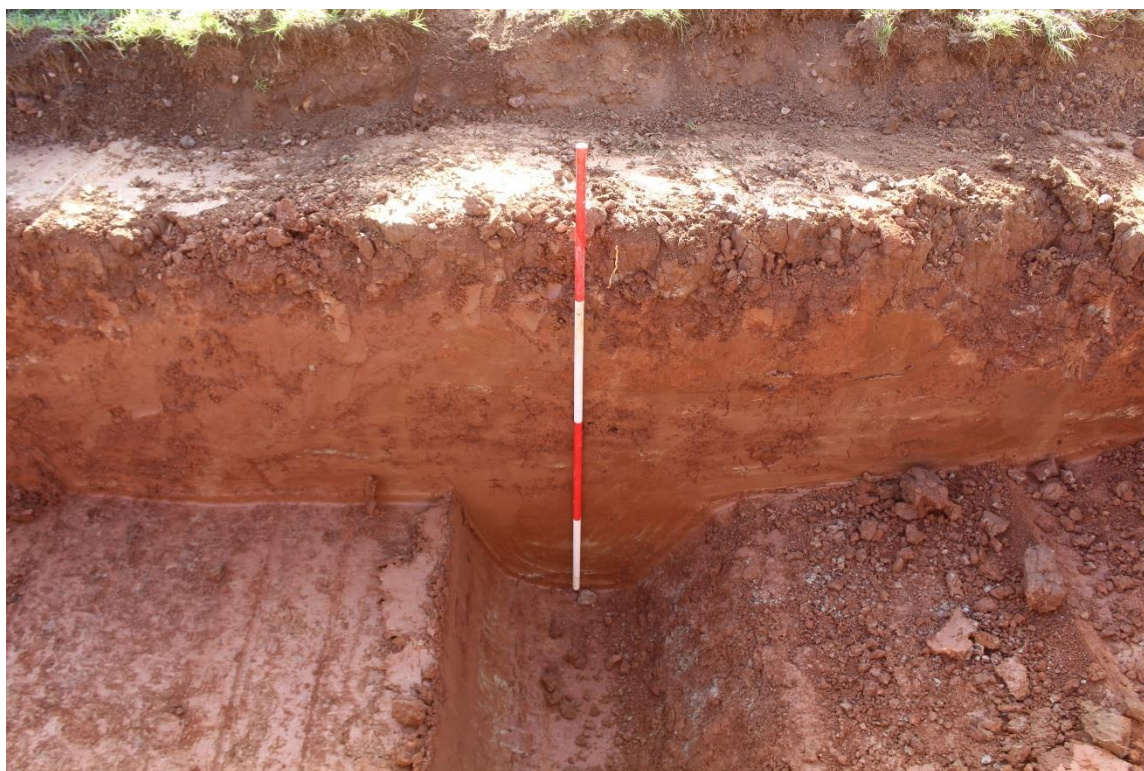
SE facing shot of section through fill (1006) palaeochannel [1004], Trench 1

- 5.1.5 This river deposit **(1005)** was sealed by subsoil **(1002)**, a mid-yellowish grey compact silty clay ranging from 0.28m to 0.10m in thickness. This in turn was overlain by topsoil **(1001)**, a mid-greyish brown sandy clayey silt, varying in thickness from 0.10m to 0.04m.

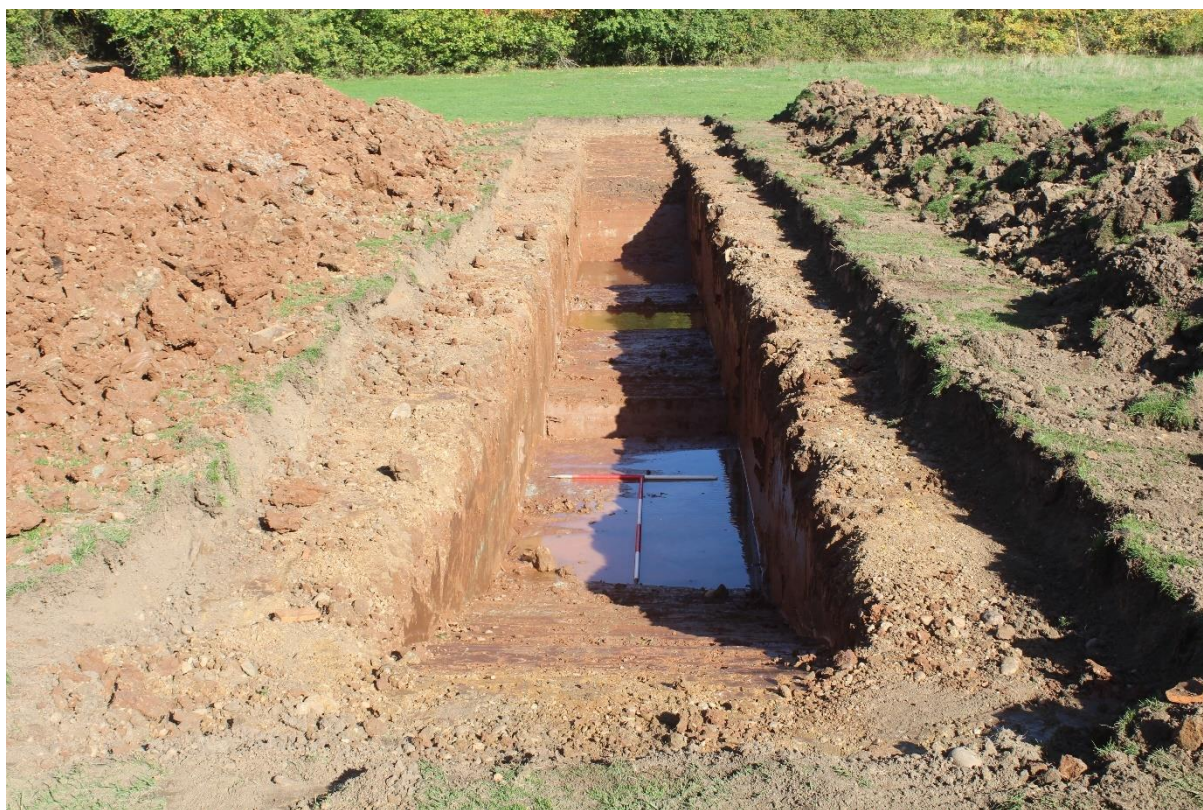
NE facing shot of channel [3004] in Trench 3

- 5.1.7 Trench 3 also ran northeast to southwest, to the southeast of Trench 2 and the northwest of Trench 4. The natural substrate **(3003)** was revealed at 92.38m AOD (0.49m BPGL). The river channel **[3004]** was revealed in full, however the full section was not visible as it was cut by modern land drain ditch **[3006]**. The modern ditch **[3006]** was 1.72m wide and was filled by a yellow plastic pipe and fill **(3007)**, a mid-reddish brown soft silty clay. It cut through the far north-eastern edge of the river channel **[3004]**, obscuring the full extent, leaving a width of 18.50m visible.

- 5.1.8 Again, the base of the channel was not reached, however, based on depths reached in the sondages, it was below 90.67m AOD (2.07m BPGL) in depth. The fill **(3005)** was the same as in the previous two trenches and sterile of any dateable evidence. The channel was overlain by the subsoil **(3002)** which

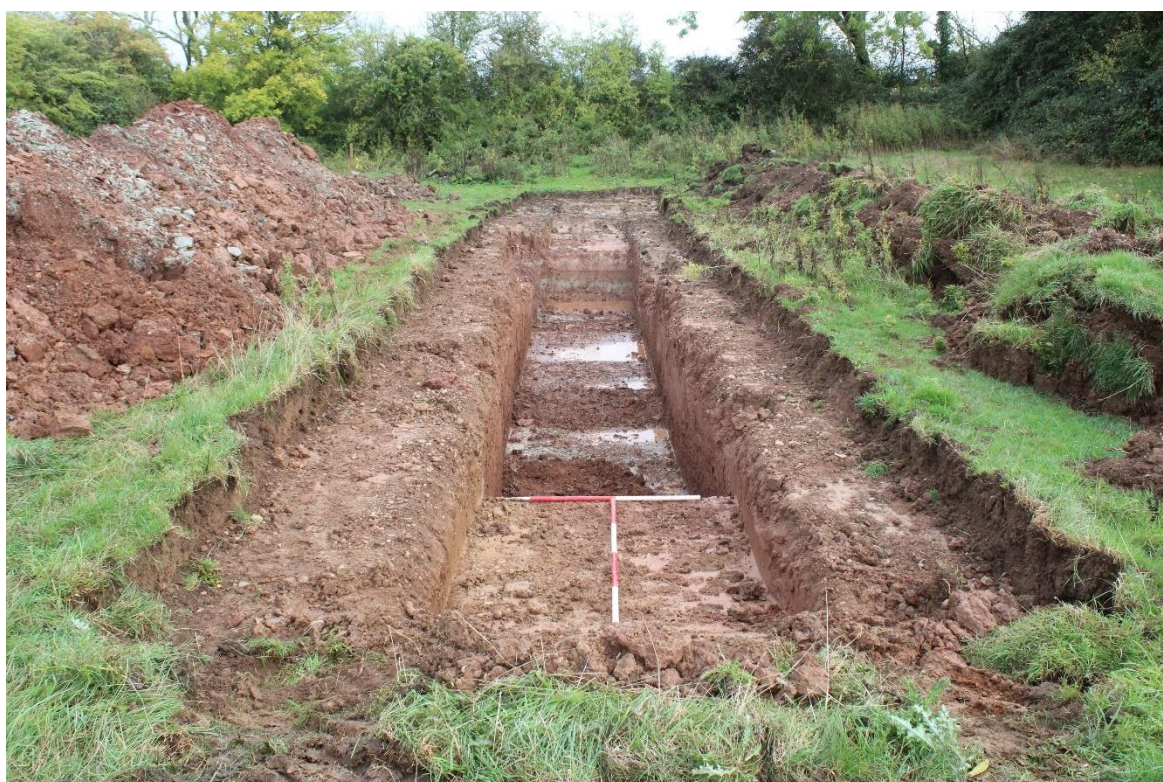
SE facing shot of channel [5004] in Trench 5

5.1.10 Trench 5 was aligned southeast to northwest, and the full width of the channel was not revealed. The natural substrate **(5003)** was recorded at 91.49m AOD (0.76m BPGL) in the northwest corner of the trench only. This trench was the only location where the possible base of the river channel **[5004]** was reached. Trial pit 5.1 recorded a clear horizon with the underlying gravel deposits, interpreted as representing the possible base of the channel, at 89.15m AOD (3.05m BPGL). No archaeological finds or organic deposits were recovered in the full profile of river channel fill **(5005)**, although a single small fragment of burnt wood was recovered from the upper level of the fill. The river deposit **(5005)** was sealed by subsoil **(5002)** at 0.43m thick, which in turn was sealed by topsoil **(5001)** at 0.11m thick.

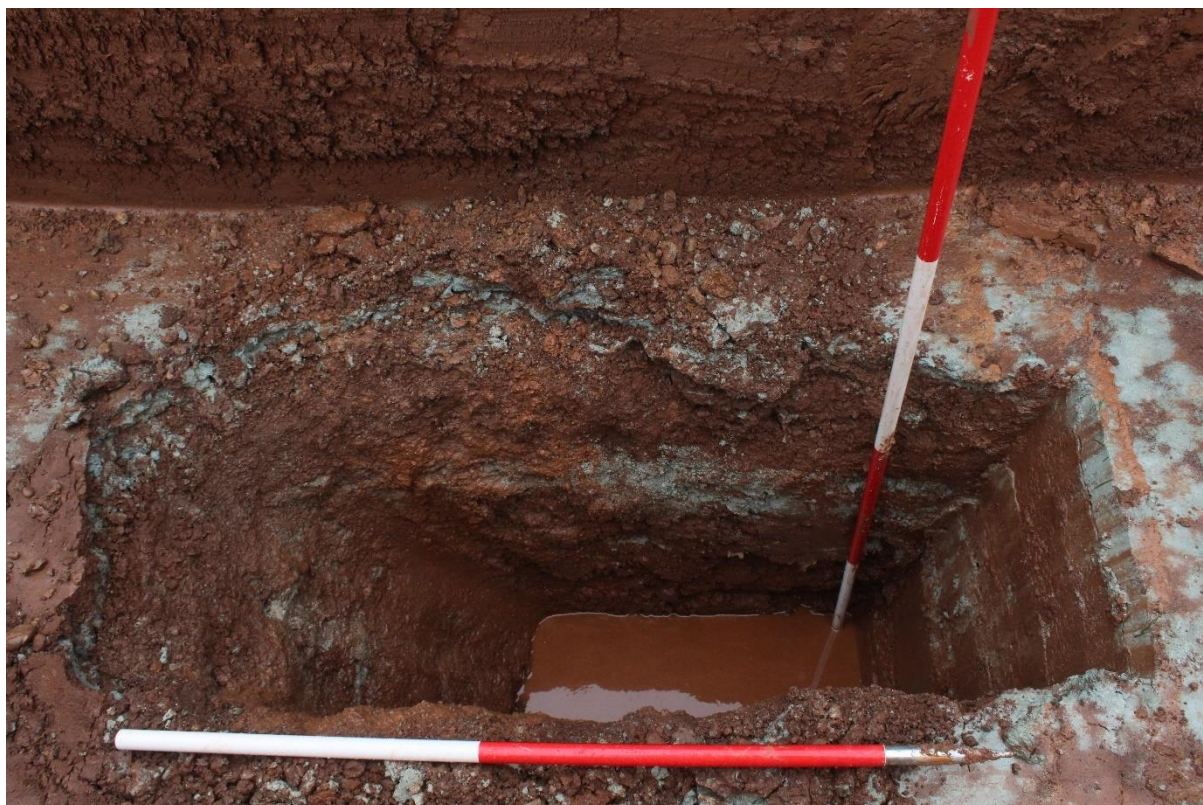
Sondage cut through Trench 5 channel fill (5005) to gravel deposits below (obscured by water)

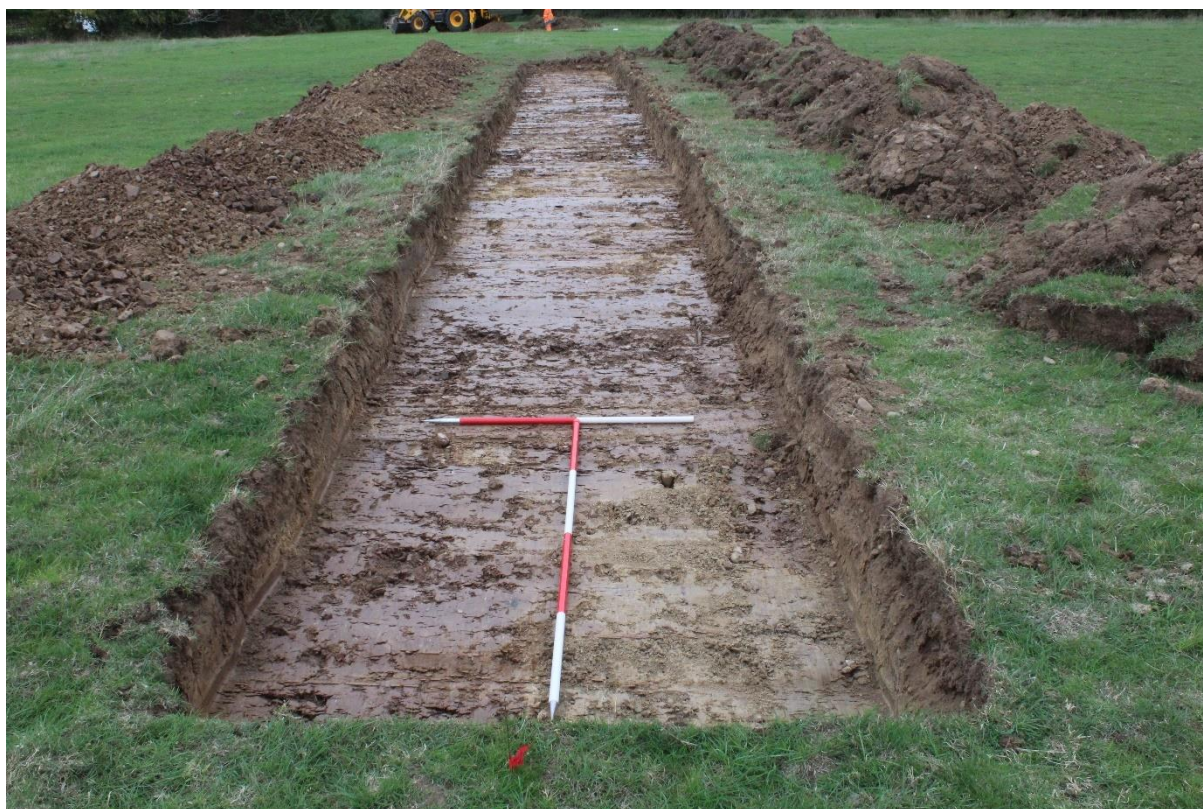
N facing shot of Trench 7

5.2.2 In all four trenches the earliest deposit recorded was the natural substrate **(6003)**, **(7003)**, **(8003)** and **(9003)**, a mid-greyish red compact silty clay,

revealed at 93.82m AOD (0.17m BPGL) in Trench 7, at 93.14m AOD (0.40m BPGL) in Trench 8 and at 92m AOD (0.31m BPGL) in Trench 9. This was sealed by subsoil **(6002)**, **(7002)**, **(8002)** and **(9002)**, a mid-yellowish brown compact sandy clay that varied in thickness from 0.20m in Trench 6, 0.23m in Trench 7 and 0.15m in Trenches 8 and 9. In turn this was sealed by the topsoil **(6001)**, **(7001)**, **(8001)** and **(9001)**, a mid greyish brown silty clay that had a thickness of 0.16m in Trench 6, 0.18m in Trench 7, 0.16m in Trench 8 and finally 0.19m in Trench 9. No archaeological finds or features were recovered from these trenches.

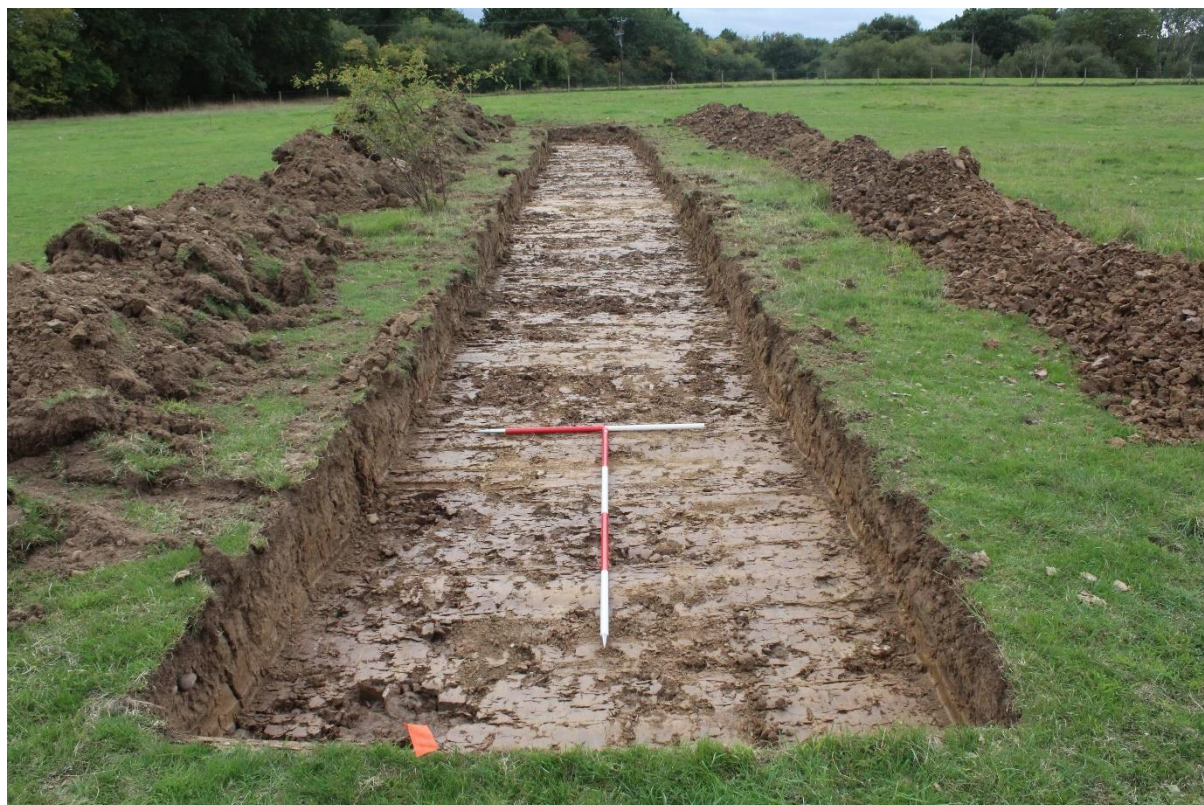
SW shot of Trench 8
