HINCKLEY NATIONAL RAIL FREIGHT INTERCHANGE

ES Appendix 15.2: Preliminary Ground Investigation Report (Part 1 of 2)

Report Prepared by: Hydrock

Document reference: 6.2.15.2

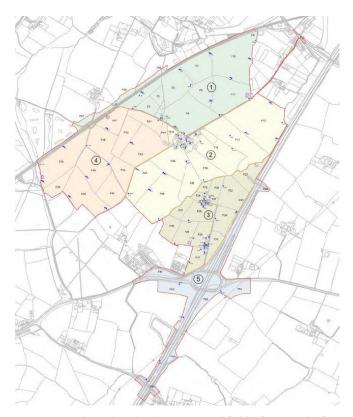
Figure 2.1: Site boundary detailing zones and field references. (Refer to Appendix A for full drawing).

As reported in the desk study the site has been split into five zones (Zones 1 to 5) with individual references assigned to each field as shown on Figure 2.1 and Drawings RFI-HYD-XX-ZZ-DR-GE-1005 and RFI-HYD-XX-ZZ-DR-GE-1006, which are presented in Appendix A.
