HINCKLEY NATIONAL RAIL FREIGHT INTERCHANGE

Sapcote Technical Note [Appendix 2 (D) – Enhanced Scheme Stage 1 RSA and Designers Response Report]

PROPOSED TRAFFIC CALMING AND ZEBRA CROSSING

STAGE 1 - ROAD SAFETY AUDIT

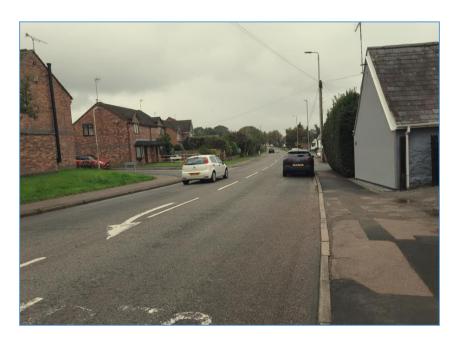
3.2. **Problem 1**

Location: B4669 Hinckley Road - proposed pedestrian crossing to the west of the junction with Stanton Road.

Summary: Restricted visibility risks vehicle to pedestrian collisions.

Although visibility was available during the site visit, historical images show parking along the northern kerb outside of the Sapcote Club and adjacent properties that will limit visibility for and of pedestrians looking to cross north to south at the proposed pedestrian dropped crossing here. This risks pedestrians entering the carriageway into the path of an eastbound vehicle, resulting in vehicle to pedestrian collisions.

Recommendation:

It is recommended that, as part of the detailed design, waiting restrictions are provided to ensure that unobstructed visibility commensurate with approaching vehicle speeds is provided at the crossing.

RSA Ref.	RSA Problem and Recommendation	Design organisation response	Auditor Response	Agreed RSA action
	Location: B4669 Hinckley Road - proposed pedestrian crossing to the west of the junction with Stanton Road.			
	Summary: Restricted visibility risks vehicle to pedestrian collisions.			
	Although visibility was available during the site visit, historical images show parking along the northern kerb outside of the Sapcote Club and adjacent properties that will limit visibility for and of pedestrians looking to cross north to south at the proposed pedestrian dropped crossing here. This risks pedestrians entering the carriageway into the path of an eastbound vehicle, resulting in vehicle to pedestrian collisions.	Agree with RSA recommendation: Yes As part of the detailed design, waiting restrictions will be considered and provided through a TRO if agreed by the Overseeing Organisation and subject to appropriate consultation. A note has been added to the revised drawings.	The Audit Team would consider this response to provide unobstructed visibility splays, as per the recommendation, pending the length of the proposed restrictions.

Recommendation:			
	It is recommended that, as part of the detailed design, waiting restrictions are provided to ensure that unobstructed visibility commensurate with approaching vehicle speeds is provided at the crossing.

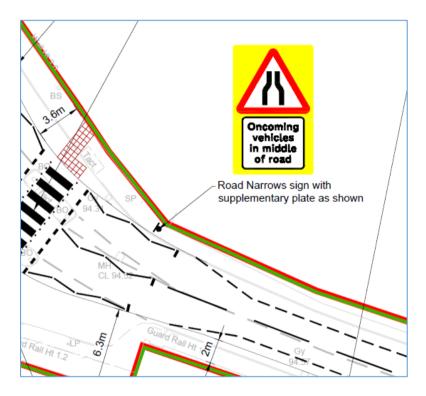
3.3. **Problem 2**

Location: B4669 Hinckley Road – eastbound "Oncoming vehicles" sign.

Summary: Sign within narrow footway risks pedestrian collisions / vehicle to pedestrian collisions.

The "Oncoming vehicles in middle of road" and road narrows sign is located at a point where the footway is already very narrow. The sign may therefore force pedestrians into the carriageway, risking vehicle to pedestrian collisions, and may pose a risk to visually impaired pedestrians who may walk into the sign post.

Recommendation:

It is recommended that the sign is relocated to a wider part of the footway.

RSA Ref.	RSA Problem and Recommendation	Design organisation response	Auditor Response	Agreed RSA action
	Location: B4669 Hinckley Road – eastbound "Oncoming vehicles" sign. Summary: Sign within narrow footway risks pedestrian collisions / vehicle to pedestrian collisions. The "Oncoming vehicles in middle of road" and road narrows sign is located at a point where the footway is already very narrow. The sign may therefore force pedestrians into the carriageway, risking vehicle to pedestrian collisions, and may pose a risk to visually impaired pedestrians who may walk into the sign post. Recommendation: It is recommended that the sign is relocated to a wider part of the footway.	Agree with RSA recommendation: Yes The sign has been relocated on the updated general arrangement drawing.	Noted – this would mitigate against the problem as described in the RSA1.	
	Location: B4669 Hinckley Road – "Oncoming vehicles in middle or the road" section. Summary: Unfamiliar use of signing / road markings risks offside to offside collisions. The "Oncoming vehicles in middle of road" signs are generally used where a physical restriction – such as a bridge requires large vehicles to be driven in the centre of the carriageway. The lack of an obvious reason for the warning signs and markings may result in failures for some drivers to slow or give way to large vehicles, resulting in offside to offside collisions. Recommendation: It is recommended that reference is made to the need for large vehicles specifically to use the centre of the carriageway, for example the use of a vehicle activated sign with large vehicle detection.	Agree with RSA recommendation: Yes A location for vehicle activated signage has been shown on the updated general arrangement with the exact details of the form of sign, text and activation to be agreed at detailed design.	Noted – The exact location and design of fixed and vehicle activated signage should be agreed at Detailed Design and reviewed at the Stage 2 RSA.

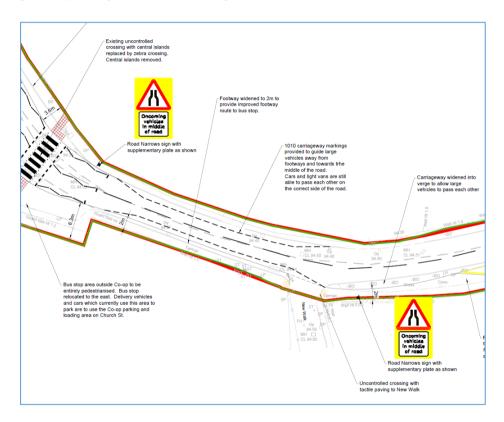
3.4. **Problem 3**

Location: B4669 Hinckley Road – "Oncoming vehicles in middle or the road" section.

Summary: Unfamiliar use of signing / road markings risks offside to offside collisions.

The "Oncoming vehicles in middle of road" signs are generally used where a physical restriction – such as a bridge requires large vehicles to be driven in the centre of the carriageway. The lack of an obvious reason for the warning signs and markings may result in failures for some drivers to slow or give way to large vehicles, resulting in offside to offside collisions.

Recommendation:

It is recommended that reference is made to the need for large vehicles specifically to use the centre of the carriageway, for example the use of a vehicle activated sign with large vehicle detection.

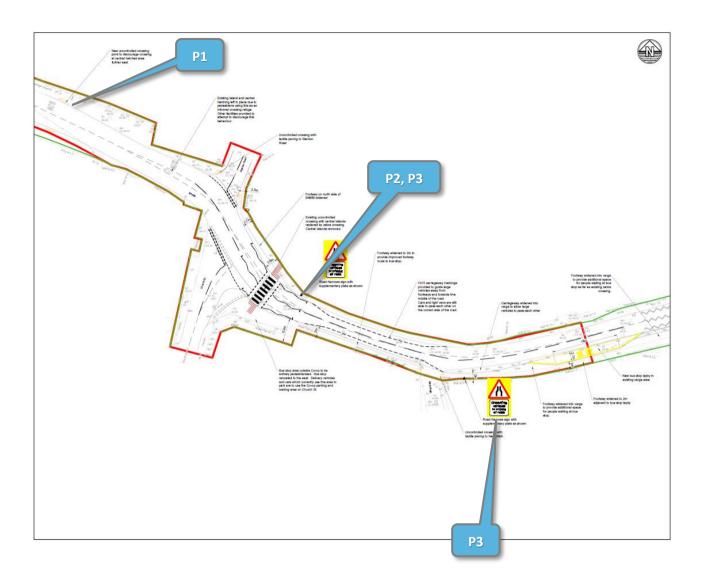
Figure 2 – Problem Location Plan

The location of any problems/observations that have been identified in Section 3 of this report can be seen on the extracts of the drawings supplied to the Audit Team, as listed in Appendix A.

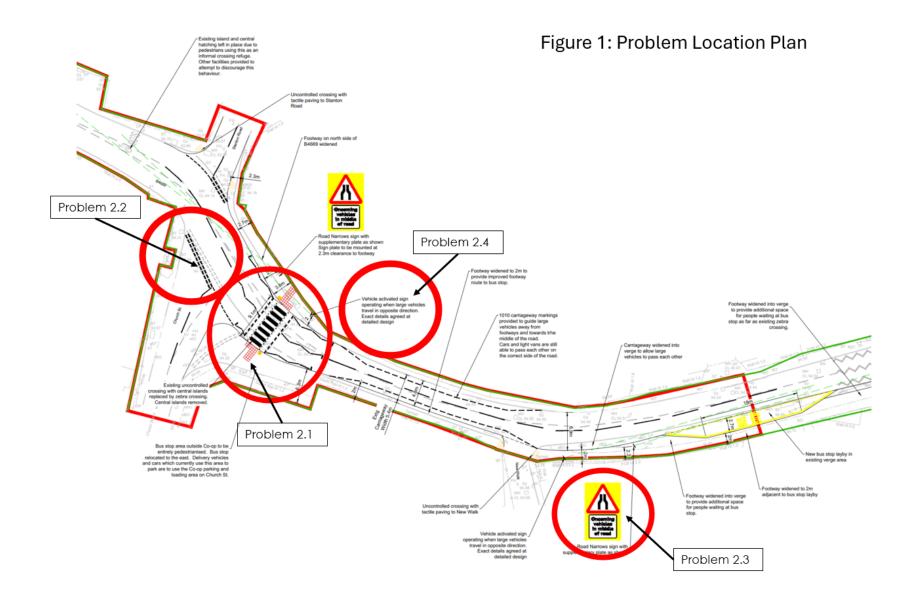
FIGURE 1: Location of problems identified in this audit

- 1.8 All comments and recommendations refer to the highway proposal drawings and the locations have been indicated in **Figure 1**.
- 1.9 In summary, the proposals include:
