EAST NORTANTS RESOURCE MANAGEMENT FACILITY WESTERN EXTENSION

WRITTEN SUBMISSIONS ON BEHALF OF THE CECIL ESTATE FAMILY TRUST

Soil Sampling

Inspection of CEFT owned Land adjacent to Augean Landfill Site at Kings Cliffe

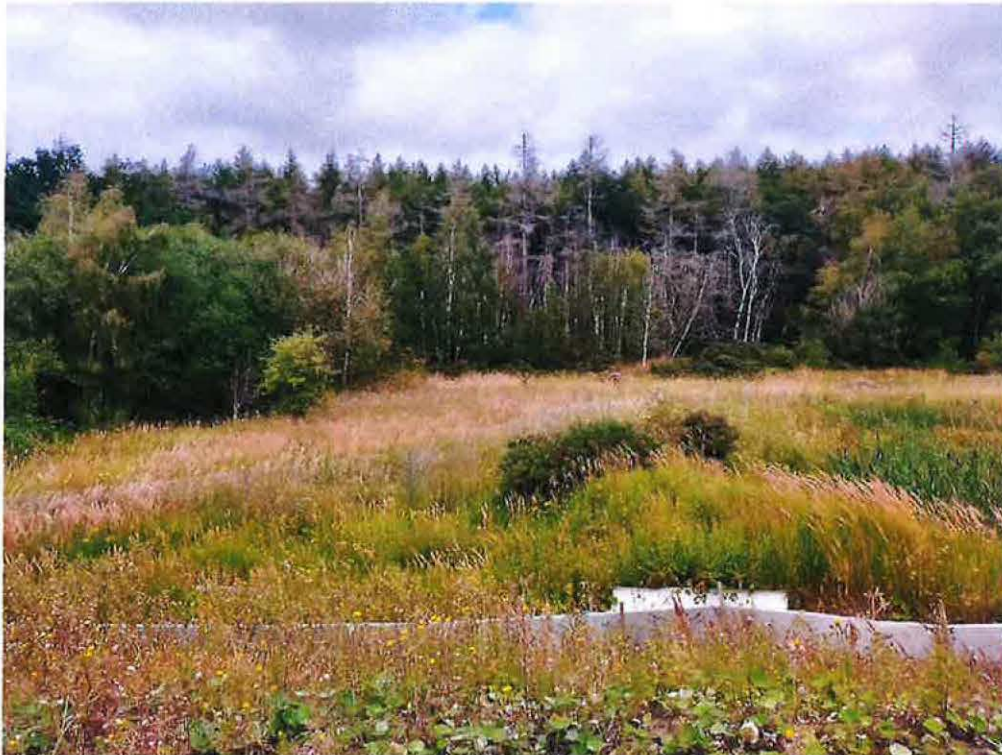
Photograph 1. – Affected area (looking to the north) from site's northern boundary - taken 26/08/21.

- 4.6 In summary all areas impacted by the spill have begun to regenerate and this regeneration is expected to continue. Further monitoring is recommended but the early indications are that the affected areas are recovering naturally and remediation in the form of topsoil removal should not be required however this requires more comprehensive ecological surveys to be confirmed.

- 5.1 It is recommended that the soil sampling exercise is repeated in the spring following another winter weather cycle and to allow for the Autumn leaf fall to identify any changes in the concentrations across the sampling area.
- 5.2 Augean would recommend that a formal ecological and arboricultural survey of the land is undertaken to advise on the ongoing management and monitoring of the affected area.

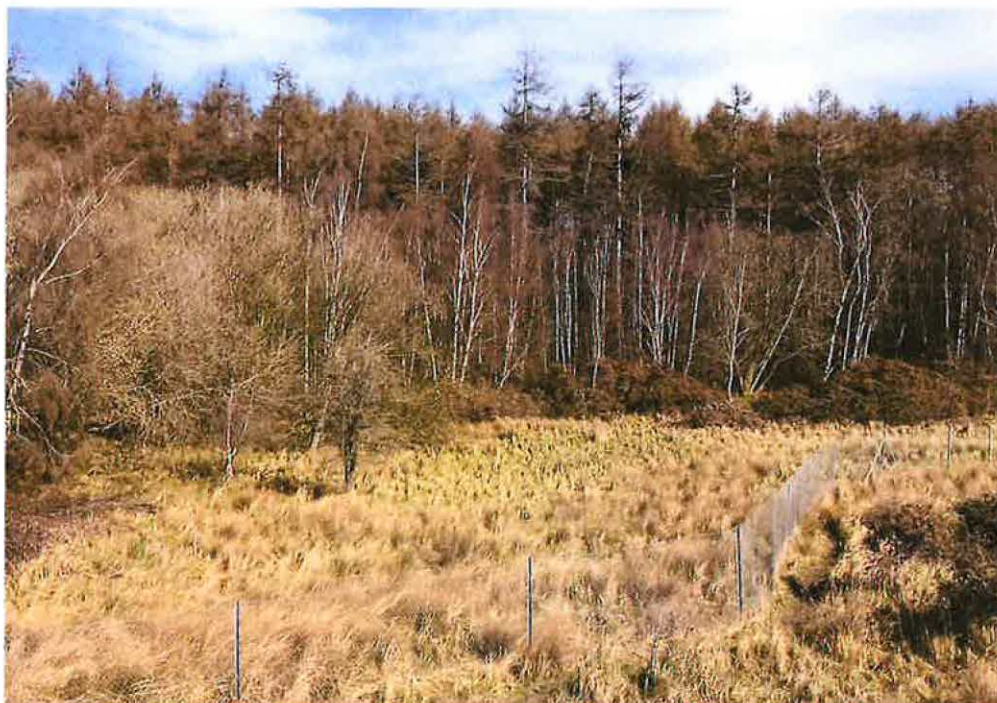
Photograph 2 - Affected area (looking to the north) from site's northern boundary - taken Feb 2021.

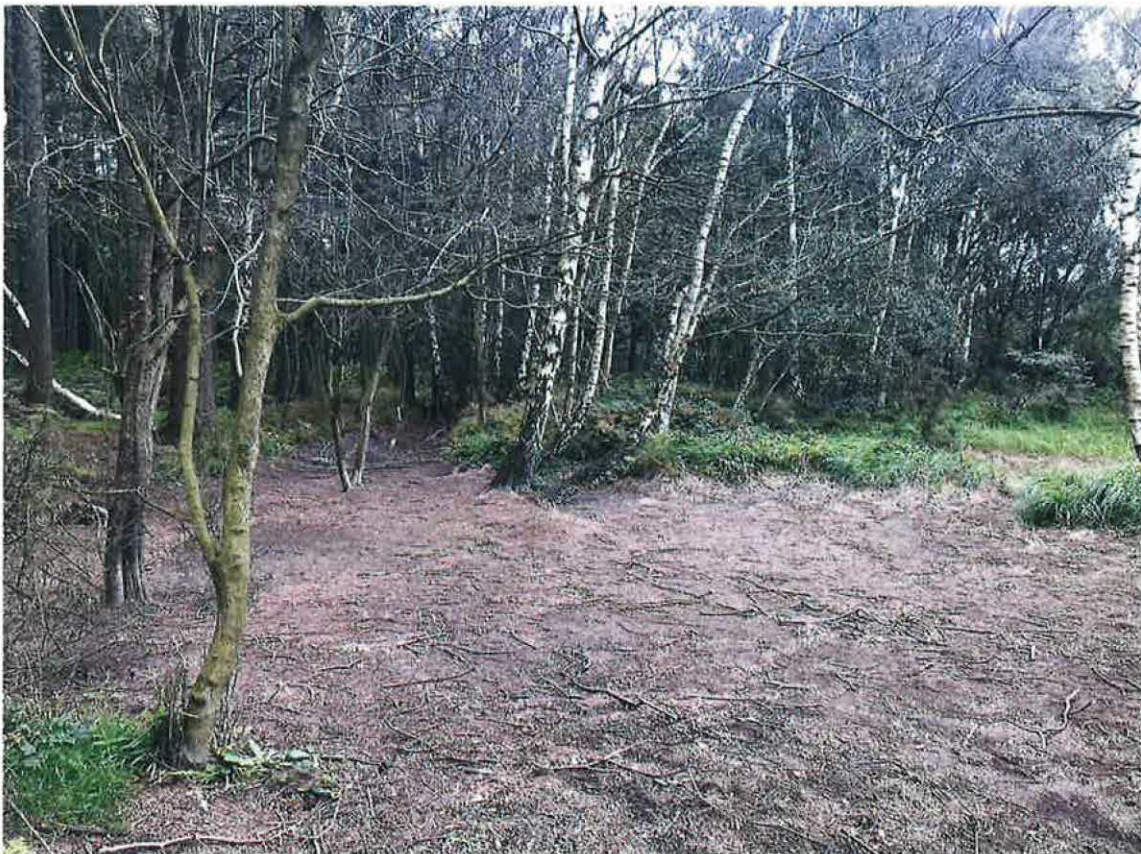
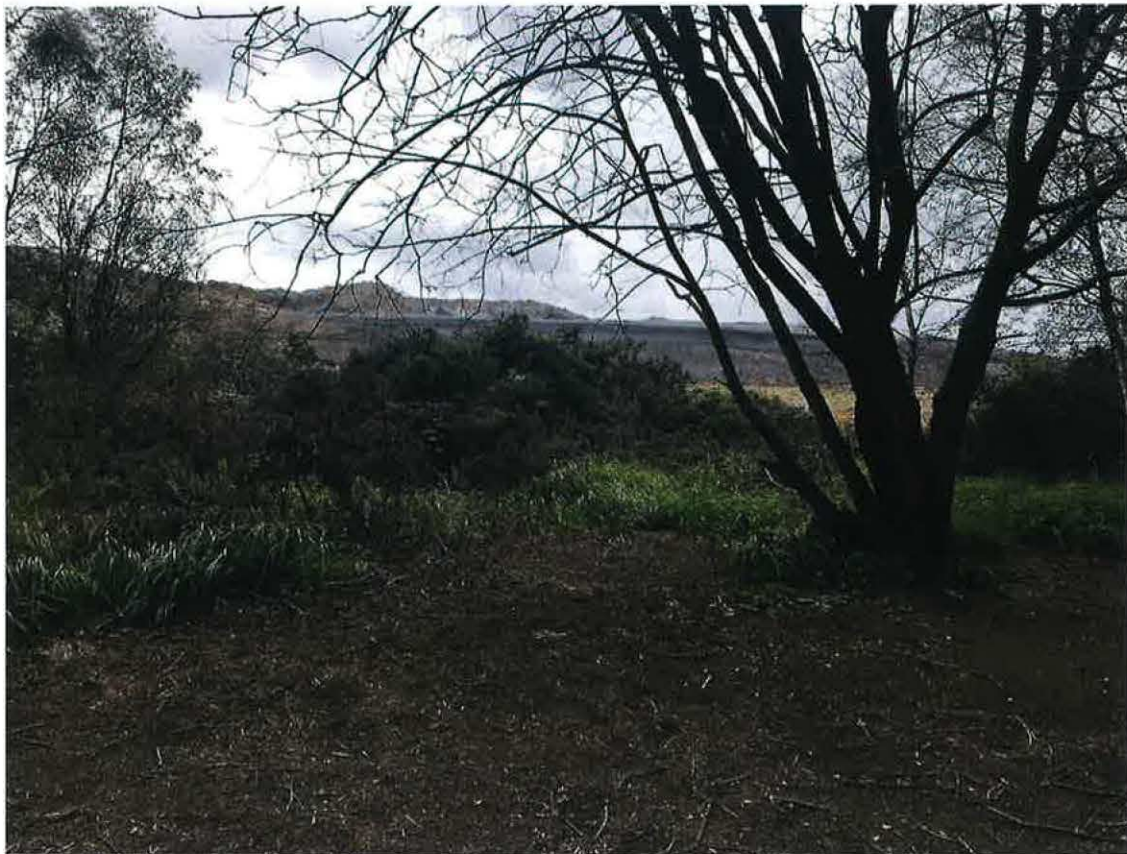
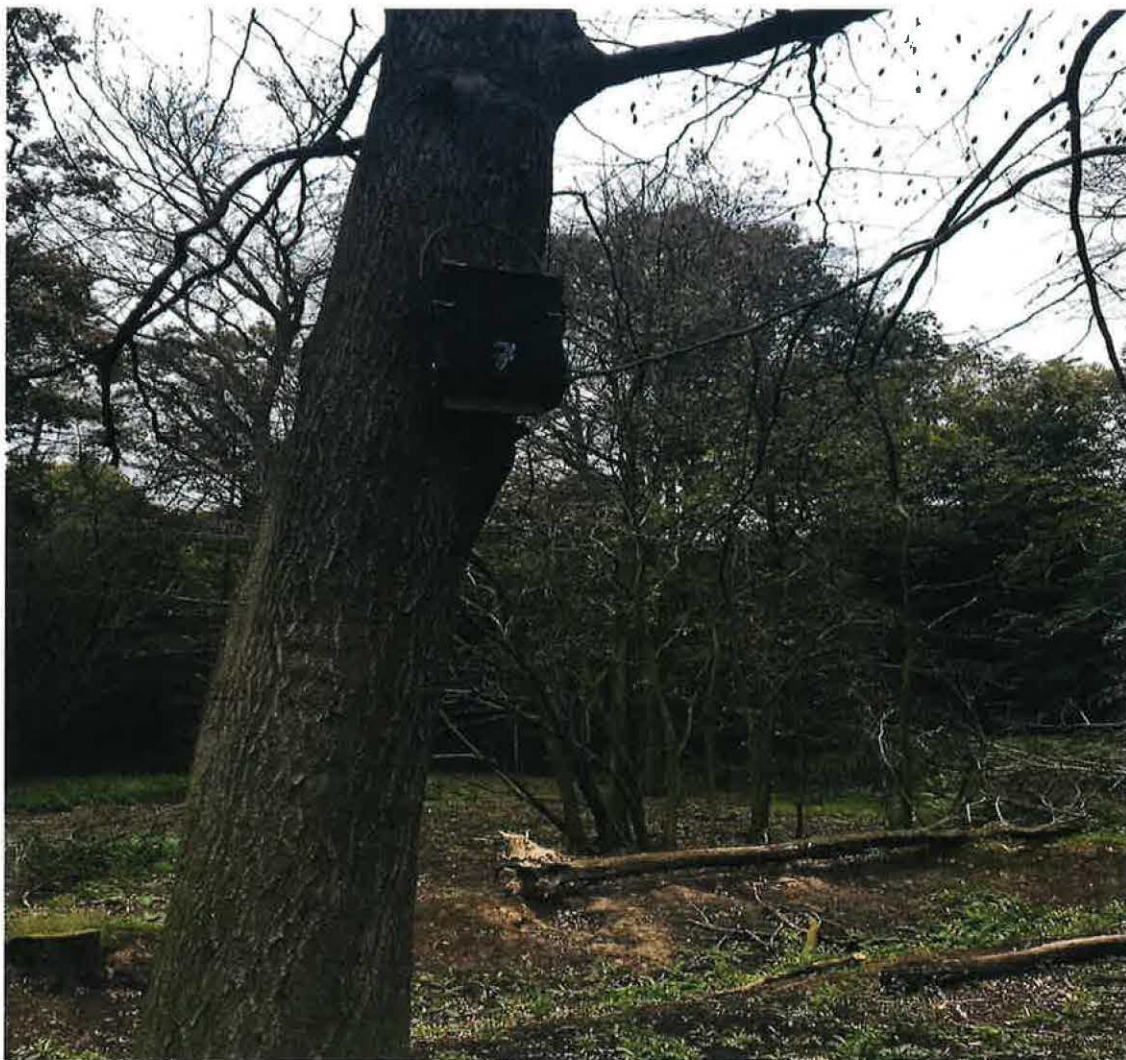
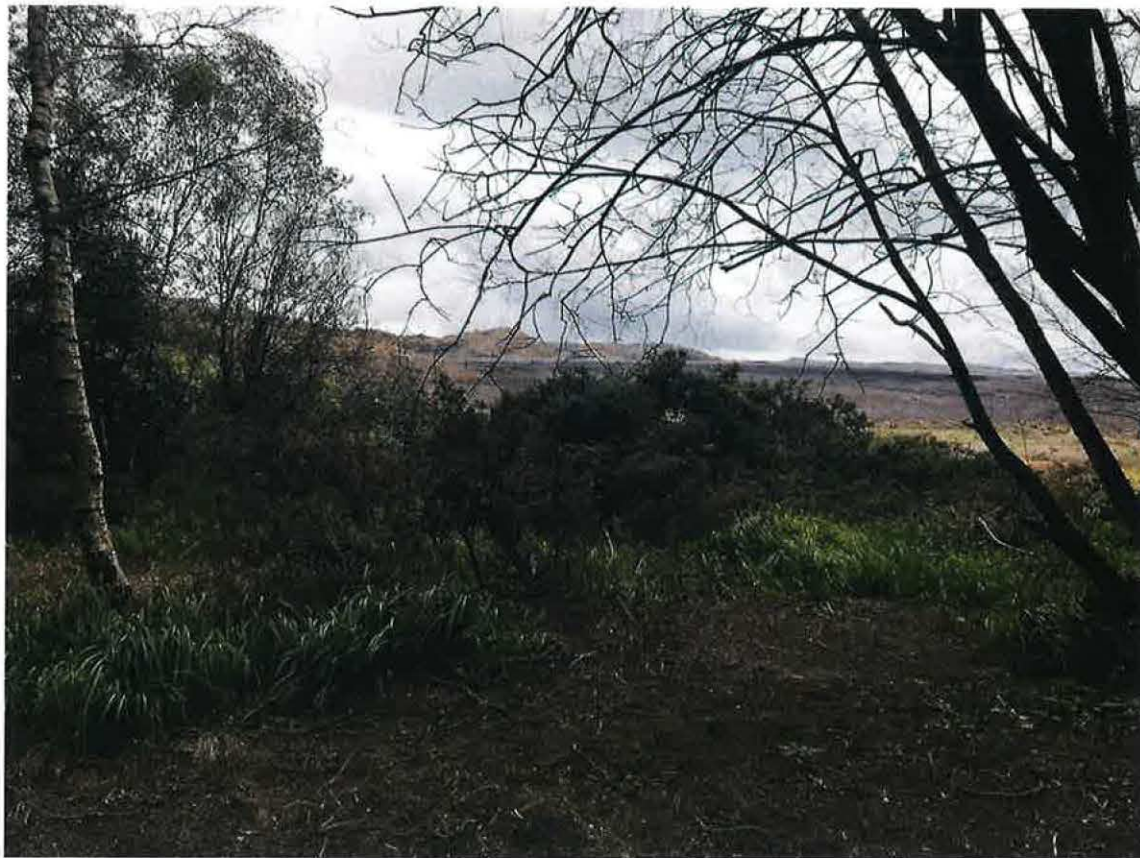
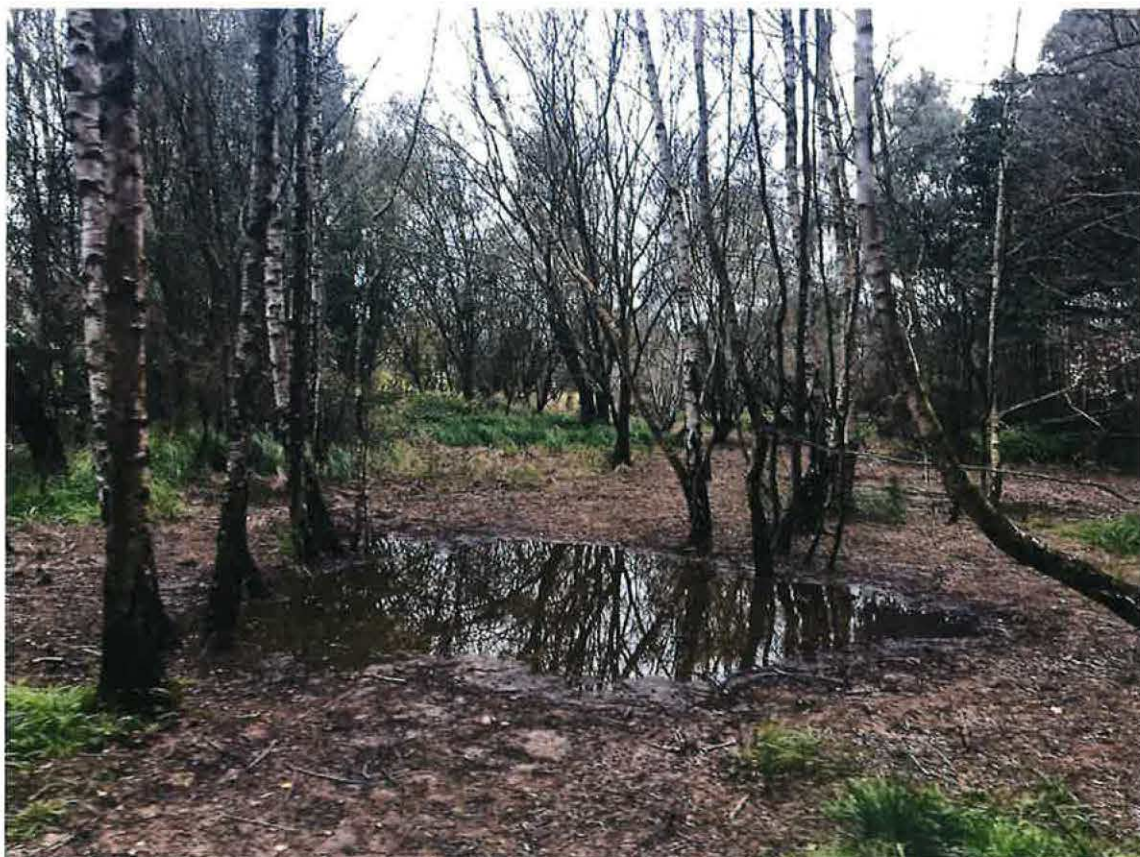
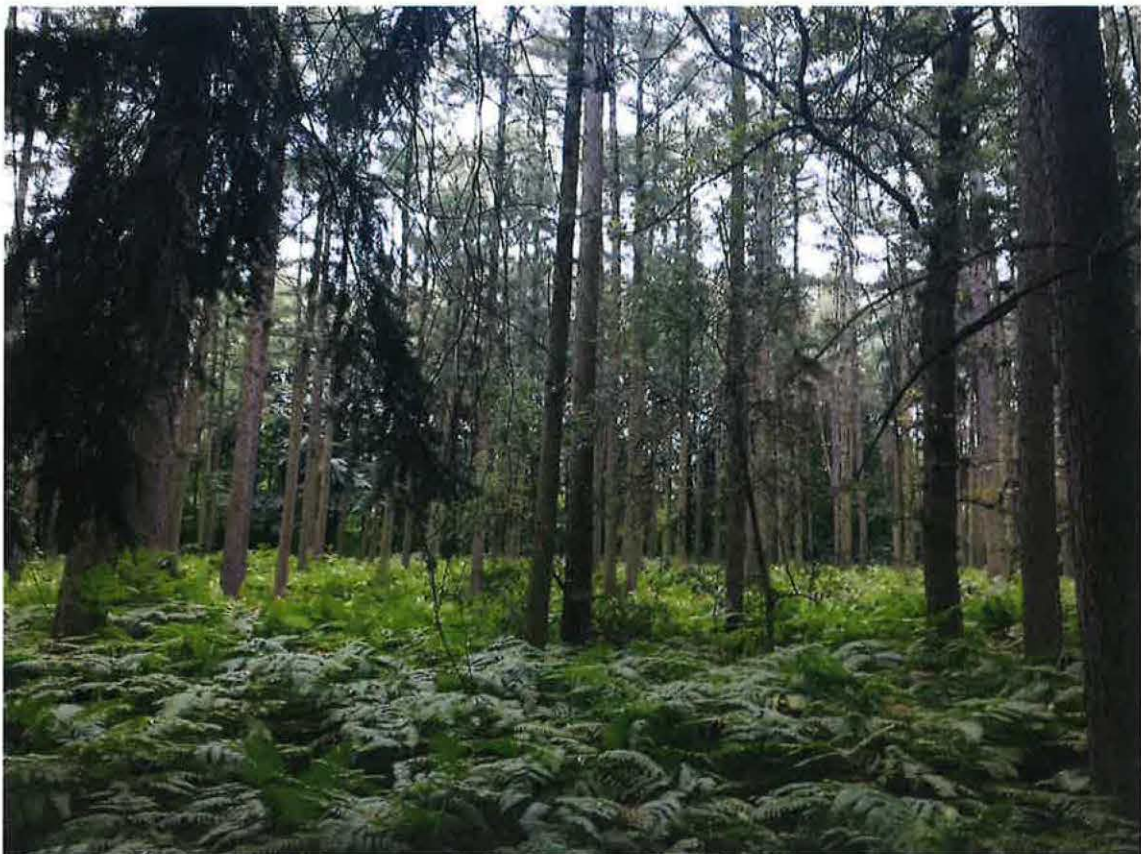
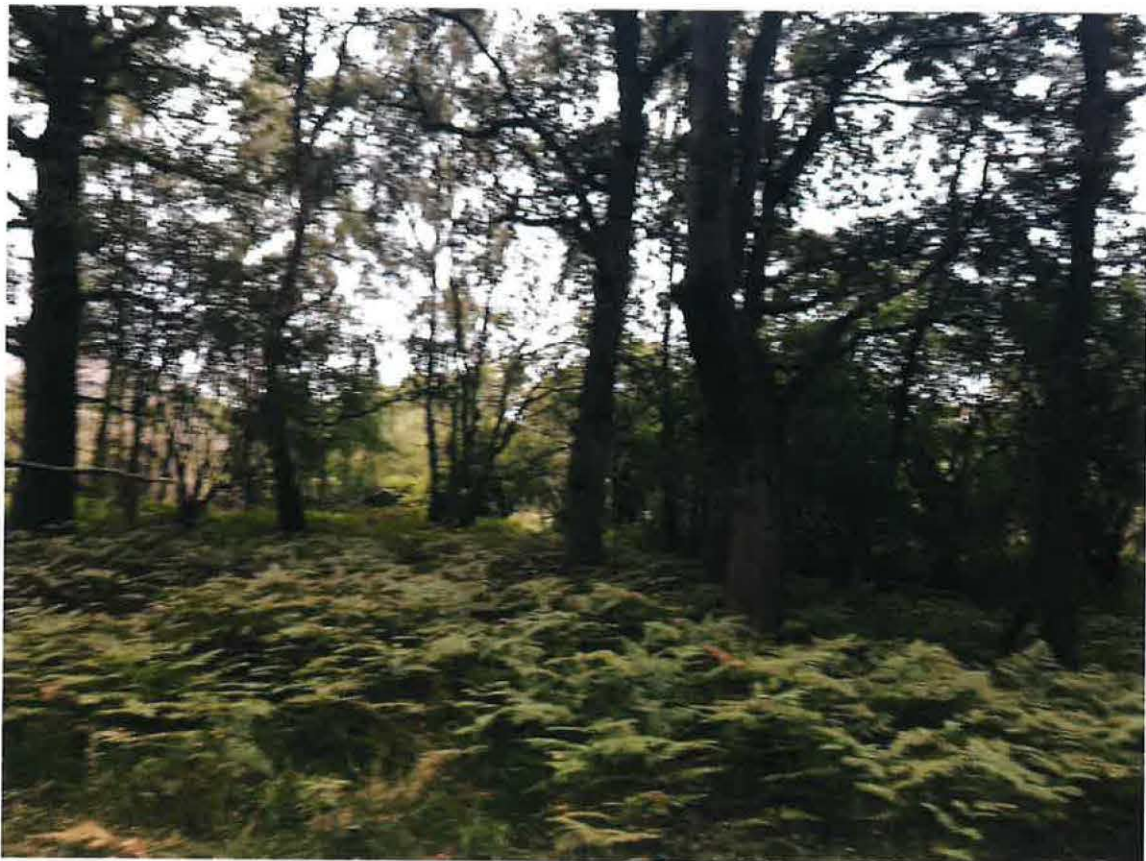
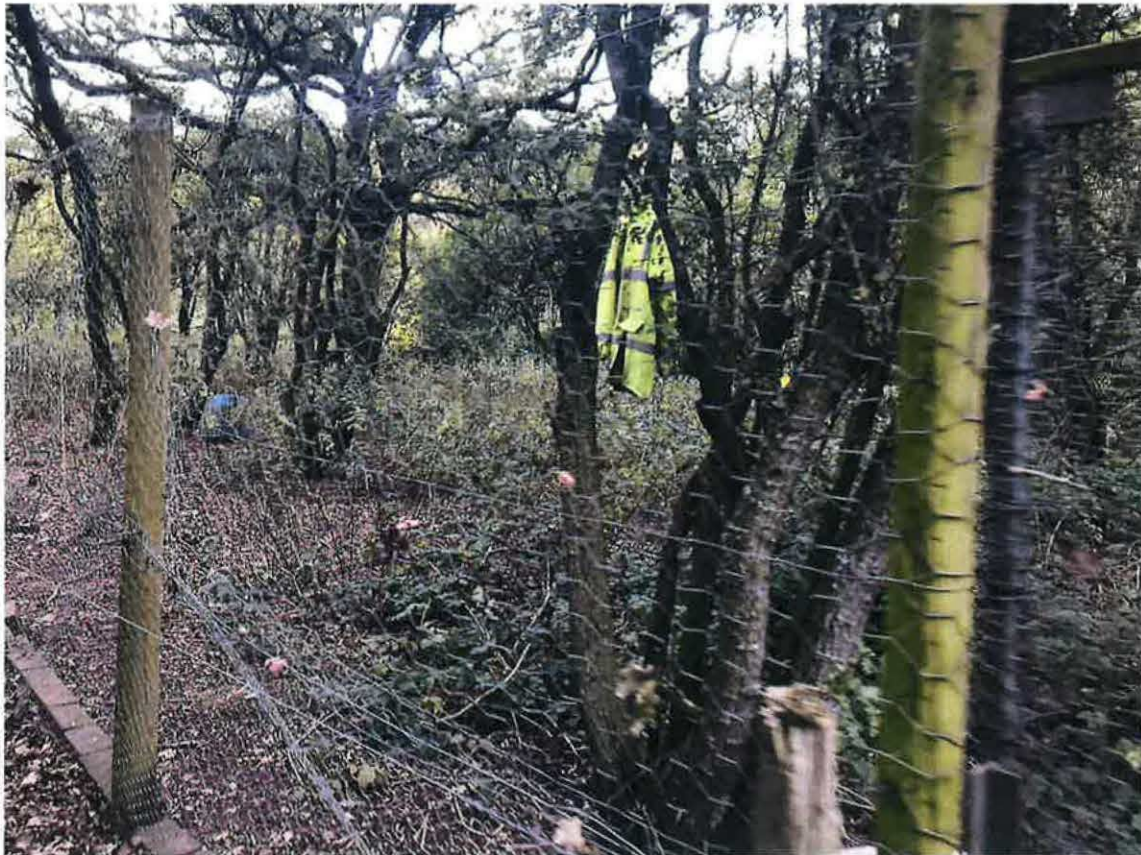
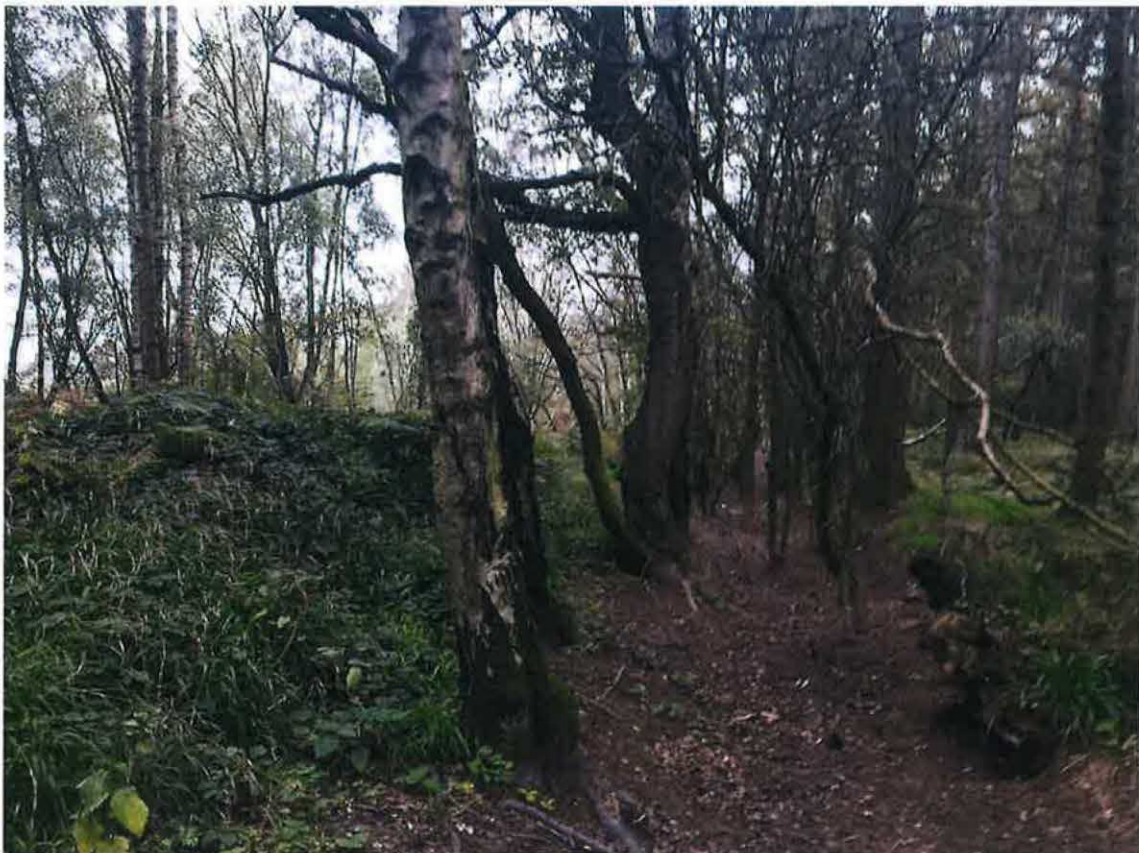
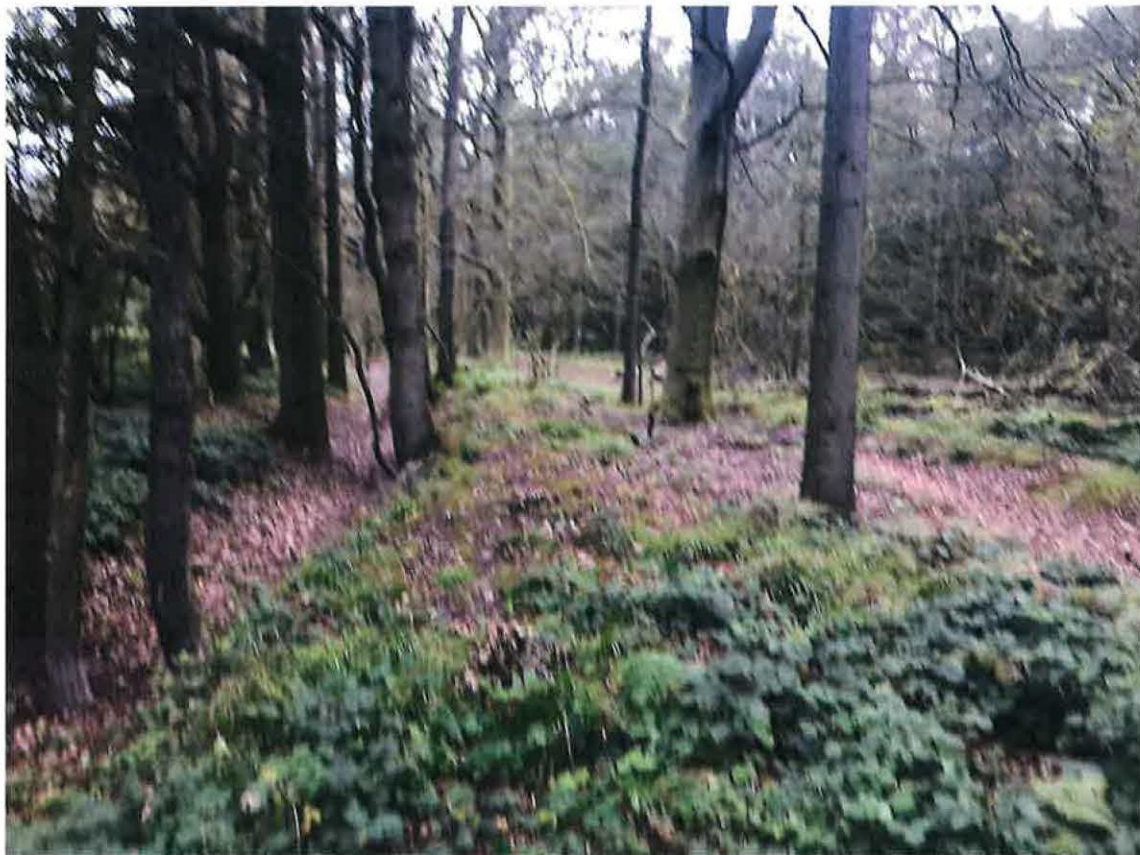
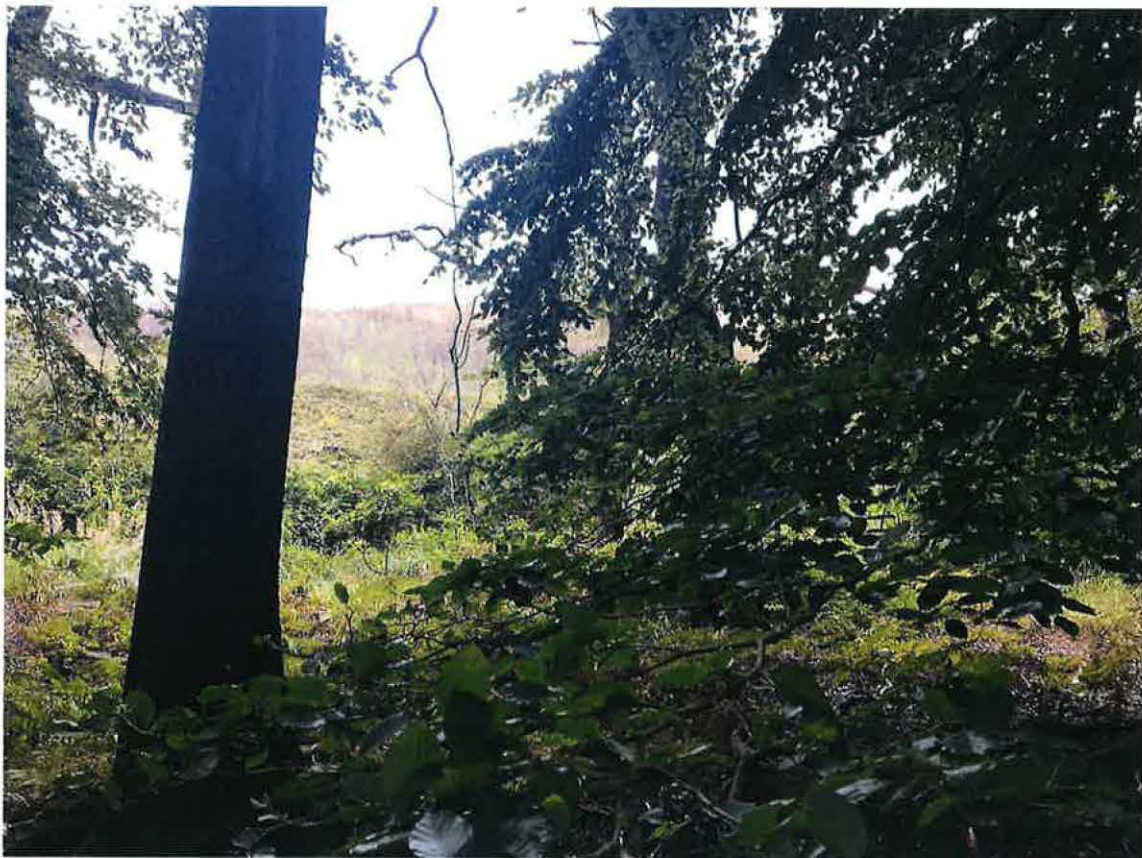
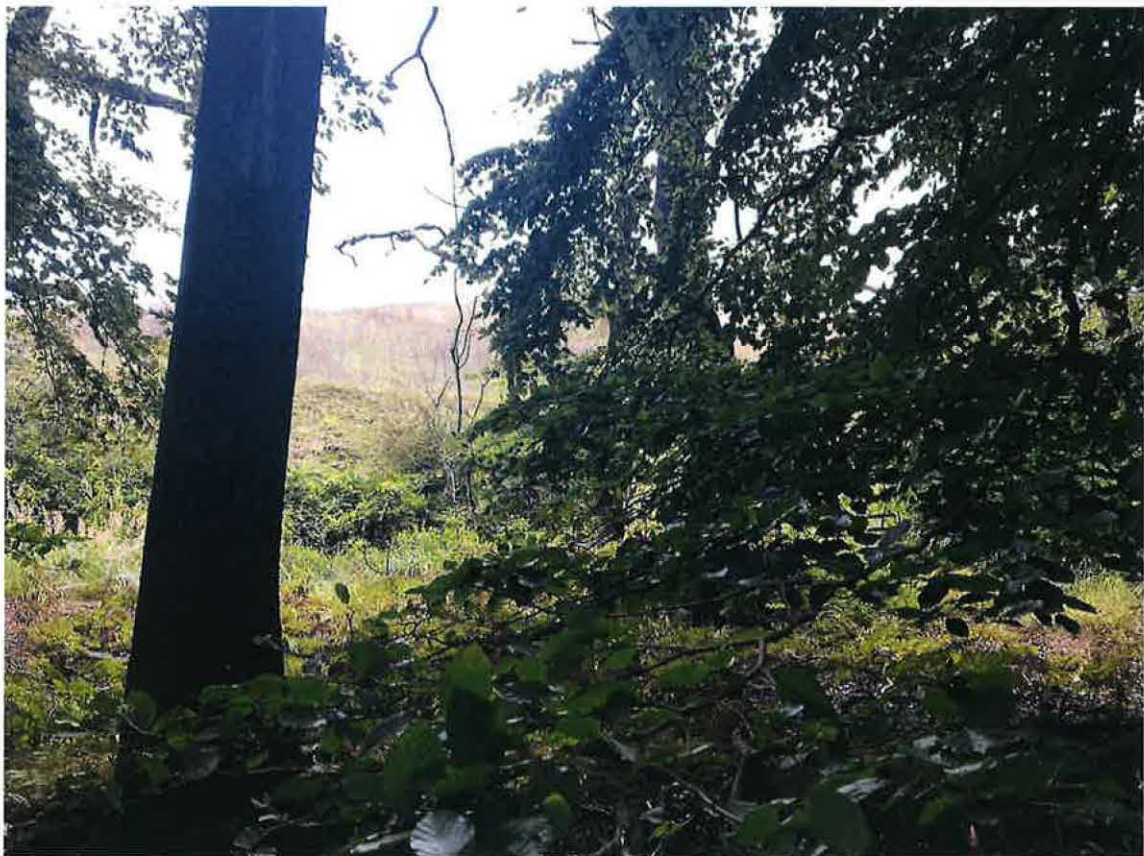
In Spring 2020 a pollution incident arose as a result of the flooding of the existing surface water catchment system in respect of the currently consented waste facility. Contaminated water flowed onto the Trust’s land affecting the area shown edged in pink on the first plan at Appendix 3. The contaminated water was high in chloride levels and has resulted in the denuding of vegetation in the affected area. Also at Appendix 3 is the Applicant’s own sampling results

Since the incident in Spring 2020 the Applicant has not sought to clean up or remediate the pollution caused by the incident and instead they simply have proposed leaving the area to recover over time. Given the inaction of the Applicant since the incident and the proximity of the SSSI on the Trust's land the Trust has significant concerns about the suitability of the Applicant to operate an extended hazardous waste facility.
