**LANDFILL ENVIRONMENTAL PERMIT APPLICATION
STABILITY RISK ASSESSMENT (SRA) REPORT**

**FOR THE DEVELOPMENT CONSENT ORDER
APPLICATION FOR THE ALTERATION AND
CONSTRUCTION OF HAZARDOUS WASTE AND LOW
LEVEL RADIOACTIVE WASTE FACILITIES AT THE EAST
NORTHANTS RESOURCE MANAGEMENT FACILITY,
STAMFORD ROAD, NORTHAMPTONSHIRE**

STABILITY RISK ASSESSMENT REPORT

Report reference: AU/KCW/AW/5646/01/SRA
May 2021

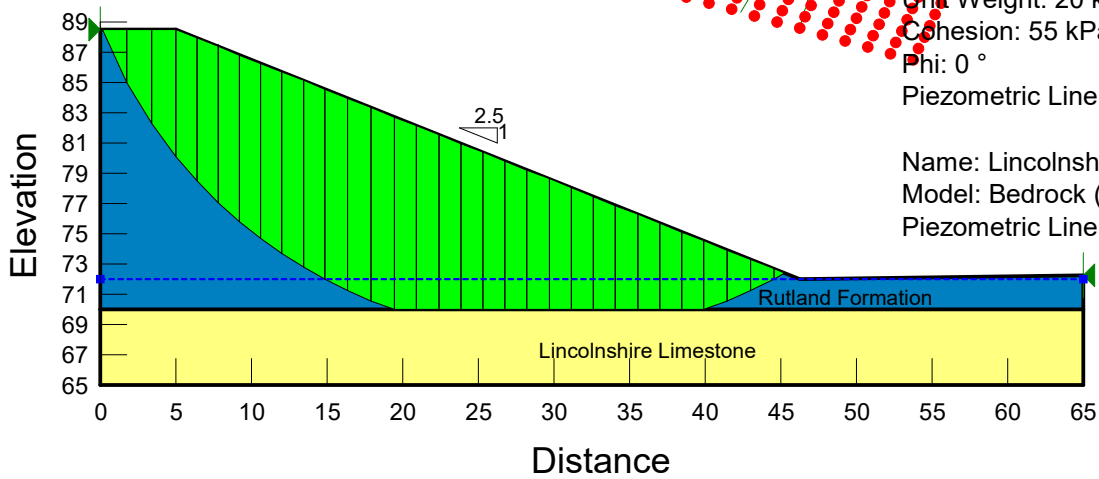
Plot 1a
 ENRMF western extension area
 File Name: 01a_Sideslope sub-grade - 16.5m slope - undrained FOS 1.400.gsz
 Method: Spencer
 FOS: 1.400

Name: Rutland Formation - undrained
 Model: Mohr-Coulomb
 Unit Weight: 20 kN/m³
 Cohesion: 55 kPa
 Phi: 0 °
 Piezometric Line: 1

Name: Lincolnshire Limestone
 Model: Bedrock (Impenetrable)
 Piezometric Line: 1

maximum anticipated 16.5m high sub-grade sideslopes at the maximum gradient of 1v:2.5h as described in paragraph 6.3.8. The calculated factors of safety against rotational failure of the 16.5m high sideslope sub-grade are 1.400 for the undrained (short term) conditions and 1.330 for the drained (long term) conditions.

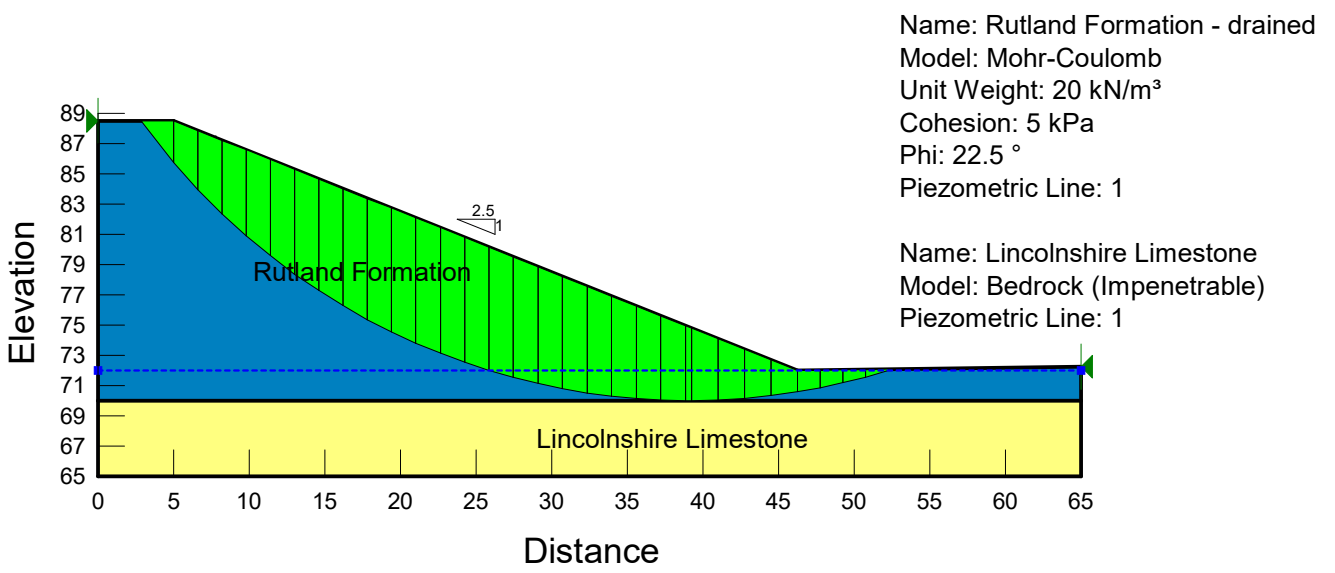
Plot 1b
 ENRMF western extension area
 File Name: 01b_Sideslope sub-grade - 16.5m slope - drained FOS 1.330.gsz
 Method: Spencer
 FOS: 1.330

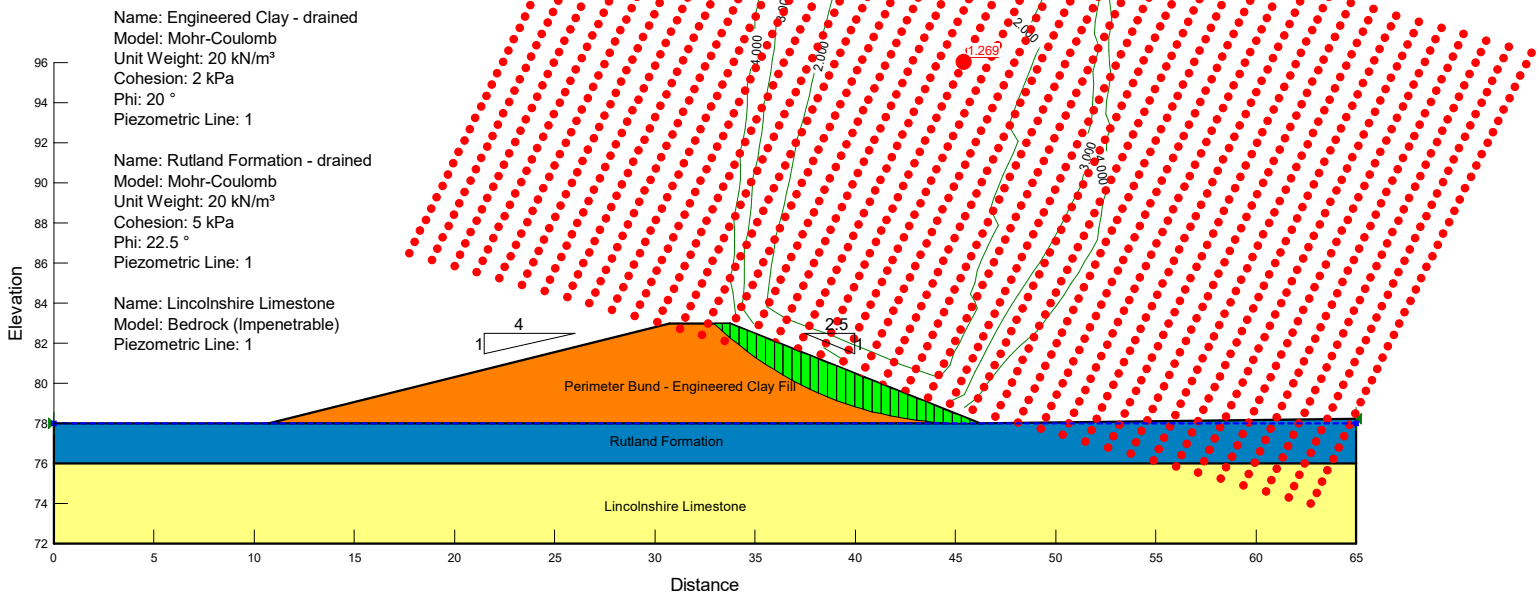
Plot 1d
 ENRMF western extension area
 File Name: 01d_Perimeter bund - 5m slope - drained FOS 1.269.gsz
 Method: Spencer
 FOS: 1.269

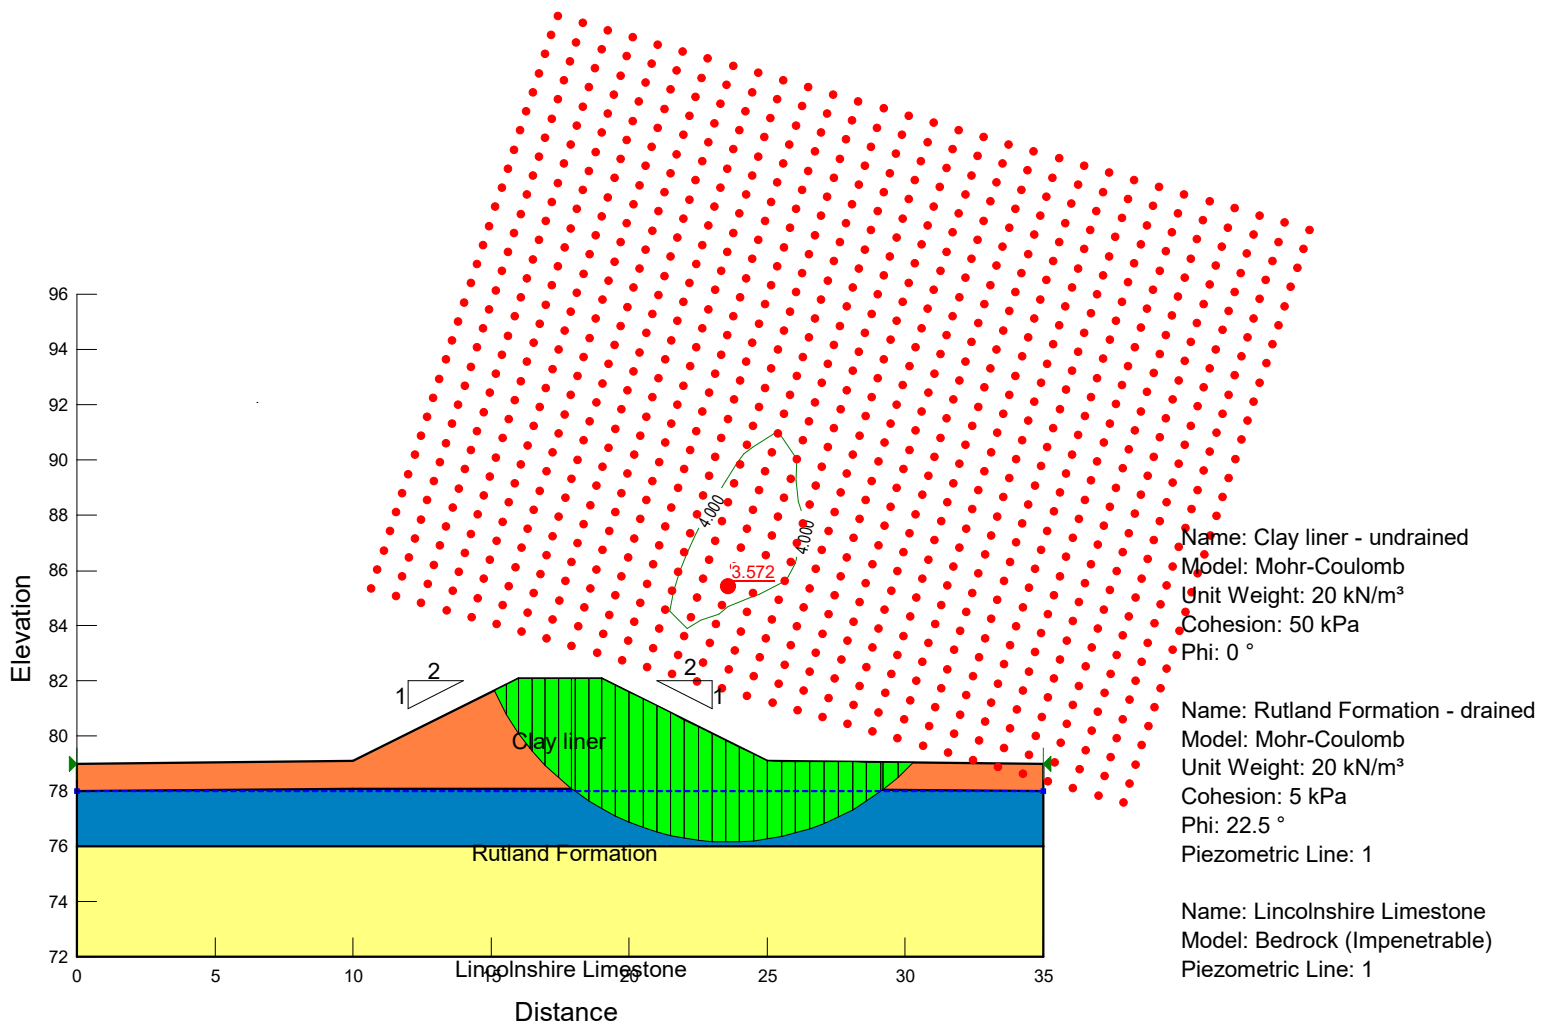
Plot 2a
 ENRMF western extension area
 File Name: 02a_Basal liner - intercell bund - undrained FOS 3.572.gsz
 Method: Spencer
 FOS: 3.572
