Cambridge Waste Water Treatment Plant Relocation Project
Anglian Water Services Limited

Appendix 20.2: Water Walkover

Application Document Reference: 5.4.20.2
PINS Project Reference: WW010003
APFP Regulation No. 5(2)a

Subject: Water Survey - walkover

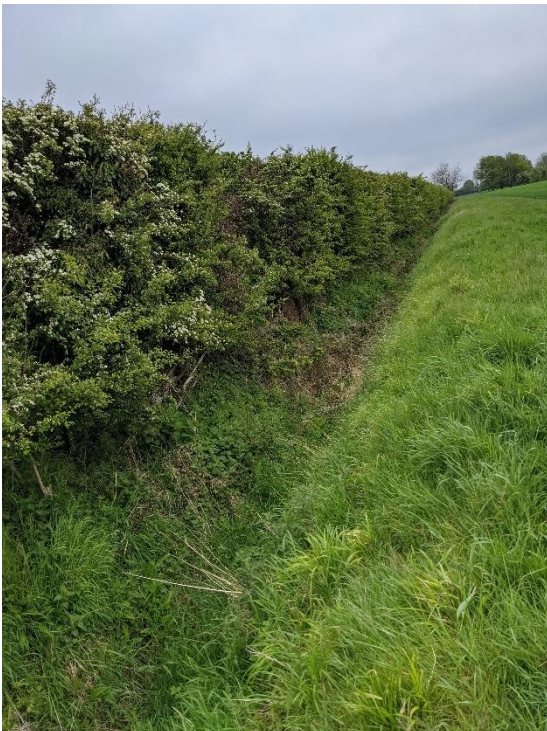
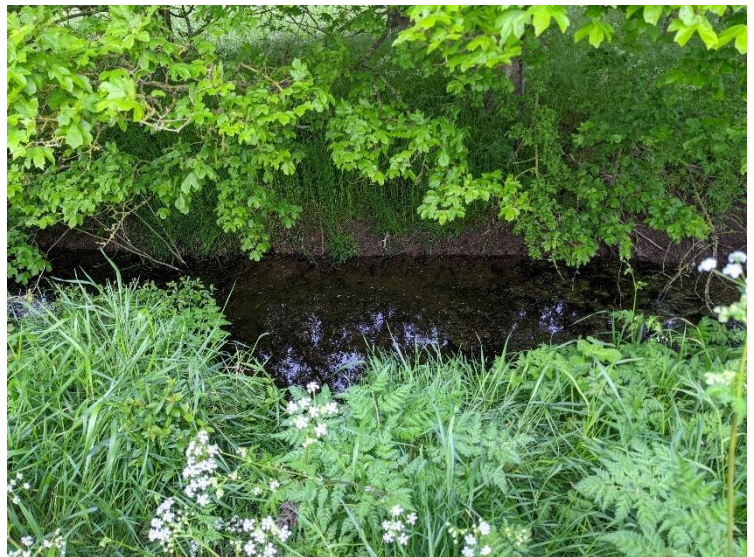
There are several field drains across the site. These were observed to be consistent with what is presented on OS maps. Field drains were mostly dry, boggy or had low flows. Drains were generally 0.5 to 1m deep.

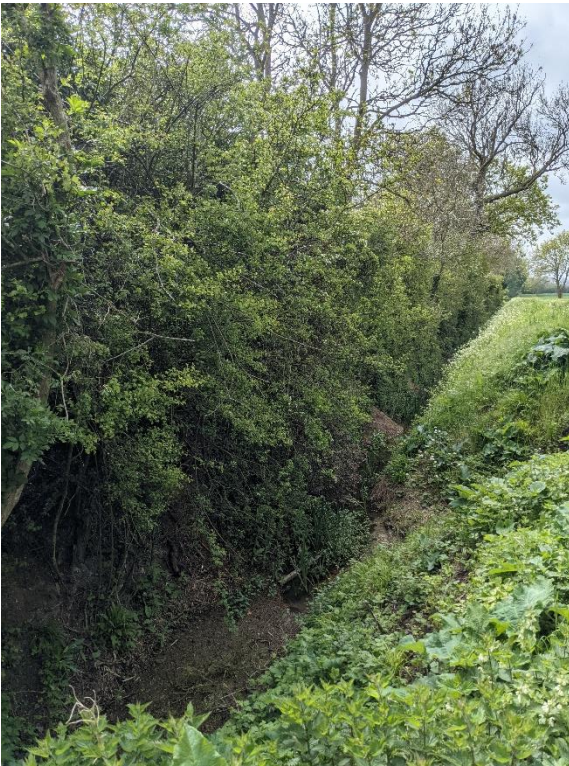
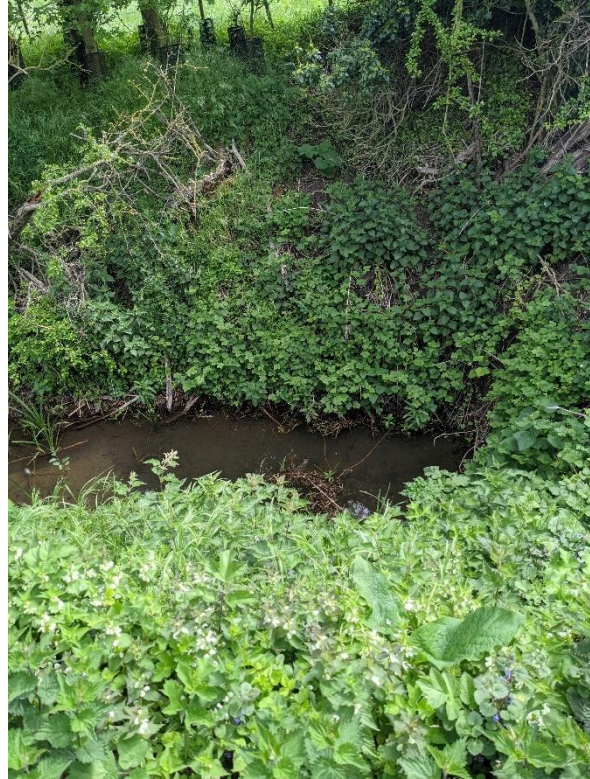
Black ditch was observed in the north and was noted to be significantly deeper with steep sides. This was approximately 2-3m deep. Water was flowing gently and was estimated to be 0.2m deep.

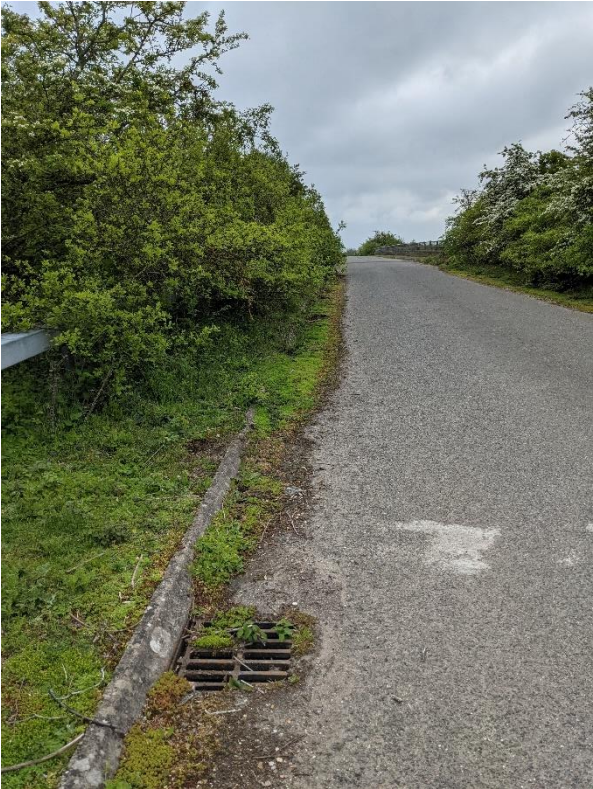
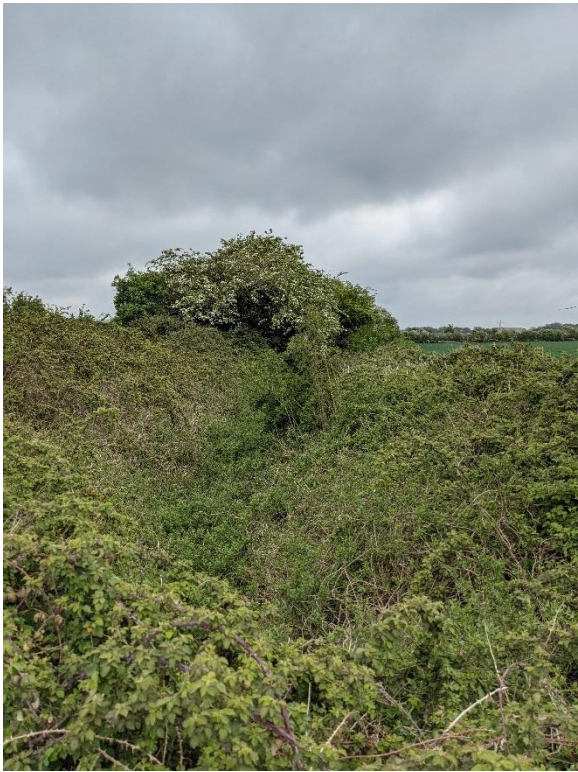
There are several ditches noted around LFDW bridge which crosses the A14. These are as noted on the OS maps. The ditches are either dry or have shallow water. The area is heavily vegetated and many of the ditches were difficult to access or view due to high hedges. All viewed ditches were observed to be dry.

It was noted that the south side of the LFDW bridge has drain covers over catchpits. It was not obvious where these discharge to but it is likely to one of the drains alongside the LFDW bridge.

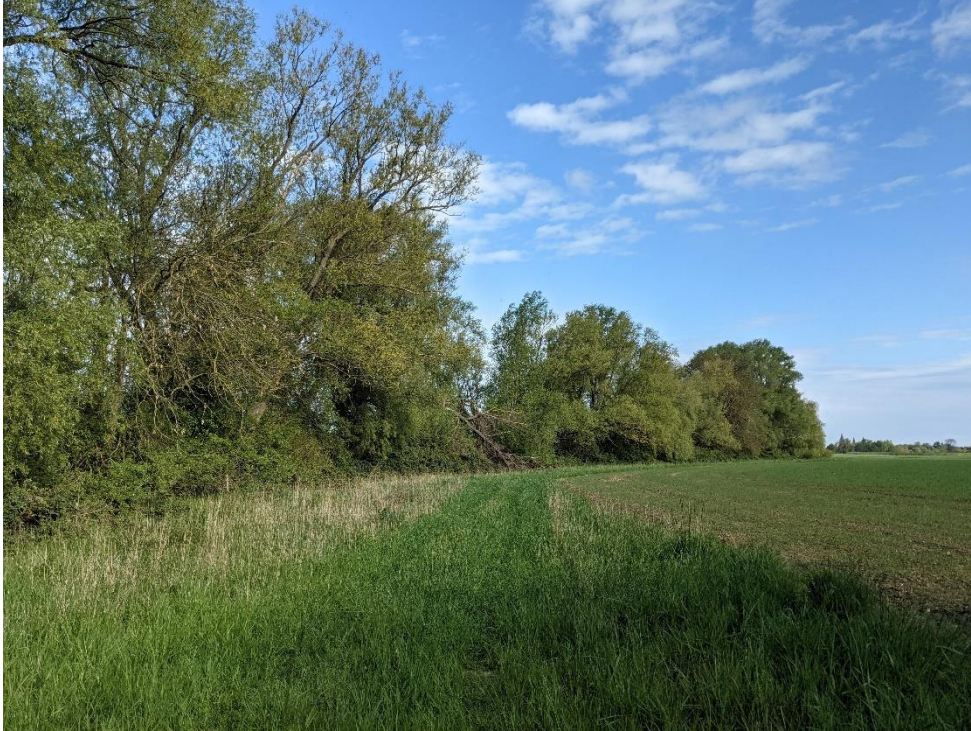
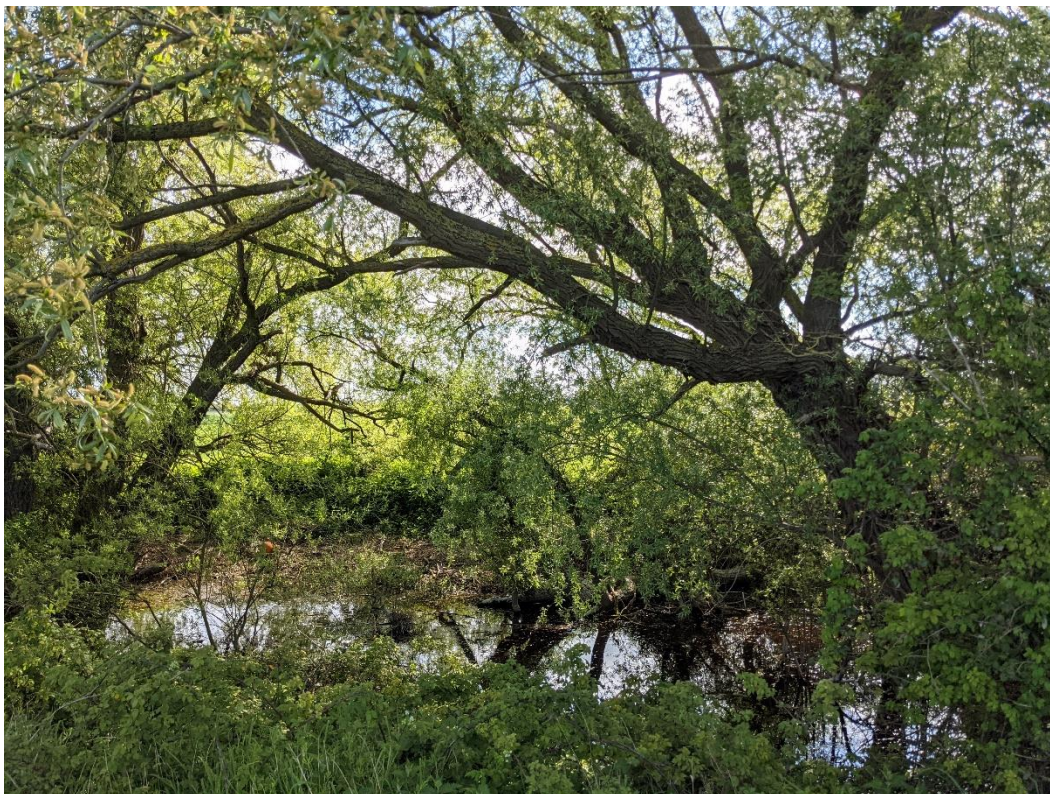
This pond was noted to be present as noted on OS maps. The pond has sloped sides which are approximately 3m deep and the pond is 5m wide. The water in the pond is stagnant and there was no obvious source of inflow to the pond. The pond is surrounded by trees and hedges and so is difficult to access.

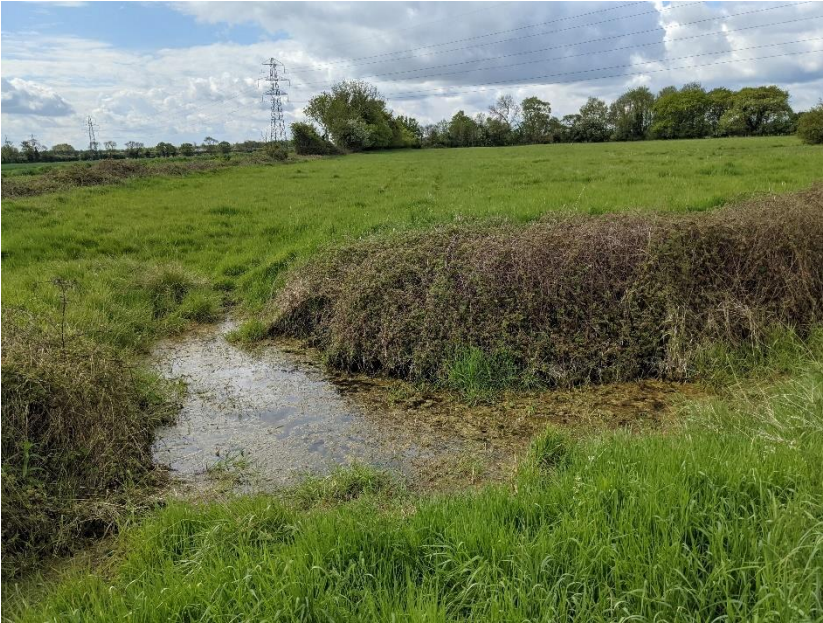
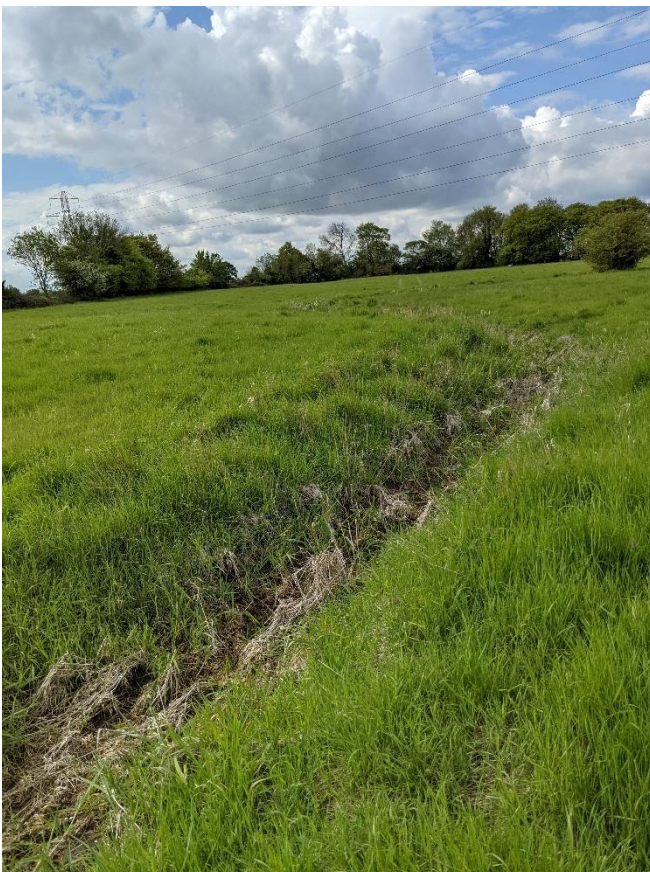
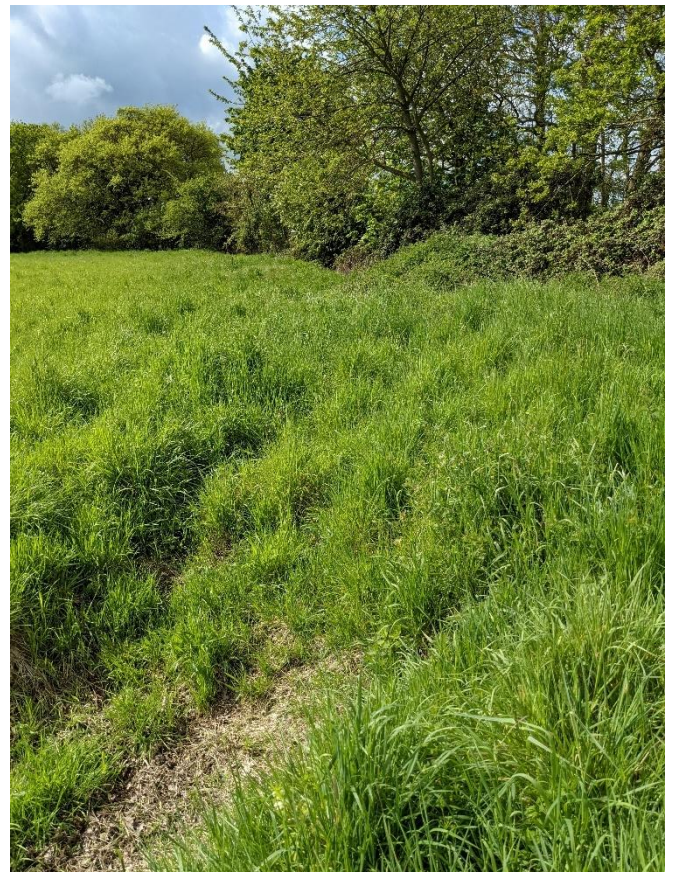
OS maps note a small surface water feature on honey hill, of a small drain which runs to a pond. On site observations noted that the pond was present but the upstream drain was dry/boggy. The pond was stagnant. There was no indication of the pond/drain being fed by a chalk spring.

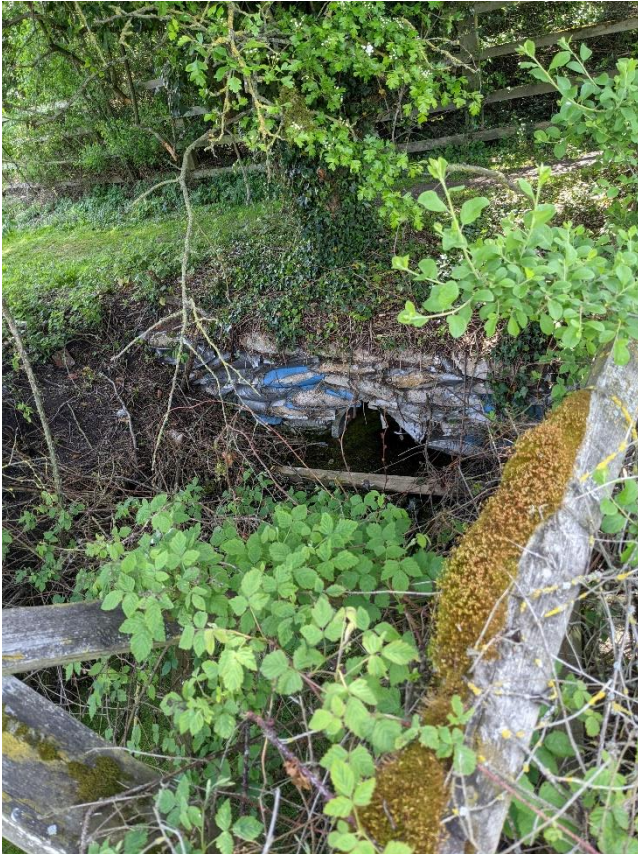
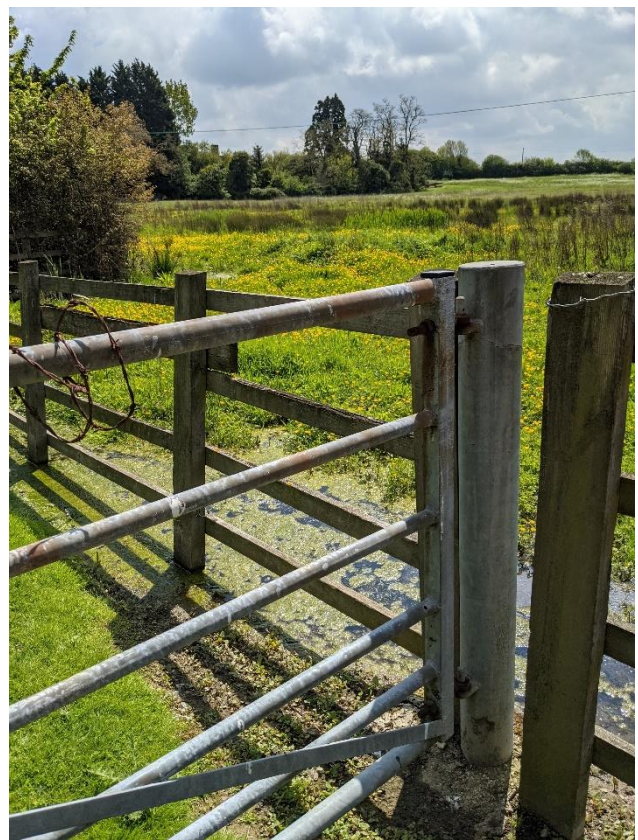
In general, drains located adjacent to the River Cam at the A14 bridge are as they appear on OS maps. However, it was noted that the drain north of the bridge appears culverted under the bridge embankments. It is not known where this then discharges to.

It was observed on site that the private land south of the A14 bridge, Poplar Hall, was extremely boggy.

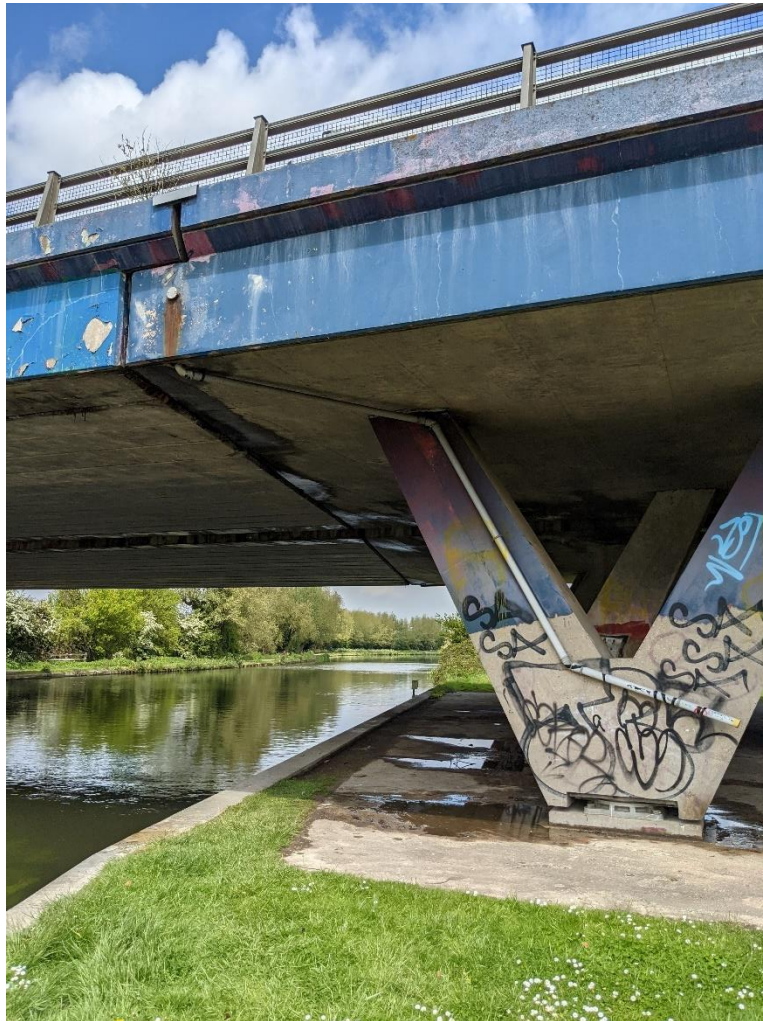
The bridge drainage appears to be through drain pipes which then discharge onto ground under the bridge. Four of these were noted.
