Cambrige Northern Fringe Development

McGee Group has undertaken review of demolition and site remediation requirements for the Cambridge Northern Fringe Development. We believe the programme for the works is achievable, the contamination testing to date appears to show fairly low levels of contamination but insufficient testing has been carried out to confirm that this is reflective of the whole site.

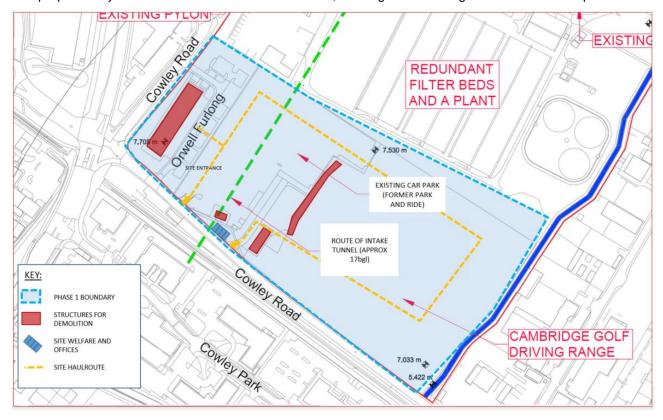
Existing accesses from Cowley Road will be used as the main access and exit points to the phase 1 site. The proposed layout of site haul roads is shown below, existing hardstanding will be used where possible.

An outline plan has been developed to demonstrate the logistic requirements for the phase 1 works. The first activity will be to secure the site, erect site offices and welfare facilities and establish haul routes within the site.

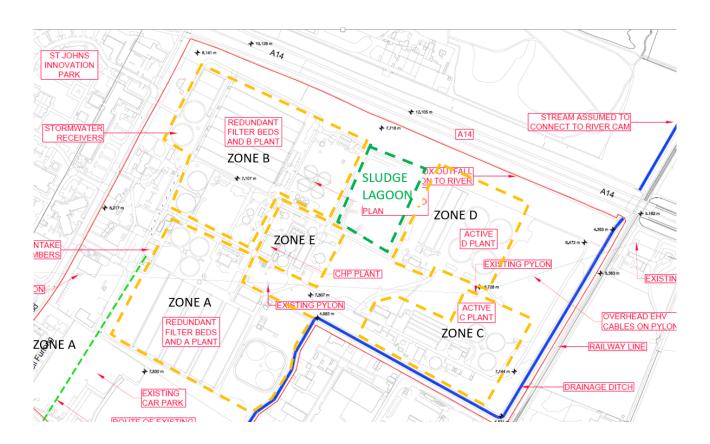
The key demolition work fronts are shown below, in order to meet the programme each area would need to be worked on concurrently. It is noted that a number of the structures are redundant, if there is any opportunity to commence demolition works on redundant structures in advance of the proposed start date the programme would be significantly de-risked.

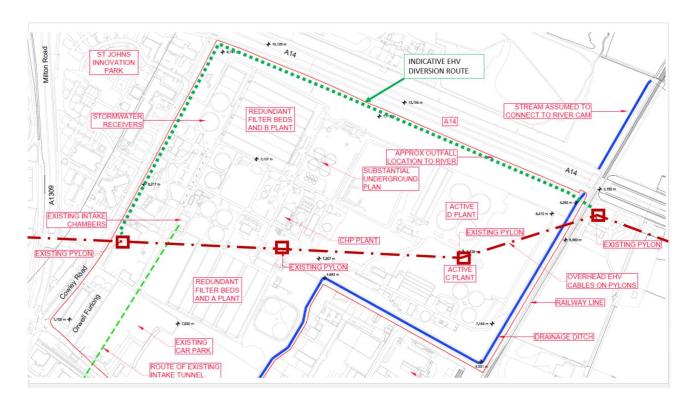
Overhead EHV cables cross the phase 2 site with two pylons located within the site boundary. It is understood that these lines are to be undergrounded on the Northern and Western boundary of the site. It appears that the cable route will require tree removal on the northern boundary to maximize development footprint. The it is thought that the cable diversion be direct buried cable for the most part with ducting only installed at road crossings.

A number of constraints are likely to affect the timing of this diversion

- Nesting birds season will affect tree clearance to the northern boundary
- The cable diversion will likely need to be carried out during the summer months when power demand is reduced
- The site remediation will need to be complete within the service corridor
- Ducting will need to be installed at road crossings
- Directional drilling or similar will need to be carried out to provide a crossing under the railway line and stream to the east side of the site. The approvals process for this is likely to be significant

The diversion can be significantly de-risked by undertaking the enabling works early, there is no apparent reason why the vegetation clearance, ground remediation, duct crossings and railway crossing cannot be carried out during the phase1 works or earlier.

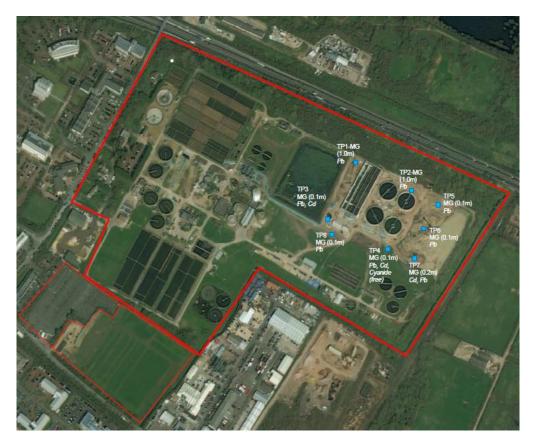
Above: Locations where soil contamination has been identified in previous site investigations

The soil contamination identified is detailed in table 3 below extracted from the document. The majority of contamination is within the made ground, the majority is heavy metal exceedances with some hydrocarbons.

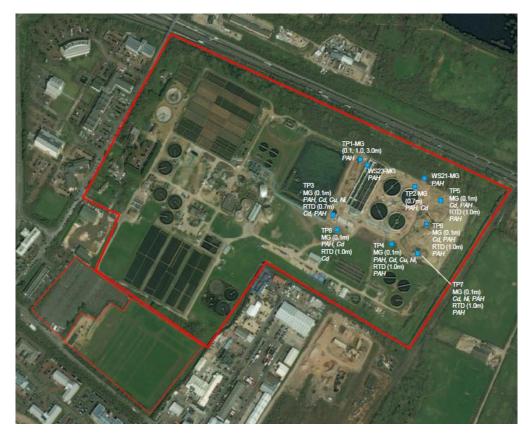
Above: Locations where soil leachate contamination has been identified in previous site investigations

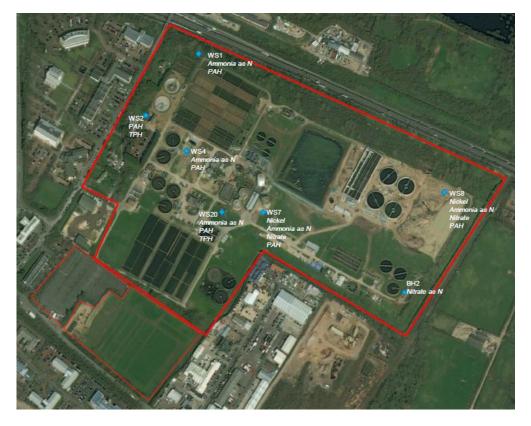
Above: Locations where groundwater contamination has been identified in previous site investigations
