Item 3: Accident analysis of the Beijing lithium battery explosion which killed two firefighters

Accident analysis of Beijing Jimei Dahongmen 25 MWh DC solar-storage-charging integrated station project

Institute of energy storage and novel electric technology, China Electric Power Technology Co., Ltd.

April 2021

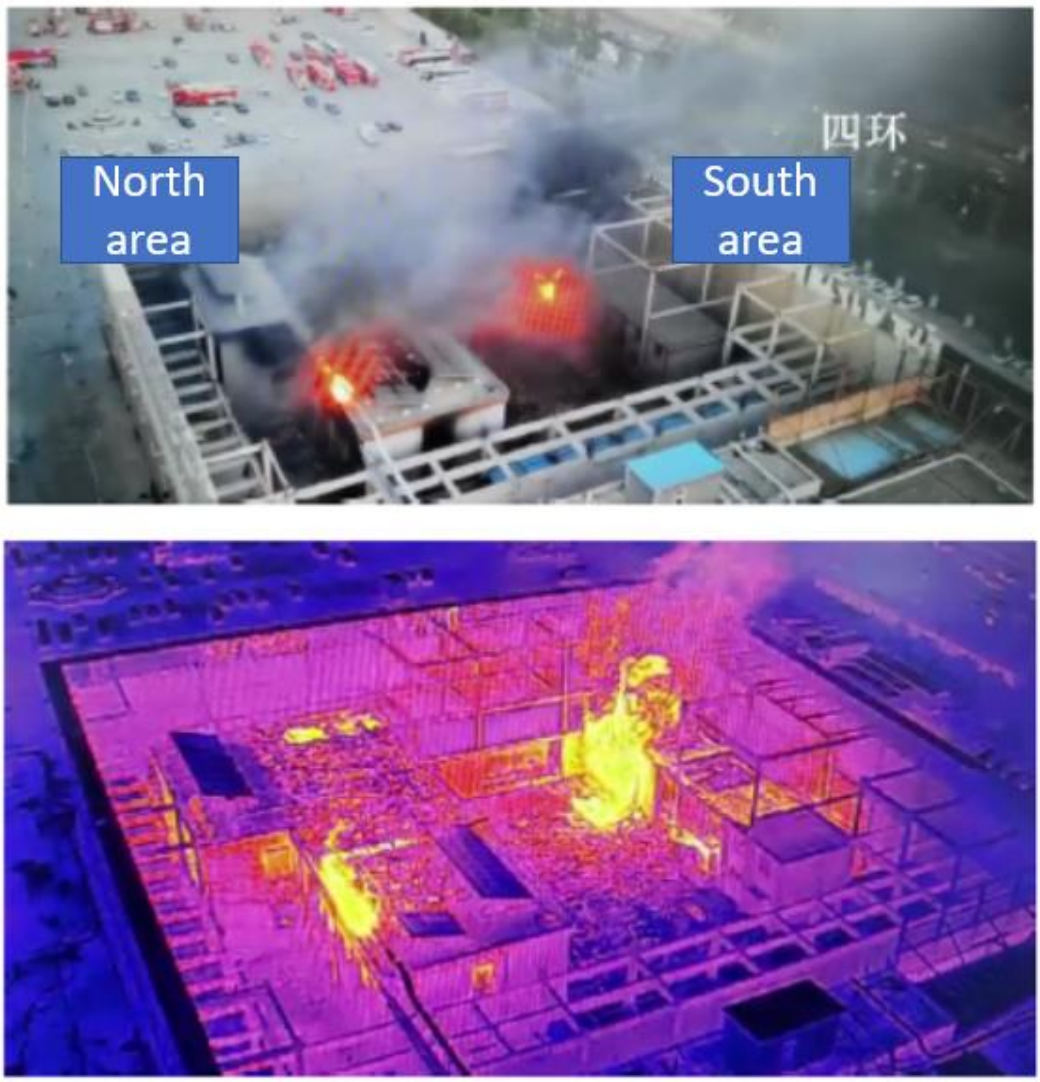
Fig. 8 Aerial photography of the accident scene

Around 14:15 pm, when the fire fighters were dealing with the fire of the power station in the south area, a sudden explosion occurred in the power station in the north area without a warning, **leading to the death of 2 fire fighters, injury of 1 fire fighter and missing of 1 employee of the power station.**

It was learnt through preliminary investigation that on-site debugging was undertaken prior to the accident. At 23:40 pm on 16th April 2021, the naked fire was extinguished. However, the cooling-down was still in process. The reasons and property loss were under investigation.
