# SPR EA1N and EA2 PROJECTS

## ACCOMPANIED SITE INSPECTION

Interested Party: SASES PINS Refs: 20024106 & 20024110

Date: 22 January 2021

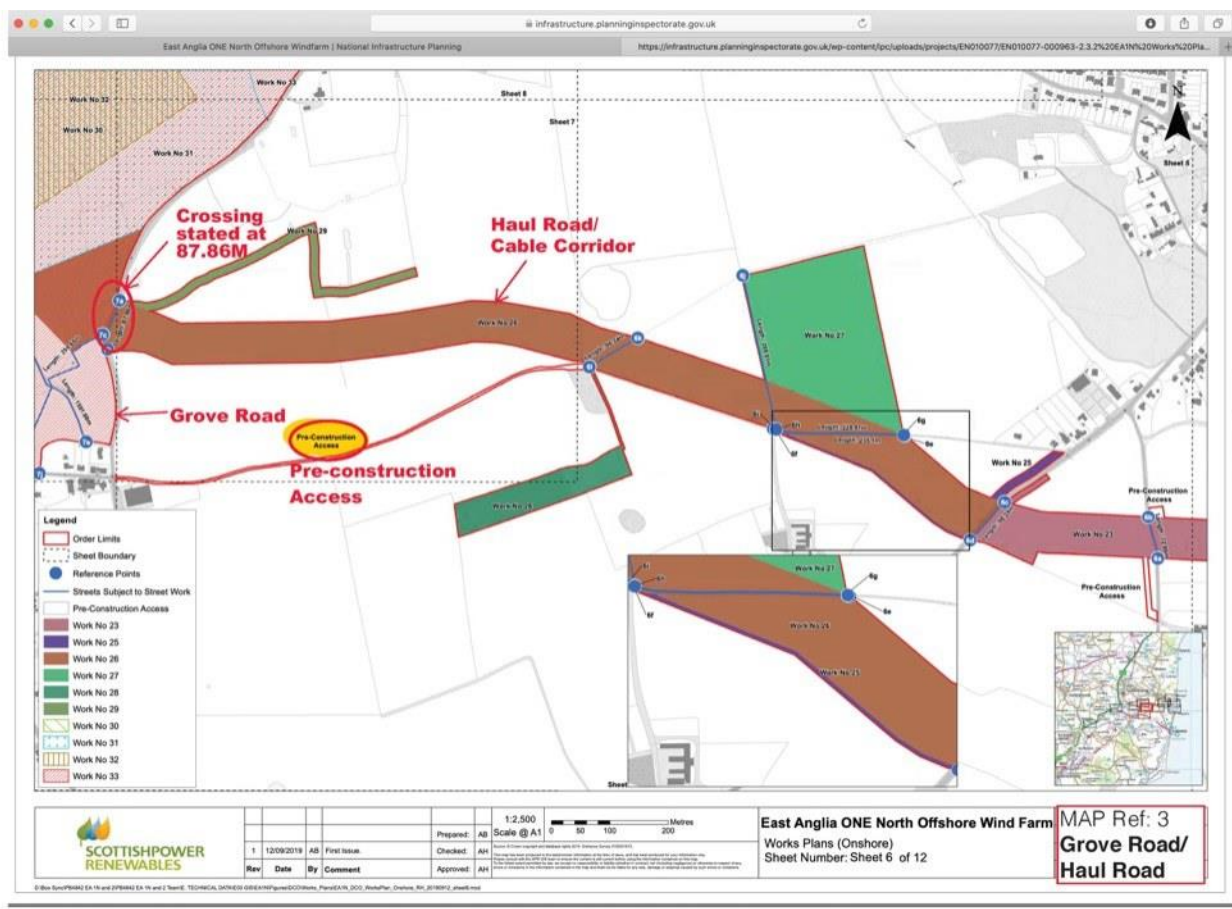
**Item 3 – Grove Road (proposed haul road/cable route crossing the public highway (Work No 26)).**

- Proposed Bridleway FP6 to be used as Pre-construction Access – safety issues. Floods on to Grove Road.
- Grove Road is narrow and winding with no footpaths. Also liable to flood as no ditches either side of road.
- Be prepared for agricultural vehicles and cyclists.
- The field where the haul road crosses floods onto Grove Road due to the slope of the land.
- Width of haul road crossing = 87.86M, plus large marshalling area for HGVs – this is the area where the alternative PRoW is planned, as well as Construction Consolidation Sites.

- Grove Wood and Laurel Covert are slightly to the north – there is an area where the felling of trees under Forestry Commission licences has taken place and will continue as a rolling programme.
- Relevant photographs follow on the following pages.
