Report on the investigation of the
collision between

Saga Sky

Stema Barge II

on 20 November 2016

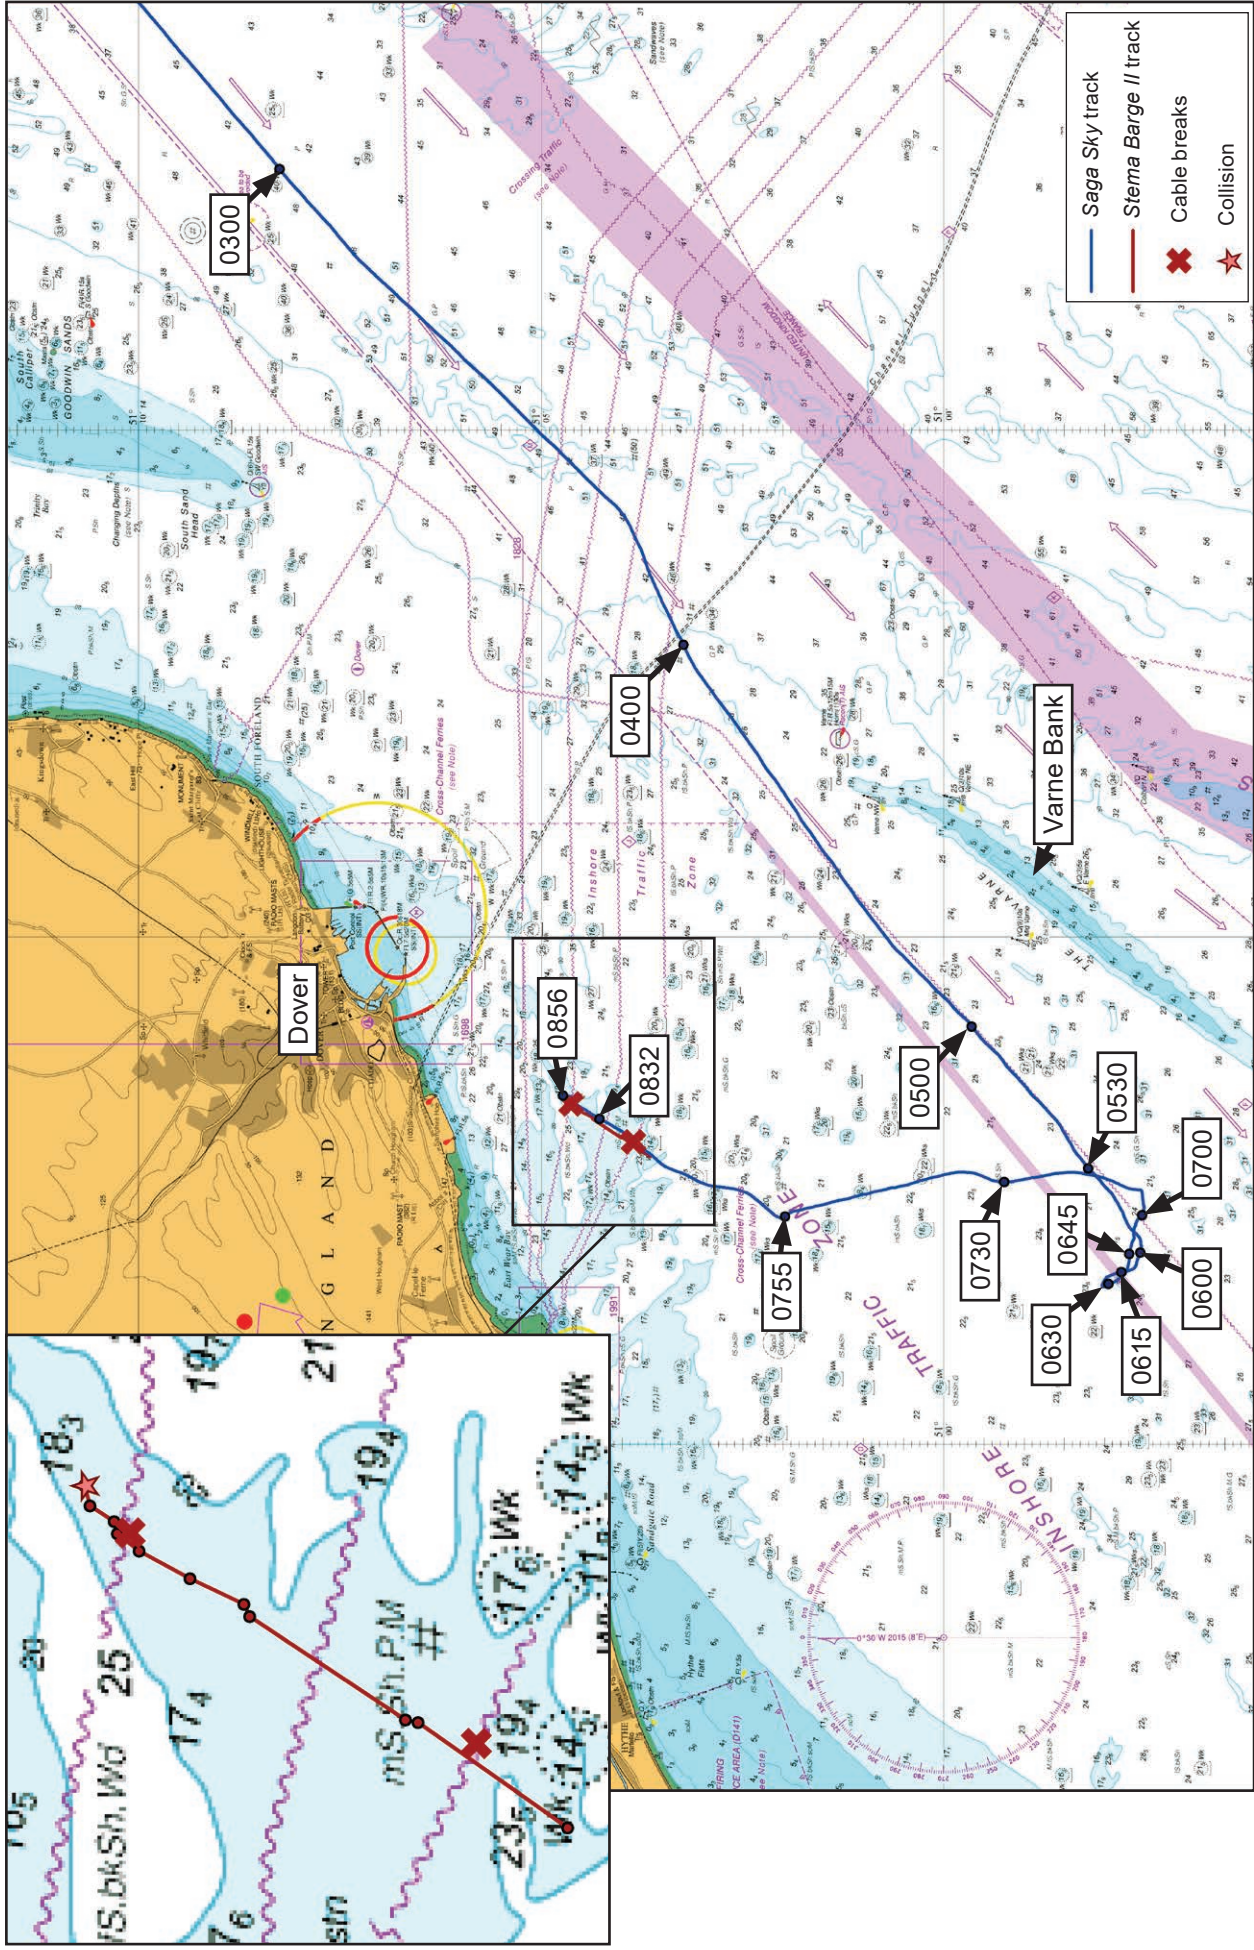
Figure 1: Reconstructed approximate tracks of Saga Sky and Stema Barge I using recorded positional radar information

Between 7 and 10 November, *Stema Barge II* had dragged anchor approximately 0.5nm before settling at a position close to cable route 4, the most southerly cable route of IFA 1, where it remained until the arrival of Storm Angus on the morning of 20 November. As the storm reached its peak off Dover, the barge's anchor again began to drag. Over the course of several hours, the barge moved a further 1.2nm until it reached the point at which the collision occurred, about 2 miles off the coast (**Figure 1**).

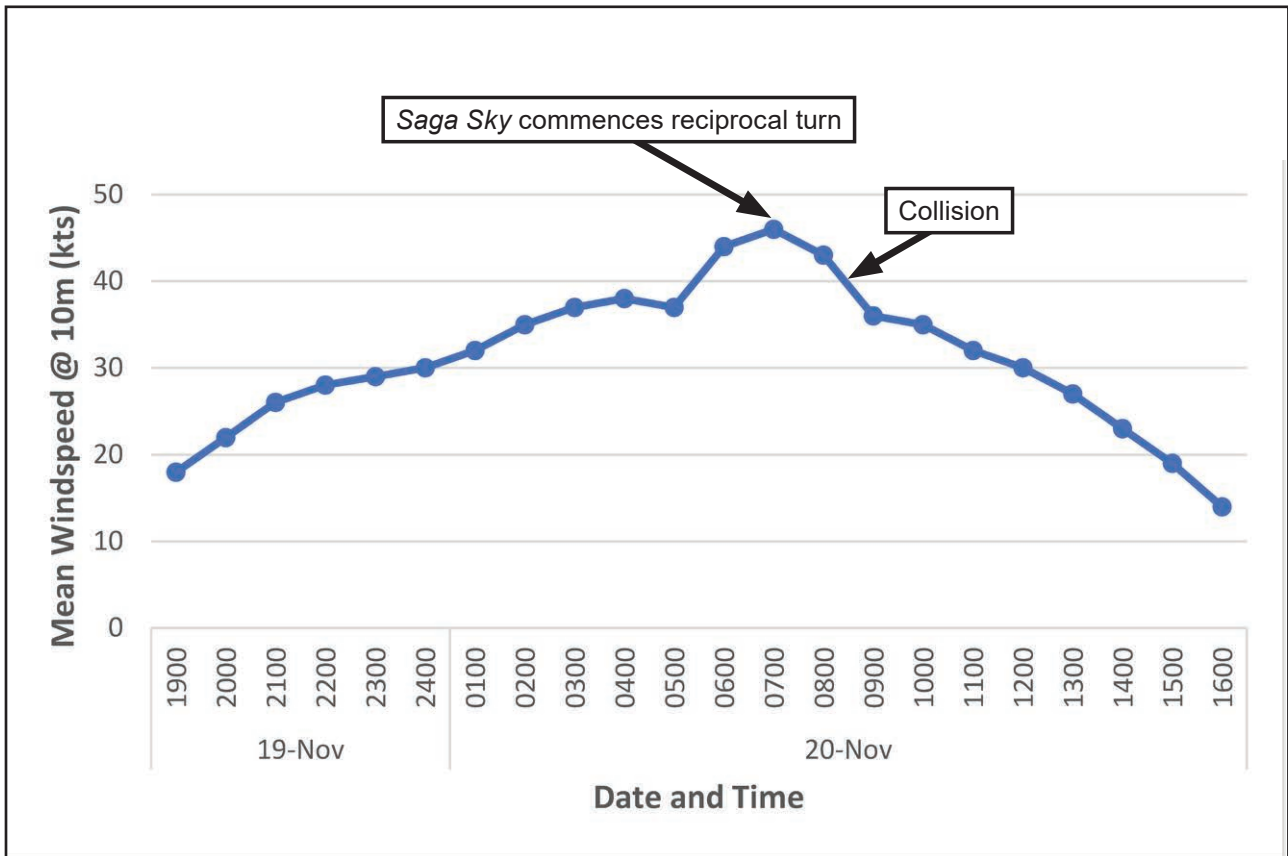
Figure 2: Graph showing wind speed against time

During the next 2 hours the wind continued to increase, reaching severe gale force 9 with the ship noting wind gusts of up to 80kts. This caused *Saga Sky* to slow further as the force of the wind acted against its structure. The master attempted to counter the effects of the weather by increasing main engine speed, but this resulted in the ship pitching heavily. The pitching, coupled with the ballast condition, allowed the propeller to come clear of the water, causing the main engine to overspeed and shut down. This happened on several occasions but the engineers were able to restart the engine promptly each time.

In the event, south-westerly wind speeds in excess of 64kts and wave heights up to 6m were recorded in the Dover area between 0500 and 0900 on the morning of 20 November (**Figure 2**).

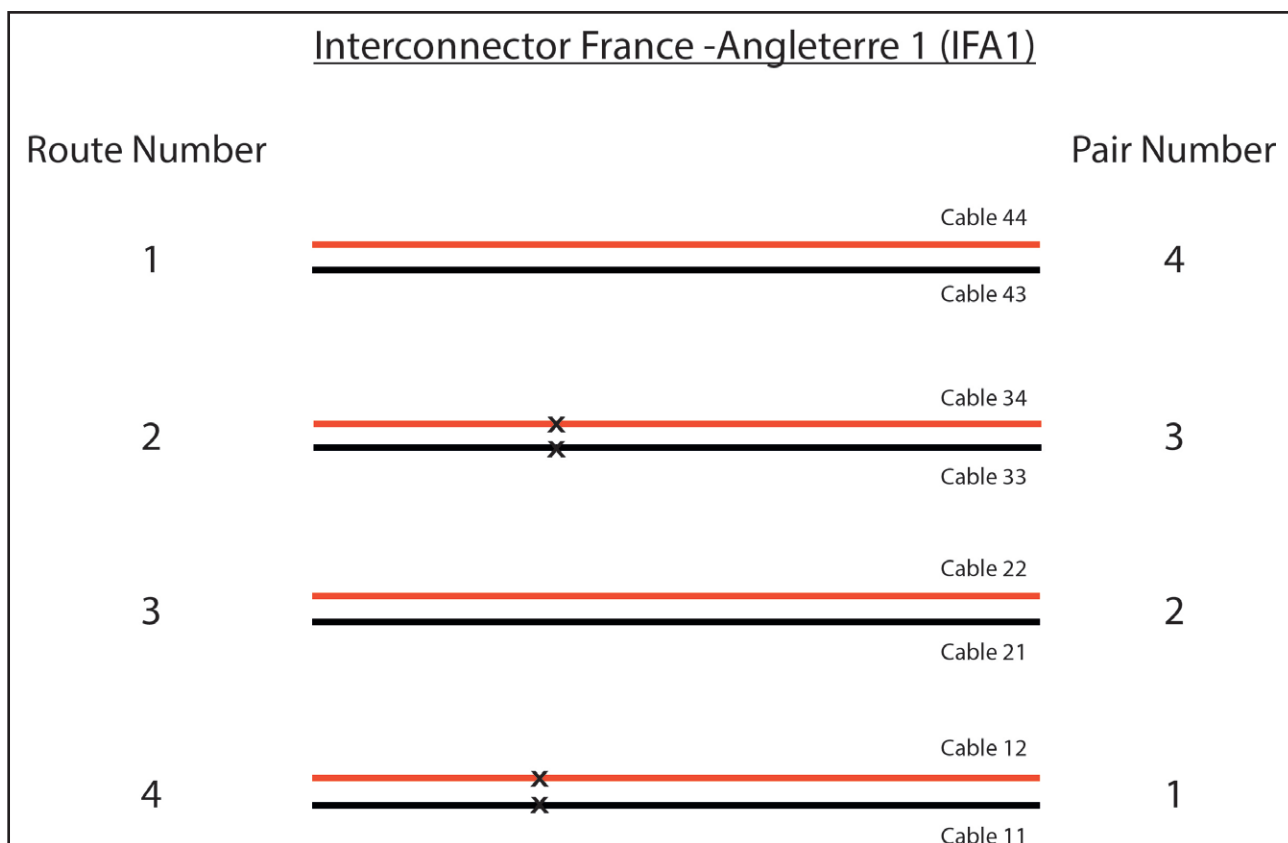
Figure 6: Interconnector France-Angleterre 1 (IFA 1)

IFA 1 consists of four pairs of cables (**Figure 6**). Cable pairs 1 and 3 (cable routes 4 and 2) are owned by Réseau de Transport d'Électricité (RTE), the French transmission system operator. Pairs 2 and 4 (routes 3 and 1) are owned by the UK company National Grid Interconnectors Limited, which is a wholly owned subsidiary of National Grid Plc.

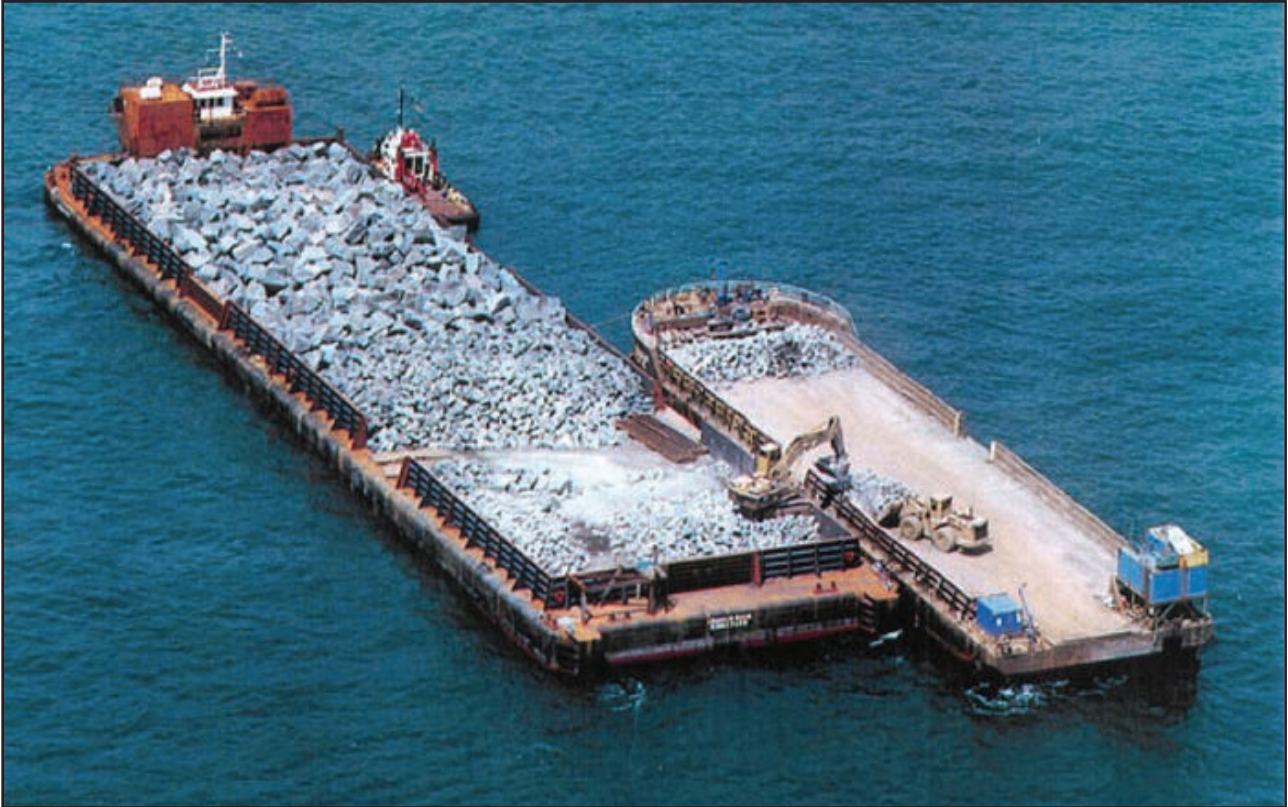
Figure 7a: *Stema Barge II* transferring rock to *Charlie Rock*

The offshore delivery of rock using *Stema Barge II* commenced in July 2016. The rocks were transported from Norway in *Stema Barge II*, which was then anchored offshore between Folkestone and Dover. The rocks were moved inshore via a specified transshipment route on a smaller barge, *Charlie Rock*, and deposited at Shakespeare Beach (**Figures 7a** and **7b**). Both barges had no integral means of propulsion and were manoeuvred using tugs.

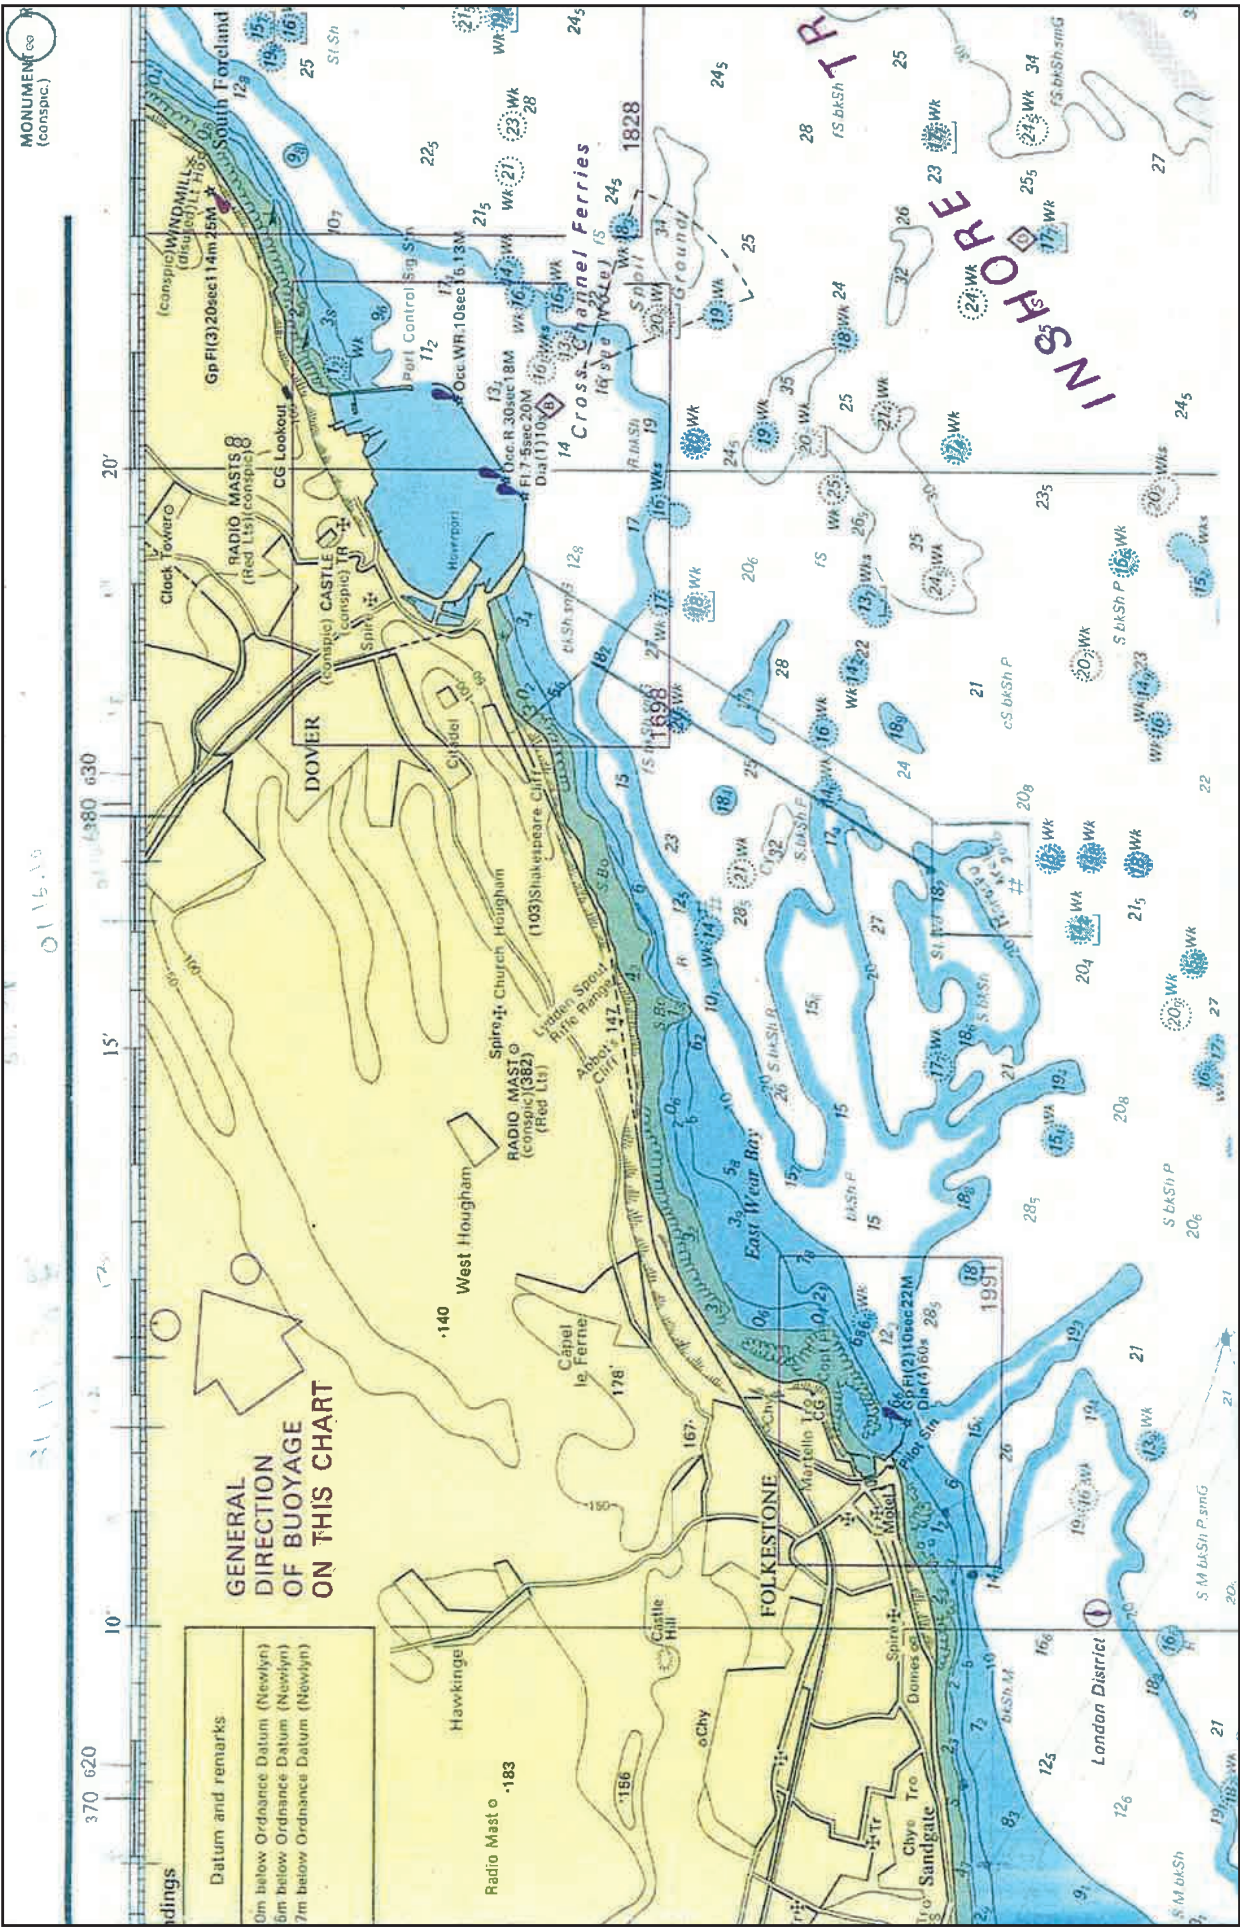
Figure 8: Stema Shipping UK Ltd chart extract

The proposed square anchorage box with top left and bottom right co-ordinates of 51° 04.40'N, 01° 17.00'E and 51° 03.85'N, 01° 16.10'E respectively was highlighted on an extract from an Admiralty chart. The box was located directly above IFA 1, cable route 3, which was not shown on the chart extract (**Figure 8**).

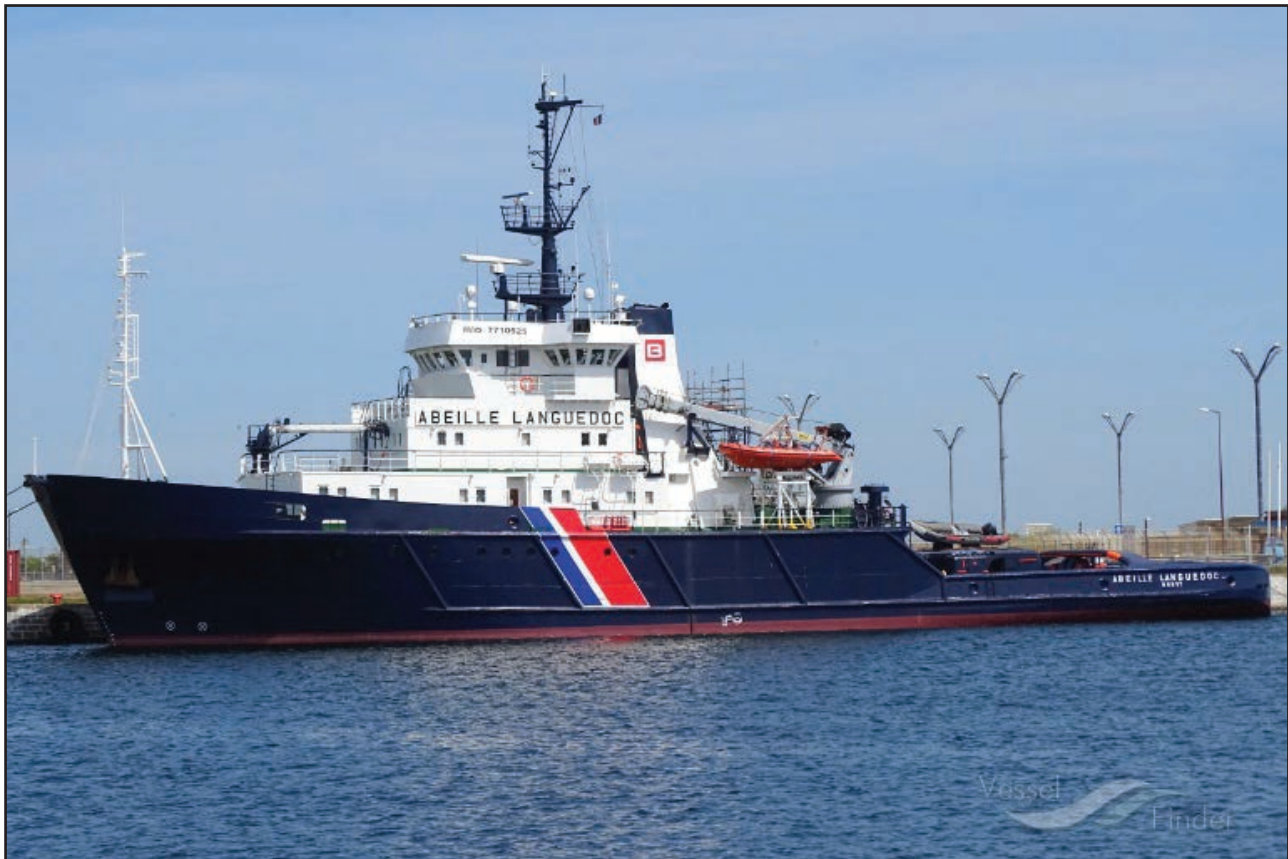
Figure 10: French tug *Abeille Languedoc*

The French tug *Abeille Languedoc* (**Figure 10**), a response, rescue and salvage tug, which was located in Boulogne, was tasked at approximately 0840. The tug was at 30 minutes' notice to sail and had an estimated transit time of 2 hours. At 0943, Cap Griz-Nez reported an ETA of 2 hours. It arrived on scene at approximately 1140.
