**Four Firefighters Injured in Lithium-Ion Battery Energy Storage System
Explosion – Arizona**

Authors: Mark B. McKinnon
Sean DeCrane
Stephen Kerber

Institution: *Underwriters Laboratories*, Firefighter Safety Research Institute,
Columbia, Maryland, USA

Date: 28 July 2020

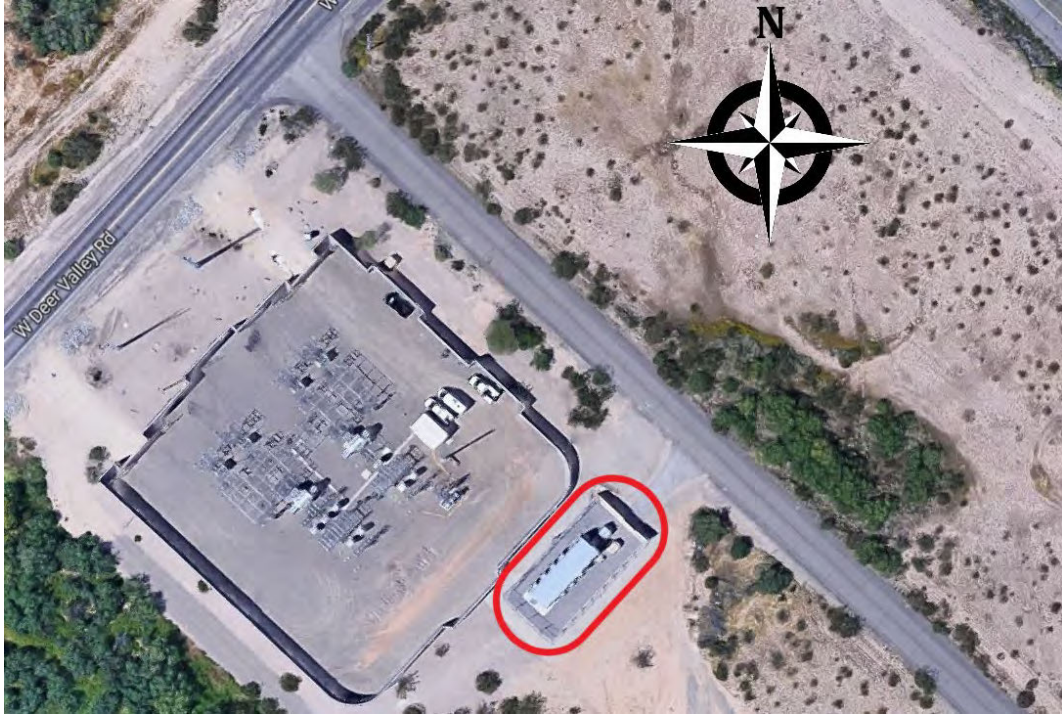
The lithium-ion battery ESS was housed within a steel structure with approximate exterior dimensions 50 ft x 14.25 ft x 13 ft. An aerial image of the building site is provided in Figure 4.1, with the facility highlighted with a red outline. The building was oriented such that the side with the longer dimension ran from the southwest to the northeast. The structure had a steel door on the northeast side of the southeast-facing wall as well as a steel door in the center of the southwest-facing wall. These steel doors included transparent vision panels that allowed optical access to the interior of the building. The interior of the building was lined with insulation of unknown material and thickness [11]. The installation was put into service in March 2017. The building fire code at the time of construction was IFC 2012. This version of the fire code did not dictate specific thermal runaway management or ventilation for lithium-ion battery ESS, but set forth requirements for signage, seismic protection, and smoke detection. Note that the date the ESS was commissioned was prior to release of a first draft of the current consensus standard on ESS installations, NFPA 855 [1].

Figure 4.1: Aerial photo of lithium-ion battery ESS site with the facility outlined in red. (modified from [12])

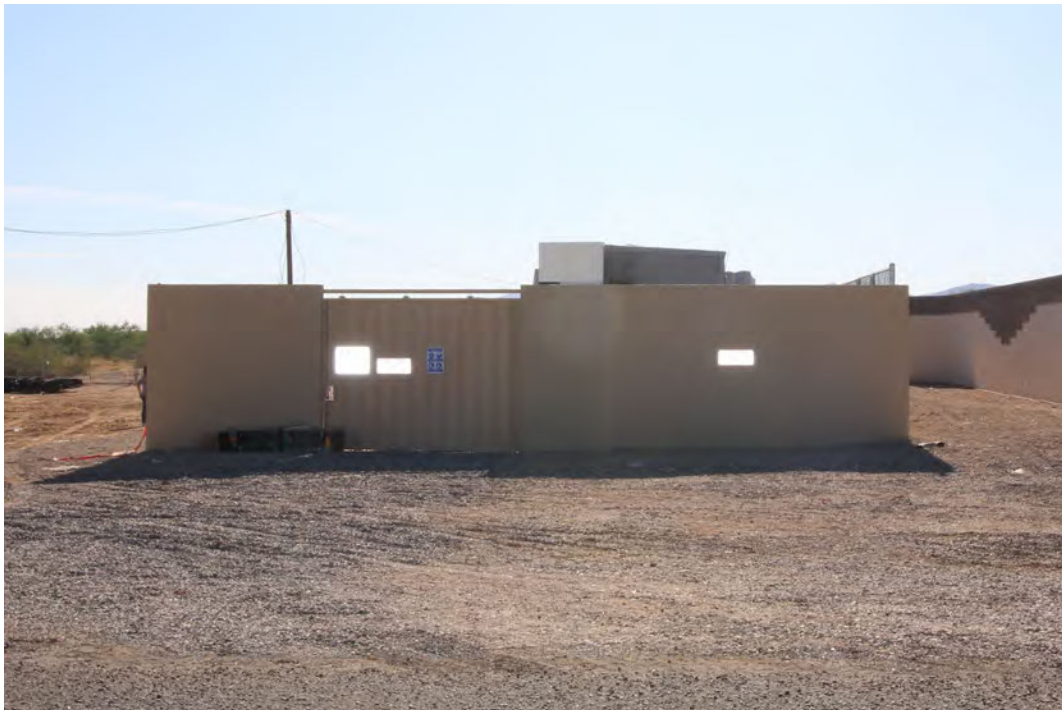
Photographs of the ESS and fence collected after overhaul of the scene are provided in the following figures. Figure 4.2 displays the solid wall and gate that isolated the structure from the frontage road. Figure 4.3 displays the southeast side of the ESS, Figure 4.4 displays the northeast side of the ESS, Figure 4.5 displays the northwest side of the ESS, and Figure 4.6 displays the southwest side of the ESS. Each of these photographs have been modified to remove brand names and logos to protect the anonymity of the owner and designer of the ESS. Note that both doors were removed and destroyed in the deflagration, and those that appear in the following images were installed to retain control of entry and protect the structure from weather.

Figure 4.2: Photograph of the solid wall and gate to the northeast of the ESS [13].

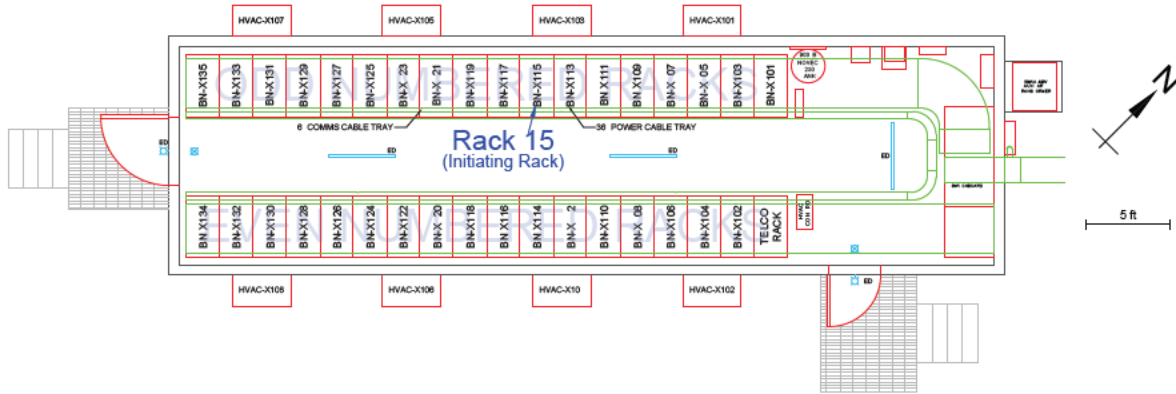
A schematic of the ESS is provided in Figure 4.7. A photo of a typical battery rack installed in the system is displayed in Figure 4.8. The racks also housed a battery protection unit, a node controller, and an inverter. At the time the ESS communication system first indicated an anomaly, all of

Figure 4.7: Schematic of the ESS (adapted from [15]).

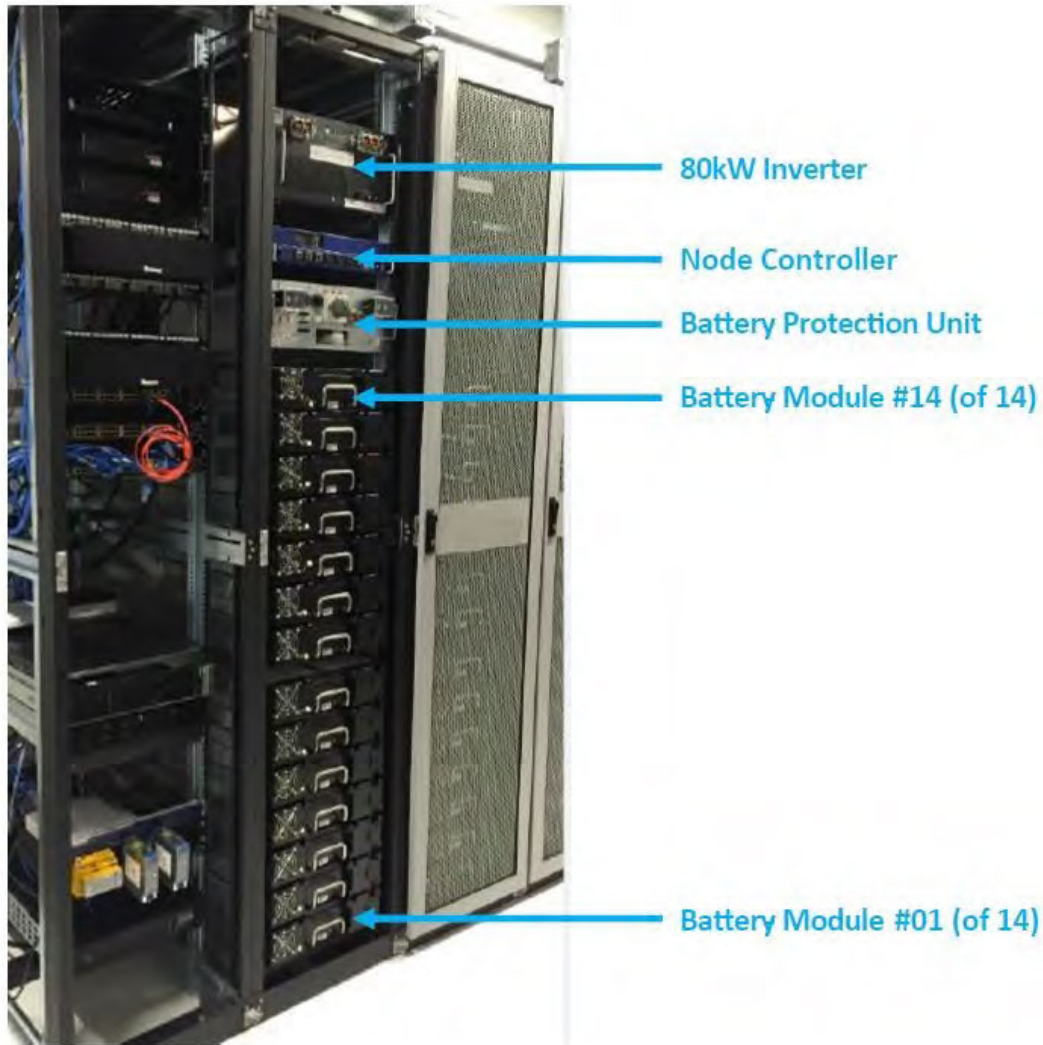
Figure 4.8: Photo of an example battery rack in an ESS [15].

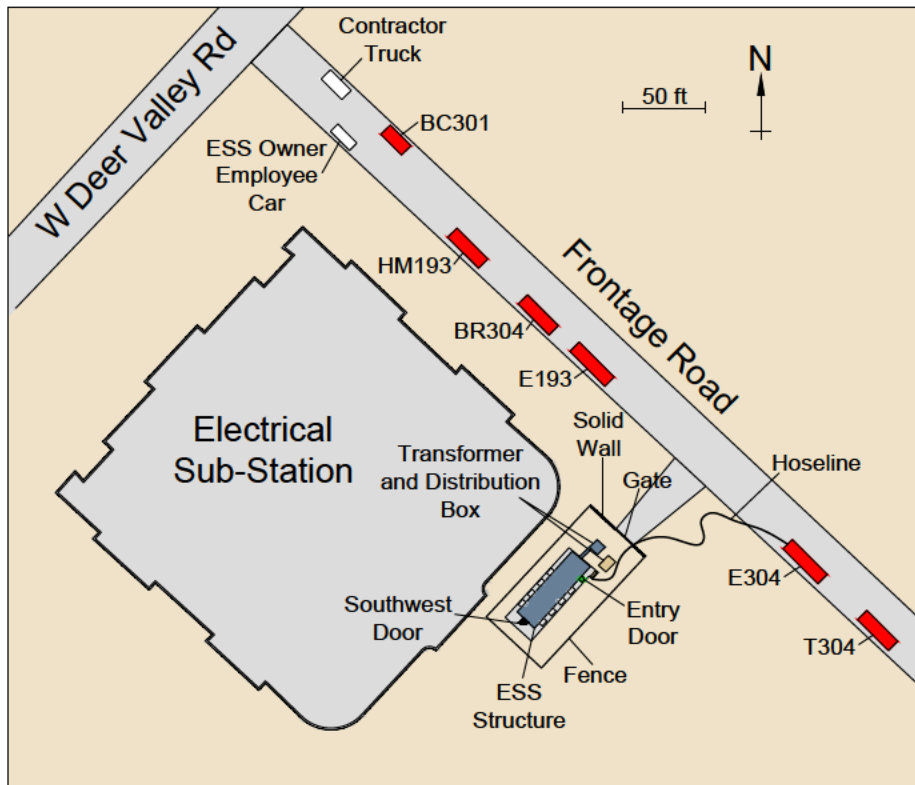
gate to the fenced area (above 50 ppm and 500 ppm, respectively). The team walked through the desert outside the fenced area to define the extent of the hot zone and found hazardous conditions at all locations where the gas/vapor cloud was visible. The HAZMAT team inspected the outer surface of the structure using a TIC to determine if an active fire was present in the ESS. A relatively small hot spot (~6 in. x 24 in.) with a maximum temperature of approximately 130°F was identified on the northwest side of the ESS at the approximate location of the Rack 15 inverter [6, 9]. The HAZMAT team reported back gas levels and TIC temperatures to BC301 BC, who had set up the command vehicle (BC301) north of the gate on the frontage road. A diagram of the approximate locations of each vehicle relative to the ESS is provided in Figure 4.10.

Figure 4.10: Diagram representing approximate locations of vehicles relative to the ESS [6,7]

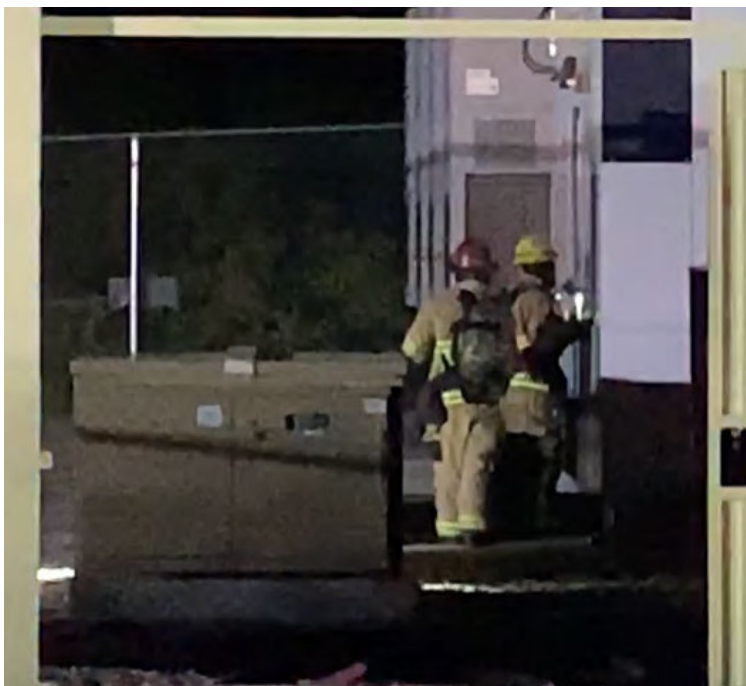
the container with the TIC. A visible white gas/vapor mixture immediately poured out of the open door while the HAZMAT team measured gas concentrations and continued to monitor the ESS. Images extracted from a video recorded on the scene as the door was opened are displayed here. Figure 4.11 displays E193 Capt (red helmet) and E193 FE (yellow helmet) just prior to E193 FE opening the door to the ESS. The hoseline that the HAZMAT team had brought into the hot zone in preparation of opening the door can be seen at the bottom of the image at the entrance gate. Figure 4.12 displays E193 Capt, E193 FE, and HM193 FF1 (far left of image) approximately 5 s after the door was opened. Dense gases and vapors can be seen in the image in Figure 4.12 flowing out of the ESS through the door.

Figure 4.11: Image of the HAZMAT team just prior to door opening [14].

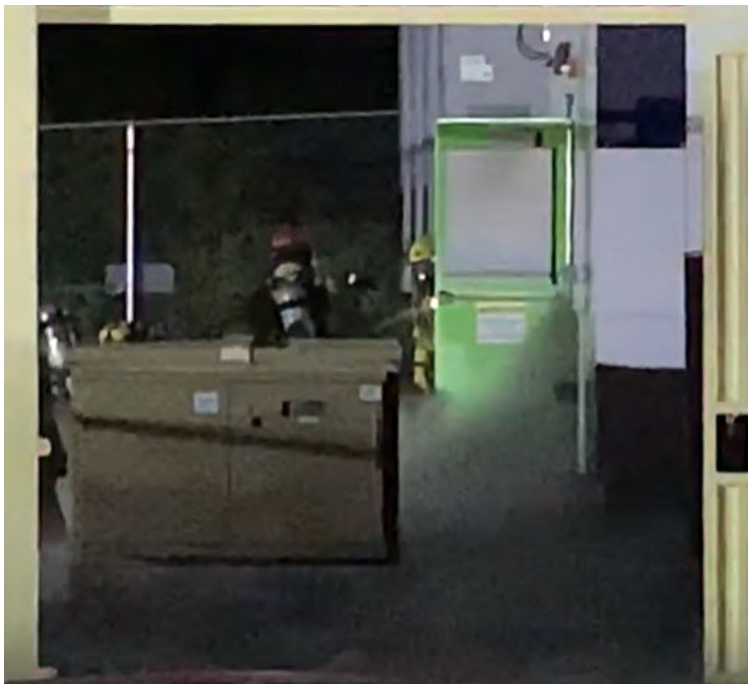
Figure 4.13 displays E193 Capt, E193 FE, and HM193 FF1 approximately 22 s after the door was opened. E193 Capt is shown using a TIC to monitor temperatures inside the ESS. Apparent in the image is an increased flow of high-density gases and vapors out the door as well as increased coverage of the ground in the vicinity of the ESS by the gas/vapor mixture. Figure 4.14 shows E193 FE holding the door open and E193 stepping away from the ESS to retrieve a gas meter approximately 33 s after the door was opened. The high-density gas/vapor mixture can be seen flowing from the door from high elevation to low elevation.

Figure 4.13: Image of HAZMAT team 22 s after opening the door [14].

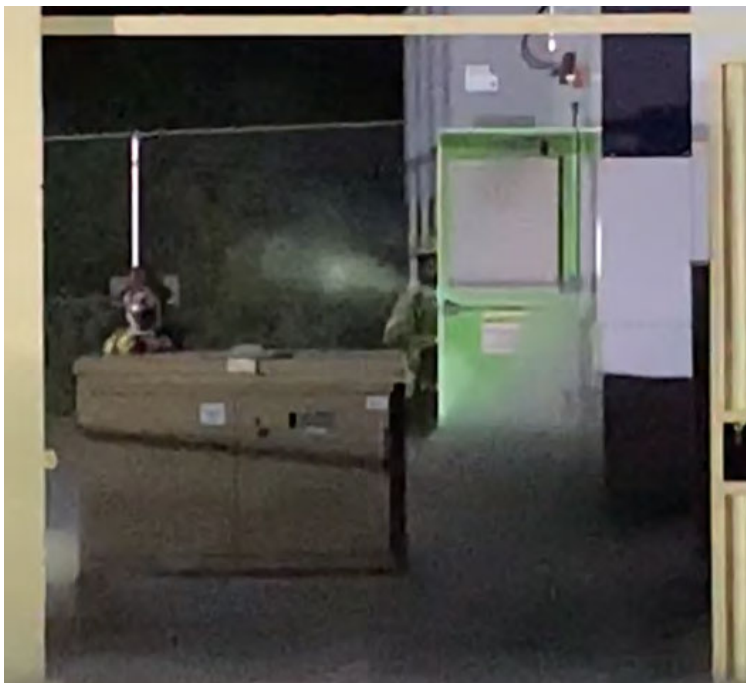
Figure 4.14: Image of the HAZMAT team 33 s after opening the door [14].

it was. HM193 FF1 advised that he could see the top of the round object without the TIC as the gas/vapor mixture flowed out of the doorway but he did not know what it was [6]. This indicates that prior to the deflagration event, visibility was such that the back wall of the ESS was visible, the gas/vapor mixture was flowing out of the doorway from high elevation, and the level of the gas/vapor mixture in the ESS had descended to approximately 5 ft above the floor. A photograph facing into the ESS taken from the entry door after decommissioning is presented in Figure 4.15. This image shows the red suppression agent storage tank, which is the object the HAZMAT team was able to see just prior to the deflagration event.

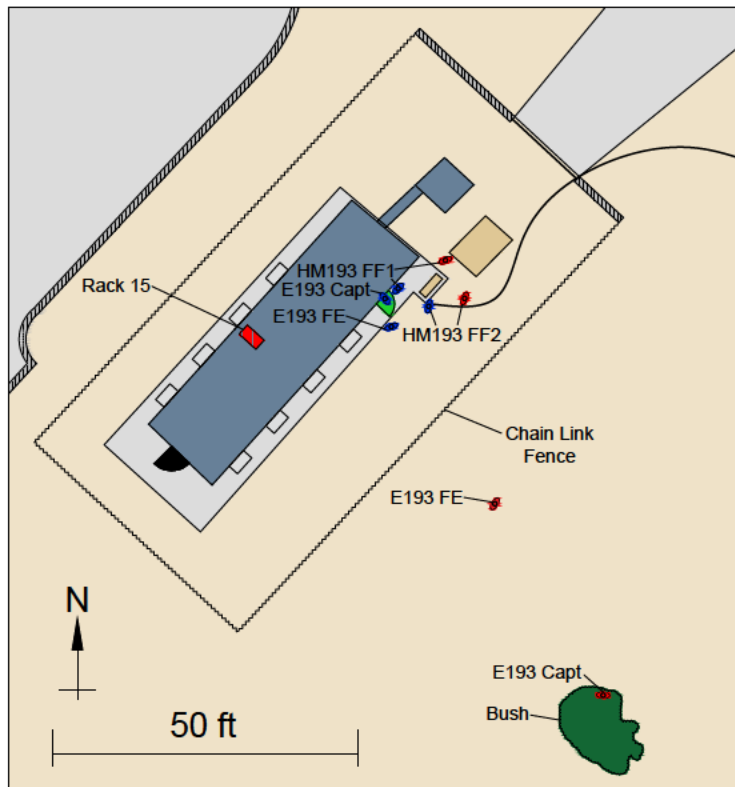
The approximate locations of the members of the HAZMAT team are displayed in Figure 4.16, in which positions just prior to the deflagration are displayed in blue and approximate positions after the deflagration are displayed in red. E193 Capt was at the door, E193 FE was back and to the left at a 45-degree angle from the door, HM193 FF1 was to the right of the door with a multi-gas meter, and HM193 FF2 manned the hoseline at a 45-degree angle back and to the right of the door [6].

Figure 4.16: Diagram representing the locations of firefighters just before the deflagration event. Approximate positions prior to the deflagration event are displayed in blue, and approximate positions after the deflagration event are displayed in red [6].

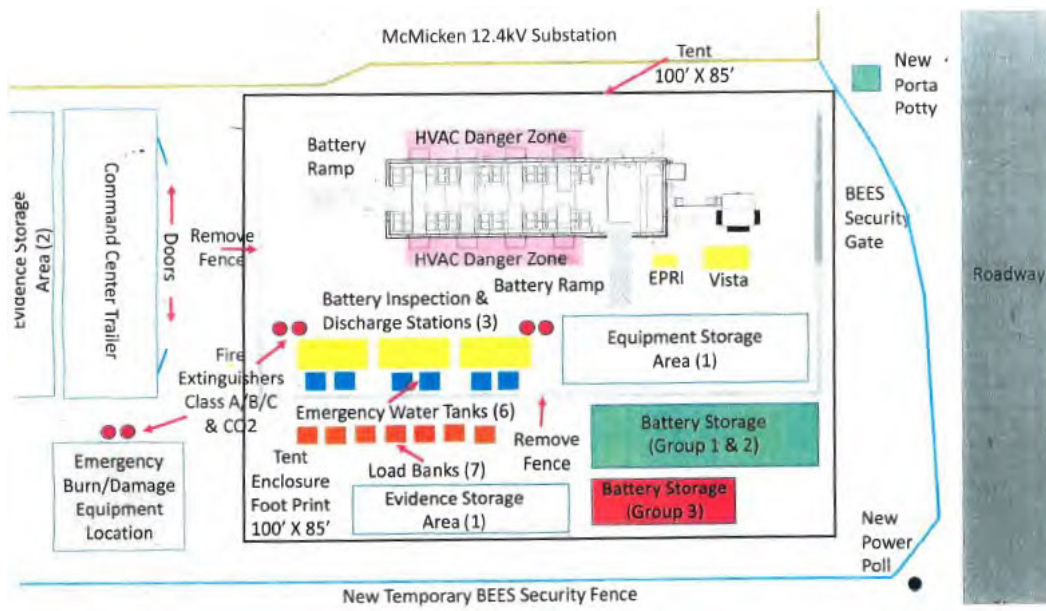
All technicians involved in the decommissioning process wore PPE, and fire safety and first aid equipment was readily available on the site. With three inspection and discharge stations available, the entire decommissioning process required almost two months to safely discharge, inspect, and store all of the battery modules. This process ensured that none of the battery cells would undergo thermal runaway while in storage, isolated the origin, and confirmed all damage was confined to the modules in Rack 15.

Figure 8.1: Map of decommissioning operation surrounding the ESS [11].
