Report: Fire Investigation Report 132-20

Incident number: 018965

## 3. **Significant Incident Report**

Information relating to a fire incident at an Orsted Battery Energy Storage System (BESS) site, Carnegie Road, Liverpool on 15<sup>th</sup> September 2020.

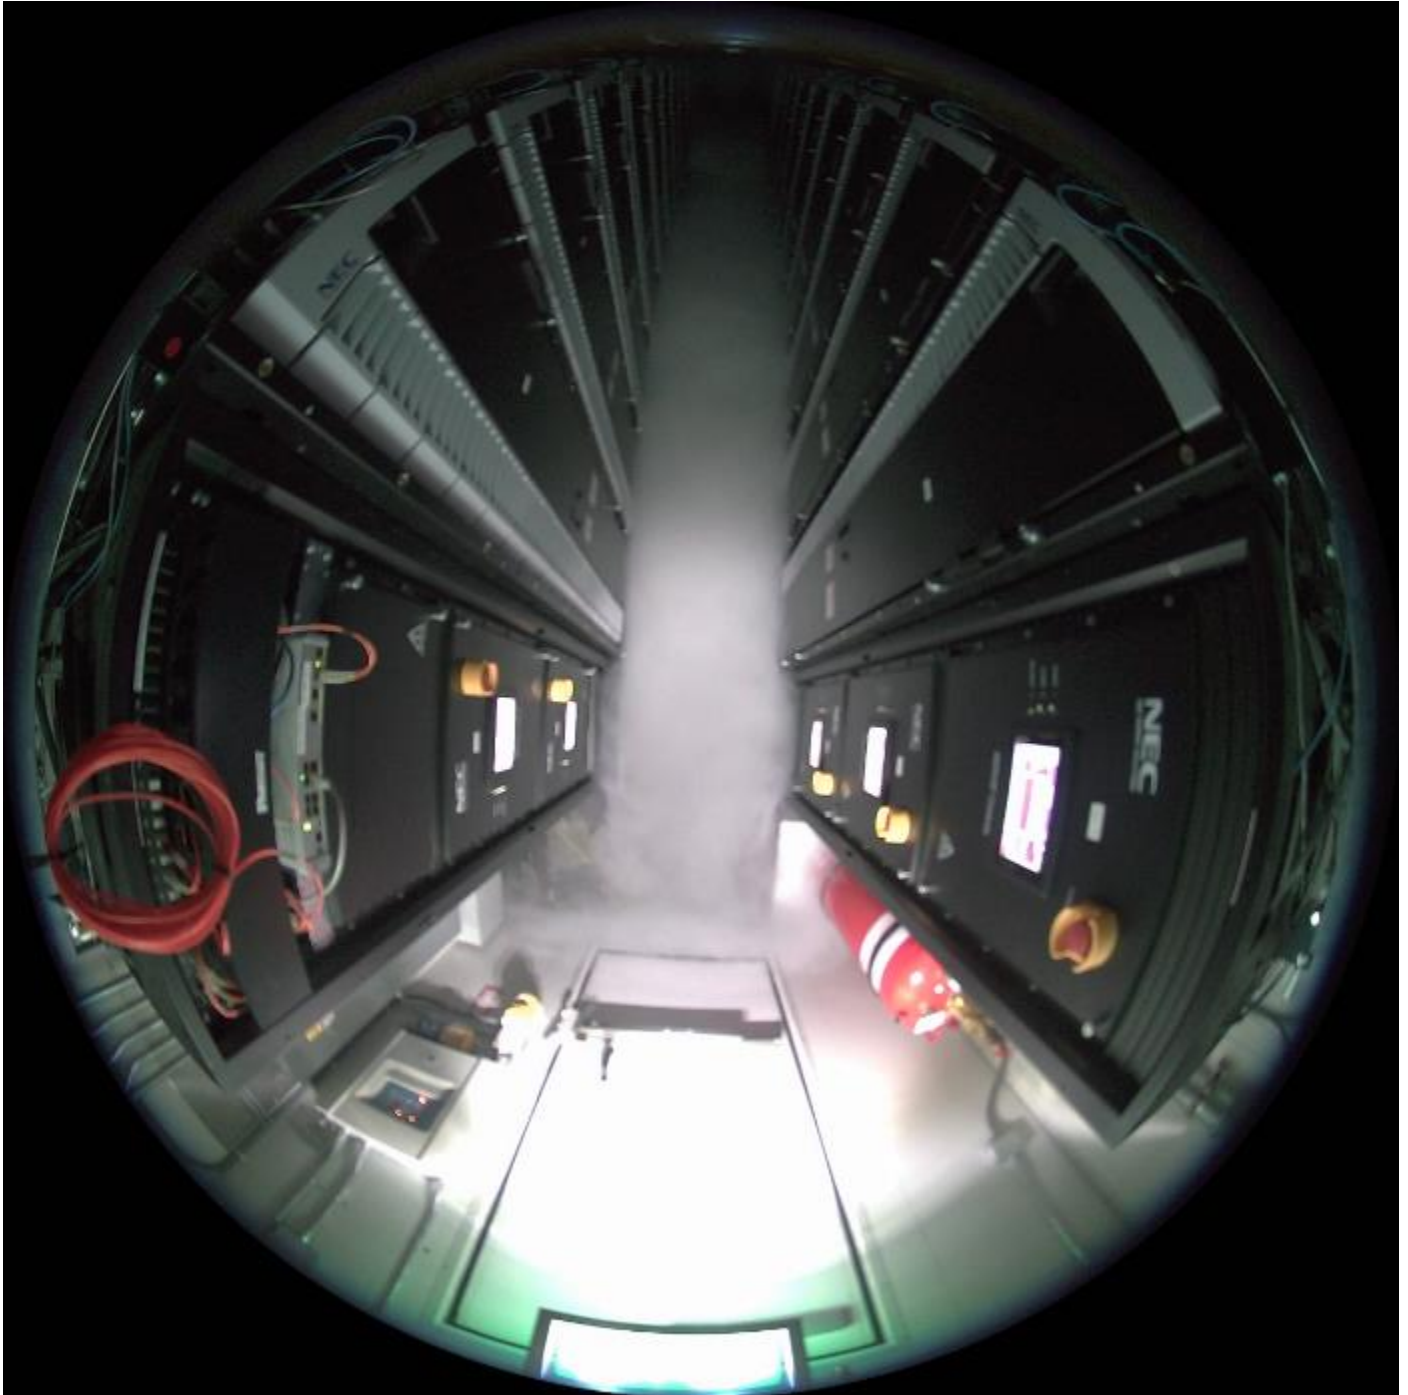
Internal CCTV showing the activated alarm panel to the bottom left, the NOVEC system to the bottom right and the fire exit door in the bottom centre. The fish eye view is due to the position of the CCTV camera located on the ceiling near the rear door. A vapour cloud can be scene within the container

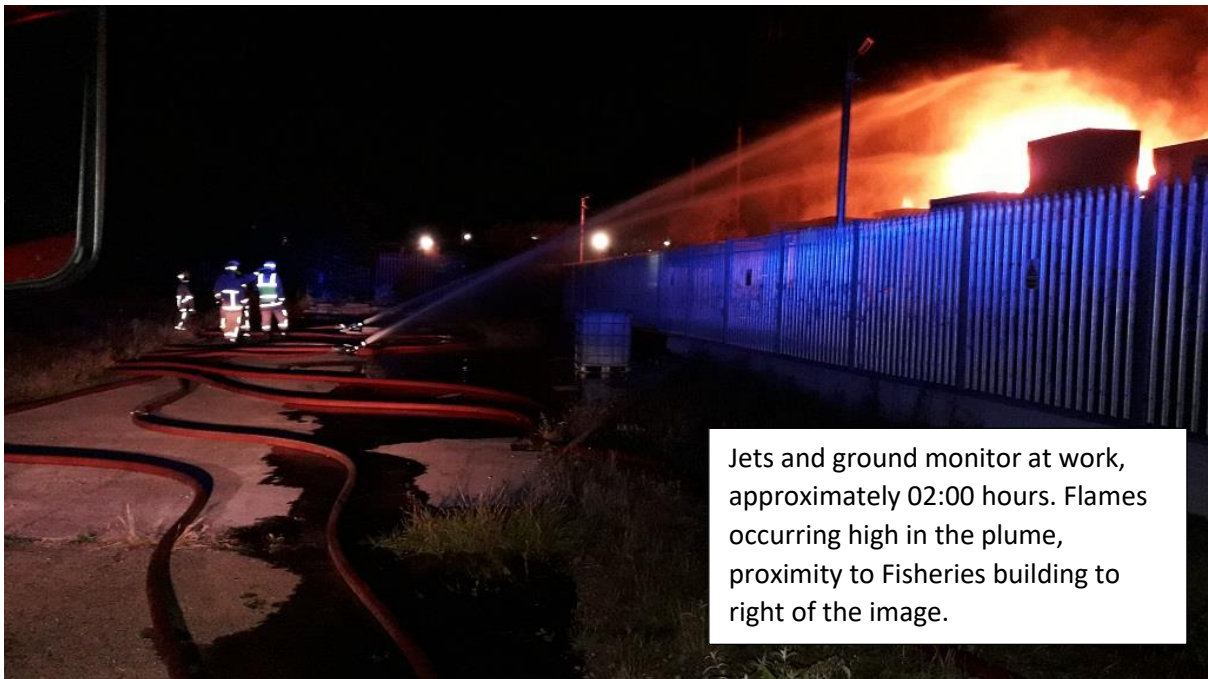
Jets and ground monitor at work, approximately 02:00 hours. Flames occurring high in the plume, proximity to Fisheries building to right of the image.

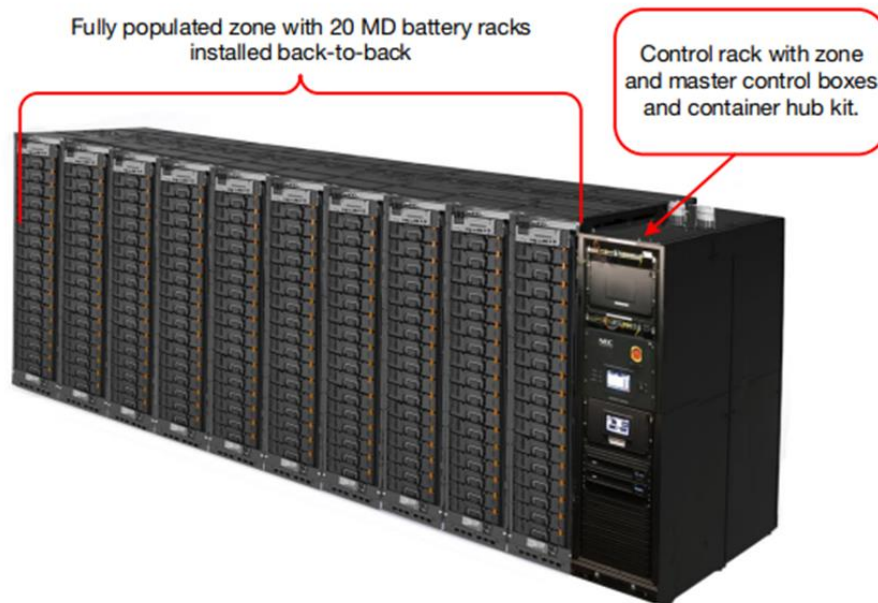
Figure 5: A populated array of 20 racks (two rows of 10, installed back to back) and a control rack

Note configuration of lithium ion banks, narrow access corridor and cooling vents fitted to ceiling.
