Speaking notes Sunnica – Memorial Hall Newmarket 6th December 2022 – 1800hrs

Unique reference No - 20030246

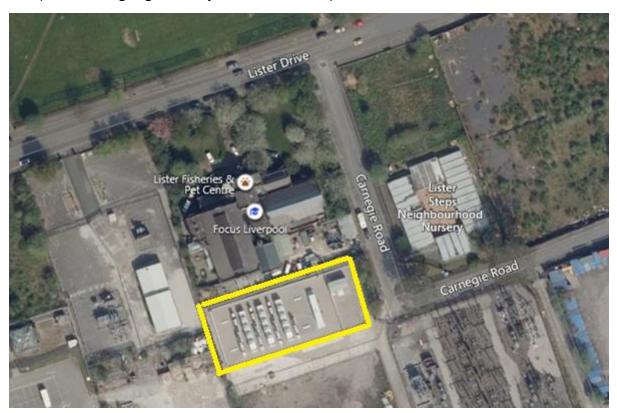
Two appliances, from Old Swan fire station were mobilised to the incident as per the predetermined attendance. On arrival, they discovered a large container unit fully involved in fire with evidence consistent of a blast. One of the container doors had been ejected from its setting and was laying some 6 metres away within the secure compound. The compound is highlighted in yellow on the map below:

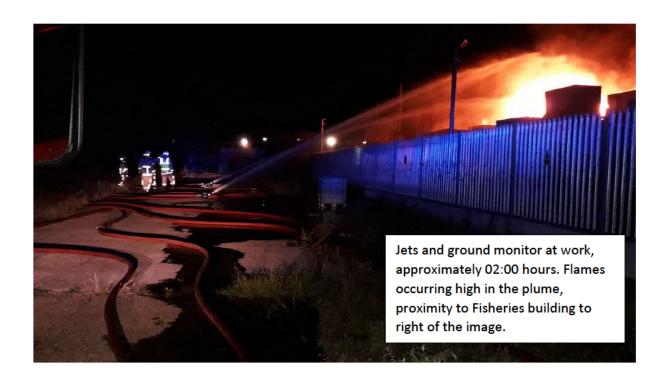
Fire development from the unit at approximately 01:30 hours.

Note the intensity of fire and therefore heat from the centre of the unit and extension of flame into the plume.

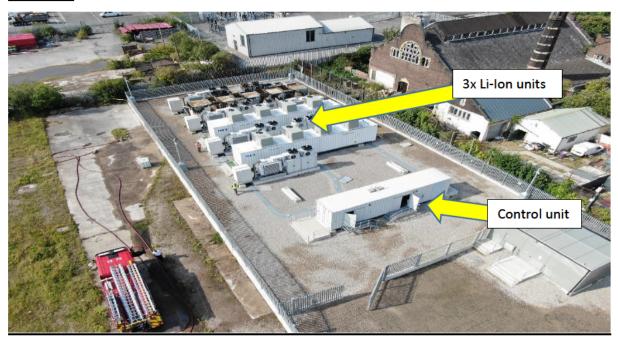
AIR unit aerial view of Orsted BESS:

AIR Unit. Full extent of damage
visible. Roof mounted cooling units
ejected to side of unit. Pressure
damage visible along length of unit.
Note scorching of top edge of
second unit to mid-right of image.
Firefighting tactics mitigated
further spread and damaged
beyond original unit and blast.

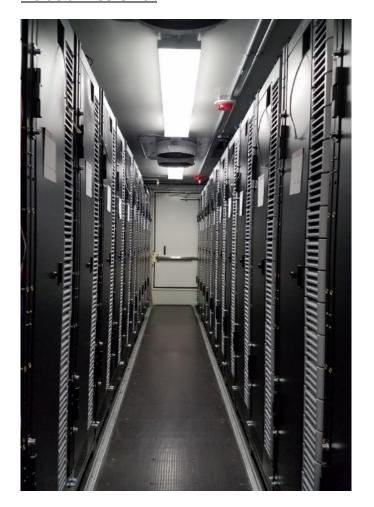
Inside a BESS Unit²:

Note configuration of lithium ion banks, narrow access corridor and cooling vents fitted to ceiling.
