**CONDITION SURVEY AND  
EXCEPTION REPORT  
For**

**FLIXBOROUGH WHARF  
JETTY**

**GUNNESS WHARF  
MAIN JETTY**

**PROJECT NO. 41450  
RPT001**

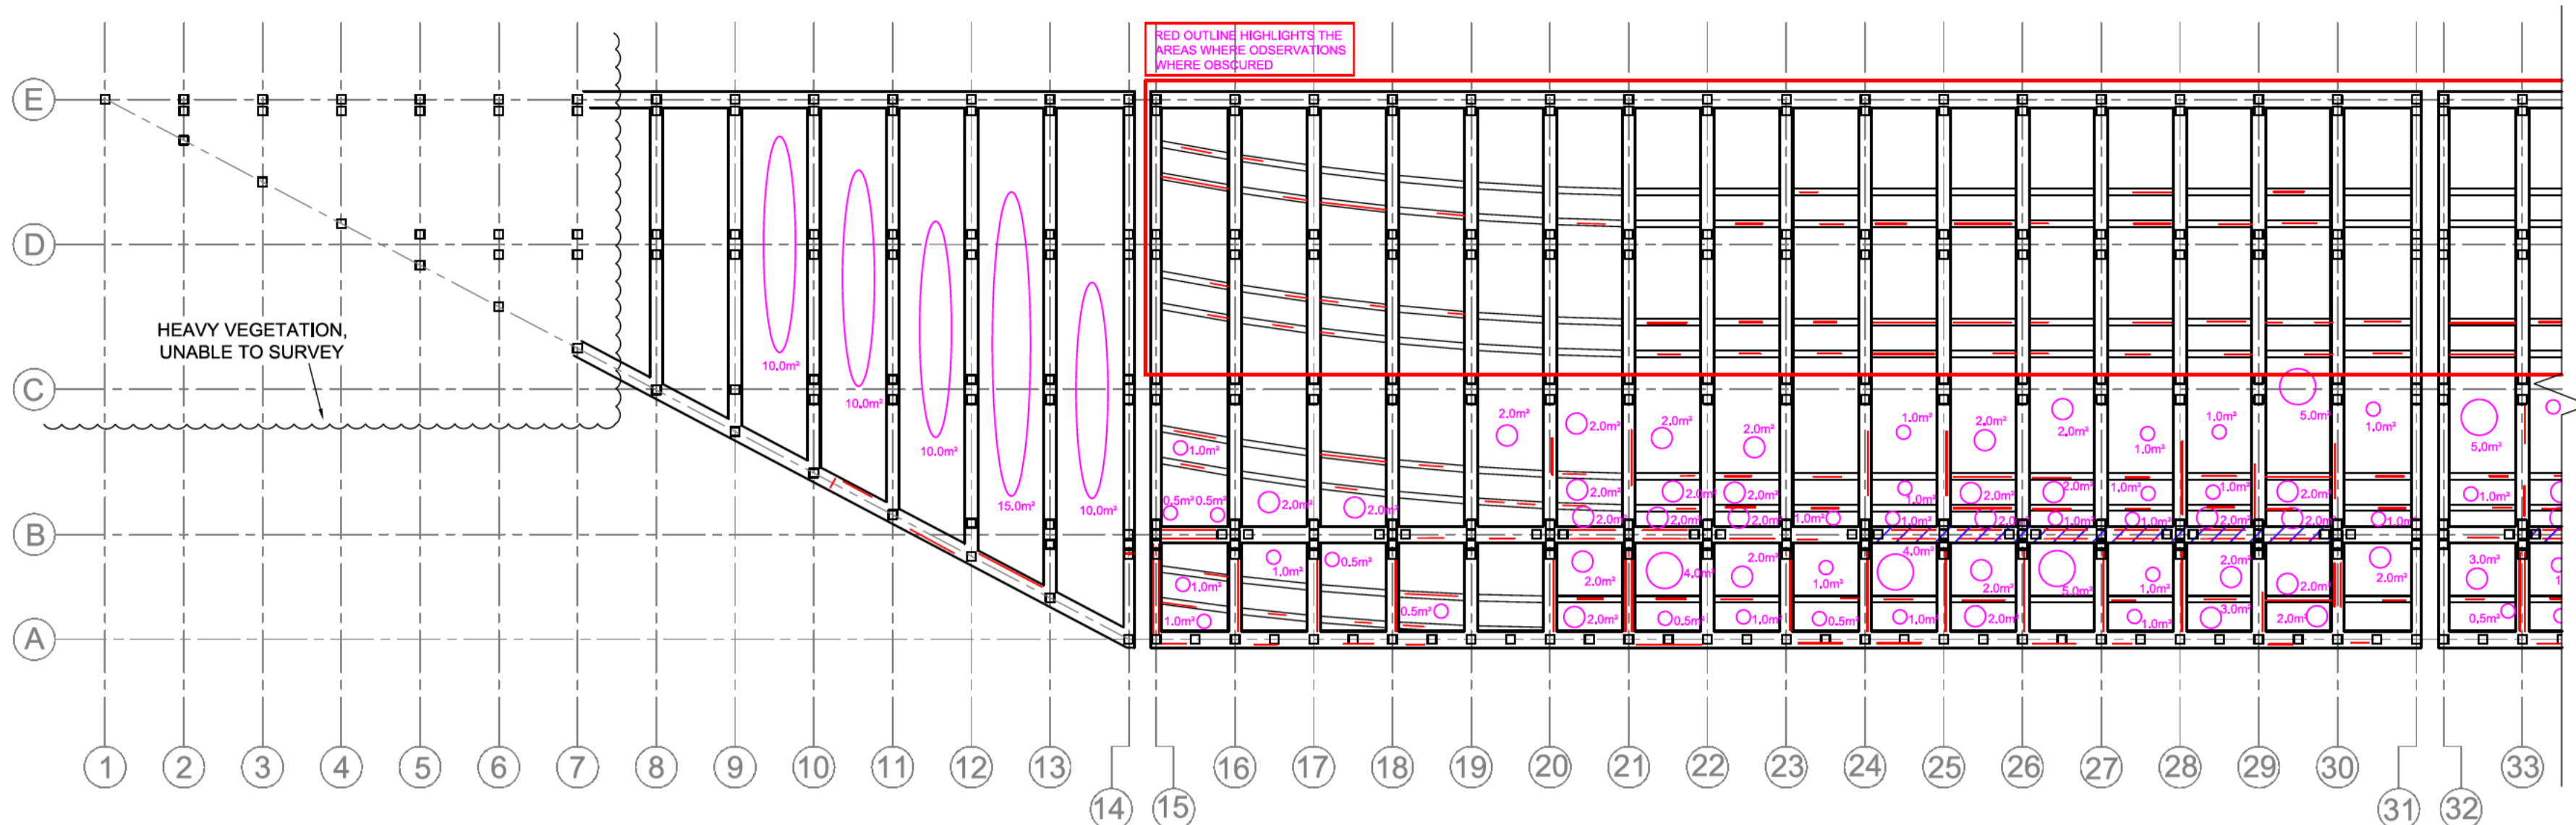
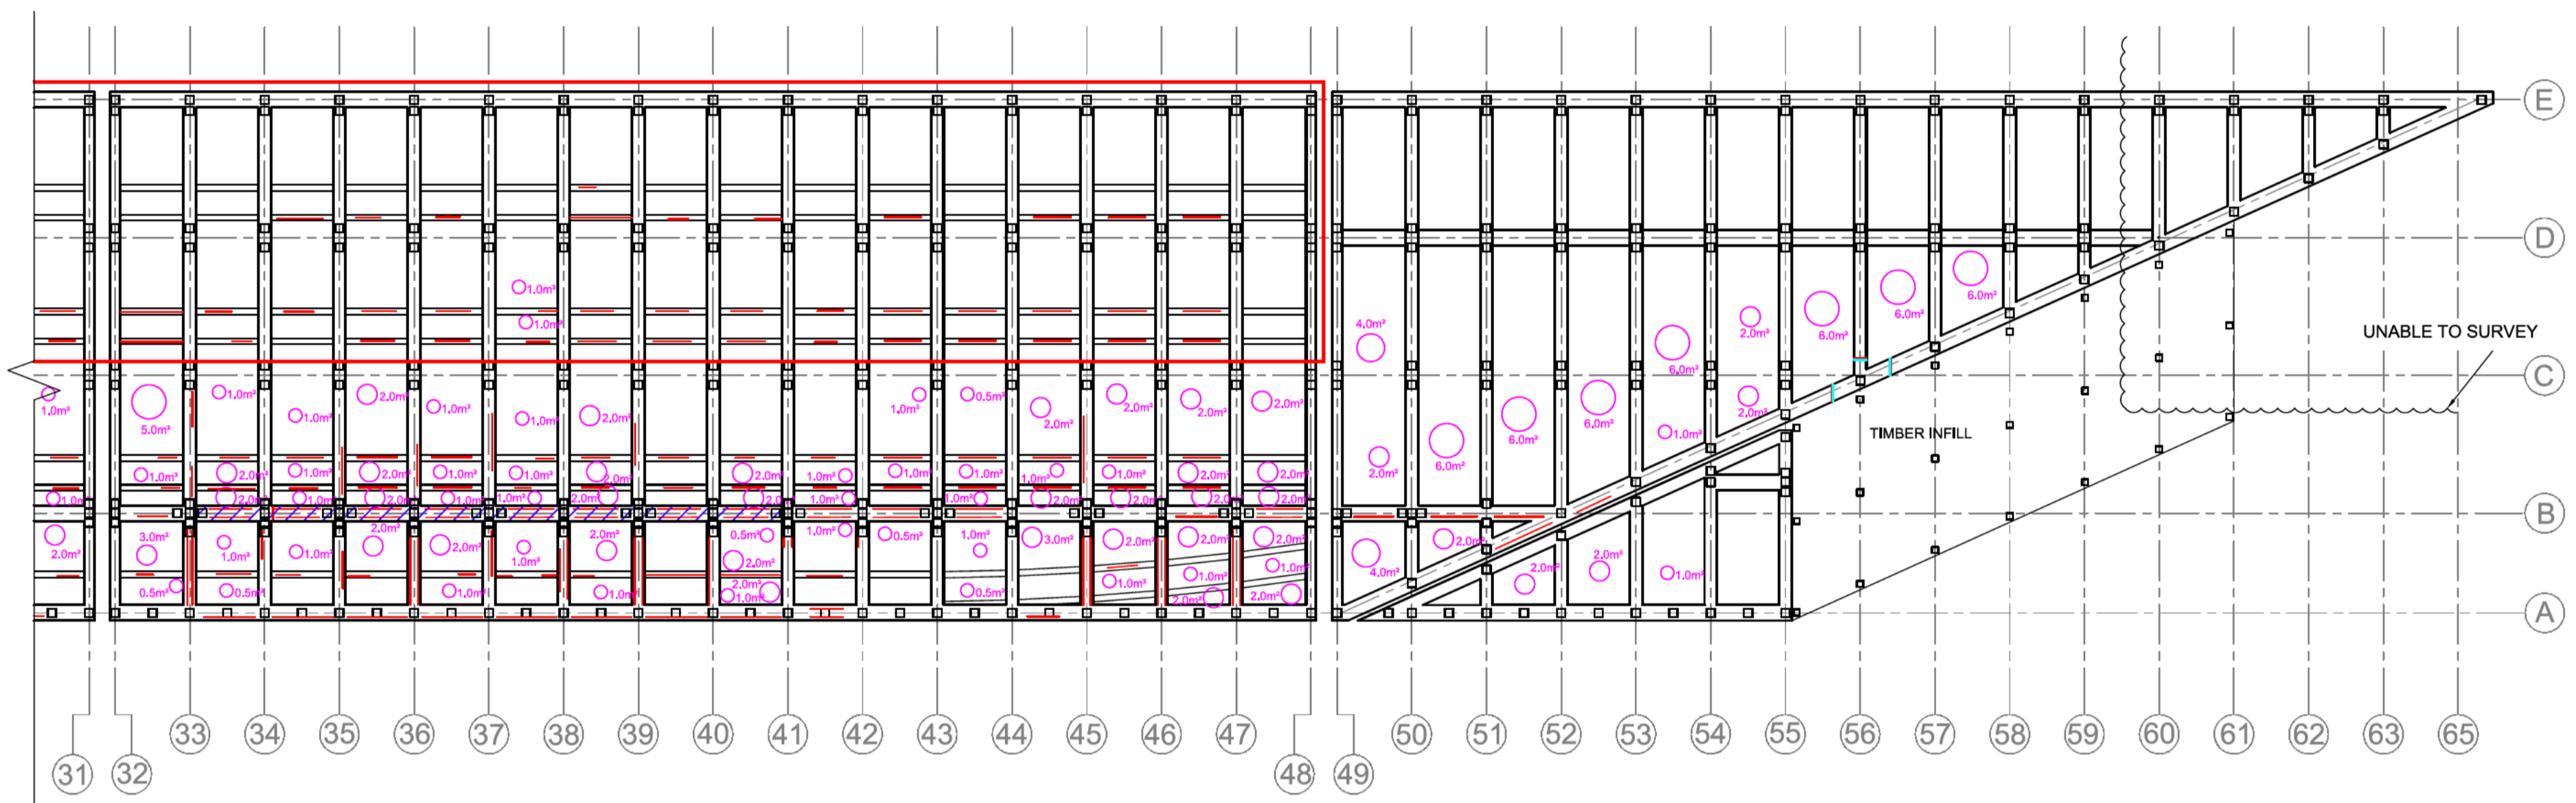
PLAN SHOWING PILING LAYOUT  
SCALE 1:250

**Piles** The extent of repairs required to the piles since the 2017 survey has increased from 1.5m<sup>2</sup> to 12.0m<sup>2</sup> (+700%). Although the total extent of repairs required remains small and the majority of piles are in fair condition, this is the most significant area of measurable change on the jetty. Typical pile damage is shown in photos 1 to 3). It is notable that the pile head damage tends to reveal existing corroded rebar (photos 2&3) whilst the damage lower down (photo1) reveals uncorroded rebar suggesting that this latter damage may have been caused by impact rather than structural condition.

**Deck Soffit** The extent of repairs to the deck soffits since the 2017 survey has increased nominally from 323m<sup>2</sup> to 325m<sup>2</sup> (0.6%) and suggests a low rate of deterioration of this element.

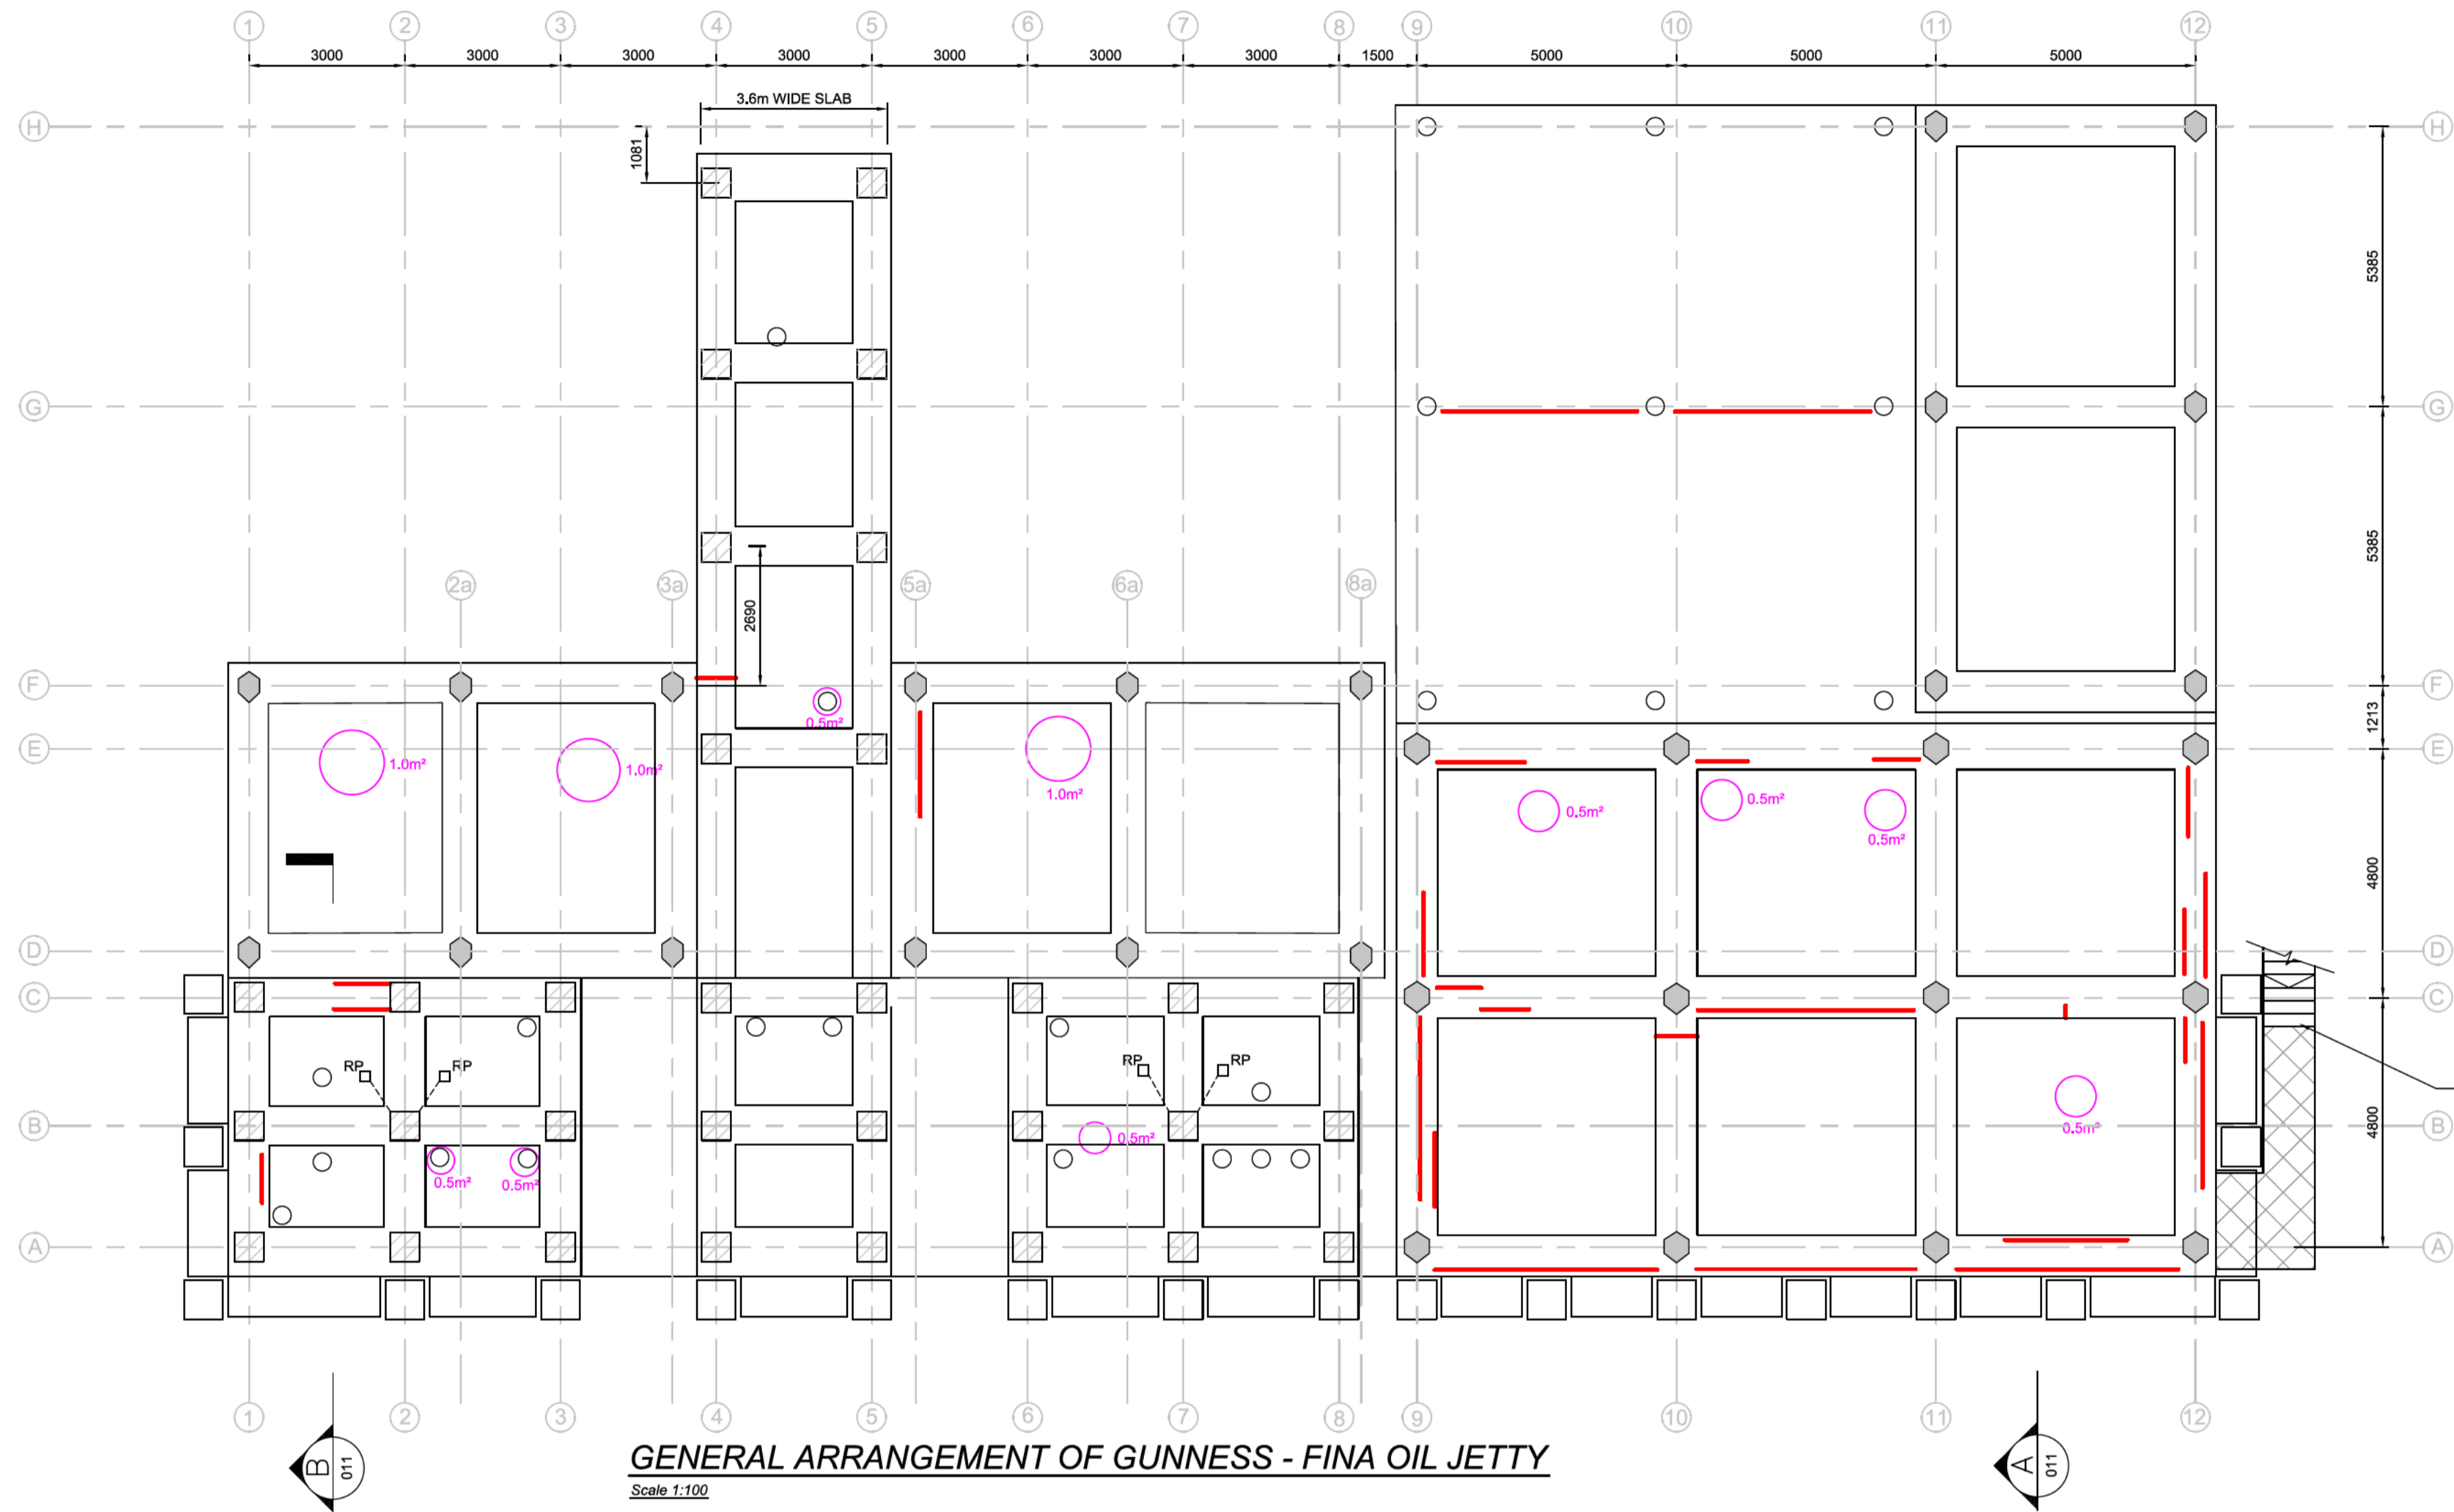
**GENERAL ARRANGEMENT OF GUINNESS - FINA OIL JETTY**  
Scale 1:100

NOTE SEE CONDITION SCHEDULE FOR DETAILS OF LOSS OF SECTION ON TIMBER PILE
