NORTH FALLS

Offshore Wind Farm

Appendix 23.1 Extended Phase 1 Habitat
Survey Report (Part 3 of 3)

Document Reference:	3.3.30
Volume:	3.3
APFP Regulation:	5(2)(a)
Date:	July 2024
Revision:	0

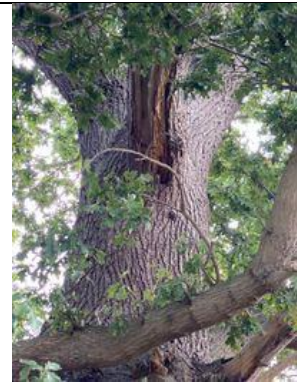
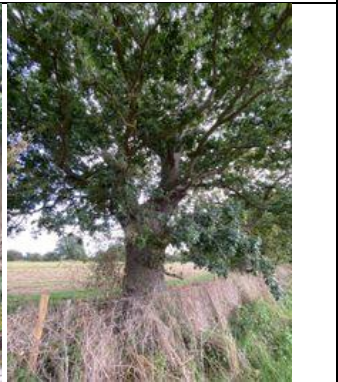
Bat roost feature reference	Notes	Habitat suitability	Photographs	
BR180	Mature potentially veteran oak with some cracked limbs and split bark.	Moderate

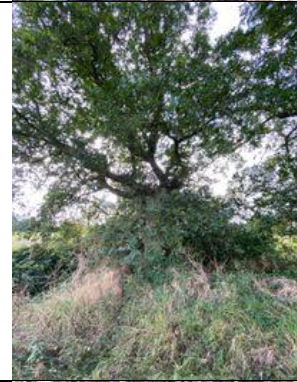
BR181	Mature oak with no visible PRFs	Negligible

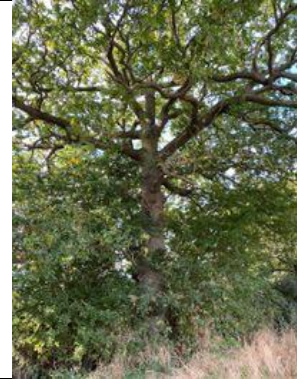
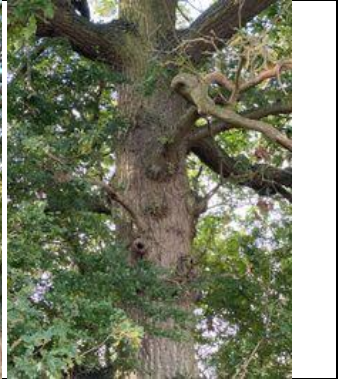
BR182	Mature oak with one visible hole.	Low

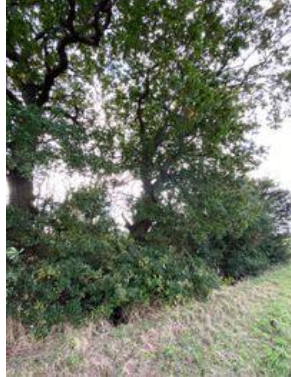
Bat roost feature reference	Notes	Habitat suitability	Photographs
BR185	Two mature oak with limited visible PRFs	Low

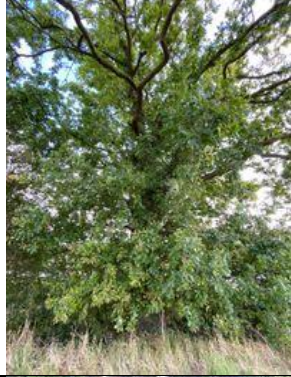
BR186	Large mature ivy clad oak with limited visible PRFs	Low

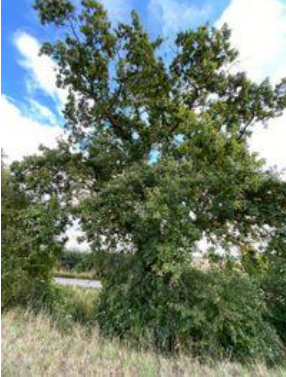
Bat roost feature reference	Notes	Habitat suitability	Photographs
BR188	Mature ivy clad oak with some cracks and holes.	Moderate

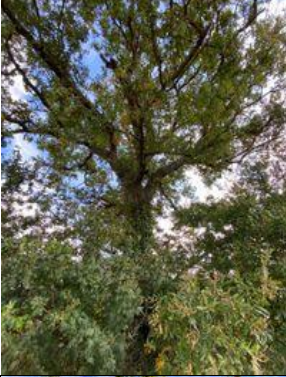
BR189	Mature oak in roadside hedge. Ivy clad with some cracked limbs	Low

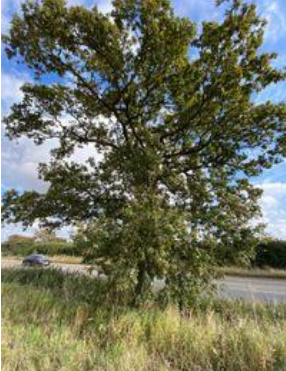
BR190	Standalone mature oak with a cracked limb however largely isolated from wider habitat	Negligible

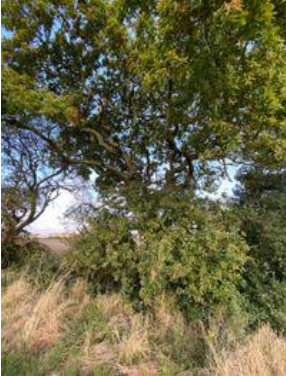
Bat roost feature reference	Notes	Habitat suitability	Photographs
BR191	Semi mature oak with some visible holes and cracked limbs, however nothing substantial and largely unconnected to wider habitats	Low

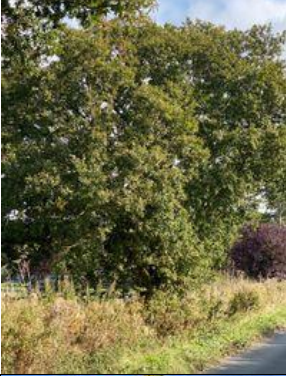
BR192	Mature oak with no visible PRFs	Negligible

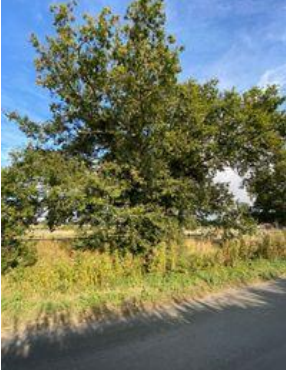
BR193	Mature ivy clad oak with some visible cracked limbs	Low

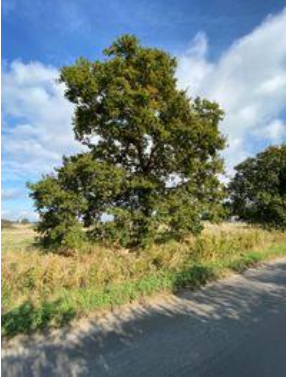
Bat roost feature reference	Notes	Habitat suitability	Photographs
BR194	Mature oak with some visible PRFs	Low

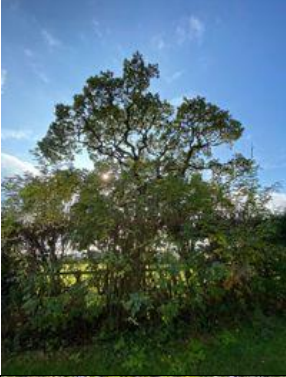
BR195	Mature oak behind hedge, no visible PRFs	Negligible

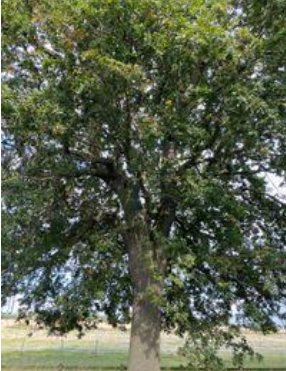
BR196	Mature oak with no visible PRFs	Negligible

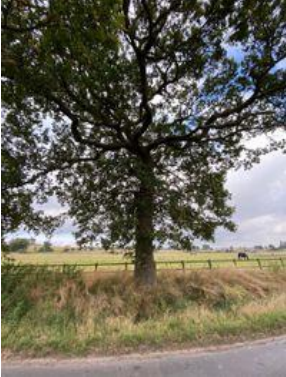
Bat roost feature reference	Notes	Habitat suitability	Photographs
BR197	Large mature oak with limited visible PRFs	Low

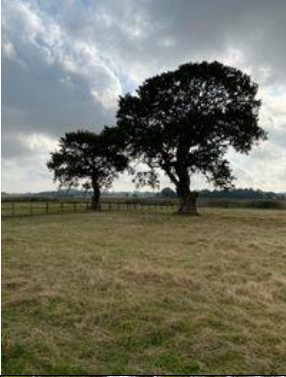
BR198	Two Large mature oak, potentially veteran with some visible cracks and holes though largely disconnected from wider habitat.	Low

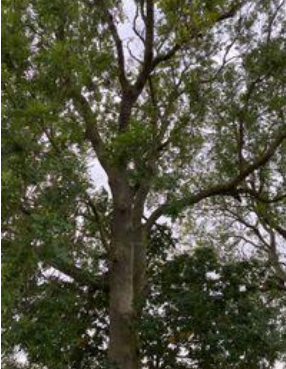
BR199	Mature ash tree, no visible signs of PRF. Present within intact hedge	Negligible

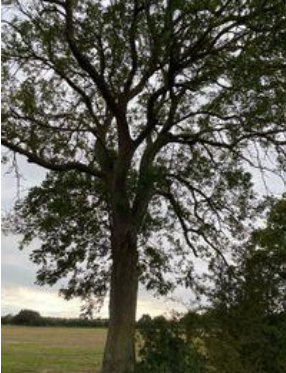
Bat roost feature reference	Notes	Habitat suitability	Photographs
BR200	Mature ash tree, visible signs of PRF. Present within intact hedge	Moderate

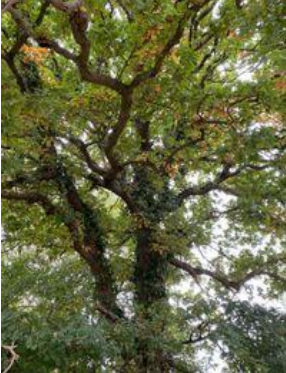
BR201	Mature oak tree, no visible signs of PRF. Present within intact hedge	Low

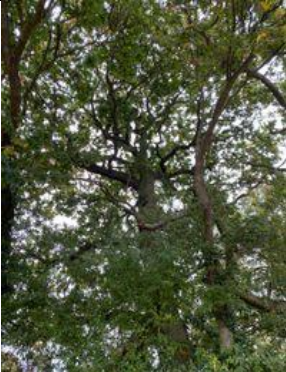
BR202	Mature oak tree, visible signs of PRF. Present within intact hedge	Moderate

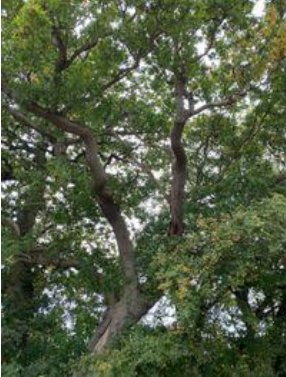
Bat roost feature reference	Notes	Habitat suitability	Photographs
BR203	Mature oak tree, visible signs of PRF. Present within intact hedge	Moderate

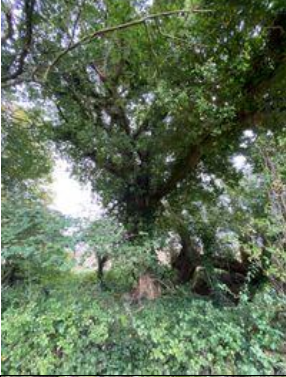
BR204	Large ivy clad oak with a few cracked limbs.	Low

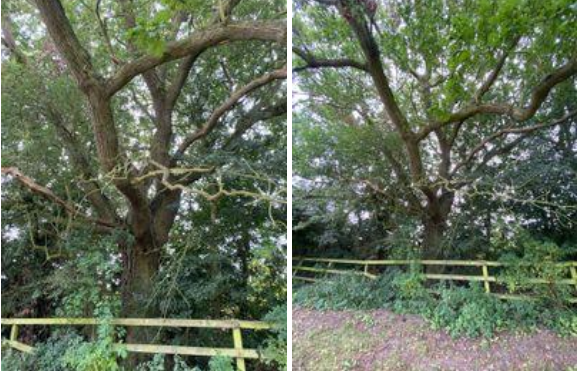
BR205	Mature potentially veteran oak with multiple holes visible.	Moderate

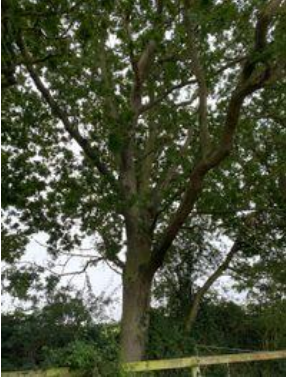
Bat roost feature reference	Notes	Habitat suitability	Photographs	
BR206	Mature oak with limited visible PRFs	Low

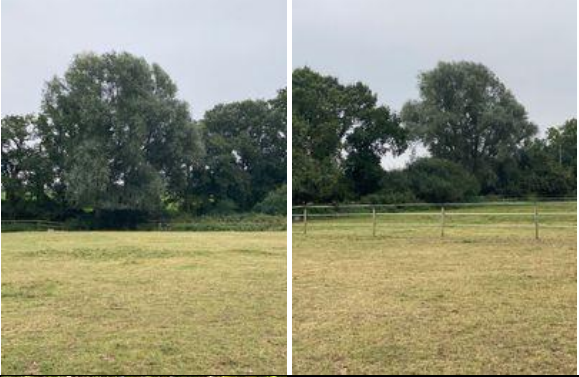
BR207	Trees in hedge look to have limited suitability for roosting bats, however closer inspection impossible due to electric fencing and horses.	Low

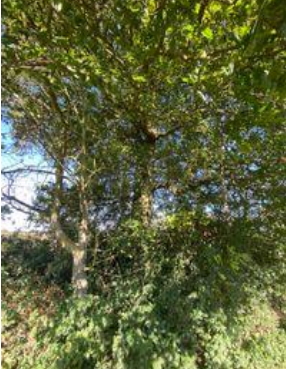
BR208	Mature oak with no visible PRFs	Negligible

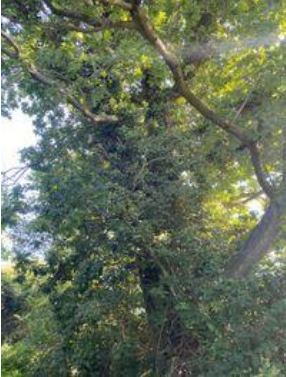
Bat roost feature reference	Notes	Habitat suitability	Photographs	
BR209	Mature ivy clad oak with a few visible holes though depth is questionable.	Low

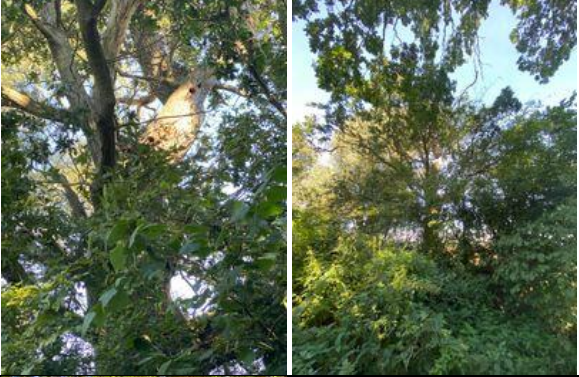
BR210	Mature oak with dead branches on top. Multiple holes visible, look to be woodpecker	Moderate

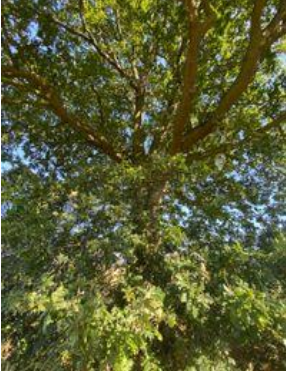
BR211	Mature oak with several visible holes and a potential woodpecker hole	Moderate

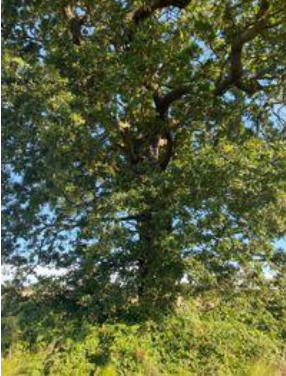
Bat roost feature reference	Notes	Habitat suitability	Photographs
BR212	Mature oak on field boundary with limited visible PRFs	Low

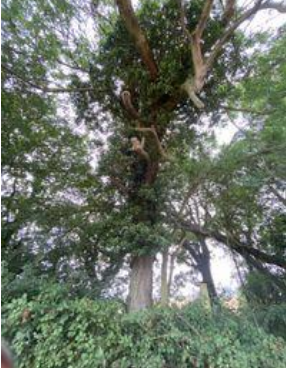
BR214	Mature ivy clad oak with limited visible PRFs	Low

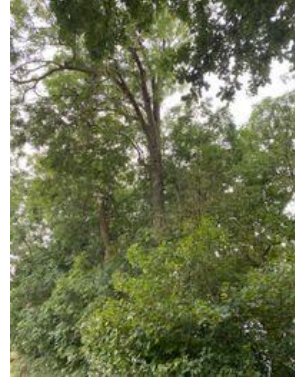
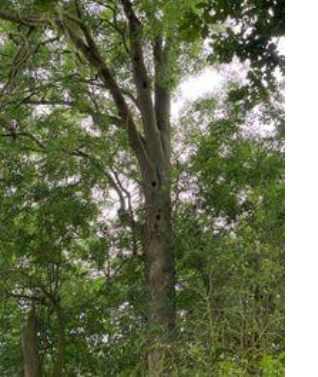
Bat roost feature reference	Notes	Habitat suitability	Photographs	
BR215	Mature ash with multiple woodpecker holes visible. Landowner mentioned seeing green woodpecker regularly.	Moderate

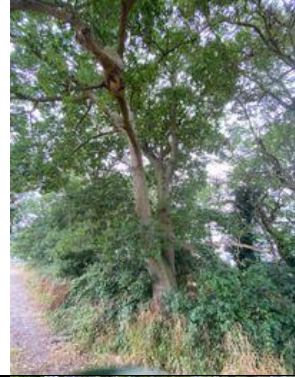
BR216	Mature oak with no visible PRFs	Negligible

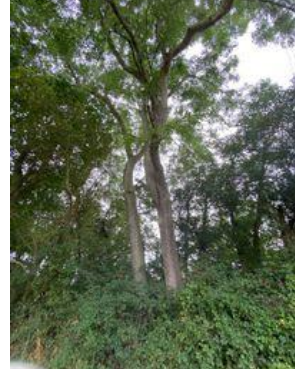
BR217	Mature ash tree with no visible PRFs	Negligible

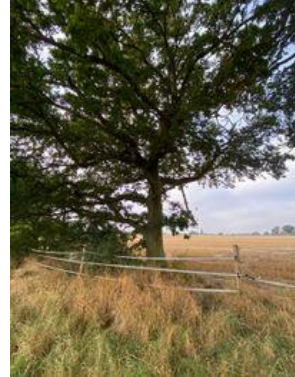
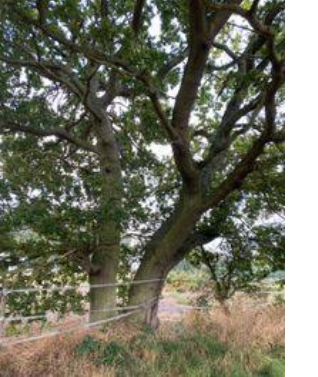
Bat roost feature reference	Notes	Habitat suitability	Photographs	
BR218	Two oaks along field boundary with some visible PRFs however look to be to open to weather.	Low

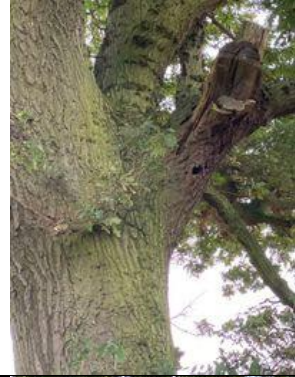
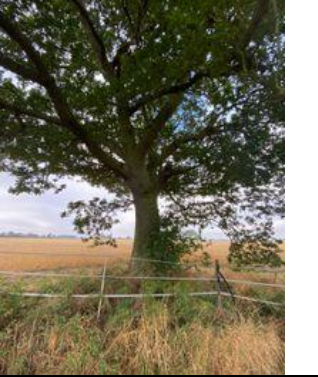
BR219	Large mature oak with a few visible holes suitable for roosting bats.	Moderate

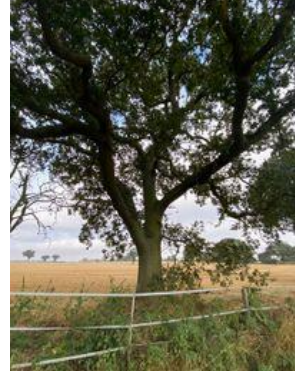
BR220	Large mature oak with no visible PRFs	Negligible

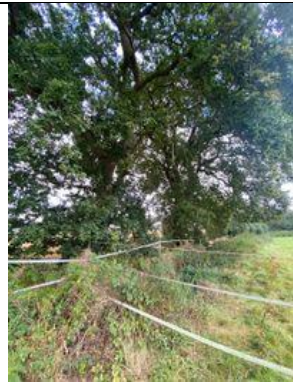
Bat roost feature reference	Notes	Habitat suitability	Photographs
BR221	Two mature oak with no visible holes, though unable to properly observe from other side	Low

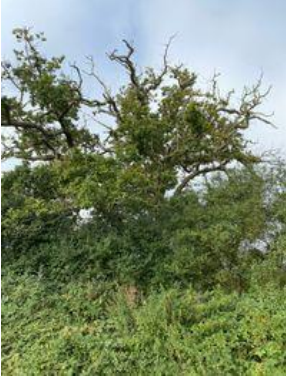
Bat roost feature reference	Notes	Habitat suitability	Photographs
BR223	Large mature oak with visible crack and holes and dead branches	Moderate

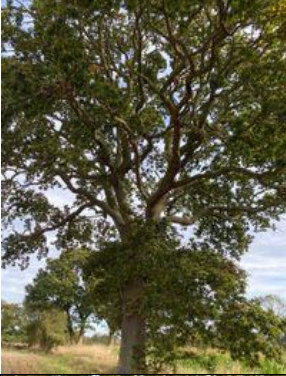
BR224	One oak, near hedges, limited visible PRF, mature	Low

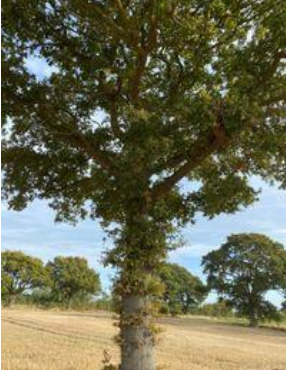
BR225	One oak, isolated, limited visible PRF, semi-mature	Negligible

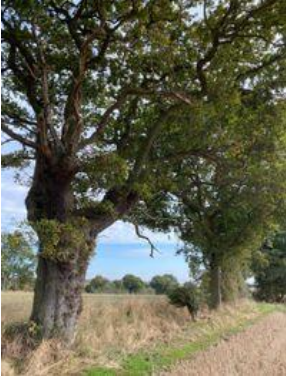
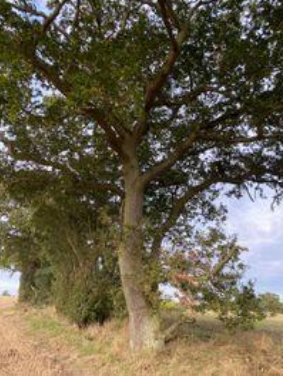
Bat roost feature reference	Notes	Habitat suitability	Photographs	
BR226	3 oaks, part of defunct hedge, limited visible PRF, mature	Low

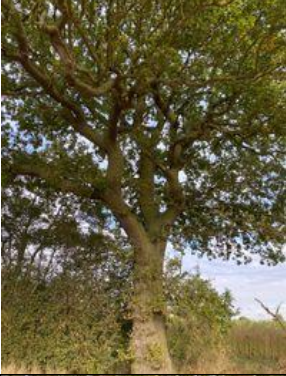
BR227	One oak, in defunct hedge, limited visible PRF, semi-mature	Low

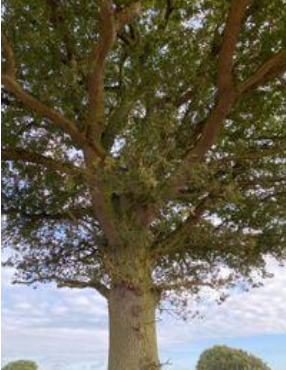
BR228	One oak, in defunct hedge, limited visible PRF, semi-mature	Low

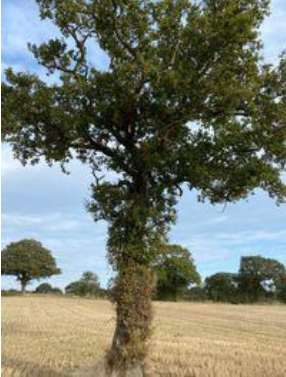
Bat roost feature reference	Notes	Habitat suitability	Photographs
BR229	One oak, isolated, limited visible PRF, semi-mature	Negligible

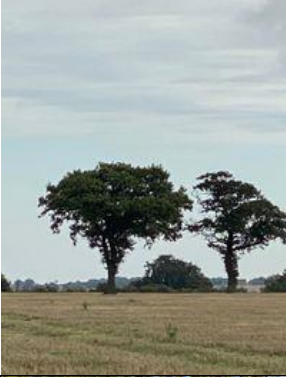
BR230	Two Oak tree semi-mature. No PRFs visible, isolated	Negligible

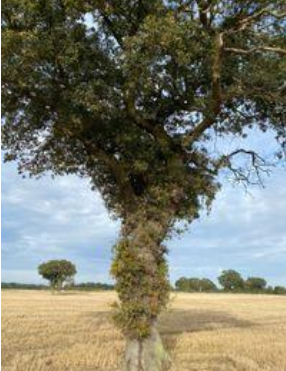
BR231	Two oaks, isolated, limited visible PRF, semi-mature	Negligible

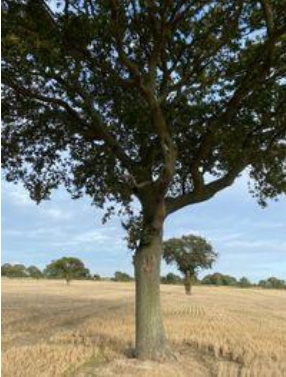
Bat roost feature reference	Notes	Habitat suitability	Photographs	
BR232	One oak, isolated, potential visible PRF, semi-mature,	Negligible

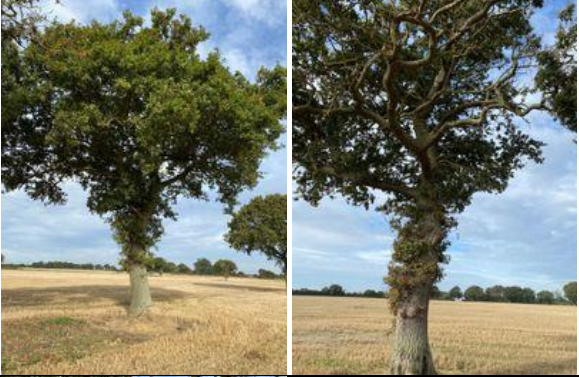
BR233	Two oaks, isolated, limited visible PRF, semi-mature	Negligible

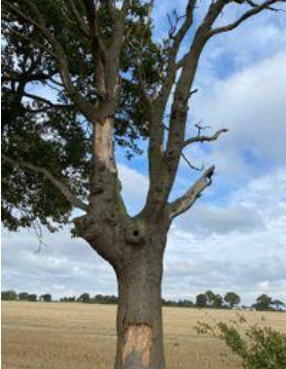
BR234	One Oak tree mature and dead. Some PRFs visible, semi-isolated in defunct hedge.	Moderate

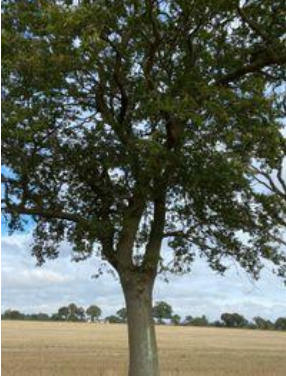
Bat roost feature reference	Notes	Habitat suitability	Photographs
BR235	One Oak tree mature. Some PRFs visible, semi-isolated in defunct hedge.	Low

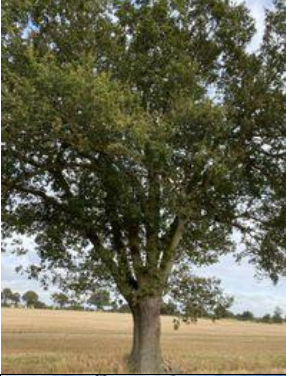
BR236	One Oak tree mature. No PRFs visible, semi-isolated in defunct hedge.	Low

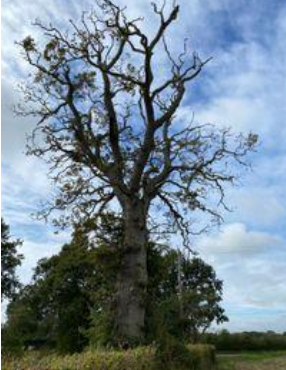
BR237	One Oak tree mature. Some PRFs visible, semi-isolated in defunct hedge.	Negligible

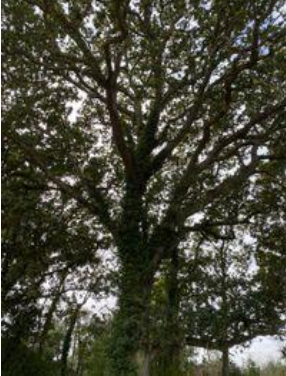
Bat roost feature reference	Notes	Habitat suitability	Photographs
BR238	Mature oak tree, no visible PRFs, ivy clad, part of dense scrub.	Low

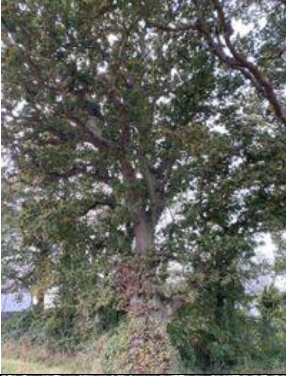
BR239	Mature oak tree, no visible PRFs, part of dense scrub.	Low

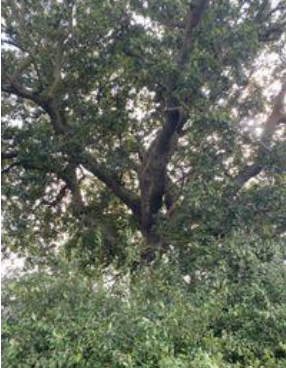
BR240	Mature oak with no visible PRFs	Negligible

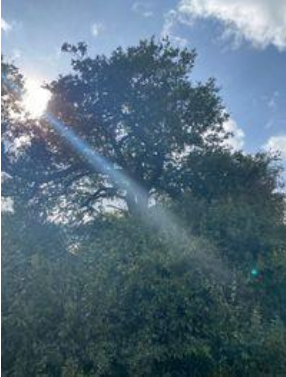
Bat roost feature reference	Notes	Habitat suitability	Photographs	
BR241	Mature oak with some cracked limbs however look to be unsuitable for roosting bats	Negligible

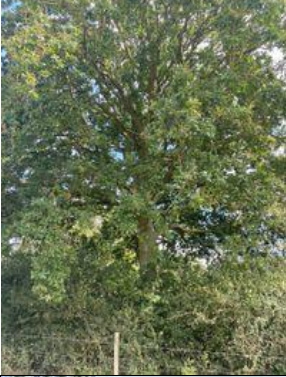
BR242	Mature oak with no visible PRFs	Negligible

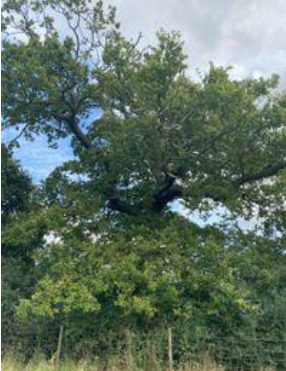
BR243	Large mature oak with several holes present.	Moderate

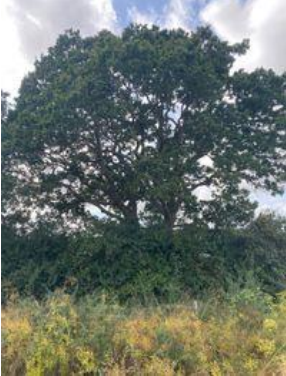
Bat roost feature reference	Notes	Habitat suitability	Photographs	
BR244	2 x mature oak with limited visible PRFs	Low

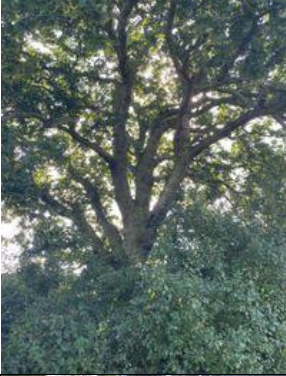
BR245	Mature oak in hedge with no visible PRFs	Negligible

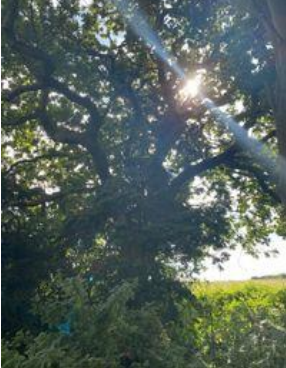
BR246	Mature oak with a few visible PRFs	Low

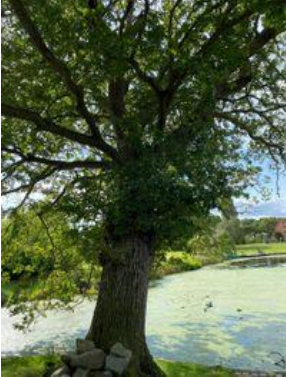
Bat roost feature reference	Notes	Habitat suitability	Photographs
BR247	Mature oak adjacent to pond with some visible holes	Moderate

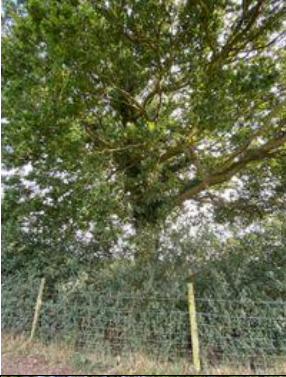
BR248	Mature oak in hedge, several visible holes and cracks	Moderate

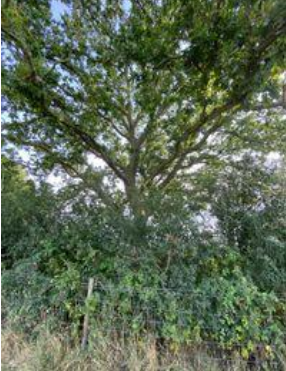
BR249	Mature oak with no visible PRFs	Negligible

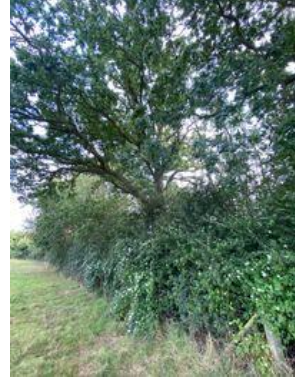
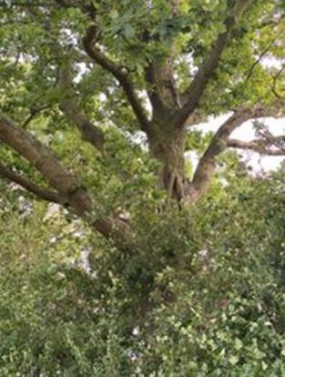
Bat roost feature reference	Notes	Habitat suitability	Photographs	
BR250	Mature oak with some visible PRFs	Moderate

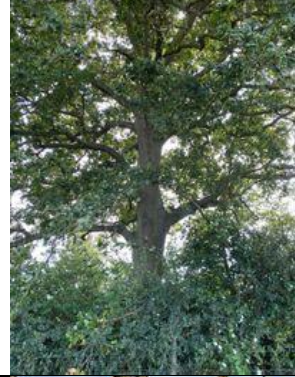
BR251	Mature oak with no visible PRFs	Negligible

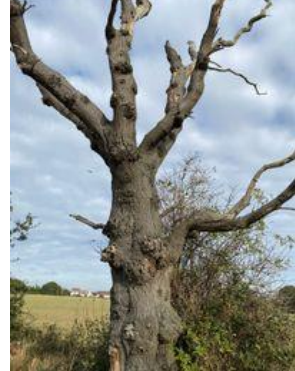
BR252	One oak, part of defunct hedge, some PRF, dead tree	Moderate

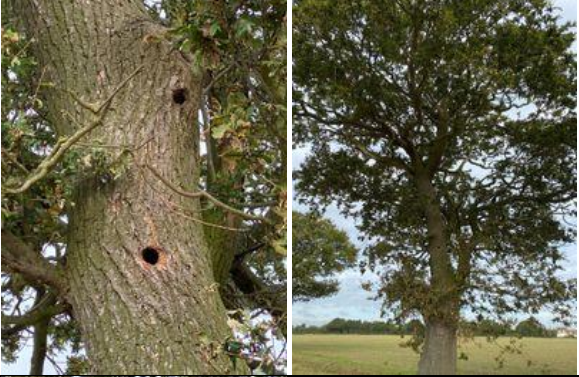
Bat roost feature reference	Notes	Habitat suitability	Photographs
BR253	One oak, semi-isolated in line of trees, limited visible PRF, mature	Low	 
BR254	One oak tree semi-mature. Some PRFs visible, semi-isolated in defunct hedge.	Moderate

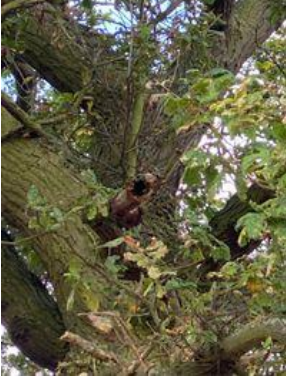
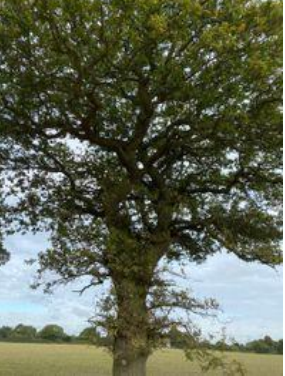
Bat roost feature reference	Notes	Habitat suitability	Photographs	
BR256	One Oak tree mature. Some PRFs visible, semi-isolated in defunct hedge.	Moderate

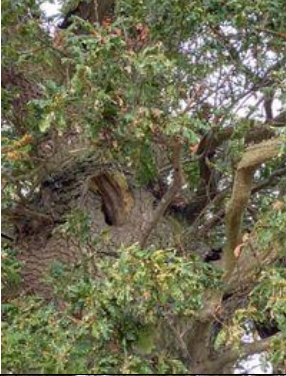
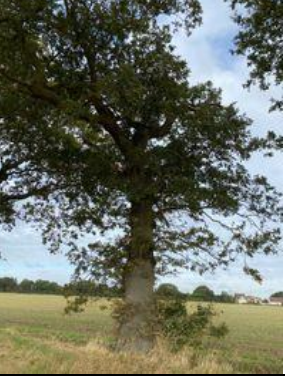
BR257	One Oak tree mature. Some PRFs visible, semi-isolated in defunct hedge.	Moderate

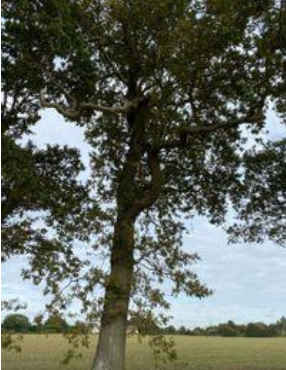
BR258	One Oak tree semi-mature. No PRFs visible, semi-isolated in defunct hedge.	Low

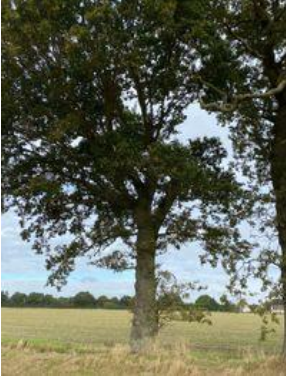
Bat roost feature reference	Notes	Habitat suitability	Photographs
BR259	One Oak tree semi-mature. No PRFs visible, semi-isolated in defunct hedge.	Negligible

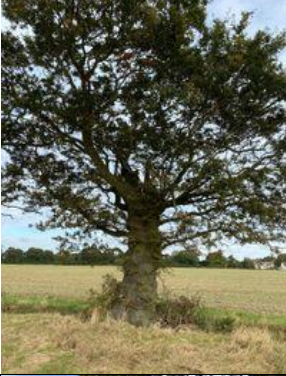
BR260	One Oak tree mature and completely hollow. Some PRFs visible but completely hollow, semi-isolated in defunct hedge.	Negligible

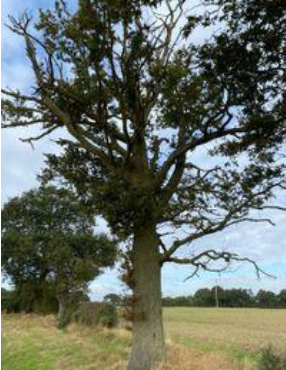
BR261	One Oak tree semi-mature. No PRFs visible, semi-isolated in defunct hedge.	Negligible

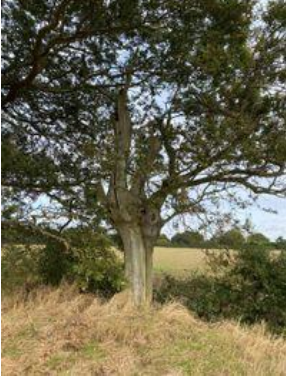
Bat roost feature reference	Notes	Habitat suitability	Photographs	
BR262	One Oak tree mature and nearly dead. Some PRFs visible, semi-isolated in defunct hedge.	Low

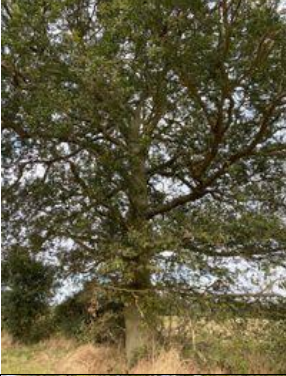
BR263	One Oak tree mature. No PRFs visible, semi-isolated in defunct hedge.	Negligible

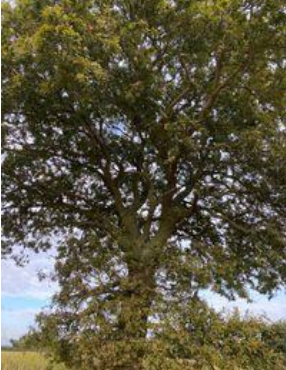
BR264	One Oak tree semi-mature. No PRFs visible, semi-isolated in defunct hedge.	Negligible

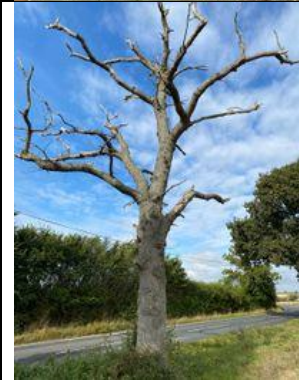
<p>The photographs show the exterior of a brick barn. The top-left photo shows a corner with a tiled roof and a hole in the brickwork. The top-right photo shows a long wall with a hole and a crack in the roofline. The bottom-left photo shows a close-up of a hole in the brick wall. The bottom-right photo shows a close-up of a hole in the brick wall with some vegetation growing nearby.</p>
BR266	One Oak tree mature dead. No PRFs visible, semi-isolated	Negligible

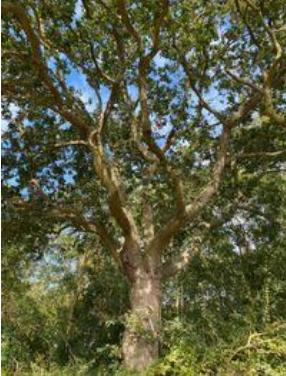
Bat roost feature reference	Notes	Habitat suitability	Photographs	
BR267	One Oak tree mature. Some PRFs visible, semi-isolated in defunct hedge.	Low

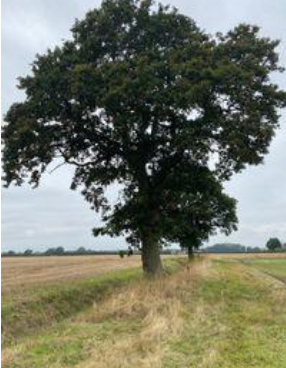
BR269	Large mature oak with some splits and cracks visible.	Low

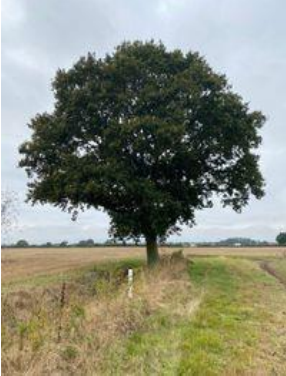
Bat roost feature reference	Notes	Habitat suitability	Photographs
BR270	Mature oak with some visible splits and cracks	Low

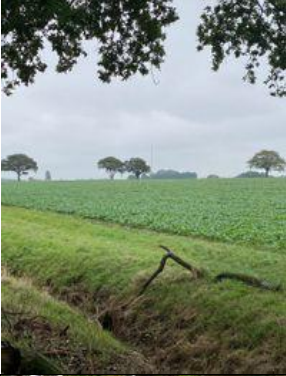
BR271	Four oak, isolated along field boundary. Observed with binoculars, no visible PRFs and all are semi mature.	Negligible

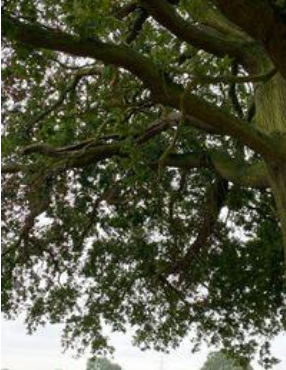
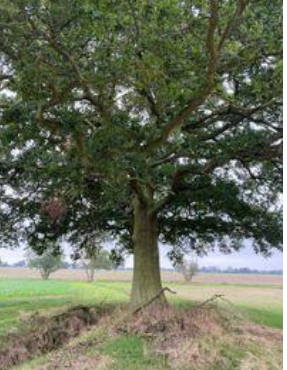
BR272	Large mature potentially veteran oak with a few cracked limbs.	Low

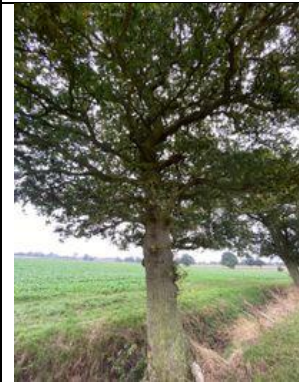
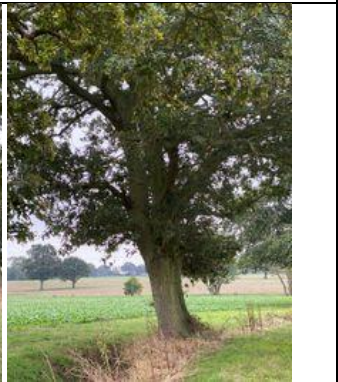
Bat roost feature reference	Notes	Habitat suitability	Photographs	
BR273	Two mature oaks with no visible PRFs	Negligible

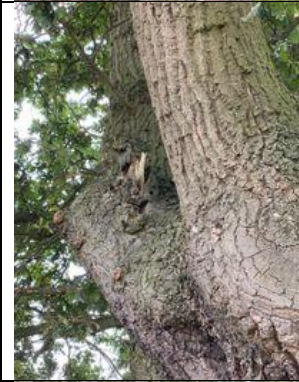
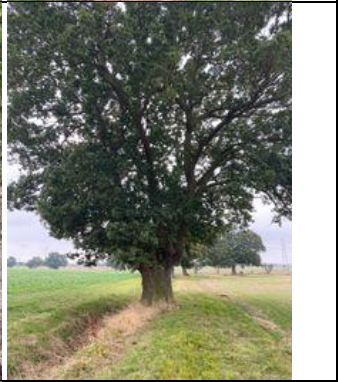
BR274	Mature, potentially veteran oak. No visible holes though several knots present which may have access inside	Low

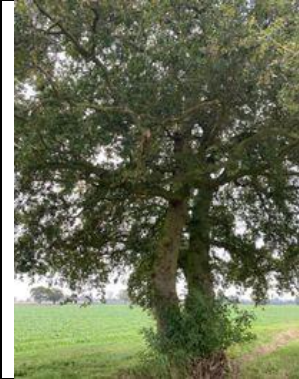
BR275	Mature oak with no visible PRFs.	Negligible

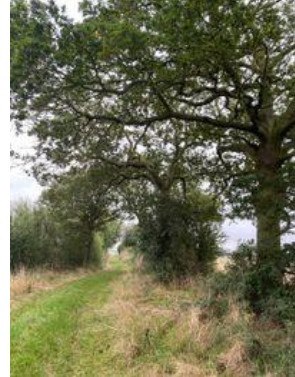
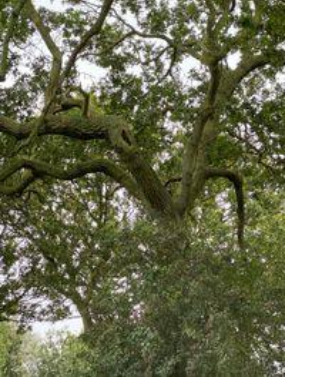
Bat roost feature reference	Notes	Habitat suitability	Photographs	
BR276	Mature oak with large hole and additionally cracks, though tree trunk is rather small. Potential opportunistic roosting only.	Low

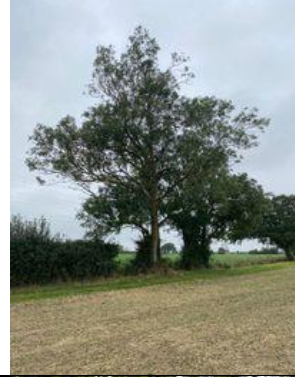
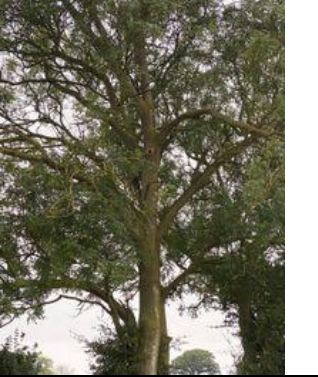
BR277	Mature willow with at least one visible hole. Some discolouration visible.	Moderate

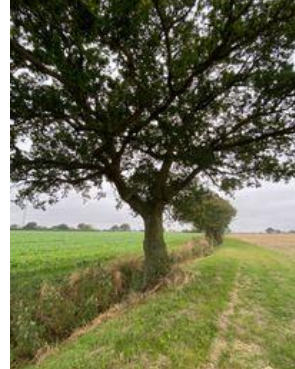
BR278	Semi mature oak with no visible PRFs	Negligible

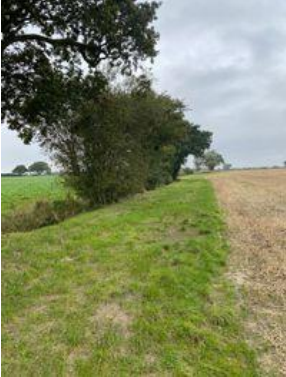
Bat roost feature reference	Notes	Habitat suitability	Photographs
BR279	Looks like potential remnant section of hedge, with hawthorn and semi mature oak. No suitability for roosting bats	Negligible

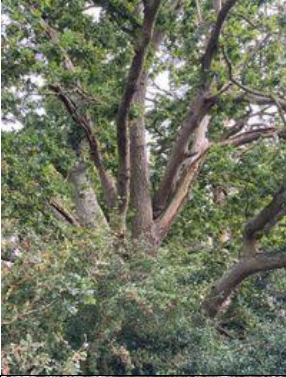
BR280	Mature oak with splits and cracks however nothing that looks substantial.	Low

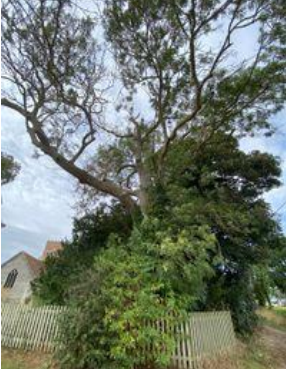
BR281	Mature ash with a few cracks but nothing substantial	Low

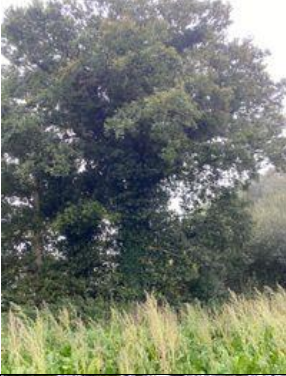
N/A	<i>BR283-BR303 not used</i>	N/A	N/A
BR304	Large mature ivy clad oak, difficult to see any potential PRFs.	Low

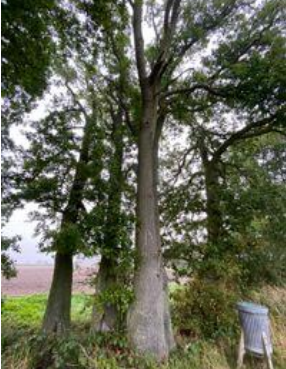
BR305	Mature oak with large hole, potentially woodpecker.	Moderate

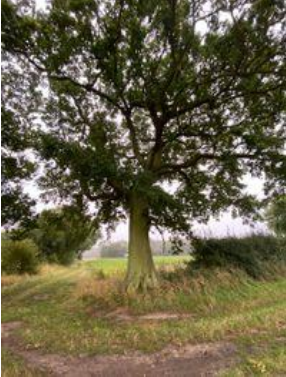
Bat roost feature reference	Notes	Habitat suitability	Photographs
BR306	Mature oak with no visible PRFs	Negligible

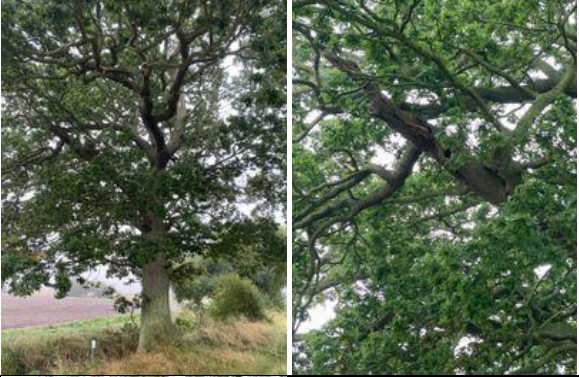
BR307	Mature oak with multiple holes, adjacent to hedgeline and close to woodland.	Moderate

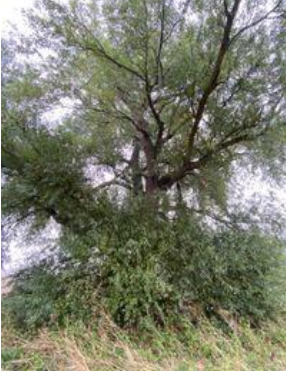
BR308	Mature willow with lots of visible woodpecker holes that could potentially be used by roosting bats.	Moderate

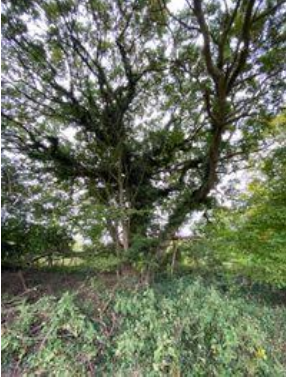
Bat roost feature reference	Notes	Habitat suitability	Photographs
BR309	Large mature ivy clad oak with some cracked limbs	Low

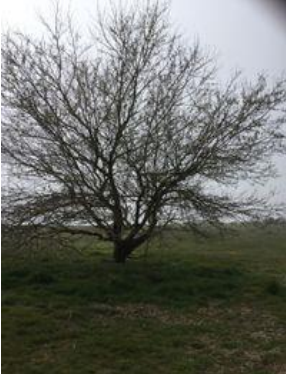
<i>BR311 not used</i>	N/A	N/A
BR312	Single tree with negligible potential for roosting bats given absence of suitable PRFs.	Negligible

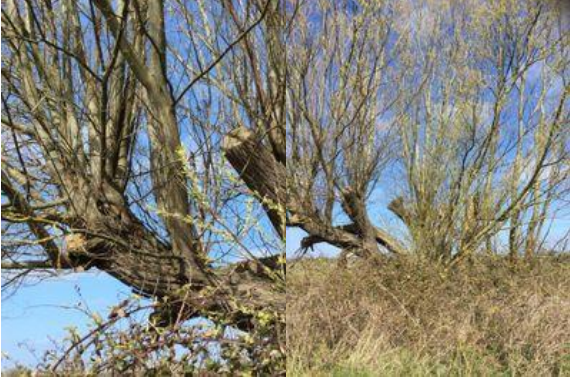
Bat roost feature reference	Notes	Habitat suitability	Photographs
BR313	Group of willow trees assessed as providing moderate to high bat potential.	Moderate

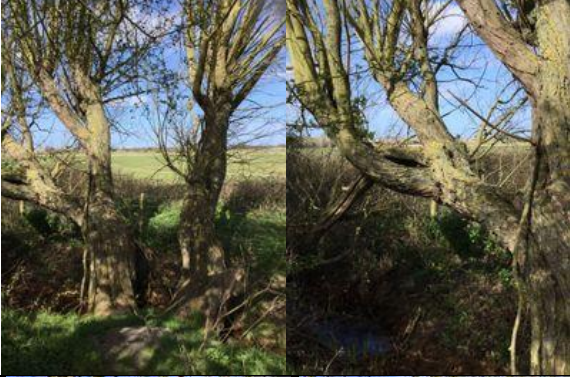
BR314	Willow tree assessed as providing moderate to high bat potential.	Moderate/high

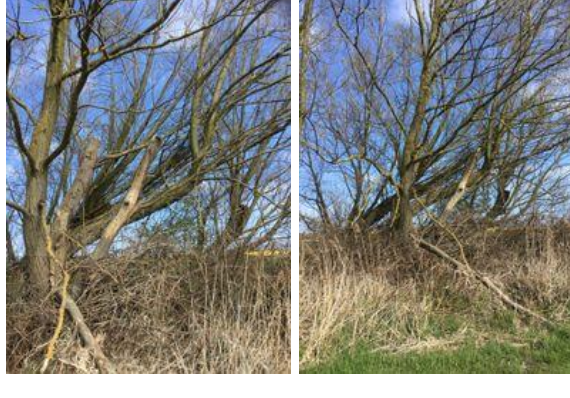
BR315	Group of willow trees with sections of fallen limbs. All assessed as providing moderate to high potential for supporting roosting bats.	Moderate/high

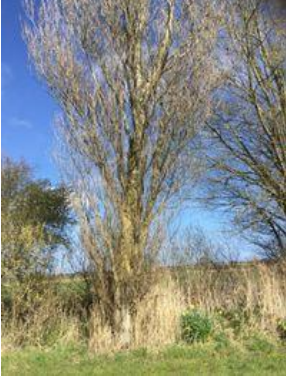
Bat roost feature reference	Notes	Habitat suitability	Photographs
BR316	Single willow trees assessed as negligible for roosting bats due to absence of suitable PRFs.	Negligible

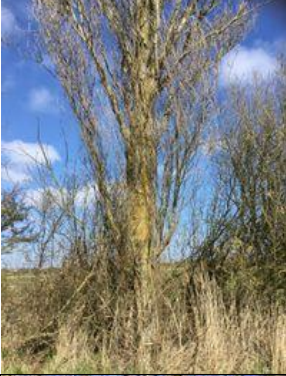
BR317	Single willow trees assessed as negligible for roosting bats due to absence of suitable PRFs.	Negligible

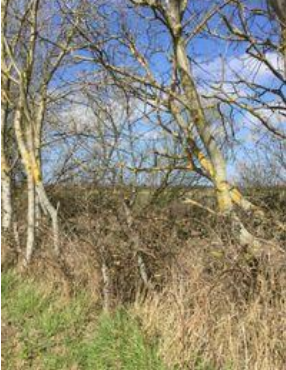
BR318	Trees assessed as providing negligible potential for roosting bats due to absence of suitable PRFs.	Negligible

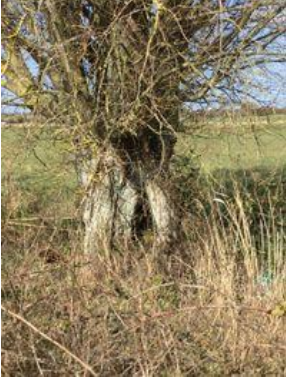
Bat roost feature reference	Notes	Habitat suitability	Photographs
BR319	Single tree assessed as providing moderate-high suitability for roosting bats due to presence of suitable PRFs.	Moderate/high

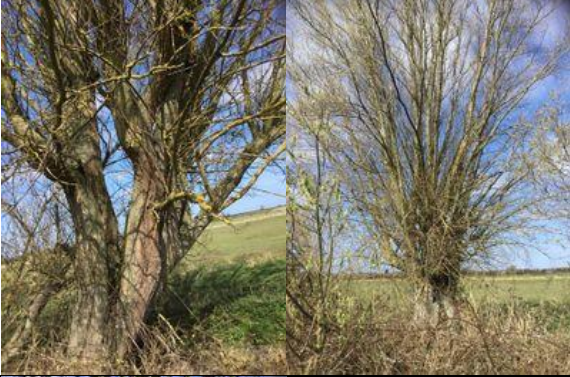
BR320	Tree assessed as providing low - negligible potential for roosting bats due to limited number of PRFs.	Low/negligible.

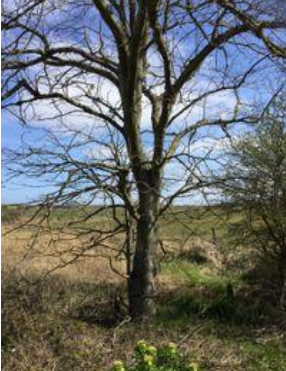
BR321	Single tree assessed as providing negligible bat potential.	Negligible

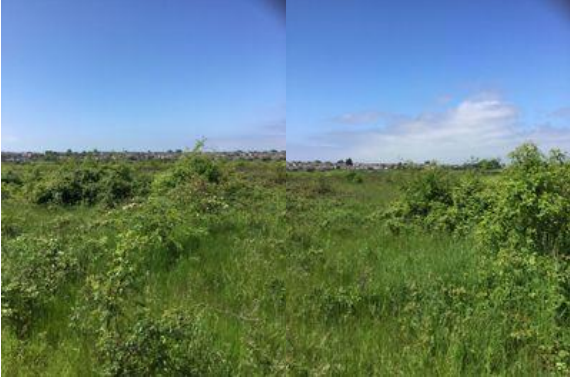
Bat roost feature reference	Notes	Habitat suitability	Photographs
BR322	Area of oak saplings (negligible bat potential) with bramble, hawthorn, dogrose scrub present.	Negligible

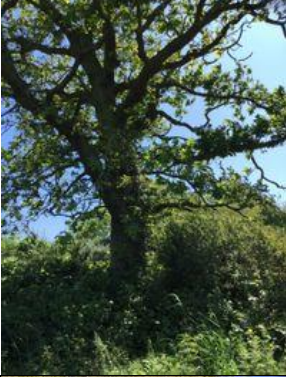
BR325	Single oak tree with loose bark and broken limbs. Assessed as providing low bat potential.	Low

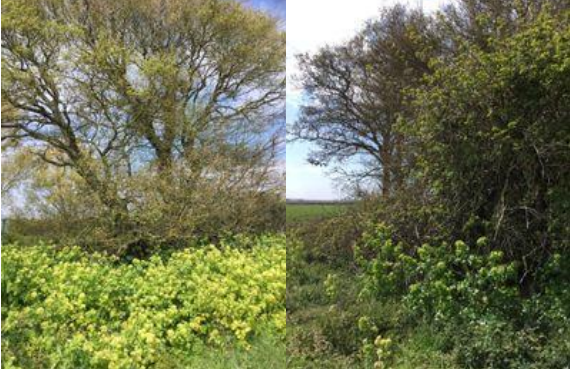
BR326	Group of elder trees, all of which assessed as providing negligible to low bat potential. Some are ivy clad and associated bramble scrub also present.	Negligible

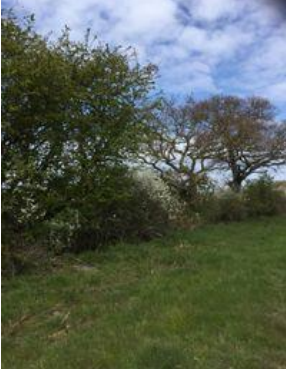
BR329	Three single trees within hedge line assessed as providing low bat potential. Loose bark and broken limbs also present.	Low

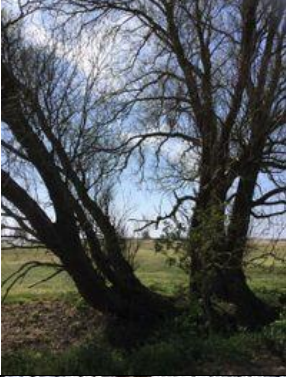
BR331	Three mature willow trees with broken limbs and assessed as providing low bat potential.	Low

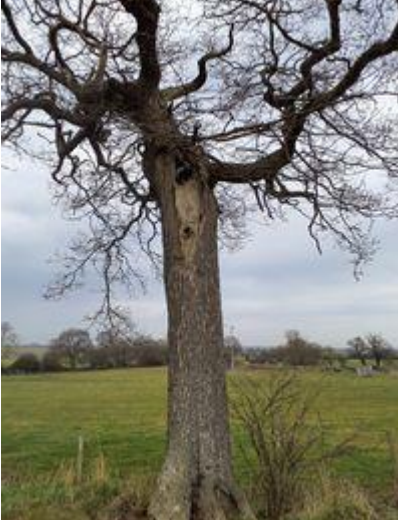
BR332	Veteran oak tree which is isolated in landscape. May provide limited roosting habitat.	Low

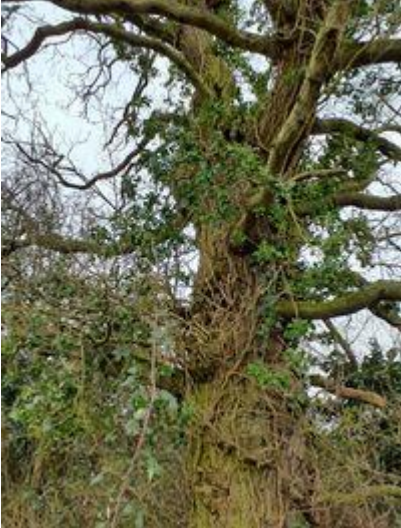
Bat roost feature reference	Notes	Habitat suitability	Photographs
BR333	Veteran tree with woodpecker and knot holes. Potential roosting habitat, part of hedgerow network.	Low

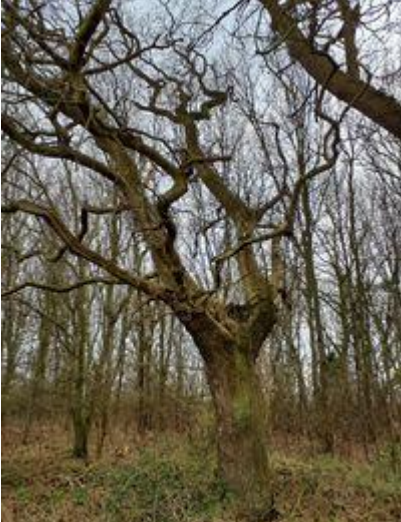
BR334	Veteran oak within moderate suitability woodland with holes and crevices which may provide roosting habitat.	Moderate

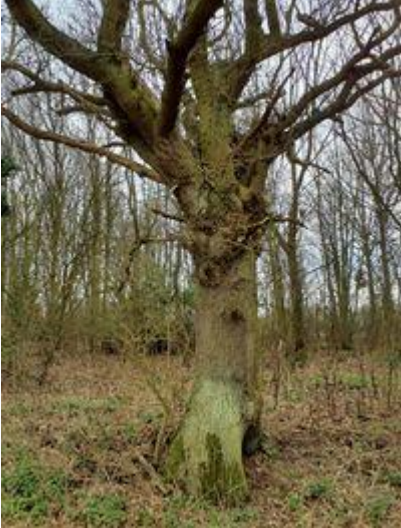
Bat roost feature reference	Notes	Habitat suitability	Photographs
BR335	<p>Veteran oak tree with crevices and holes which may provide roosting habitat for bats. Within woodland with connectivity to wider landscape.</p>	Moderate

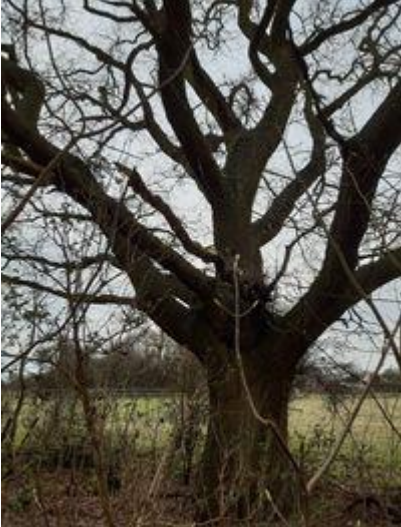
BR336	<p>Tiny knot hole, however located in good commuting habitat (woodland).</p>	Low

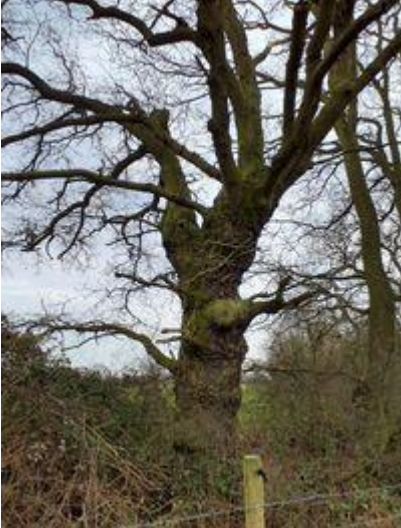
Bat roost feature reference	Notes	Habitat suitability	Photographs
BR337	<p>Veteran oak tree with woodpecker hole which may provide roosting habitat. Within hedgerow and connected to good woodland habitat.</p>	Moderate

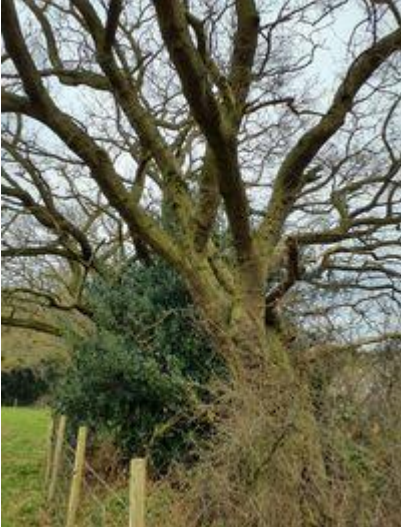
BR338	<p>Veteran oak tree with crevices which may provide roosting habitat. Within hedgerow and connected to good woodland habitat.</p>	Low

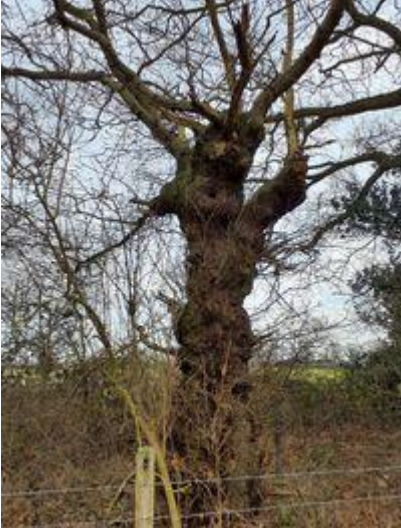
Bat roost feature reference	Notes	Habitat suitability	Photographs
BR339	<p>Veteran oak tree with crevices and holes which may provide roosting habitat. Within hedgerow and connected to good woodland habitat.</p>	Moderate

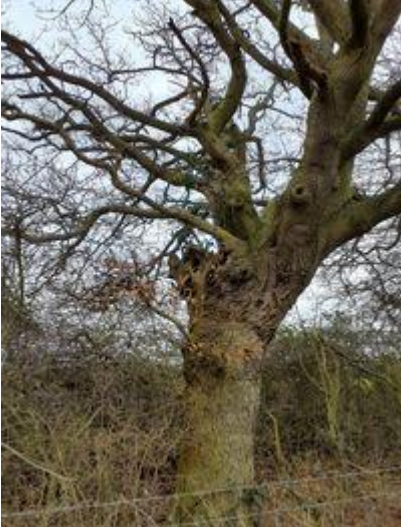
BR340	<p>Veteran oak tree with crevices and holes which may provide roosting habitat. Within hedgerow and connected to good woodland habitat.</p>	Moderate

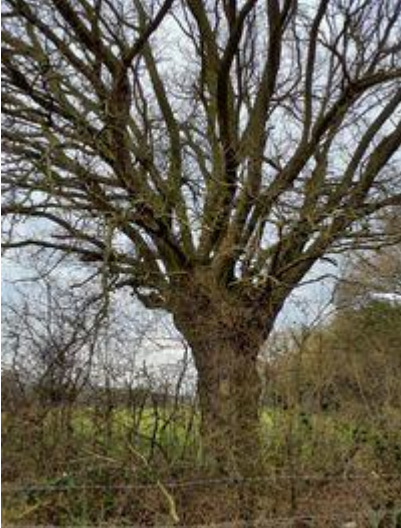
Bat roost feature reference	Notes	Habitat suitability	Photographs
BR341	<p>Veteran oak tree with crevices which may provide roosting habitat. Within hedgerow and connected to good woodland habitat.</p>	Moderate

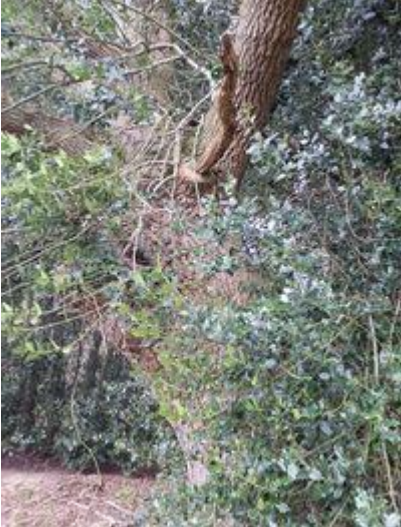
BR342	<p>Veteran oak, large cavity 3m above ground. Located in good foraging habitat.</p>	Moderate

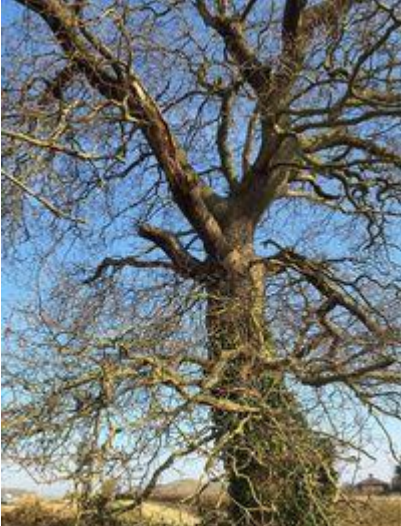
BR348	<p>2x veteran oak trees with broken limbs providing potential capacity for a larger roosts. Part of hedgerow providing connectivity to wider landscape.</p>	Moderate

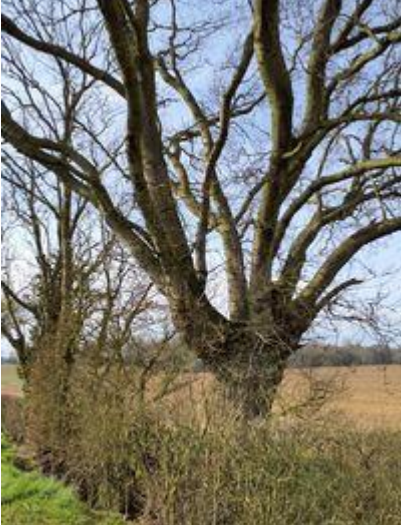
BR350	Mature oak with old woodpecker hole, potential for large, sheltered cavity inside. Very isolated in landscape (500m from foraging), in centre of arable fields.	Low	No photograph
BR351	Veteran oak tree with crevices and some holes which may provide roosting habitat. Within hedgerow and adjacent to field drain which provides connectivity to wider landscape including woodland.	Moderate

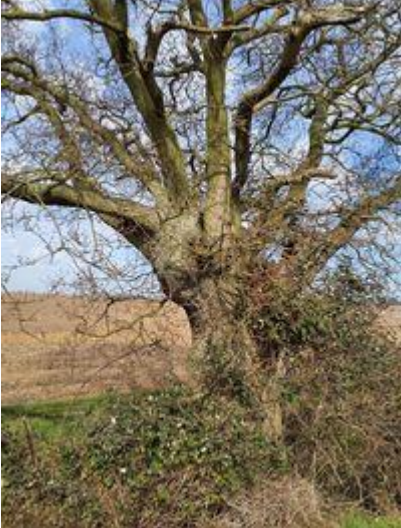
Bat roost feature reference	Notes	Habitat suitability	Photographs
BR352	<p>Veteran oak tree with crevices which may provide roosting habitat. Within hedgerow providing some connectivity to wider landscape and adjacent to stream.</p>	Moderate

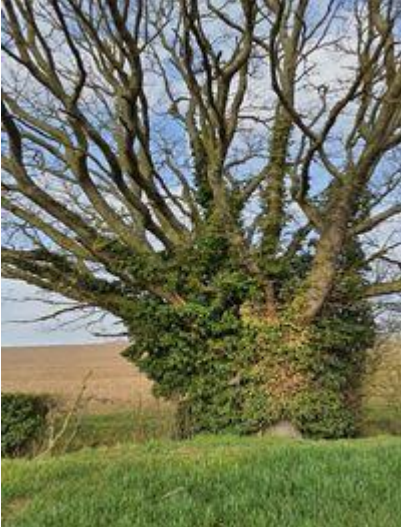
BR353	<p>Large veteran oak with many limbs and lots of ivy cover which may provide roosting habitat for bats. Within hedgerow providing some connectivity to wider landscape including woodland. Also adjacent to stream.</p>	Moderate
