NORTH FALLS

Offshore Wind Farm

Appendix 23.1 Extended Phase 1 Habitat
Survey Report (Part 3 of 3)

Document Reference:	3.3.30
Volume:	3.3
APFP Regulation:	5(2)(a)
Date:	July 2024
Revision:	0

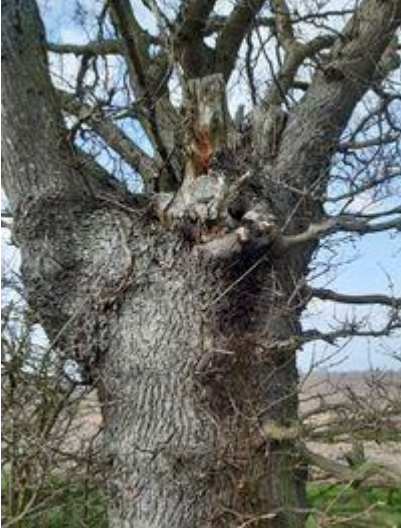
Bat roost feature reference	Notes	Habitat suitability	Photographs
BR354	Veteran oak with small cavity in dead limbs. Isolated in landscape.	Low

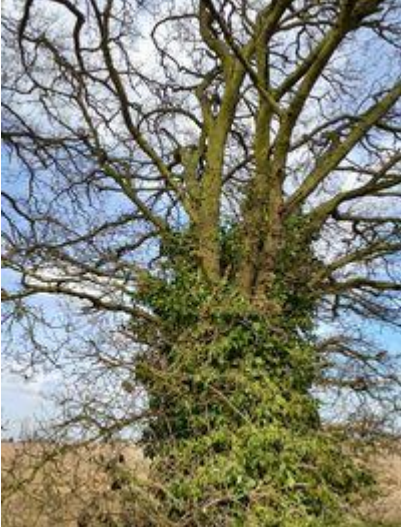
BR355	Veteran ivy covered oak which may provide roosting habitat for bats. Within a hedgerow which provides some connectivity to wider landscape including woodland.	Low

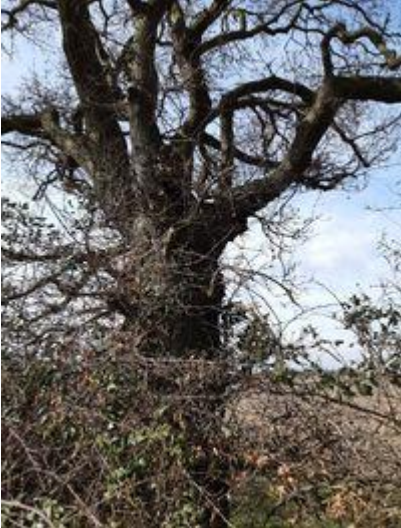
Bat roost feature reference	Notes	Habitat suitability	Photographs
BR356	Mature oak with small cavity in dead limbs. Isolated in landscape.	Low

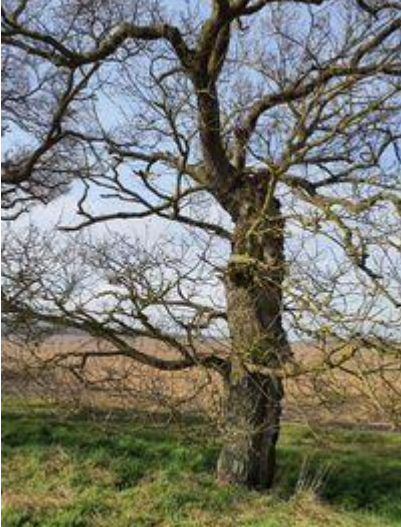
BR357	Veteran oak tree with crevices which may provide roosting habitat. Within hedgerow providing some connectivity to wider landscape including woodland.	Moderate

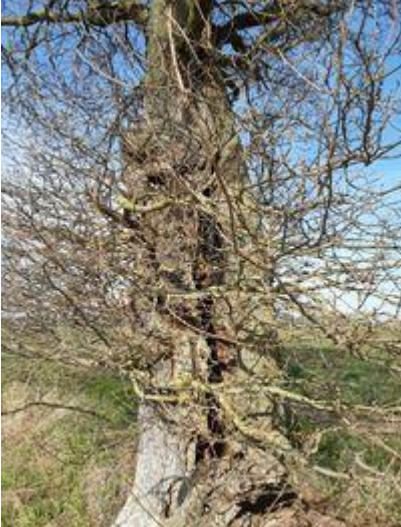
BR359	Mature oak with large exposed opening in trunk. Isolated in landscape.	Low

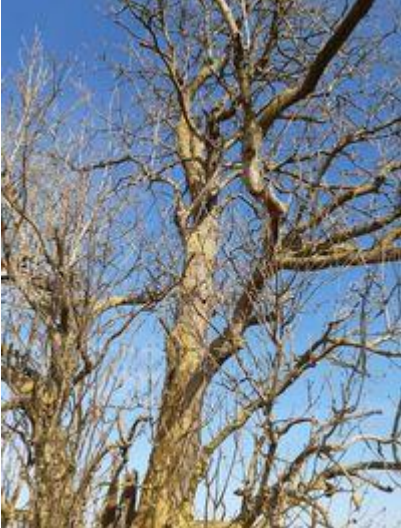
Bat roost feature reference	Notes	Habitat suitability	Photographs
BR360	3x woodpecker hole in upper trunk of mature ash tree. Located in hedgerow, but isolated from wider landscape.	Low

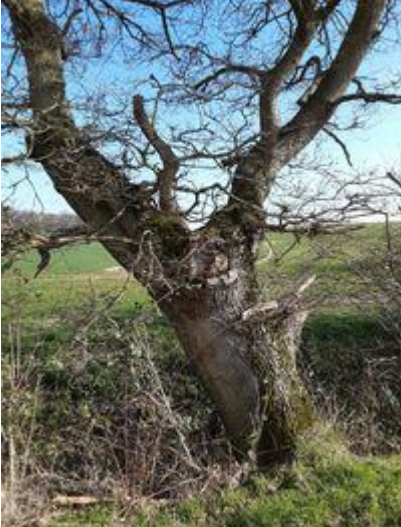
BR363	Mature oak, small cracks around knot holes, but located adjacent to excellent foraging habitats around Tendring Brook.	Moderate

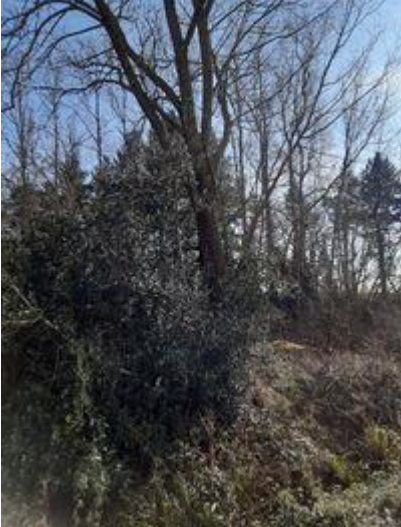
BR365	Mature willow, small crevices, but located in excellent foraging habitat, by pond and Tendring Brook.	Moderate

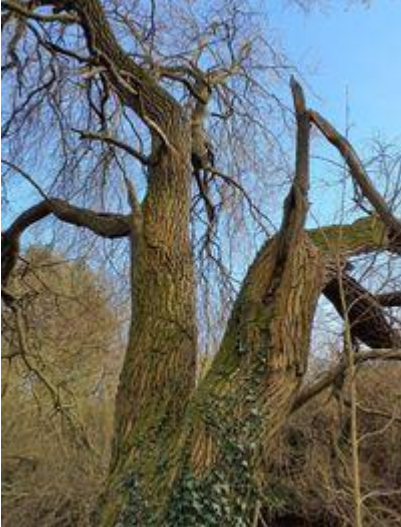
BR367	Veteran willow tree with large fallen branch providing a scar and crevices for potential roosting. Adjacent to pond and Tendring Brook, therefore well connected to surrounding habitat and other local woodland habitat.	Moderate

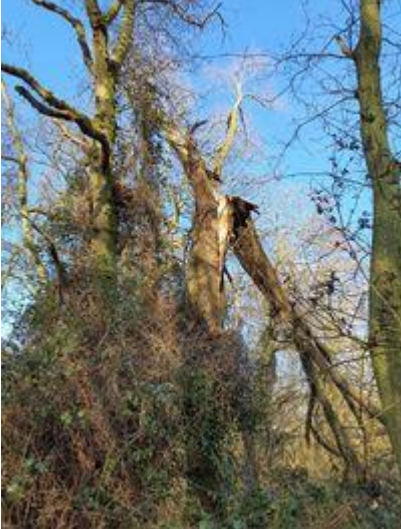
Bat roost feature reference	Notes	Habitat suitability	Photographs
BR368	<p>Tree with fallen crown, large crevices within trunk / branches which may provide roosting habitat. Within mature woodland adjacent to Tendring Brook and pond habitats as well as wider connectivity to other woodland habitat.</p>	Moderate

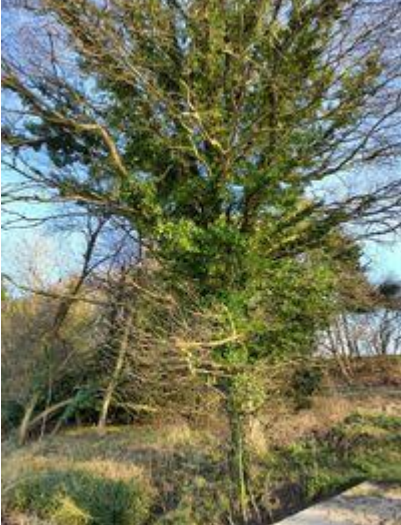
BR369	<p>Mature oak tree with ivy cover which provide potential bat roosting habitat. Connected to linear commuting and foraging habitat to other woodland parcels and adjacent to Tendring Brook.</p>	Moderate

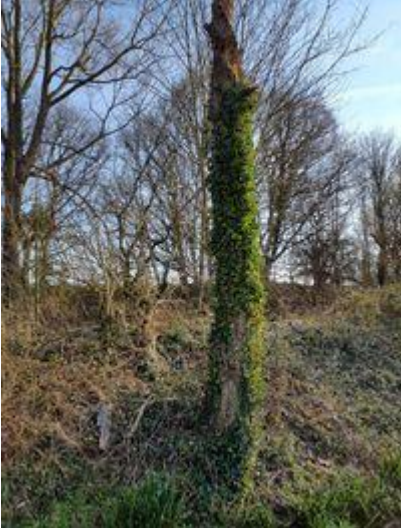
Bat roost feature reference	Notes	Habitat suitability	Photographs
BR370	Tall dead stump with woodpecker holes which provide potential bat roosting habitat. Connected to linear commuting and foraging habitat to other woodland parcels and adjacent to Tendring Brook.	Moderate

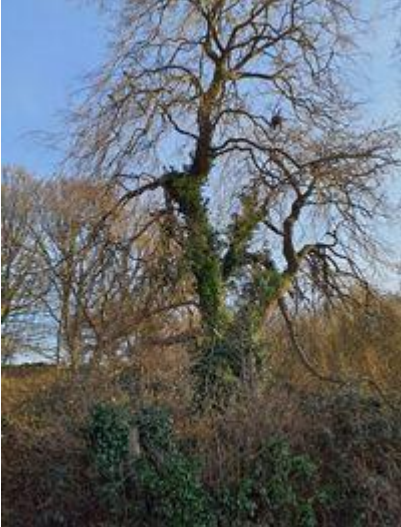
BR371	Veteran willow tree with broken limbs and crevices which provide potential bat roosting habitat. Connected to linear commuting and foraging habitat to other woodland parcels and adjacent to Tendring Brook.	Moderate

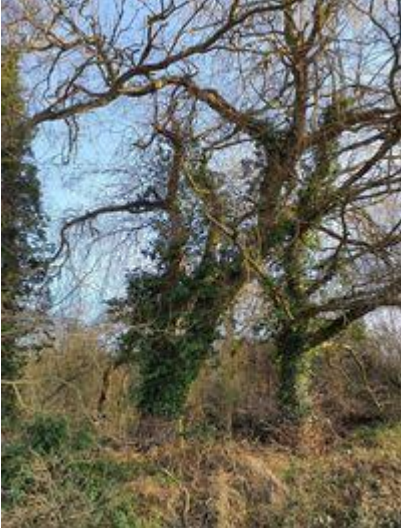
Bat roost feature reference	Notes	Habitat suitability	Photographs
BR372	<p>Veteran willow tree with ivy cover and crevices which provide potential roosting habitat. Connected to linear commuting and foraging habitat to other woodland parcels and adjacent to Tendring Brook.</p>	Moderate

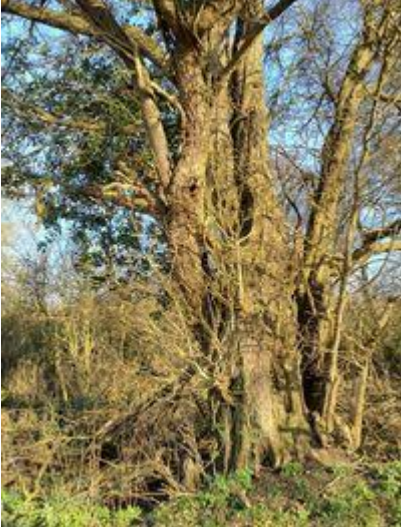
BR373	<p>Mature oak tree with woodpecker holes and crevices which provide potential roosting habitat. Connected to linear commuting and foraging habitat to other woodland parcels and adjacent to Tendring Brook.</p>	Moderate

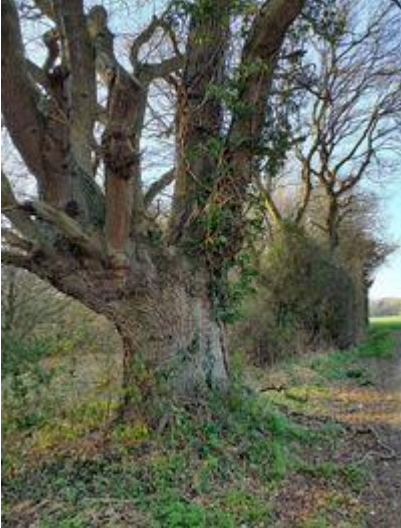
Bat roost feature reference	Notes	Habitat suitability	Photographs
BR374	Mature oak no obvious PRFs, but cannot see canopy in full. In good connecting habitat.	Low

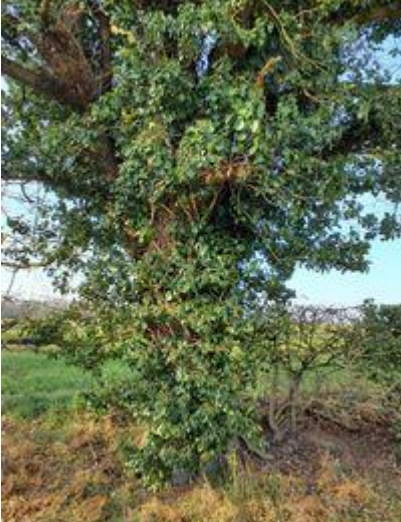
BR375	Veteran oak clad with ivy although with no other obvious PRFs, isolated in landscape.	Low

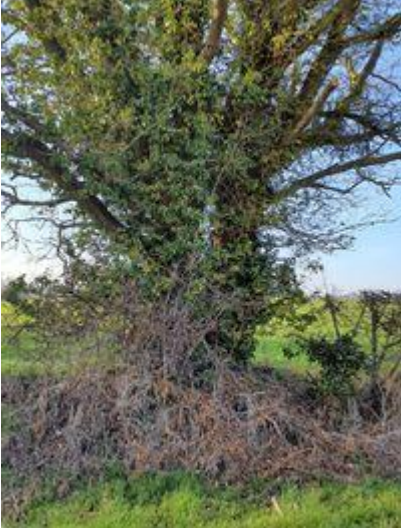
Bat roost feature reference	Notes	Habitat suitability	Photographs
BR376	Veteran oak clad with ivy although with no other obvious PRFs, isolated in landscape.	Low

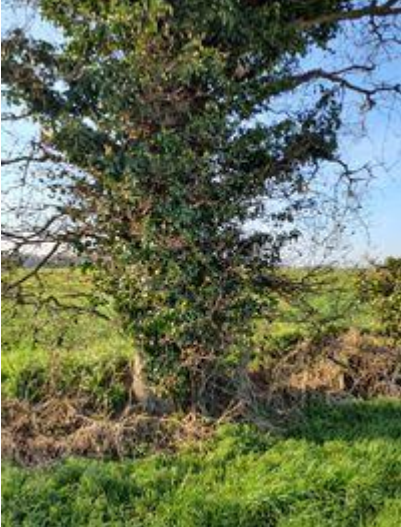
BR377	Veteran oak clad with ivy although with no other obvious PRFs, isolated in landscape.	Low

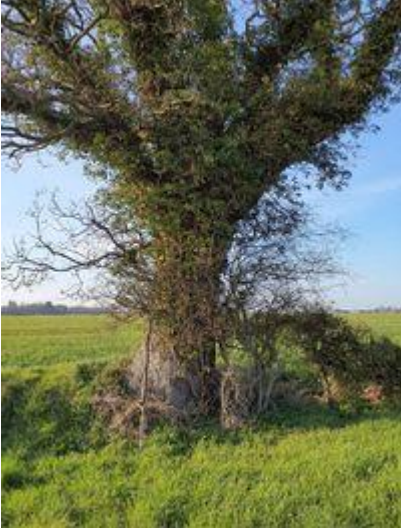
Bat roost feature reference	Notes	Habitat suitability	Photographs
BR378	Veteran oak clad with ivy although with no other obvious PRFs, isolated in landscape.	Low

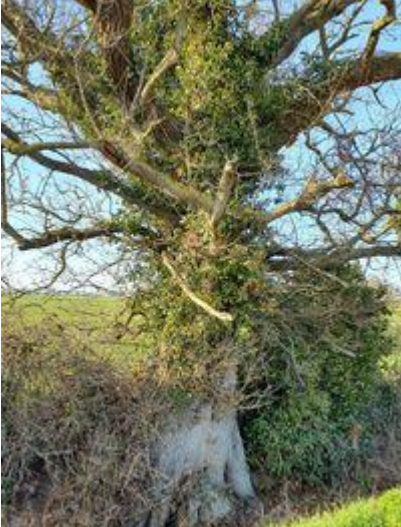
BR379	Mature oak with small crack under immature ivy, isolated in landscape.	Low

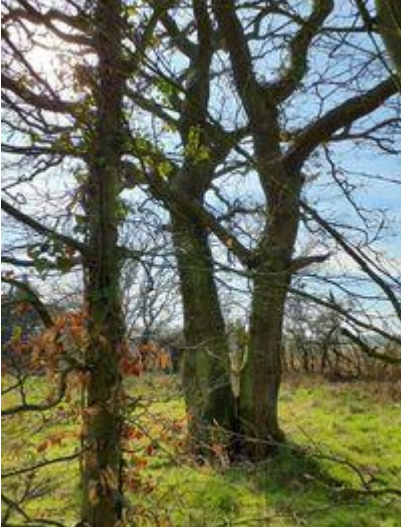
BR381	Mature oak with some crevices which may provide roosting material. well connected to woodland and wider landscape.	Low

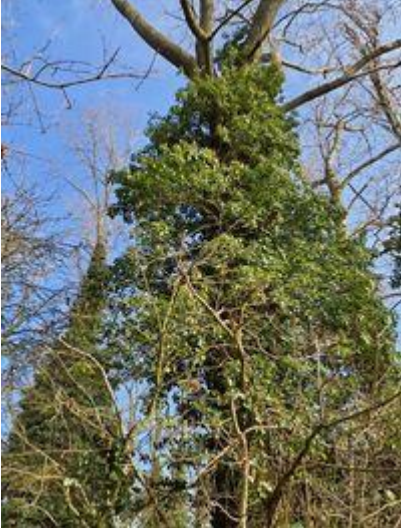
Bat roost feature reference	Notes	Habitat suitability	Photographs
BR382	Mature oak covered with ivy which may provide some roosting habitat. Within woodland and well connected to wider landscape and other local woodland.	Low

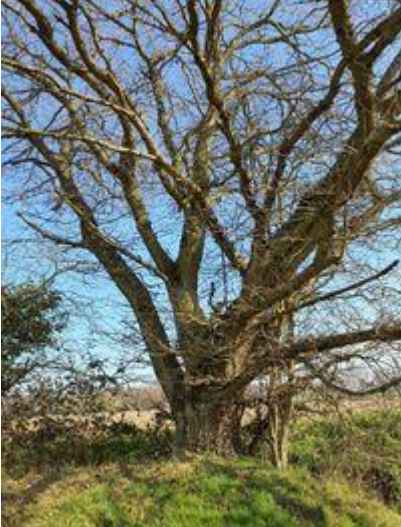
BR383	Veteran oak tree with small crevices and many limbs. Potential roosting habitat with good connectivity to landscape and woodland via stream and hedgerow.	Low

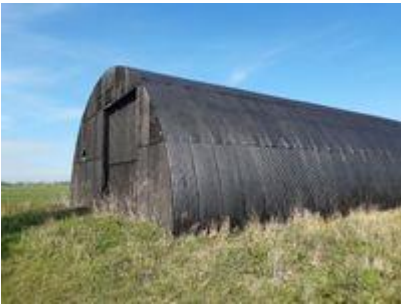
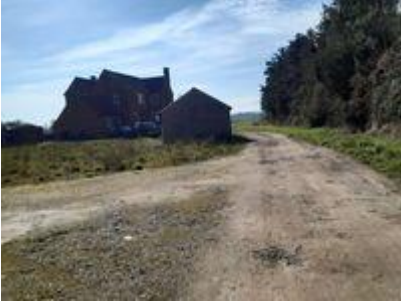
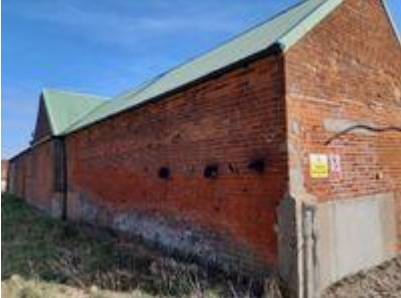
BR385	Collection of farm buildings (8 no.), some old brick buildings and some corrugated steel barns. Potential roosting space under roof flashing, especially the brick buildings. Connecting habitat to south.	Moderate

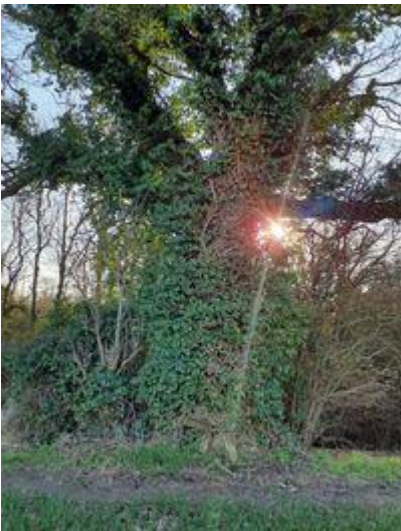
A photograph showing the side of a brick building with a green metal roof. The building is situated on a slight rise with some vegetation in the foreground.
BR386	Veteran oak, ivy clad, well connected by watercourse and woodland	Moderate

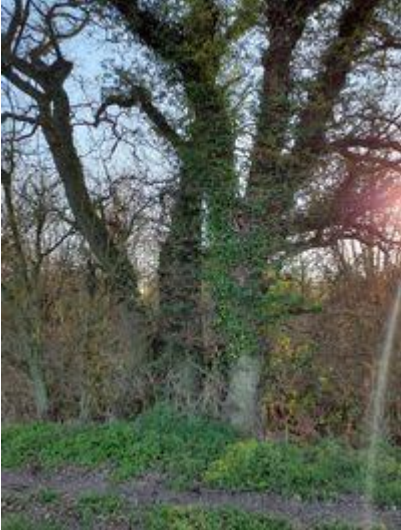
Bat roost feature reference	Notes	Habitat suitability	Photographs
BR387	Veteran oak clad with ivy, in woodland by watercourse. Well connected.	Moderate

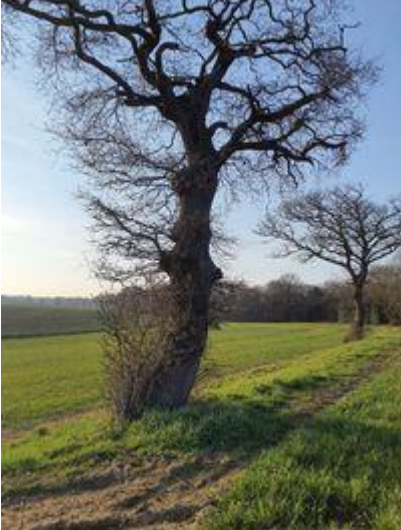
BR388	Veteran oak with large hole in trunk, not exposed to elements. Isolated in landscape, but woodland to north and south.	Moderate

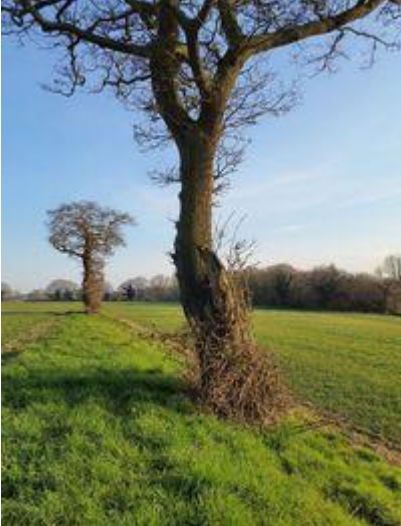
Bat roost feature reference	Notes	Habitat suitability	Photographs
BR389	Mature oak, isolated in landscape but woodlands nearby. Minimal PRFs observed.	Low

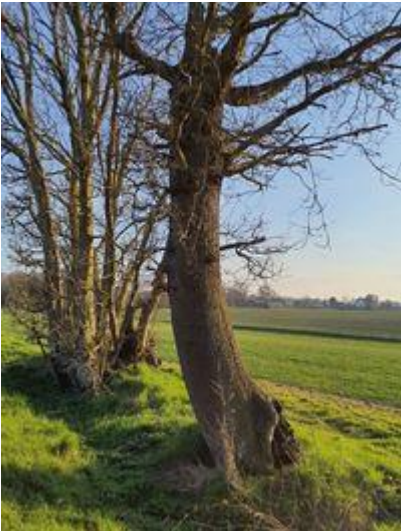
BR390	Veteran oak, large empty cavity, isolated in landscape but woodland to north.	Moderate

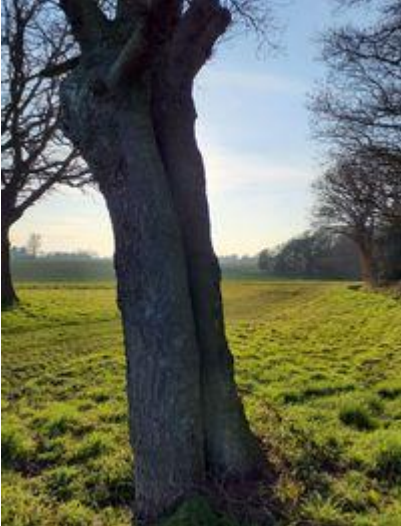
Bat roost feature reference	Notes	Habitat suitability	Photographs
BR391	Veteran oak, with large open scar. Potential for moderate internal roost. Good connecting habitat with woodland to north.	Moderate

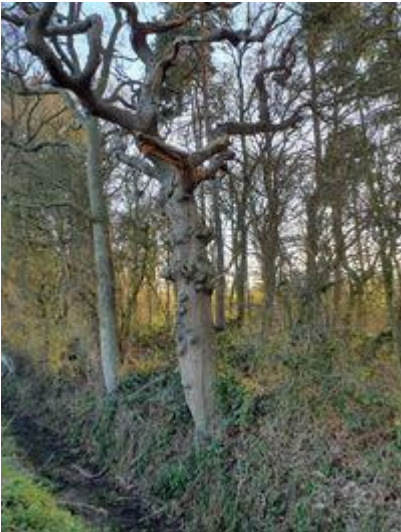
BR392	Dead oak with large cavities under bark. Located in good foraging habitat, wet woodland.	Moderate

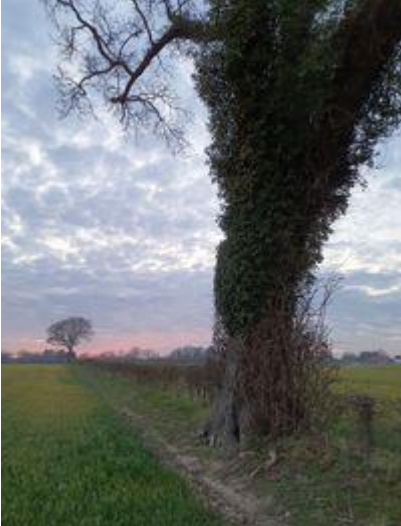
Bat roost feature reference	Notes	Habitat suitability	Photographs
BR393	Mature oak tree with ivy cover, connected to foraging habitat and woodland, potential roosting habitat.	Low

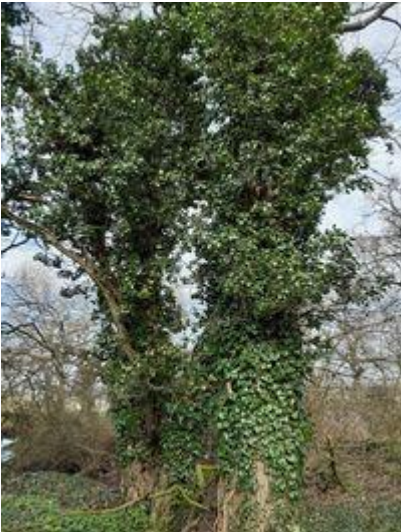
BR394	2x veteran oaks with extensive ivy cover and large crevices, located in semi-natural woodland with ponds and field margin/hedgerows adjacent.	Moderate

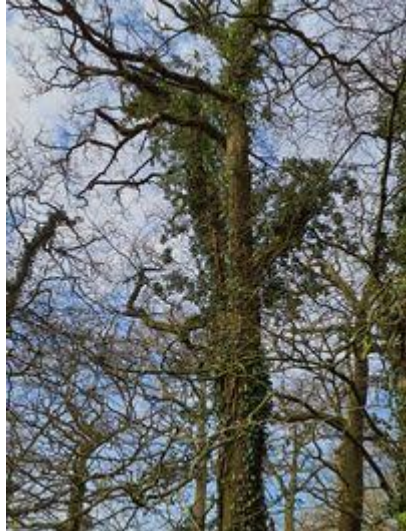
Bat roost feature reference	Notes	Habitat suitability	Photographs
BR395	Oak tree with woodpecker holes. Within woodland that is well connected to surrounding landscape. Provides potential roosting habitat.	Moderate

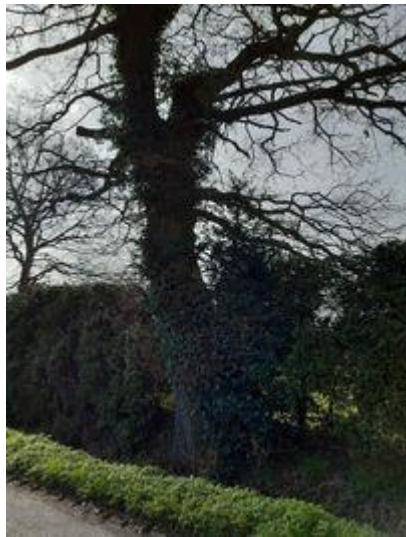
BR396	Veteran oak, small crevices in upper limbs. Located in leylandii hedgerow. Near pond for foraging.	Low

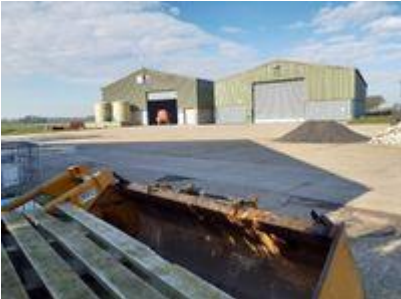
Bat roost feature reference	Notes	Habitat suitability	Photographs
BR397	4x barns - exposed internal timbers, but small cracks and crevices under the flashing suitable for temporary roosts.	Low

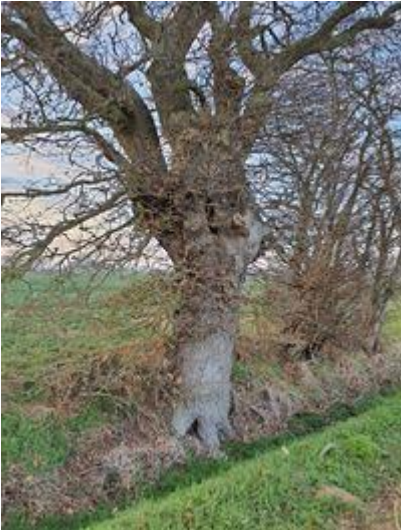
A photograph showing four green metal barns with large doors, situated in an open area. In the foreground, there is a wooden structure, possibly a boat or a large crate, partially visible.
BR398	Mature oak with small knot hole and crevices. Isolated in landscape.	Low

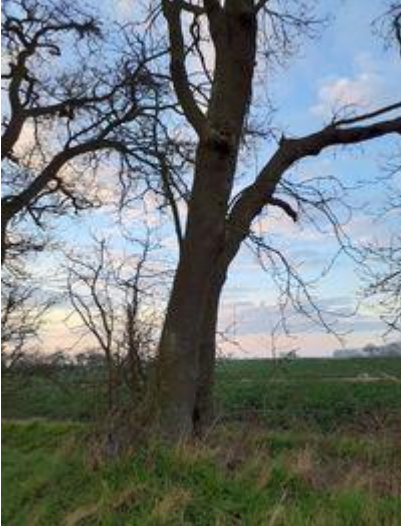
Bat roost feature reference	Notes	Habitat suitability	Photographs
BR401	Mature ash, woodpecker hole in bole. Isolated in landscape.	Low

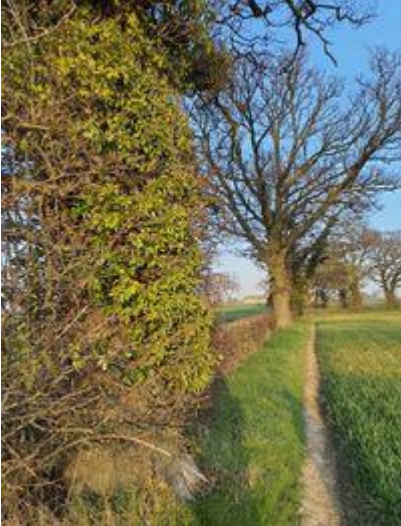
Bat roost feature reference	Notes	Habitat suitability	Photographs
BR403	3x mature oaks, ivy-clad with potential PRFs present underneath. Isolated in landscape.	Low

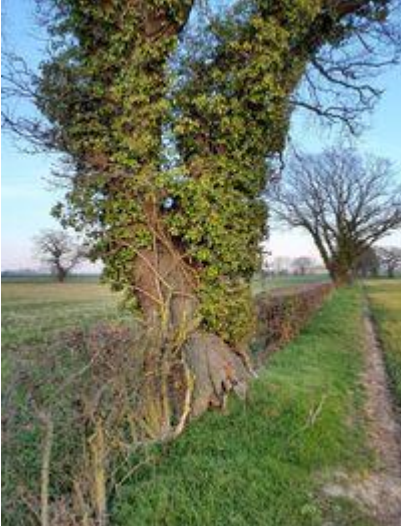
Bat roost feature reference	Notes	Habitat suitability	Photographs
BR405	Mature oak with cracks in dead limbs and ivy-clad. Isolated in landscape.	Low

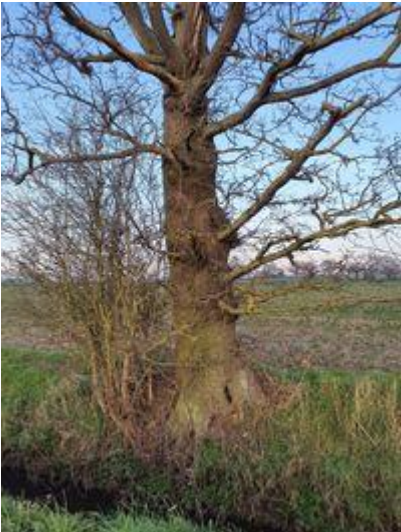
BR406	Mature oak with exposed dead limb. Isolated in landscape.	Low

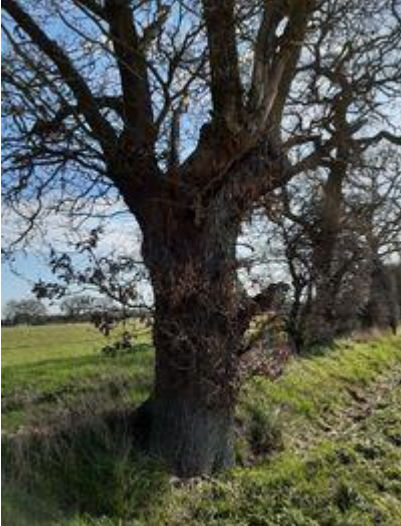
Bat roost feature reference	Notes	Habitat suitability	Photographs
BR409	Veteran oak with cavity under bark and cracks in dead limbs. Good foraging and roosting into woodland to east.	Moderate

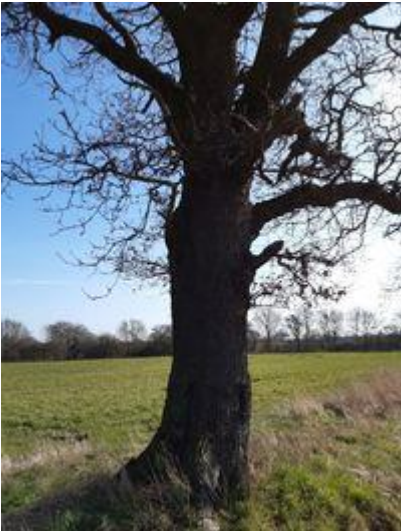
BR410	Mature isolated oak tree, no obvious PRFs.	Negligible

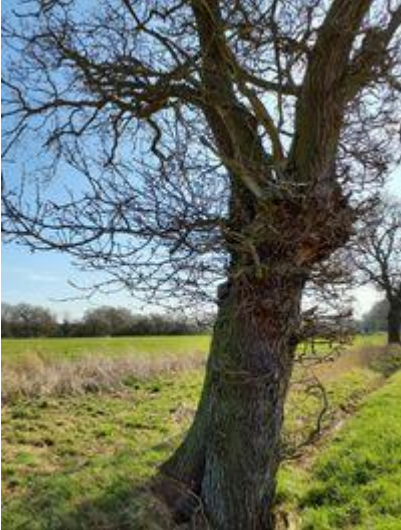
Bat roost feature reference	Notes	Habitat suitability	Photographs
BR411	<p>Veteran oak with holes and crevices which may provide roosting habitat. However relatively isolated in landscape, although close to woodland.</p>	Low

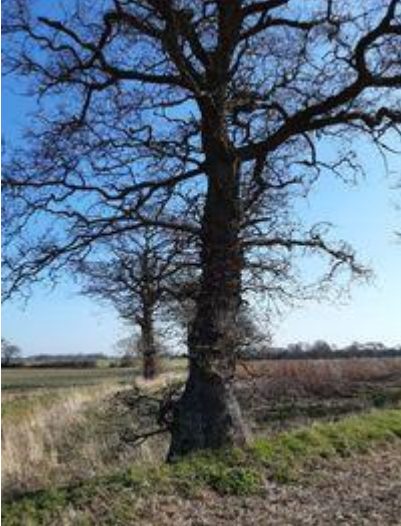
Bat roost feature reference	Notes	Habitat suitability	Photographs
BR413	Mature oak with small cracks in trunk. Isolated in landscape	Low

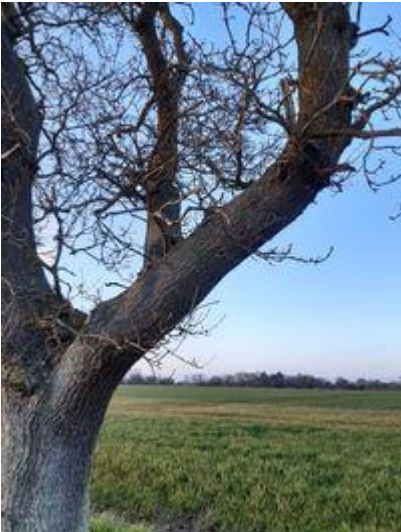
BR414	Mature oak tree with small crevices, but isolated in landscape.	Low

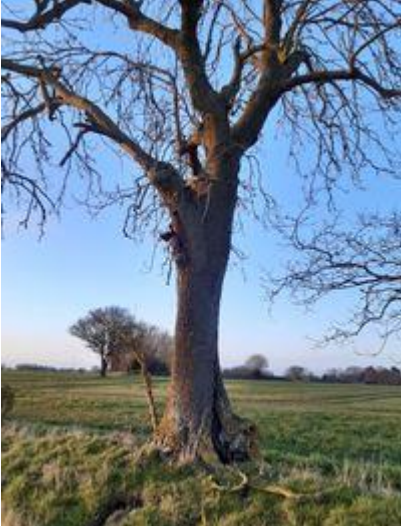
Bat roost feature reference	Notes	Habitat suitability	Photographs
BR415	Mature ash tree with woodpecker hole, but isolated in landscape.	Low

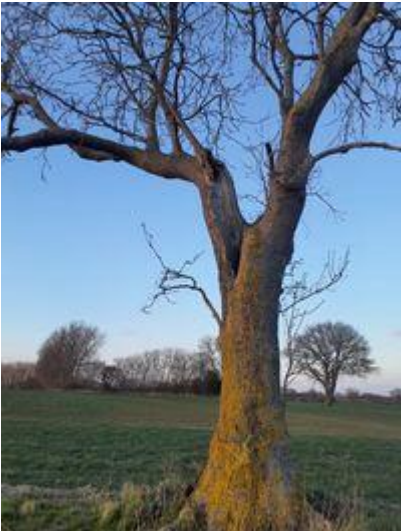
BR416	Oak tree with large cavity in centre, potential roosting habitat for bats. However, isolated in landscape with no connectivity to other habitat.	Low

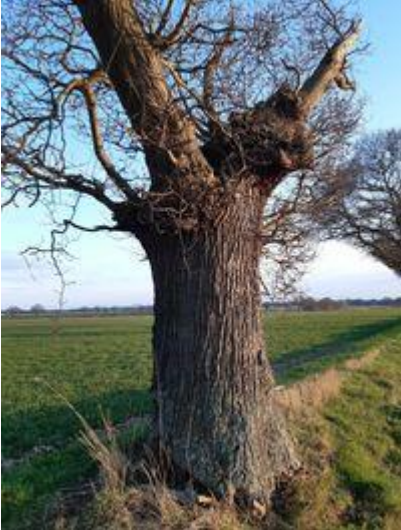
Bat roost feature reference	Notes	Habitat suitability	Photographs
BR417	Large cavity inside trunk, but exposed to elements. Isolated in landscape.	Low

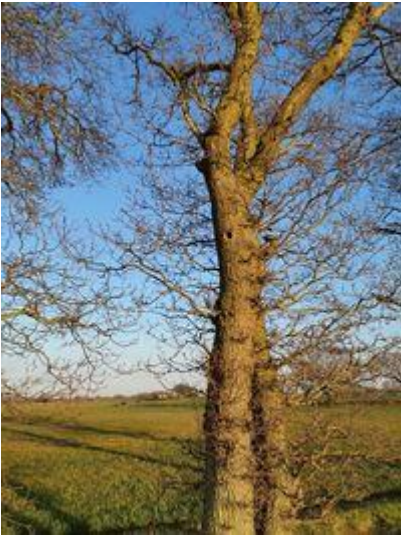
BR418	Oak tree with woodpecker hole which may provide some roosting habitat. Low connectivity to surrounding landscape.	Low

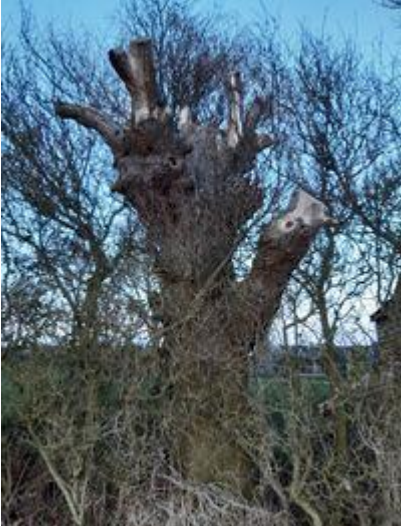
Bat roost feature reference	Notes	Habitat suitability	Photographs
BR419	Dead oak with multiple crevices, part of hedgerow network with moderate connectivity.	Moderate

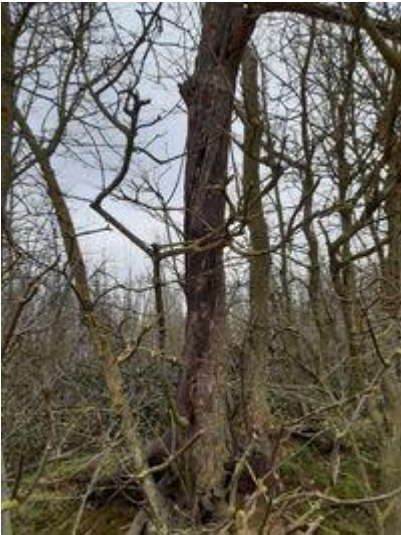
BR424	Dead sycamore with large scars in trunk, holes in woodland, with drains nearby providing good connecting habitat.	Moderate

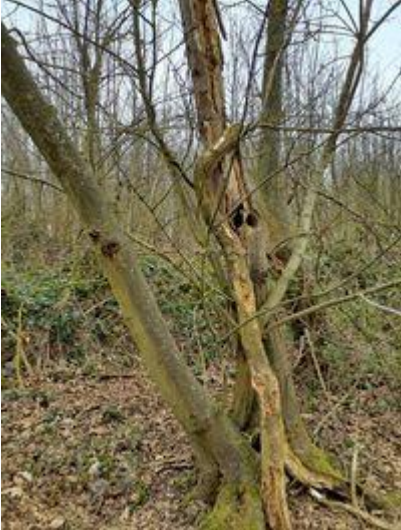
Bat roost feature reference	Notes	Habitat suitability	Photographs
BR425	Tree with dead branches and cavities providing potential for roosting habitat within woodland, with good connectivity to wider landscape.	Moderate

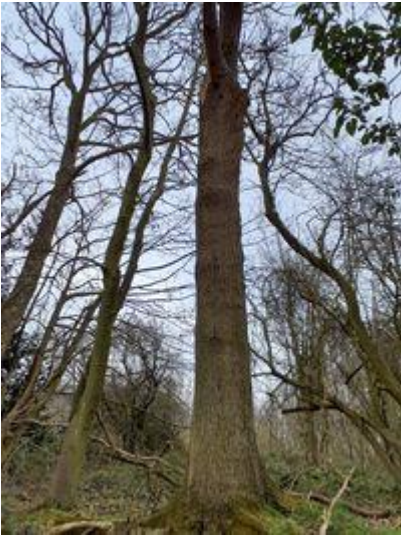
BR426	Dead oak tree with woodpecker holes and cavity in one side (not visible in photo). Potential roosting habitat, part of woodland with good connectivity to commuting and foraging habitat in wider landscape.	Moderate

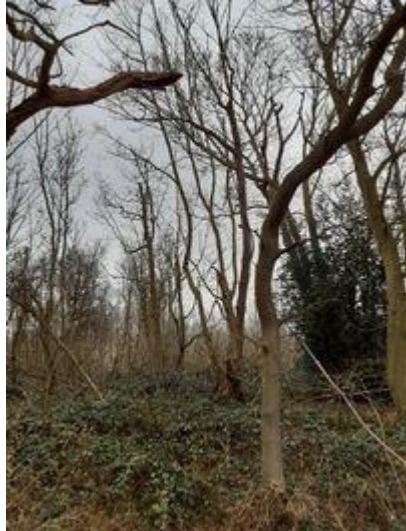
Bat roost feature reference	Notes	Habitat suitability	Photographs
BR427	Dead sycamore x2, with large knot holes/scars in trunks, in woodland, with drains nearby providing good connecting habitat.	Moderate

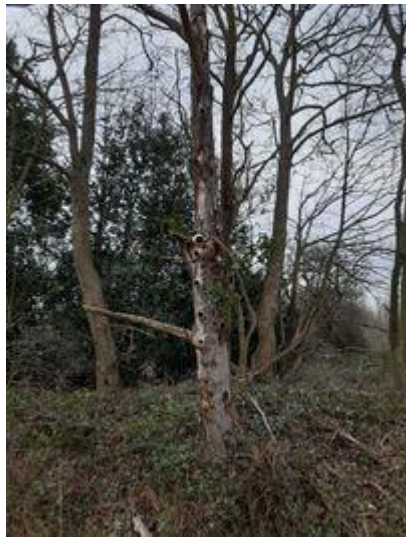
BR428	Dead sycamore with large knot holes in woodland, with drains nearby therefore good connecting habitat.	Moderate

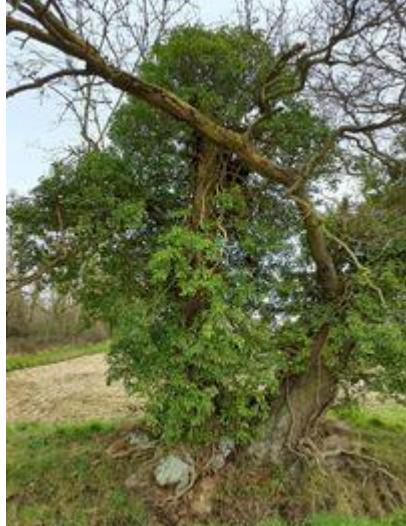
Bat roost feature reference	Notes	Habitat suitability	Photographs
BR429	Ivy-covered veteran oak tree with cavity in one limb. Potential for larger bat roost which is well connected to wider habitat and adjacent to woodland.	Moderate

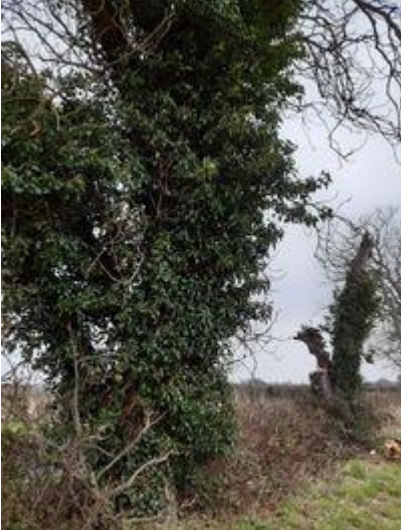
Bat roost feature reference	Notes	Habitat suitability	Photographs
BR433	Mature ivy clad sycamore, no obvious PRFs but ivy may provide some. Moderate connecting habitat to woodland to east. Dead sycamore with new PRFs adjacent.	Low

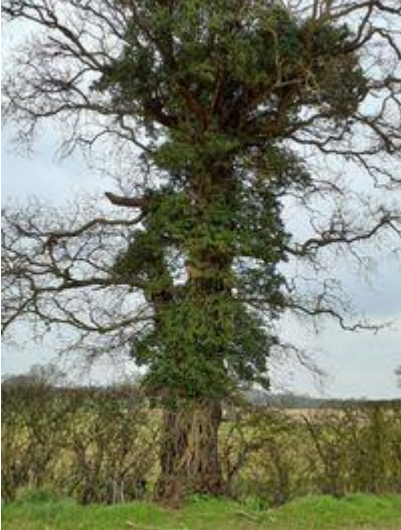
BR434	Mature oak tree with significant ivy cover and branch cavity. Provides potential roosting habitat with connectivity to woodland and wider landscape.	Moderate

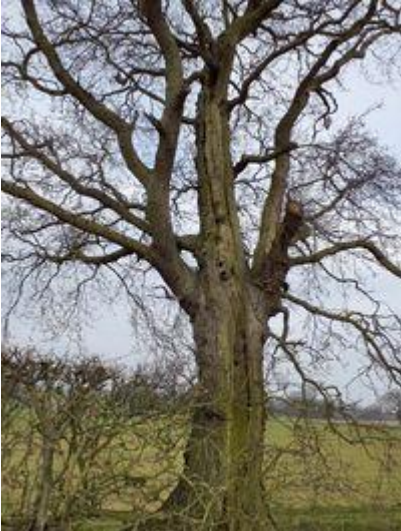
Bat roost feature reference	Notes	Habitat suitability	Photographs
BR435	Mature oak tree within hedgerow with good connectivity to wider landscape and woodland. No ivy cover, but small holes and cavities.	Low

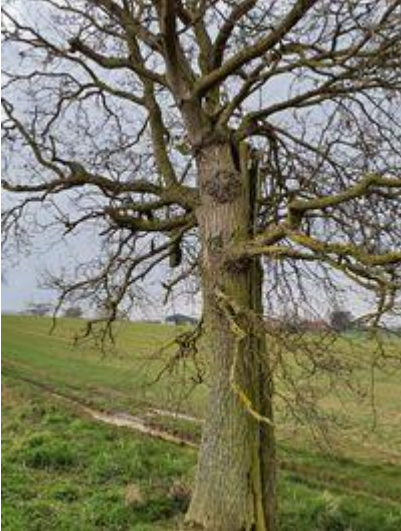
BR436	Veteran oak with significant central cavity providing potential large capacity bat roost habitat with reasonable connectivity to wider landscape including woodland.	Moderate

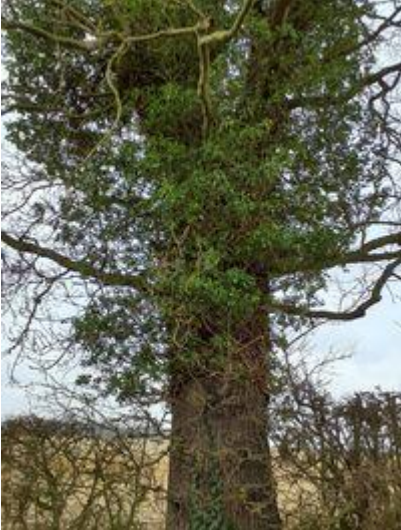
Bat roost feature reference	Notes	Habitat suitability	Photographs
BR437	Mature oak, significant ivy cover, within hedgerow with good connectivity to woodland and wider landscape.	Low

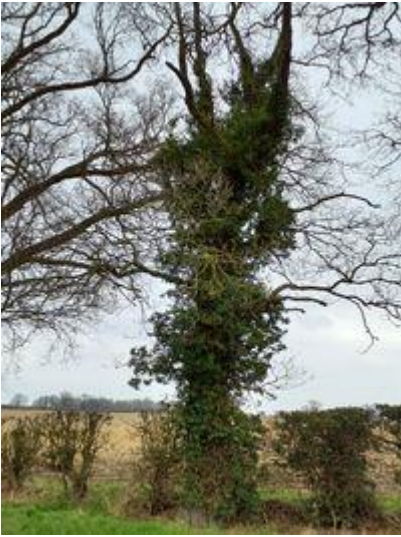
BR438	Mature oak with significant ivy cover, part of hedgerow with good connectivity to wider landscape including some woodland.	Low

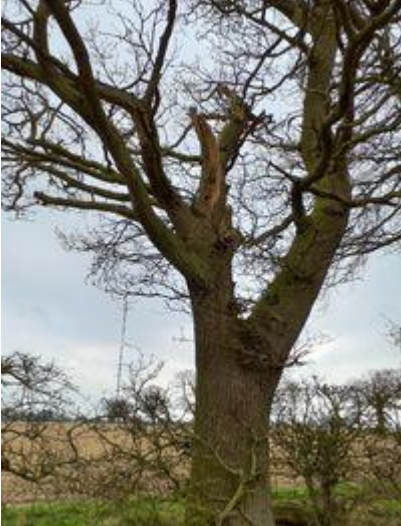
Bat roost feature reference	Notes	Habitat suitability	Photographs
BR439	Mature oak with cavity, part of hedgerow with good connectivity to wider landscape.	Moderate

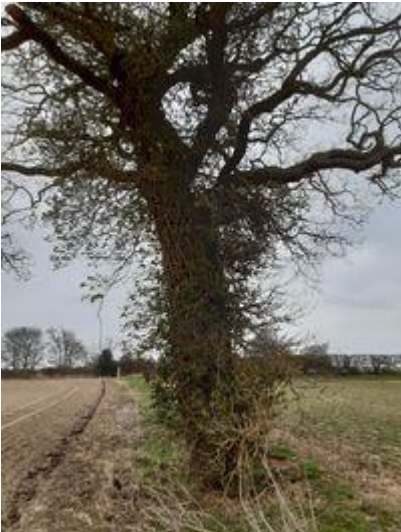
BR440	Mature ivy clad oak no obvious PRFs but ivy may provide some. No surrounding habitat, but watercourse to west.	Low

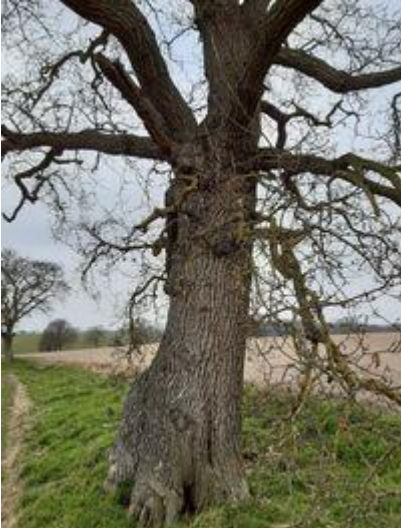
Bat roost feature reference	Notes	Habitat suitability	Photographs
BR441	Mature oak, no visible PRFs and isolated. Note watercourse to west (300m).	Negligible

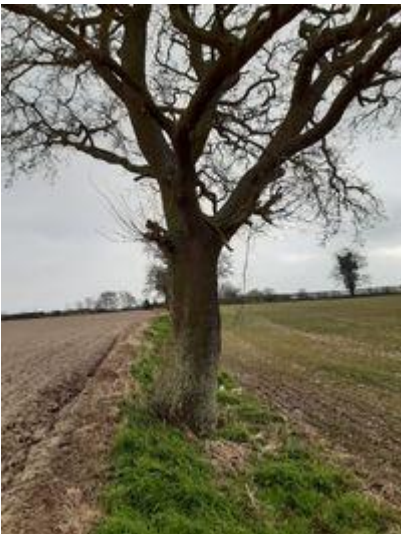
BR442	Mature oak, no visible PRFs and isolated. Note watercourse to west (200m).	Negligible

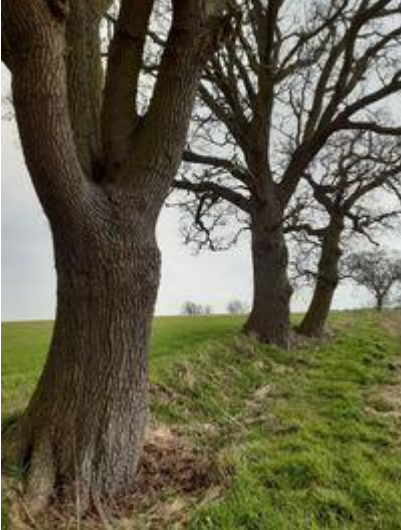
Bat roost feature reference	Notes	Habitat suitability	Photographs
BR443	3x mature oaks, no visible PRFs, and isolated, although watercourse to west.	Low

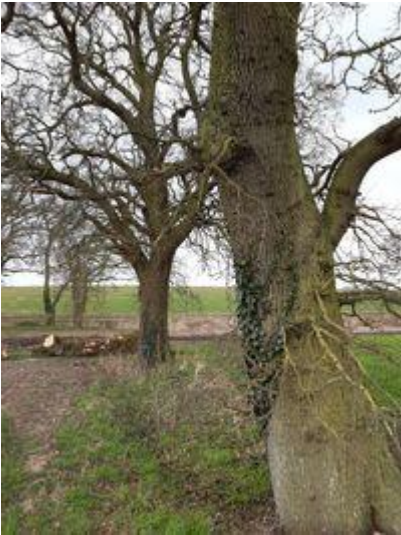
A photograph showing three large, mature oak trees in a grassy field. The trees are bare, suggesting a winter or late autumn setting. The ground is covered in green grass and some brown leaves. The sky is overcast.
BR444	2x mature oaks, no visible PRFs, and isolated, although watercourse to west.	Low

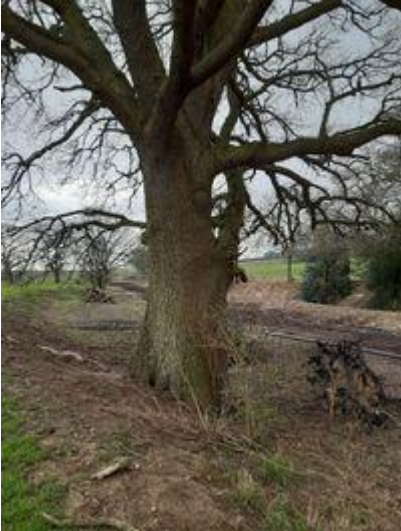
Bat roost feature reference	Notes	Habitat suitability	Photographs
BR445	Mature oak, no visible PRFs, and isolated, although watercourse adjacent.	Low

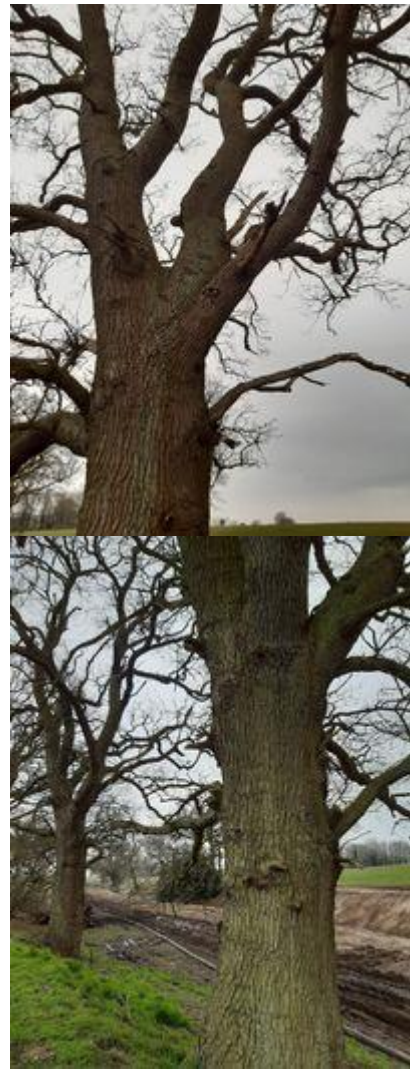
Bat roost feature reference	Notes	Habitat suitability	Photographs
BR446	2x mature oaks, 1 visible PRF (small hole in limb and isolated, although watercourse to west).	Low

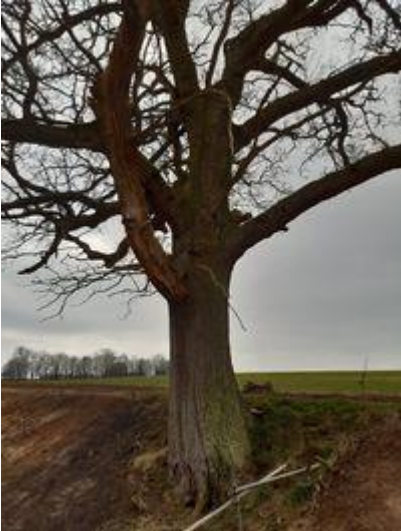
Bat roost feature reference	Notes	Habitat suitability	Photographs
BR447	Mature oak, small PRFs in dead limb, and isolated, although watercourse adjacent.	Low

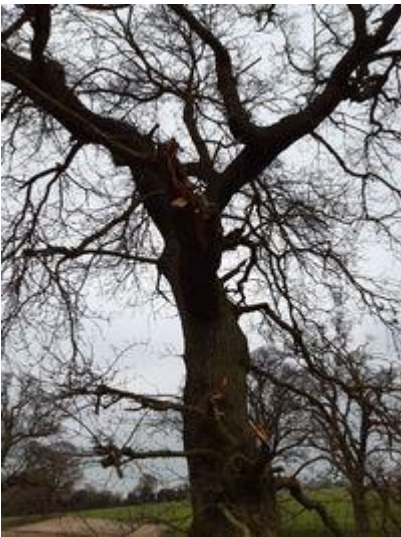
BR448	Mature oak, small PRFs in dead limb, and isolated, although watercourse adjacent.	Low

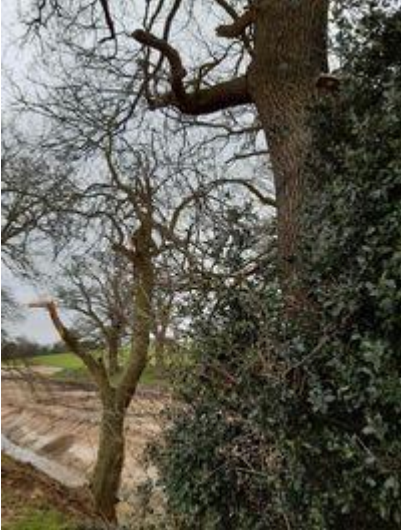
Bat roost feature reference	Notes	Habitat suitability	Photographs
BR449	Mature oak and mature ash, small PRFs in dead limbs, and isolated, although watercourse adjacent.	Low

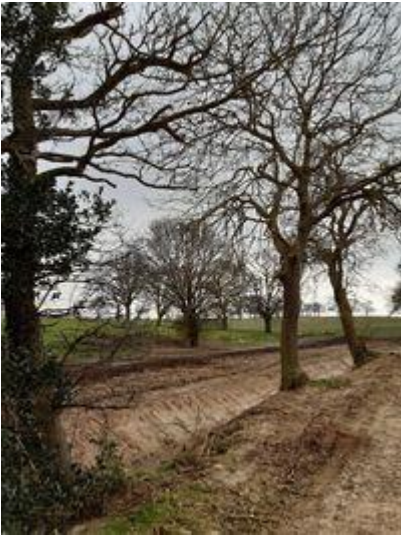
BR450	3x mature ash trees, no visible PRFs and isolated, although watercourse to west.	Negligible

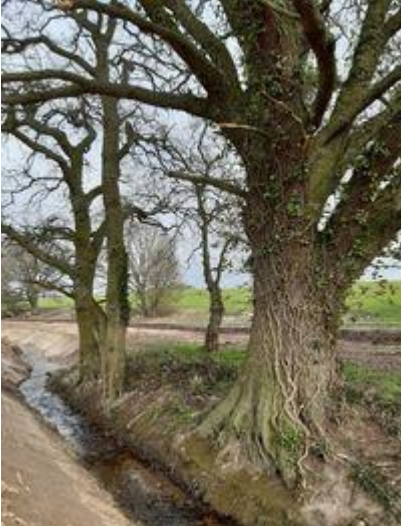
Bat roost feature reference	Notes	Habitat suitability	Photographs
BR451	4x mature oak trees, no visible PRFs and isolated, although watercourse adjacent.	Negligible

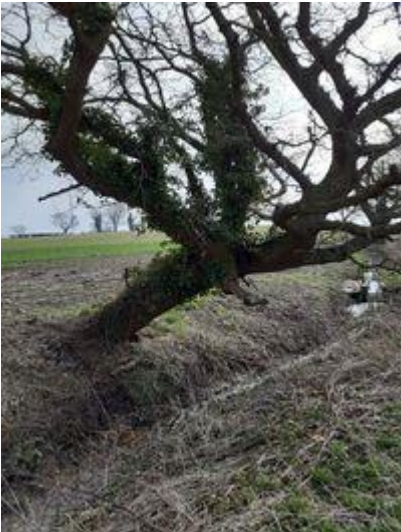
BR452	Mature oak overhanging stream. Small PRFs in dead limbs. Stream provides connectivity, but no vegetation.	Low

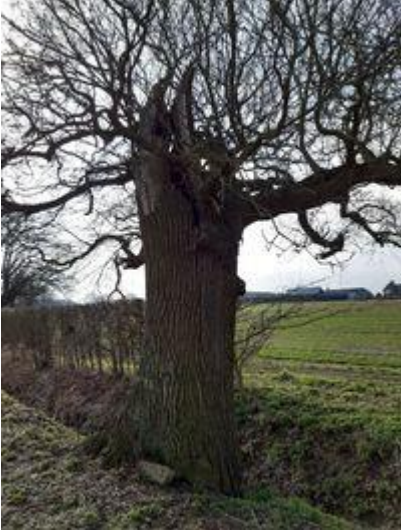
Bat roost feature reference	Notes	Habitat suitability	Photographs
BR453	<p>Veteran oak, with large hollow central cavity. Adjacent to stream and hedgerow, and woodland away to north. Could support larger roost.</p>	Moderate

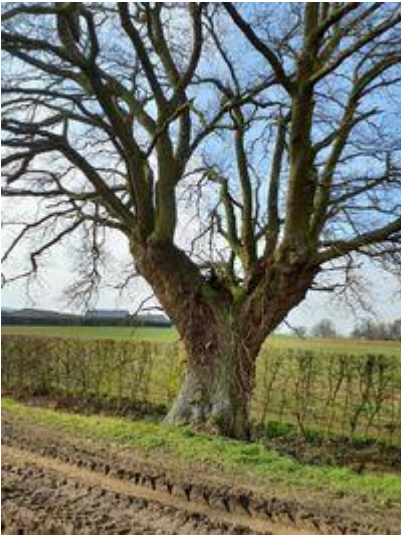
BR454	<p>Veteran oak tree with large cavity in centre. Part of hedgerow providing connectivity to wider landscape including woodland. Potential for larger capacity roost.</p>	Moderate

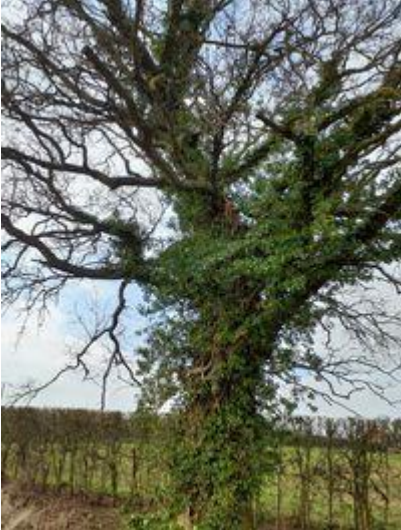
Bat roost feature reference	Notes	Habitat suitability	Photographs
BR455	Mature oak with significant ivy cover. Crevices may provide roosting habitat, within hedgerow providing connectivity to wider landscape including woodland.	Moderate

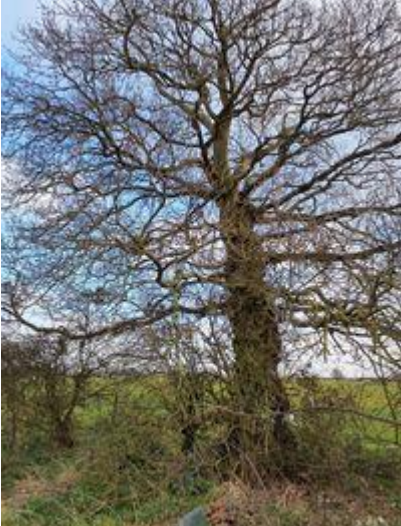
Bat roost feature reference	Notes	Habitat suitability	Photographs
BR457	Oak tree with some crevices, and some holes. Within hedgerow providing some connectivity to wider landscape.	Low

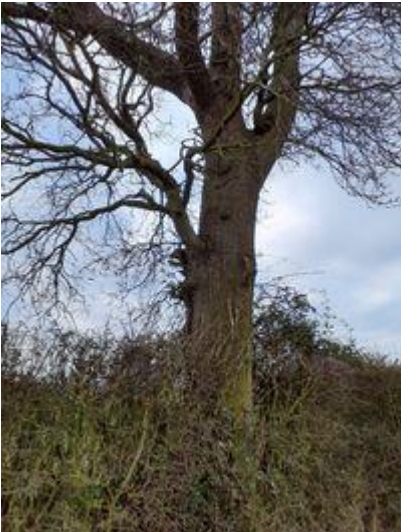
BR458	Mature oak tree with crevices in trunk and woodpecker hole, providing potential bat roosting habitat. Located within hedgerow providing some connectivity to wider landscape.	Low

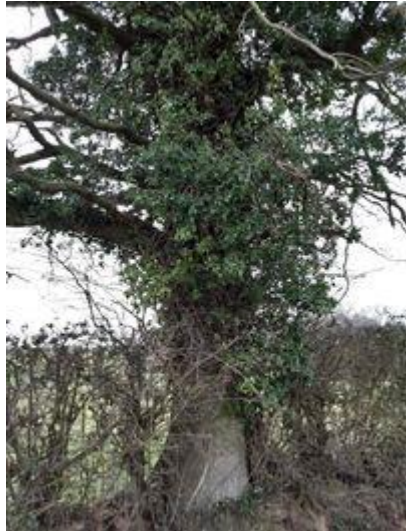
Bat roost feature reference	Notes	Habitat suitability	Photographs
BR459	Veteran oak with dense ivy, could provided limited PRFs. Good lake and ditch foraging nearby.	Low

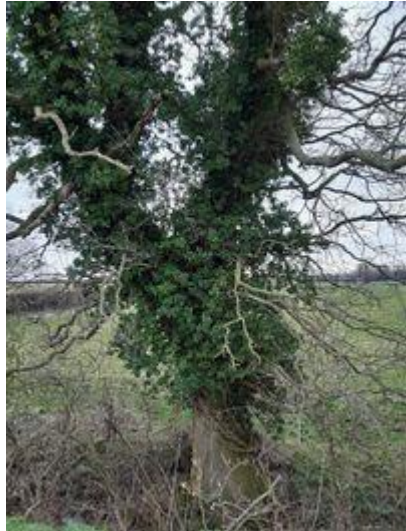
BR460	Veteran oak with dense ivy, could provided extensive PRFs. Good lake and ditch foraging nearby.	Moderate

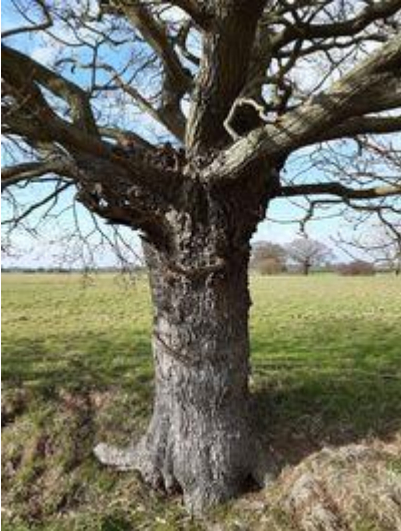
Bat roost feature reference	Notes	Habitat suitability	Photographs
BR461	Veteran oak huge but exposed cavity inside, suitable for large roost. However tree is isolated.	Moderate

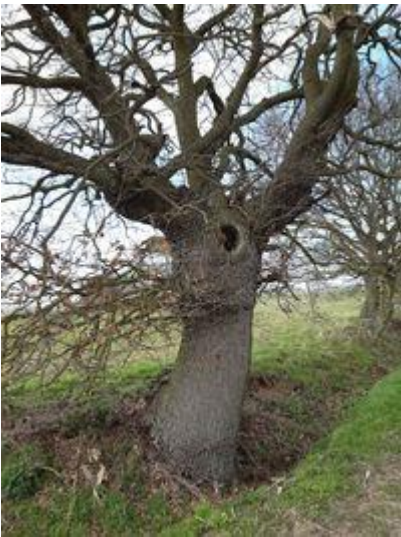
BR462	Mature oak, moderate cavity, but isolated - nearby woodland has minimal roosting features.	Low
