NORTH FALLS

Offshore Wind Farm

Appendix 23.1 Extended Phase 1 Habitat
Survey Report (Part 3 of 3)

Document Reference:	3.3.30
Volume:	3.3
APFP Regulation:	5(2)(a)
Date:	July 2024
Revision:	0

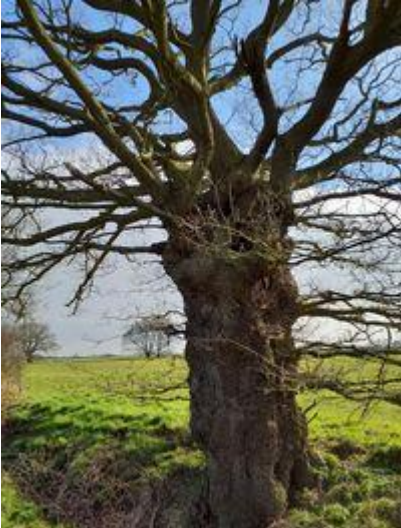
Bat roost feature reference	Notes	Habitat suitability	Photographs
BR463	<p>Veteran oak tree with a hole in trunk potentially providing roosting opportunities. However, poorly connected to wider landscape.</p>	Low

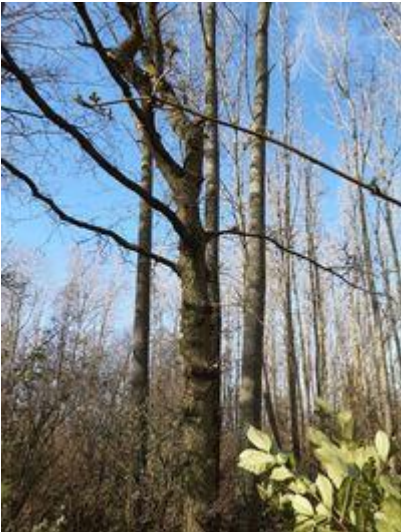
BR464	<p>Mature oak with woodpecker holes, in woodland and adjacent to ditches providing connecting habitat.</p>	Moderate

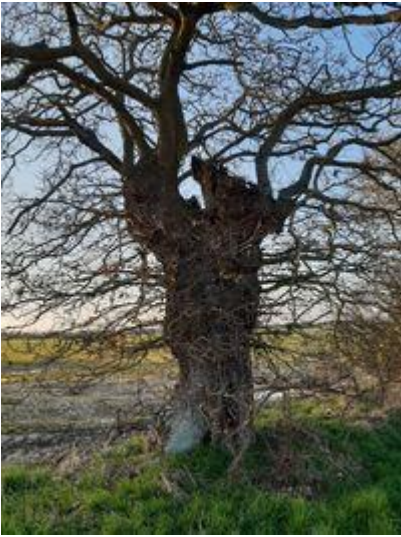
BR468	<p>Veteran oak, large cavities capable of supporting large roosts. Some limited commuting habitat to the south.</p>	Moderate

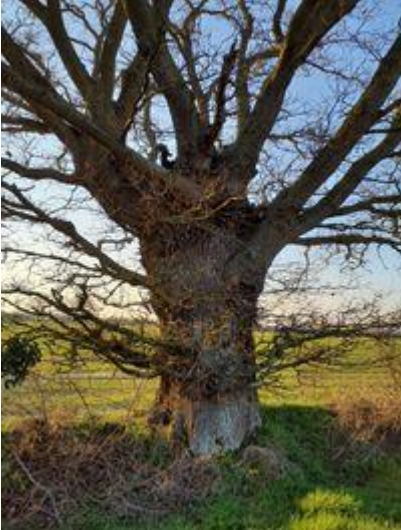
Bat roost feature reference	Notes	Habitat suitability	Photographs
BR469	Veteran oak tree with crevices, potential large bat roosting habitat with connectivity to wider habitat within hedgerow.	Moderate

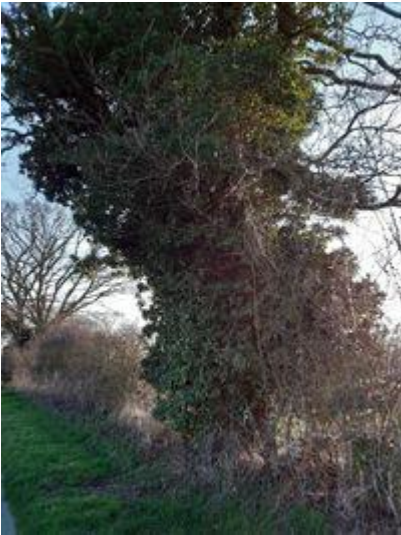
BR470	Veteran oak, covered in ivy, with potential PRFs beneath, connecting habitat of scrub to south.	Moderate

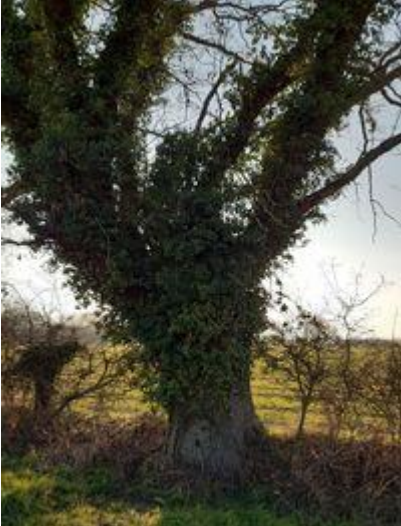
Bat roost feature reference	Notes	Habitat suitability	Photographs
BR471	Veteran oak, covered in ivy, but limited PRFs underneath, connecting habitat of scrub to south.	Low

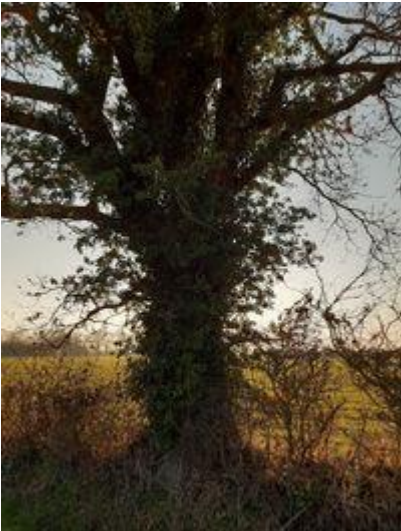
BR472	Veteran oak, covered in ivy, but limited PRFs underneath, connecting habitat of scrub to south.	Low

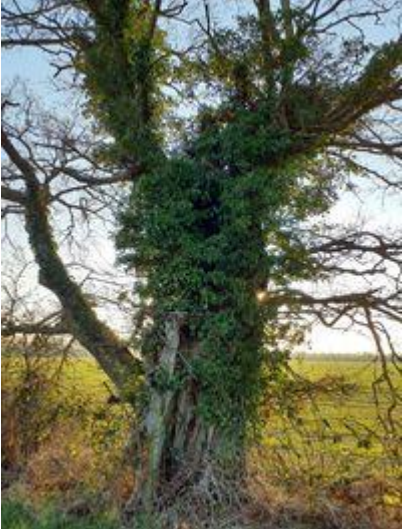
Bat roost feature reference	Notes	Habitat suitability	Photographs
BR473	<p>Veteran oak tree with large cavity and ivy cover, potential roosting habitat within a hedgerow providing commuting and foraging connectivity to wider landscape.</p>	Moderate

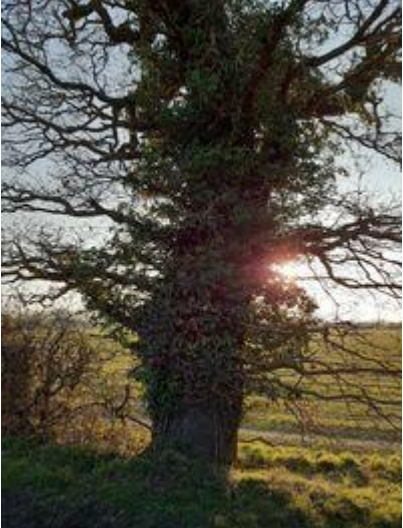
BR474	<p>Veteran oak, covered in ivy, but limited PRFs underneath, connecting habitat of scrub to south.</p>	Low

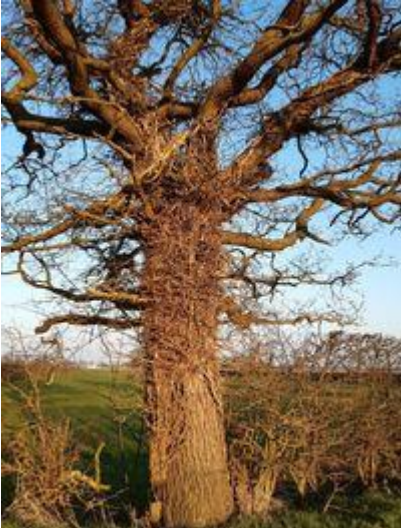
Bat roost feature reference	Notes	Habitat suitability	Photographs
BR475	Veteran oak, covered in dead ivy, but limited PRFs underneath, connecting habitat of scrub to south.	Low

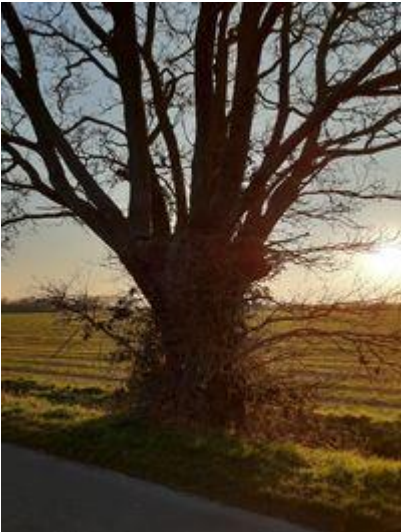
BR476	Veteran oak, covered in ivy, and with limited cavities underneath, connecting habitat of scrub to south.	Low

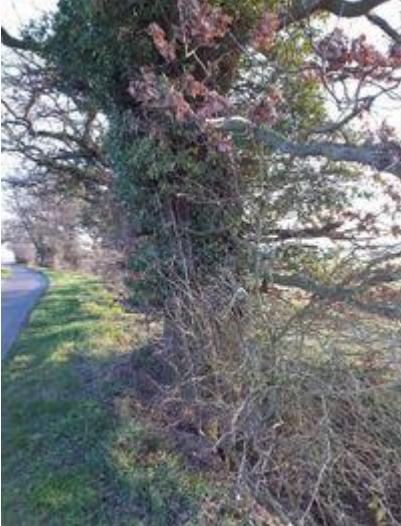
Bat roost feature reference	Notes	Habitat suitability	Photographs
BR477	Veteran oak, covered in ivy, and with limited cavities underneath, connecting habitat of scrub to south.	Low

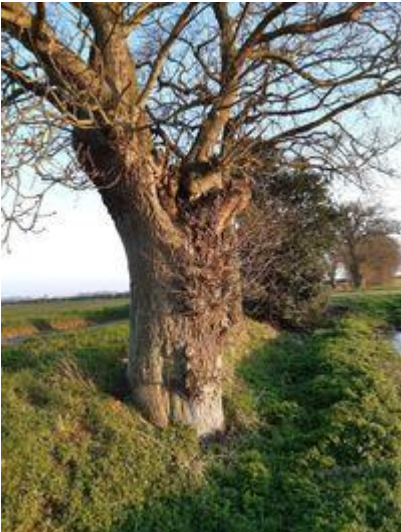
BR478	Veteran oak, with limited cavities connecting habitat of hedgerow to south.	Low

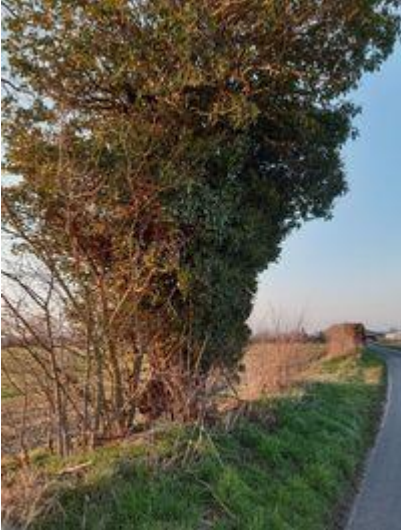
Bat roost feature reference	Notes	Habitat suitability	Photographs
BR479	Veteran oak, with ivy providing PRFs. Limited connectivity.	Low

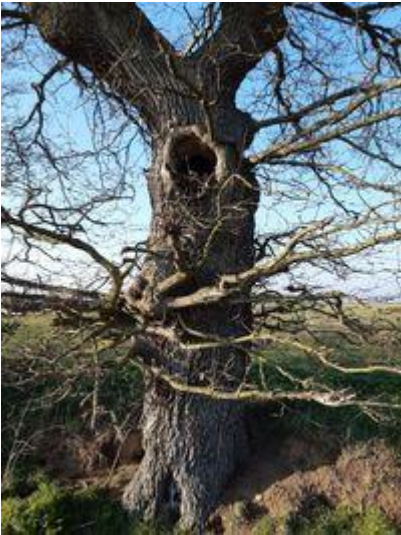
BR480	Veteran oak, large cavities capable of supporting large roosts. However isolated from commuting habitat.	Low

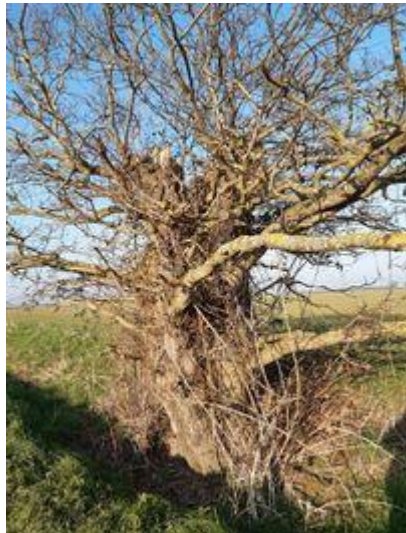
Bat roost feature reference	Notes	Habitat suitability	Photographs
BR481	Veteran oak, large cavities capable of supporting large roosts. However isolated from commuting habitat.	Low

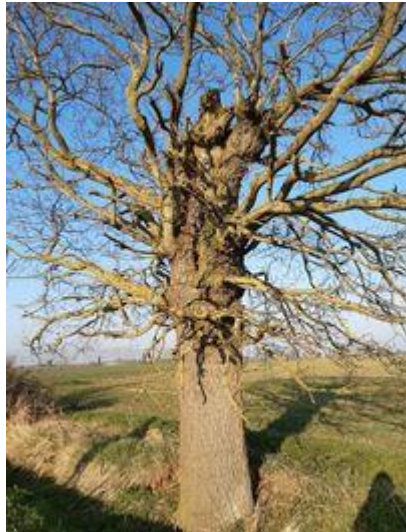
BR482	Veteran oak, large cavities capable of supporting large roosts. However isolated from commuting habitat.	Low

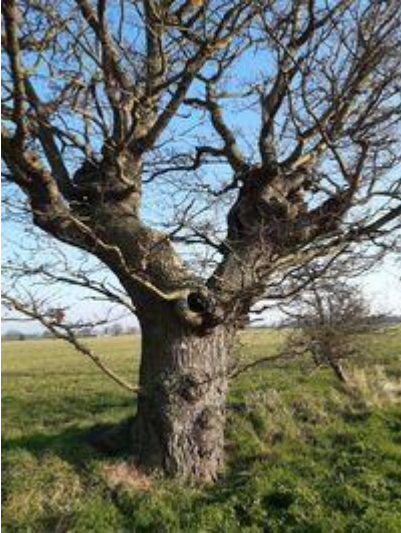
Bat roost feature reference	Notes	Habitat suitability	Photographs
BR483	<p>Veteran oak, large cavities capable of supporting large roosts. More isolated than adjacent tree to the north.</p>	<p>Moderate</p>

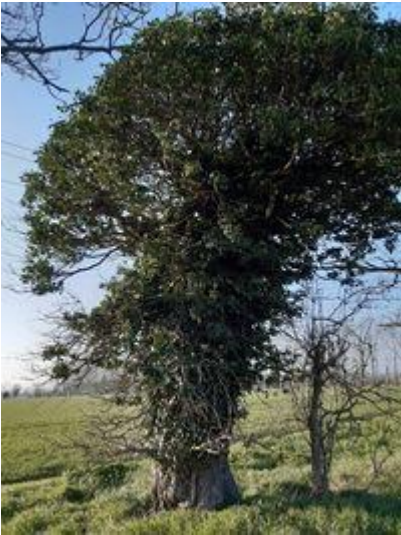
BR484	<p>Veteran oak, covered with ivy - potential PRFs under ivy. More isolated than adjacent tree to north.</p>	<p>Low</p>

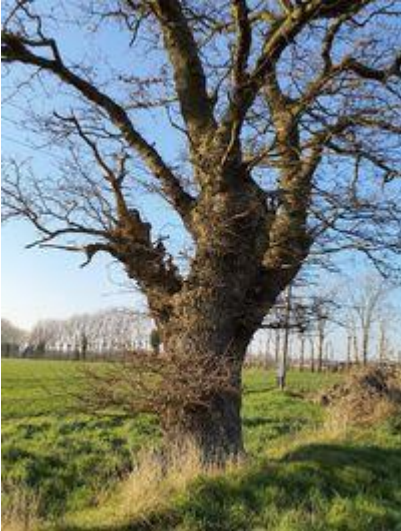
Bat roost feature reference	Notes	Habitat suitability	Photographs
BR485	<p>Veteran oak tree with crevices. Potential larger bat roosting site with connectivity to other commuting and foraging habitat within wider landscape.</p>	Moderate

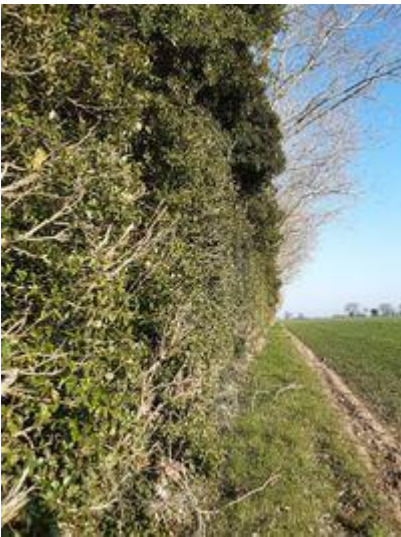
BR486	<p>Line of mature black poplar with ivy, all with low bat potential with small crevices underneath the ivy.</p>	Low

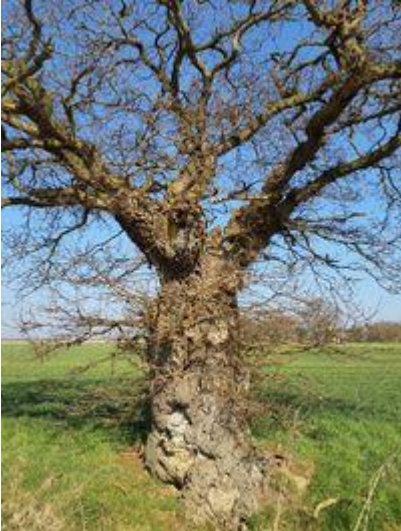
Bat roost feature reference	Notes	Habitat suitability	Photographs
BR487	<p>Veteran oak tree, cavity in centre and scar down trunk. Potential large roosting habitat, however isolated in landscape.</p>	Moderate

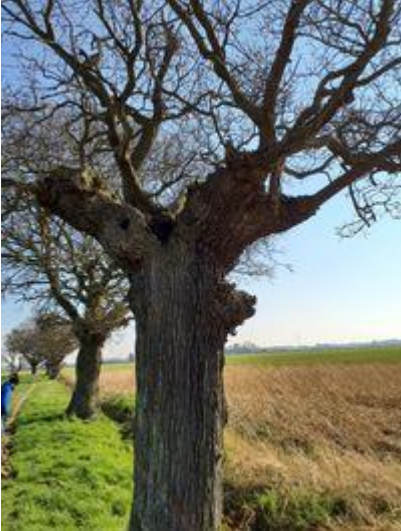
BR488	<p>Veteran oak tree, potential cavity inside which may provide capacity for larger bat roosting habitat. Isolated in landscape.</p>	Moderate

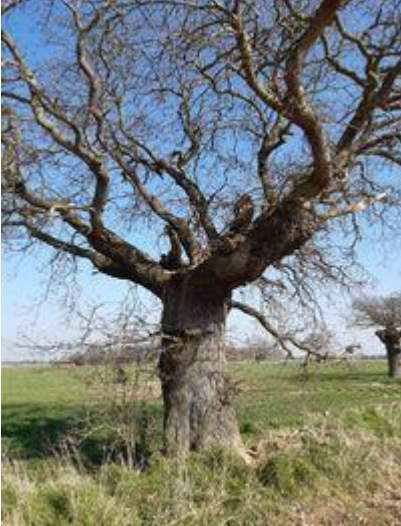
Bat roost feature reference	Notes	Habitat suitability	Photographs
BR489	Veteran oak, decaying bark around limbs provides crevices, suitable for small roosts. Isolated.	Low

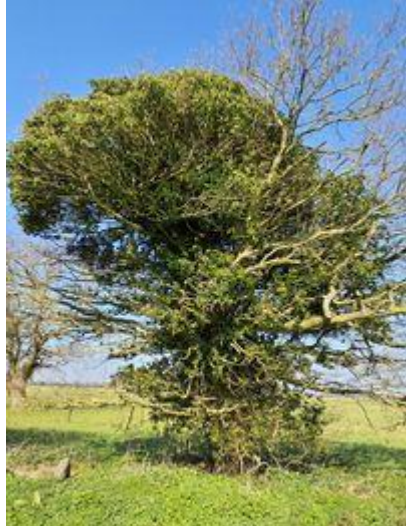
Bat roost feature reference	Notes	Habitat suitability	Photographs
BR491	Oak tree with significant ivy cover, potential for roosting habitat underneath ivy. Low connectivity to surrounding landscape	Moderate

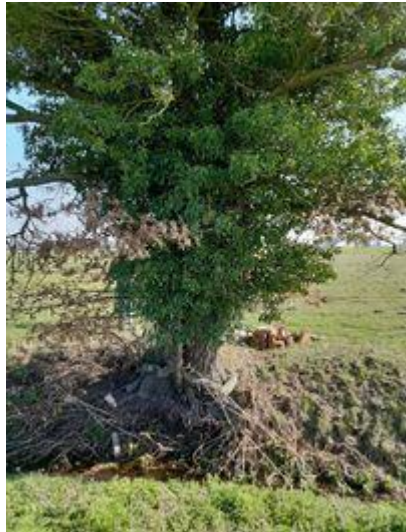
BR492	Veteran isolated oak, ivy provides for opportunistic roosting.	Low

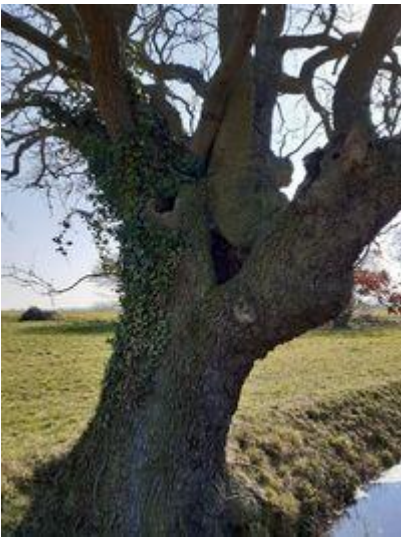
BR494	Veteran oak, large open cavity in centre, suitable for larger roost. Isolated, but ditch provides some nearby foraging habitat.	Moderate

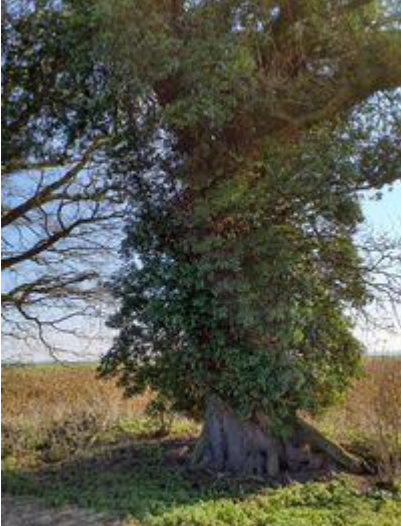
Bat roost feature reference	Notes	Habitat suitability	Photographs
BR495	Mature oak tree covered in mature ivy. Potential for extensive roosting habitat below ivy. Isolated in landscape.	Moderate

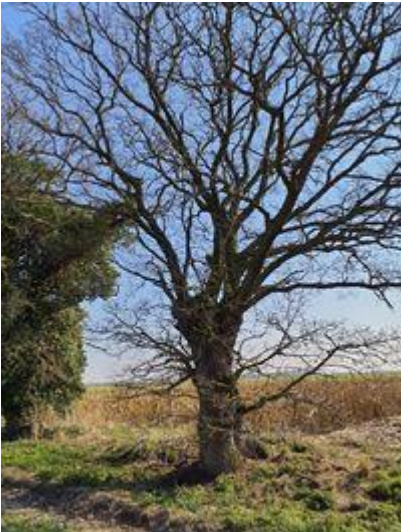
BR496	Mature oak tree with some crevices. Isolated in landscape.	Low

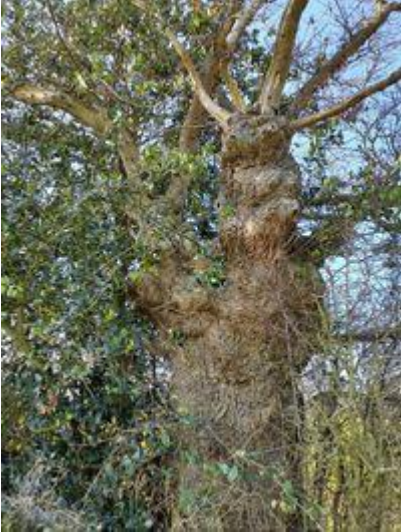
Bat roost feature reference	Notes	Habitat suitability	Photographs
BR497	Mature oak tree, potential for extensive roost space underneath retained bark. In a mature tree line connected to plantation woodland.	Moderate

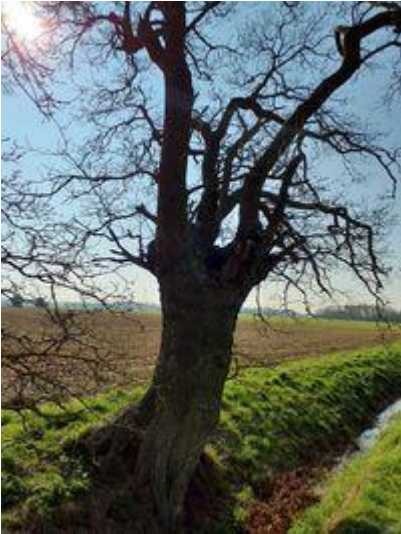
BR498	Veteran oak tree with cavity inside, therefore potential capacity for large roost. However, very isolated in landscape, so limited connectivity to supporting habitat.	Low

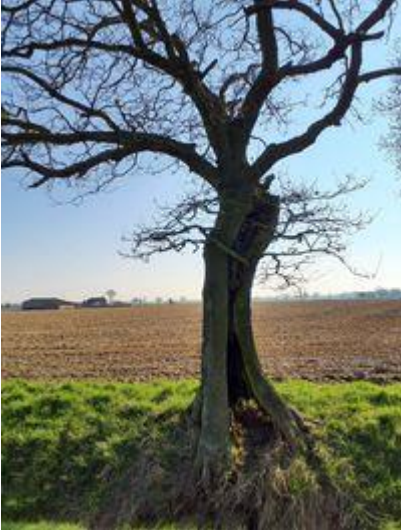
Bat roost feature reference	Notes	Habitat suitability	Photographs
BR499	<p>Veteran oak tree with cavity inside, therefore potential capacity for large roost. However, very isolated in landscape, so limited connectivity to supporting habitat.</p>	Low

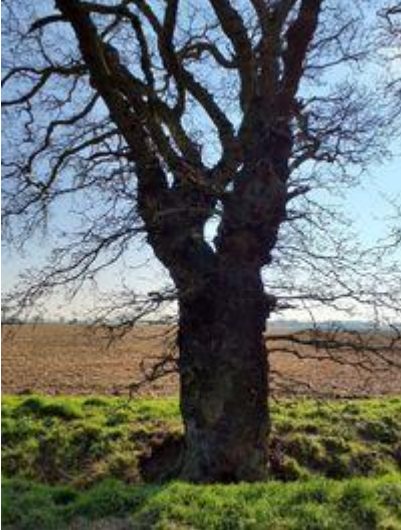
BR500	<p>Veteran oak tree with cavity inside, therefore potential capacity for large roost. However, very isolated in landscape, so limited connectivity to supporting habitat.</p>	Low

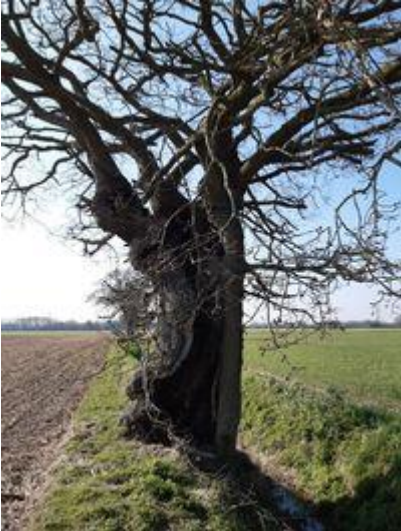
Bat roost feature reference	Notes	Habitat suitability	Photographs
BR501	<p>Veteran oak tree, huge open cavity, exposed to the elements but with multiple roosting opportunities. However very isolated, with no nearby suitable foraging/commuting habitat.</p>	Low

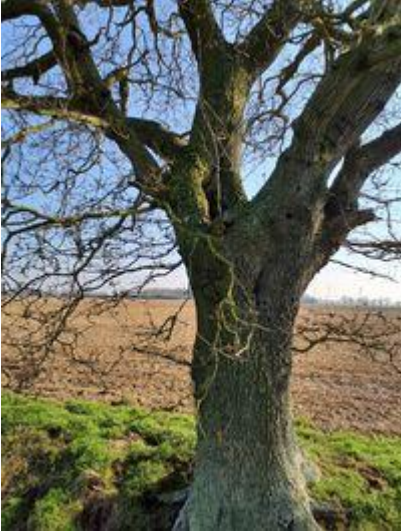
BR502	<p>Veteran oak tree with cavity inside, therefore potential capacity for large roost. However, very isolated in landscape, so limited connectivity to supporting habitat. Epiphytic hawthorn growing out of cavity.</p>	Low

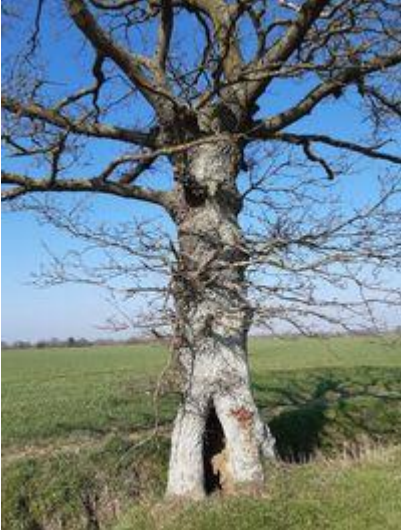
Bat roost feature reference	Notes	Habitat suitability	Photographs
BR503	<p>Veteran oak tree, cavity exposed to the elements. However very isolated, with no nearby suitable foraging/commuting habitat.</p>	Low

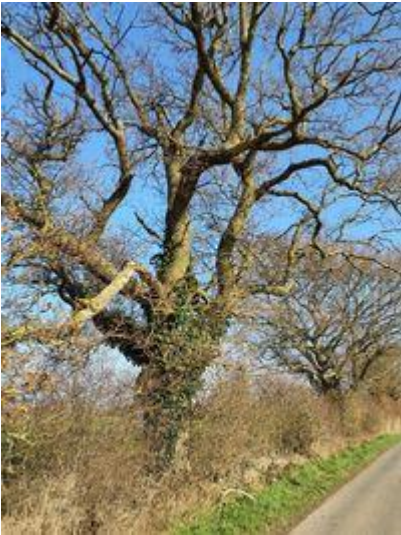
BR504	<p>Mature oak tree with crevices potentially suitable for roosting. Part of a mature hedgerow with good commuting routes from tree.</p>	Low

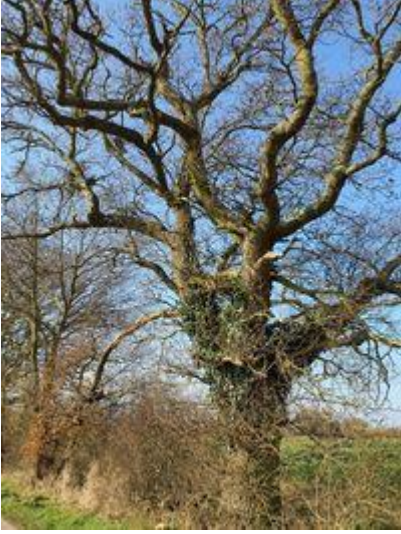
BR505	Veteran oak, with large decay cavity in centre, but open to elements and vulnerable to ground predators. Isolated in landscape.	Low

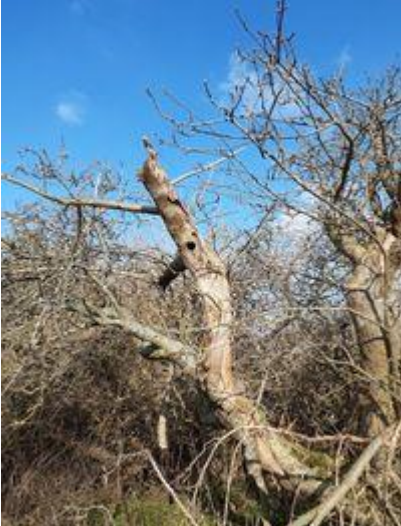
Bat roost feature reference	Notes	Habitat suitability	Photographs
BR506	Old woodpecker hole, in broken willow branch. Exposed to the elements.	Low

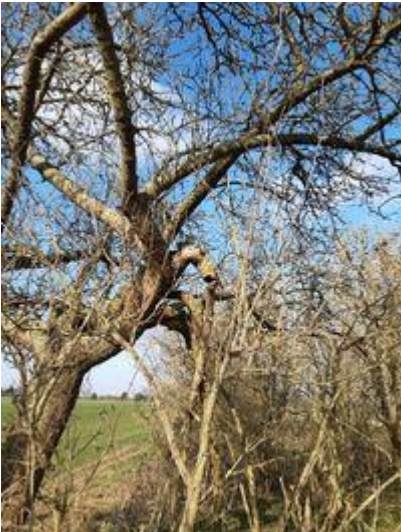
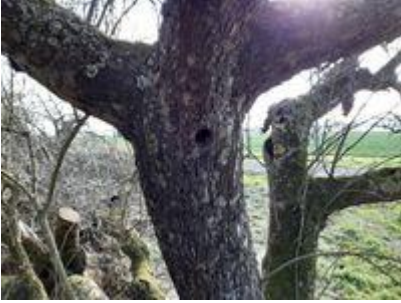
BR507	Old woodpecker hole within mature tree, with larger cavity inside and safe from ground predators. 2x other openings.	Moderate

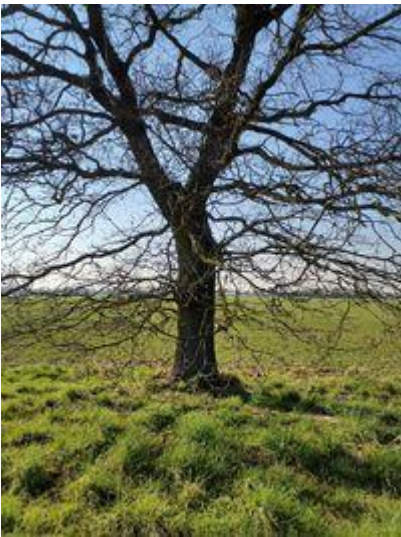
BR508	Mature oak with crevices. However, isolated from surrounding potential habitat features.	Negligible

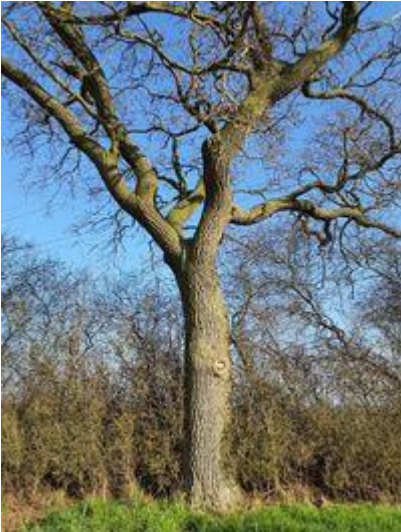
Bat roost feature reference	Notes	Habitat suitability	Photographs
BR509	Mature oak tree with woodpecker hole. Potential for roosting, part of mature hedgerow with links to wider habitat.	Low

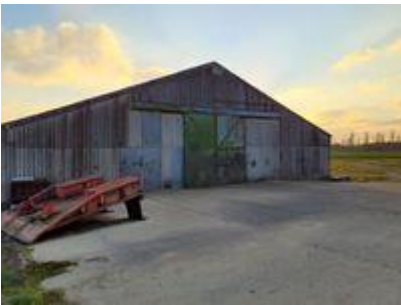
BR510	Large barn, multiple openings around eaves, could not see inside, but potential for summer roosts.	Moderate

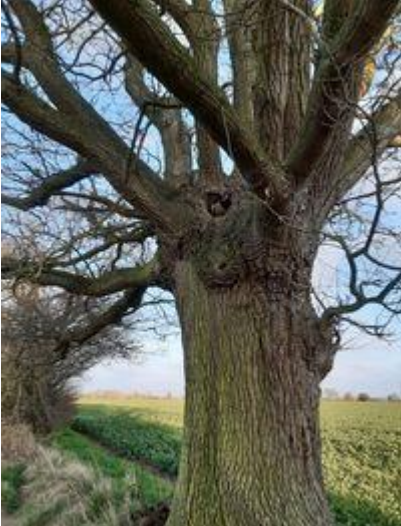
Bat roost feature reference	Notes	Habitat suitability	Photographs
BR511	Mature oak, a number of holes and openings present, although largely isolated landscape.	Low

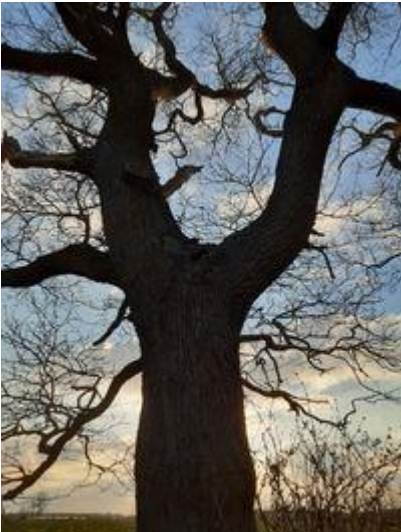
BR512	Mature oak, 2x tiny pipistrelle-sized holes present.	Low
