**NORTH FALLS**

*Offshore Wind Farm*

## **ENVIRONMENTAL STATEMENT**

### Appendix 21.1 Geomorphology Baseline Survey

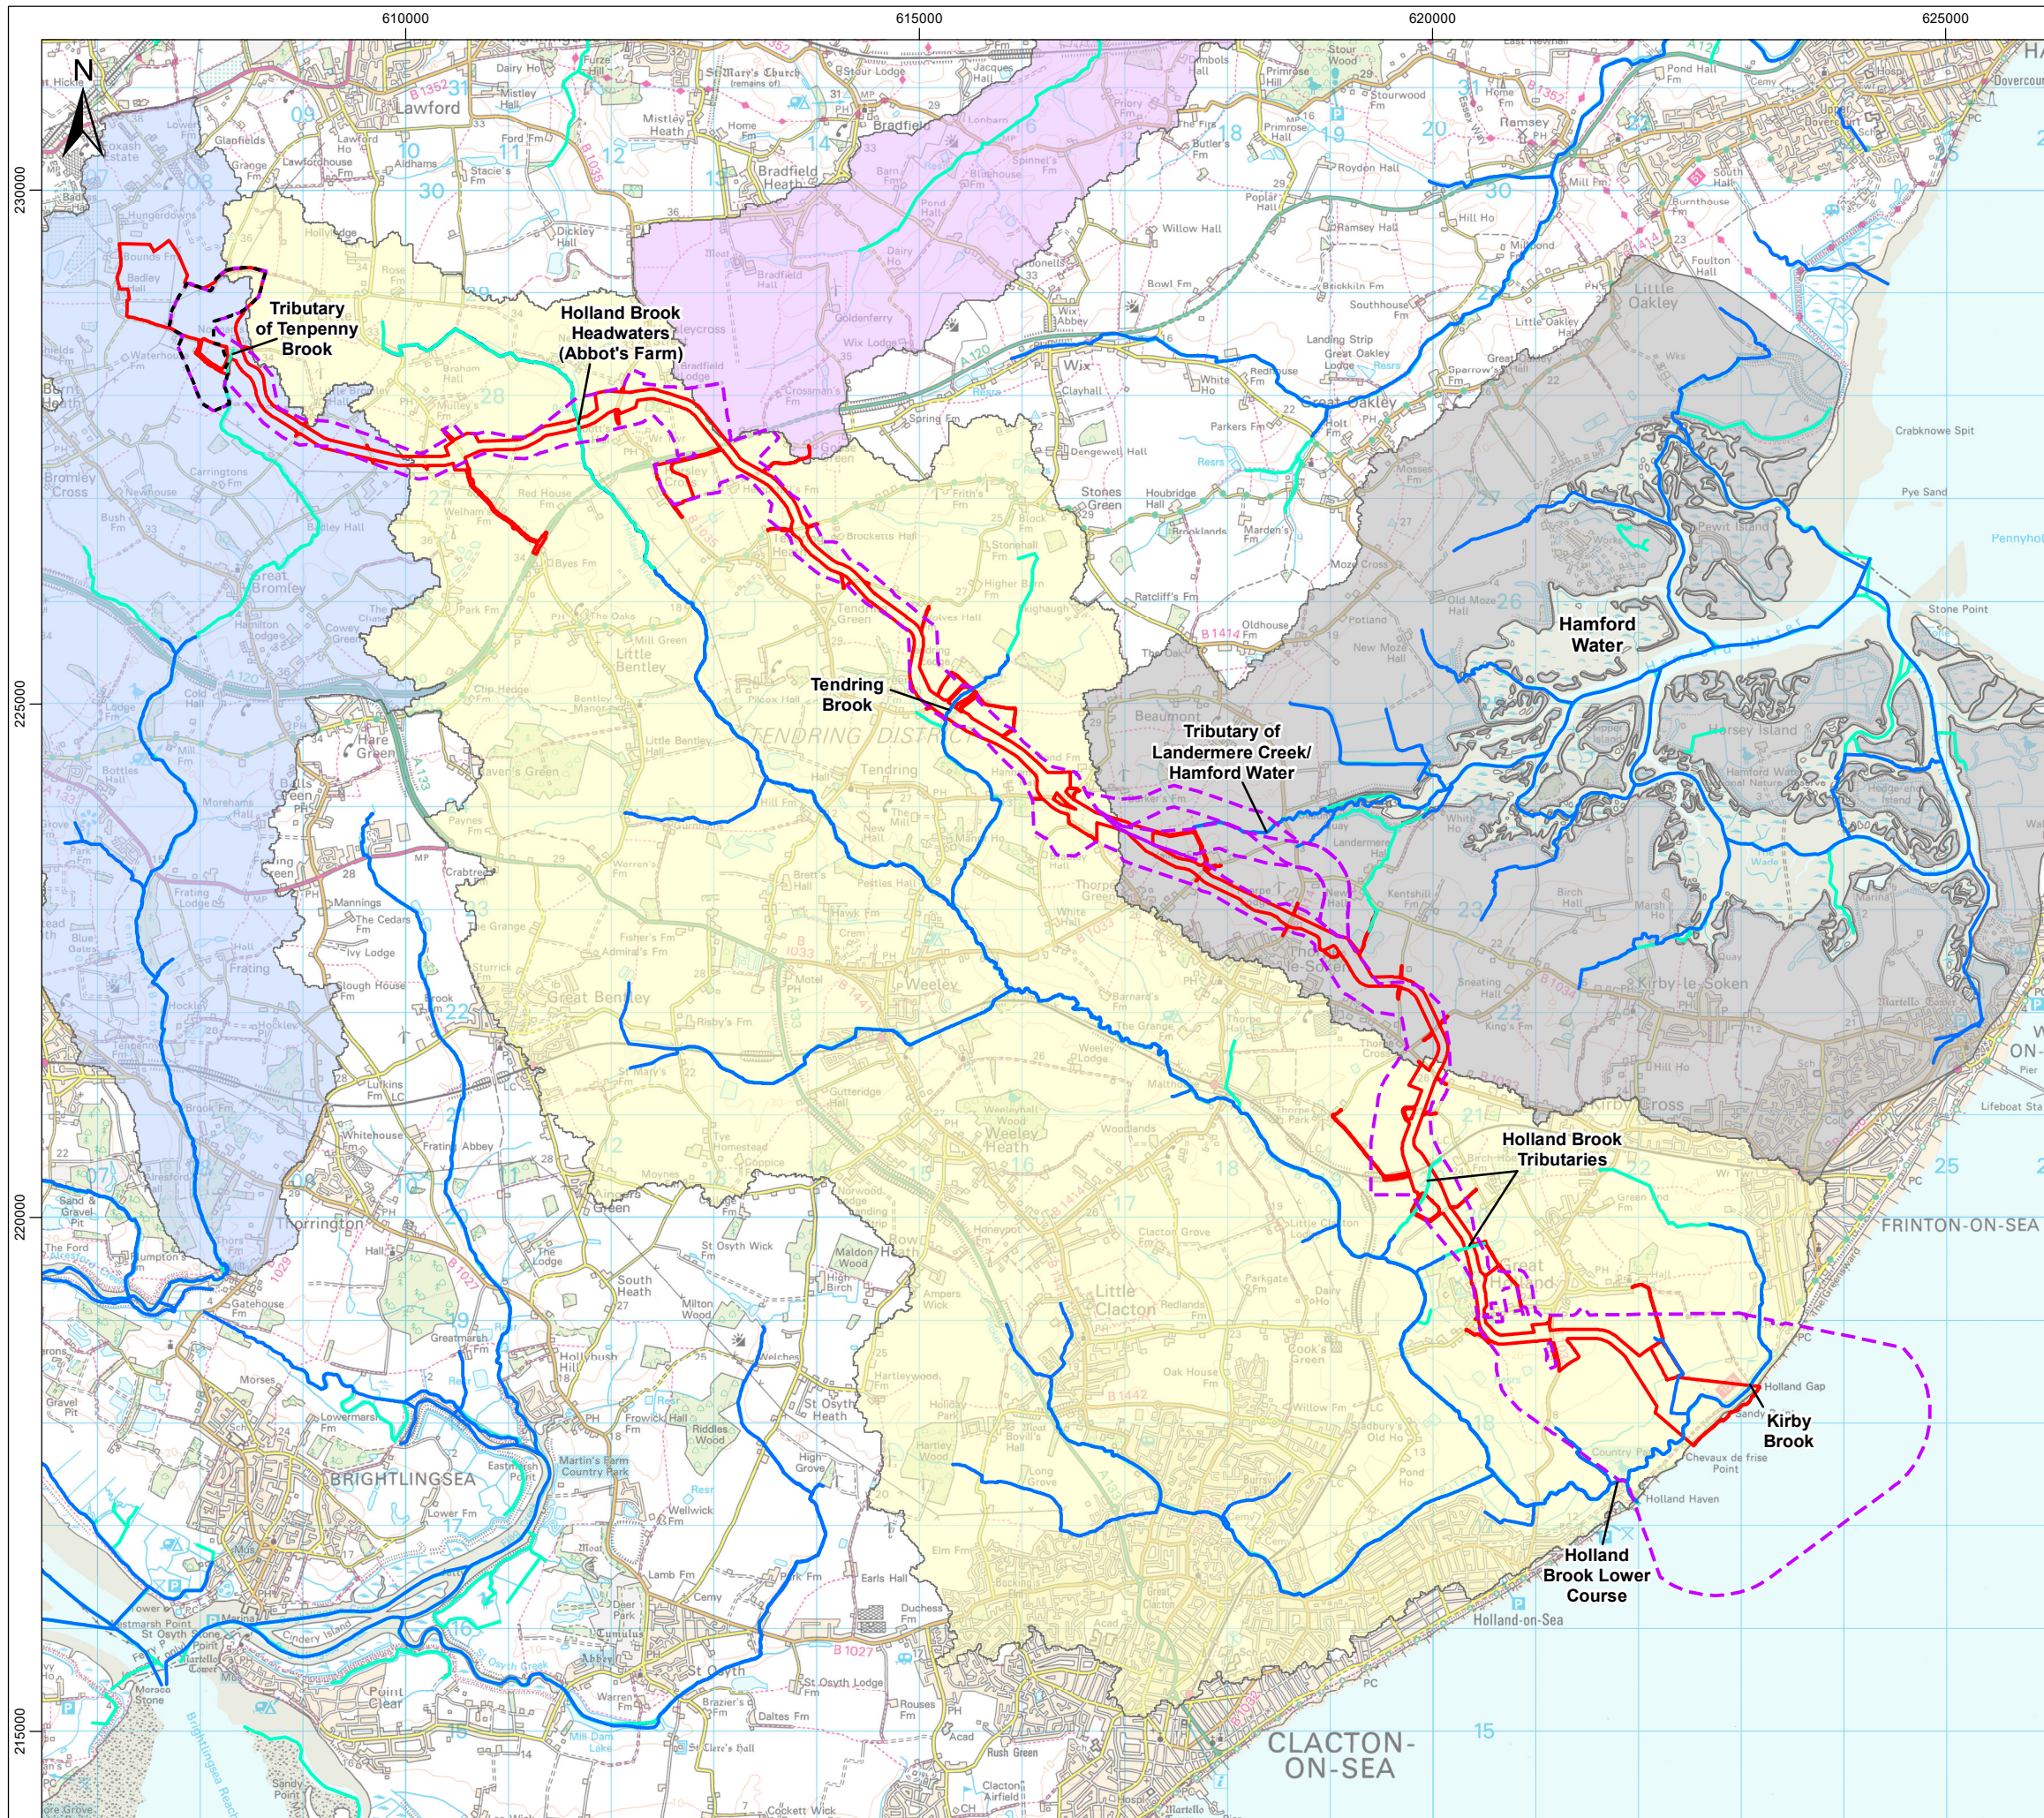
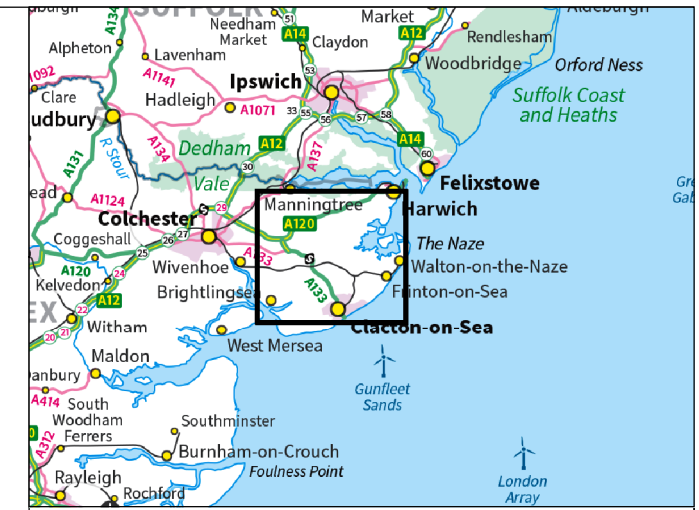
**Figure 1. Geomorphology Baseline Study Area**

3. The location of surveyed watercourses is shown in Figure 1 (Annex 21.1.1) and summarised in Table 1. The study area includes all Main Rivers and Ordinary Watercourses within the onshore project area. The baseline surveyed was carried out based on the onshore project area at Preliminary Environmental Information Report (PEIR), which has since been updated for the ES. Figure 1 shows the onshore project area at PEIR and how this overlaps with the onshore project area at ES.
