**Tillbridge Solar Project
EN010142**

**Volume 6
Environmental Statement**
Appendix 9-10: Baseline Report for Riparian mammals
Document Reference: EN010142/APP/6.2

**April 2024
Revision Number: 00**

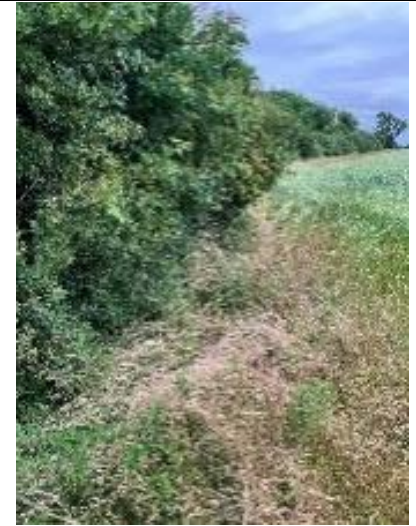
28 ■ Hedgerow in dry, shallow ditch

N/A

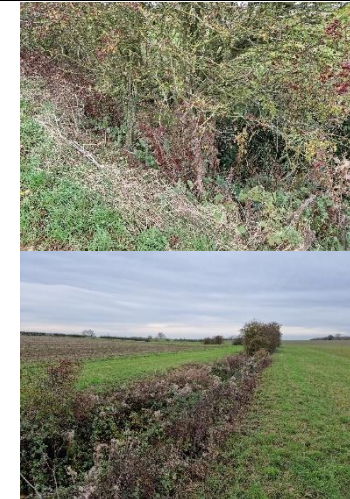
- 62
- Connected to two on-site watercourses (59 and 61)
 - Hedgerow encroaching ditch from the south side
 - Mixture of grass, herbaceous and woody vegetation on banksides
 - Mixture of grass, herbaceous and woody vegetation in channel
 - Limited year-round food source
 - Wet in November 2022 (<10cm)
 - Heavily shaded by encroaching hedgerow from the south side and by in channel vegetation
 - Very steep banks suitable for burrowing
 - Heavy disturbance - adjacent to arable and evidence of hedgerow management
 - Water quality moderate - no litter debris but a few signs of agriculture run-off / pollution e.g., green algae, oil on surface of water etc.
 - Condition assessment: poor

Suitable but poor

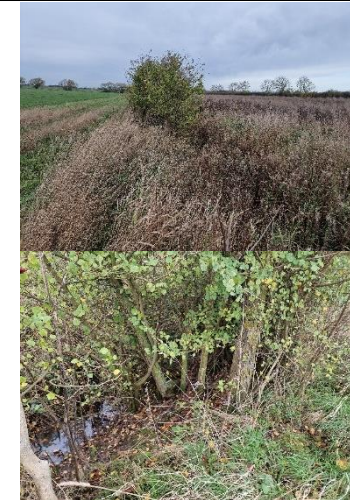
- 65
- Connected to one on-site watercourse (64)
 - Defunct hedgerow in wet ditch
 - Mixture of grass, herbaceous and woody vegetation on banksides
 - Mainly woody vegetation in channel, limited grass and herbaceous vegetation
 - No year-round food source
 - Wet in November 2022 (<20cm)
 - Heavily shaded by hedgerow in channel
 - Very steep banks suitable for burrowing
 - Heavy disturbance - adjacent to arable and evidence of hedgerow management
 - Water quality moderate - no litter debris but a few signs of agriculture run-off / pollution e.g., green algae, oil on surface of water etc.
 - Condition assessment: poor

Unsuitable
