Botley West Solar Farm

Environmental Statement

Appendix 9.15: Veteran Tree Survey Report

November 2024

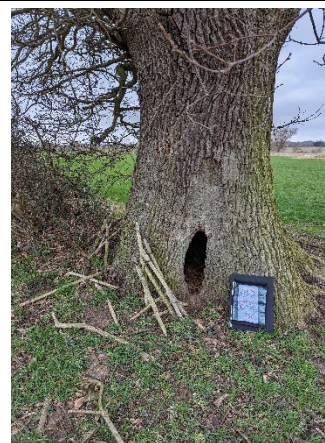
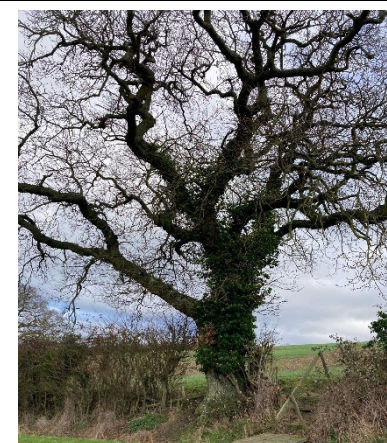
T13	Species	Height (m)	Crown spread (m)				Stem dia. (mm) including irregularities information	Stem no. at 1.5m	Height of crown clearance (m)	Dir/height	Age class	Condition	Type	General observations Management recommendations	Estimated remaining contribution (years)	Tree Quality Category (BS5837)	Tree Typology
			N	E	S	W											
	<i>Quercus robur</i> - Pedunculate Oak	12.0	8.0	5.0	7.0	8.0	900	2	0.50	N/1	V	Good	-	Notable local tree. Squat, wind-pruned riverbank oak. Northern surface roots exposed from river bank erosion. Notable landscape form	40+	A1	Riverside

Primary Tree Qualities							
Extensive Decay			Previous aged management		Senescence / Aged decline		Retrenchment / Canopy Reduction
Brown rot	Exposed heartwood	Hollowing (by %)					
X	X	10%	Maiden		X		X

Secondary Tree Qualities											
Attached deadwood >150mm dia	Storm Damage	Roosts, nests, crevices	Aerial Roots	Bark flux / Sap	Wet pockets	Bark loss/decay	Fungi		Other epiphytic plants		
							Major	Minor	Lichens	Ferns	Other
Yes	Yes	Yes	Yes	Yes	Yes	Yes	Yes	X	Yes	X	-

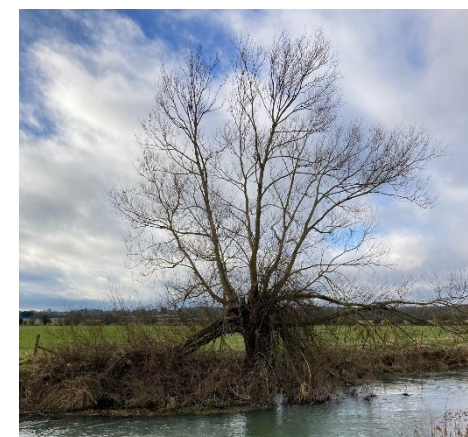
Species	Height (m)	Crown spread (m)				Stem dia. (mm) including irregularities information	Stem no. at 1.5m	Height of crown clearance (m)	Dir/height	Age class	Condition	Type	General observations Management recommendations	Estimated remaining contribution (years)	Tree Quality Category (BS5837)	Tree Typology	
		N	E	S	W												
T15	<i>Quercus robur</i> - Pedunculate Oak	15.0	6.0	6.0	7.0	6.0	1290	1	-	N/4	V	Good	-	Large Ganoderma applanatum/australe bracket on northern buttress. Cavity openings on western side at 1m and 8m. Locally notable future veteran.	40+	A1	Field Boundary

Primary Tree Qualities								
Extensive Decay			Previous aged management		Senescence / Aged decline		Retrenchment / Canopy Reduction	
Brown rot	Exposed heartwood		Hollowing (by %)					
X	Yes		50%		Maiden		X

Secondary Tree Qualities											
Attached deadwood >150mm dia	Storm Damage	Roosts, nests, crevices	Aerial Roots	Bark flux / Sap	Wet pockets	Bark loss/decay	Fungi		Other epiphytic plants		
							Major	Minor	Lichens	Ferns	Other
Yes	X	Yes	X	X	X	Yes	Yes	X	Yes	X	-

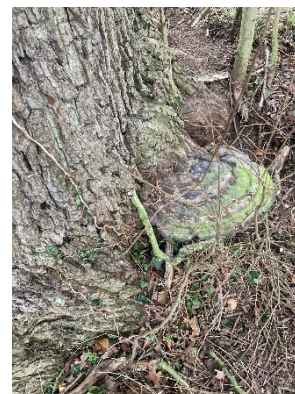
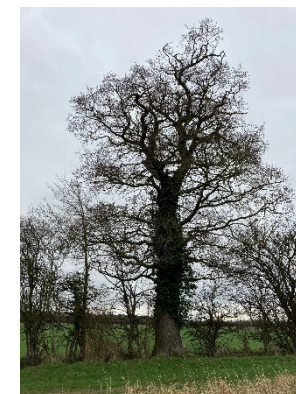
Species	Height (m)	Crown spread (m)				Stem dia. (mm) Including irregularities information	Stem no. at 1.5m	Height of crown clearance (m)	Dir/height	Age class	Condition	Type	General observations Management recommendations	Estimated remaining contribution (years)	Tree Quality Category (BS5837)	Tree Typology	
		N	E	S	W												
T16	<i>Fraxinus excelsior</i> - Ash	10.0	5.0	7.0	5.0	2.0	970	1	4	N/3	M/V	Poor	-	Near veteran girth, displaying significant decay/hollowing indicative of veteran characteristic and habitat value. Western side of stem exposed hollow to 40%. Healthy buds from old pollard point.	20+	B3	Field Boundary

Primary Tree Qualities						
Extensive Decay			Previous aged management	Senescence / Aged decline	Retrenchment / Canopy Reduction	
Brown rot	Exposed heartwood	Hollowing (by %)				
X	Yes	40%	Pollard	Yes	X

Secondary Tree Qualities												
Attached deadwood >150mm dia	Storm Damage	Roosts, nests, crevices	Aerial Roots	Bark flux / Sap	Wet pockets	Bark loss/decay	Fungi		Other epiphytic plants			
							Major	Minor	Lichens	Ferns	Other	
X	X	Yes	X	X	Yes	Yes	Yes	Yes	X	X	-

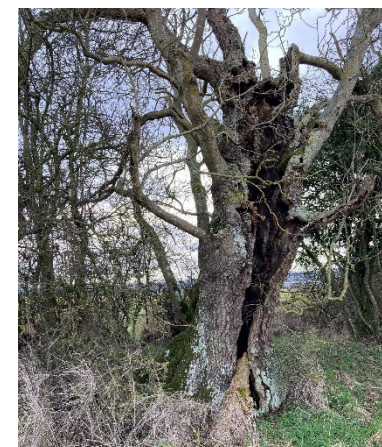
Species	Height (m)	Crown spread (m)				Stem dia. (mm) Including irregularities information	Stem no. at 1.5m	Height of crown clearance (m)	Dir/ height	Age class	Condition	Type	General observations Management recommendations	Estimated remaining contribution (years)	Tree Quality Category (BS5837)	Tree Typology	
		N	E	S	W												
T17	<i>Fraxinus excelsior</i> - Ash	11.0	8.0	8.0	6.0	6.0	1120	-	2	-	V	Good	-	Single stem. Formation of lower crown through established epicormic growth. Sap runs down south of stem. Branch socket cavities. Hollowing and brown rot around buttress roots. Major deadwood in crown from dieback of primary leaders. Water pockets and exposed heartwood from large tear wounds.	10+	A1	Field Boundary

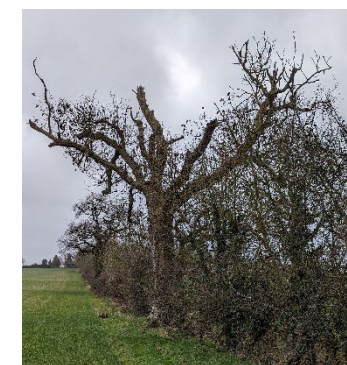
T28	Species	Height (m)	Crown spread (m)				Stem dia. (mm) Including irregularities information	Stem no. at 1.5m	Height of crown clearance (m)	Dir/height	Age class	Condition	Type	General observations Management recommendations	Estimated remaining contribution (years)	Tree Quality Category (BS5837)	Tree Typology
			N	E	S	W											
	<i>Fraxinus excelsior</i> - Ash	17.0	8.0	8.0	8.0	10.0	1210	1	2	W4	V	Poor	Maiden/Field Boundary	Major crown failures, Moderate deadwood, Ivy on main stem, Epicormics on stem and crown, Decay in main stem	10+	C3	Field Boundary

Primary Tree Qualities						
Extensive Decay			Previous aged management	Senescence / Aged decline	Retrenchment / Canopy Reduction	
Brown rot	Exposed heartwood	Hollowing (by %)				
Main Stem	X	X	Maiden	Moderate decline	Partial live residual canopy

Secondary Tree Qualities											
Attached deadwood >150mm dia	Storm Damage	Roosts, nests, crevices	Aerial Roots	Bark flux / Sap	Wet pockets	Bark loss/decay	Fungi		Other epiphytic plants		
							Major	Minor	Lichens	Ferns	Other
<10% in crown	Yes	Possible birds and bats	None	None	None	Crown and Stem	Inonoyus hispidus scars in crown and stem	X	X	X	Ivy

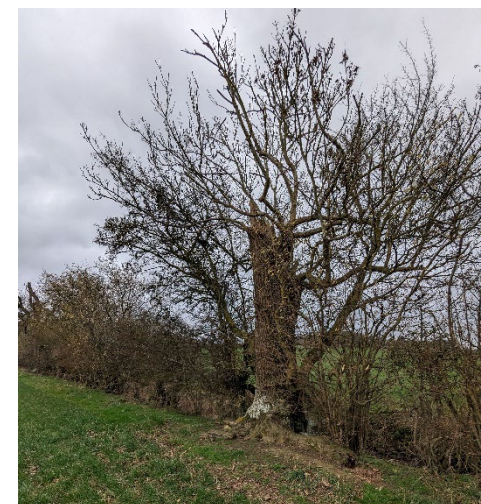
Species	Height (m)	Crown spread (m)				Stem dia. (mm) Including irregularities information	Stem no. at 1.5m	Height of crown clearance (m)	Dir/height	Age class	Condition	Type	General observations Management recommendations	Estimated remaining contribution (years)	Tree Quality Category (BS5837)	Tree Typology	
		N	E	S	W												
T29	<i>Quercus robur</i> - Pedunculate Oak	20.0	8.0	10.0	8.0	8.0	1080	1	2	E/2.5	V	Fair	Maiden/Field Boundary	Scars and tears to crown, Epicormics to stem and crown, Moderate deadwood in crown, Ivy on main stem.	40+	A3	Field Boundary

Primary Tree Qualities						
Extensive Decay			Previous aged management	Senescence / Aged decline	Retrenchment / Canopy Reduction	
Brown rot	Exposed heartwood	Hollowing (by %)				
X	Minor	X	Maiden	Minor decline	Full crown

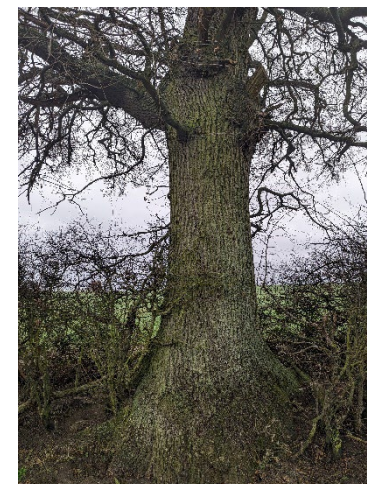
T33	Species	Height (m)	Crown spread (m)				Stem dia. (mm) Including irregularities information	Stem no. at 1.5m	Height of crown clearance (m)	Dir/height	Age class	Condition	Type	General observations Management recommendations	Estimated remaining contribution (years)	Tree Quality Category (BS5837)	Tree Typology
			N	E	S	W											
	<i>Quercus robur</i> - Pedunculate Oak	17.0	8.0	6.0	8.0	7.0	1110	1	3	N/3	V	Fair	Maiden/Field Boundary	Basal decay fungi present, Moderate deadwood in crown, Tears, stubs, Epicormics in crown	20+	B3	Field Boundary

Primary Tree Qualities						
Extensive Decay			Previous aged management	Senescence / Aged decline	Retrenchment / Canopy Reduction	
Brown rot	Exposed heartwood	Hollowing (by %)				
Base	X		X	Maiden	Moderate decline	Full crown

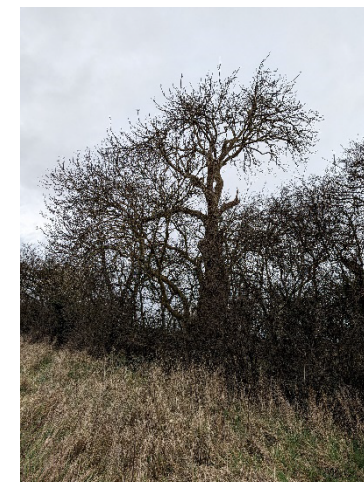
Species	Height (m)	Crown spread (m)				Stem dia. (mm) including irregularities information	Stem no. at 1.5m	Height of crown clearance (m)	Dir/height	Age class	Condition	Type	General observations Management recommendations	Estimated remaining contribution (years)	Tree Quality Category (BS5837)	Tree Typology	
		N	E	S	W												
T37	<i>Populus canadensis</i> - Hybrid Black Poplar	20.0	7.0	4.0	6.0	8.0	1230	1	9	W/9	V	Poor	Maiden/Field Boundary	Major crown failure, Restricted inspection due to ivy on stem and crown, Stubs and tears in crown, Decay in stem, Sesia apiformis flight holes at base	10	C3	Field Boundary

Primary Tree Qualities						
Extensive Decay			Previous aged management	Senescence / Aged decline	Retrenchment / Canopy Reduction	
Brown rot	Exposed heartwood	Hollowing (by %)				
X	X	Main stem possibly hollow	Maiden	Major decline	Partial live residual canopy

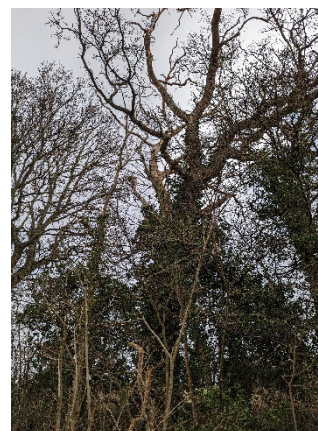
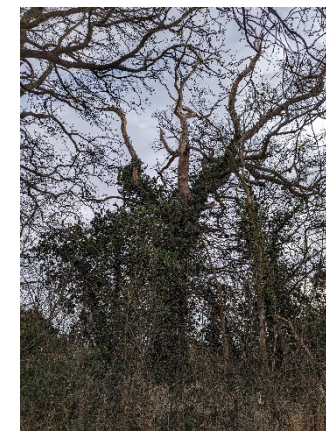
Species	Height (m)	Crown spread (m)				Stem dia. (mm) including irregularities information	Stem no. at 1.5m	Height of crown clearance (m)	Dir/ height	Age class	Condition	Type	General observations Management recommendations	Estimated remaining contribution (years)	Tree Quality Category (BS5837)	Tree Typology	
		N	E	S	W												
T39	<i>Alnus glutinosa</i> - Common Alder	11.0	7.0	7.0	7.0	7.0	840	6.00	0.30	-	V	Good	River edge	Epicormics base and crown, multi stemmed form, Minor deadwood in the crown	40+	A3	Riverside

Primary Tree Qualities								
Extensive Decay			Previous aged management		Senescence / Aged decline		Retrenchment / Canopy Reduction	
Brown rot	Exposed heartwood	Hollowing (by %)						
X	X	X		Coppice		X		X

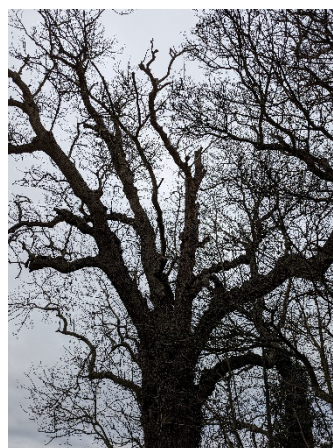
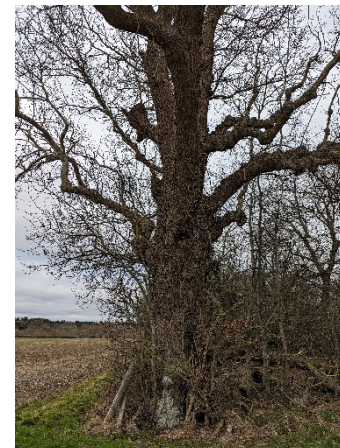
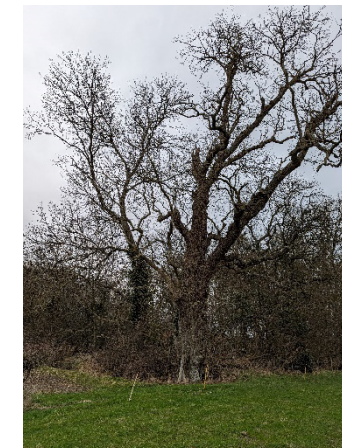
T43	Species	Height (m)	Crown spread (m)				Stem dia. (mm) Including irregularities information	Stem no. at 1.5m	Height of crown clearance (m)	Dir/ height	Age class	Condition	Type	General observations Management recommendations	Estimated remaining contribution (years)	Tree Quality Category (BS5837)	Tree Typology
			N	E	S	W											
	<i>Salix alba</i> - White Willow	10.0	15.0	20.0	4.0	4.0	2000	2.00	0.00	-	V	Fair	River edge pollard	Collapsed crown, Layering with Pheonix growth, Multiple failures	20+	B3	Riverside

Primary Tree Qualities						
Extensive Decay			Previous aged management		Senescence / Aged decline	Retrenchment / Canopy Reduction
Brown rot	Exposed heartwood	Hollowing (by %)				
In stem	Main stem	Partial		Pollard	Major decline associated with collapse	Over mature decline

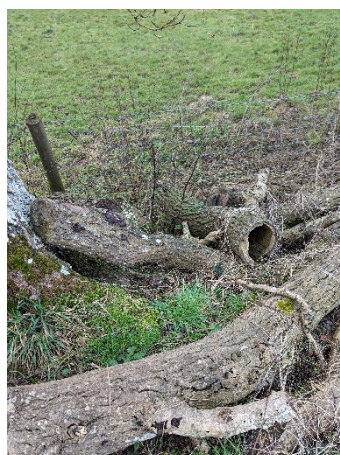
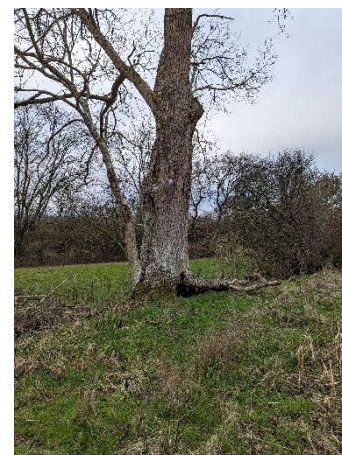
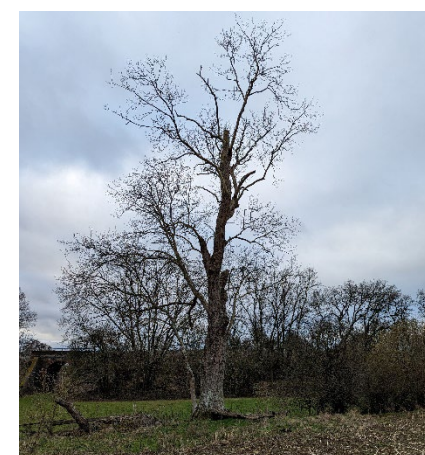
Species	Height (m)	Crown spread (m)				Stem dia. (mm) Including irregularities information	Stem no. at 1.5m	Height of crown clearance (m)	Dir/ height	Age class	Condition	Type	General observations Management recommendations	Estimated remaining contribution (years)	Tree Quality Category (BS5837)	Tree Typology	
		N	E	S	W												
T46	<i>Quercus robur</i> - Pedunculate Oak	20.0	8.0	8.0	8.0	8.0	1430	1.00	1.00	S/5	V	Fair	Woodland edge/Maiden	Epicormics on stem and crown, Moderate deadwood, Previous limb failures,	40+	A3	Woodland

Primary Tree Qualities							
Extensive Decay			Previous aged management		Senescence / Aged decline		Retrenchment / Canopy Reduction
Brown rot	Exposed heartwood	Hollowing (by %)					
X	X	X		Maiden	Minor decline	Starting to Retrench

Secondary Tree Qualities												
Attached deadwood >150mm dia	Storm Damage	Roosts, nests, crevices	Aerial Roots	Bark flux / Sap	Wet pockets	Bark loss/decay	Fungi		Other epiphytic plants			
							Major	Minor	Lichens	Ferns	Other	
<10% of canopy	Yes	Possible birds and bats	X	X	X	X	X	X	>2	X	Moss

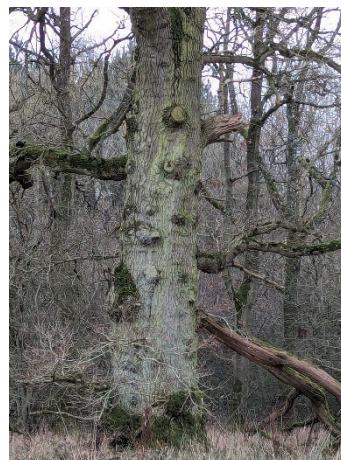
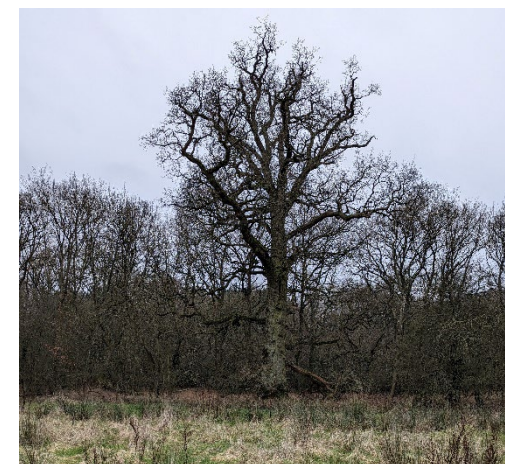
Species	Height (m)	Crown spread (m)					Stem dia. (mm) Including irregularities information	Stem no. at 1.5m	Height of crown clearance (m)	Dir/ height	Age class	Condition	Type	General observations Management recommendations	Estimated remaining contribution (years)	Tree Quality Category (BS5837)	Tree Typology
		N	E	S	W												
T47	<i>Quercus robur</i> - Pedunculate Oak	27.0	9.0	12.0	8.0	6.0	1400	1.00	5.00	E/5	V	Poor	Woodland edge/Maiden	Fungi fruiting bodies at base, Epicormics stem and crown, Pruning wounds to crown and stem.	20+	B3	Woodland

Primary Tree Qualities						
Extensive Decay			Previous aged management	Senescence / Aged decline	Retrenchment / Canopy Reduction	
Brown rot	Exposed heartwood	Hollowing (by %)				
Internal decay of stem	X		X	Maiden	<10%	Retrenching

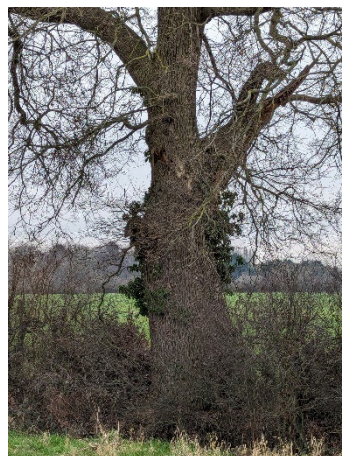
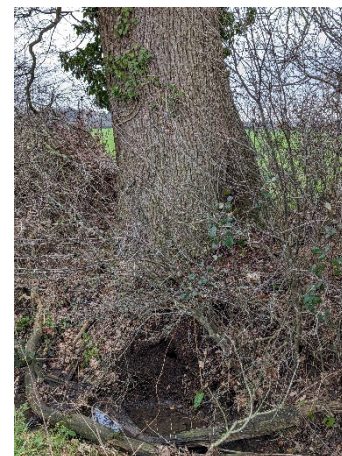
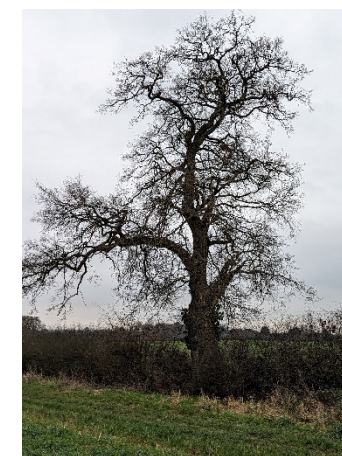
Species	Height (m)	Crown spread (m)				Stem dia. (mm) Including irregularities information	Stem no. at 1.5m	Height of crown clearance (m)	Dir/ height	Age class	Condition	Type	General observations Management recommendations	Estimated remaining contribution (years)	Tree Quality Category (BS5837)	Tree Typology
		N	E	S	W											
T49	<i>Quercus robur</i> - Pedunculate Oak	13.0	6.0	6.0	6.0	1200	1.00	2.50	E/5	V	Fair	Field boundary	Storm damage, Epicormics stem and crown, Splits, cracks, Large scar main stem,	40+	A3	Field boundary

Primary Tree Qualities							
Extensive Decay			Previous aged management		Senescence / Aged decline		Retrenchment / Canopy Reduction
Brown rot	Exposed heartwood	Hollowing (by %)					
Scar in stem	X	Possible main stem		Maiden		Minor decline	<10%

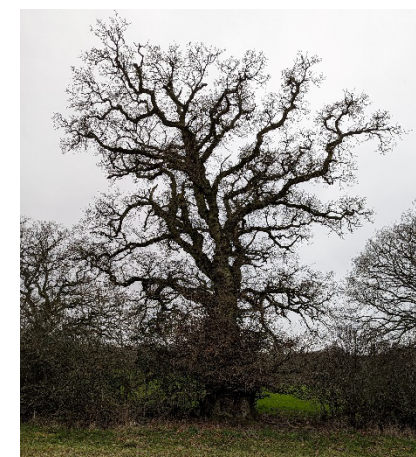
Species	Height (m)	Crown spread (m)				Stem dia. (mm) Including irregularities information	Stem no. at 1.5m	Height of crown clearance (m)	Dir/ height	Age class	Condition	Type	General observations Management recommendations	Estimated remaining contribution (years)	Tree Quality Category (BS5837)	Tree Typology	
		N	E	S	W												
T51	<i>Quercus robur</i> - Pedunculate Oak	12.0	3.0	4.0	3.0	2.0	1100	1.00	3.00	N/5	V	Poor	Field boundary	Major crown loss, Epicormics stem and crown, Large deadwood, Splits and tears in crown, Ivy on main stem.	20+	B3	Field boundary

Primary Tree Qualities								
Extensive Decay			Previous aged management		Senescence / Aged decline		Retrenchment / Canopy Reduction	
Brown rot	Exposed heartwood	Hollowing (by %)						
X	X	X		Maiden	Decline due to damage		50% crown loss

Secondary Tree Qualities											
Attached deadwood >150mm dia	Storm Damage	Roosts, nests, crevices	Aerial Roots	Bark flux / Sap	Wet pockets	Bark loss/decay	Fungi		Other epiphytic plants		
							Major	Minor	Lichens	Ferns	Other
30% crown	Yes	Possible birds and bats	X	X	X	X	X	X	X	Ivy

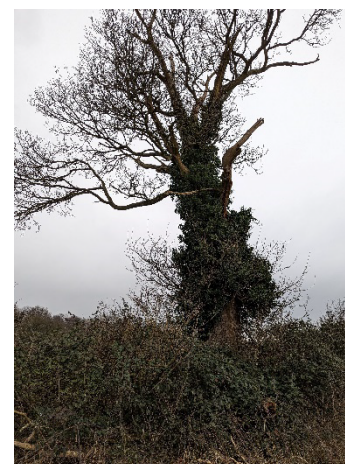
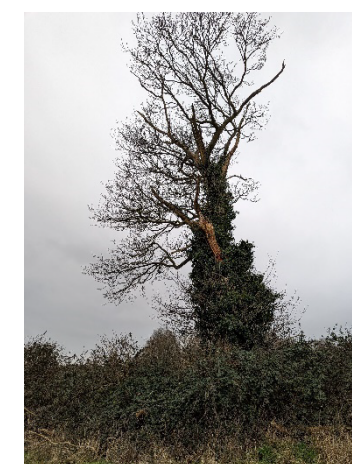
Species	Height (m)	Crown spread (m)					Stem dia. (mm) Including irregularities information	Stem no. at 1.5m	Height of crown clearance (m)	Dir/ height	Age class	Condition	Type	General observations Management recommendations	Estimated remaining contribution (years)	Tree Quality Category (BS5837)	Tree Typology
		N	E	S	W												
T52	<i>Quercus robur</i> - Pedunculate Oak	10.0	7.0	8.0	4.0	6.0	1100	Multi-stem	2.00	-	V	Fair	Woodland	Phoenix growth from collapsed tree, Minor deadwood in crown.	40+	A3	Woodland

Primary Tree Qualities						
Extensive Decay			Previous aged management	Senescence / Aged decline	Retrenchment / Canopy Reduction	
Brown rot	Exposed heartwood	Hollowing (by %)				
X	X	X	Phoenix	X	10%

Secondary Tree Qualities											
Attached deadwood >150mm dia	Storm Damage	Roosts, nests, crevices	Aerial Roots	Bark flux / Sap	Wet pockets	Bark loss/decay	Fungi		Other epiphytic plants		
							Major	Minor	Lichens	Ferns	Other
10% crown	Minor	None evident	X	X	X	X	X	X	2	X	Moss

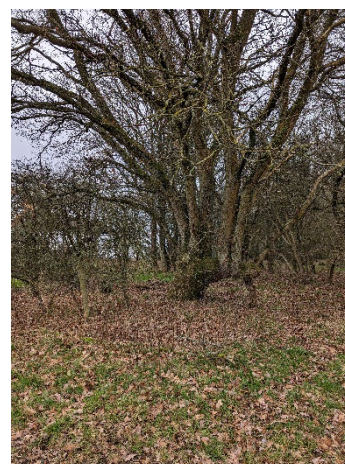
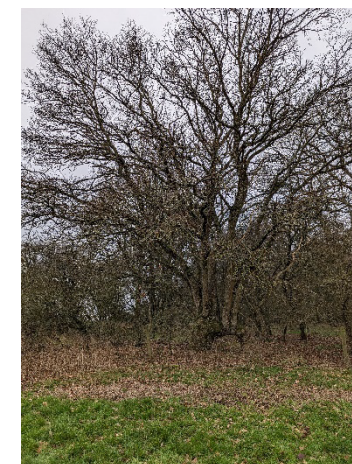
T53	Species	Height (m)	Crown spread (m)				Stem dia. (mm) Including irregularities information	Stem no. at 1.5m	Height of crown clearance (m)	Dir/ height	Age class	Condition	Type	General observations Management recommendations	Estimated remaining contribution (years)	Tree Quality Category (BS5837)	Tree Typology
			N	E	S	W											
	<i>Salix alba</i> - White Willow	7.0	3.0	3.0	3.0	3.0	1200	Multi-stem	2.00	-	OM/V	Poor	Field Boundary	Collapsing stems, open main stem, various failures, decay and rot in main stem.	20+	B3	Field Boundary

Primary Tree Qualities					
Extensive Decay			Previous aged management	Senescence / Aged decline	Retrenchment / Canopy Reduction
Brown rot	Exposed heartwood	Hollowing (by %)			
In main stem	In stem	30% of main stem	Pollard	Reducing as collapsing	Collapsing not retrenching

Secondary Tree Qualities											
Attached deadwood >150mm dia	Storm Damage	Roosts, nests, crevices	Aerial Roots	Bark flux / Sap	Wet pockets	Bark loss/decay	Fungi		Other epiphytic plants		
							Major	Minor	Lichens	Ferns	Other
X	Yes	Possible birds and bats	X	X	X	Stem	X	X	2	X	Ivy

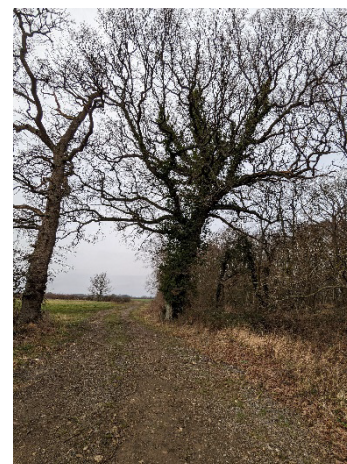
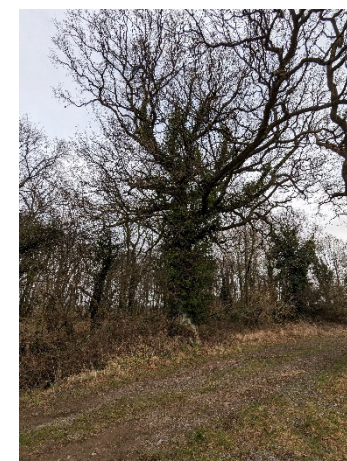
Species	Height (m)	Crown spread (m)				Stem dia. (mm) Including irregularities information	Stem no. at 1.5m	Height of crown clearance (m)	Dir/ height	Age class	Condition	Type	General observations Management recommendations	Estimated remaining contribution (years)	Tree Quality Category (BS5837)	Tree Typology	
		N	E	S	W												
T55	<i>Quercus robur</i> - Pedunculate Oak	23.0	10.0	10.0	7.0	5.0	2260	1.00	3.00	S/6	V	Fair	Field Boundary	Large branch and limb failures, Epicormics to stem and crown, Basal cavities with brown rot, Ivy on main stem.	20+	A3	Field Boundary

Primary Tree Qualities								
Extensive Decay			Previous aged management		Senescence / Aged decline		Retrenchment / Canopy Reduction	
Brown rot	Exposed heartwood	Hollowing (by %)						
At base and exposed crown	2 areas of base	Main Stem hollow		Maiden		Moderate decline		10% of remaining crown

Secondary Tree Qualities											
Attached deadwood >150mm dia	Storm Damage	Roosts, nests, crevices	Aerial Roots	Bark flux / Sap	Wet pockets	Bark loss/decay	Fungi		Other epiphytic plants		
							Major	Minor	Lichens	Ferns	Other
10% of crown	Yes	Possible birds and bats	X	X	X	Stem and crown	X	X	1	X	Ivy

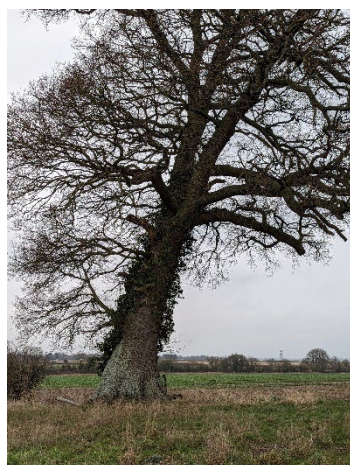
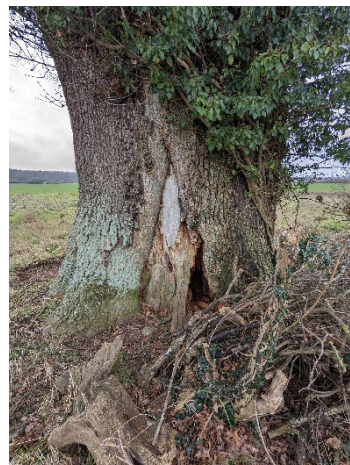
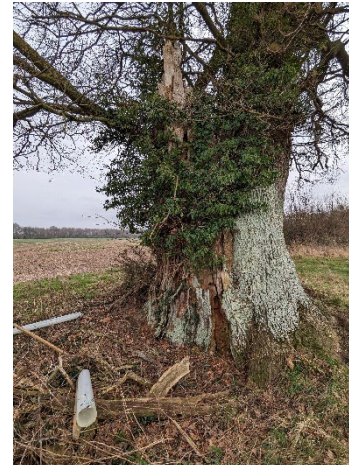
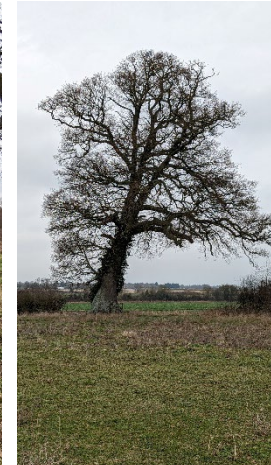
Species	Height (m)	Crown spread (m)				Stem dia. (mm) Including irregularities information	Stem no. at 1.5m	Height of crown clearance (m)	Dir/ height	Age class	Condition	Type	General observations Management recommendations	Estimated remaining contribution (years)	Tree Quality Category (BS5837)	Tree Typology
		N	E	S	W											
T56	<i>Quercus robur</i> - Pedunculate Oak	8.0	6.0	6.0	6.0	1600	1.00	3.00	S/4	V	Poor	Field Boundary	Major dieback, splits and tears in crown	40+	A3	Field Boundary

Primary Tree Qualities						
Extensive Decay			Previous aged management	Senescence / Aged decline	Retrenchment / Canopy Reduction	
Brown rot	Exposed heartwood	Hollowing (by %)				
In exposed crown	In crown	X	Maiden	Major decline	Partial live residual canopy

Secondary Tree Qualities											
Attached deadwood >150mm dia	Storm Damage	Roosts, nests, crevices	Aerial Roots	Bark flux / Sap	Wet pockets	Bark loss/decay	Fungi		Other epiphytic plants		
							Major	Minor	Lichens	Ferns	Other
70% of crown	Yes	Possible birds and bats	X	X	X	Stem and crown	X	X	X	X	-

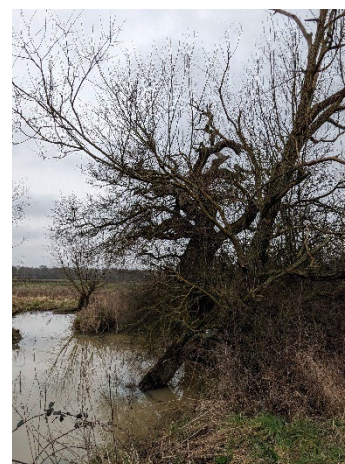
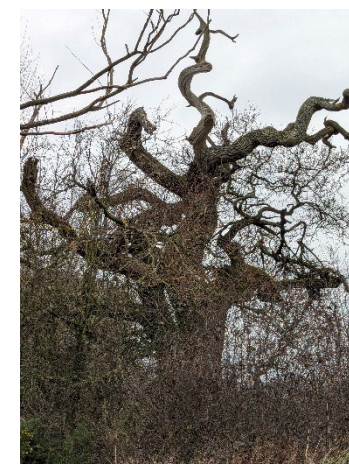
Species	Height (m)	Crown spread (m)				Stem dia. (mm) Including irregularities information	Stem no. at 1.5m	Height of crown clearance (m)	Dir/ height	Age class	Condition	Type	General observations Management recommendations	Estimated remaining contribution (years)	Tree Quality Category (BS5837)	Tree Typology	
		N	E	S	W												
T57	<i>Quercus robur</i> - Pedunculate Oak	14.0	8.0	5.0	8.0	7.0	1500	1.00	3.00	W/6	V	Fair	Field Boundary	Pruning wounds to stem and crown, Moderate deadwood in crown, epicormics on stem and crown, Splits and tears in crown.	40+	A3	Field Boundary

Primary Tree Qualities						
Extensive Decay			Previous aged management		Senescence / Aged decline	Retrenchment / Canopy Reduction
Brown rot	Exposed heartwood	Hollowing (by %)				
None visible	None visible	X	Maiden		Mature no clear decline	Partial live residual canopy

Secondary Tree Qualities											
Attached deadwood >150mm dia	Storm Damage	Roosts, nests, crevices	Aerial Roots	Bark flux / Sap	Wet pockets	Bark loss/decay	Fungi		Other epiphytic plants		
							Major	Minor	Lichens	Ferns	Other
15% of crown	Yes	Possible	X	X	X	Localised in crown	X	X	X	X	-

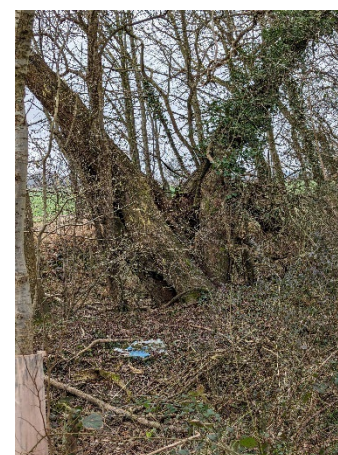
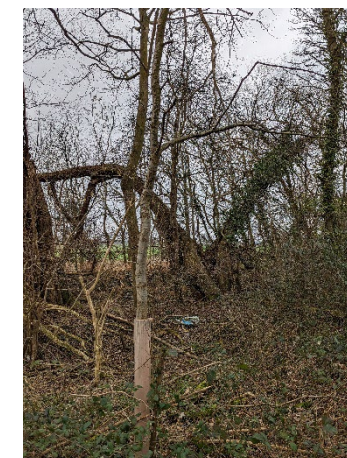
T59	Species	Height (m)	Crown spread (m)				Stem dia. (mm) Including irregularities information	Stem no. at 1.5m	Height of crown clearance (m)	Dir/ height	Age class	Condition	Type	General observations Management recommendations	Estimated remaining contribution (years)	Tree Quality Category (BS5837)	Tree Typology
			N	E	S	W											
	<i>Salix alba</i> - White Willow	11.0	12.0	5.0	7.0	5.0	1300	1.00	0.00	-	OM/V	Poor	Field Boundary	Collapsing tree major decay in main stem, multi stemmed above 1.8m, inspection restricted by vegetation and failed limbs.	20+	C3	Field Boundary

Primary Tree Qualities						
Extensive Decay			Previous aged management		Senescence / Aged decline	Retrenchment / Canopy Reduction
Brown rot	Exposed heartwood	Hollowing (by %)				
In main stem unions	Split main stem	Split with hollowing of main stem	Pollard		Reducing as collapsing	Collapsing not retrenching

Secondary Tree Qualities											
Attached deadwood >150mm dia	Storm Damage	Roosts, nests, crevices	Aerial Roots	Bark flux / Sap	Wet pockets	Bark loss/decay	Fungi		Other epiphytic plants		
							Major	Minor	Lichens	Ferns	Other
<5% in crown	Yes	X	X	X	X	Main Stem	X	X	X	X	Ivy

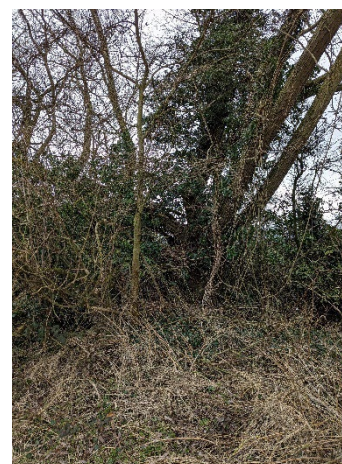
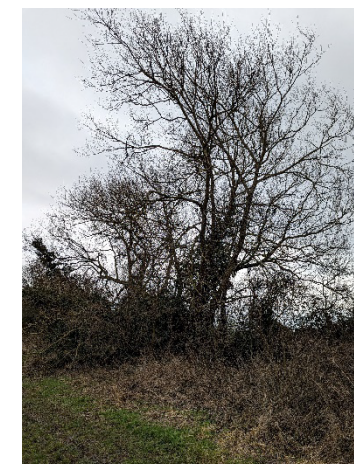
Species	Height (m)	Crown spread (m)				Stem dia. (mm) Including irregularities information	Stem no. at 1.5m	Height of crown clearance (m)	Dir/ height	Age class	Condition	Type	General observations Management recommendations	Estimated remaining contribution (years)	Tree Quality Category (BS5837)	Tree Typology	
		N	E	S	W												
T60	<i>Fagus sylvatica</i> - Beech	30.0	8.0	8.0	6.0	9.0	1110	1.00	10.00	N/6	OM/V	Poor	Woodland edge/Maiden	Major storm damage with associated limb failures, Pine hung up in crown, Ivy on stem, Moderate deadwood in the crown, Ganoderma sp. Bracket at base	10+	C3	Woodland

Primary Tree Qualities												
Extensive Decay			Previous aged management			Senescence / Aged decline			Retrenchment / Canopy Reduction			
Brown rot	Exposed heartwood	Hollowing (by %)										
None visible	None visible	X	Maiden			Minor decline			<10% mostly storm damage			
Secondary Tree Qualities												
Attached deadwood >150mm dia	Storm Damage	Roosts, nests, crevices	Aerial Roots	Bark flux / Sap	Wet pockets	Bark loss/decay	Fungi		Other epiphytic plants			
							Major	Minor	Lichens	Ferns	Other	
10-15% of crown	None evident	X	X	X	X	X	Ganoderma sp. At base	X	1	X	Ivy

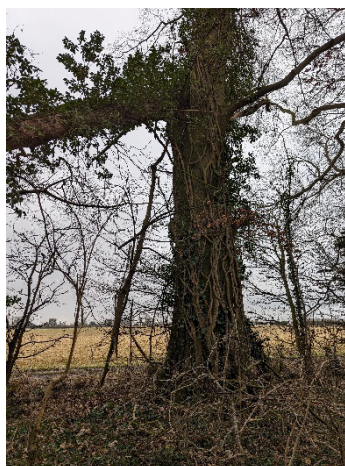
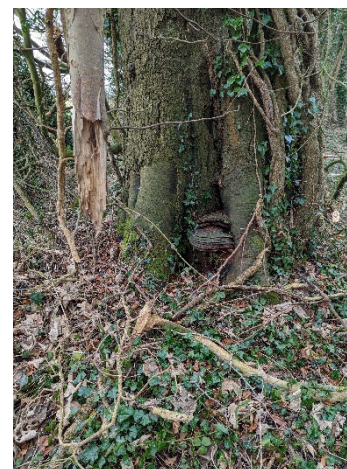
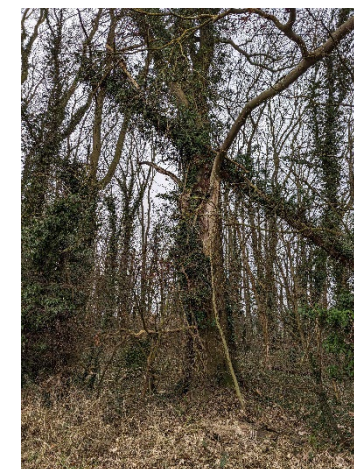
Species	Height (m)	Crown spread (m)				Stem dia. (mm) Including irregularities information	Stem no. at 1.5m	Height of crown clearance (m)	Dir/ height	Age class	Condition	Type	General observations Management recommendations	Estimated remaining contribution (years)	Tree Quality Category (BS5837)	Tree Typology	
		N	E	S	W												
T61	<i>Fagus sylvatica</i> - Beech	27.0	12.0	4.0	8.0	9.0	1080	1.00	12.00	S/10	V	Fair	Woodland edge/Maiden	Large limb and branch wood failures, Tears, rips in crown, Possible <i>Kretzschmaria deusta</i> at base	20+	B3	Woodland

Primary Tree Qualities							
Extensive Decay			Previous aged management		Senescence / Aged decline		Retrenchment / Canopy Reduction
Brown rot	Exposed heartwood	Hollowing (by %)					
None visible	None visible	X		Maiden	Mature no clear decline	<10% mostly storm damage

Secondary Tree Qualities											
Attached deadwood >150mm dia	Storm Damage	Roosts, nests, crevices	Aerial Roots	Bark flux / Sap	Wet pockets	Bark loss/decay	Fungi		Other epiphytic plants		
							Major	Minor	Lichens	Ferns	Other
5-10% of crown	Yes	X	X	X	X	Scars to main stem	Possible <i>Kretzschmaria deusta</i> at base.	X	1	X	Ivy

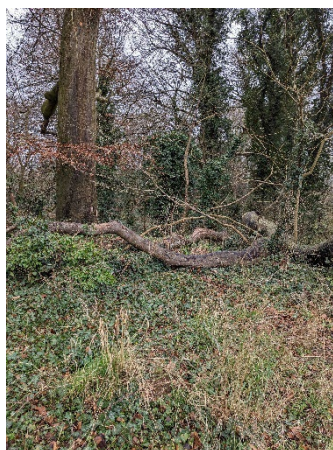
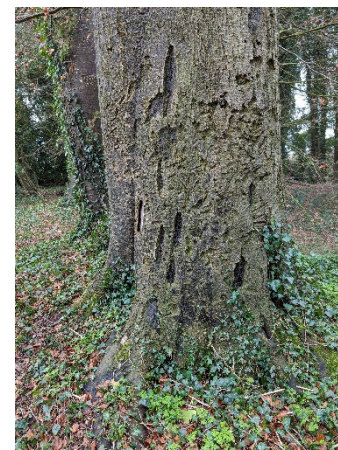
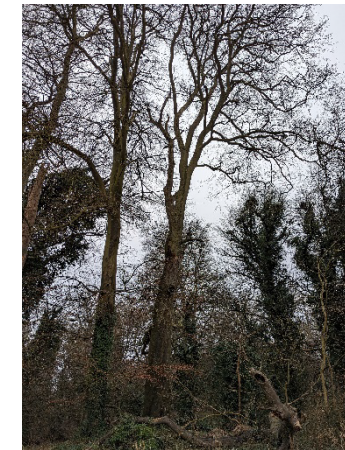
Species	Height (m)	Crown spread (m)				Stem dia. (mm) Including irregularities information	Stem no. at 1.5m	Height of crown clearance (m)	Dir/ height	Age class	Condition	Type	General observations Management recommendations	Estimated remaining contribution (years)	Tree Quality Category (BS5837)	Tree Typology	
		N	E	S	W												
T62	<i>Fraxinus excelsior</i> - Ash	13.0	5.0	5.0	5.0	5.0	1270	1.00	2.00	S/5	V	Poor	Field Boundary	Major crown failure, Restricted inspection due to volume of ivy on stem and crown, Ash Dieback present, Scars and rips to crown. Hollow main stem.	10+	C3	Field Boundary

Primary Tree Qualities												
Extensive Decay						Previous aged management			Senescence / Aged decline			Retrenchment / Canopy Reduction
Brown rot		Exposed heartwood		Hollowing (by %)								
Likely in main stem		In upper crown		Main Stem hollow		Maiden			< 20 years to failure			Partial Live Residual Canopy
Secondary Tree Qualities												
Attached deadwood >150mm dia	Storm Damage	Roosts, nests, crevices	Aerial Roots	Bark flux / Sap	Wet pockets	Bark loss/decay	Fungi		Other epiphytic plants			
							Major	Minor	Lichens	Ferns	Other	
Sections of remaining crown	Yes	Possible	X	X	X	Stem and crown	X	X	>3	X	Ivy

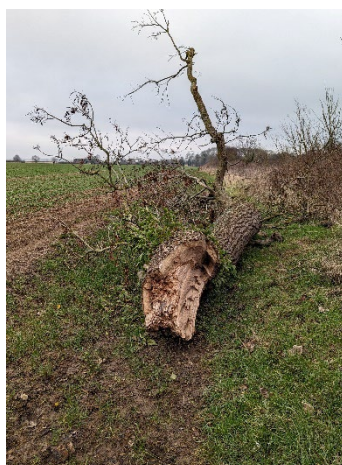
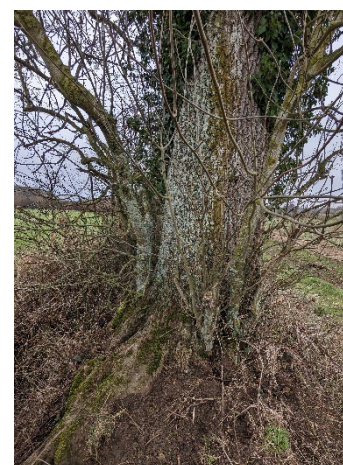
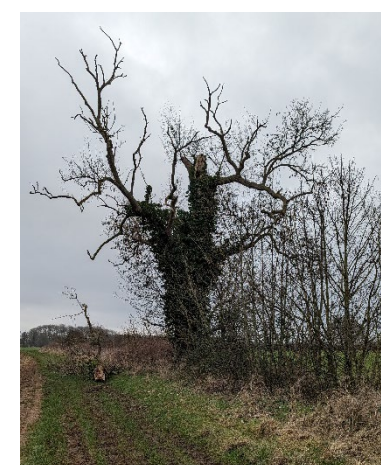
Species	Height (m)	Crown spread (m)				Stem dia. (mm) Including irregularities information	Stem no. at 1.5m	Height of crown clearance (m)	Dir/ height	Age class	Condition	Type	General observations Management recommendations	Estimated remaining contribution (years)	Tree Quality Category (BS5837)	Tree Typology	
		N	E	S	W												
T63	<i>Fraxinus excelsior</i> - Ash	10.0	5.0	6.0	4.0	4.0	1210	1.00	2.50	N/5	V	Poor	Field Boundary	Major crown failure, Restricted inspection due to volume of ivy on stem and crown, Ash Dieback present, Scars and rips to crown, Cavity at base appears to be being used by an animal.	20+	C3	Field Boundary

Primary Tree Qualities						
Extensive Decay			Previous aged management	Senescence / Aged decline	Retrenchment / Canopy Reduction	
Brown rot	Exposed heartwood	Hollowing (by %)				
In main stem	X	Main Stem hollow	Natural Pollard	< 20 years to death	50% Retrenching, Live Partial Canopy

Secondary Tree Qualities											
Attached deadwood >150mm dia	Storm Damage	Roosts, nests, crevices	Aerial Roots	Bark flux / Sap	Wet pockets	Bark loss/decay	Fungi		Other epiphytic plants		
							Major	Minor	Lichens	Ferns	Other
Minor extent in crown	Yes	Yes	X	X	X	Stem and crown	Innonotus hispidus to crown	X	>3	X	Ivy

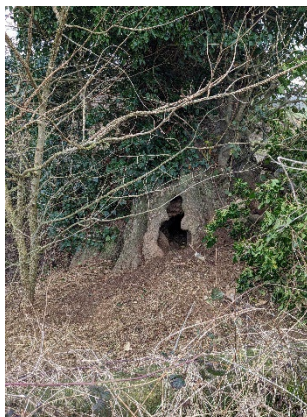
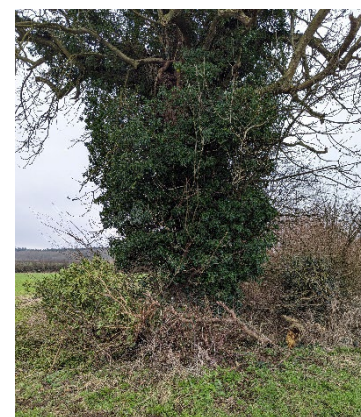
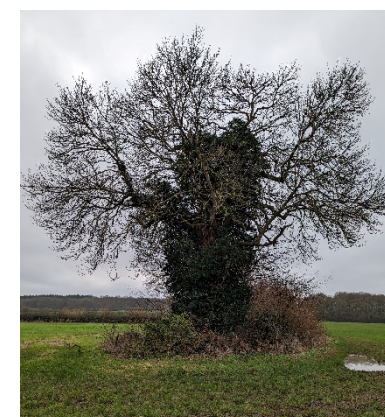
Species	Height (m)	Crown spread (m)				Stem dia. (mm) Including irregularities information	Stem no. at 1.5m	Height of crown clearance (m)	Dir/ height	Age class	Condition	Type	General observations Management recommendations	Estimated remaining contribution (years)	Tree Quality Category (BS5837)	Tree Typology	
		N	E	S	W												
T64	<i>Fraxinus excelsior</i> - Ash	8.0	2.0	3.0	3.0	2.0	950	1.00	0.30	-	V	Poor	Field Boundary	Major crown failure, Restricted inspection due to volume of ivy on stem and crown, Ash Dieback - Moderate extent	<20	C3	Field Boundary

Primary Tree Qualities							
Extensive Decay			Previous aged management		Senescence / Aged decline		Retrenchment / Canopy Reduction
Brown rot	Exposed heartwood	Hollowing (by %)					
None visible	None visible	Main Stem hollow		Natural Pollard		< 20 years to failure	>75% Live residual Canopy

Secondary Tree Qualities												
Attached deadwood >150mm dia	Storm Damage	Roosts, nests, crevices	Aerial Roots	Bark flux / Sap	Wet pockets	Bark loss/decay	Fungi		Other epiphytic plants			
							Major	Minor	Lichens	Ferns	Other	
None outside of stubs	Yes	Possible	X	X	X	Stem and crown	X	X	X	X	Ivy

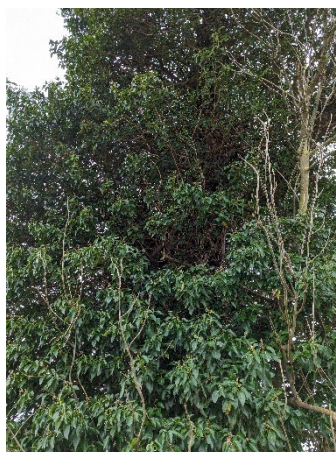
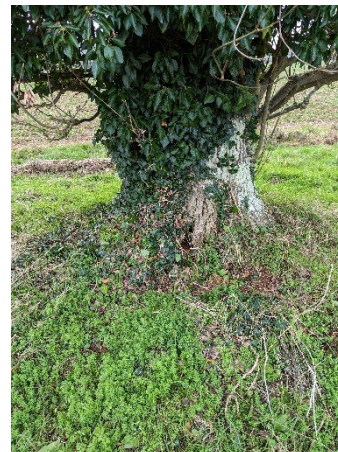
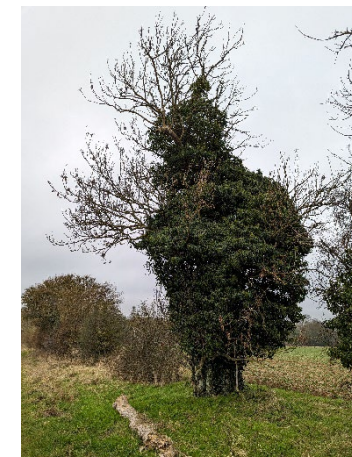
Species	Height (m)	Crown spread (m)				Stem dia. (mm) Including irregularities information	Stem no. at 1.5m	Height of crown clearance (m)	Dir/ height	Age class	Condition	Type	General observations Management recommendations	Estimated remaining contribution (years)	Tree Quality Category (BS5837)	Tree Typology	
		N	E	S	W												
T65	<i>Quercus robur</i> - Pedunculate Oak	18.0	10.0	6.0	5.0	10.0	1080	1.00	4.00	NW/7	V	Fair	Woodland edge/Maiden	Previous branch failures, Stubs, tears and splits in crown, Woodpecker activity in upper crown.	40+	A3	Woodland

Primary Tree Qualities					
Extensive Decay			Previous aged management	Senescence / Aged decline	Retrenchment / Canopy Reduction
Brown rot	Exposed heartwood	Hollowing (by %)			
None visible	None visible	X	Maiden	Mature no clear decline	<10% mostly storm damage

Secondary Tree Qualities											
Attached deadwood >150mm dia	Storm Damage	Roosts, nests, crevices	Aerial Roots	Bark flux / Sap	Wet pockets	Bark loss/decay	Fungi		Other epiphytic plants		
							Major	Minor	Lichens	Ferns	Other
5-10% of crown	Yes	Possible	X	X	X	Localised in crown	X	X	>2	X	Moss/Ivy

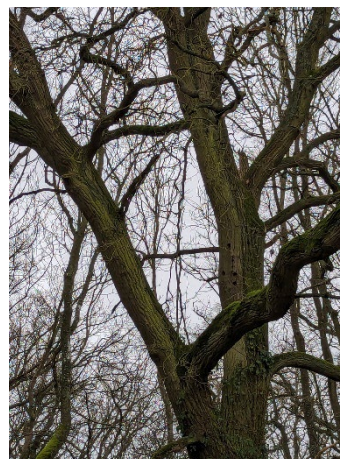
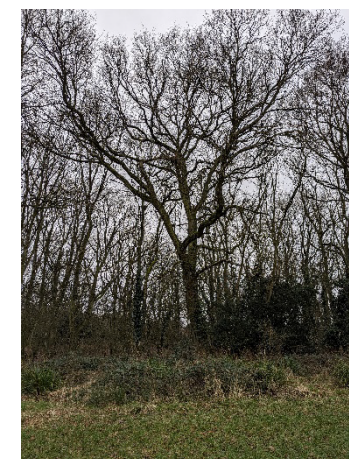
T66	Species	Height (m)	Crown spread (m)				Stem dia. (mm) Including irregularities information	Stem no. at 1.5m	Height of crown clearance (m)	Dir/ height	Age class	Condition	Type	General observations Management recommendations	Estimated remaining contribution (years)	Tree Quality Category (BS5837)	Tree Typology
			N	E	S	W											
	<i>Fraxinus excelsior</i> - Ash	10	7	7	7	6	1430	4	2	NE/3	V	Poor	Field Boundary	Remnant of large multi-stemmed tree, only half of hollow main stem remaining	10+	A3	Field Boundary

Primary Tree Qualities					
Extensive Decay			Previous aged management	Senescence / Aged decline	Retrenchment / Canopy Reduction
Brown rot	Exposed heartwood	Hollowing (by %)			
In main stem	In main stem	>50%	Previously coppice/ pollard	X	Previously reduced along with hedgerow

Secondary Tree Qualities											
Attached deadwood >150mm dia	Storm Damage	Roosts, nests, crevices	Aerial Roots	Bark flux / Sap	Wet pockets	Bark loss/decay	Fungi		Other epiphytic plants		
							Major	Minor	Lichens	Ferns	Other
X	X	Multiple crevasses at base of tree	X	X	X	X	Remnant of Inonotus hispidus Bracket noted	X	X	X	X

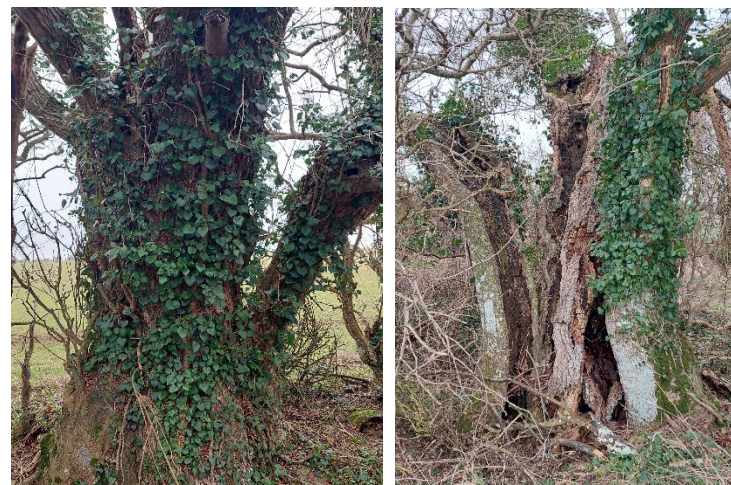
Species	Height (m)	Crown spread (m)				Stem dia. (mm) Including irregularities information	Stem no. at 1.5m	Height of crown clearance (m)	Dir/ height	Age class	Condition	Type	General observations Management recommendations	Estimated remaining contribution (years)	Tree Quality Category (BS5837)	Tree Typology	
		N	E	S	W												
T67	<i>Fraxinus excelsior</i> - Ash	10	7	8	7	7	1650	1	2	NE/2	V	Fair/Poor	Hedgerow/ Maiden	Open Hollow stem to 2m, Previously pollarded to 2m, Crown consists of only regrowth.	20+	A3	Field Boundary

Primary Tree Qualities					
Extensive Decay			Previous aged management	Senescence / Aged decline	Retrenchment / Canopy Reduction
Brown rot	Exposed heartwood	Hollowing (by %)			
X	Open main stem	>75%	Pollarded to 2m	X	Canopy consists only of regrowth following pollard to 2m.

Secondary Tree Qualities											
Attached deadwood >150mm dia	Storm Damage	Roosts, nests, crevices	Aerial Roots	Bark flux / Sap	Wet pockets	Bark loss/decay	Fungi		Other epiphytic plants		
							Major	Minor	Lichens	Ferns	Other
1x hanging in crown	X	Multiple crevices	X	X	X	X	X	X	X	X	X

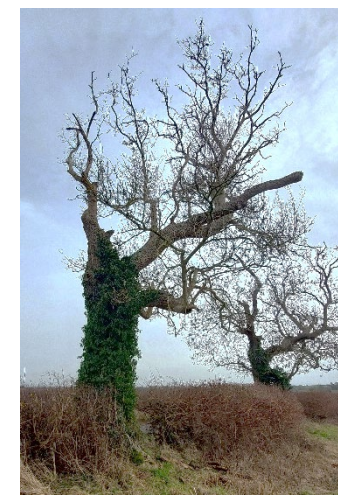
T68	Species	Height (m)	Crown spread (m)				Stem dia. (mm) Including irregularities information	Stem no. at 1.5m	Height of crown clearance (m)	Dir/ height	Age class	Condition	Type	General observations Management recommendations	Estimated remaining contribution (years)	Tree Quality Category (BS5837)	Tree Typology
			N	E	S	W											
	<i>Fraxinus excelsior</i> - Ash	10	1	3	7	5	1050	1	2	S/1	V	Good/ Fair	Field Boundary	Lost main leader, Ivy on main stem.	20+	A3	Field Boundary

Primary Tree Qualities					
Extensive Decay			Previous aged management	Senescence / Aged decline	Retrenchment / Canopy Reduction
Brown rot	Exposed heartwood	Hollowing (by %)			
X	Open wound at main nexus from loss of main leader	X	X	In decline	Crown has begun to retrench

Secondary Tree Qualities											
Attached deadwood >150mm dia	Storm Damage	Roosts, nests, crevices	Aerial Roots	Bark flux / Sap	Wet pockets	Bark loss/decay	Fungi		Other epiphytic plants		
							Major	Minor	Lichens	Ferns	Other
X	Previously lost main leader	Some crevasses around base of tree	X	X	X	X	X	X	X	X	Ivy

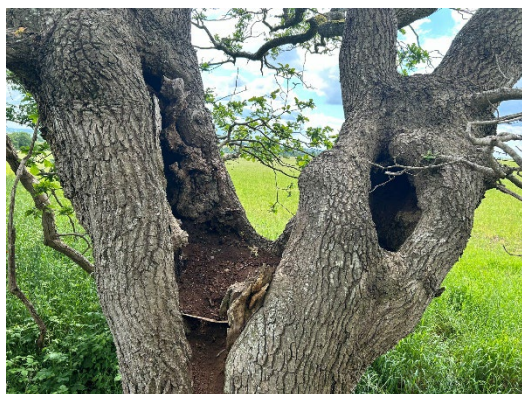
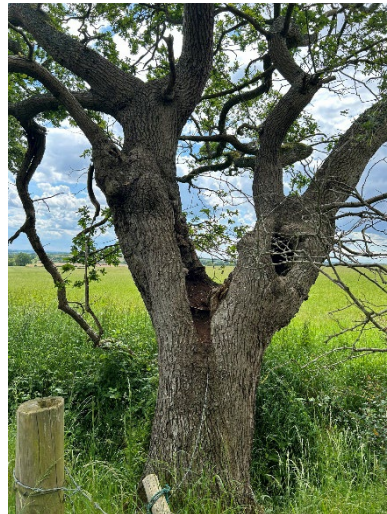
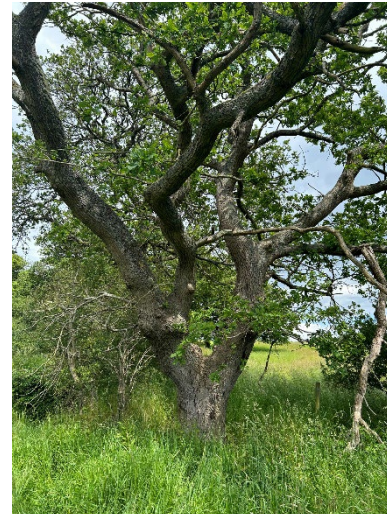
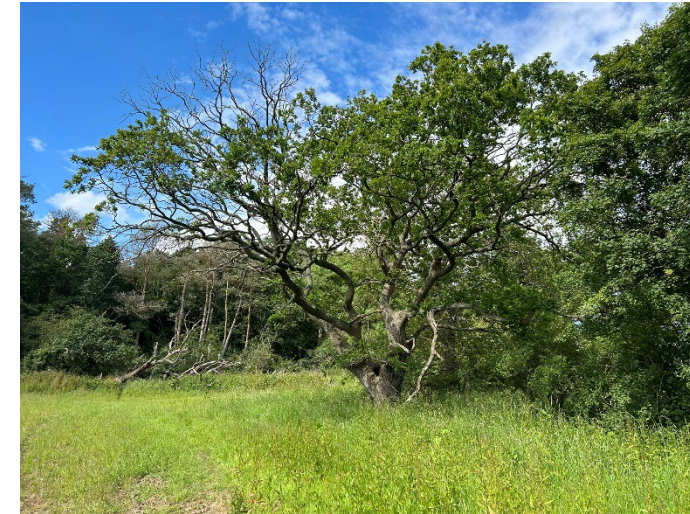
Species	Height (m)	Crown spread (m)				Stem dia. (mm) Including irregularities information	Stem no. at 1.5m	Height of crown clearance (m)	Dir/ height	Age class	Condition	Type	General observations Management recommendations	Estimated remaining contribution (years)	Tree Quality Category (BS5837)	Tree Typology	
		N	E	S	W												
T69	<i>Quercus robur</i> - Pedunculate Oak	11	6	7	10	8	0.98	1	1.5	E	V	F / G	Field boundary	n/a	=40	A3	Field boundary

Primary Tree Qualities					
Extensive Decay			Previous aged management	Senescence / Aged decline	Retrenchment / Canopy Reduction
Brown rot	Exposed heartwood	Hollowing (by %)			
Yes, extensive	Yes, extensive, at forked union.	50%	None, possible fomer pollard of huge bifurcation at 1.9m	Yes, retrenching, large decay in main fork.	Yes, to north west bough dead / decaying.

Secondary Tree Qualities												
Attached deadwood >150mm dia	Storm Damage	Roosts, nests, crevices	Aerial Roots	Bark flux / Sap	Wet pockets	Bark loss/decay	Fungi		Other epiphytic plants			
							Major	Minor	Lichens	Ferns	Other	
Yes, multiple		Mainly crevice type				Huge decay saddle at main union						None, but set on deep, dry ditch (to west)

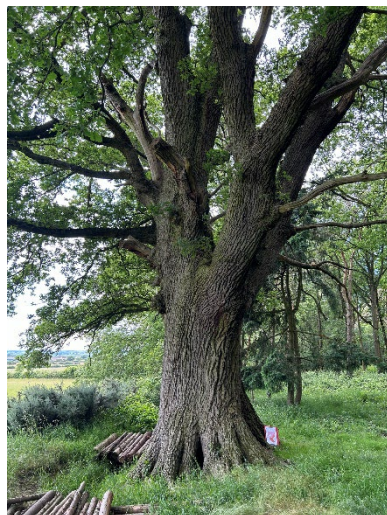
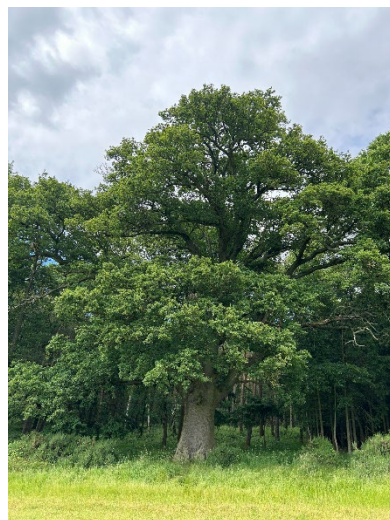
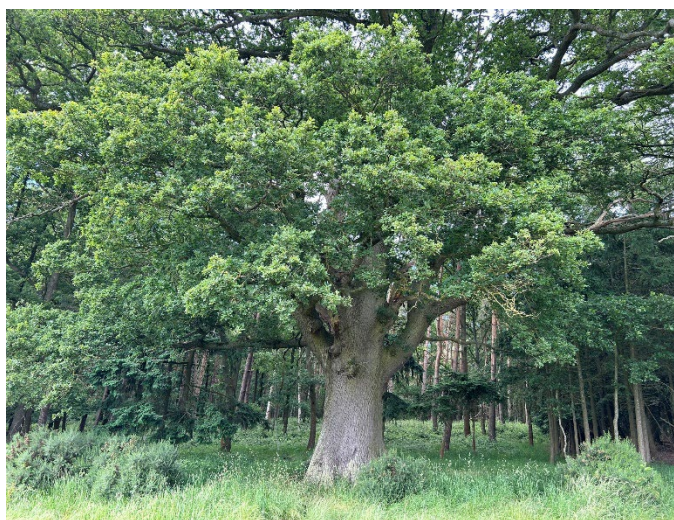
Species	Height (m)	Crown spread (m)					Stem dia. (mm) Including irregularities information	Stem no. at 1.5m	Height of crown clearance (m)	Dir/ height	Age class	Condition	Type	General observations Management recommendations	Estimated remaining contribution (years)	Tree Quality Category (BS5837)	Tree Typology
		N	E	S	W												
T70	<i>Quercus robur</i> - Pedunculate Oak	18	12	14	12	15	1.70	1	2	S	V	G	Woodland	Huge former pollard on ditch	+40	A2/3	Woodland

Primary Tree Qualities					
Extensive Decay			Previous aged management	Senescence / Aged decline	Retrenchment / Canopy Reduction
Brown rot	Exposed heartwood	Hollowing (by %)			
Yes, internal, single hollow at root flare to south leading to deep hollow heartwood.	Single hollow to south	Est. 40%	Pollard at 3-4m. Local children swing, play and bridges beneath canopy.	Major attached deadwood. Decayed stubs	Yes, 25% to north west and north east.

Secondary Tree Qualities											
Attached deadwood >150mm dia	Storm Damage	Roosts, nests, crevices	Aerial Roots	Bark flux / Sap	Wet pockets	Bark loss/decay	Fungi		Other epiphytic plants		
							Major	Minor	Lichens	Ferns	Other
Yes, +300mm		Lifted bark				Yes, on decayed bough

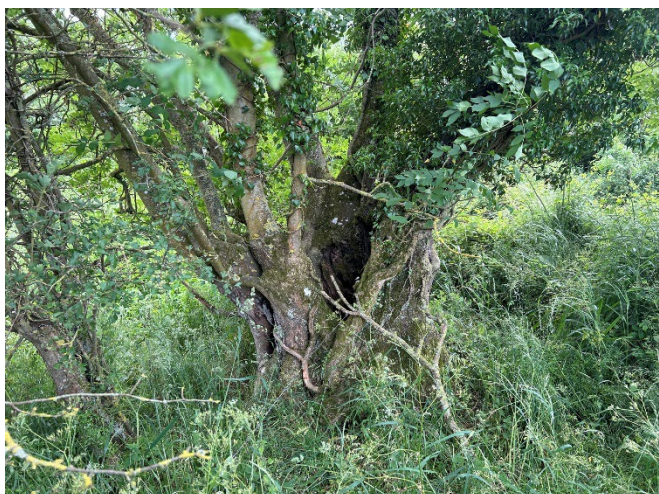
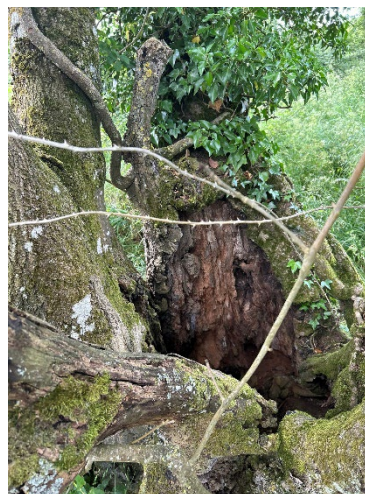
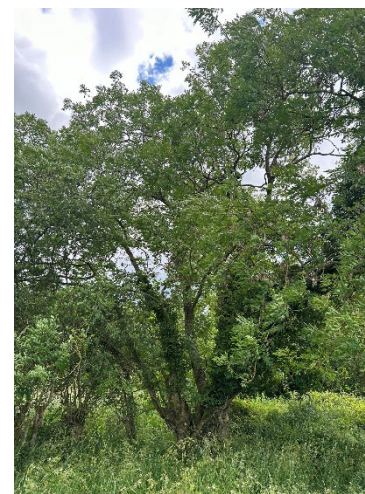
Species	Height (m)	Crown spread (m)				Stem dia. (mm) Including irregularities information	Stem no. at 1.5m	Height of crown clearance (m)	Dir/ height	Age class	Condition	Type	General observations Management recommendations	Estimated remaining contribution (years)	Tree Quality Category (BS5837)	Tree Typology	
		N	E	S	W												
T71	<i>Fraxinus excelsior</i> - Ash	10	5	5	5	6	1.3 (at coppice head)	1	1.8	NW	V	P / F	Hedgerow	Former low pollard or coppice	+10	A3	Hedgerow

Primary Tree Qualities											
Extensive Decay			Previous aged management			Senescence / Aged decline		Retrenchment / Canopy Reduction			
Brown rot	Exposed heartwood	Hollowing (by %)									
Yes, 80%	Yes, 80% in open coppice head	70%	High coppice, or low pollard at 1.4m			Outer cambium decay, circa 30cm open decayed hollow approx. 80-90cm		No, no current ash die back indications.			
Secondary Tree Qualities											
Attached deadwood >150mm dia	Storm Damage	Roosts, nests, crevices	Aerial Roots	Bark flux / Sap	Wet pockets	Bark loss/decay	Fungi		Other epiphytic plants		
							Major	Minor	Lichens	Ferns	Other
		Open decayed heart				Yes, open decayed coppice head

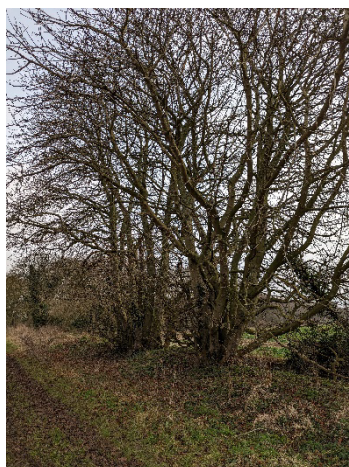
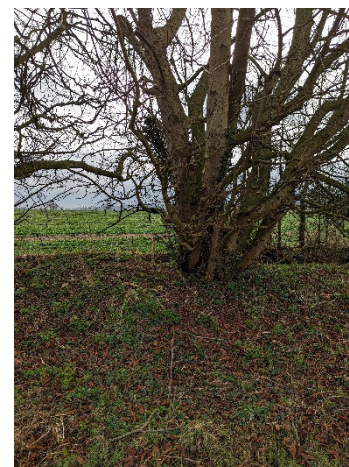
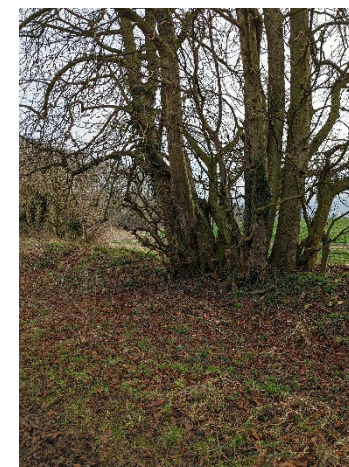
Species	Height (m)	Crown spread (m)				Stem dia. (mm) Including irregularities information	Stem no. at 1.5m	Height of crown clearance (m)	Dir/ height	Age class	Condition	Type	General observations Management recommendations	Estimated remaining contribution (years)	Tree Quality Category (BS5837)	Tree Typology
		N	E	S	W											
G1 <i>Acer pseudoplatanus</i> - Sycamore	10.0	6.0	5.0	6.0	5.0	1000	Multi-stem	0.00	-	EM/V	Fair/Poor	Field Boundary	Growing off old stumps, multi stemmed, Minor deadwood, Crossing branches	20+	B3	Field Boundary

Primary Tree Qualities							
Extensive Decay			Previous aged management		Senescence / Aged decline		Retrenchment / Canopy Reduction
Brown rot	Exposed heartwood	Hollowing (by %)					
None visible	None visible	X		Coppice		Minor decline	None

Secondary Tree Qualities												
Attached deadwood >150mm dia	Storm Damage	Roosts, nests, crevices	Aerial Roots	Bark flux / Sap	Wet pockets	Bark loss/decay	Fungi		Other epiphytic plants			
							Major	Minor	Lichens	Ferns	Other	
5% of crown	X	Possible birds	X	X	X	X	X	X	X	X	X	lvy
