Botley West Solar Farm

Environmental Statement

Appendix 9.15: Veteran Tree Survey Report

November 2024

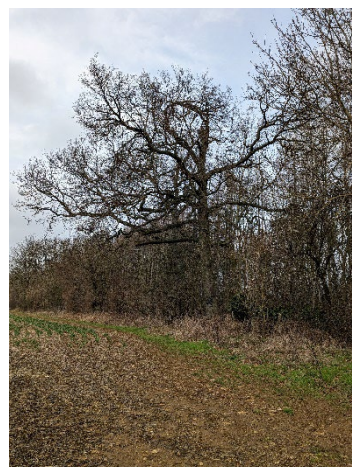
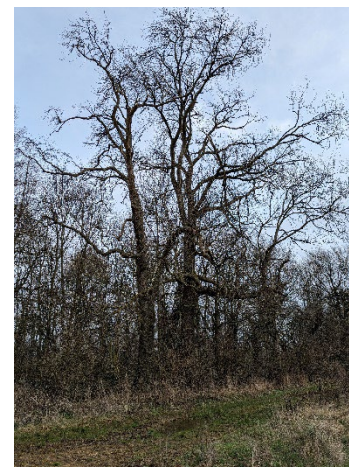
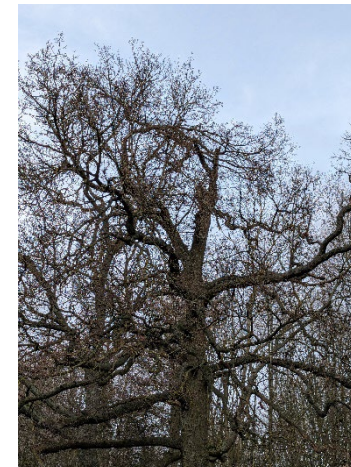
G2	Species	Height (m)	Crown spread (m)				Stem dia. (mm) Including irregularities information	Stem no. at 1.5m	Height of crown clearance (m)	Dir/ height	Age class	Condition	Type	General observations Management recommendations	Estimated remaining contribution (years)	Tree Quality Category (BS5837)	Tree Typology
			N	E	S	W											
	<i>Fraxinus excelsior</i> - Ash / <i>Quercus robur</i> - Pedunculate Oak	25.0	8.0	8.0	8.0	8.0	1080	1.00	3.00	-	V	Fair/Poor	Woodland edge/Maidens	Ash poor Oak fair, Storm damage to crowns, Splits and tears to branches, Moderate deadwood, Ash have signs of Ash Die Back.	40+/20+	A3/C3	Woodland

Primary Tree Qualities						
Extensive Decay			Previous aged management		Senescence / Aged decline	Retrenchment / Canopy Reduction
Brown rot	Exposed heartwood	Hollowing (by %)				
None visible	None visible	X	Maiden		Minor decline	Minor retrenchment

Secondary Tree Qualities												
Attached deadwood >150mm dia	Storm Damage	Roosts, nests, crevices	Aerial Roots	Bark flux / Sap	Wet pockets	Bark loss/decay	Fungi		Other epiphytic plants			
							Major	Minor	Lichens	Ferns	Other	
<10% of canopy	X	Possible birds	X	X	X	Main stem	X	X	>2	X	Ivy

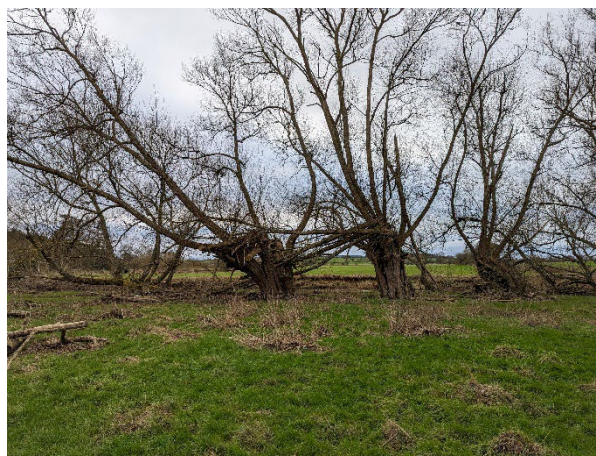
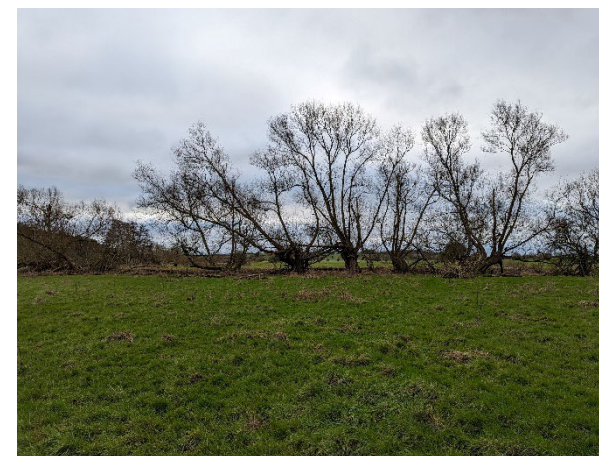
Species	Height (m)	Crown spread (m)				Stem dia. (mm) Including irregularities information	Stem no. at 1.5m	Height of crown clearance (m)	Dir/ height	Age class	Condition	Type	General observations Management recommendations	Estimated remaining contribution (years)	Tree Quality Category (BS5837)	Tree Typology	
		N	E	S	W												
G3	<i>Salix alba</i> - White Willow	15.0	8.0	8.0	8.0	8.0	1000	Multi-stem	0.00	-	V	Poor	River edge	Collapsing trees (6) Main stem split and decayed, Regenerating from failed limbs.	20+	B3	Riverside

Primary Tree Qualities					
Extensive Decay			Previous aged management	Senescence / Aged decline	Retrenchment / Canopy Reduction
Brown rot	Exposed heartwood	Hollowing (by %)			
Main stem	80% of main stem	N/A	Pollard	Reducing as collaping	Collapsing not retrenching

Secondary Tree Qualities											
Attached deadwood >150mm dia	Storm Damage	Roosts, nests, crevices	Aerial Roots	Bark flux / Sap	Wet pockets	Bark loss/decay	Fungi		Other epiphytic plants		
							Major	Minor	Lichens	Ferns	Other
20% in crown	Yes	Possible birds and bats	X	X	X	Main stem	X	X	1	X	Moss
