Southampton to London Pipeline Project

Environmental Statement (Volume D)
Appendix 7.7: Bat Factual Report (1 of 3)

Appendix 7.7: Bat Factual Report

B2325300-JAC-000-ENV-APP-000077

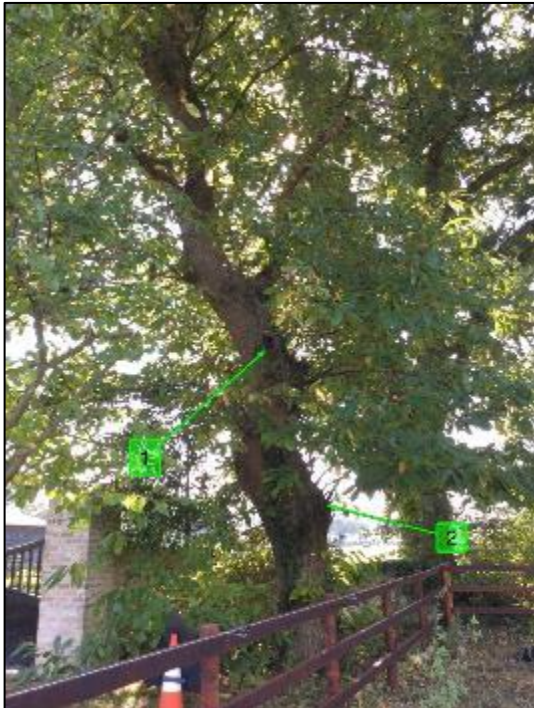
Photograph 1: Tree 180_00329, Land Parcel 180, 05/10/2018, standard lens.

Tree 180_00329 was a semi-mature sweet chestnut growing between a wall and a fence. This tree had knot holes at 5m on the eastern aspect and at 2m on the south east aspect. Both features were downgraded from moderate to low suitability to support roosting bats following aerial survey as they offered limited shelter (see photograph 1 below).

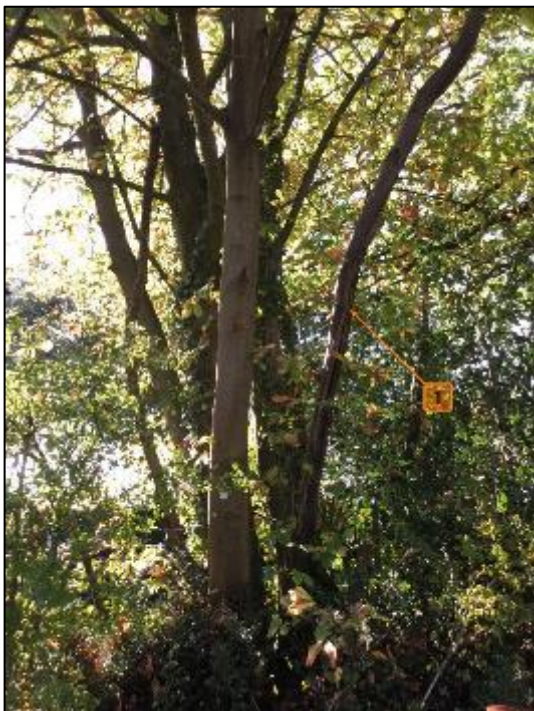
Photograph 3: Tree 180_00331, Land Parcel 180, 05/10/2018, standard lens.

Tree 180_00331 was a group of semi-mature sweet chestnuts west of the pipeline route. A wound present at 2.5m on the northern aspect was re-classified from moderate to high suitability to support roosting bats following aerial survey. The feature had an entrance of 30cm x 1cm and led upwards 15cm in a tube shelter leading to a cone apex. Some woodlice and slugs were present, but the feature was dry and secure (see photograph 3 below).

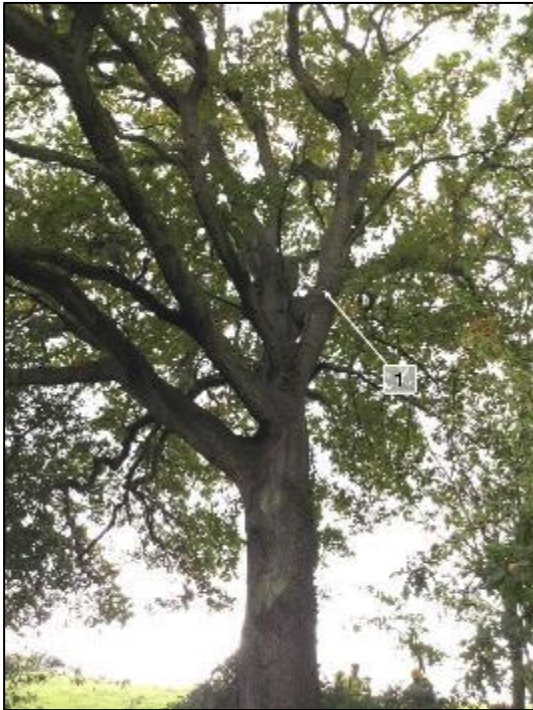
Photograph 4: Tree 200_4_00547, Land Parcel 200, 20/09/2018, standard lens

Tree 200_4_00547 was a mature oak in a hedge adjacent to an arable field. The survey recorded one woodpecker hole on the eastern aspect of the main stem at approximately 8.5m height. Further survey downgraded the tree from moderate to negligible suitability to support roosting bats due to the high quantity of heartwood present, blocking much of the hole, and lack of suitable roosting features (see photograph 4 below).

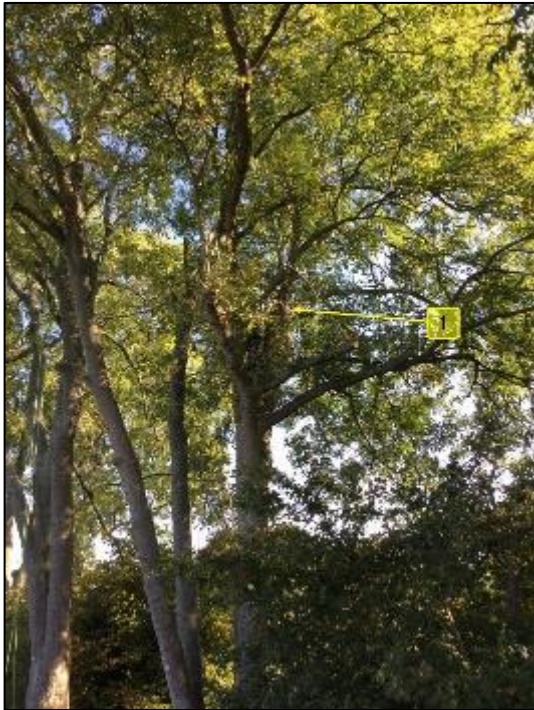
Photograph 6: Tree 420_00327, Land Parcel 420, 05/10/2018, standard lens

Tree 420_00327 was a mature multi-stemmed ash by the main gate on Cross Lane with evidence of decay. The survey recorded woodpecker holes on the south east aspect of a dead limb with soft heartwood at approximately 8 metres height; further survey showed that these led back 7cm. Butt rot was observed at the base of the trunk, with an opening of 20cm by 10cm, depth of 10cm and internal cavity approximately 1.1m high with an internal diameter of 10cm. This was confirmed to have moderate suitability to support roosting bats due to being very low to the ground and obscured by vegetation (see photograph 6 below).

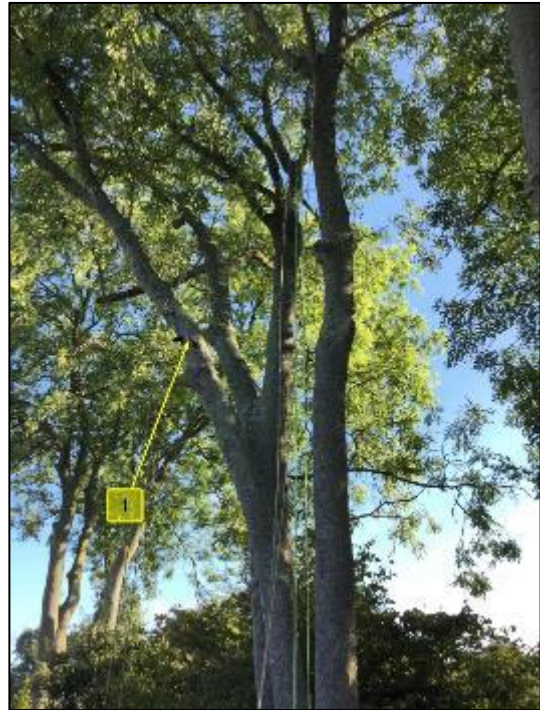
Photograph 7: Tree 420_00326, Land Parcel 420, 05/10/2018, standard lens

Tree 420_00326 was a mature multi-stemmed ash by the main gate on Cross Lane. The survey recorded a wound on the south aspect of the main stem at approximately 7m height, with a bracket fungus indicating a possible cavity. Further survey confirmed this, showing a hole of 3cm by 6cm leading down 10cm with a rotten, wet base. Overall suitability was confirmed as moderate after aerial inspection (see photograph 7 below).

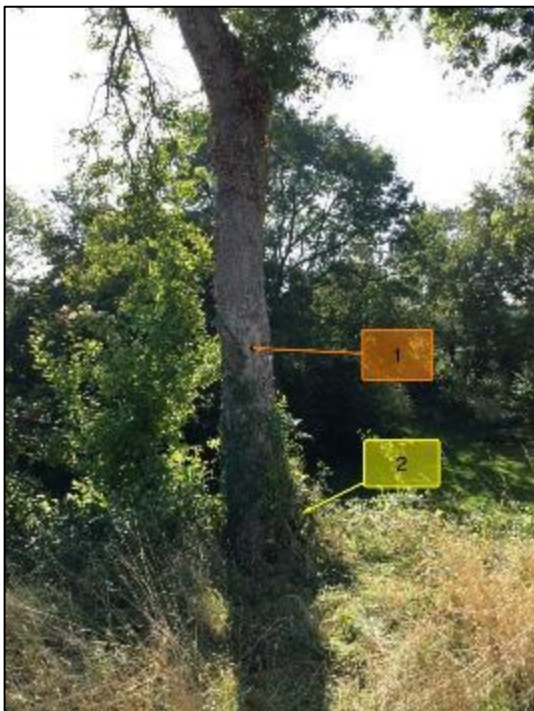
Photograph 8: Tree 420_00325, Land Parcel 420, 05/10/2018, standard lens

Tree 420_00325 was a mature ash by the main gate on Cross Lane. The survey recorded several knot holes on the north west aspect of the main stem at approximately 1.5m height. Further surveys showed an entrance of 5cm by 3cm leading to a dry and clean 1m high cavity with a wedged apex. Survey also noted butt rot at the base of the main trunk on the west aspect; an entrance of 30cm by 60cm leading down to a depth of approximately 20cm and a height of 60cm. A possible bird nest was present at top of the domed cavity with vegetation covering the entrance. Classification of high suitability to support roosting bats was confirmed during aerial survey (see photograph 8 below).

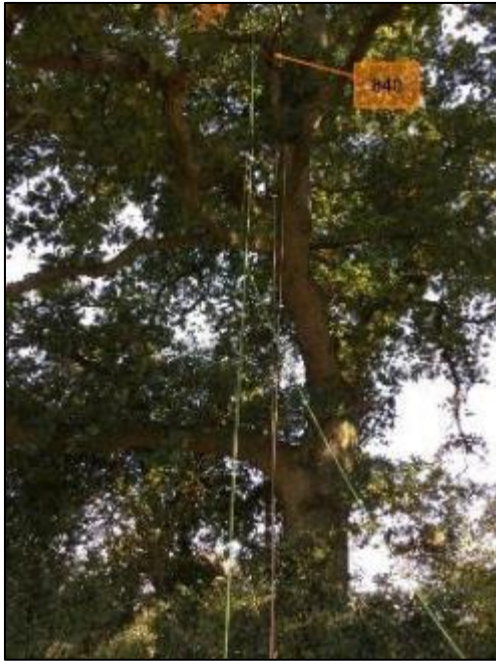
Photograph 10: Tree 441_7_00840, Land Parcel 441, 05/10/2018, standard lens.

Tree 441_7_00840 was a mature oak in hedgerow 10 metres north west of a gap in the hedgerow in a farm yard. The survey recorded a cluster of three woodpecker holes on the south west aspect of a limb at approximately 10m height. Further survey re-classified this tree from having moderate to high suitability to support roosting bats; the woodpecker holes were of 4cm diameter and lead approximately 12cm to multiple cavities back along the branch. The cavities were clean, dry, secure, smooth and contained material from a defunct squirrel drey (see photograph 10 below).

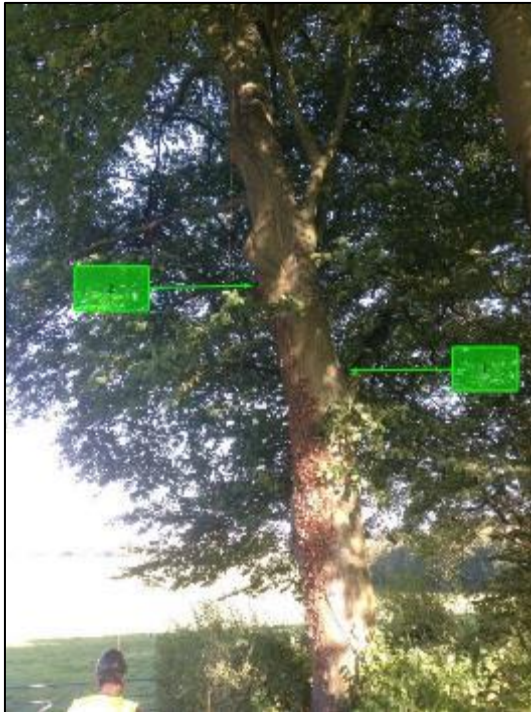
Photograph 13: Tree 22360_14_01805, Land Parcel 22360, 27/09/2018, standard lens.

Tree 22360_14_01805 was a mature beech with knot holes at 3m height on the northern aspect and 4.5m height on the southern aspect. The lower knot hole was 5cm in diameter at the entrance and went 15cm back into the tree, however the hole was damp and exposed, offering low suitability for roosting bats and the higher knot hole was shallow and exposed, so considered to have negligible suitability to support roosting bats. Overall this tree was downgraded from moderate to low suitability to support roosting bats following aerial inspection (see photograph 13 below).

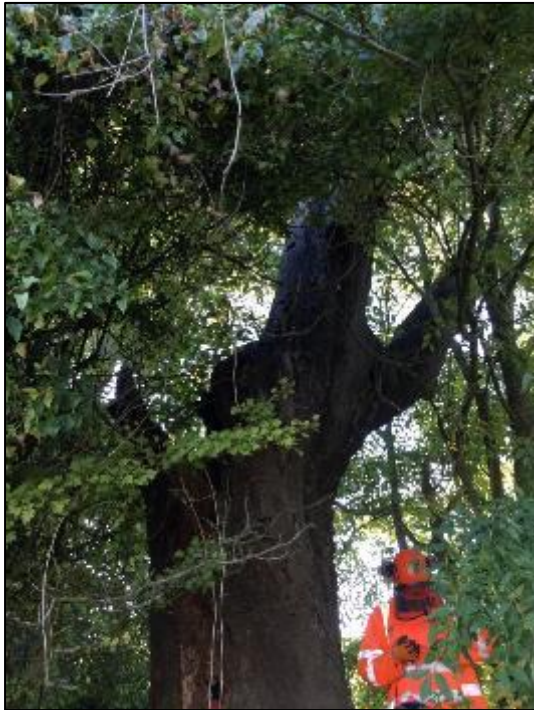
Photograph 14: Tree 740_00339, Land Parcel 740, 10/09/2018, standard lens

Tree 740_00339 was a mature beech tree that has snapped off at 5m height. Wounds on the south aspect between 0m and 5m with rot all over, providing cavities with limited shelter. Overall suitability was re-classified from moderate to low after aerial inspection (see photograph 14 below).

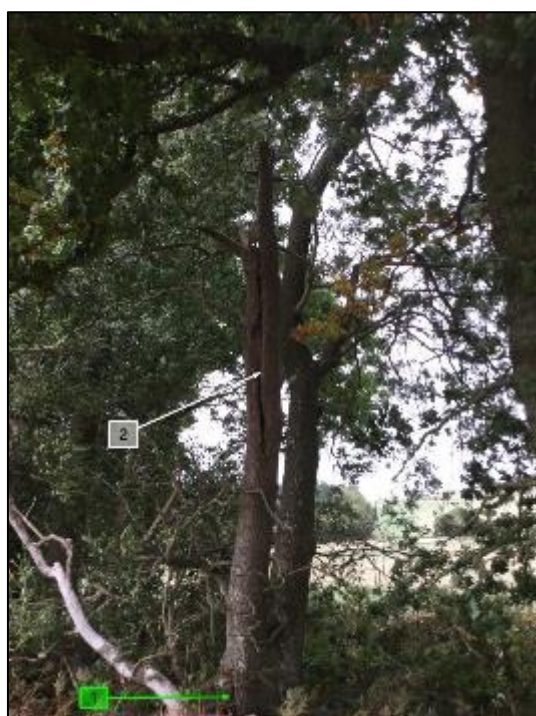
Photograph 25: Tree 820_28_00931, Land Parcel 802, 20/09/2018.

820_28_00931	N	No change	Low	Low
--------------	---	-----------	-----	-----

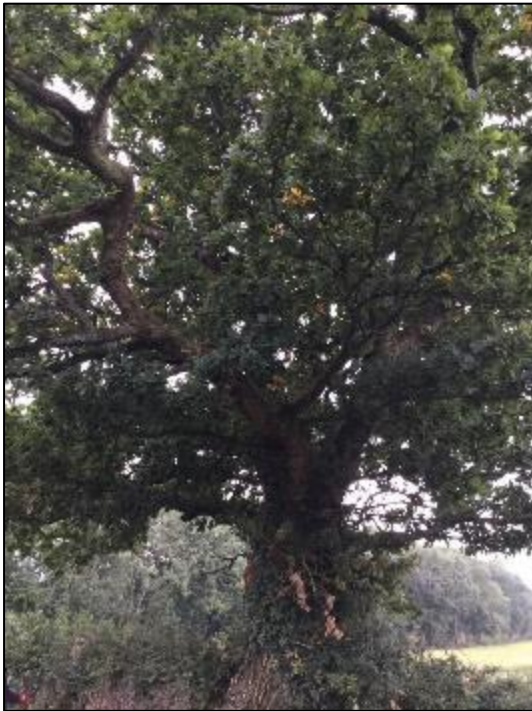
Photograph 26: Tree 840_31_00947, Land Parcel 840, 20/09/2018, standard lens.

Tree ID	Climbed (Y/N)	Re-classified? (up down or no change)	Original Classification following GBBRA	Classification after aerial inspection
840_31_00947	Y	Down	Moderate	Negligible
840_30_00942	Y	No change	High	High

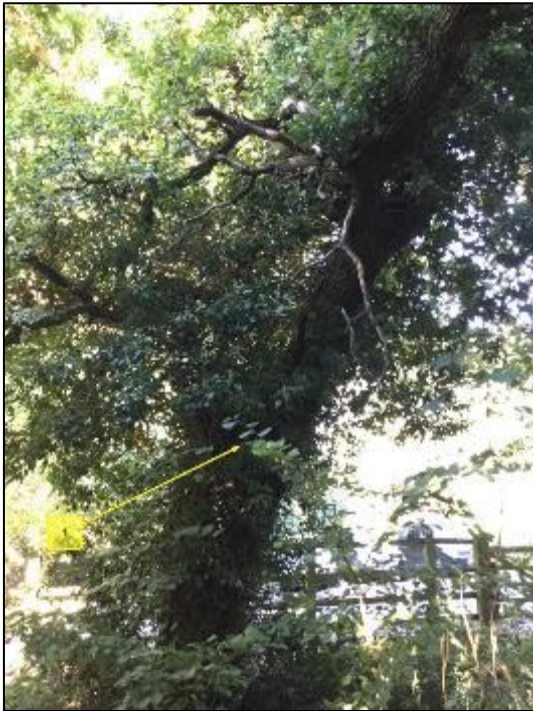
Tree 3230_089_01880 was a double-stemmed Oak species with a pruning cut at 3m on the eastern aspect with rotten heartwood inside and a hole extending horizontally backwards 12cm with a bowl-shaped base. This feature was found to offer limited shelter so was considered to have low bat roost suitability. A woodpecker hole was also present at 2.5m on the eastern aspect that lead backwards 12cm with additional minor crevices off the main hole and was dry with a bumpy surface internally. This feature, and the tree overall were confirmed to have moderate suitability to support roosting bats following aerial inspection.

Photograph 101: Tree 3230_089_01880, Land Parcel 3230, 17/09/2018, standard lens.

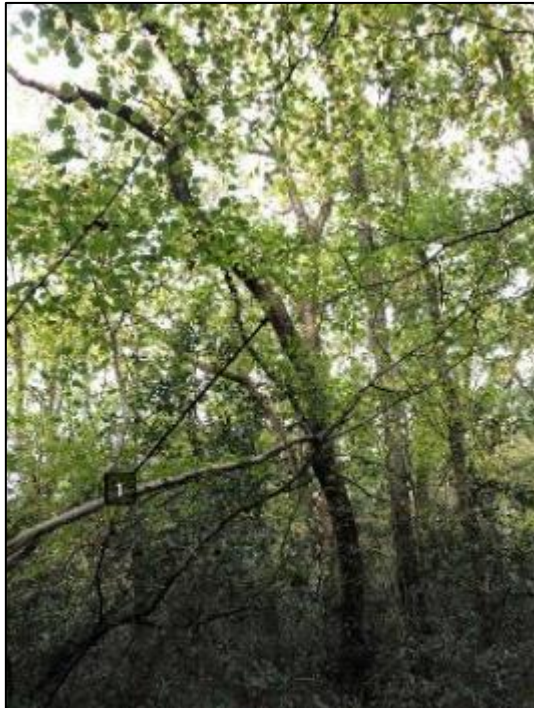
Tree 3200_993 was a mature oak in a woodland area, close to two others. This tree was initially assessed using a high-powered torch from the ground. Knot holes and a wound were both present at 5m on the eastern aspect. Following closer inspection both features were downgraded from moderate to negligible suitability to support roosting bats as they were shallow offering limited shelter (see photograph 103 below).

Photograph 103: Tree 3200_993 Land Parcel 3200, 03/10/2018, standard lens.

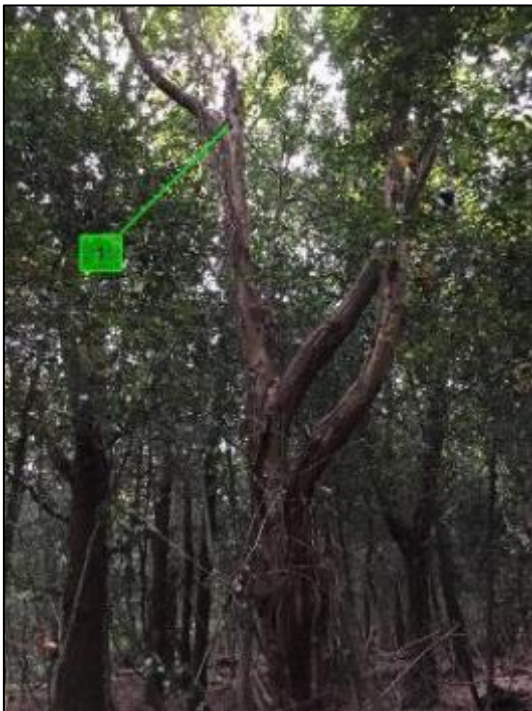
Tree 3200_91_01848 was a dead tree of unknown species with a woodpecker hole at 6m on the western aspect. This tree was considered unsafe to climb; however, the hole was inspected with a torch and endoscope from ground level and was found to be very exposed with limited shelter. This tree was downgraded from moderate to low suitability to support roosting bats (see photograph 104 below).

Photograph 104: Tree 3200_91_01848 Land Parcel 3200, 03/10/2018, standard lens.

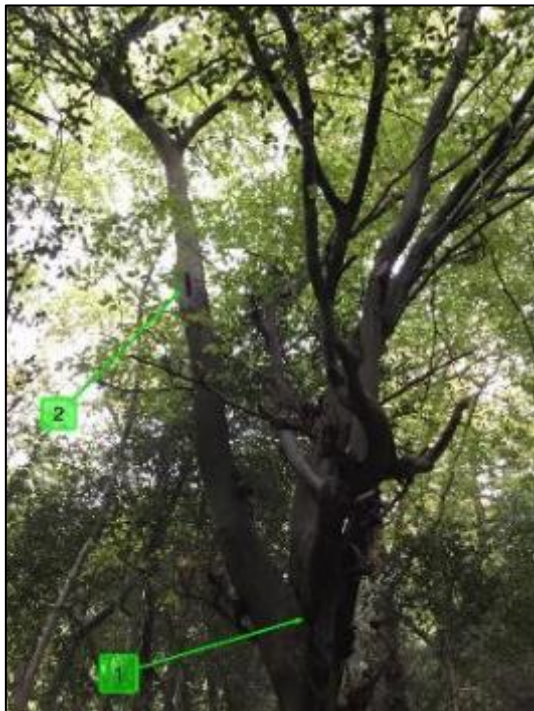
Tree 3200_1640 was a mature multi-stemmed beech in open woodland with two wounds at 2m and 5m on the northern aspect of the main stem. These features were found to offer limited shelter during aerial inspection and were downgraded from moderate to low suitability to support roosting bats (see photograph 105 below).

Photograph 105: Tree 3200_1640 Land Parcel 3200, 03/10/2018, standard lens.

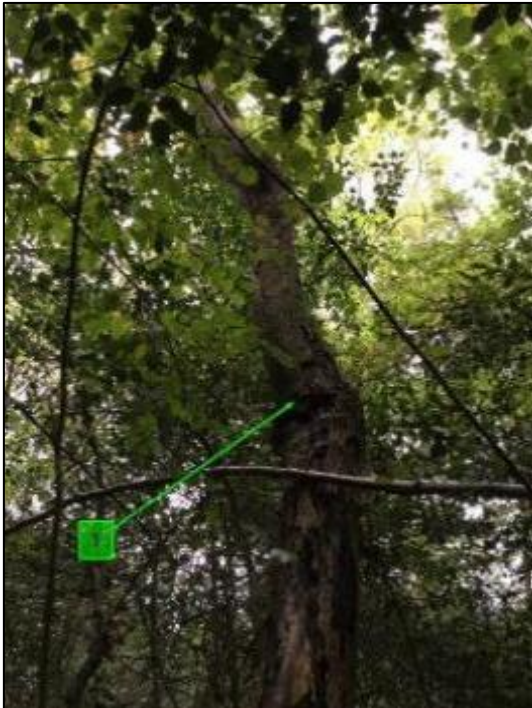
Tree 3200_992 was a dead tree missing much of its bark and with a large lifted bark plate at 2m on the eastern aspect. This tree was considered unsafe to climb, however was inspected from the ground during climbing surveys using an endoscope from the ground level and downgraded from moderate to low suitability to support roosting bats due to it being rotten, soft wood with a dense covering of cobwebs and debris leaving little space behind the bark plates (see photograph 106 below).

Photograph 106: Tree 3200_992 Land Parcel 3200, 03/10/2018, standard lens.

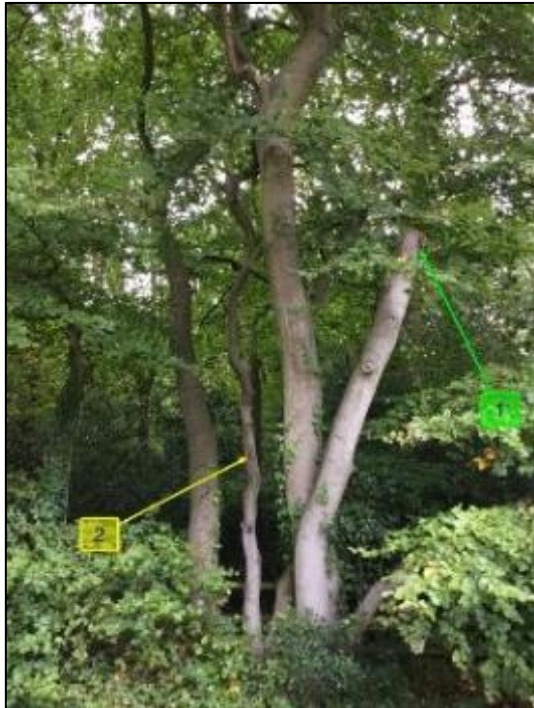
Tree 3200_91_01846 was a mature beech close to the side of a road. A wound at 2.5m on the southern aspect was confirmed as having low suitability to support roosting bats as it had a very narrow entrance just 6mm wide. A woodpecker hole at 4m on the southern aspect was downgraded from moderate to low suitability as it didn't extend more than 5cm into the tree and was dirty inside. Overall this tree was re-classified from moderate to low suitability to support roosting bats following aerial inspection (see photograph 107 below).

Photograph 107: Tree 3200_91_01846 Land Parcel 3200, 03/10/2018, standard lens.

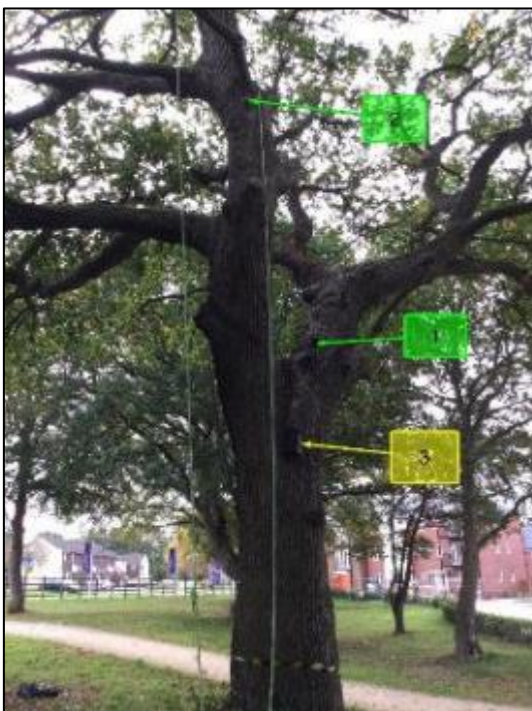
Tree 3200_885 was a mature oak with a bat box on it. Two knot holes were downgraded to negligible bat roost suitability as they were found to be shallow and exposed. The bat box was fairly old, had cobwebs around the entrance at the time of survey and was being used as a birds' nest, however still had potential for roosting bats. Overall this tree was confirmed to have moderate suitability to support roosting bats following aerial inspection (see photograph 108 below).

Photograph 108: Tree 3200_885 Land Parcel 3200, 03/10/2018, standard lens.

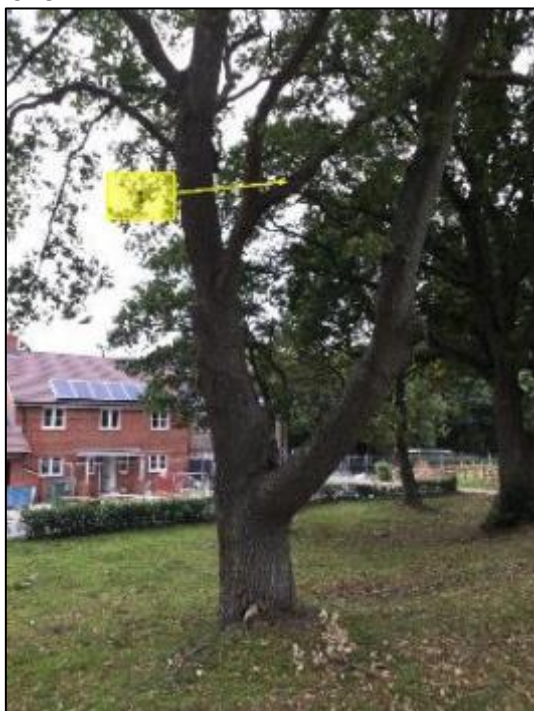
Tree 3200_939 was a mature oak with a hazard beam from a split branch at 4m on the south east aspect. This feature was found to offer moderate bat roost suitability, it was a 35cm by 2cm split leading into a 12cm cavity at the top with a conical apex. There were numerous slugs and woodlice present but inside was sheltered and secure. This tree was confirmed as having moderate suitability to support roosting bats following aerial inspection (see photograph 109 below).

Photograph 109: Tree 3200_939 Land Parcel 3200, 03/10/2018, standard lens.

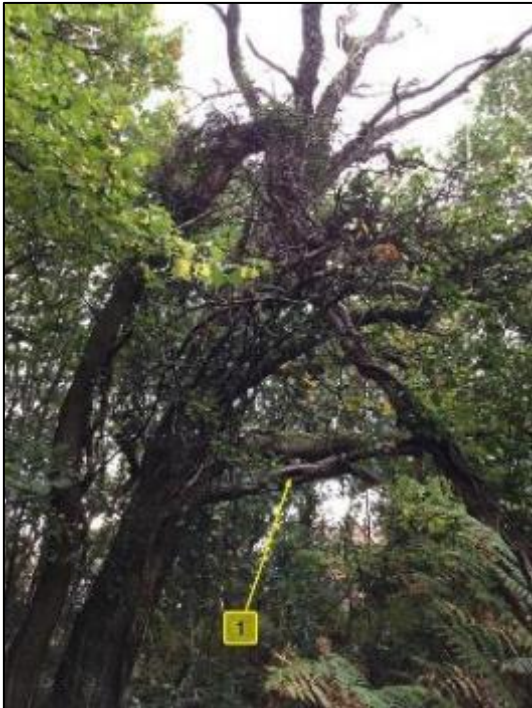
Tree 3200_995 was a dead tree of unknown species with a tear out at 2m on the southern aspect less than a meter from the main trunk. The feature had a 2-3cm entrance into a cavity which lead 15cm into the branch with a cone apex, was dry and secure and offered shelter behind a callous. This tree was confirmed to have moderate suitability to support roosting bats following aerial inspection (see photograph 110 below).

Photograph 110: Tree 3200_995 Land Parcel 3200, 03/10/2018, standard lens.

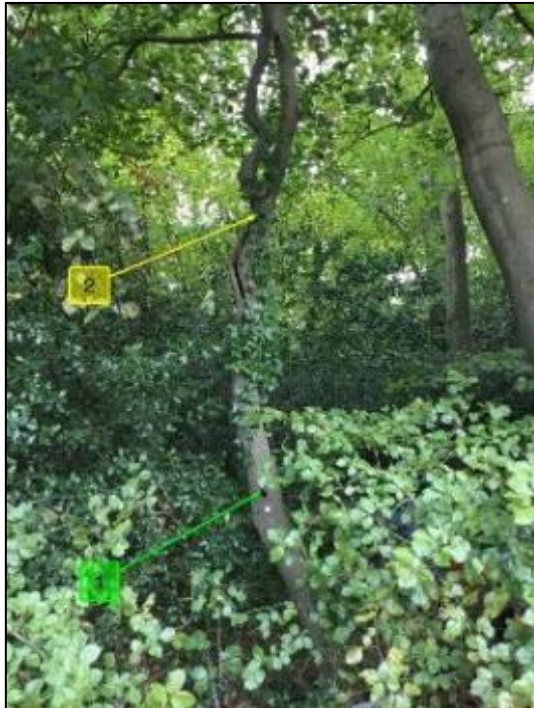
Tree 3200_91_01847 was a semi-mature beech close to the side of the road with two features that were subject to aerial survey. A knot hole present at 1m on the western aspect was downgraded to low suitability following aerial survey as it was small and very dirty with an obstructed drop zone. A large frost crack approximately 1m long at 3m height on the western aspect was confirmed as having moderate suitability to support roosting bats. It had a hollow stem leading upwards 40cm with a bumpy substrate and some cobwebs and debris inside. Overall this tree was confirmed to have moderate suitability to support roosting bats following aerial inspection (see photograph 111 below).

Photograph 111: Tree 3200_91_01847 Land Parcel 3200, 03/10/2018, standard lens.

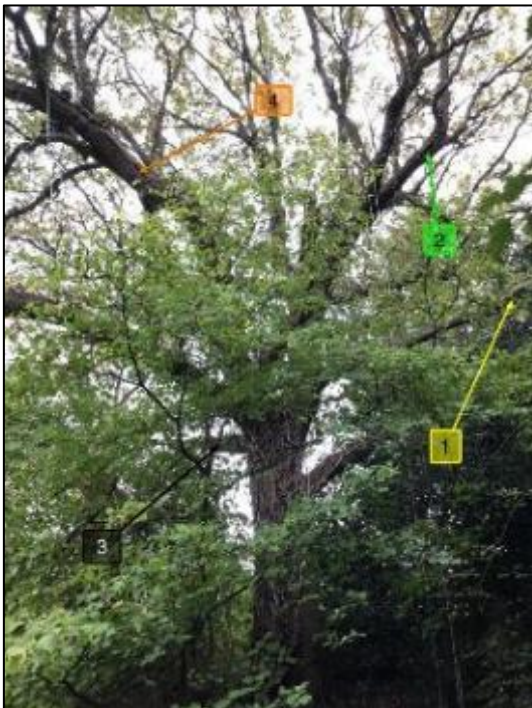
Tree 3200_887 was a very large oak overhanging the surrounding trees with multiple suitable roost features. Two features were downgraded from moderate to low and negligible suitability respectively following aerial inspection; a wound at 14m on the western aspect and a transverse snap from a large broken limb with splits along the remaining portion at 8m on the southern aspect. A transverse snap from another large broke limb was present at 10m on the western aspect that was found to have moderate bat roost suitability as it sloped downwards 20cm with a cone apex but was dirty with debris inside. A wound present at 13m on the north east aspect was confirmed as having high bat roost suitability following aerial survey it had a 5cm x 6cm entrance which narrowed and lead diagonally upwards 1m into a cavity with a wedge apex. Internally the feature was dry, smooth and secure. Overall this tree was confirmed to have high suitability to support roosting bats following aerial inspection (see photograph 112 below).

Photograph 112: Tree 3200_887 Land Parcel 3200, 03/10/2018, standard lens.

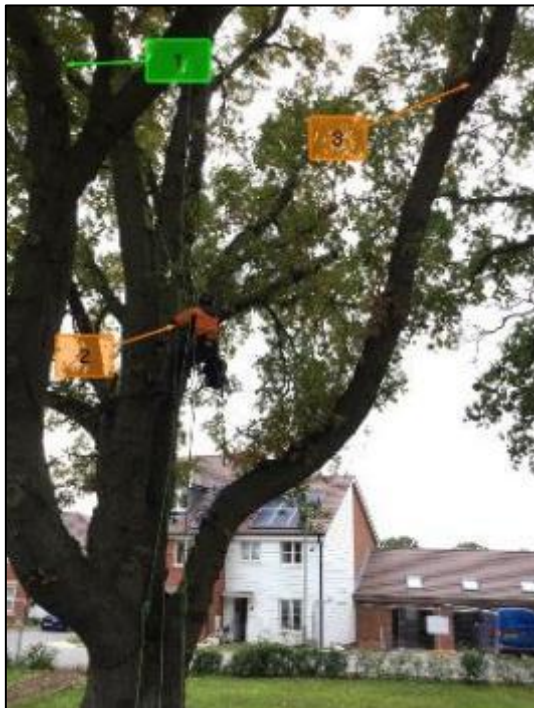
Tree 3200_884 was a mature oak with three suitable roost features that were subject to aerial survey. One feature, a wound at 4m on the southern aspect was found to be shallow and exposed and was downgraded from low to negligible suitability. A tear out at 7m on a branch on the south east aspect had a cavity behind with a 3x6cm entrance which lead upwards 80cm within the branch with additional crevices inside. Internally this feature was dry, smooth, secure and sheltered. A hazard beam was also present at 6m on the southeast aspect which was split 4m from the main

stem with a 4cm wide opening, extending 80cm with sheltered 15cm wedges at either end. Internally the space was smooth and clean with some woodlice and several cobwebs present. Overall this tree was re-classified from moderate to high suitability to support roosting bats following aerial inspection (see photograph 113 below).

Photograph 113: Tree 3200_884 Land Parcel 3200, 03/10/2018, standard lens.

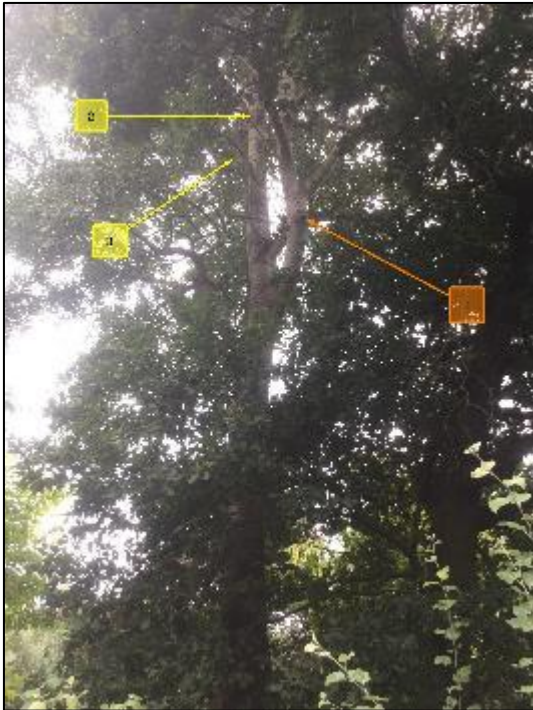
Tree 10530_00900 was a mature twin stem ash with two wound holes that were subject to aerial survey. One wound on the lowest branch at 6m height on the southern aspect was thought to have high suitability to support roosting bats, the hole was 7x7cm at the entrance with an internal width of 20cm. The feature extended outwards from the stem 2cm and in towards the stem 80cm. Internally this feature was smooth, clean and dry. The second wound was on one of the top stems, at 15m height on the southern aspect. This feature was thought to have moderate suitability to support roosting bats, with an entrance of 10x5cm and an internal width of 15cm. The feature went upwards 5cm with a chambered top and extended 20cm downwards. Internally the feature was dry and smooth but there were some woodlice at the base as well as some nesting material. Overall this tree was considered to have high suitability to support roosting bats (see photograph 165 below).

Photograph 165: Tree 10530_00900, Land Parcel 10530, 05/09/2018, standard lens.

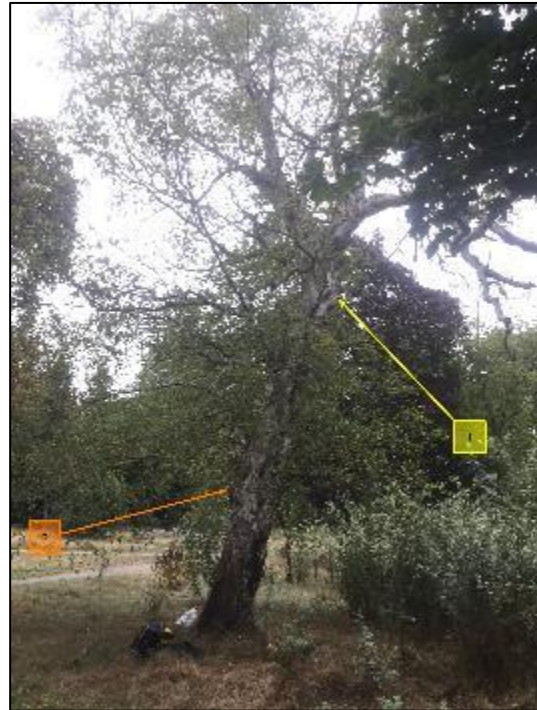
Tree 10530_00898 was a mature poplar tree with four features that were subject to aerial survey. A knot hole present at 13m height on the east aspect was downgraded to low suitability as it was open at the top, lead downwards only and offered limited shelter. Two knot holes were considered to have moderate suitability to support roosting bats; both were on the north west aspect, one at 11.5m height and one at 12m height. The higher knot hole was on the base of a snapped branch on the main stem, went upwards 8cm with a wedge apex within the tree, but was covered with cobwebs. The lower knot hole was on a vertical branch from the main stem, lead downwards 40cm within the tree and was very exposed with some debris and numerous earwigs, however it led 25cm upwards to a vertical dead branch. A knot hole at 10m height on the south west aspect of the secondary stem was considered to have high suitability to support roosting bats. This feature was a squirrel drain with a chambered edge apex and lead upwards 40cm with a few slugs and woodlice within. Overall this tree was considered to have high suitability to support roosting bats (see photograph 166 below).

Photograph 166: Tree 10530_00898, Land Parcel 10530, 05/09/2018, standard lens.

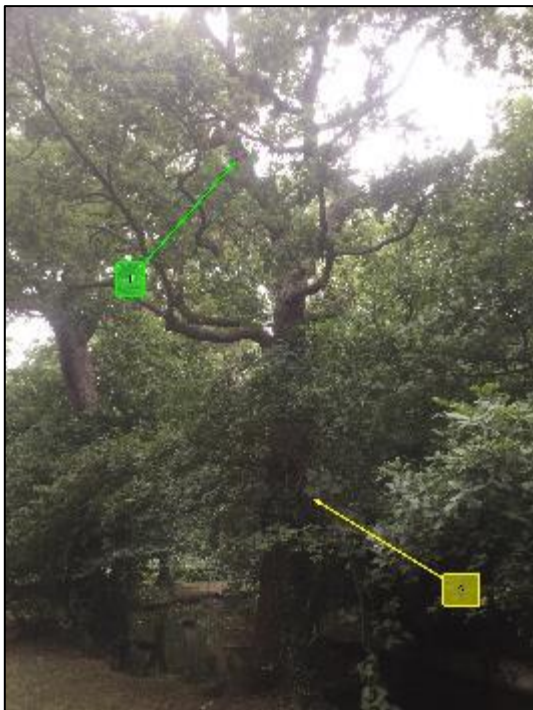
Tree 10230_00904 was a mature oak tree with two features that were subject to aerial survey. The first, a large wound at 7m height on the eastern aspect, was found to have low suitability to support roosting bats as it was a largely open wound with bird feathers inside, offering limited shelter. The second feature was a woodpecker hole at 3m height on the northern aspect. This feature was considered to have moderate suitability to support roosting bats as it led backwards 50cm into the stem and was dry and dusty inside, offering good shelter. Overall this tree was considered to have moderate suitability to support roosting bats (see photograph 168 below).

Photograph 168: Tree 10230_00904, Land Parcel 10230, 06/09/2018, standard lens.

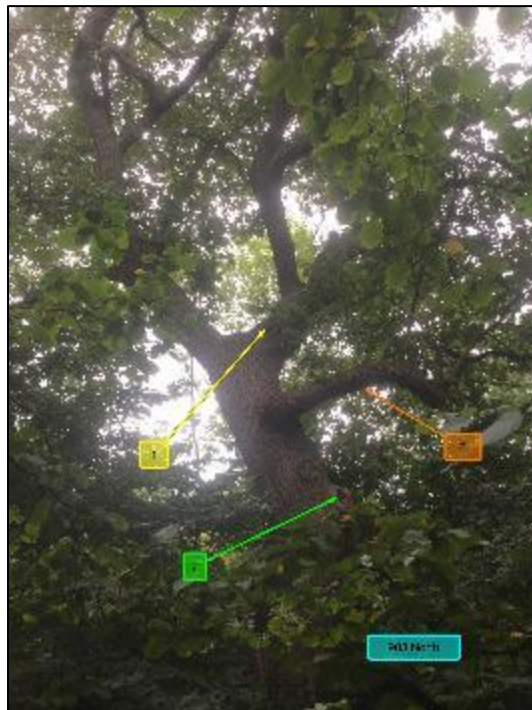
for roosting bats. Two features were considered to have moderate suitability to support roosting bats; knot holes present at 2.5m height on the south aspect and at 3m height on the south east aspect. Lastly, a woodpecker hole present at 6m height on the northern aspect was considered to have high suitability to support roosting bats; the hole was on a branch over a stream and faced downwards, the entrance was 7x7cm with an internal width of 8cm. The feature went 15cm in towards the stem and 3cm away from the stem. Internally there was some debris the substrate was smooth, dry and mostly clean. Overall this tree was considered to have high suitability to support roosting bats (see photograph 169 and 170 below).

Photograph 169: Tree 10230_00903 northern aspect, Land Parcel 10230, 06/09/2018, standard lens.

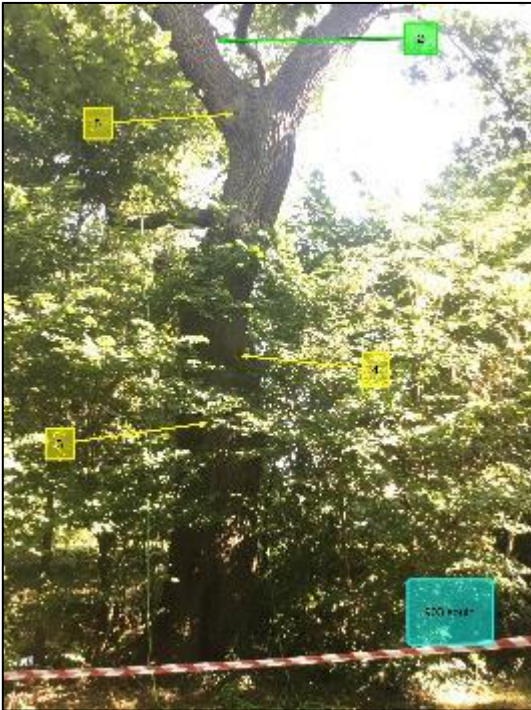
Photograph 170: Tree 10230_00903 southern aspect, Land Parcel 10230, 06/09/2018, standard lens.

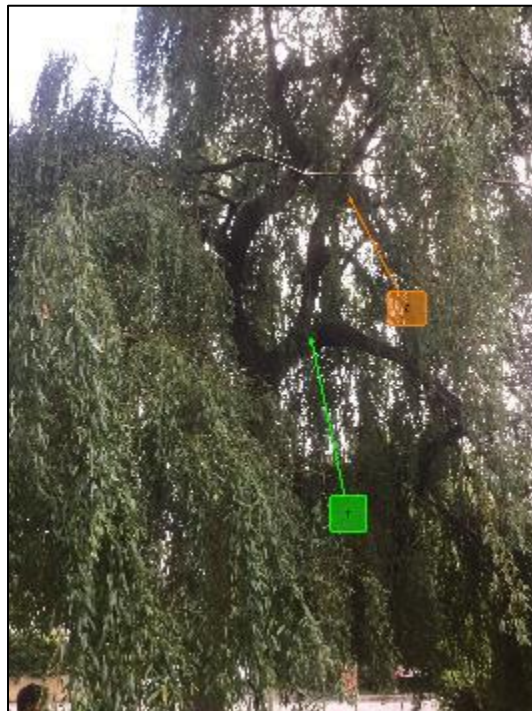
found to be very open, offering limited shelter and considered to have low suitability to support roosting bats. A second feature was a transverse snap, a snapped limb at 4.5m height on the southeast aspect. This feature lead inwards 60cm but got increasingly narrow further in, it was partly open but very secure, so was considered t have moderate suitability to support roosting bats. Lastly, a desiccation fissure, a hollow cavity within the limb located at 7m height on the south west aspect was considered to have high suitability to support roosting bats. This feature had an entrance of 10x5cm and extended upwards 15cm into a clean chamber. Internally the feature was smooth, dry and secure. A secondary egress was present extending backwards 40cm which was dry, smooth and clean internally. Overall this tree was confirmed to have high suitability to support roosting bats (see photograph 172 below).

Photograph 172: Tree 10300_00891, Land Parcel 10300, 06/09/2018, standard lens.

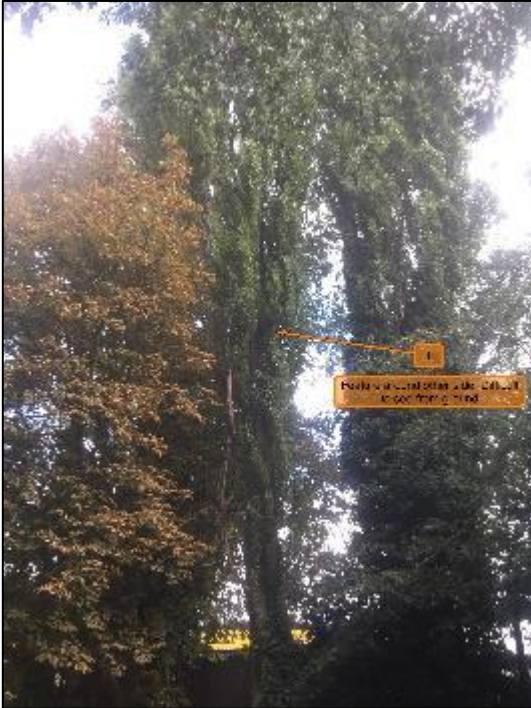
Tree 12540_00905 was a mature poplar with several woodpecker holes at 12m height on the eastern aspect. The aerial inspection inspected three holes; the top one was open and exposed with negligible suitability to support roosting bats, the middle hole was dry and lead downwards 20cm inside the tree with moderate bat roost suitability and the third hole was revealed to be an active squirrel drey. Overall this tree was re-classified from high to moderate suitability to support roosting bats (see photograph 173 below).

Photograph 173: Tree 12540_00905, Land Parcel 12540, 06/09/2018, standard lens.

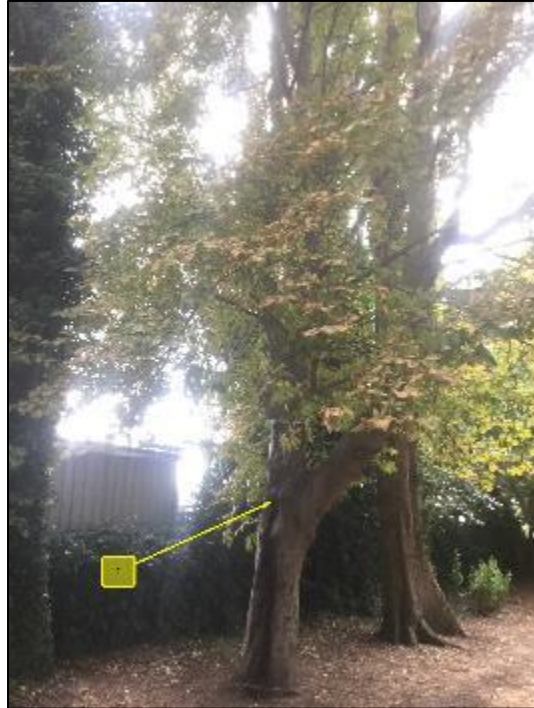
Tree 12540_00906 was a mature horse chestnut with a wound hole at 2m height on the eastern aspect. The hole was inspected with an endoscope from the ground and was found to lead upwards 40cm within the tree with a wedge apex, the inside was damp, and cobwebs were present. This feature was thought to have moderate suitability, and the tree retained its ground-based classification of moderate suitability to support roosting bats (see photograph 174 below).

Photograph 174: Tree 12540_00906, Land Parcel 12540, 06/09/2018, standard lens.
