HYDROGEOLOGICAL IMPACT APPRAISAL OF OPEN CUT CROSSING, ALLTAMI BROOK

HyNet Carbon Dioxide Pipeline DCO

Document Reference Number D.7.36

Applicant: Liverpool Bay CCS Limited

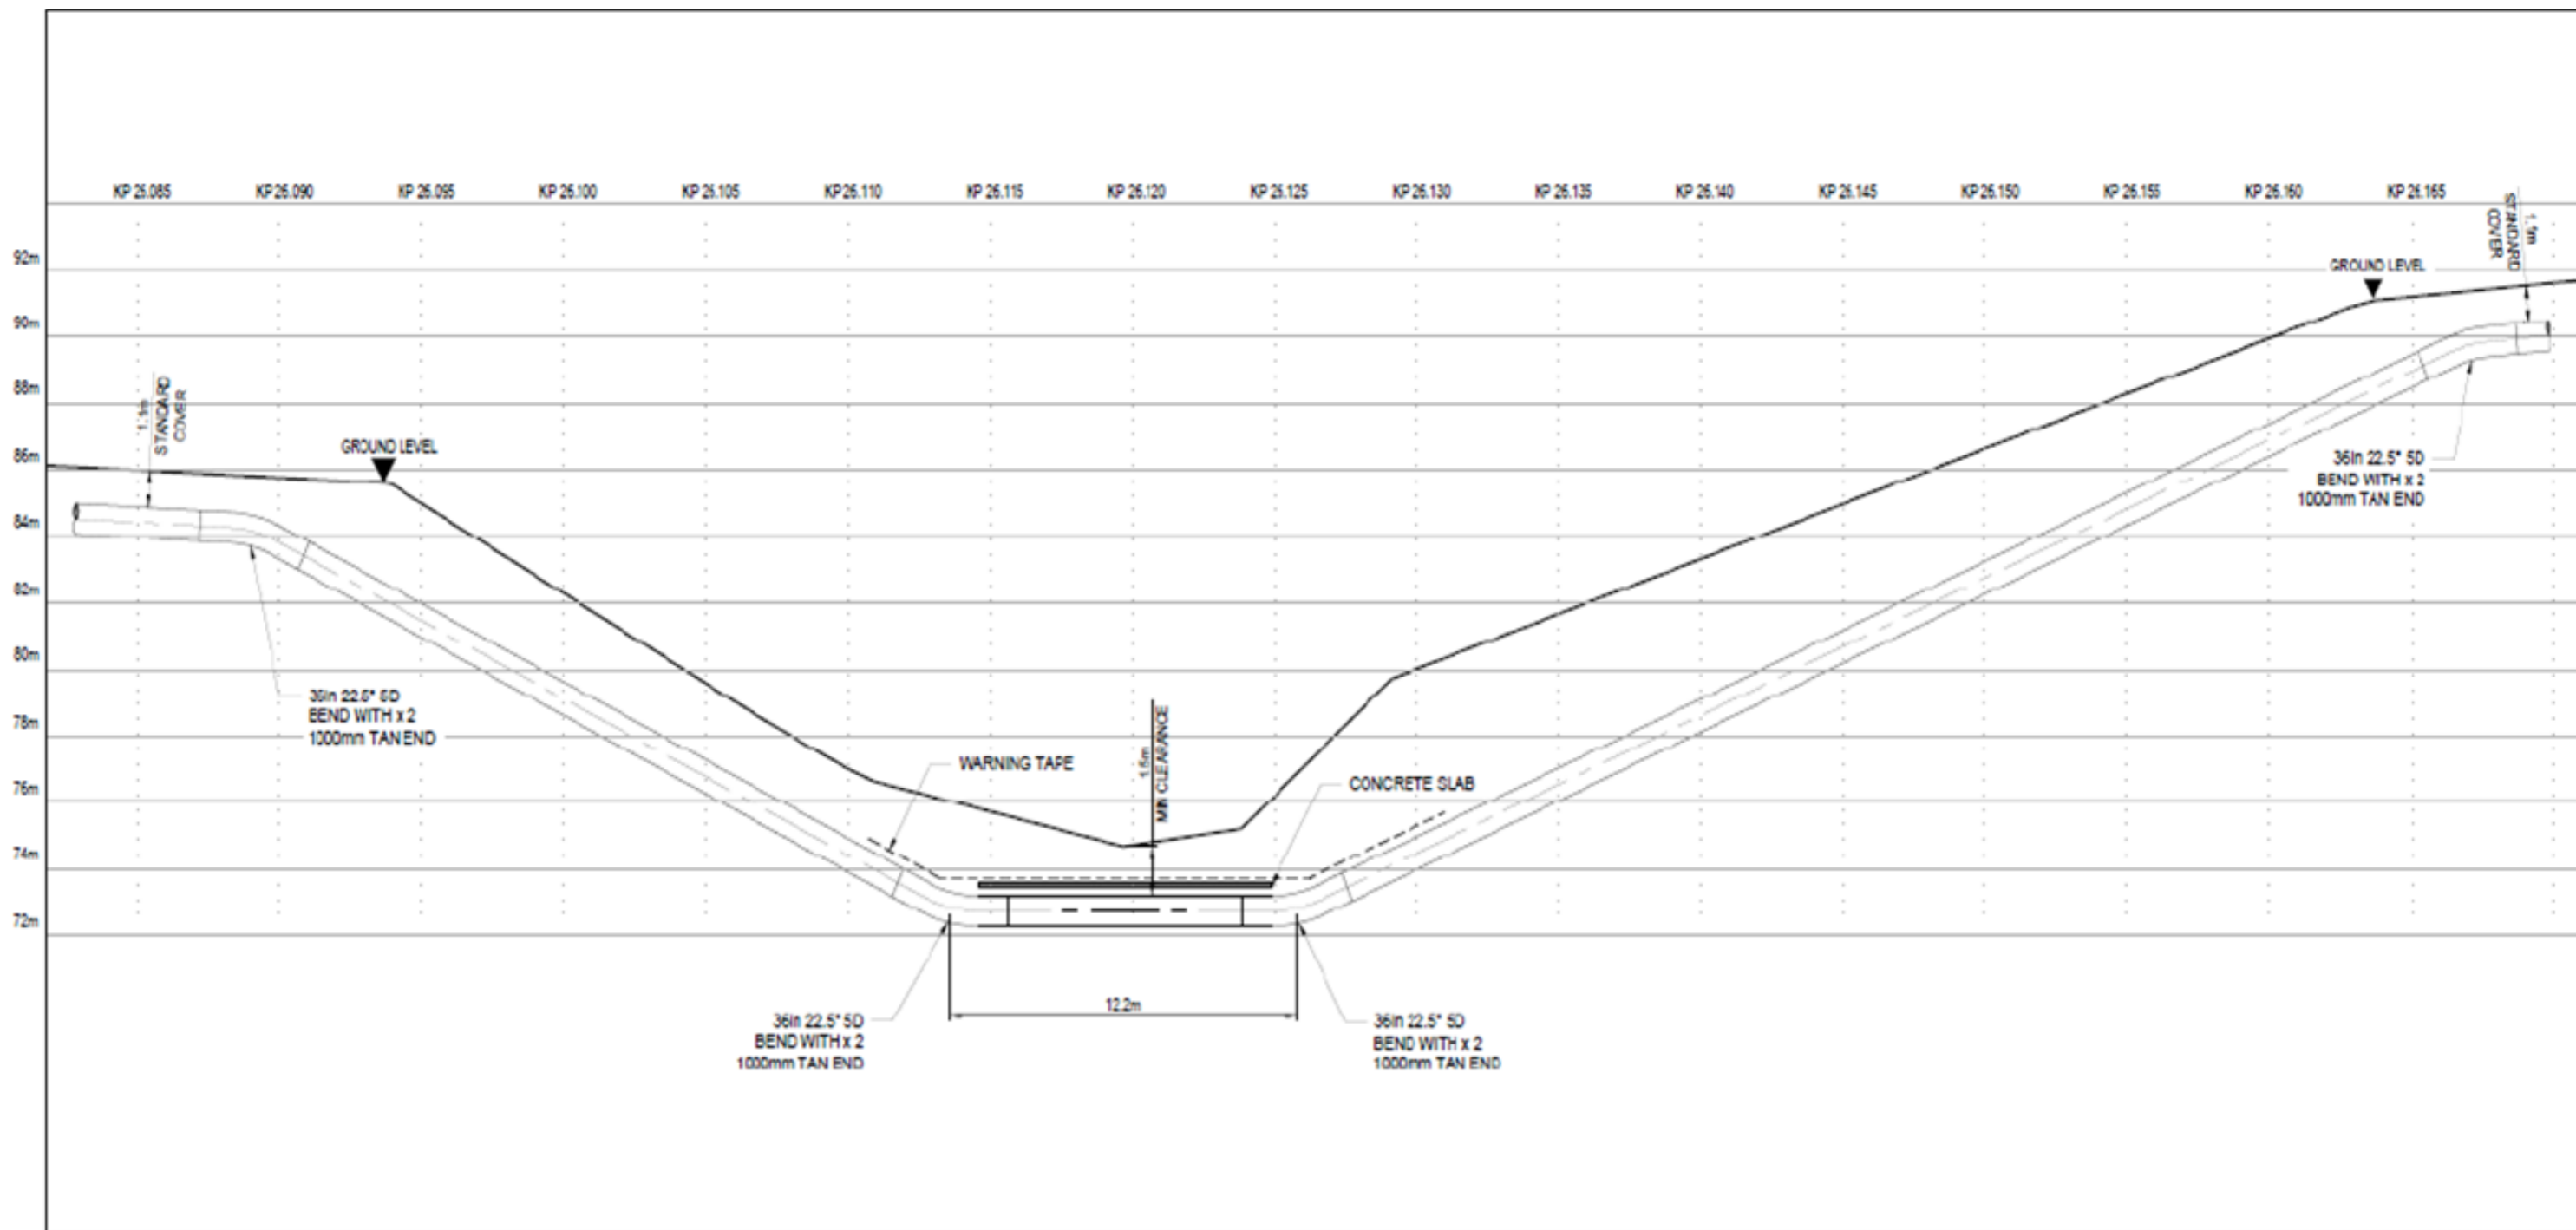
Figure 1.1: Preliminary design for open-trenched Alltami Brook crossing approach

- 1.7.3. During the construction stage, excavations will be required along the banks and within the Alltami Brook to lay the pipeline. The likely maximum depth of the excavation beneath the watercourse is approximately 4 metres below ground level (mbgl) and the maximum width of the excavation parallel to the pipeline is expected to be 4 m.

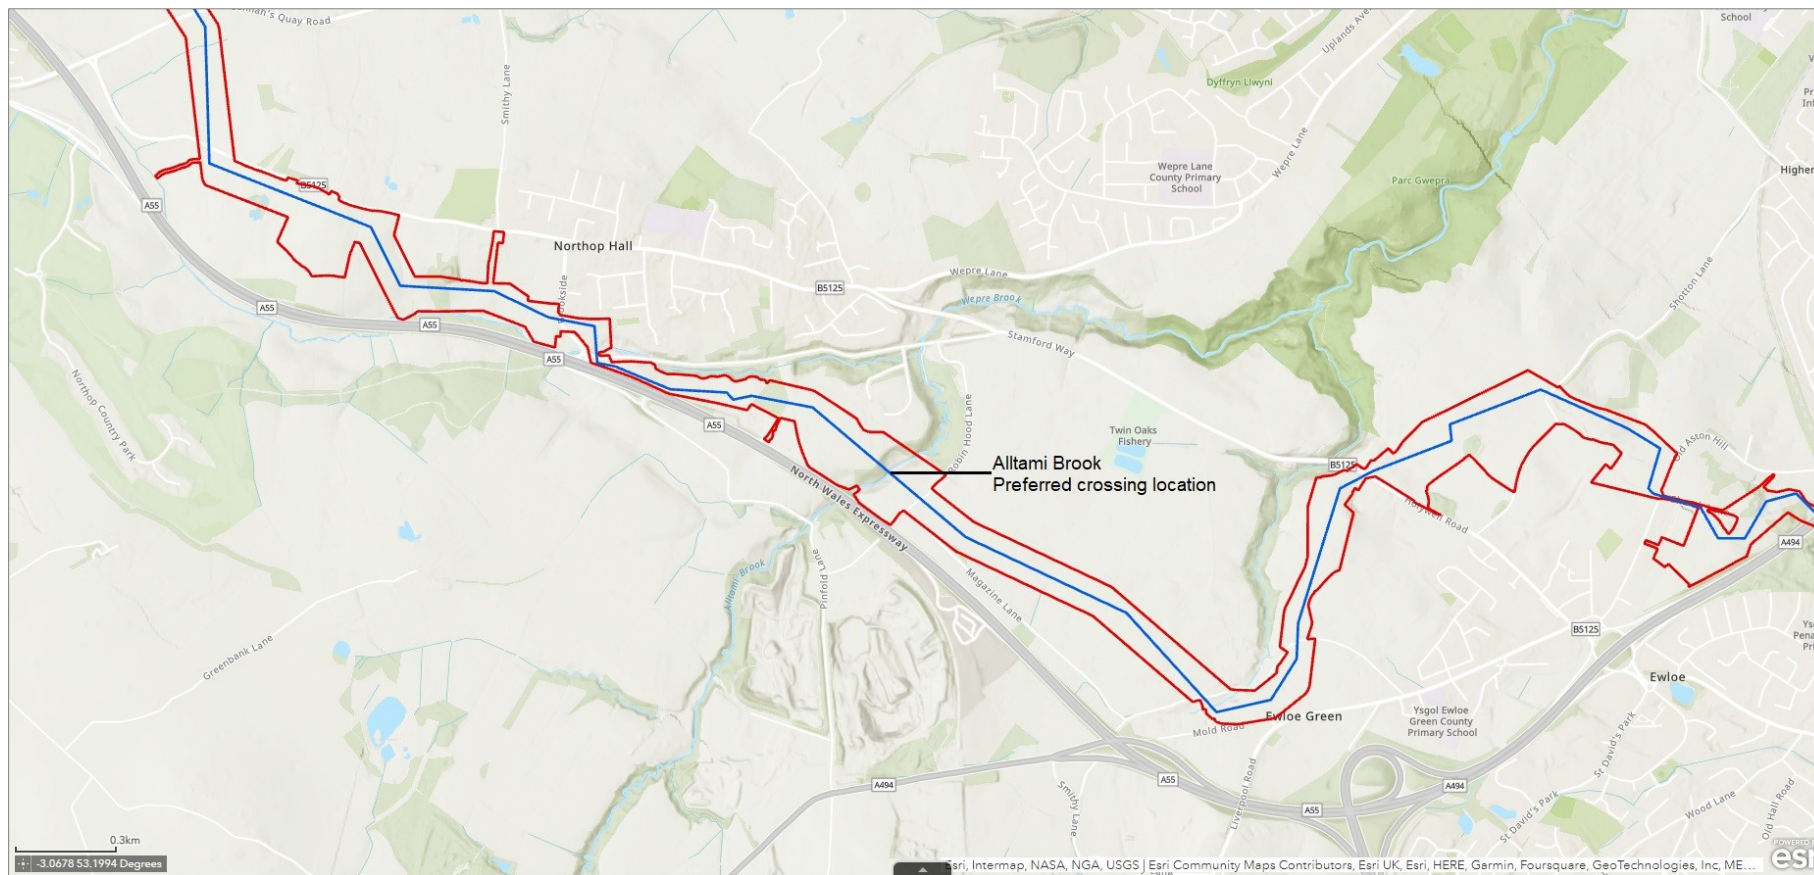
Figure 2.1. Preferred crossing location and setting around the Alltami Brook

2.2.3. There is an approximately 200 m stretch of the Alltami Brook within which the river crossing could be built within the Newbuild Infrastructure Boundary (shown in [Figure 2.1](#)~~Figure 2~~). Within the Newbuild Infrastructure Boundary the preferred open cut crossing location from an engineering perspective is near NGR SJ 27650 67144. This is the crossing location that is considered within this report although the crossing could be located anywhere within the Newbuild Infrastructure Boundary.

2.3.1. The preferred crossing location is located at the bottom of a steep sided valley with an elevation of approximately 78 metres above Ordnance Datum (mAOD). The ground elevation rises to 92 mAOD in the northwest and 87 mAOD in the southeast towards Pinfold Lane.

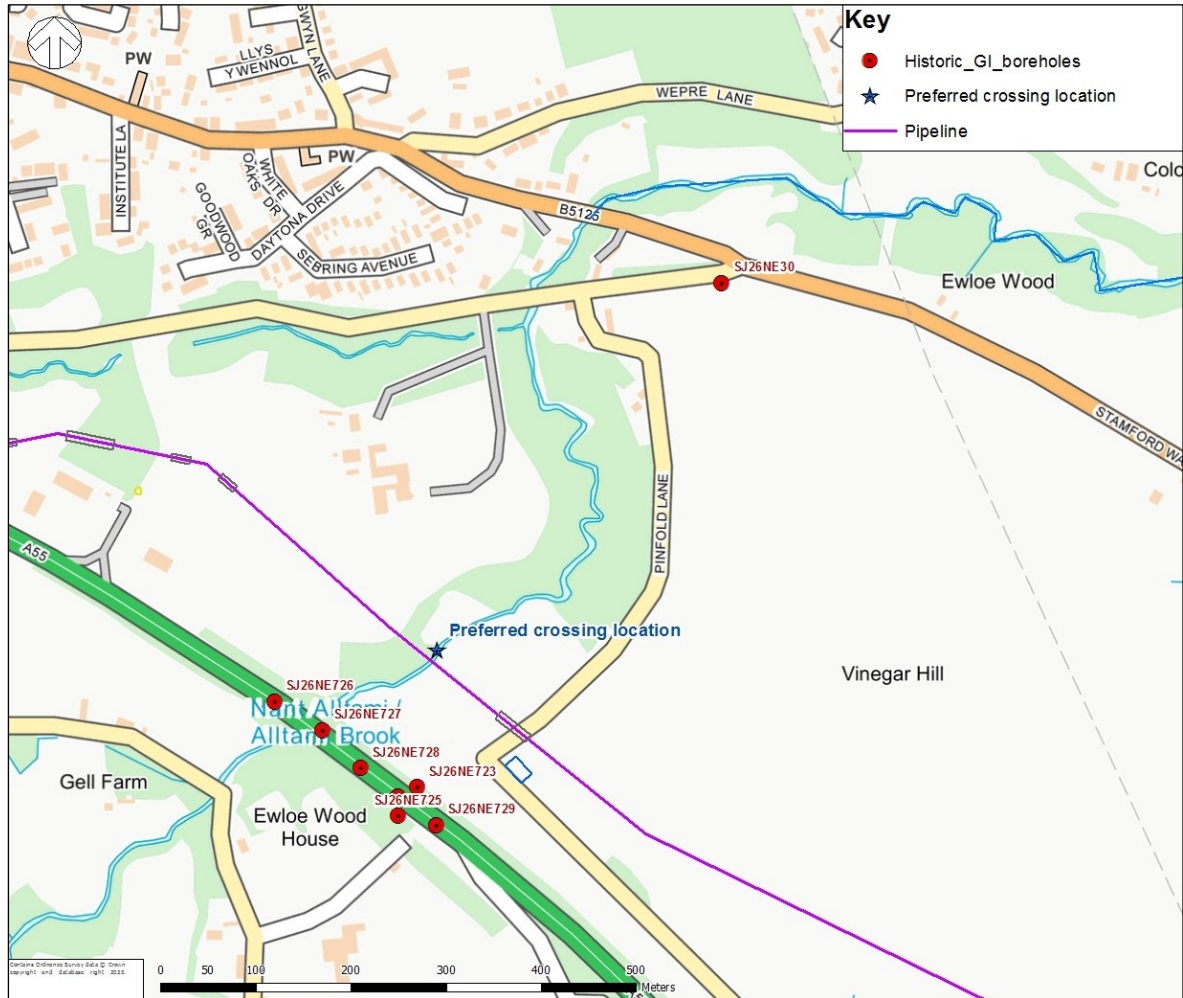
Figure 2.2. Nearby historic boreholes (source: BGS GeoIndex, 2023)

2.7.12. The locations of these are shown in Figure 2.2. The relevant information from these borehole logs is shown in Table 2.2 and the borehole logs are presented in Annex C.

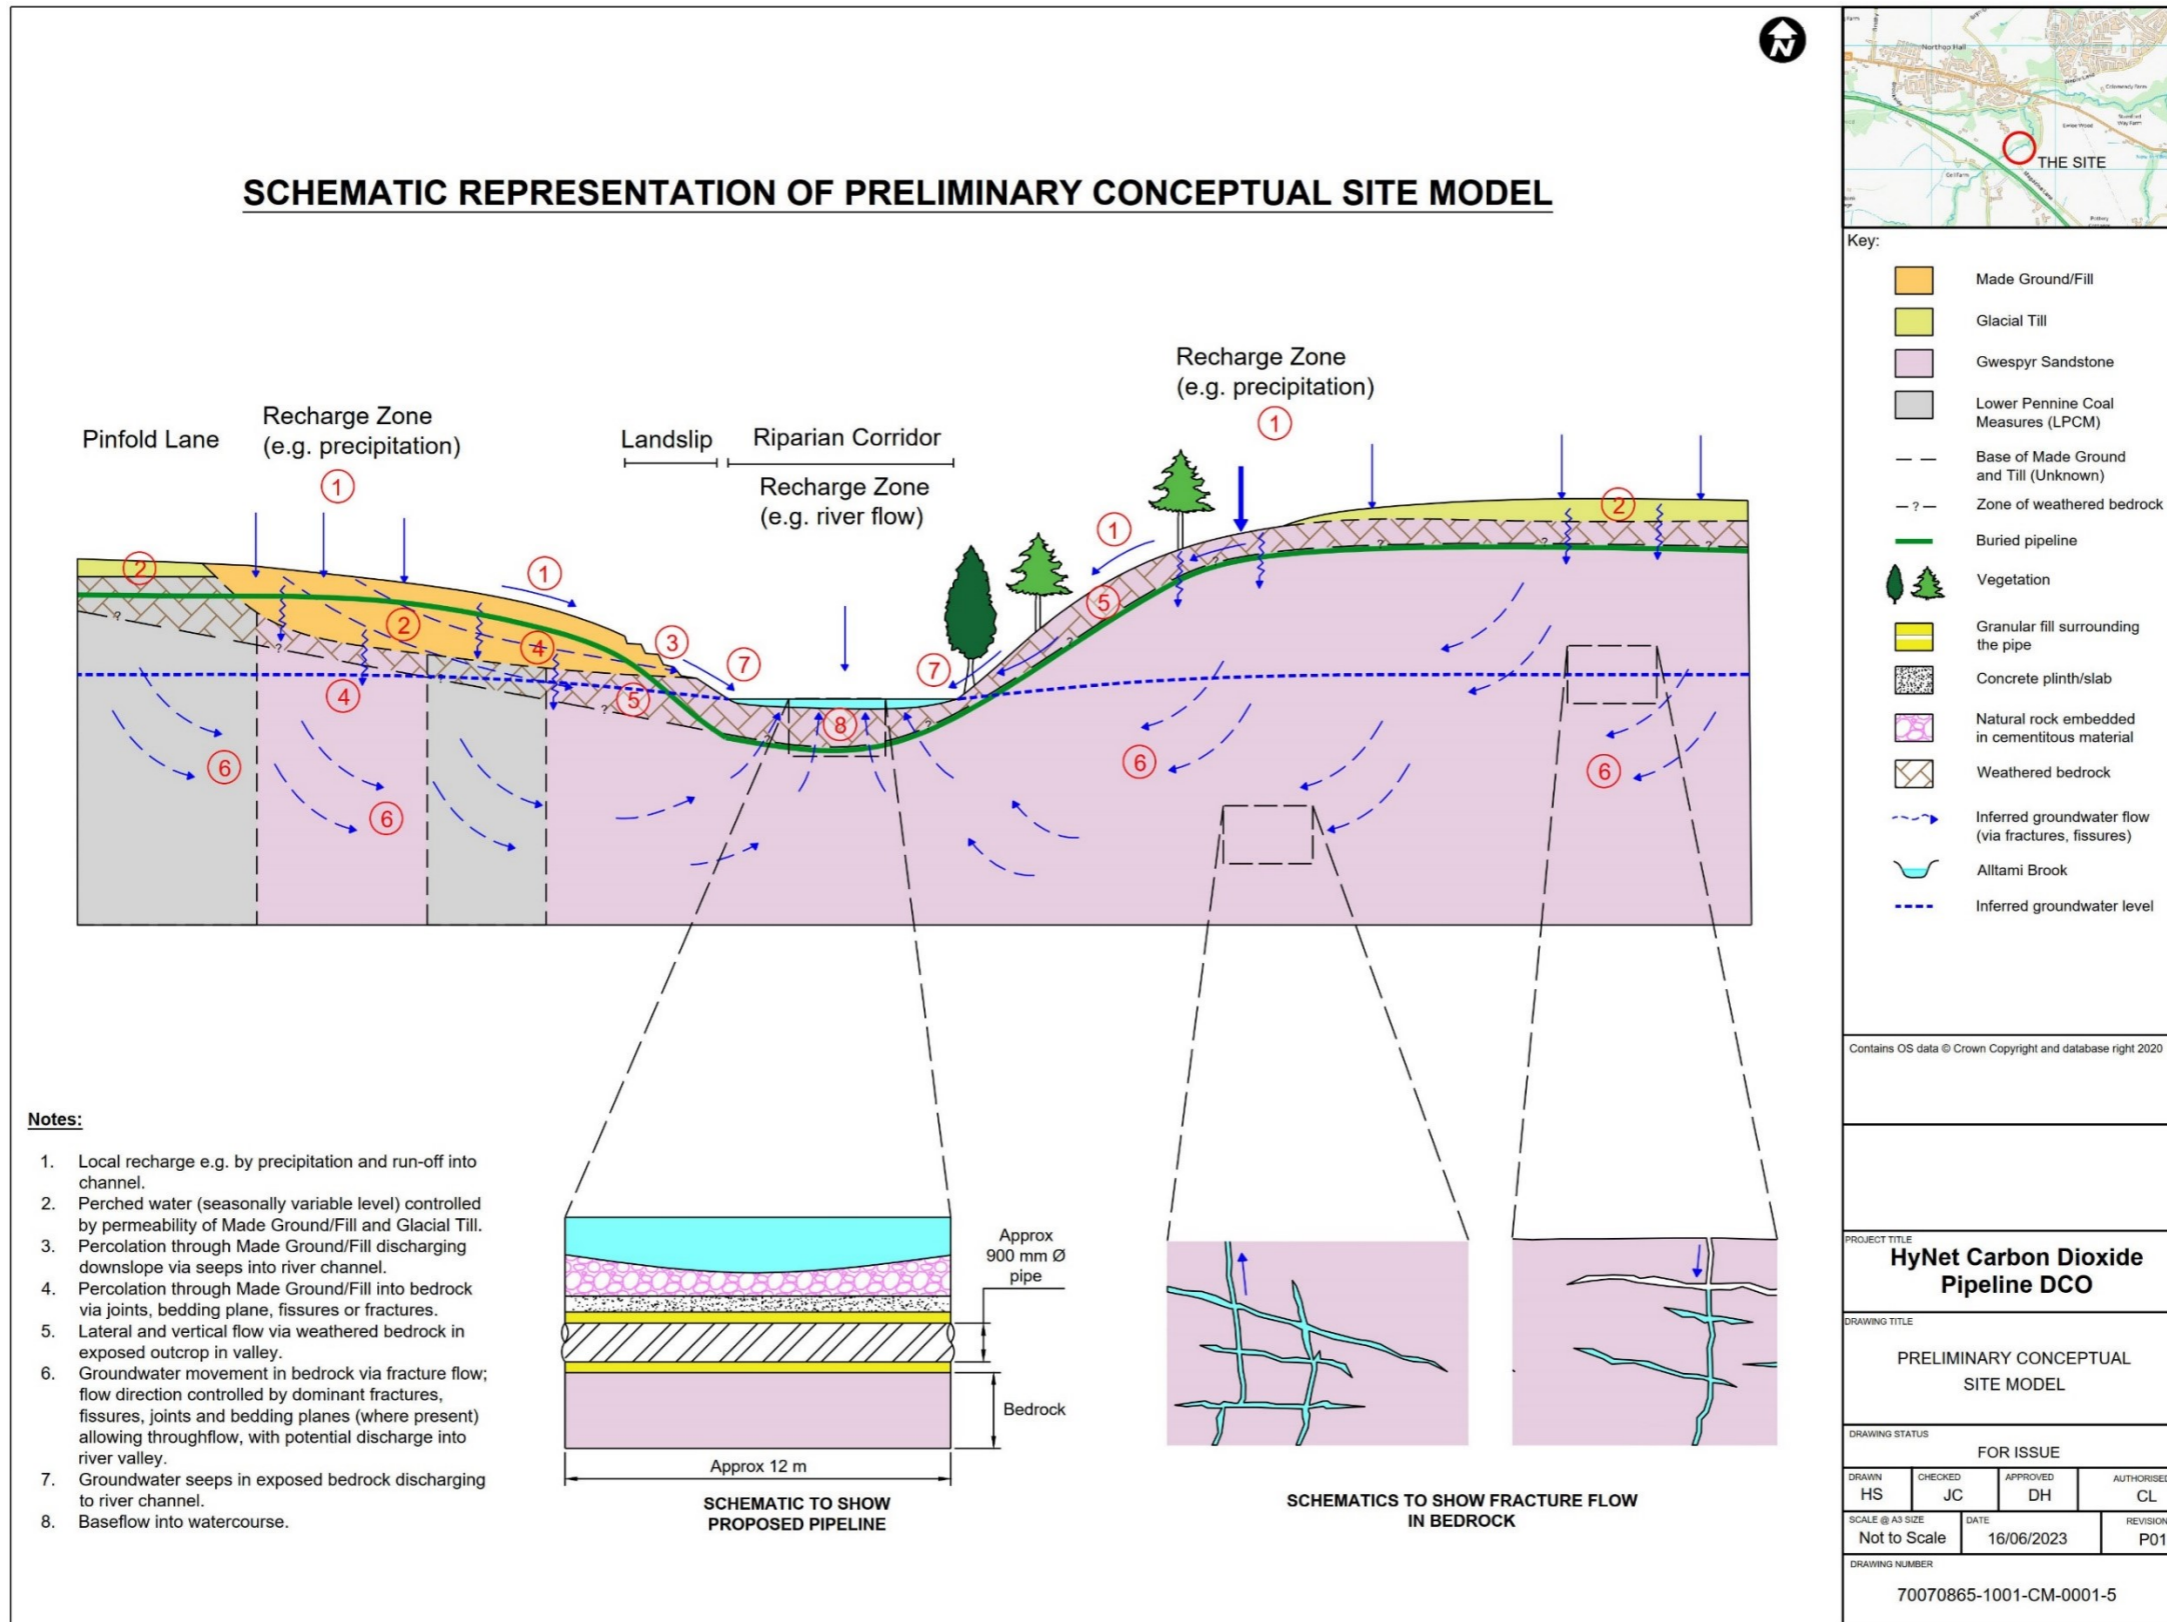
Figure 3.1. Preliminary Hydrogeological Conceptual Model

- 3.1.3. The conceptual model illustrates the key physical relationships and interactions that are assessed as primary controls for groundwater-surface water interactions in and around the Alltami Brook. Using this interpretation, the baseline conditions are described in Section 3.2.

- 3.1.4. Whilst the conceptual model is derived largely on published information and site observations, it does provide the framework for considering the how the proposed construction using the open cut method and subsequent operation of the pipeline may impact the baseline conditions. This is discussed in Section 3.3.

- 3.2.7. [Figure 3.1](#)~~Figure 5~~). These conditions are likely to be laterally and vertically discontinuous.
- 3.2.8. There are known former collieries near to Pinfold Lane. On the abandonment plans [**Appendix 11.2: Coal Mining Risk Assessment – Part 9** of the **ES, REP4-128**] these are indicated to be approximately 100 m northeast of the preferred crossing point on the Alltami Brook.
- 3.2.9. There are some mine adits shown on historic maps for these abandoned mines indicated to be buried beneath an area of made ground which forms the eastern slope of the valley of Alltami Brook. The mines were known to extend to a depth of 45 m below ground level. Due to this relatively shallow depth and considering the duration of time (75 years approximately) since abandonment, it is considered that mine water levels have likely recovered to natural equilibrium.
