Viking CCS Pipeline

**Environmental
Statement Volume IV –
Appendix 11-2: Site
Visit Technical Note -
Water**

Document Reference: EN070008/APP/6.4.11.2

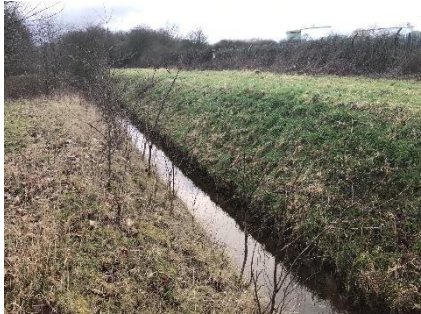
Parameter	Details	Photograph
Channel Form	The watercourse had been straightened between the former golf course on the right bank and industrial area on the left bank. The channel was overly deep and had a trapezoidal cross section.

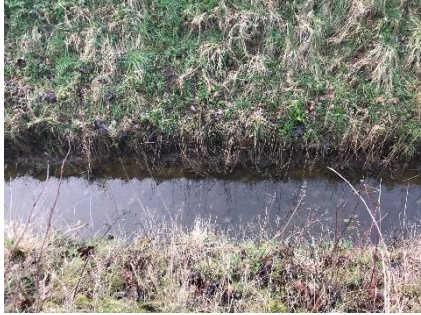
Substrate Conditions	The bed comprised silt and organic material. Historic channel modifications and current land use practices, coupled with natural low energy conditions likely contribute to the input and settling of fine sediment in the watercourse.

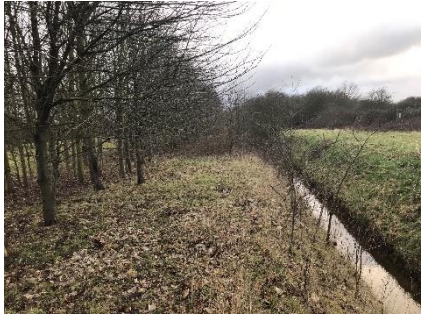
Flow Conditions	Flow was smooth and sluggish. These conditions are likely a result of the modified channel and low energy conditions.	
Floodplain Characteristics	Floodplain connectivity was non-existent due to the overly deep channel.

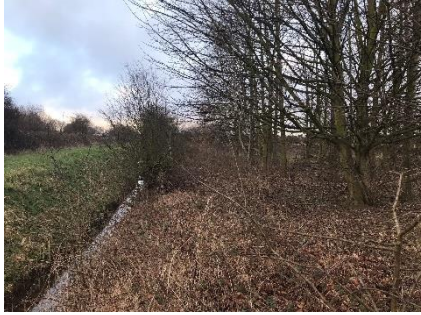
Riparian Zone	The right bank riparian zone comprised a narrow, wooded corridor on the border of a former golf course upstream of the crossing. Trees, grasses and scrub were all present in the right bank riparian zone. The left bank riparian zone comprised a narrow strip of short grasses adjacent to an industrial area.

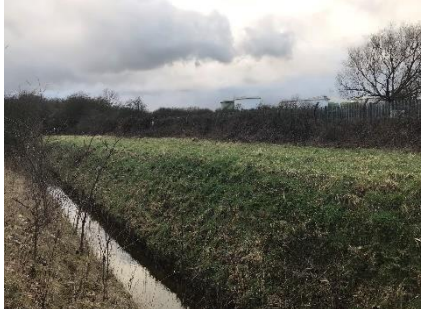
Parameter	Details	Photograph
Modifications	The watercourse has been historically straightened and the channel has a modified trapezoidal cross section. Adjacent land use comprises industrial units, a golf course and agricultural fields, with very little buffer space between the watercourse and these modified land uses.

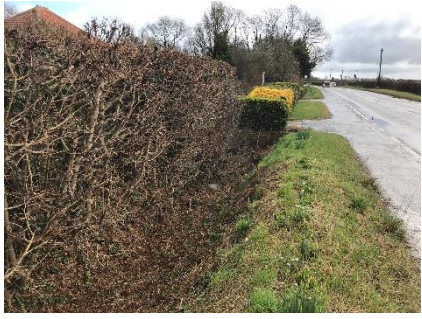
Floodplain Characteristics	There is no floodplain associated with this artificial drainage ditch.	
Riparian Zone	The riparian zone comprised a road on one side with a narrow grass verge, and an agricultural field with hedgerow on the other side.

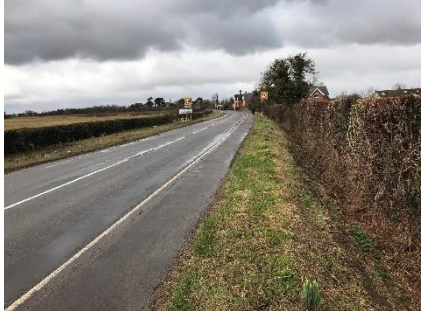
Modifications	The channel is artificial.

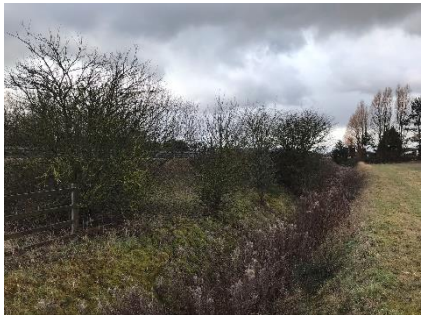
Parameter	Details	Photograph
Channel Form	Straight, artificial drainage channel which runs along boundary between road and agricultural field.

Substrate Conditions	The bed was boggy and heavily vegetated with grasses.	 
Flow Conditions	The drainage channel was mostly dry during survey, although the bed was boggy. There were some small areas of standing water.	 
Floodplain Characteristics	There is no floodplain associated with this artificial drainage channel.	
Riparian Zone	The riparian zone comprised a narrow, grassed embankment with planted trees adjacent to a dual carriageway on the right bank. The left bank riparian zone comprised an agricultural field.	 
Modifications	The channel is artificial and riparian land use is heavily modified.

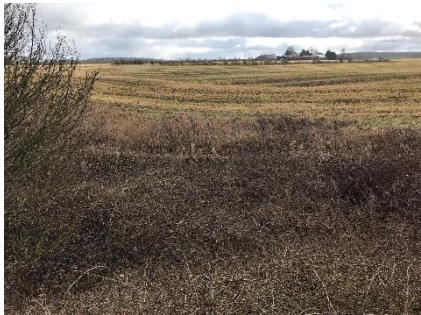
Parameter	Details	Photograph
Channel Form	Straight, artificial or heavily modified drainage channel which runs along boundary between road and agricultural field.

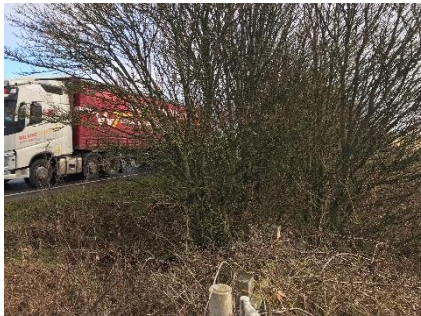
Substrate Conditions	The bed could not be observed but is likely dominated by fine material. The channel appeared to be heavily vegetated with reeds, so it is likely this vegetation traps finer material.	
Flow Conditions	The channel could not be observed to determine flow conditions; however, it is likely that flow is slow or not perceptible due to the modified channel and low gradient. The presence of reeds growing from the channel indicates slower flow.	
Floodplain Characteristics	The channel is completely disconnected from the floodplain.	
Riparian Zone	The riparian zone comprised a narrow strip of scrubland adjacent to a dual carriageway on the left bank. The right bank riparian zone comprised an agricultural field.

Modifications	The channel is artificial or heavily modified and riparian land use is heavily modified.

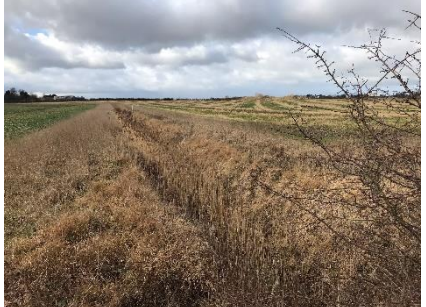
Parameter	Details	Photograph
Channel Form	Straight, artificial drainage channel which runs along field boundary.

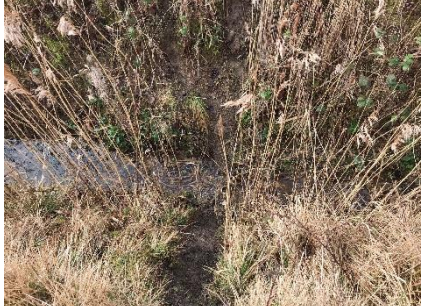
Substrate Conditions	The bed was heavily vegetated with reeds and appeared to comprise fine sediment.

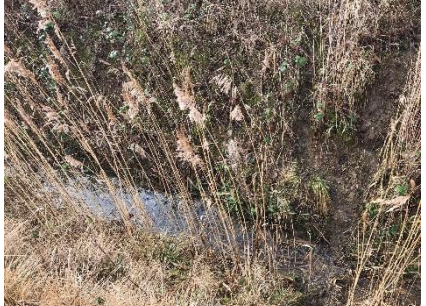
Flow Conditions	There was standing water within the drainage channel.

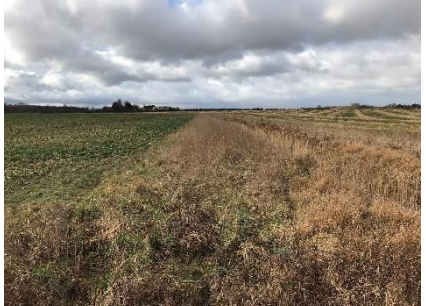
Floodplain Characteristics	There is no natural floodplain associated with this artificial drainage channel.

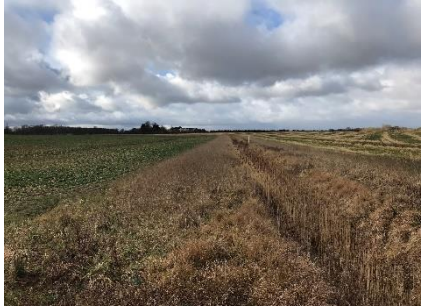
Riparian Zone	The riparian zone comprised a narrow strip of tall grasses set between two agricultural fields.

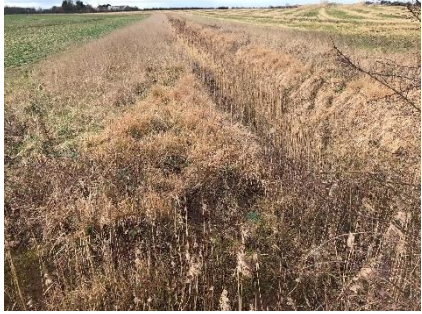
Parameter	Details	Photograph
Modifications	The channel is artificial and riparian land use is heavily modified for agricultural farming purposes.

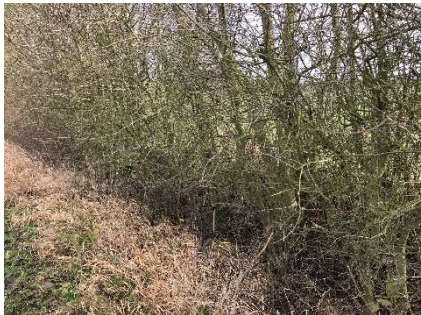
Parameter	Details	Photograph
Channel Form	Straight, artificial drainage channel which runs along the boundary between an agricultural field and a road.

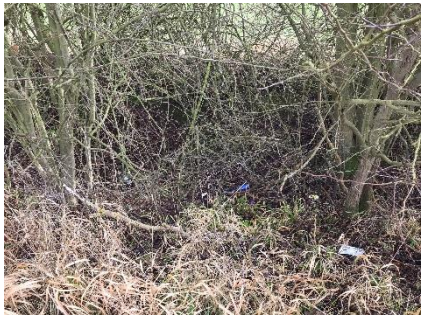
Substrate Conditions	The bed was littered with organic detritus and vegetated with tall grasses, scrub and trees. Bed sediment was formed of earth.

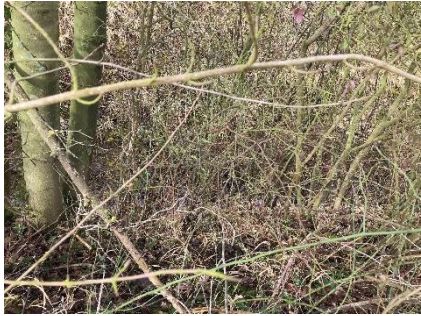
Flow Conditions	The channel was dry at the time of survey.

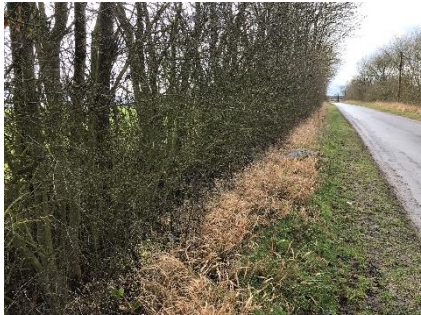
Floodplain Characteristics	There is no natural floodplain associated with this artificial drainage channel.	
Riparian Zone	The riparian zone comprised a line of trees adjacent to an agricultural field on one side and a narrow strip of grasses adjacent to a road.

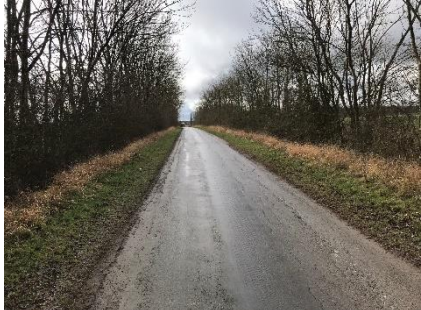
Modifications	The channel is artificial and riparian land use is heavily modified for agricultural farming and transport purposes.

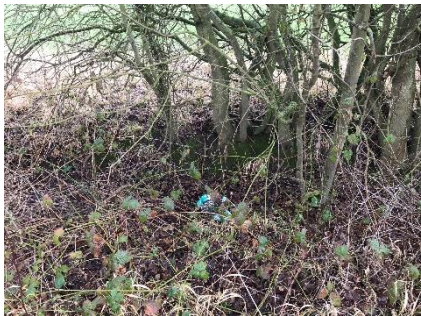
Parameter	Details	Photograph
Channel Form	Straight, artificial drainage channel which runs along the boundary between an agricultural field and a road.

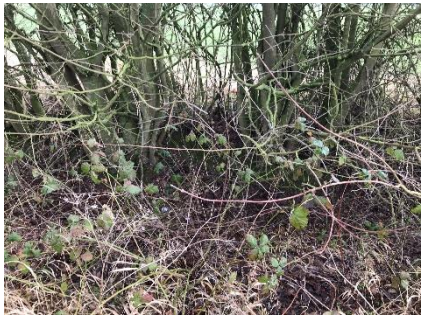
Substrate Conditions	The bed was littered with organic detritus and vegetated with tall grasses, scrub and trees. Bed sediment was formed of earth.

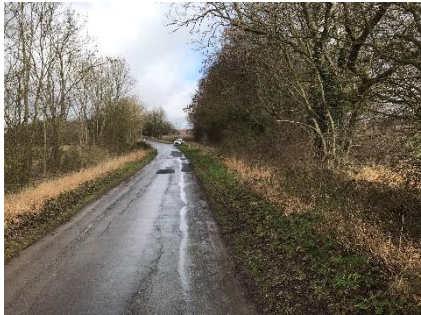
Flow Conditions	The channel was dry at the time of survey.	
Floodplain Characteristics	There is no natural floodplain associated with this artificial drainage channel.	
Riparian Zone	The riparian zone comprised a line of trees adjacent to an agricultural field on one side and a narrow strip of grasses adjacent to a road.

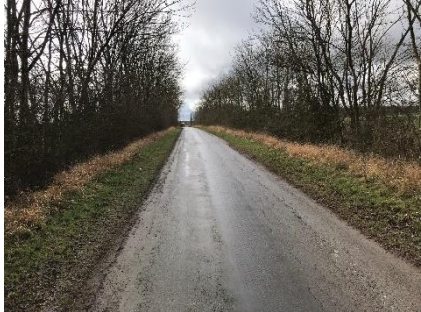
Modifications	The channel is artificial and riparian land use is heavily modified for agricultural farming and transport purposes.

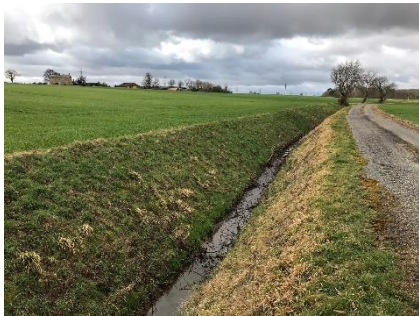
Parameter	Details	Photograph
Channel Form	Straight, artificial or heavily modified drainage channel with trapezoidal cross section. The channel was set between agricultural fields, with a gravel track running along the left bank.

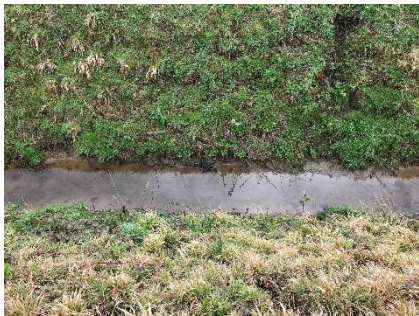
Substrate Conditions	Bed sediment comprised silt. The agricultural setting likely contributes a considerable amount of fine sediment.

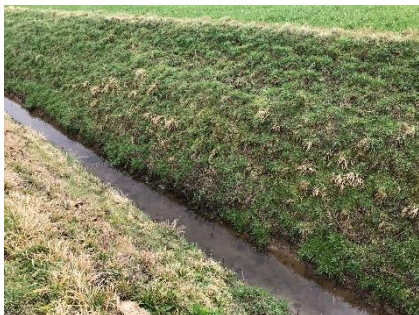
Flow Conditions	There was standing water in the channel but no perceptible flow.

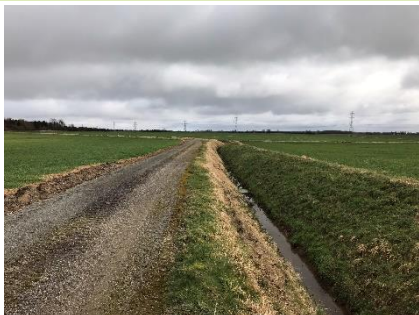
Floodplain Characteristics	The drainage channel was completely disconnected from the adjacent floodplain, being overly deep with steep sloping banks.

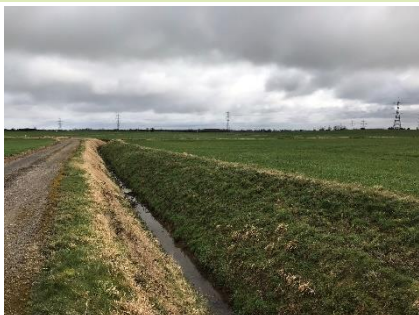
Riparian Zone	The riparian zone comprised agricultural fields, with a gravel track running along the left bank.

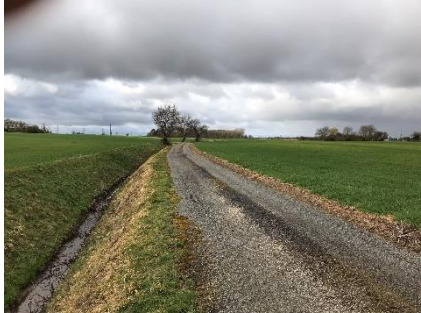
Parameter	Details	Photograph
Modifications	The channel is artificial or heavily modified, and riparian land use is heavily modified for agricultural farming and transport purposes.

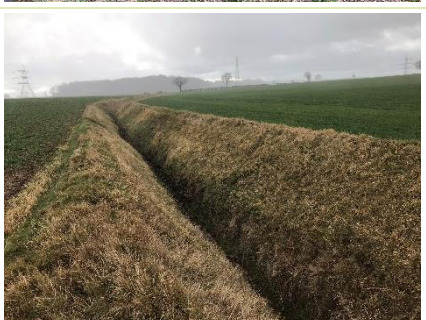
Floodplain Characteristics	The drainage channel was completely disconnected from the adjacent floodplain, being overly deep with steep sloping banks.

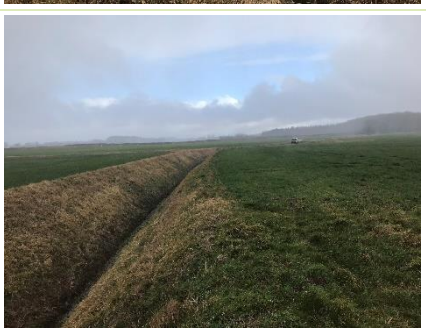
Riparian Zone	The riparian zone comprised agricultural fields.

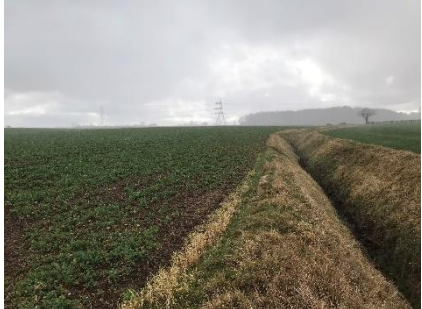
Parameter	Details	Photograph
Modifications	The channel is artificial or heavily modified to provide agricultural drainage, and riparian land use is heavily modified for agricultural farming purposes. The drainage channel is culverted under a field access.

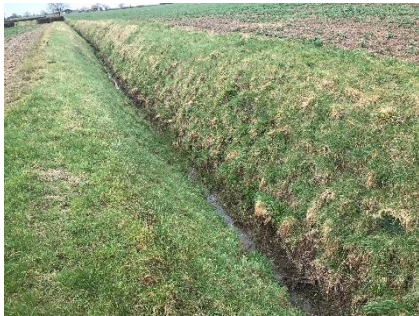
Parameter	Details	Photograph
Channel Form	Straight, artificial or heavily modified drainage channel with trapezoidal cross section. The channel was set between agricultural fields.

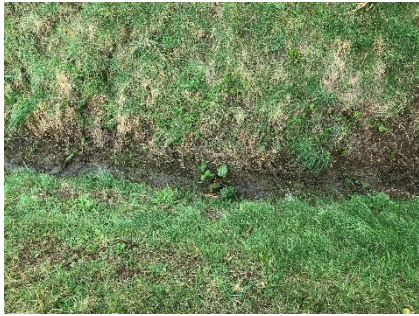
Substrate Conditions	Bed sediment comprised silt. The agricultural setting likely contributes a considerable amount of fine sediment.

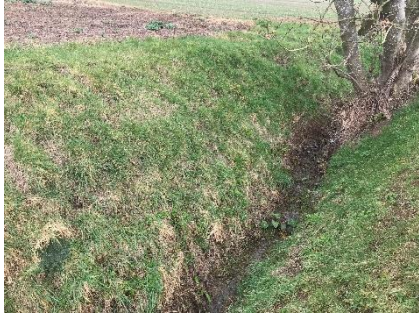
Flow Conditions	There was standing water in the channel but no perceptible flow.

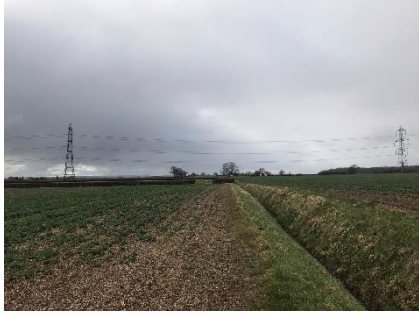
Floodplain Characteristics	The drainage channel was completely disconnected from the adjacent floodplain, being overly deep with steep sloping banks.

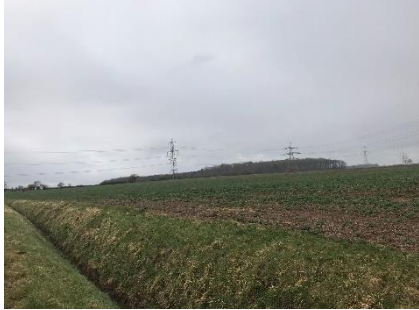
Riparian Zone	The riparian zone comprised agricultural fields.

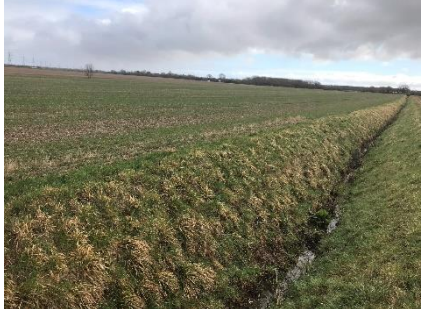
Parameter	Details	Photograph
Modifications	The channel is artificial or heavily modified to provide agricultural drainage, and riparian land use is heavily modified for agricultural farming purposes.

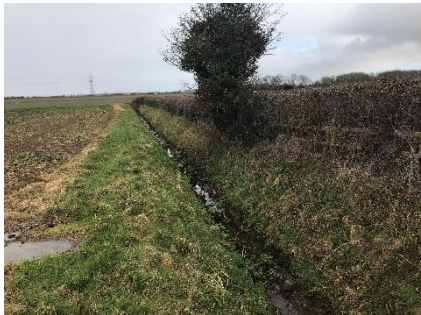
Parameter	Details	Photograph
Channel Form	Straight, artificial or heavily modified drainage channel with trapezoidal cross section. The channel was set between agricultural fields.

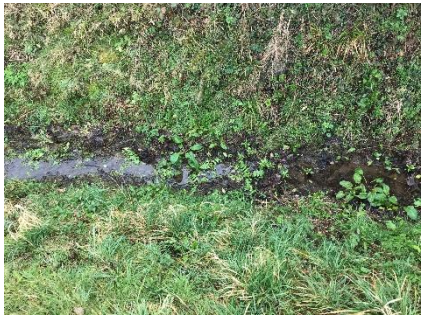
Substrate Conditions	Bed sediment comprised silt. The agricultural setting likely contributes a considerable amount of fine sediment.

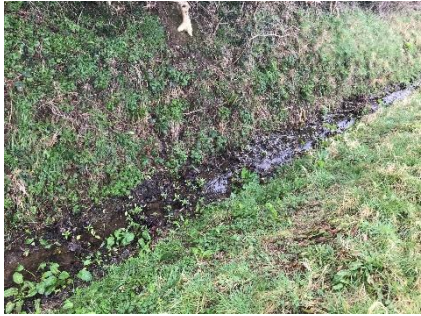
Flow Conditions	There was standing water in the channel but no perceptible flow.

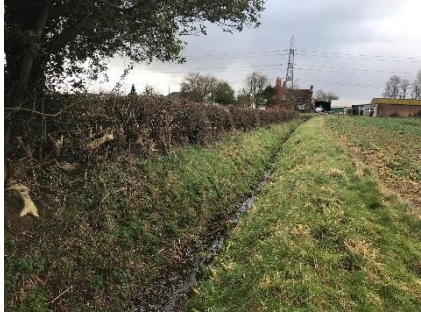
Floodplain Characteristics	The drainage channel was completely disconnected from the adjacent floodplain, being overly deep with steep sloping banks.

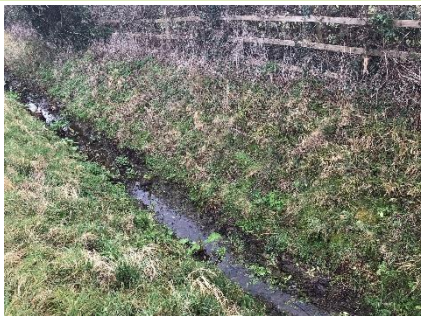
Riparian Zone	The riparian zone comprised agricultural fields.	
Modifications	The channel is artificial or heavily modified to provide agricultural drainage, and riparian land use is heavily modified for agricultural farming purposes.

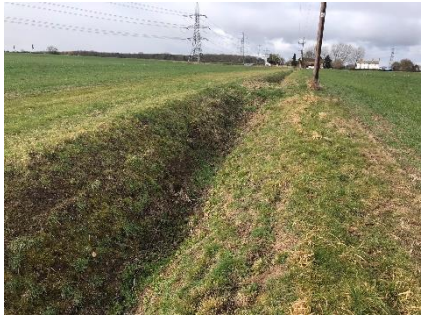
Parameter	Details	Photograph
Channel Form	Straight, artificial drainage channel with trapezoidal cross section. The channel was set between agricultural fields and was connected to North Beck at the downstream end. A field crossing disconnects the upstream length of the drainage channel from the downstream.

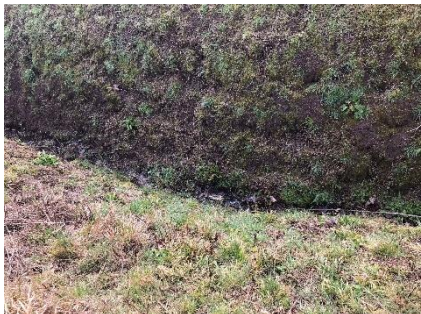
Substrate Conditions	Bed sediment comprised earth/soil. The bed was vegetated with short grasses.

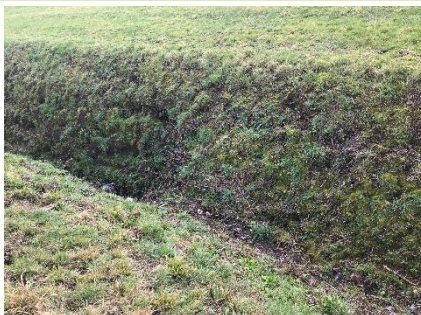
Flow Conditions	The channel was completely dry. The dry, grassed channel had no signs that it had been wetted around the time of survey and is unlikely to hold water apart from during very wet periods.

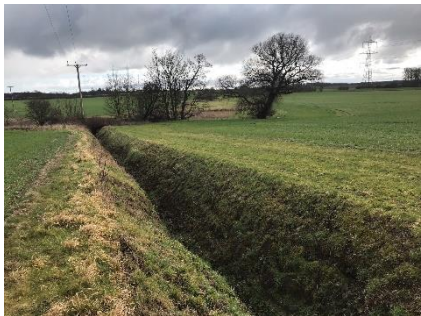
Floodplain Characteristics	The artificial drainage channel has no natural floodplain.	
Riparian Zone	The riparian zone comprised agricultural fields.

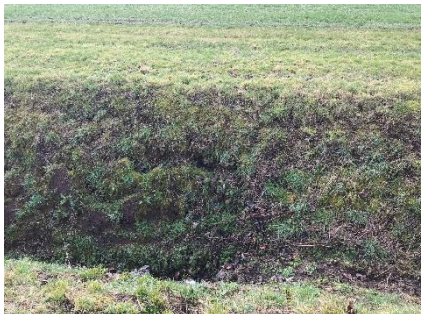
Modifications	The channel has been artificially created to provide agricultural drainage, and riparian land use is heavily modified for agricultural farming purposes.

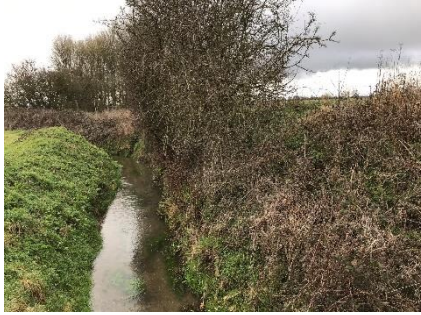
Parameter	Details	Photograph
Channel Form	North Beck Drain is a chalk stream. The watercourse displayed natural sinuosity in parts, although had been straightened in the vicinity of the proposed crossing. It was incised and disconnected from the adjacent floodplain.

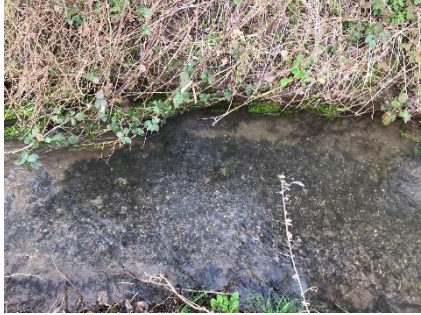
Substrate Conditions	Bed substrate largely comprised fine gravels, although there was a significant input of fine sediment which likely enters the watercourse from the adjacent agricultural land. Some areas of coarser gravels were noted in the more natural wooded areas.

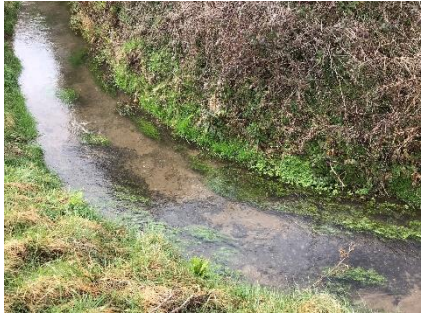
Flow Conditions	There were some varying flow types, particularly where the watercourse flows through woodland as this is a more natural length with varying widths and depths. Flow was more uniform through the straightened length in the vicinity of the proposed crossing, mostly comprising of run flow type. Some areas of coarser gravels and in-channel vegetation provided some flow variation.

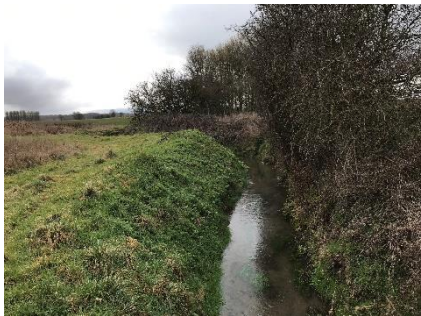
Floodplain Characteristics	The watercourse was incised and disconnected from the adjacent floodplain.

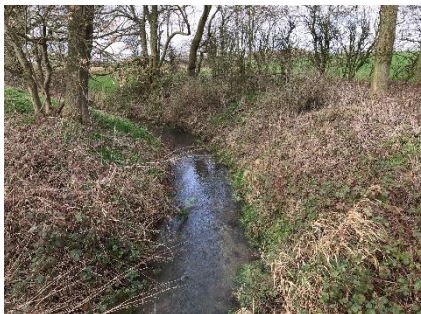
Riparian Zone	The riparian zone comprised agricultural fields, although the left bank was buffered by occasional trees, scrub and longer grasses. The watercourse also flowed through some small parcels of woodland.

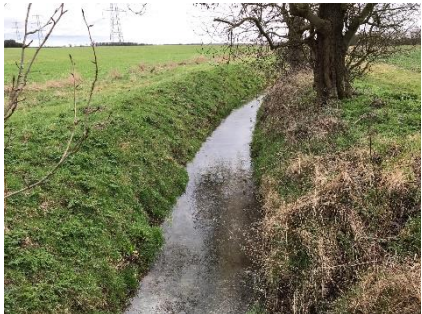
Parameter	Details	Photograph
Modifications	<p>The watercourse has been straightened in the vicinity, with modifications resulting in an incised channel that is disconnected from the floodplain. There is also a significant input of fine sediment, likely from the adjacent agricultural land use.</p>

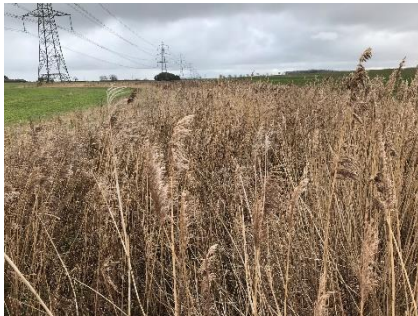
Parameter	Details	Photograph
Channel Form	This watercourse comprised a straight, heavily modified channel that was heavily vegetated with reeds.

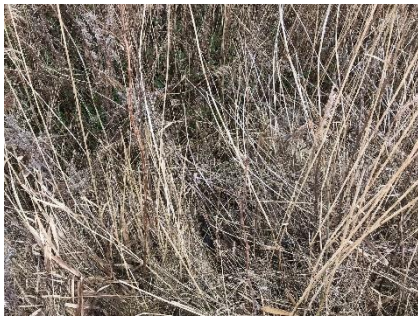
Substrate Conditions	The substrate appeared to be silty, although was largely obscured by dense reed growth.

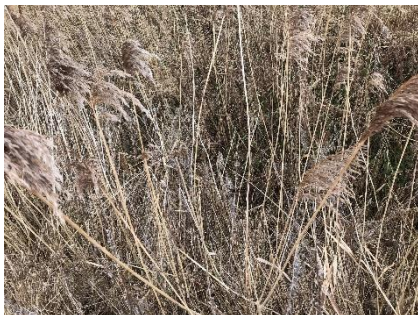
Flow Conditions	Standing water was present.

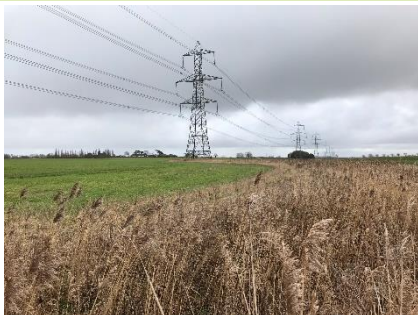
Floodplain Characteristics	The watercourse was heavily modified and completely disconnected from the adjacent floodplain.

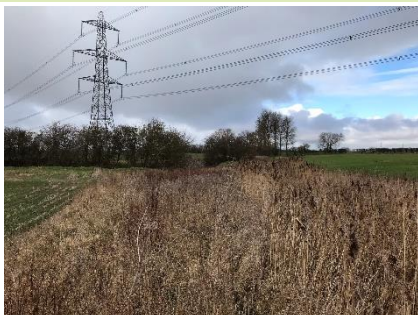
Riparian Zone	The riparian zone comprised agricultural fields.

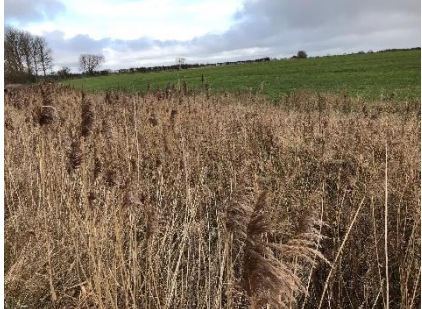
Parameter	Details	Photograph
Modifications	The watercourse has been straightened and deepened. Adjacent land use is also heavily modified for agricultural purposes.

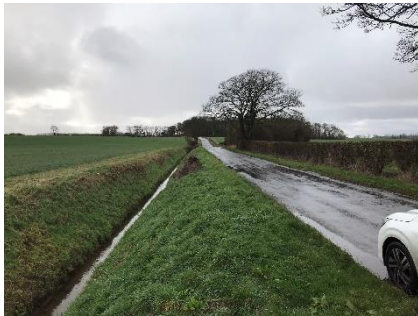
Parameter	Details	Photograph
Channel Form	This watercourse comprised a straight, heavily modified channel with a trapezoidal cross section.

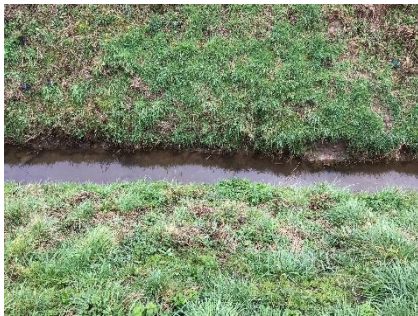
Substrate Conditions	The substrate comprised silt.

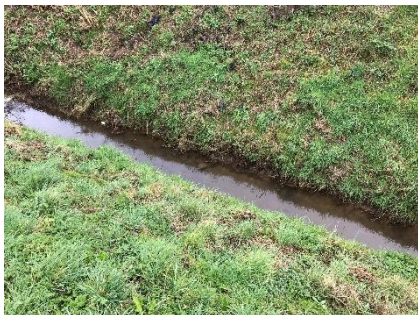
Flow Conditions	Standing water was present.

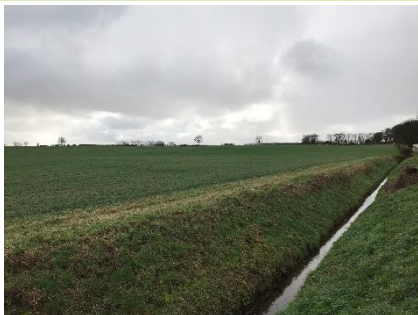
Floodplain Characteristics	The watercourse was heavily modified and completely disconnected from the adjacent floodplain.

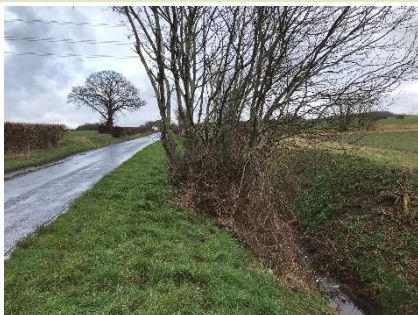
Riparian Zone	The riparian zone comprised agricultural fields and a road. There were occasional trees.

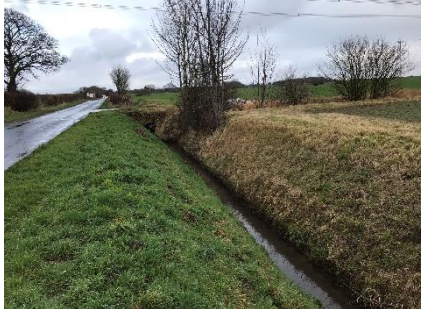
Parameter	Details	Photograph
Modifications	<p>The watercourse has been straightened and deepened and is culverted under farm access tracks. Adjacent land use is also heavily modified for agricultural and transport purposes.</p>

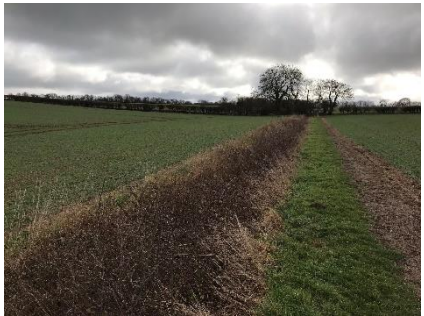
Parameter	Details	Photograph
Channel Form	This watercourse comprised a straight, artificial or heavily modified channel with a trapezoidal cross section.

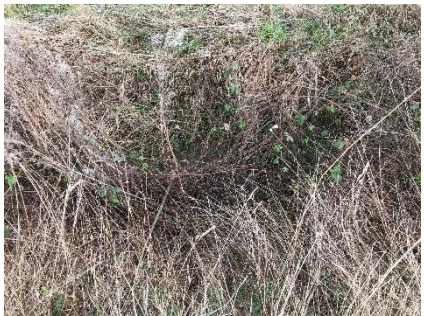
Substrate Conditions	The substrate was largely obscured due to in-channel vegetation but was likely to be silty.

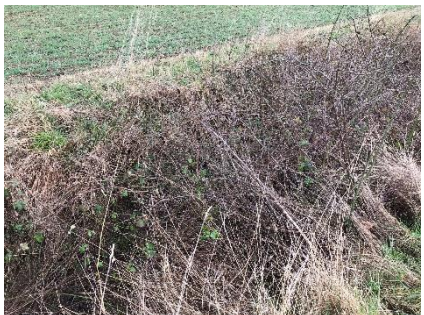
Flow Conditions	Heavy in-channel vegetation growth prevented flow observations. It is likely that the channel was dry or had some areas of standing water.

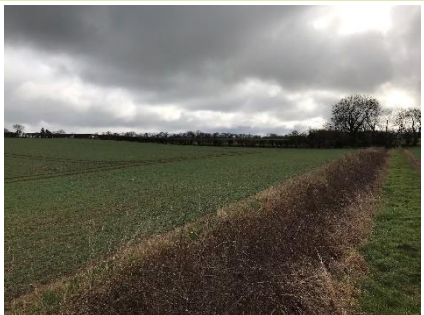
Floodplain Characteristics	The watercourse was artificial or heavily modified and completely disconnected from the adjacent floodplain.

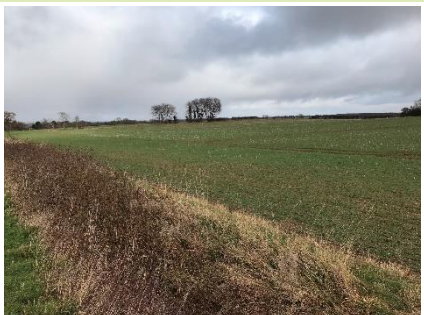
Riparian Zone	The riparian zone comprised agricultural fields.

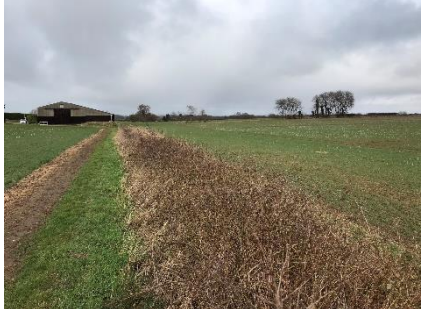
Parameter	Details	Photograph
Modifications	The watercourse is artificial or heavily modified. Adjacent land use is heavily modified for agricultural purposes.

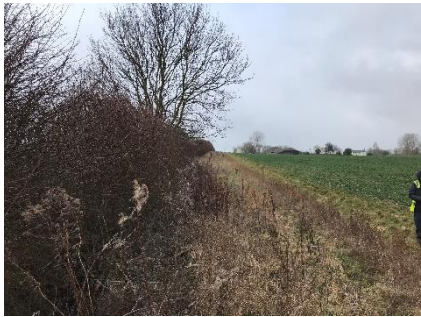
Parameter	Details	Photograph
Channel Form	This watercourse comprised a straight, artificial or heavily modified channel with a trapezoidal cross section.

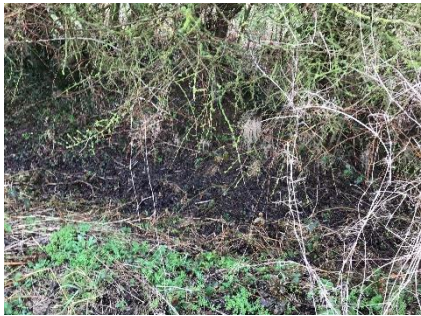
Substrate Conditions	The bed was silty.

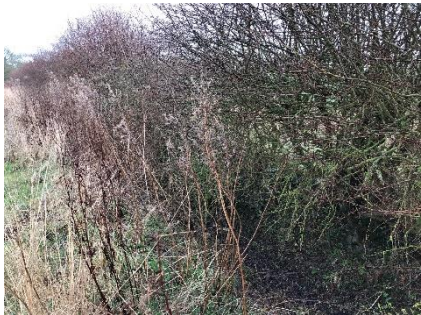
Flow Conditions	The watercourse was mostly dry with some areas of standing water.

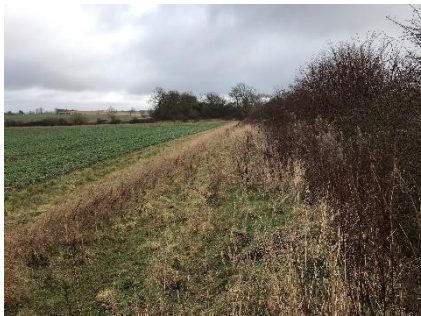
Floodplain Characteristics	The watercourse was artificial or heavily modified and completely disconnected from the adjacent floodplain.

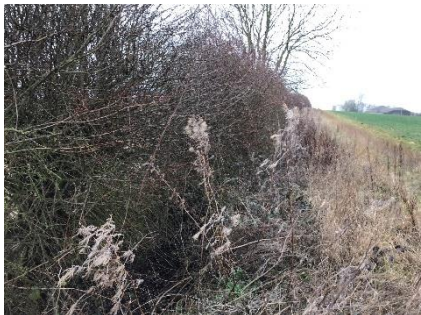
Riparian Zone	The riparian zone comprised agricultural fields, although one bank was buffered by scrub and occasional tree cover.

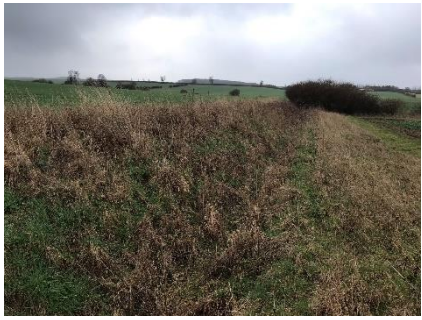
Parameter	Details	Photograph
Channel Form	This watercourse comprised a straight, artificial or heavily modified channel with a trapezoidal cross section.

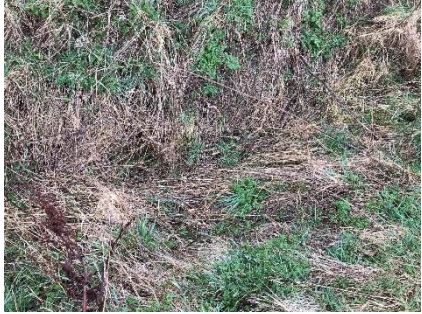
Substrate Conditions	The bed was grassed so underlying substrate could not be observed.

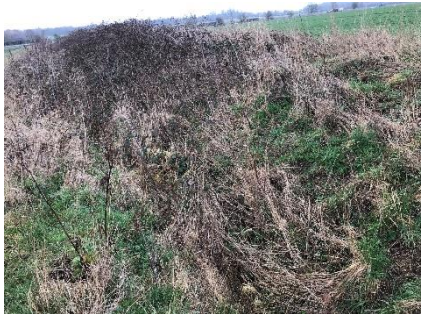
Flow Conditions	The watercourse was mostly dry with some areas of standing water.

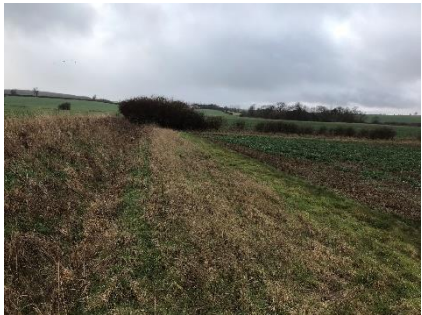
Floodplain Characteristics	The watercourse was artificial or heavily modified and completely disconnected from the adjacent floodplain.

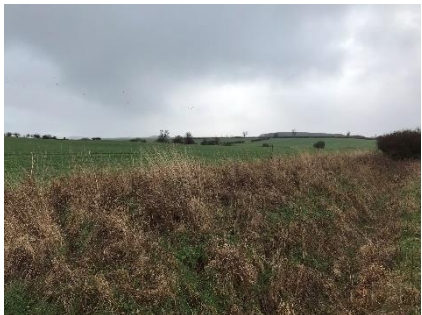
Riparian Zone	The riparian zone comprised agricultural fields.

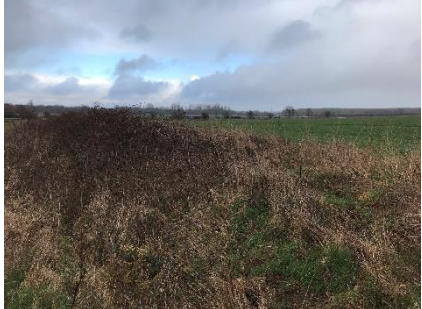
Parameter	Details	Photograph
Modifications	The watercourse is artificial or heavily modified. Adjacent land use is heavily modified for agricultural purposes.

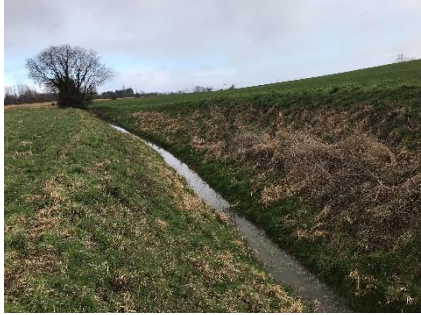
Parameter	Details	Photograph
Channel Form	This watercourse comprised a straight, artificial or heavily modified channel with a trapezoidal cross section.

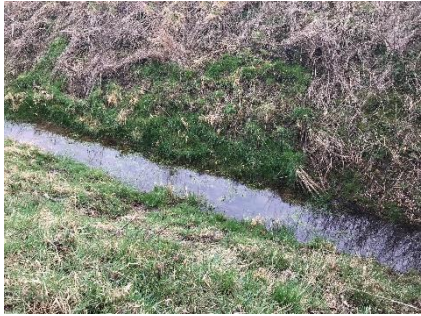
Substrate Conditions	The bed was silty.

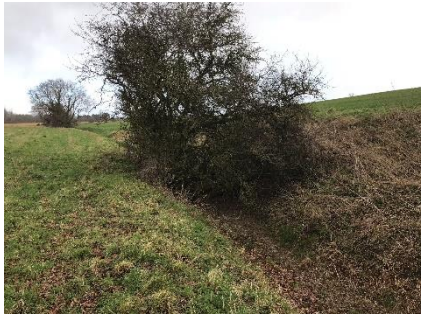
Flow Conditions	The watercourse was dry for the upstream length of around 40 m, with standing water being present downstream.

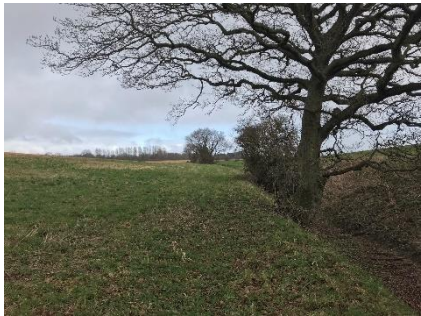
Floodplain Characteristics	The watercourse was artificial or heavily modified and completely disconnected from the adjacent floodplain.

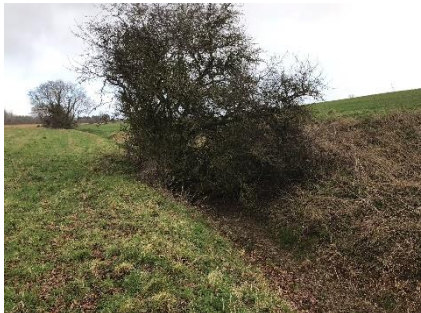
Riparian Zone	The riparian zone comprised agricultural fields, although the upstream length was located within a small parcel of woodland.

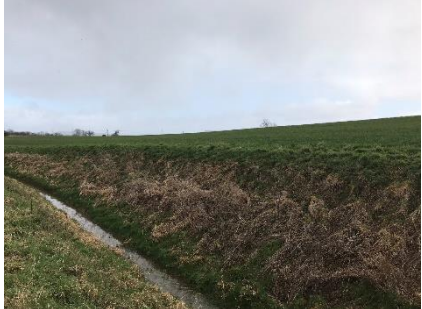
Parameter	Details	Photograph
Modifications	The watercourse is artificial or heavily modified. Adjacent land use is heavily modified for agricultural purposes.

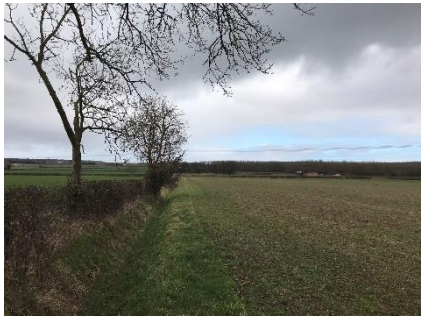
Parameter	Details	Photograph
Channel Form	This watercourse comprised a straight, artificial or heavily modified channel with a trapezoidal cross section.

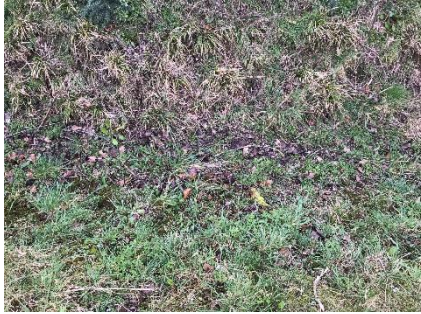
Substrate Conditions	The bed was grassed and had a covering of twigs and leaves.

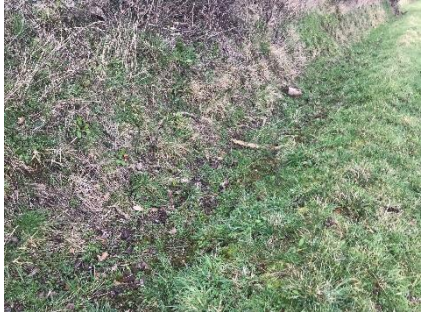
Flow Conditions	The channel was dry during survey and is unlikely to hold water apart from during particularly wet periods.

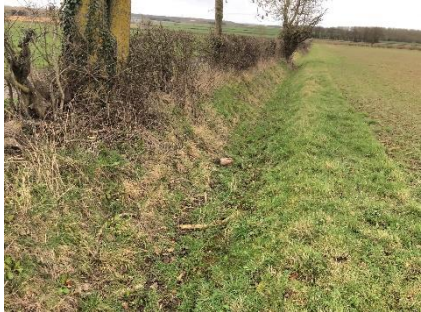
Floodplain Characteristics	The watercourse was artificial or heavily modified and completely disconnected from the adjacent floodplain.

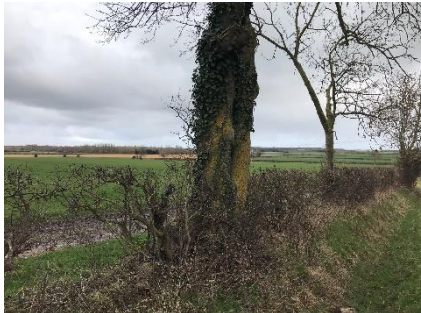
Riparian Zone	The riparian zone comprised agricultural fields and a gravel track. Some trees were also present, and a hedgerow ran along the left bank for much of the channel length.

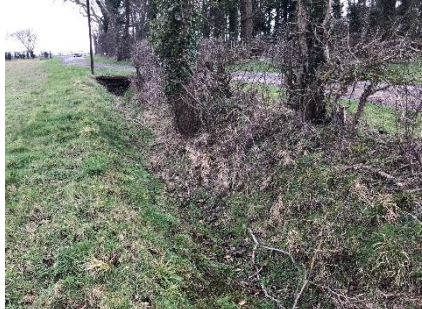
Parameter	Details	Photograph
Modifications	The watercourse is artificial or heavily modified. Adjacent land use is heavily modified for agricultural purposes.

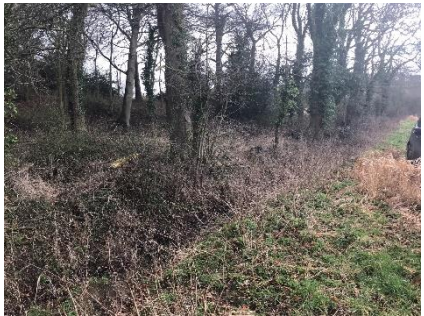
Parameter	Details	Photograph
Channel Form	This watercourse comprised a heavily modified channel which was dry during survey. The channel planform indicates that it is natural but heavily modified.

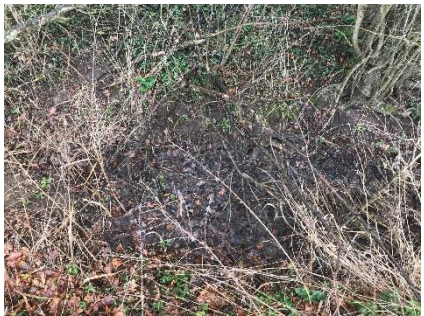
Substrate Conditions	The bed was silty and had a dense cover of twigs and leaves.

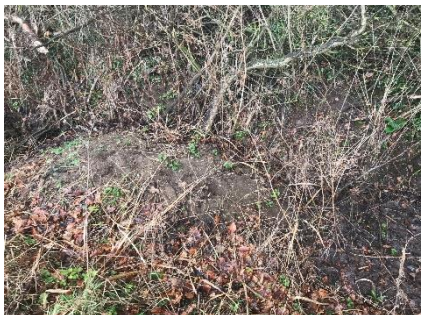
Flow Conditions	The channel was mostly dry during survey but there were areas of standing water. Mounds of dumped earth were observed which will have an impact on flow during wetter periods.

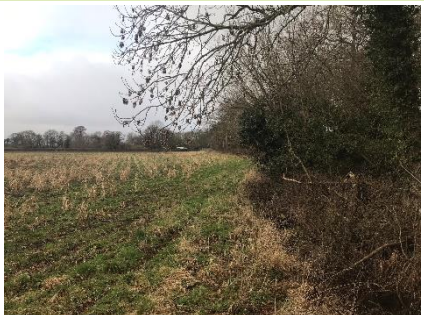
Floodplain Characteristics	The watercourse likely does not receive enough water to flood.

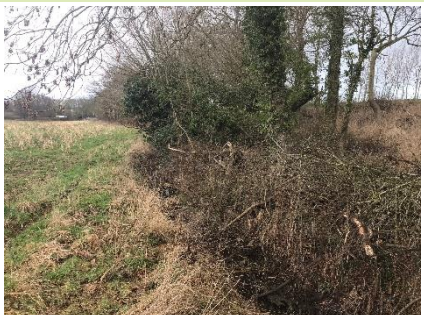
Riparian Zone	The riparian zone comprised an agricultural field on the right bank and woodland on the left bank.

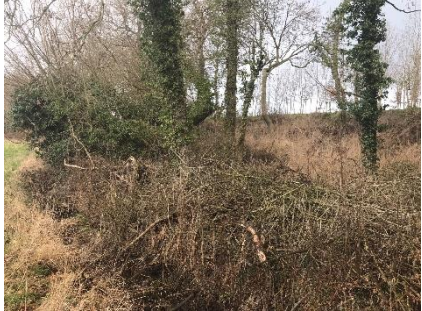
Parameter	Details	Photograph
Modifications	The watercourse has been heavily modified and historically straightened.

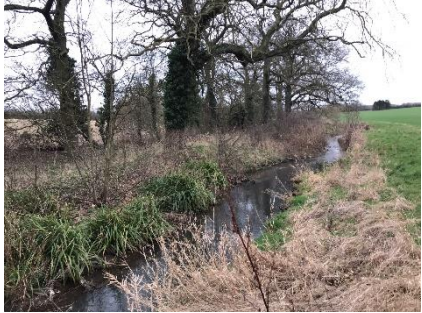
Parameter	Details	Photograph
Channel Form	<p>Waithe Beck is a chalk stream. The channel displayed a natural sinuosity through much of the survey length, although there was evidence of historic modification, including channel straightening, in parts. Vegetated berms were noted providing a variation in channel width. A review of mapping and aerial imagery indicates that channel straightening has occurred over a greater length.</p>

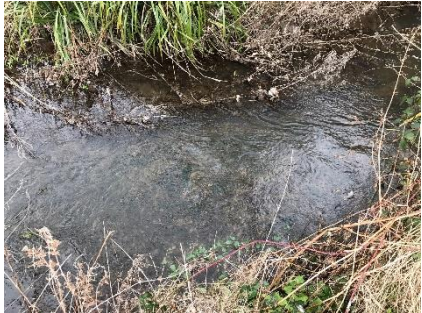
Substrate Conditions	<p>A gravel bed was observed, although fine sediment could be seen in parts. The water was turbid and not representative of the clear waters expected in a chalk stream, indicating an input of fine sediment. It is likely that adjacent land use contributes a significant input of fine sediment.</p>

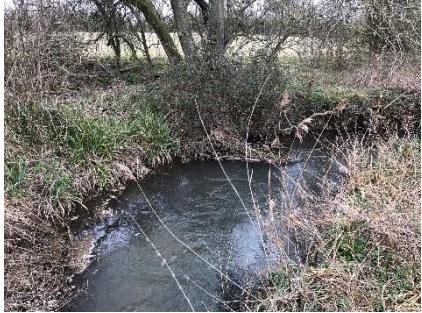
Flow Conditions	<p>Numerous flow types were noted through the more sinuous lengths, with berms, in-channel and marginal vegetation, and woody material all helping to provide varied flow.</p>

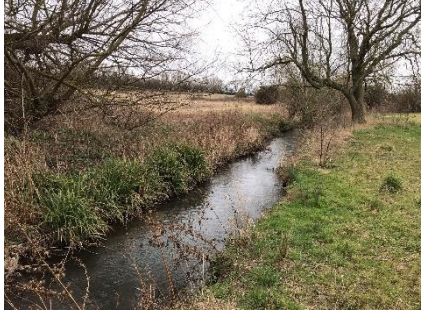
Floodplain Characteristics	<p>The floodplain mostly comprised agricultural fields, although a narrow strip of trees and grasses buffered the watercourse in parts.</p>

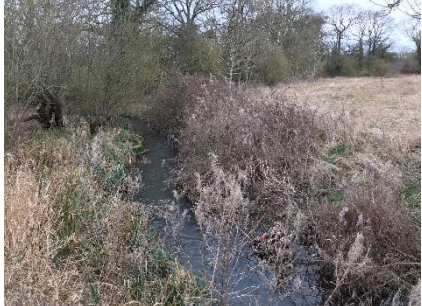
Riparian Zone	<p>The riparian zone comprised trees, grasses, shrubs and scrub in parts, although there was a considerable encroachment of agricultural fields.</p>

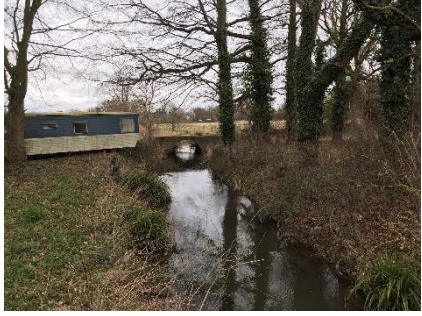
Parameter	Details	Photograph
Modifications	<p>Although the watercourse displayed a natural sinuosity over much of the surveyed length, evidence of historic straightening was present. A review of aerial imagery indicates that a greater degree of straightening has occurred beyond the surveyed length. The watercourse was culverted under a farm access track near Barnoldy Le Beck Park, and adjacent land use has been heavily modified for agricultural purposes.</p>

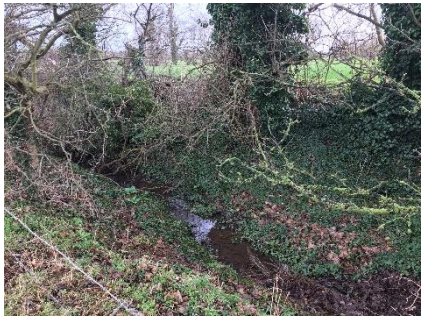
Parameter	Details	Photograph
Channel Form	This watercourse occupied a narrow channel flowing through a narrow, mostly wooded corridor set within agricultural fields. Although the channel has evidently been straightened, some localised sinuosity has developed, largely driven by vegetation and woody material.

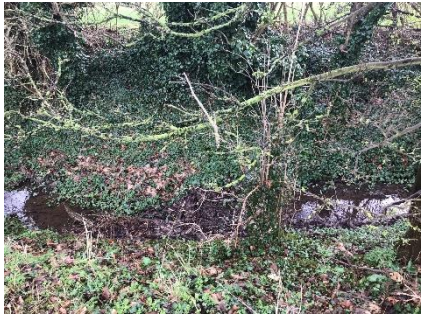
Substrate Conditions	The bed was silty, with a covering of twigs and leaves.

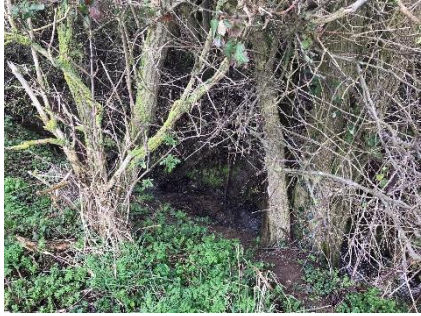
Flow Conditions	Gliding flow was observed through most of the surveyed length, although vegetation and woody material provided some flow variation.

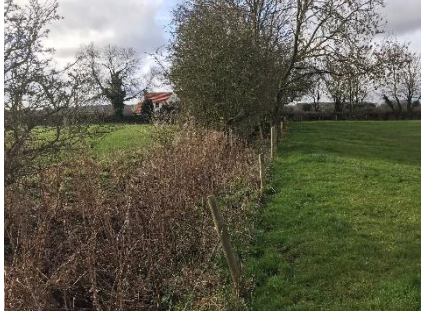
Floodplain Characteristics	The watercourse has been disconnected from the floodplain through historic modification including channel straightening.

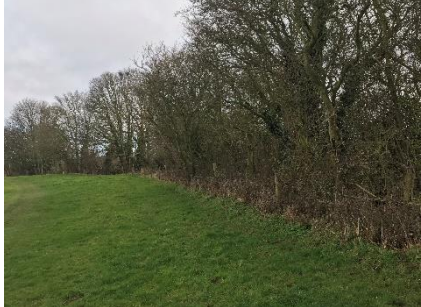
Riparian Zone	The riparian zone comprised a narrow wooded corridor surrounded by agricultural land.

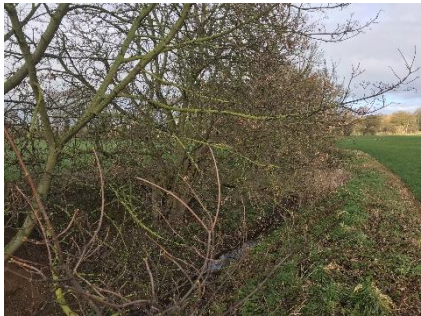
Parameter	Details	Photograph
Channel Form	This watercourse occupied a narrow channel with a narrow wooded corridor on the left bank and was surrounded by agricultural fields. Although the channel has evidently been straightened, some localised sinuosity has developed, largely driven by vegetation and woody material.

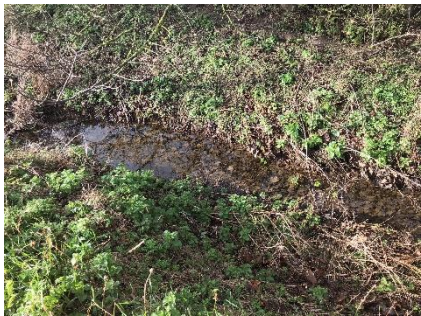
Substrate Conditions	The bed was silty, with a covering of twigs and leaves.

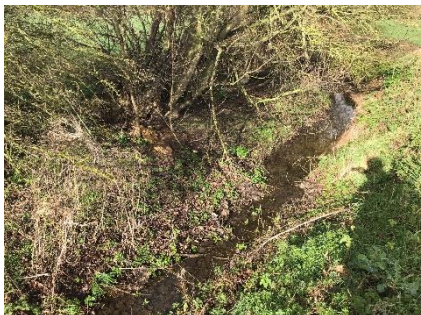
Flow Conditions	Gliding flow was observed through most of the surveyed length, although vegetation and woody material provided some flow variation.

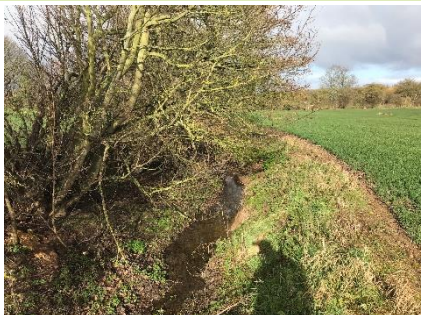
Floodplain Characteristics	The watercourse has been disconnected from the floodplain through historic modification including channel straightening.

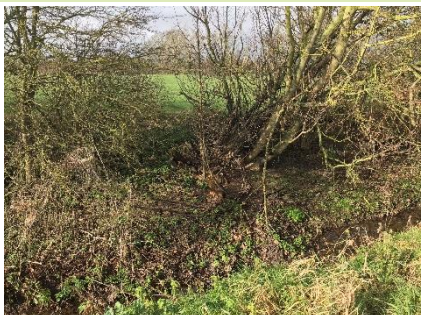
Riparian Zone	The riparian zone comprised a narrow wooded corridor on the left bank which was surrounded by agricultural land, while the right bank riparian zone comprised an agricultural field.

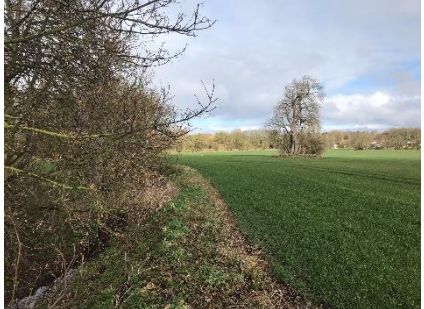
Parameter	Details	Photograph
Modifications	The watercourse has been straightened and adjacent land use has been heavily modified for agricultural use.

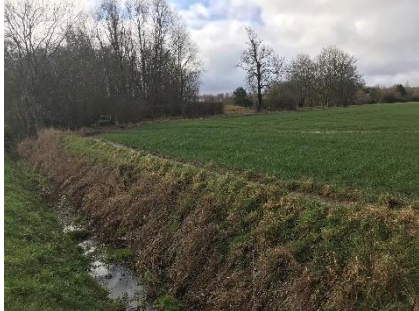
Parameter	Details	Photograph
Channel Form	This watercourse comprised a straight, artificial or heavily modified channel with a trapezoidal cross section. A linear shaped pond was connected to this drainage channel.

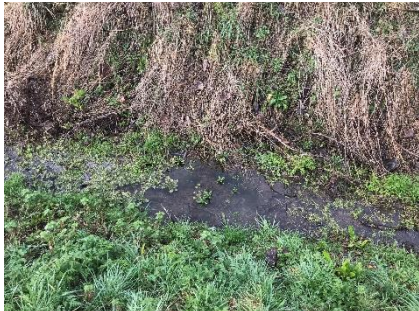
Substrate Conditions	The bed was silty.

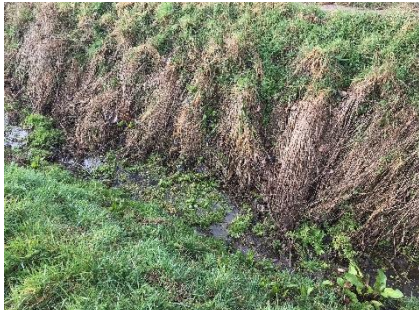
Flow Conditions	The channel had standing water.

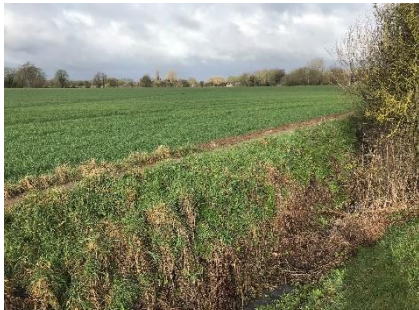
Floodplain Characteristics	The watercourse was artificial or heavily modified and completely disconnected from the adjacent floodplain.

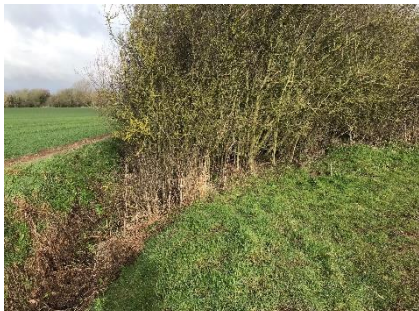
Riparian Zone	The riparian zone comprised agricultural fields with some trees.

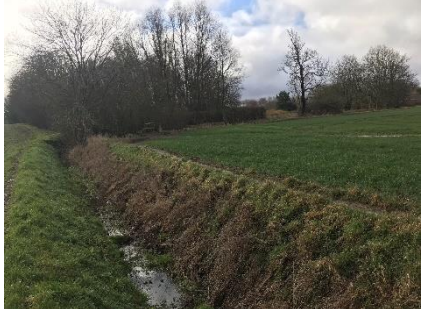
Parameter	Details	Photograph
Modifications	The watercourse is artificial or heavily modified. Adjacent land use is heavily modified for agricultural purposes.
