Viking CCS Pipeline

**Environmental
Statement Volume IV –
Appendix 11-2: Site
Visit Technical Note -
Water**

Document Reference: EN070008/APP/6.4.11.2

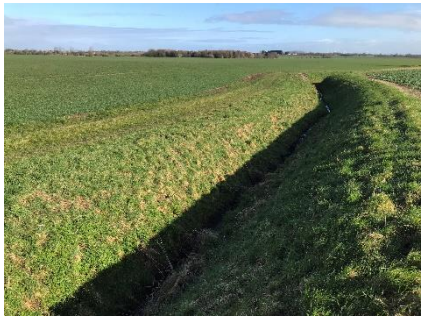
Parameter	Details	Photograph
Channel Form	This watercourse comprised a straightened, heavily modified channel with a trapezoidal cross section.

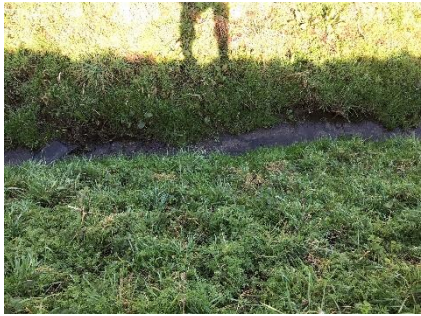
Substrate Conditions	The bed was silty, although some sand and small gravels were noted in parts.

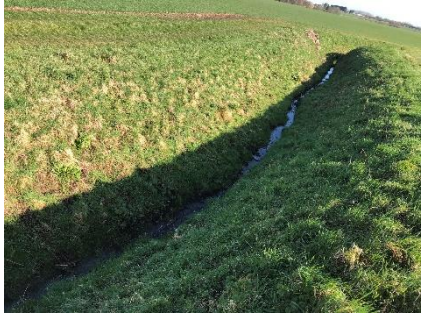
Flow Conditions	The watercourse was flowing, with some areas of rippled flow.

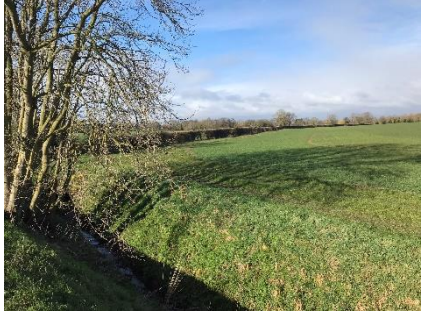
Floodplain Characteristics	The watercourse was heavily modified and completely disconnected from the adjacent floodplain.

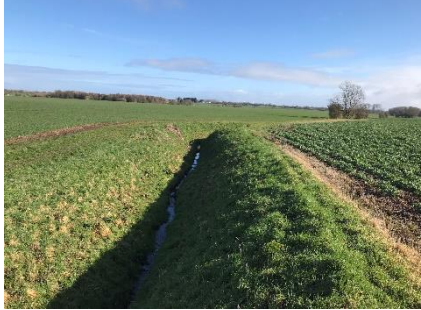
Riparian Zone	The riparian zone comprised agricultural fields.

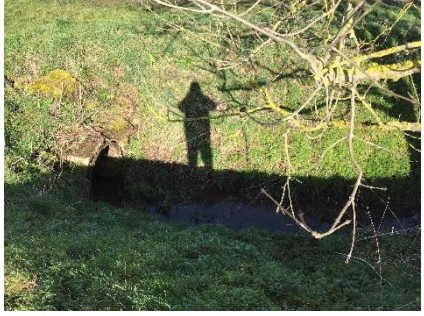
Parameter	Details	Photograph
Modifications	The watercourse is artificial or heavily modified. Adjacent land use is heavily modified for agricultural purposes. The watercourse is culverted under field access crossings.

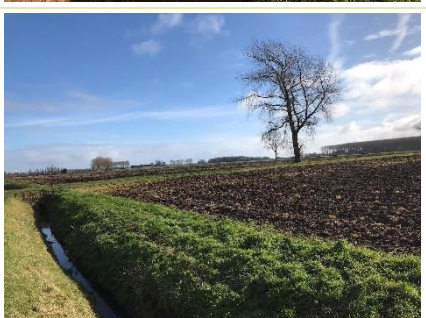
Floodplain Characteristics	The watercourse was artificial or heavily modified and completely disconnected from the adjacent floodplain.

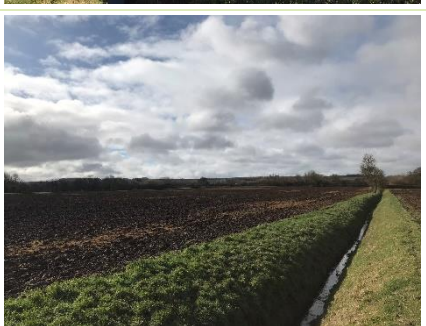
Riparian Zone	The riparian zone comprised agricultural fields.

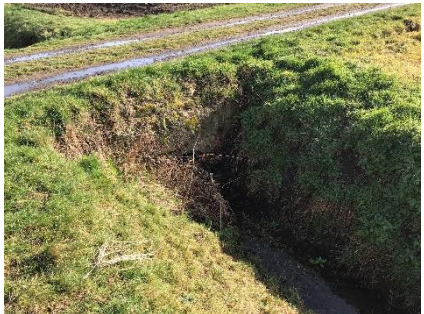
Parameter	Details	Photograph
Modifications	The watercourse is artificial or heavily modified. Adjacent land use is heavily modified for agricultural purposes. The watercourse is culverted under farm access tracks.

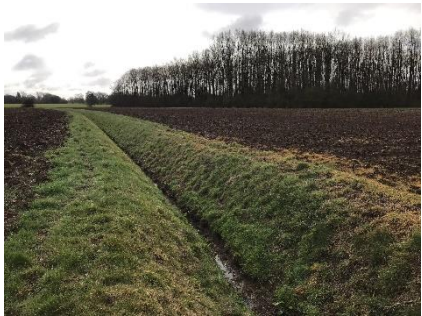
Parameter	Details	Photograph
Channel Form	This watercourse comprised a straight, artificial or heavily modified channel with a trapezoidal cross section.

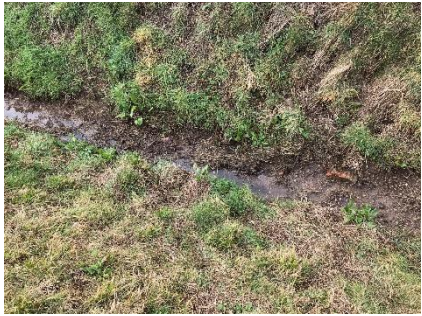
Substrate Conditions	The bed was silty.

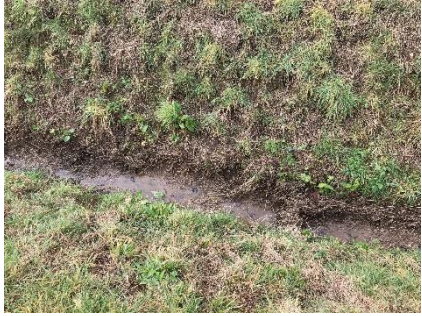
Flow Conditions	The channel had standing water through most of the surveyed length.

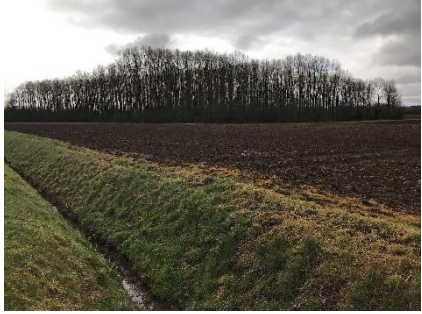
Floodplain Characteristics	The watercourse was artificial or heavily modified and completely disconnected from the adjacent floodplain.

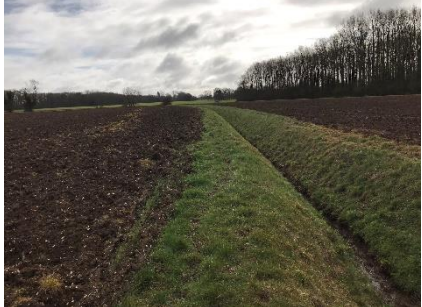
Riparian Zone	The riparian zone comprised agricultural fields with some trees.

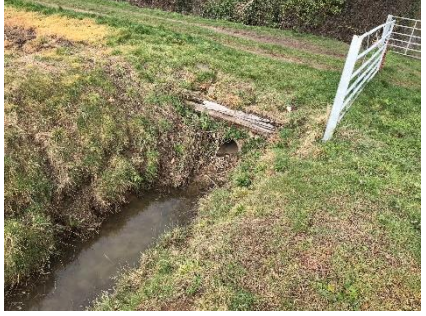
Parameter	Details	Photograph
Modifications	<p>The watercourse is artificial or heavily modified. Adjacent land use is heavily modified for agricultural purposes. The watercourse is culverted under a farm access track.</p>

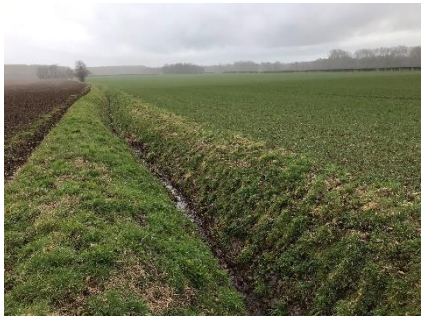
Parameter	Details	Photograph
Channel Form	This watercourse comprised a straight, artificial or heavily modified channel with a trapezoidal cross section.

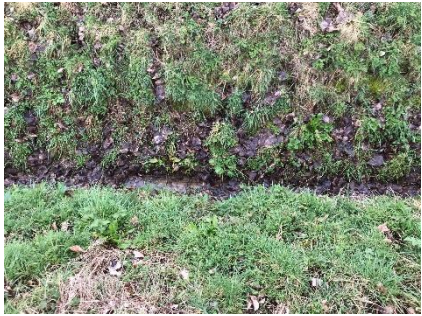
Substrate Conditions	The bed was silty.

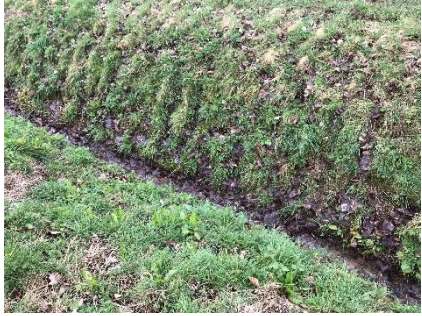
Flow Conditions	The channel had standing water.

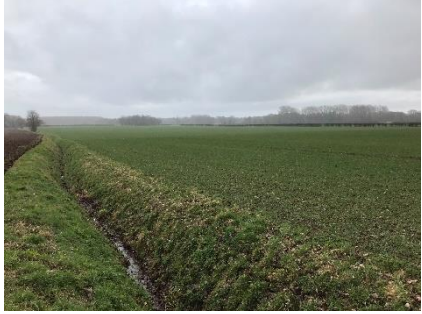
Floodplain Characteristics	The watercourse was artificial or heavily modified and completely disconnected from the adjacent floodplain.

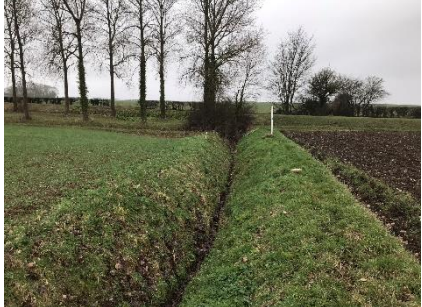
Riparian Zone	The riparian zone comprised agricultural fields.

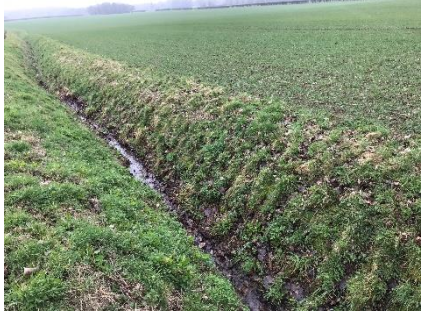
Parameter	Details	Photograph
Modifications	The watercourse is artificial or heavily modified. Adjacent land use is heavily modified for agricultural purposes.

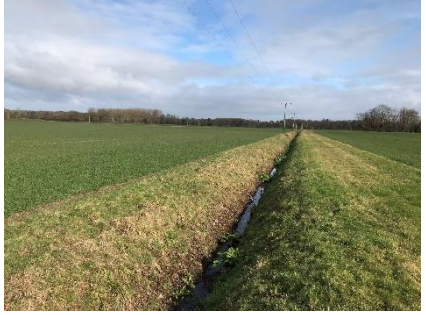
Parameter	Details	Photograph
Channel Form	This watercourse comprised a straight, artificial or heavily modified channel with a trapezoidal cross section.

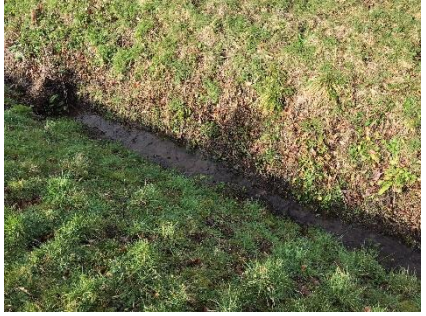
Substrate Conditions	The bed was silty.

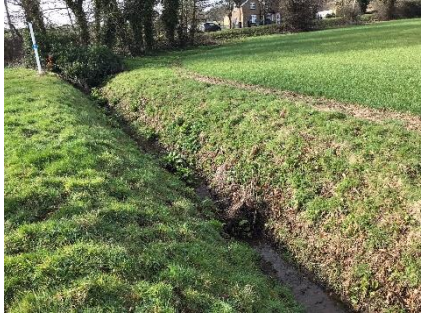
Flow Conditions	The channel had standing water.

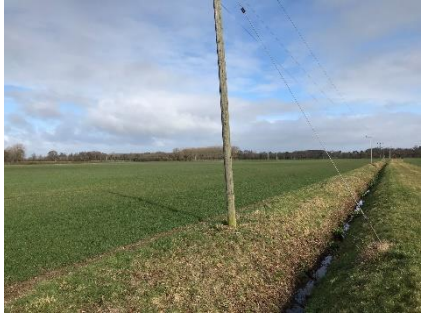
Floodplain Characteristics	The watercourse was artificial or heavily modified and completely disconnected from the adjacent floodplain.

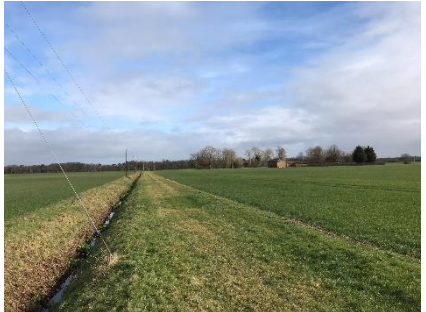
Riparian Zone	The riparian zone comprised agricultural fields.

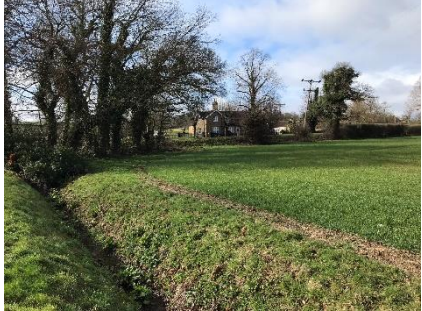
Parameter	Details	Photograph
Modifications	The watercourse is artificial or heavily modified. Adjacent land use is heavily modified for agricultural purposes.

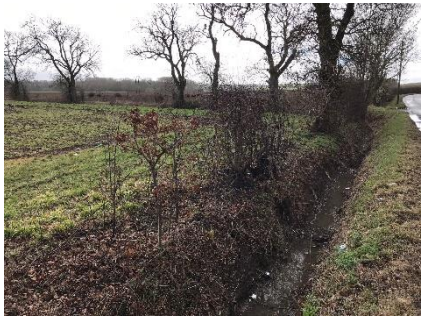
Parameter	Details	Photograph
Channel Form	This watercourse comprised a straight, artificial or heavily modified channel with a trapezoidal cross section. The channel ran parallel with a road.

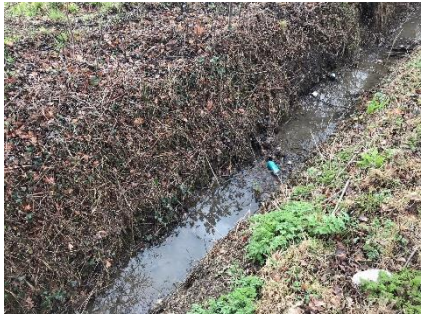
Substrate Conditions	The bed was silty.

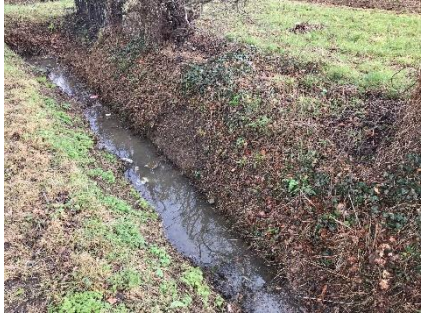
Flow Conditions	The channel had standing water.

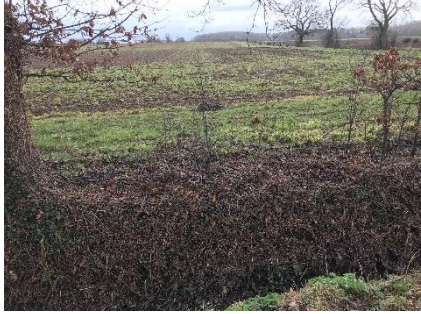
Floodplain Characteristics	The watercourse was artificial or heavily modified and completely disconnected from the adjacent floodplain.

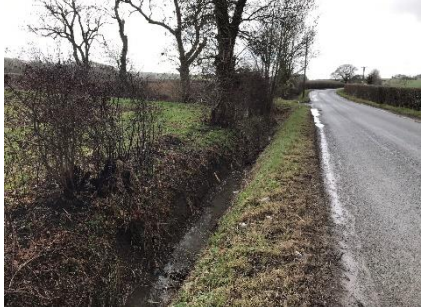
Riparian Zone	The riparian zone comprised agricultural fields with some trees on one bank and a road on the other.

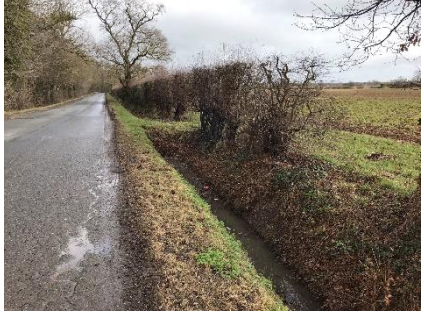
Parameter	Details	Photograph
Modifications	The watercourse is artificial or heavily modified. Adjacent land use is heavily modified for agricultural and transport purposes. The watercourse was culverted under field access crossings.

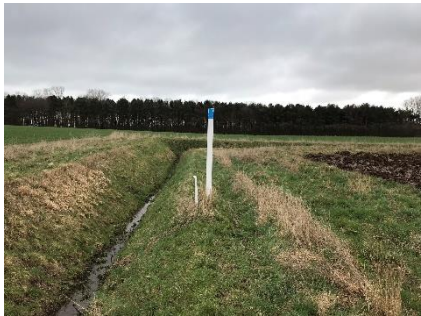
Parameter	Details	Photograph
Channel Form	This watercourse comprised a straight, artificial or heavily modified channel with a trapezoidal cross section.

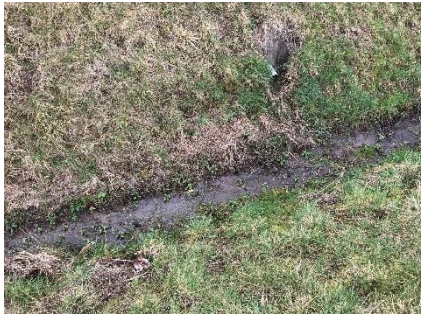
Substrate Conditions	The bed was silty.

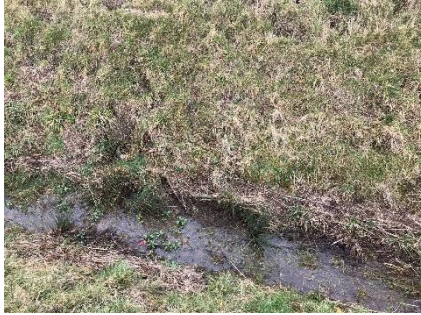
Flow Conditions	The channel had standing water.

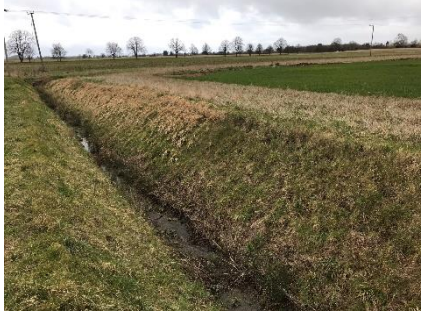
Floodplain Characteristics	The watercourse was artificial or heavily modified and completely disconnected from the adjacent floodplain.

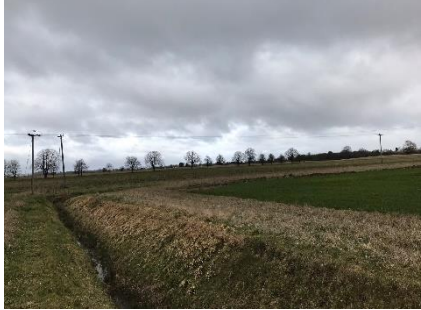
Riparian Zone	The riparian zone comprised agricultural fields.

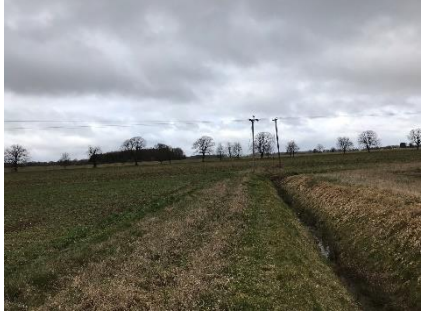
Parameter	Details	Photograph
Modifications	The watercourse is artificial or heavily modified. Adjacent land use is heavily modified for agricultural purposes.

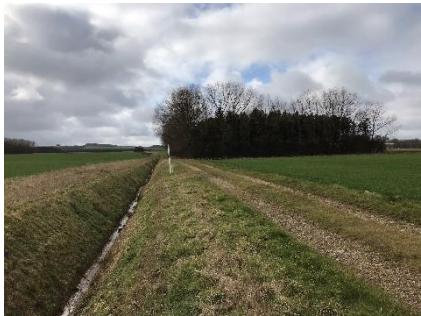
11.34 WC DX049P

Parameter	Details	Photograph
Channel Form	This watercourse comprised a straight, artificial or heavily modified channel with a trapezoidal cross section.

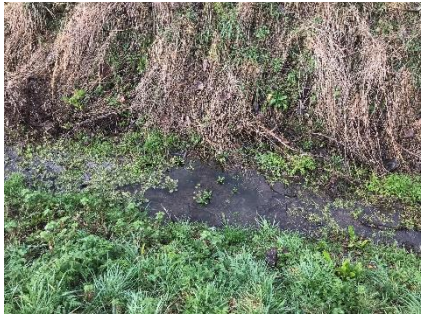
Substrate Conditions	The bed was silty.

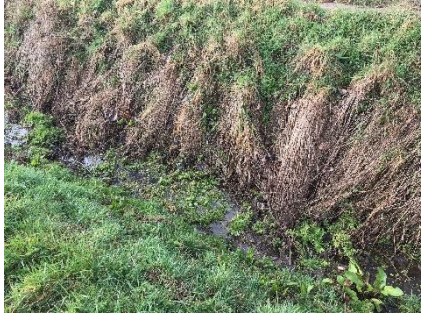
Flow Conditions	The channel had standing water.

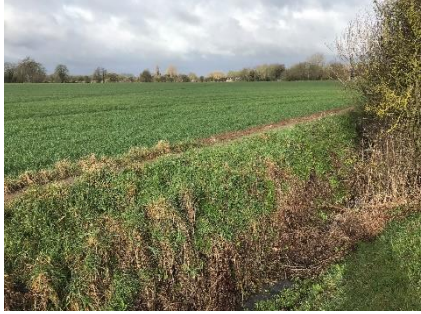
Floodplain Characteristics	The watercourse was artificial or heavily modified and completely disconnected from the adjacent floodplain.

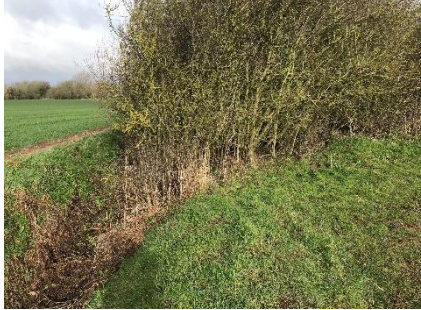
Riparian Zone	The riparian zone comprised agricultural fields.

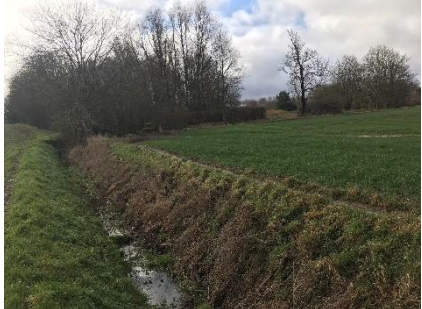
Parameter	Details	Photograph
Modifications	The watercourse is artificial or heavily modified. Adjacent land use is heavily modified for agricultural purposes.

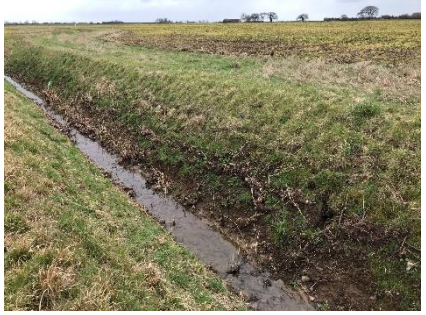
11.35 WC DX050P

Parameter	Details	Photograph
Channel Form	This watercourse comprised a straight, artificial or heavily modified channel with a trapezoidal cross section.

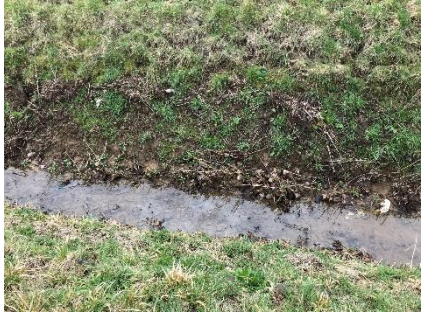
Substrate Conditions	The bed was silty.

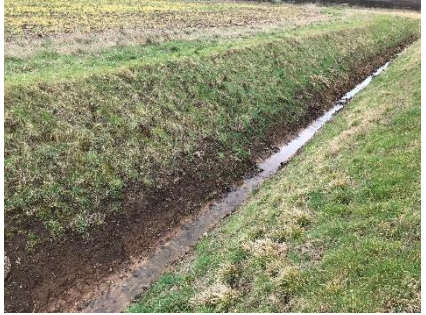
Flow Conditions	The watercourse had some flowing water which was mostly gliding, with some rippled flow where vegetation and organic material were on the channel bed.

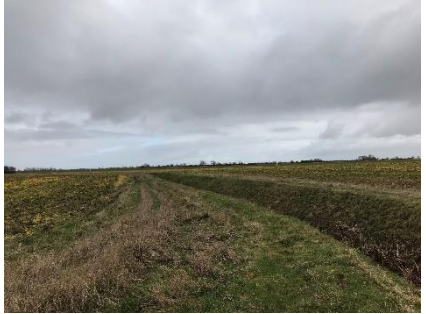
Floodplain Characteristics	The watercourse was artificial or heavily modified and completely disconnected from the adjacent floodplain.

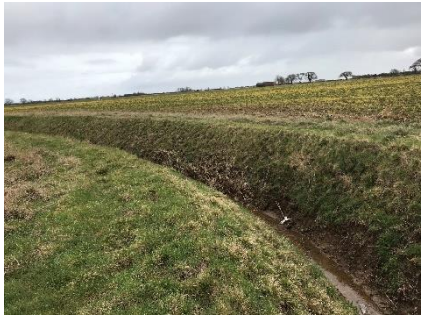
Riparian Zone	The riparian zone comprised agricultural fields.

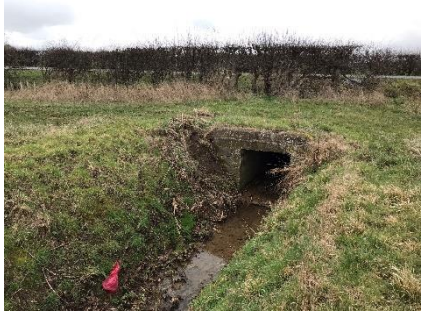
Parameter	Details	Photograph
Modifications	The watercourse is artificial or heavily modified. Adjacent land use is heavily modified for agricultural purposes. The watercourse is culverted under the A16.

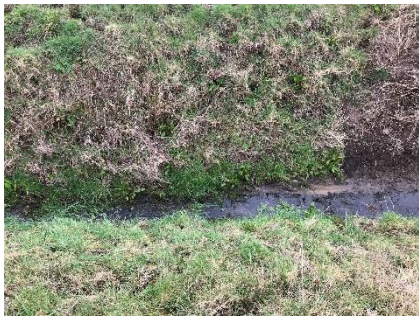
11.36 WC DX051P

Parameter	Details	Photograph
Channel Form	This watercourse comprised a straight, artificial or heavily modified channel with a trapezoidal cross section.	 
Substrate Conditions	The bed was silty.

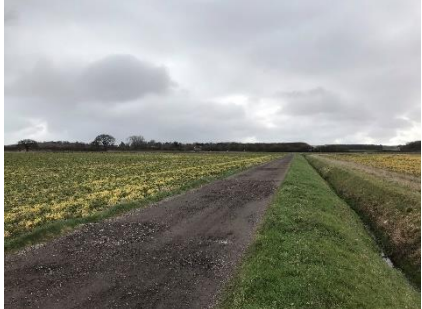
Parameter	Details	Photograph
Modifications	The watercourse is artificial or heavily modified. Adjacent land use is heavily modified for agricultural purposes.

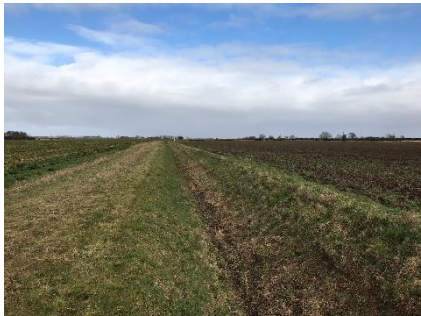
11.37 WC DX052P

Parameter	Details	Photograph
Channel Form	This watercourse comprised a straight, artificial or heavily modified channel with a trapezoidal cross section.

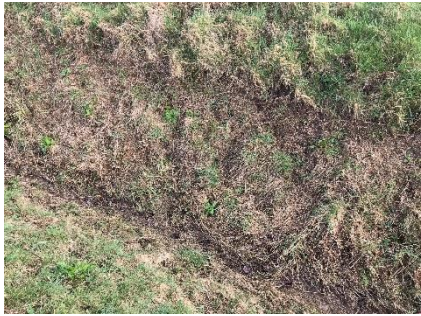
Substrate Conditions	The bed was grassed.

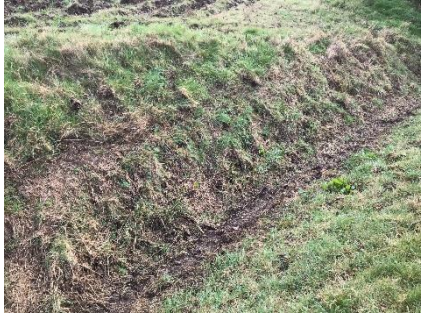
Flow Conditions	The channel was dry with a grassed bed, and is unlikely to hold water apart from during particularly wet periods.

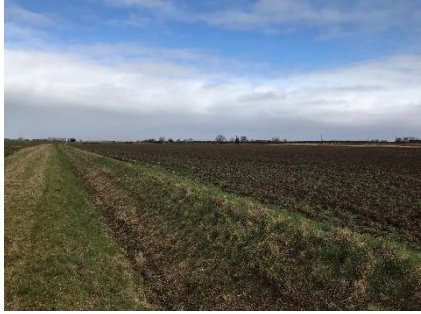
Floodplain Characteristics	The watercourse was artificial or heavily modified and completely disconnected from the adjacent floodplain.

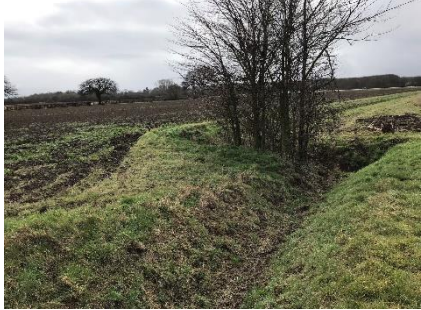
Riparian Zone	The riparian zone comprised agricultural fields. There was a small group of trees also present in one location.

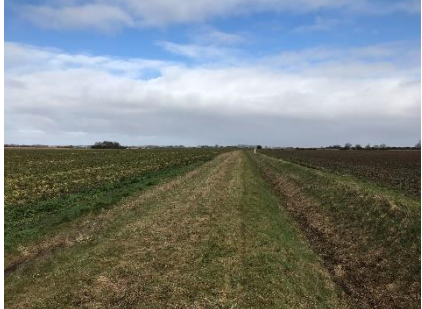
Parameter	Details	Photograph
Modifications	The watercourse is artificial or heavily modified. Adjacent land use is heavily modified for agricultural purposes.

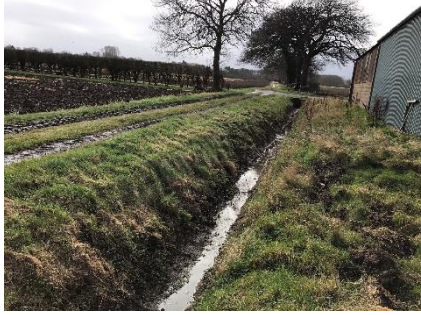
11.38 WC DX053P

Parameter	Details	Photograph
Channel Form	This watercourse comprised a straight, artificial or heavily modified channel with a trapezoidal cross section.

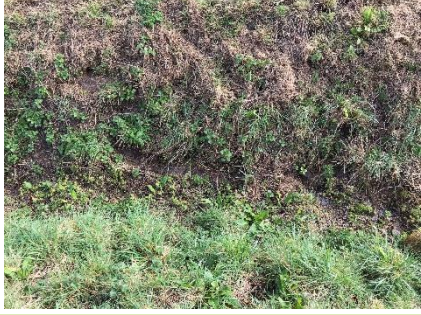
Substrate Conditions	The bed was silty where water was present, but grassed were dry obscuring sediment.

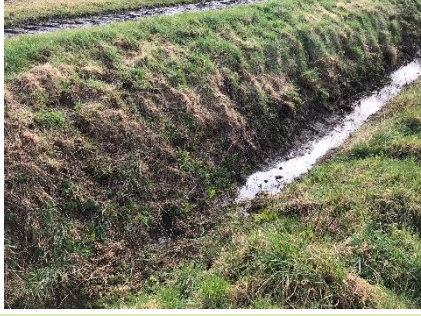
Flow Conditions	The channel had standing water in parts but was dry for much of its length.

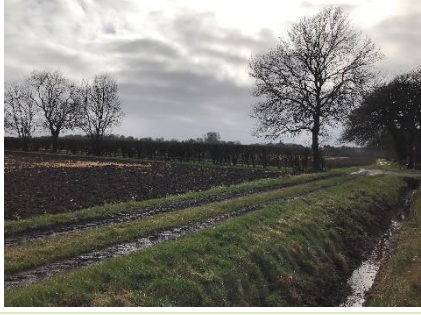
Floodplain Characteristics	The watercourse was artificial or heavily modified and completely disconnected from the adjacent floodplain.

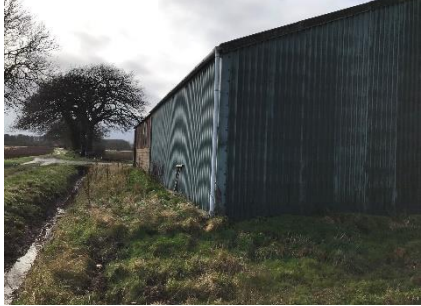
Riparian Zone	The riparian zone comprised agricultural fields with a gravel access track running down the right bank. There was also a barn within the riparian zone on the left bank.

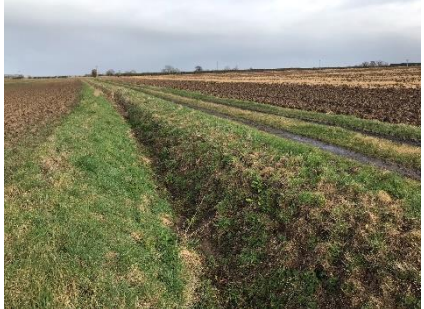
Parameter	Details	Photograph
Modifications	The watercourse is artificial or heavily modified. Adjacent land use is heavily modified for agricultural purposes.

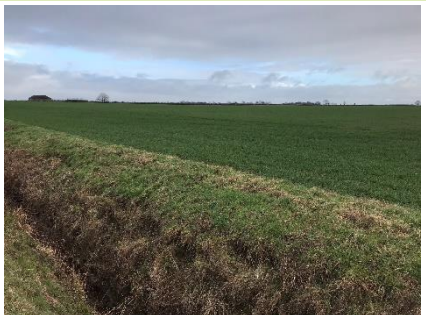
Floodplain Characteristics	The watercourse was artificial or heavily modified and completely disconnected from the adjacent floodplain.

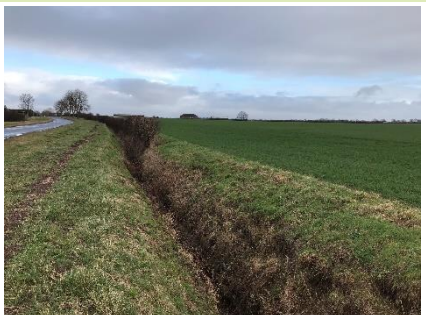
Riparian Zone	The riparian zone comprised agricultural fields, with a road also present. A hedgerow ran long part of the watercourse length.

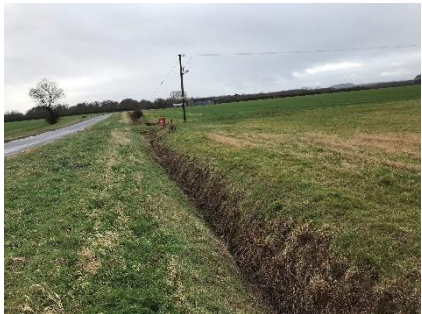
Parameter	Details	Photograph
Modifications	The watercourse is artificial or heavily modified. Adjacent land use is heavily modified for agricultural purposes and transport. The watercourse was culverted under field access crossings.

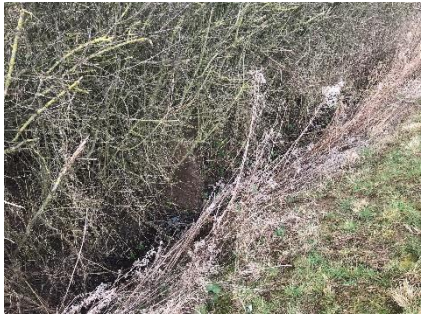
11.40 WC DX057P

Parameter	Details	Photograph
Channel Form	This watercourse comprised a straight, artificial or heavily modified channel with a trapezoidal cross section.	 
Substrate Conditions	The bed was silty.

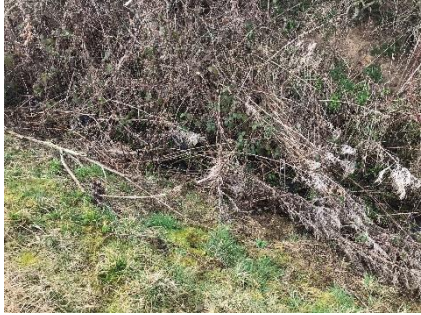
Flow Conditions	The channel had standing water.

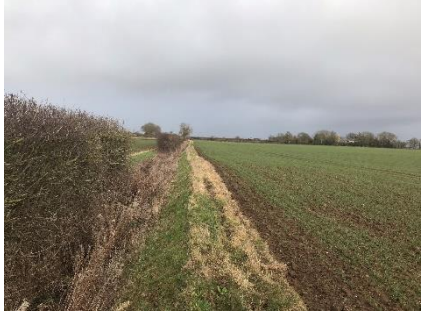
Floodplain Characteristics	The watercourse was artificial or heavily modified and completely disconnected from the adjacent floodplain.

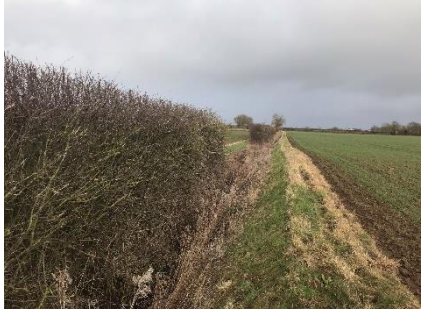
Riparian Zone	The riparian zone comprised agricultural fields, although one bank was buffered by occasional scrub cover.

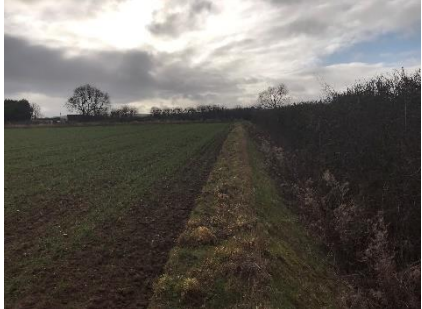
Parameter	Details	Photograph
Modifications	The watercourse is artificial or heavily modified. Adjacent land use is heavily modified for agricultural purposes.

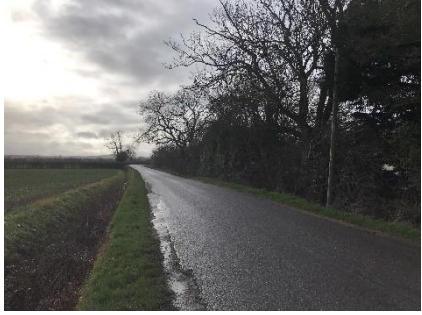
11.41 WC DX058P

Parameter	Details	Photograph
Channel Form	This watercourse comprised a straight, artificial or heavily modified channel with a trapezoidal cross section.

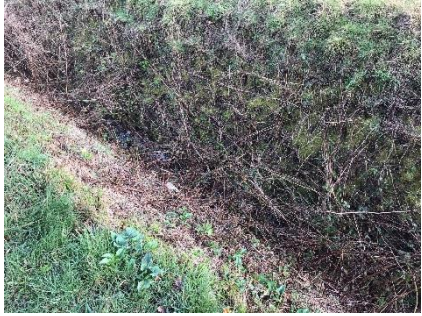
Substrate Conditions	The bed was silty.	 
Flow Conditions	The channel had standing water.

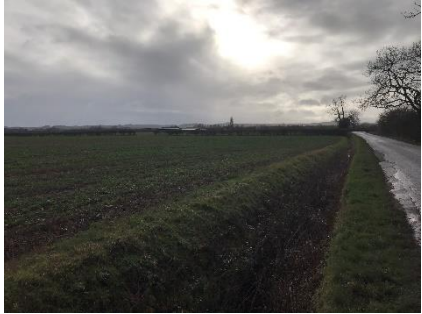
Floodplain Characteristics	The watercourse was artificial or heavily modified and completely disconnected from the adjacent floodplain.

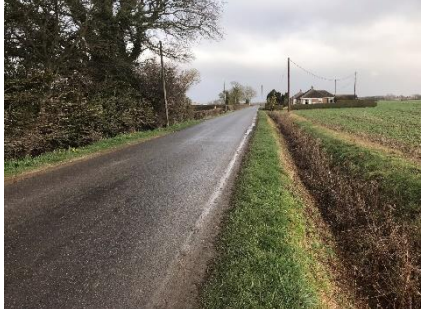
Parameter	Details	Photograph
Modifications	The watercourse is artificial or heavily modified. Adjacent land use is heavily modified for agricultural and transport purposes.

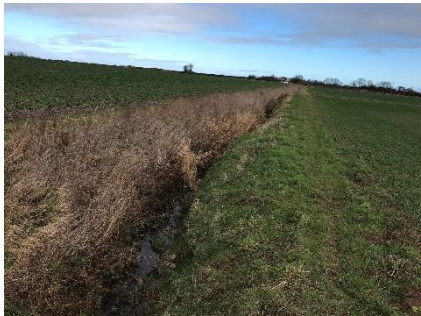
11.42 WC DX059P

Parameter	Details	Photograph
Channel Form	This watercourse comprised a straight, artificial or heavily modified channel with a trapezoidal cross section.

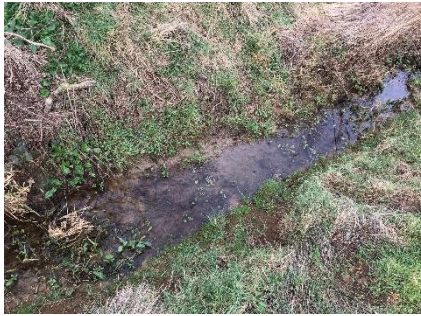
Substrate Conditions	The bed was silty.

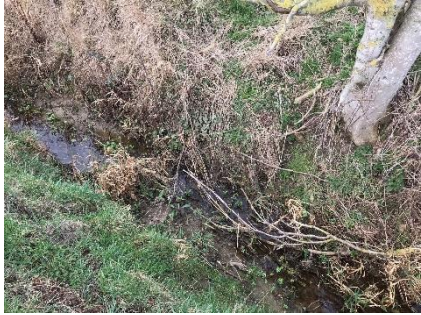
Flow Conditions	The channel had standing water.

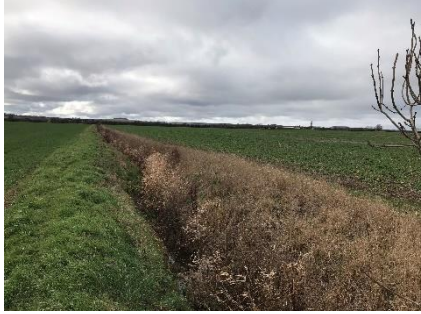
Floodplain Characteristics	The watercourse was artificial or heavily modified and completely disconnected from the adjacent floodplain.

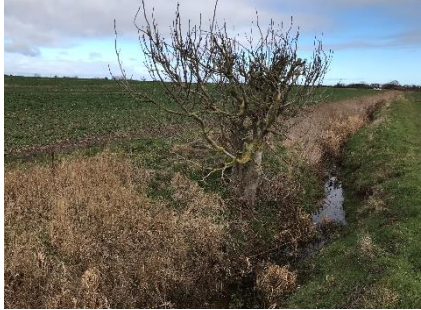
Riparian Zone	The riparian zone comprised agricultural fields.

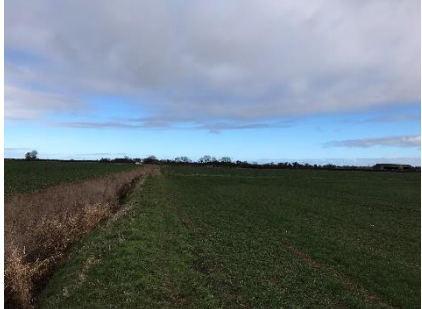
Parameter	Details	Photograph
Modifications	The watercourse is artificial or heavily modified. Adjacent land use is heavily modified for agricultural purposes.

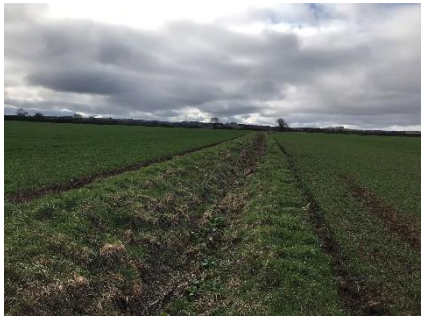
11.43 WC DX060P

Parameter	Details	Photograph
Channel Form	This watercourse comprised a straight, artificial or heavily modified channel with a trapezoidal cross section.

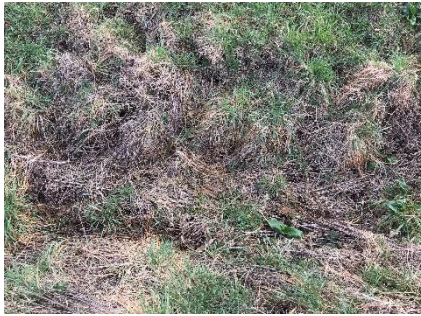
Substrate Conditions	The bed was grassed.

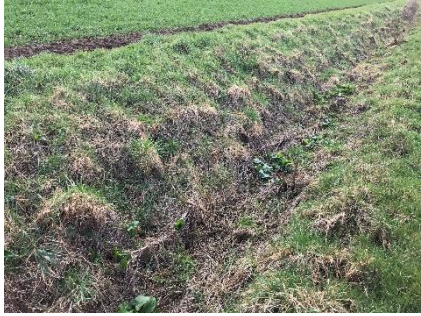
Flow Conditions	The channel was dry and appeared unlikely to hold water apart from during particularly wet periods.

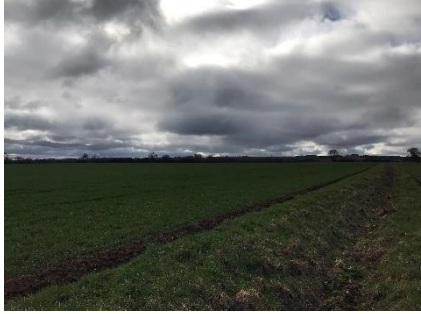
Floodplain Characteristics	The watercourse was artificial or heavily modified and completely disconnected from the adjacent floodplain.

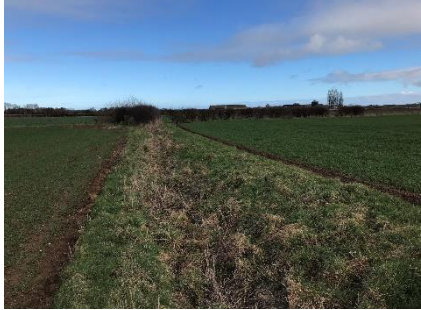
Riparian Zone	The riparian zone comprised agricultural fields.

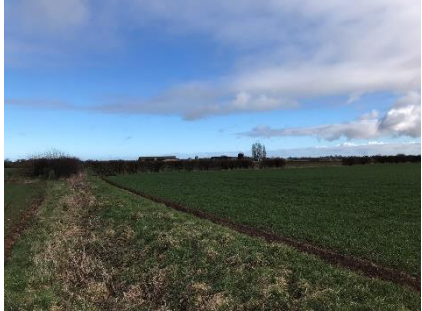
Parameter	Details	Photograph
Modifications	The watercourse is artificial or heavily modified. Adjacent land use is heavily modified for agricultural purposes.

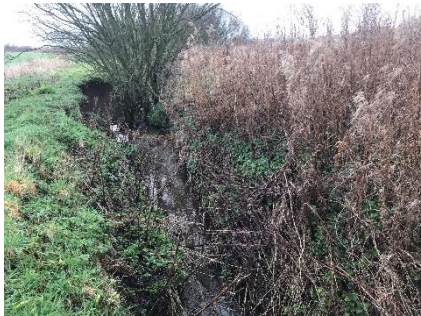
11.44 WC RVX001EP – Poulton Drain

Parameter	Details	Photograph
Channel Form	This watercourse has historically been straightened along field boundaries, although some sinuosity is developing. Planform change is largely driven by vegetation, with eroding banks associated with trees and in-channel woody material being observed.

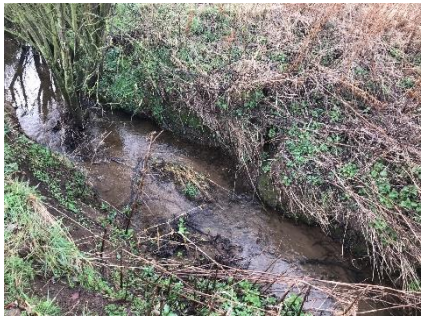
Substrate Conditions	The bed was silty, although gravels were noted in parts.

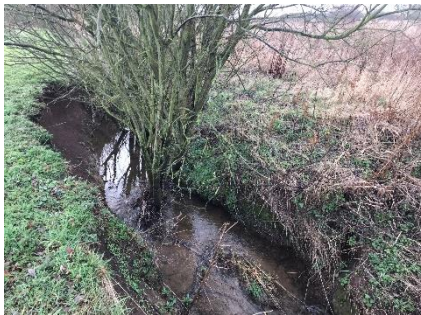
Flow Conditions	Flow was predominantly gliding, although rippled flow and other more turbulent surface flows were observed where substrate comprised coarser material and where woody material was present.

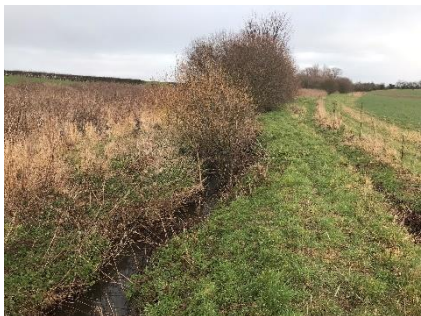
Floodplain Characteristics	Historic realignments and channel deepening have left the watercourse disconnected from the floodplain.

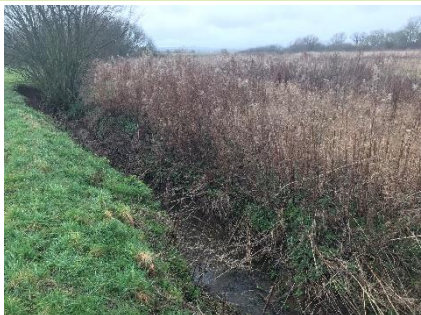
Riparian Zone	The riparian zone comprised agricultural fields, although an area of tall grasses, herbs and scrub buffered the watercourse.

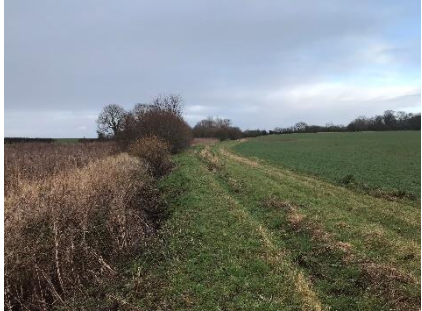
Parameter	Details	Photograph
Modifications	The watercourse has been historically straightened along field boundaries. Adjacent land use is heavily modified for agricultural purposes.

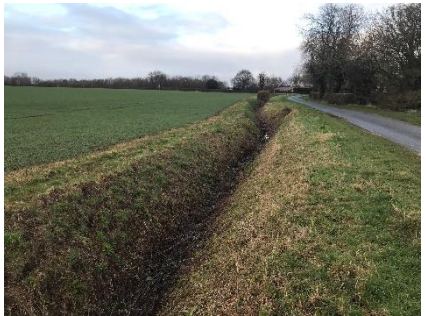
11.45 WC DX064P

Parameter	Details	Photograph
Channel Form	This watercourse comprised a straight, artificial or heavily modified channel with a trapezoidal cross section.

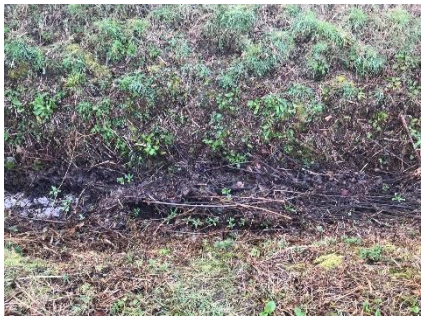
Substrate Conditions	The bed was silty.

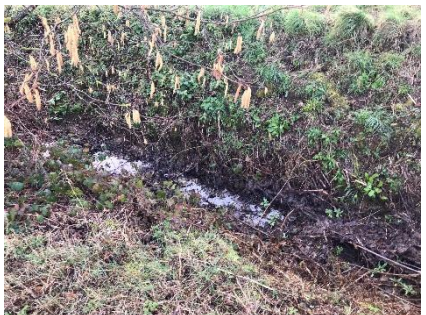
Flow Conditions	The channel had standing water in parts.

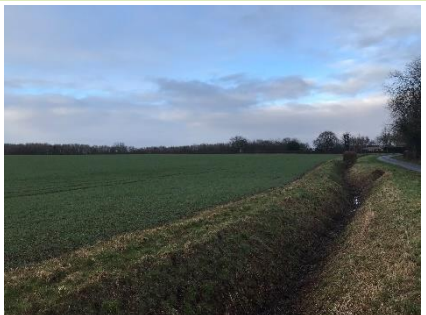
Floodplain Characteristics	The watercourse was artificial or heavily modified and completely disconnected from the adjacent floodplain.

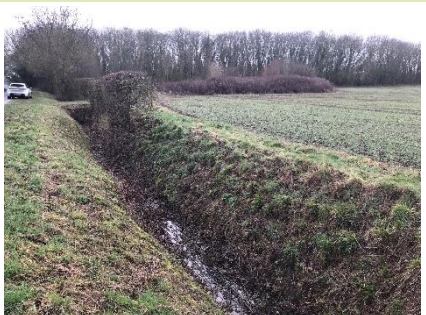
Riparian Zone	The riparian zone comprised agricultural fields on one side, with hedges and trees along part of its length. A road was present on the opposite side.

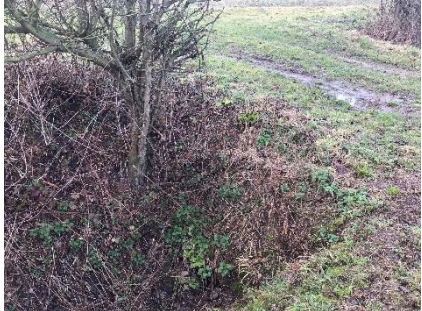
Parameter	Details	Photograph
Modifications	The watercourse is artificial or heavily modified. Adjacent land use is heavily modified for agricultural and transport purposes. The watercourse is culverted under field access crossings.

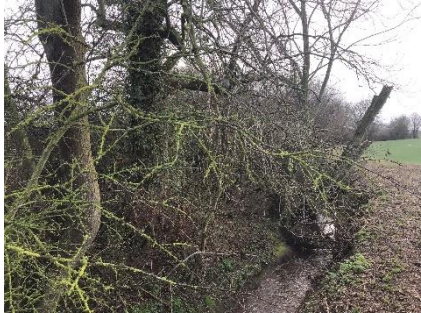
11.46 WC RVX001FP – Black Dyke

Parameter	Details	Photograph
Channel Form	This watercourse has been straightened to allow a road to cross. The channel was incised disconnecting it from the floodplain through much of its length.

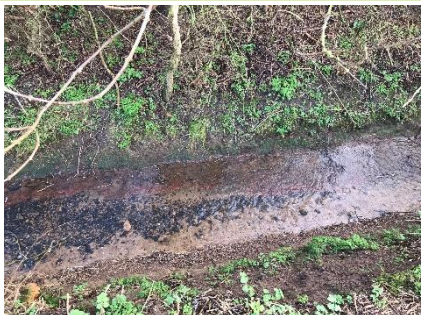
Substrate Conditions	Gravels were noted on the bed in parts, although silt dominated throughout.

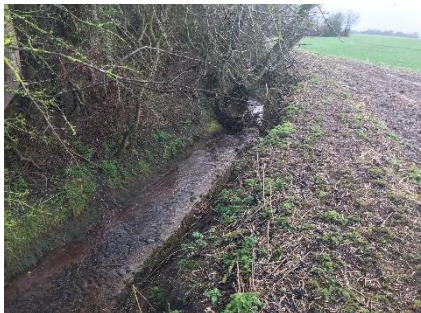
Flow Conditions	Flow was generally gliding, although ripples were noted over coarser substrate. Woody material from adjacent trees also provided some flow variation.

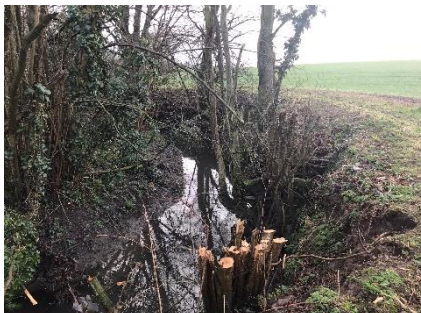
Floodplain Characteristics	The watercourse was incised and mostly disconnected from the floodplain. Some floodplain connection likely through the woodland on the right bank.

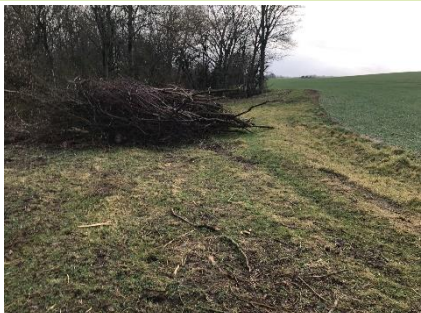
Riparian Zone	The riparian zone comprised agricultural fields, although a wooded and grassed corridor buffered the watercourse. Some trees and shrubs have been coppicing to promote new growth and enhance the riparian zone.

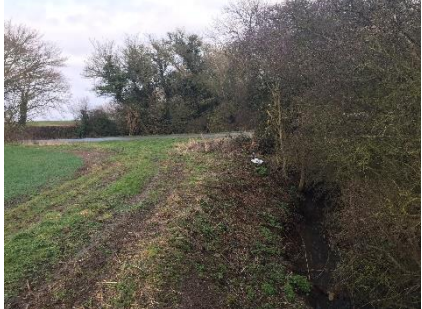
Parameter	Details	Photograph
Modifications	The watercourse has been straightened for the road crossing and adjacent land use is heavily modified for agriculture, which likely contributes fine sediment to the watercourse.

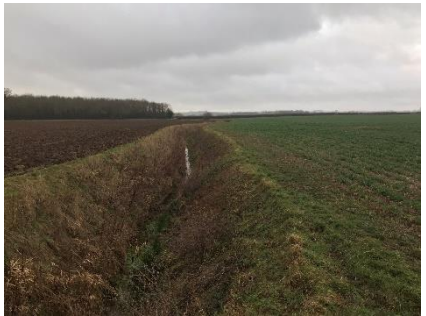
11.47 WC DX066P

Parameter	Details	Photograph
Channel Form	This watercourse comprised a straight, artificial or heavily modified channel with a trapezoidal cross section.

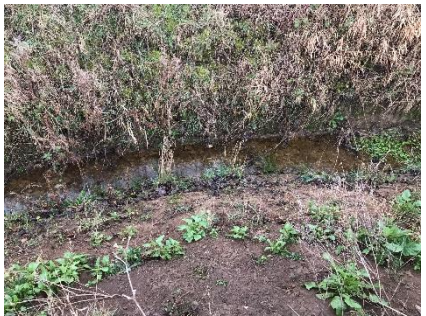
Substrate Conditions	The bed was silty.

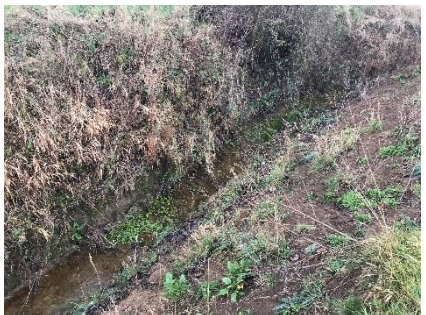
Flow Conditions	The channel had standing water.

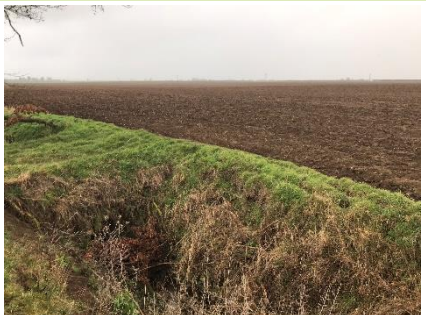
Floodplain Characteristics	The watercourse was artificial or heavily modified and completely disconnected from the adjacent floodplain.

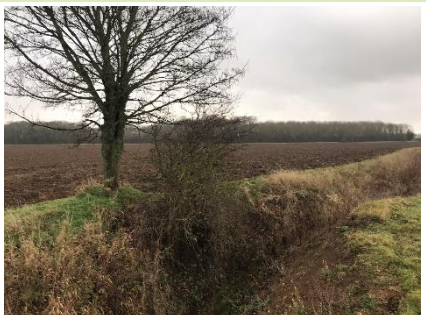
Riparian Zone	The riparian zone comprised agricultural fields with occasional lone trees.

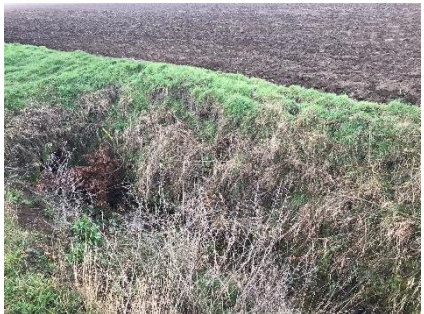
Parameter	Details	Photograph
Modifications	The watercourse is artificial or heavily modified. Adjacent land use is heavily modified for agricultural purposes. The watercourse is culverted under field access crossings.

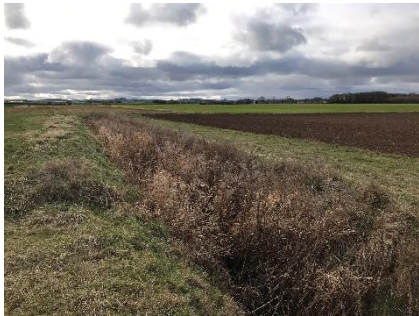
11.48 WC DX067P

Parameter	Details	Photograph
Channel Form	This watercourse comprised a straight, artificial or heavily modified channel with a trapezoidal cross section.

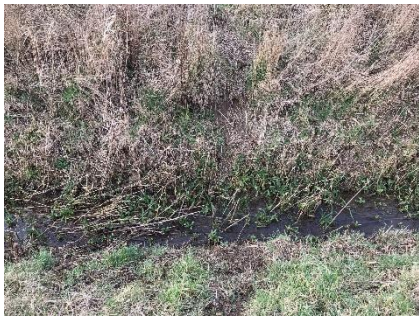
Substrate Conditions	The bed was silty.

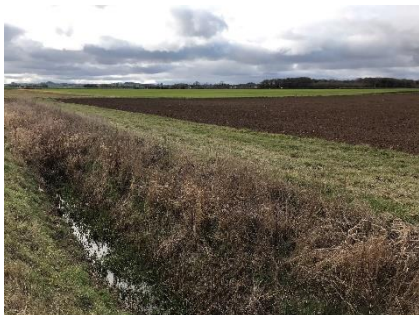
Flow Conditions	The channel had standing water.

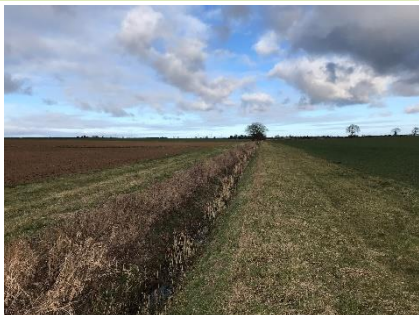
Floodplain Characteristics	The watercourse was artificial or heavily modified and completely disconnected from the adjacent floodplain.

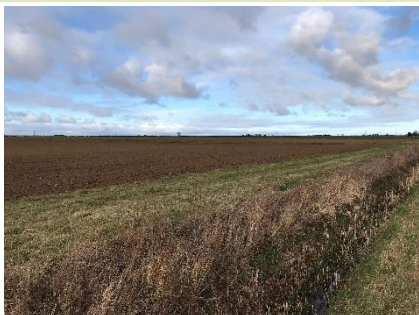
Riparian Zone	The riparian zone comprised agricultural fields with a narrow grass border buffering the watercourse.

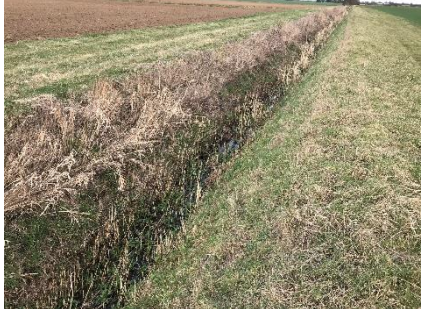
Parameter	Details	Photograph
Modifications	The watercourse is artificial or heavily modified. Adjacent land use is heavily modified for agricultural purposes. The watercourse is culverted under field access crossings.

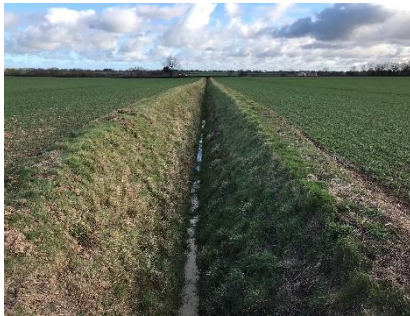
Parameter	Details	Photograph
Channel Form	No watercourse exists at the proposed crossing location, however a watercourse is nearby. This watercourse comprised a straight, artificial or heavily modified channel with a trapezoidal cross section.

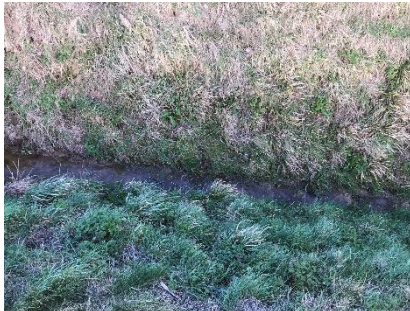
Substrate Conditions	The bed was silty.

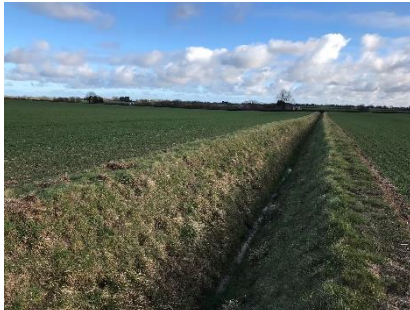
Flow Conditions	The channel had standing water.

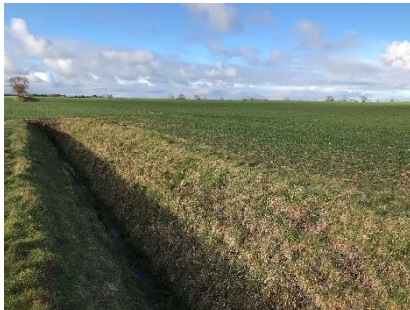
Floodplain Characteristics	The watercourse was artificial or heavily modified and completely disconnected from the adjacent floodplain.

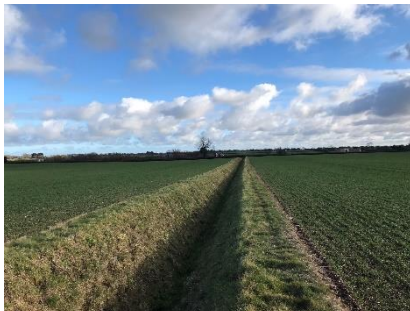
Riparian Zone	The riparian zone comprised agricultural fields.

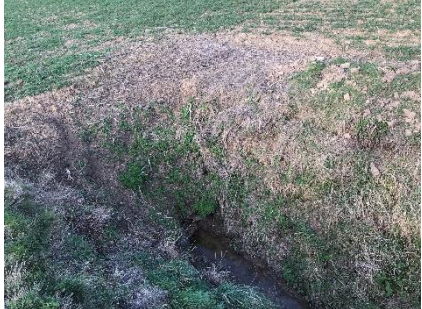
Parameter	Details	Photograph
Modifications	The watercourse is artificial or heavily modified. Adjacent land use is heavily modified for agricultural purposes.

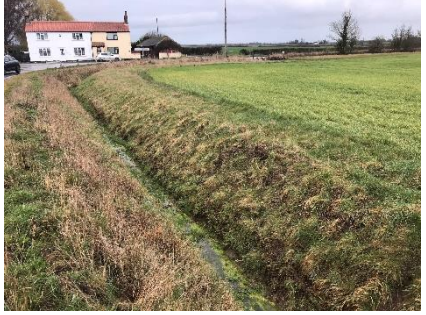
Parameter	Details	Photograph
Channel Form	This watercourse comprised a straight, artificial or heavily modified channel with a trapezoidal cross section.

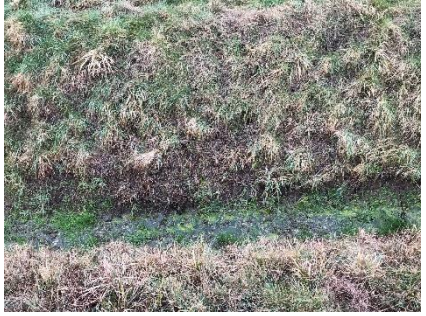
Substrate Conditions	The bed was silty.

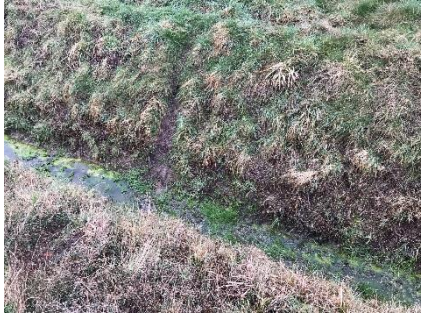
Flow Conditions	The channel had standing water.

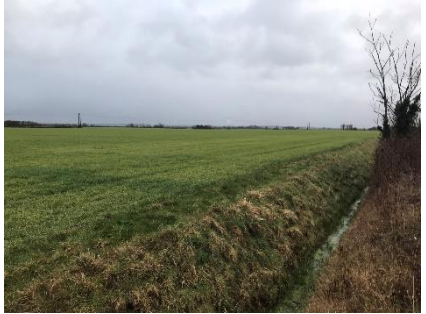
Floodplain Characteristics	The watercourse was artificial or heavily modified and completely disconnected from the adjacent floodplain.

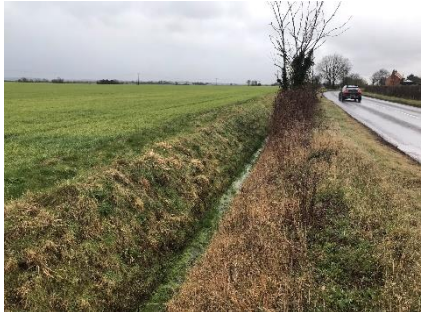
Riparian Zone	The riparian zone comprised agricultural fields and a road.

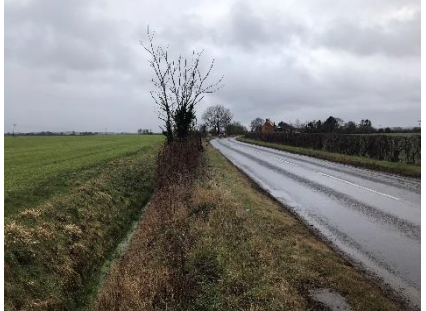
Parameter	Details	Photograph
Modifications	The watercourse is artificial or heavily modified. Adjacent land use is heavily modified for agricultural and transport purposes.

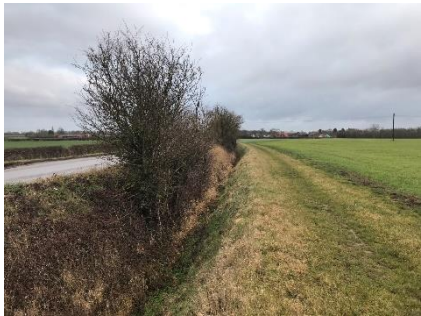
Parameter	Details	Photograph
Channel Form	This watercourse comprised a straight, artificial or heavily modified channel with a trapezoidal cross section.

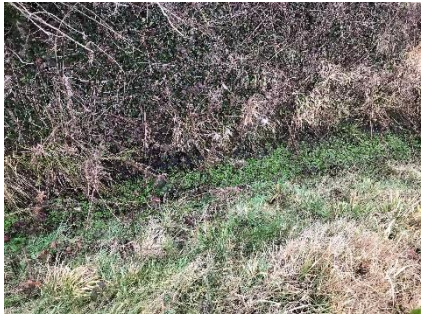
Substrate Conditions	The bed was silty.

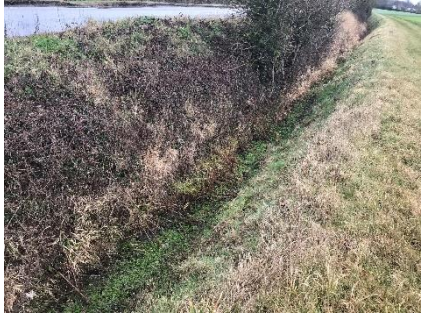
Flow Conditions	The channel had standing water and was dry elsewhere.

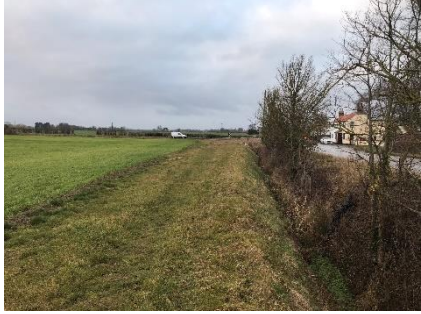
Floodplain Characteristics	The watercourse was artificial or heavily modified and completely disconnected from the adjacent floodplain.

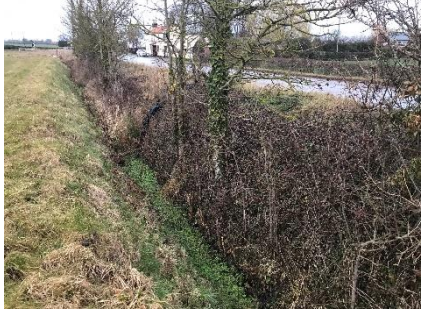
Riparian Zone	The riparian zone comprised agricultural fields with some trees and a road.
