Viking CCS Pipeline

**Environmental
Statement Volume IV –
Appendix 11-2: Site
Visit Technical Note -
Water**

Document Reference: EN070008/APP/6.4.11.2

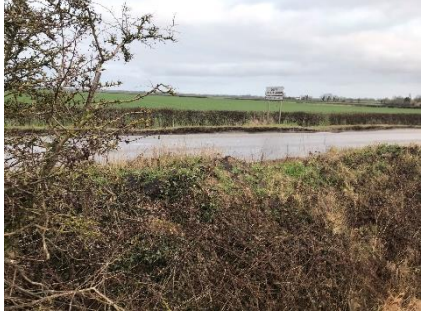
Parameter	Details	Photograph
Modifications	The watercourse is artificial or heavily modified. Adjacent land use is heavily modified for agricultural and transport purposes.

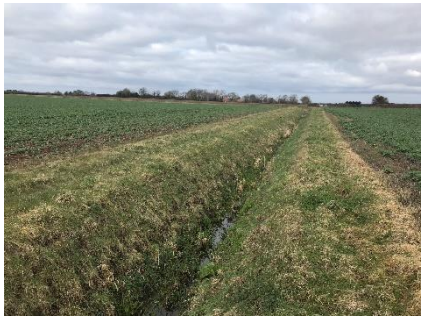
Parameter	Details	Photograph
Channel Form	This watercourse comprised a straight, artificial or heavily modified channel with a trapezoidal cross section.

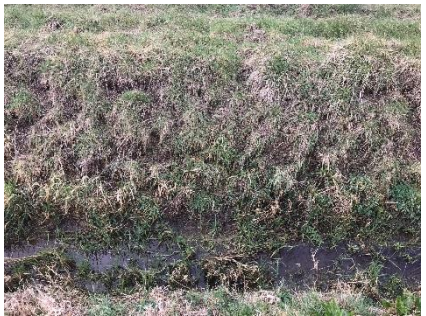
Substrate Conditions	The bed was silty.

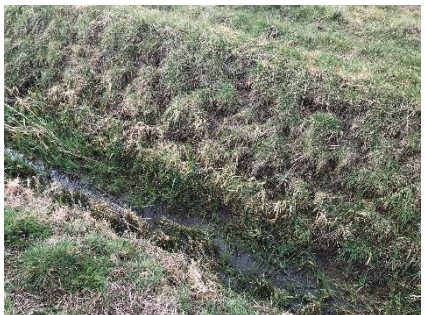
Flow Conditions	The channel had standing water.

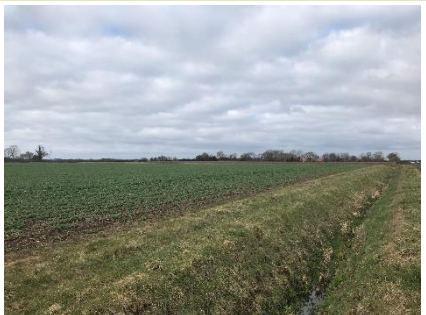
Floodplain Characteristics	The watercourse was artificial or heavily modified and completely disconnected from the adjacent floodplain.

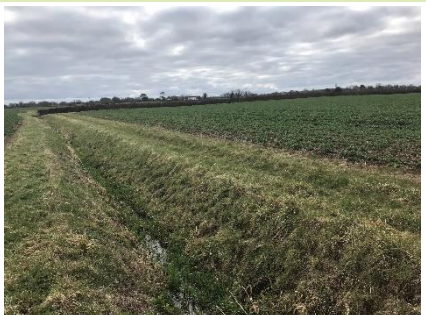
Riparian Zone	The riparian zone comprised agricultural fields.

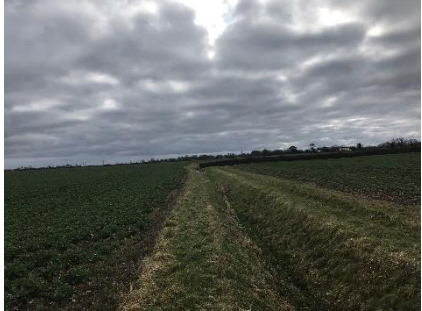
Parameter	Details	Photograph
Modifications	The watercourse is artificial or heavily modified. Adjacent land use is heavily modified for agricultural purposes.

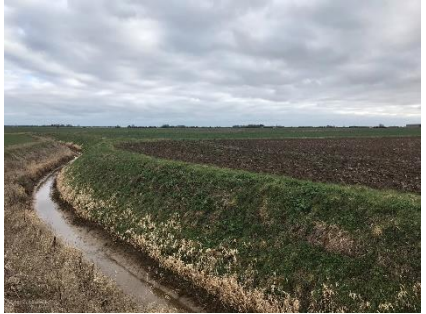
Floodplain Characteristics	The watercourse was artificial or heavily modified and completely disconnected from the adjacent floodplain.

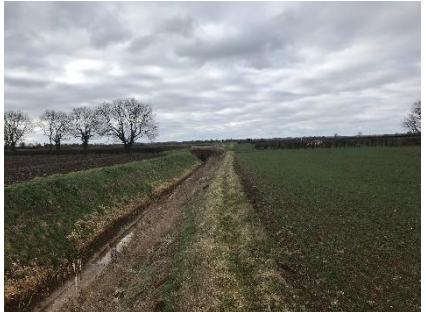
Riparian Zone	The riparian zone comprised agricultural fields.

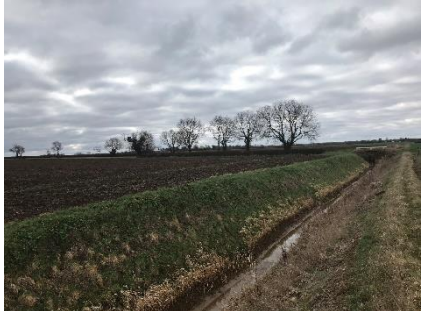
Parameter	Details	Photograph
Modifications	The watercourse is artificial or heavily modified. Adjacent land use is heavily modified for agricultural purposes. The watercourse is culverted under field access crossings.

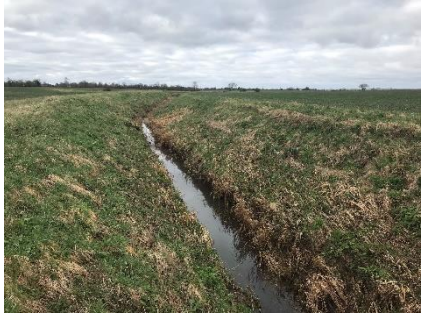
Parameter	Details	Photograph
Channel Form	This watercourse comprised a straight, artificial or heavily modified channel with a trapezoidal cross section.

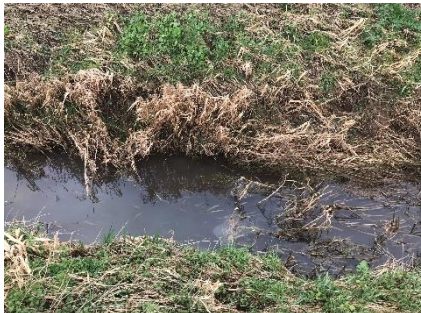
Substrate Conditions	The bed was silty.

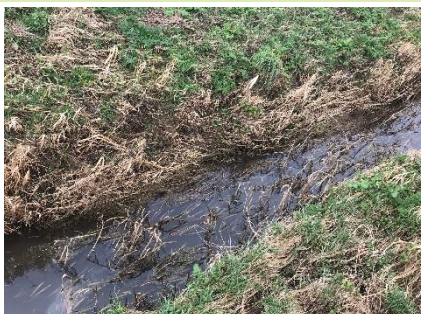
Flow Conditions	The channel had standing water.

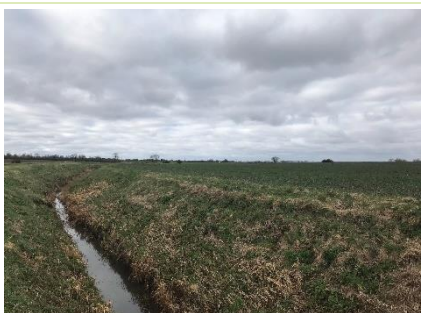
Floodplain Characteristics	The watercourse was artificial or heavily modified and completely disconnected from the adjacent floodplain.

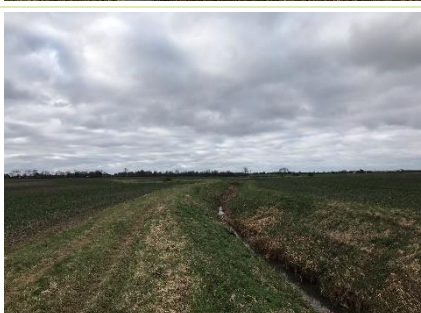
Riparian Zone	The riparian zone comprised agricultural fields.

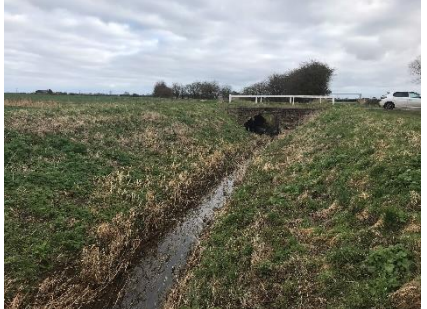
Parameter	Details	Photograph
Modifications	The watercourse is artificial or heavily modified. Adjacent land use is heavily modified for agricultural purposes. The watercourse is culverted under a road.

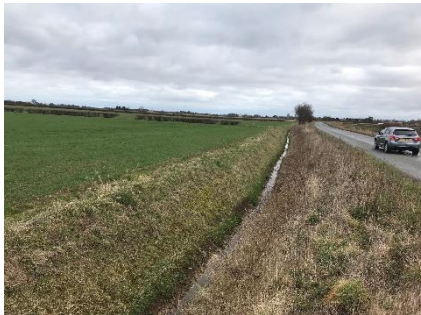
Parameter	Details	Photograph
Channel Form	This watercourse comprised a straight, artificial or heavily modified channel with a trapezoidal cross section.

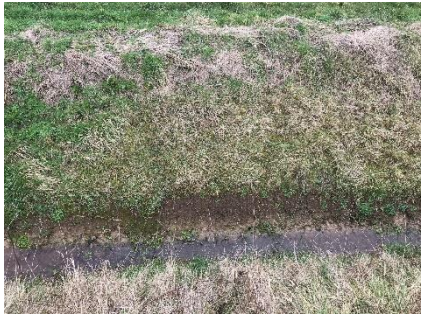
Substrate Conditions	The bed was silty.

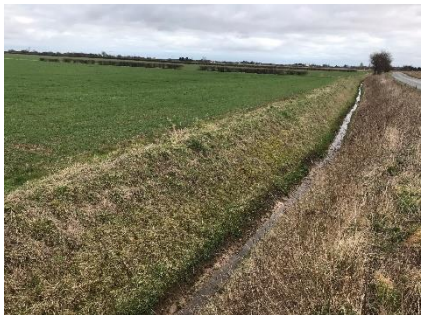
Flow Conditions	The channel had standing water.	
Floodplain Characteristics	The watercourse was artificial or heavily modified and completely disconnected from the adjacent floodplain.

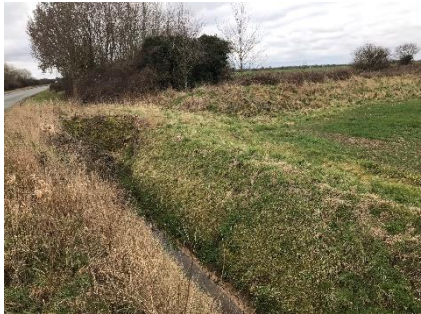
Riparian Zone	The riparian zone comprised agricultural fields.

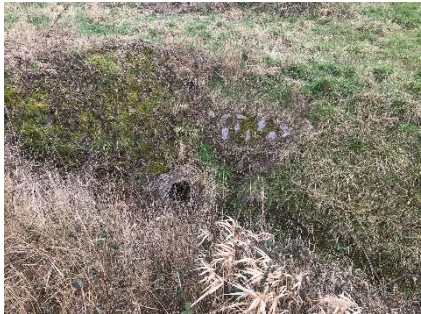
Modifications	The watercourse is artificial or heavily modified. Adjacent land use is heavily modified for agricultural purposes.

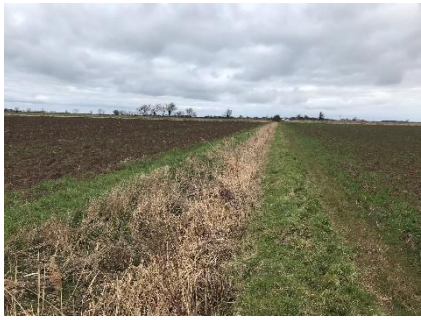
Parameter	Details	Photograph
Channel Form	This watercourse comprised a straight, artificial or heavily modified channel with a trapezoidal cross section.

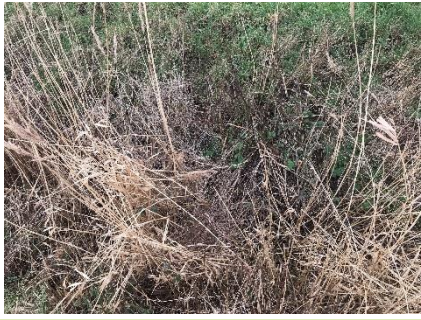
Substrate Conditions	The bed was silty.

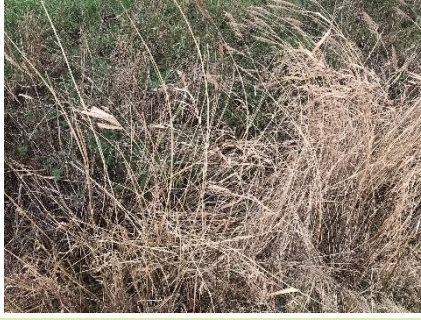
Flow Conditions	The channel had standing water.

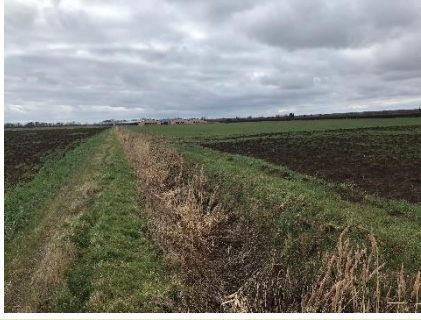
Floodplain Characteristics	The watercourse was artificial or heavily modified and completely disconnected from the adjacent floodplain.	
Riparian Zone	The riparian zone comprised agricultural fields.

Modifications	The watercourse is artificial or heavily modified. Adjacent land use is heavily modified for agricultural purposes.

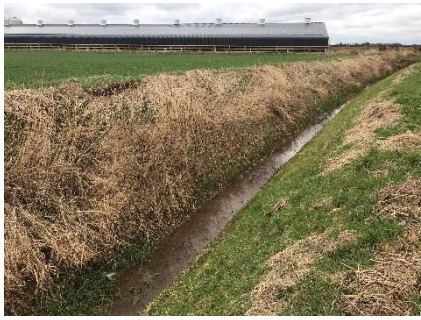
Parameter	Details	Photograph
Channel Form	This watercourse comprised a straight, artificial or heavily modified channel with a trapezoidal cross section.

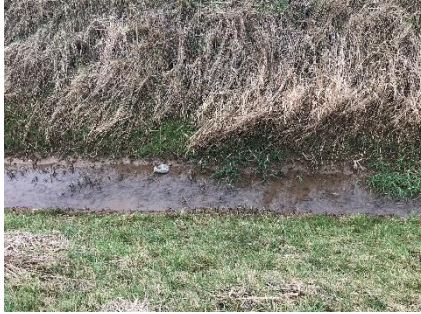
Substrate Conditions	The bed was silty.

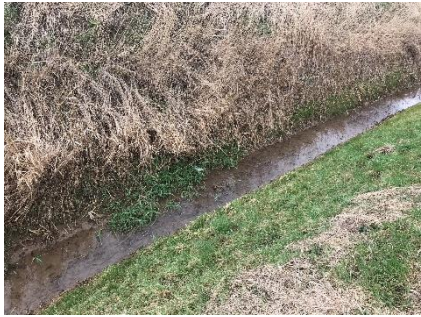
Flow Conditions	The channel had standing water.

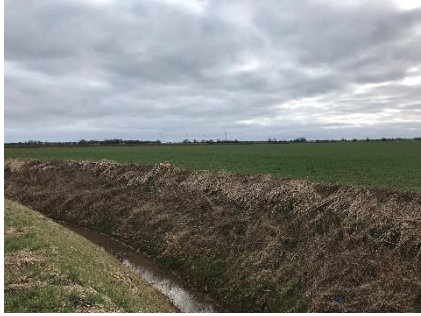
Floodplain Characteristics	The watercourse was artificial or heavily modified and completely disconnected from the adjacent floodplain.

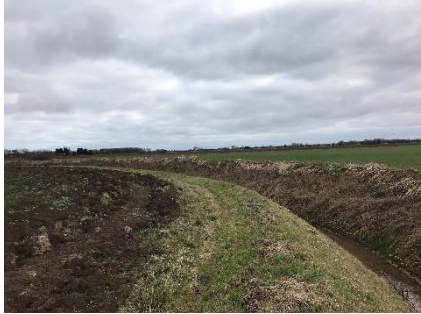
Riparian Zone	The riparian zone comprised agricultural fields.

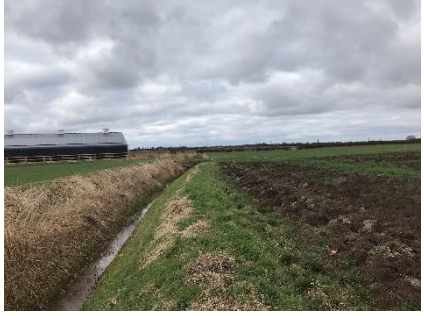
Parameter	Details	Photograph
Modifications	The watercourse is artificial or heavily modified. Adjacent land use is heavily modified for agricultural purposes. The watercourse is culverted under field access crossings.

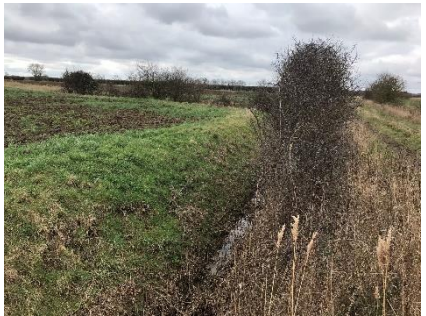
Parameter	Details	Photograph
Channel Form	This watercourse comprised a straight, artificial or heavily modified channel with a trapezoidal cross section.

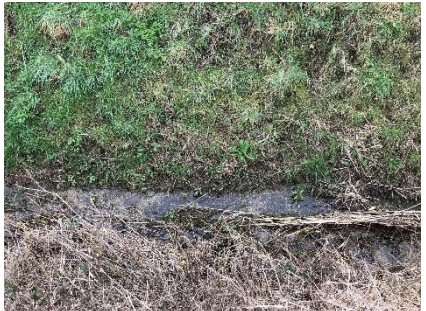
Substrate Conditions	The bed was silty.

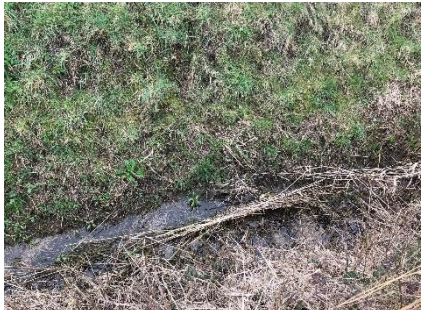
Flow Conditions	The channel had standing water.

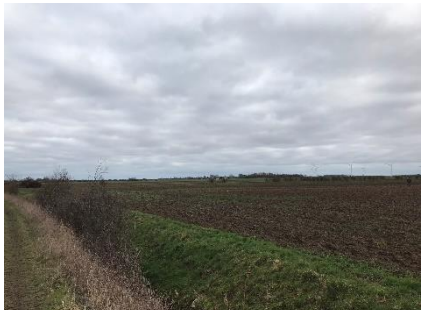
Floodplain Characteristics	The watercourse was artificial or heavily modified and completely disconnected from the adjacent floodplain.

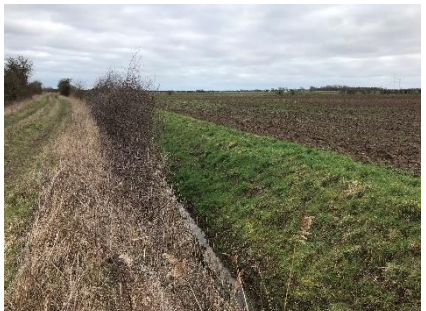
Riparian Zone	The riparian zone comprised agricultural fields with hedges and trees in parts.

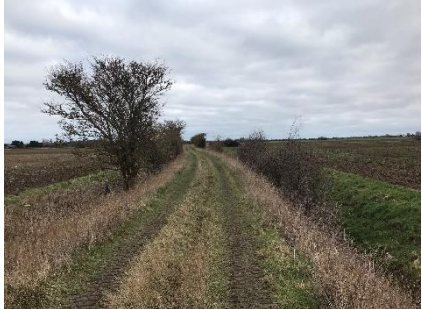
Parameter	Details	Photograph
Modifications	The watercourse is artificial or heavily modified. Adjacent land use is heavily modified for agricultural purposes.

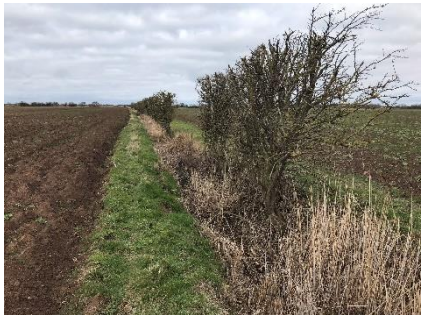
Parameter	Details	Photograph
Channel Form	This watercourse comprised a straight, artificial or heavily modified channel with a trapezoidal cross section.

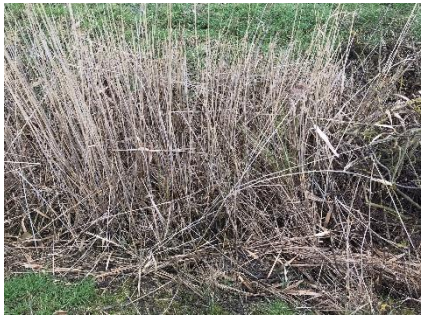
Substrate Conditions	Bed sediment was obscured by vegetation but was assumed to comprise silt.

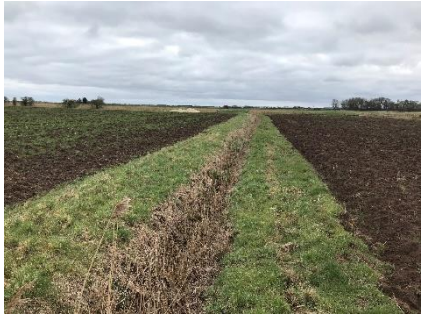
Flow Conditions	Flow conditions were obscured by vegetation, but the channel was assumed to have some standing water.

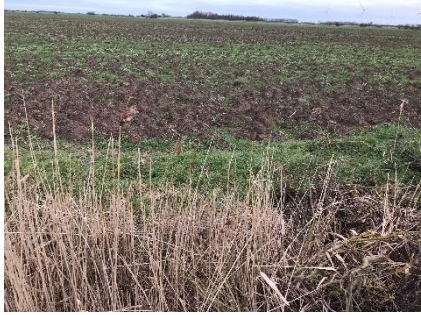
Floodplain Characteristics	The watercourse was artificial or heavily modified and completely disconnected from the adjacent floodplain.

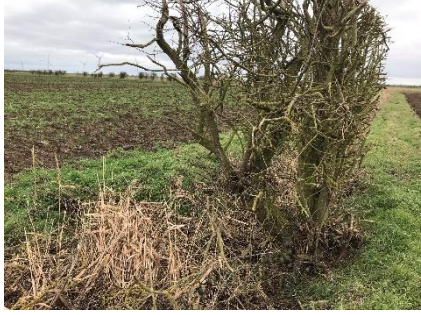
Riparian Zone	The riparian zone comprised agricultural fields with occasional trees.

Modifications	The watercourse is artificial or heavily modified. Adjacent land use

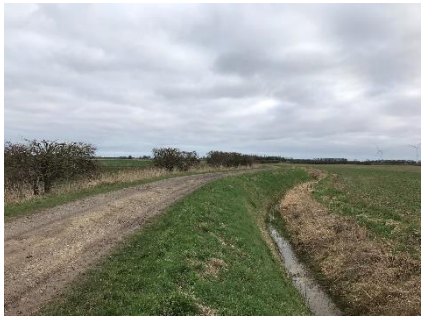
Parameter	Details	Photograph
Channel Form	This watercourse comprised a straight, artificial or heavily modified channel with a trapezoidal cross section.

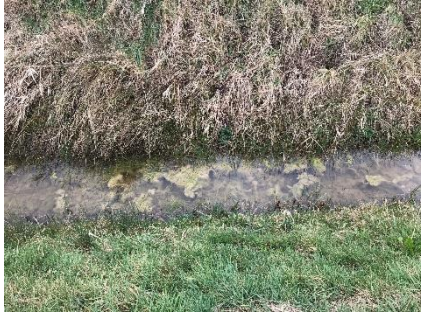
Substrate Conditions	The bed was silty.

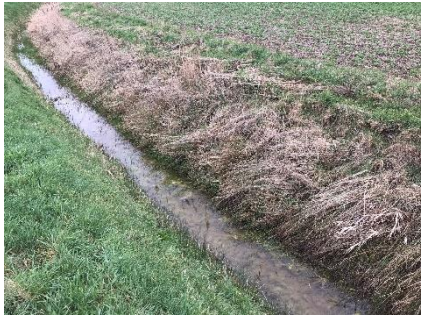
Flow Conditions	The channel had standing water.

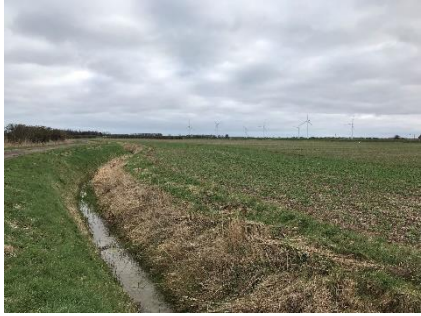
Floodplain Characteristics	The watercourse was artificial or heavily modified and completely disconnected from the adjacent floodplain.

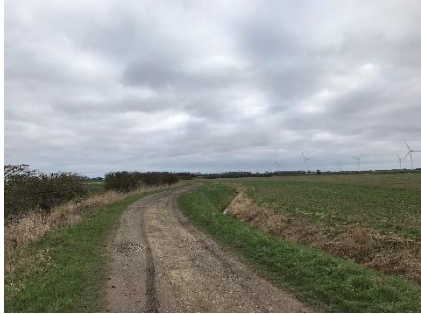
Riparian Zone	The riparian zone comprised agricultural fields. A gravel track also lay within the riparian zone.

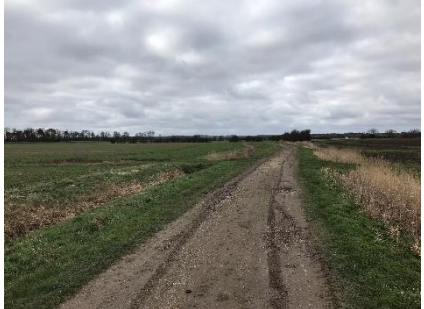
Parameter	Details	Photograph
Modifications	The watercourse is artificial or heavily modified. Adjacent land use is heavily modified for agricultural purposes.

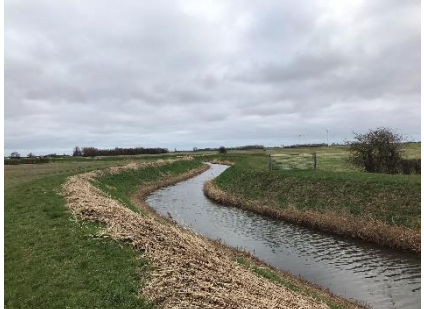
Parameter	Details	Photograph
Channel Form	This watercourse comprised a meandering channel of generally uniform width (approximately 5m). Embankments contained flow within the channel. Vegetated berms have developed within the embanked channel.

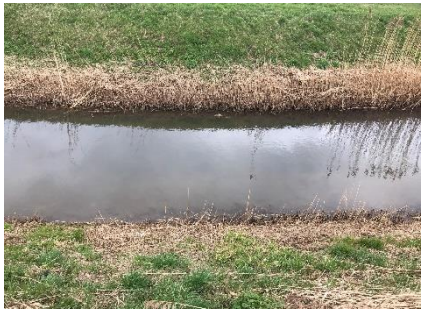
Substrate Conditions	The bed was silty.

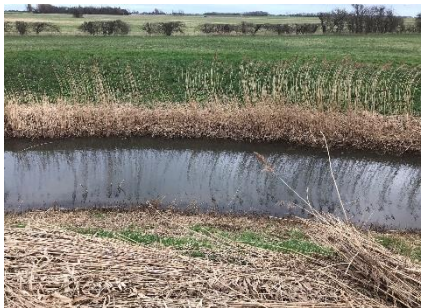
Flow Conditions	Flow was gliding and slow.

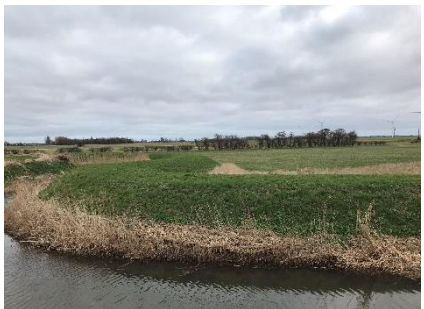
Floodplain Characteristics	The watercourse was disconnected from the floodplain by embankments of approximately 2m height.

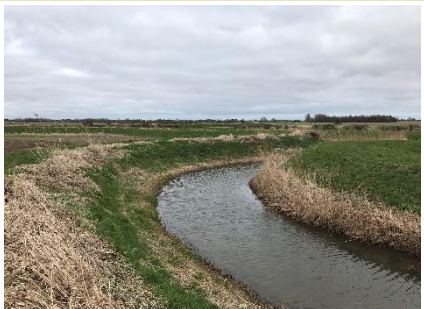
Riparian Zone	The riparian zone comprised agricultural fields, separated from the watercourse by grassed embankments.

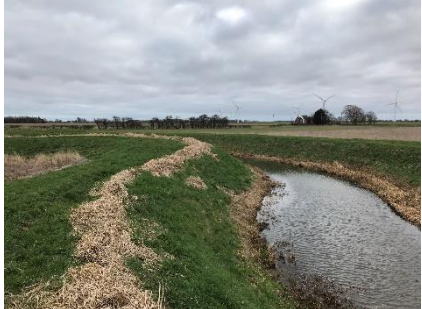
Parameter	Details	Photograph
Modifications	The watercourse has been embanked and had a considerable input of fine sediment. It is likely the embankments contribute to the fine sediment load within the watercourse by preventing overbank deposition.

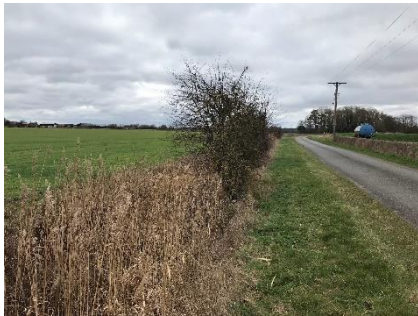
Parameter	Details	Photograph
Channel Form	This watercourse comprised a straight, artificial or heavily modified channel with a trapezoidal cross section.

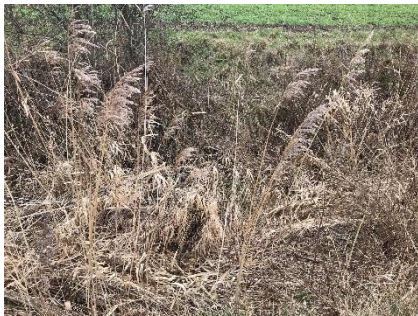
Substrate Conditions	The bed was obscured by vegetation but was assumed to be silty.

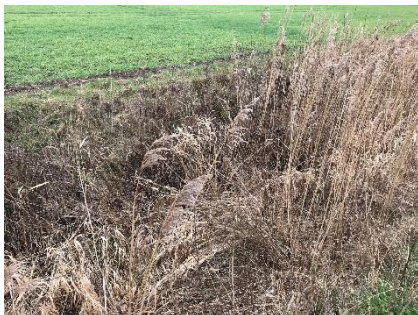
Flow Conditions	Flow conditions were obscured by vegetation, but it was assumed that there would be some standing water.

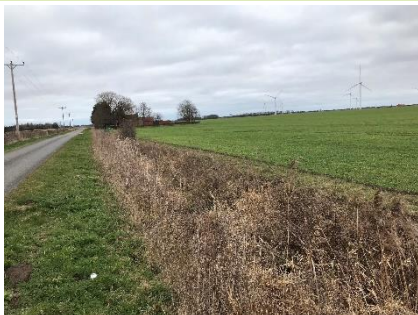
Floodplain Characteristics	The watercourse was artificial or heavily modified and completely disconnected from the adjacent floodplain.

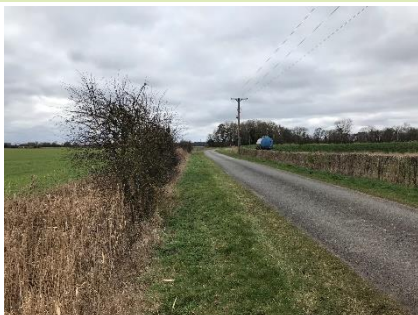
Riparian Zone	The riparian zone comprised agricultural fields and a road.

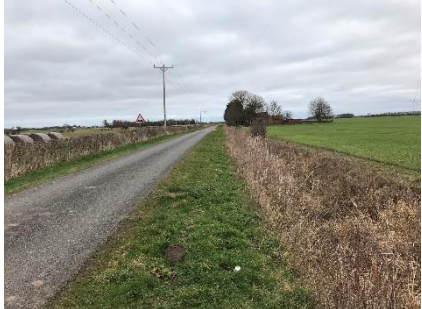
Parameter	Details	Photograph
Modifications	The watercourse is artificial or heavily modified. Adjacent land use is heavily modified for agricultural and transport purposes.

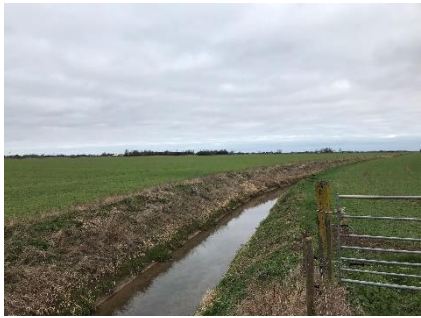
Parameter	Details	Photograph
Channel Form	This watercourse comprised a straight, artificial or heavily modified channel with a trapezoidal cross section.

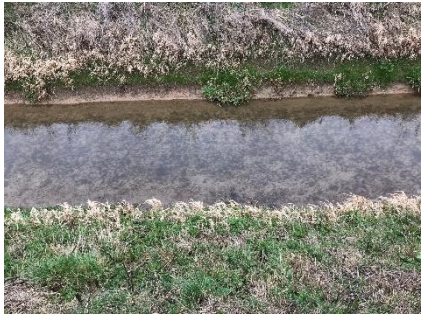
Substrate Conditions	The bed was silty.

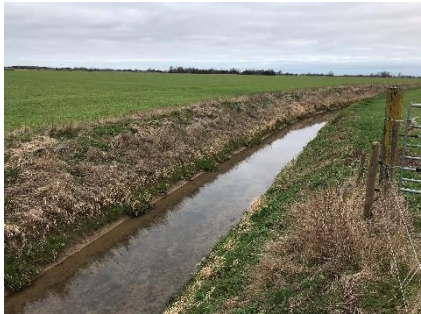
Flow Conditions	The channel had standing water.

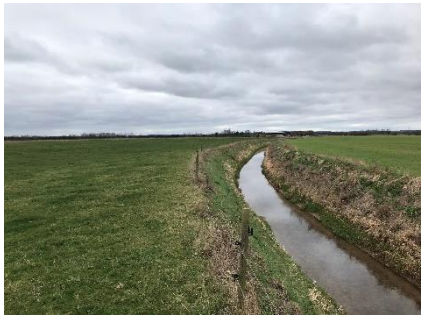
Floodplain Characteristics	The watercourse was artificial or heavily modified and completely disconnected from the adjacent floodplain.

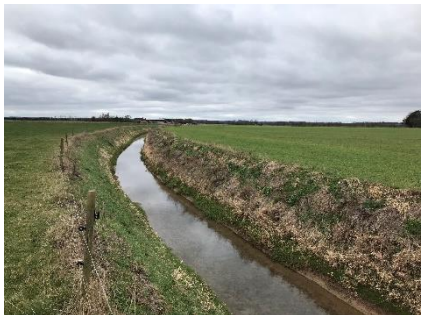
Riparian Zone	The riparian zone comprised agricultural fields.

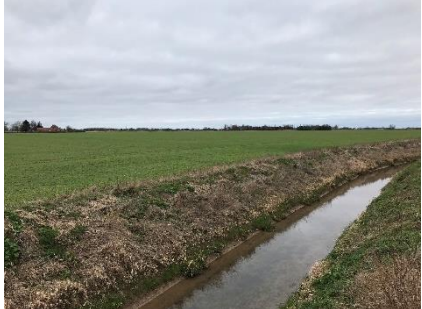
Parameter	Details	Photograph
Modifications	The watercourse is artificial or heavily modified. Adjacent land use is heavily modified for agricultural purposes.

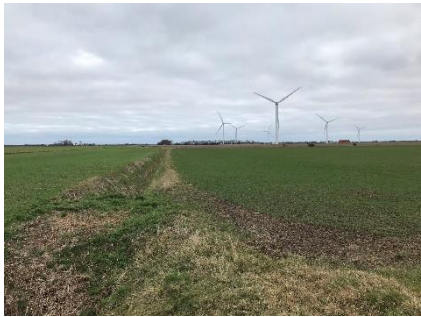
Parameter	Details	Photograph
Channel Form	This watercourse comprised a straight, artificial or heavily modified channel with a trapezoidal cross section.

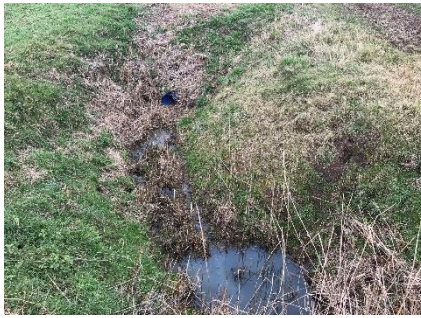
Substrate Conditions	The bed was silty.

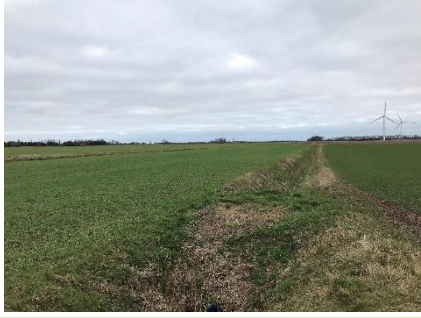
Flow Conditions	The channel had standing water in parts but was mostly dry.	 
Floodplain Characteristics	The watercourse was artificial or heavily modified and completely disconnected from the adjacent floodplain.

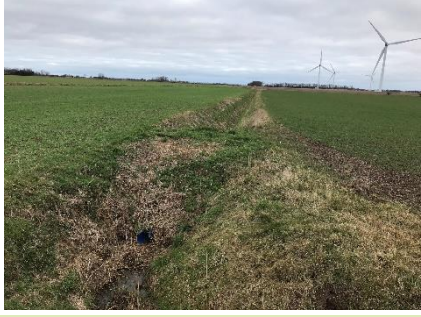
Riparian Zone	The riparian zone comprised agricultural fields.

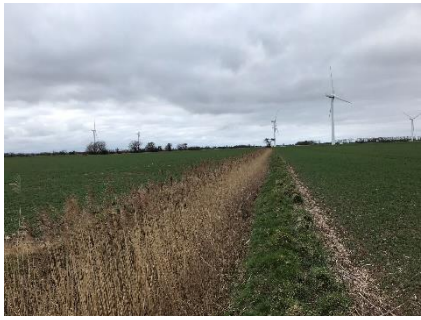
Parameter	Details	Photograph
Channel Form	This watercourse comprised a straight, artificial or heavily modified channel with a trapezoidal cross section.

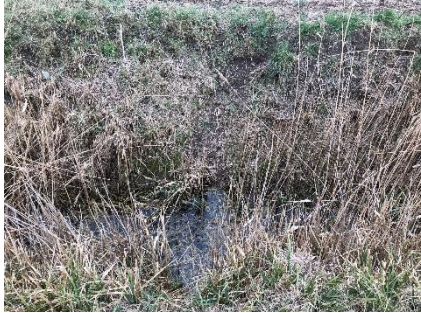
Substrate Conditions	The bed was silty.

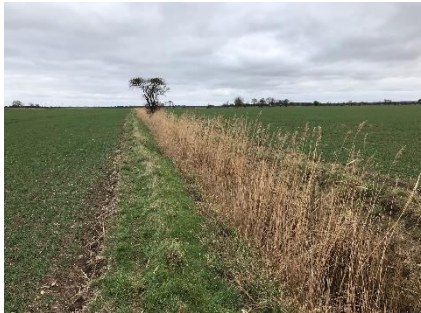
Flow Conditions	The channel had standing water.	
Floodplain Characteristics	The watercourse was artificial or heavily modified and completely disconnected from the adjacent floodplain.

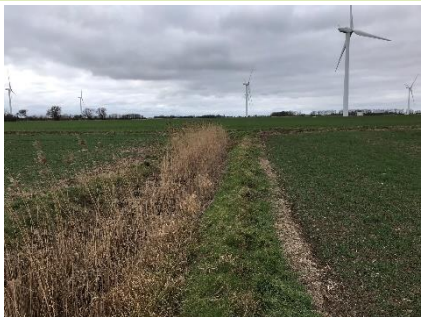
Riparian Zone	The riparian zone comprised agricultural fields.

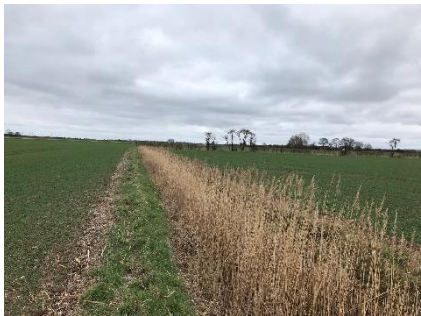
Modifications	The watercourse is artificial or heavily modified. Adjacent land use is heavily modified for agricultural purposes.

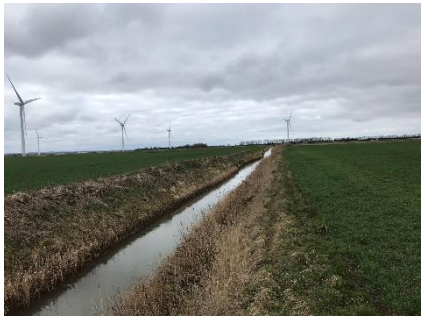
Parameter	Details	Photograph
Channel Form	This watercourse comprised a straight, artificial or heavily modified channel with a trapezoidal cross section.

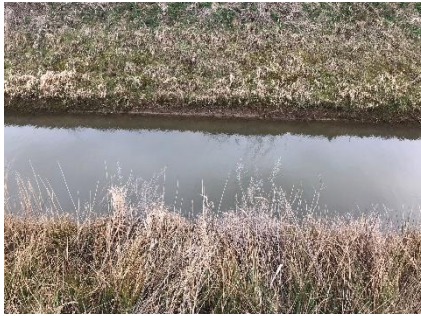
Substrate Conditions	The bed was silty.

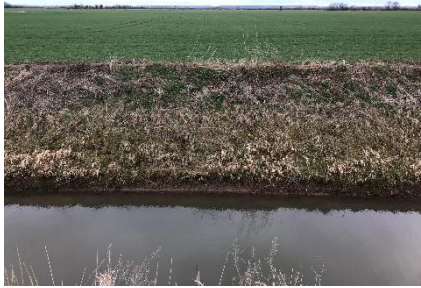
Flow Conditions	The channel had standing water.

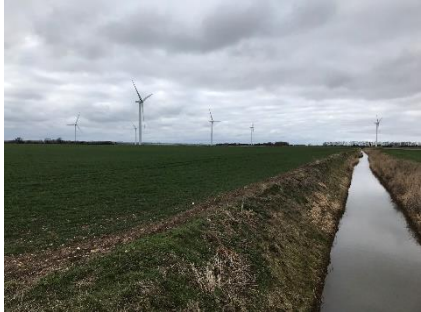
Floodplain Characteristics	The watercourse was artificial or heavily modified and completely disconnected from the adjacent floodplain.

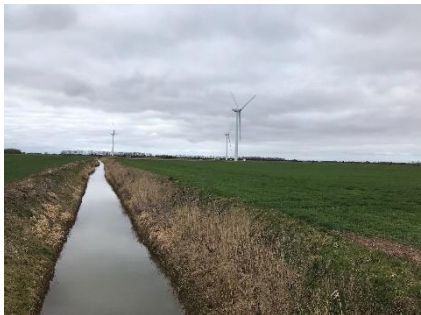
Riparian Zone	The riparian zone comprised agricultural fields.

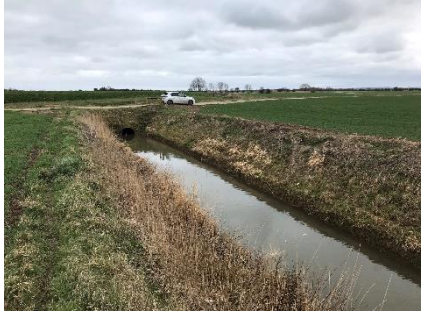
Parameter	Details	Photograph
Modifications	<p>The watercourse is artificial or heavily modified. Adjacent land use is heavily modified for agricultural purposes. The watercourse is culverted under an access track.</p>

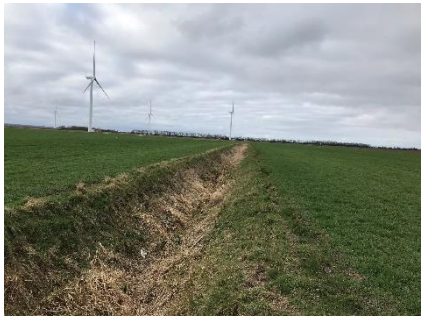
Parameter	Details	Photograph
Channel Form	This watercourse comprised a straight, artificial or heavily modified channel with a trapezoidal cross section.

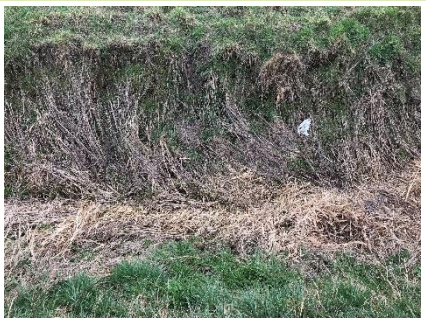
Substrate Conditions	The bed was grassed.

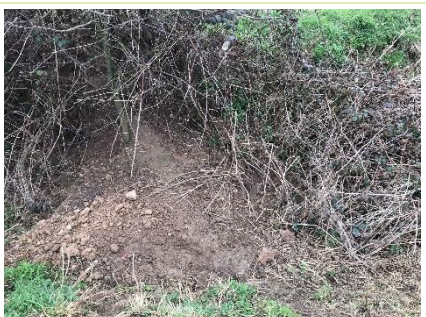
Flow Conditions	The channel was dry and unlikely to hold water apart from during particularly wet periods.

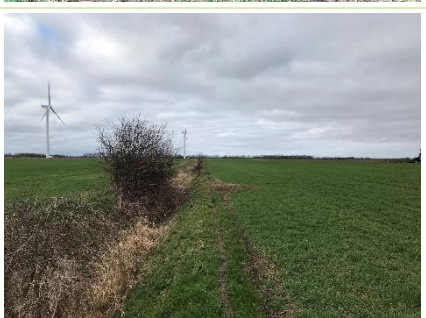
Floodplain Characteristics	The watercourse was artificial or heavily modified and completely disconnected from the adjacent floodplain.

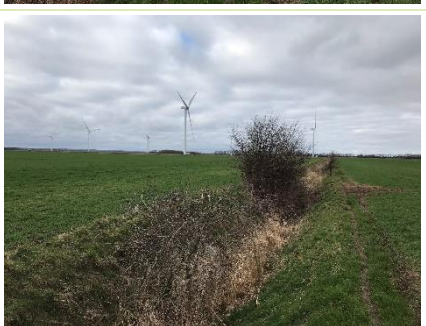
Riparian Zone	The riparian zone comprised agricultural fields with occasional trees.

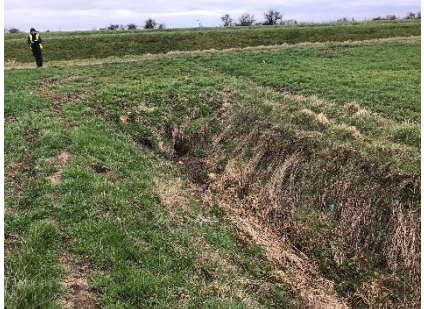
Parameter	Details	Photograph
Modifications	The watercourse is artificial or heavily modified. Adjacent land use is heavily modified for agricultural purposes. The watercourse was culverted under field access crossings.

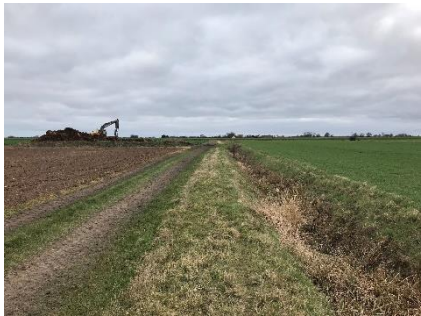
Parameter	Details	Photograph
Channel Form	This watercourse comprised a straight, artificial or heavily modified channel with a trapezoidal cross section.

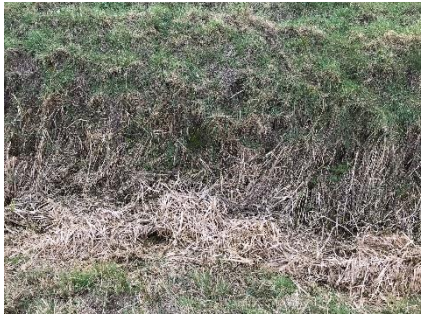
Substrate Conditions	The bed was grassed.

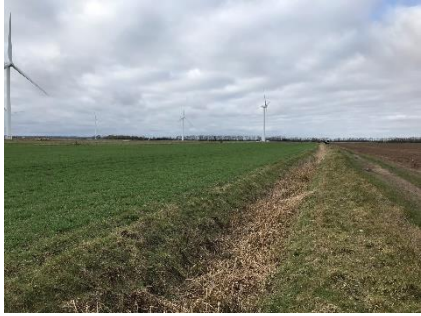
Flow Conditions	The channel was dry and unlikely to hold water apart from during particularly wet periods.

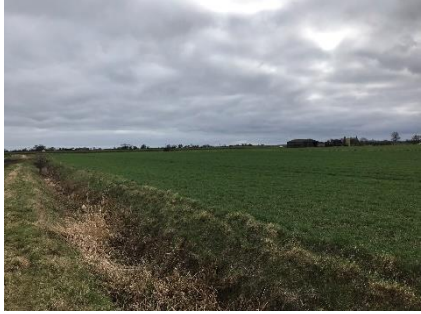
Floodplain Characteristics	The watercourse was artificial or heavily modified and completely disconnected from the adjacent floodplain.

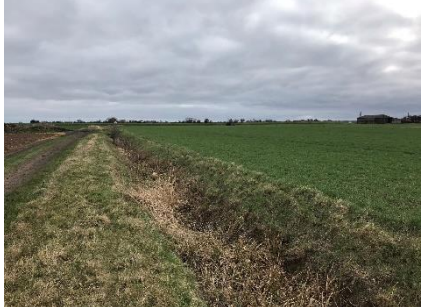
Riparian Zone	The riparian zone comprised agricultural fields.

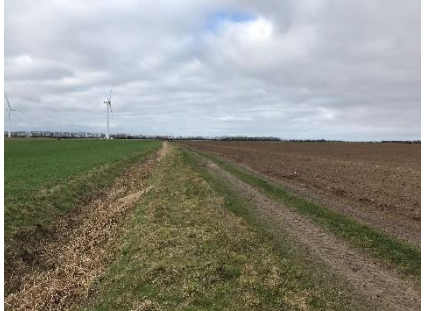
Parameter	Details	Photograph
Modifications	The watercourse is artificial or heavily modified. Adjacent land use is heavily modified for agricultural purposes.

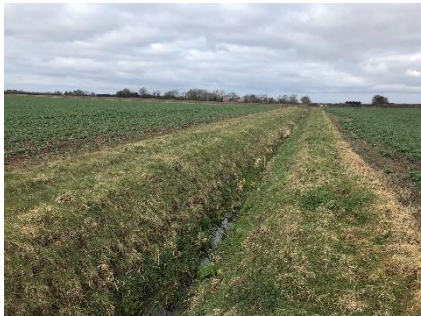
Parameter	Details	Photograph
Channel Form	This watercourse comprised a straight, artificial or heavily modified channel with a trapezoidal cross section.

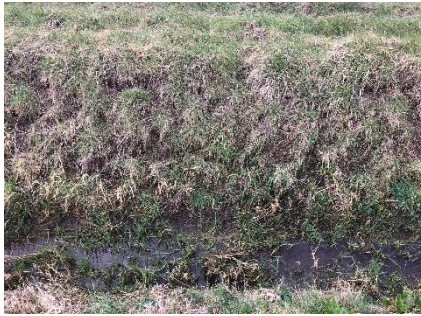
Substrate Conditions	The bed was silty.

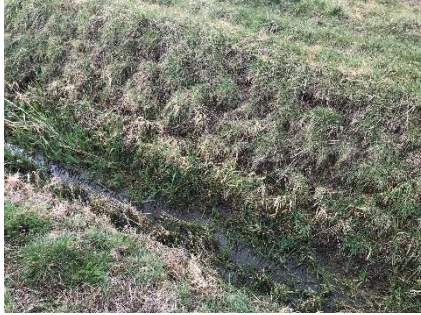
Flow Conditions	The channel had standing water.

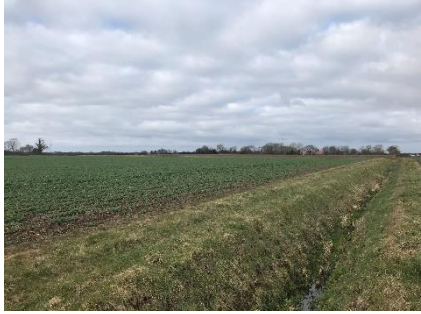
Floodplain Characteristics	The watercourse was artificial or heavily modified and completely disconnected from the adjacent floodplain.

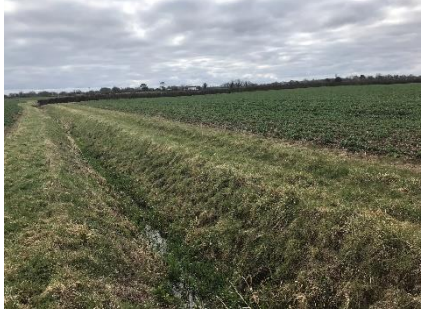
Riparian Zone	The riparian zone comprised agricultural fields.

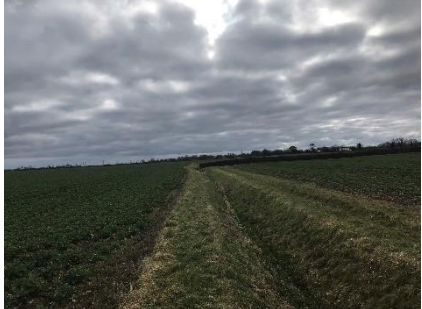
Parameter	Details	Photograph
Modifications	The watercourse is artificial or heavily modified. Adjacent land use is heavily modified for agricultural purposes.

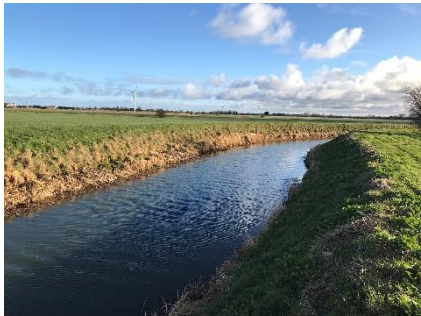
Parameter	Details	Photograph
Channel Form	The river occupied a historically straightened channel which was embanked on both sides. The channel was approximately 5m wide with 1m high (above natural bank height) embankments.

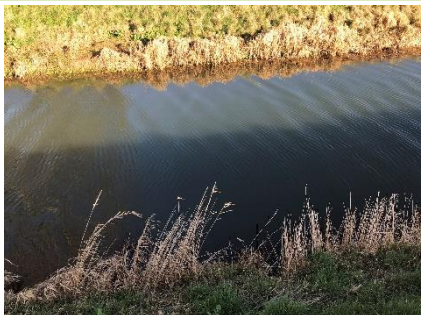
Substrate Conditions	The bed appeared to be silty.

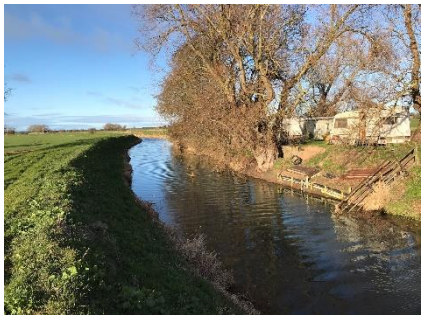
Flow Conditions	Flow was mostly gliding, with some areas of rippled flow.

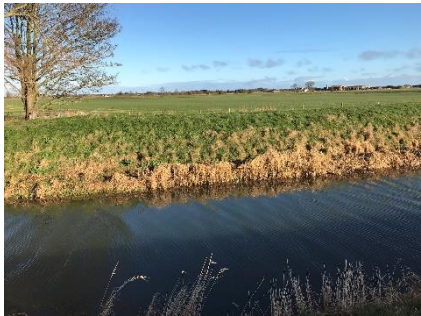
Floodplain Characteristics	The watercourse was embanked disconnecting it from the floodplain.

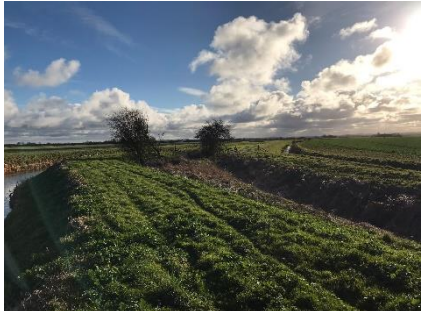
Riparian Zone	The riparian zone comprised agricultural fields, with grassed embankments separating the watercourse from the riparian zone. Occasional trees were present.

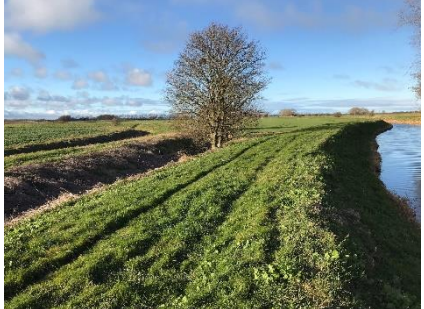
Parameter	Details	Photograph
Modifications	The watercourse has been historically straightened and embanked, disconnecting it from the floodplain and creating an artificially uniform channel. Adjacent land use has been heavily modified for agricultural purposes.

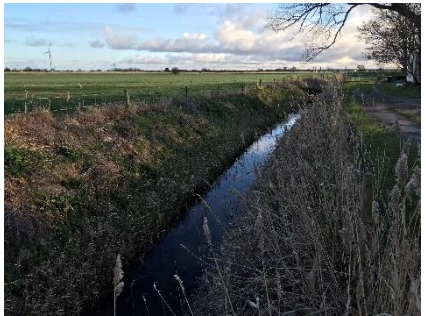
Parameter	Details	Photograph
Channel Form	This watercourse comprised a straight, artificial or heavily modified channel with a trapezoidal cross section.

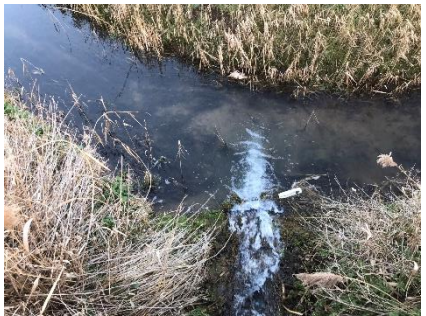
Substrate Conditions	The bed was silty.

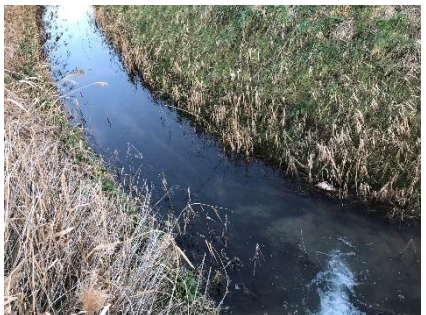
Flow Conditions	Flow was gliding.

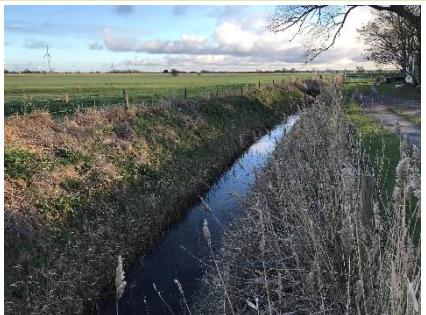
Floodplain Characteristics	The watercourse was artificial or heavily modified and completely disconnected from the adjacent floodplain.

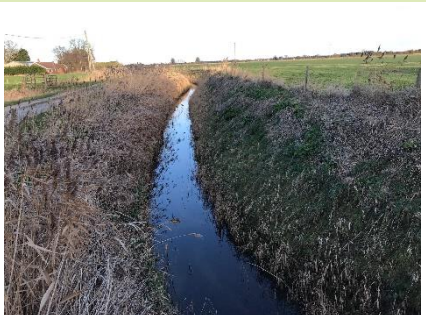
Riparian Zone	The riparian zone comprised agricultural fields and a gravel access track.

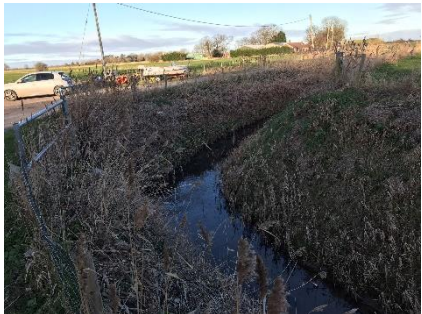
Parameter	Details	Photograph
Modifications	The watercourse is artificial or heavily modified. Adjacent land use is heavily modified for agricultural purposes. An outfall was present on the bank, with water discharging from it.

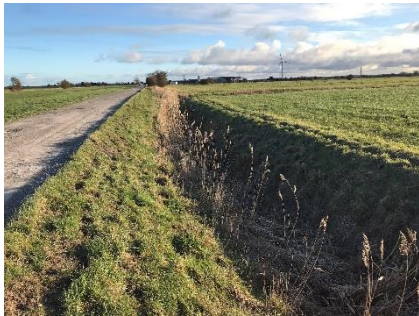
Parameter	Details	Photograph
Channel Form	This watercourse comprised a straight, artificial or heavily modified channel with a trapezoidal cross section.

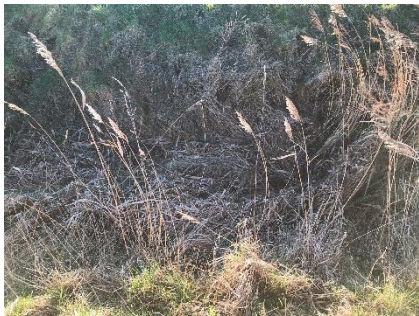
Substrate Conditions	The bed was obscured by vegetation but was assumed to be silty.

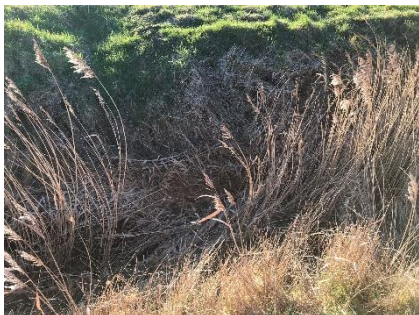
Flow Conditions	Flow conditions were obscured by vegetation, but it was assumed there would be some standing water.

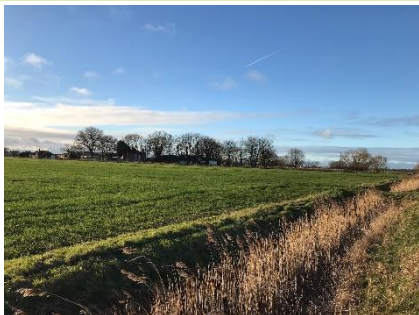
Floodplain Characteristics	The watercourse was artificial or heavily modified and completely disconnected from the adjacent floodplain.

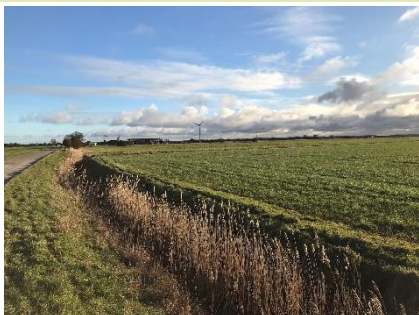
Riparian Zone	The riparian zone comprised agricultural fields. A gravel track ran alongside the watercourse.

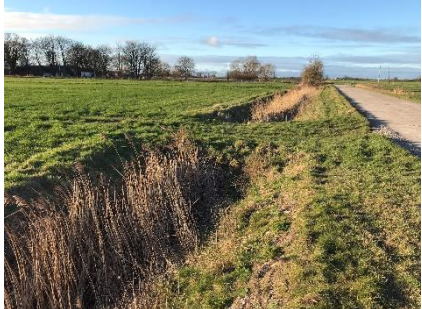
Parameter	Details	Photograph
Modifications	The watercourse is artificial or heavily modified. Adjacent land use is heavily modified for agricultural purposes. A gravel track ran alongside the watercourse. The watercourse was culverted under field access crossings.

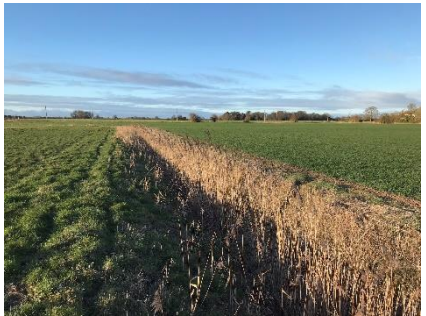
Parameter	Details	Photograph
Channel Form	This watercourse comprised a straight, artificial or heavily modified channel with a trapezoidal cross section.

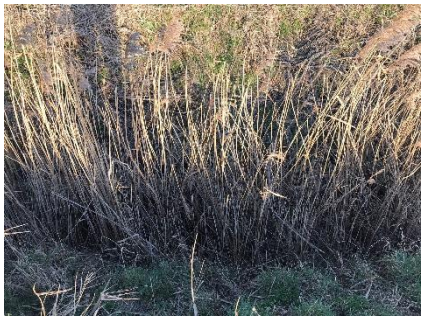
Substrate Conditions	The bed was obscured by vegetation but appeared to be silty.

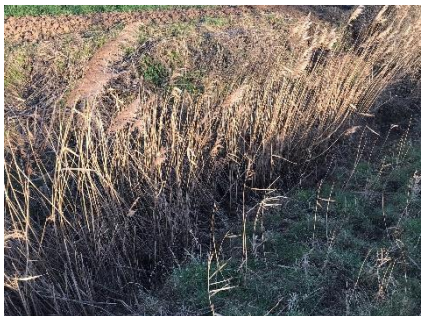
Flow Conditions	Flow conditions were obscured by vegetation, but it was assumed that there would be some standing water.

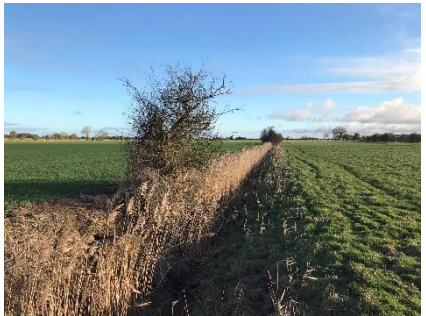
Floodplain Characteristics	The watercourse was artificial or heavily modified and completely disconnected from the adjacent floodplain.	
Riparian Zone	The riparian zone comprised agricultural fields.

Modifications	The watercourse is artificial or heavily modified. Adjacent land use is heavily modified for agricultural purposes.

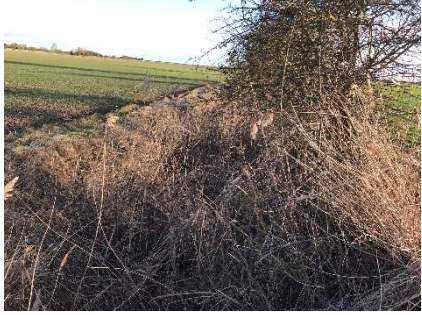
Parameter	Details	Photograph
Channel Form	This watercourse comprised a straight, artificial or heavily modified channel with a trapezoidal cross section.

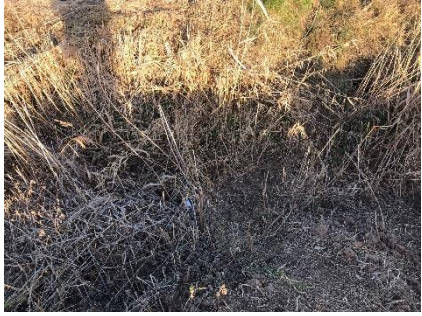
Substrate Conditions	The bed was silty.

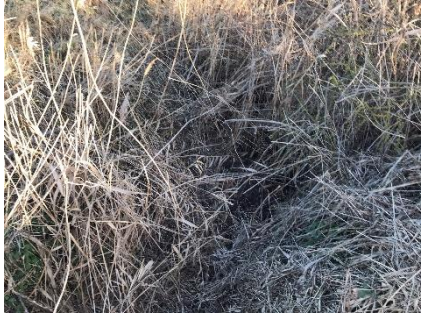
Flow Conditions	The channel had standing water.

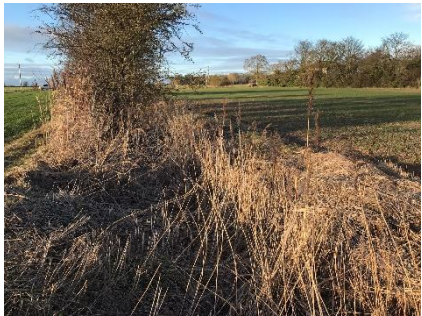
Floodplain Characteristics	The watercourse was artificial or heavily modified and completely disconnected from the adjacent floodplain.	
Riparian Zone	The riparian zone comprised agricultural fields.

Modifications	The watercourse is artificial or heavily modified. Adjacent land use is heavily modified for agricultural purposes.

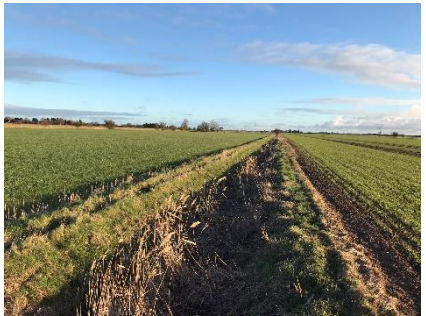
Parameter	Details	Photograph
Channel Form	This watercourse comprised a straight, artificial or heavily modified channel with a trapezoidal cross section.

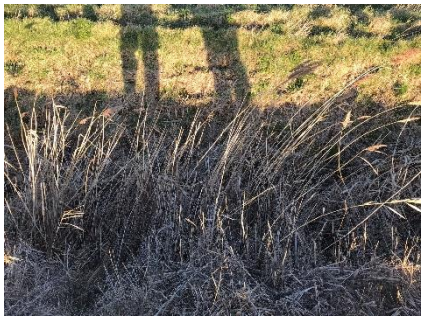
Substrate Conditions	The bed was obscured by vegetation but was assumed to be silty.

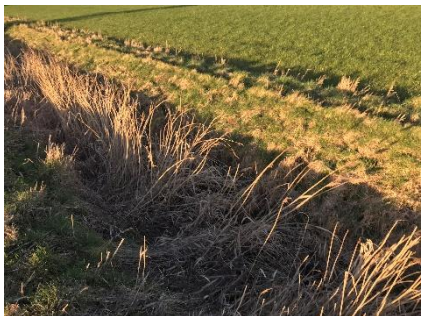
Flow Conditions	Flow conditions were obscured by vegetation, but it was assumed that there was some standing water.

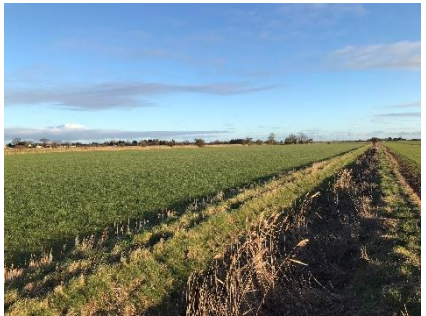
Floodplain Characteristics	The watercourse was artificial or heavily modified and completely disconnected from the adjacent floodplain.	
Riparian Zone	The riparian zone comprised agricultural fields.

Modifications	The watercourse is artificial or heavily modified. Adjacent land use is heavily modified for agricultural purposes.

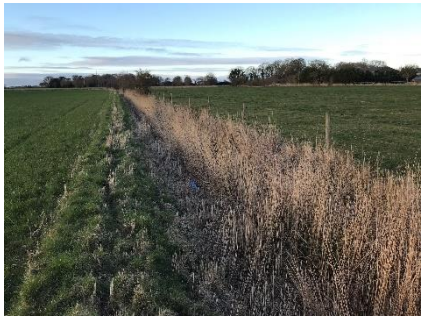
Parameter	Details	Photograph
Channel Form	This watercourse comprised a straight, artificial or heavily modified channel with a trapezoidal cross section.

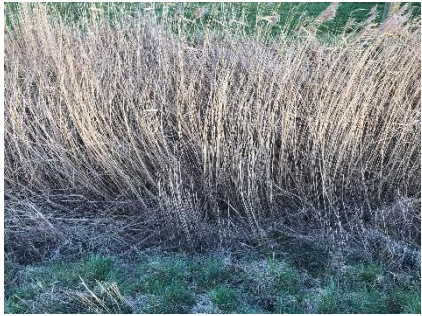
Substrate Conditions	The bed was obscured by vegetation, but it was assumed to be silty.

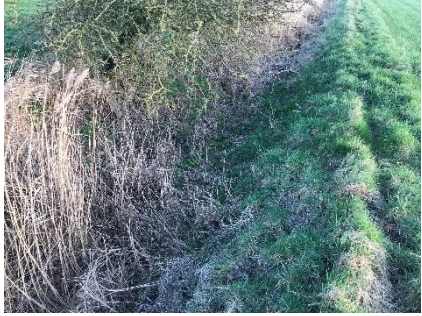
Flow Conditions	Flow conditions were obscured by vegetation, but it was assumed that there would be some standing water.

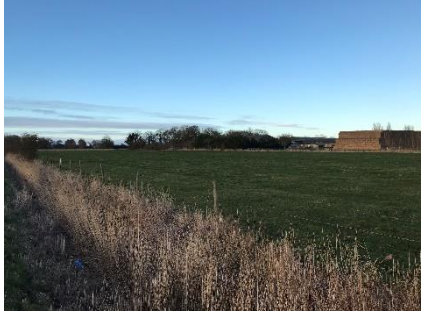
Floodplain Characteristics	The watercourse was artificial or heavily modified and completely disconnected from the adjacent floodplain.

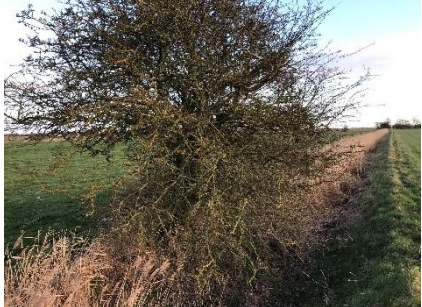
Riparian Zone	The riparian zone comprised agricultural fields.

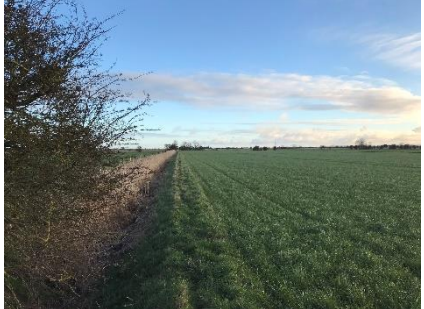
Parameter	Details	Photograph
Modifications	The watercourse is artificial or heavily modified. Adjacent land use is heavily modified for agricultural purposes.

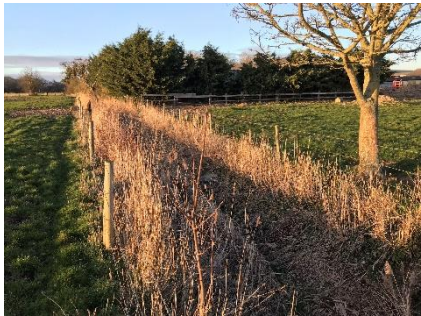
Parameter	Details	Photograph
Channel Form	This watercourse comprised a straight, artificial or heavily modified channel with a trapezoidal cross section.
