Viking CCS Pipeline

**Environmental
Statement Volume IV –
Appendix 11-2: Site
Visit Technical Note -
Water**

Document Reference: EN070008/APP/6.4.11.2

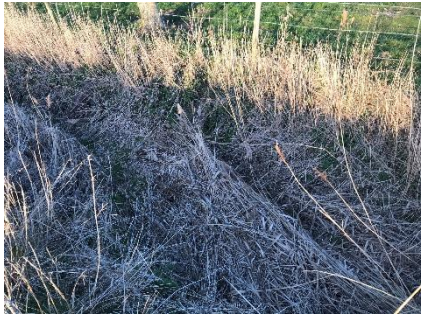
Substrate Conditions	The bed was silty.

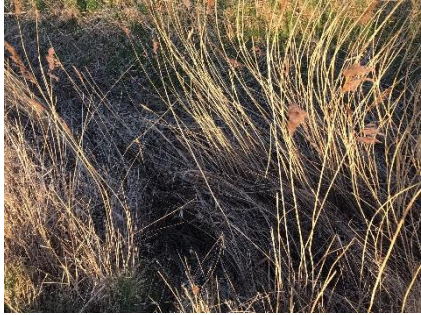
Flow Conditions	The channel had standing water.

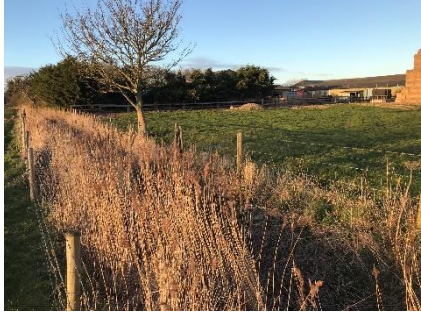
Floodplain Characteristics	The watercourse was artificial or heavily modified and completely disconnected from the adjacent floodplain.

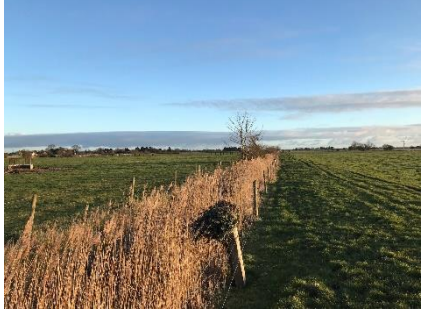
Riparian Zone	The riparian zone comprised agricultural fields.

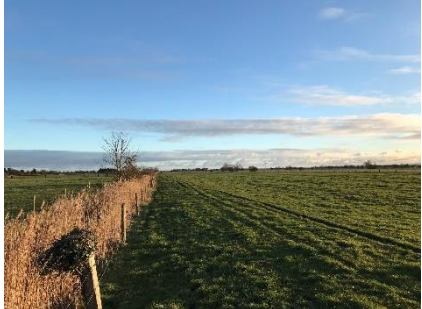
Parameter	Details	Photograph
Modifications	The watercourse is artificial or heavily modified. Adjacent land use is heavily modified for agricultural purposes.

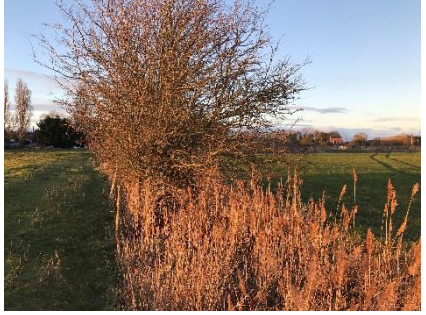
11.79 WC DX105P

Parameter	Details	Photograph
Channel Form	This watercourse comprised a straight, artificial or heavily modified channel with a trapezoidal cross section.

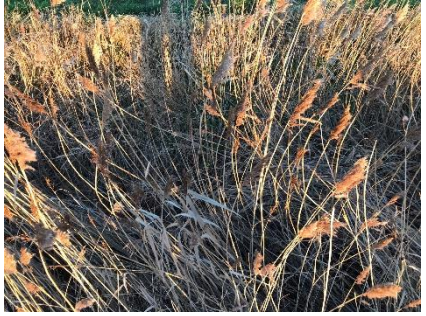
Substrate Conditions	The bed was obscured by vegetation but was assumed to be silty.

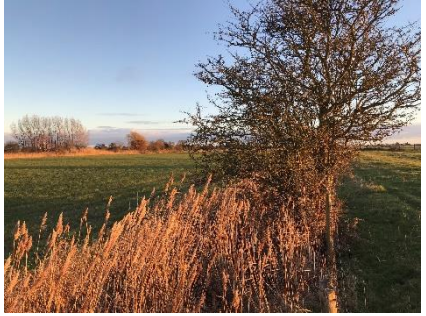
Flow Conditions	Flow conditions were obscured by vegetation, but it was assumed that there would be some standing water.

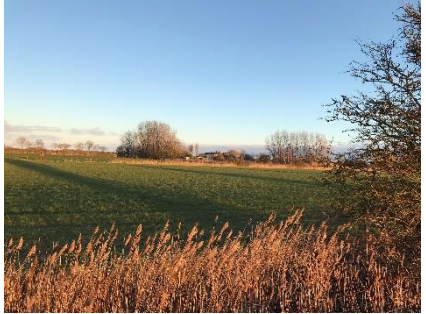
Floodplain Characteristics	The watercourse was artificial or heavily modified and completely disconnected from the adjacent floodplain.

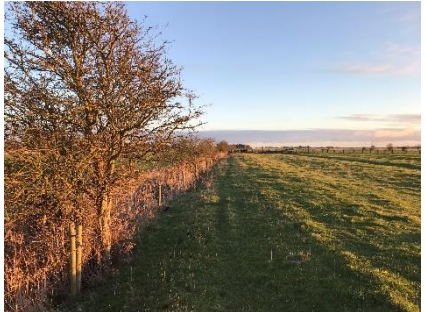
Riparian Zone	The riparian zone comprised agricultural fields.

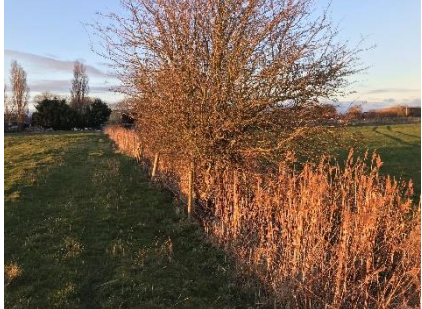
Parameter	Details	Photograph
Modifications	The watercourse is artificial or heavily modified. Adjacent land use is heavily modified for agricultural purposes.

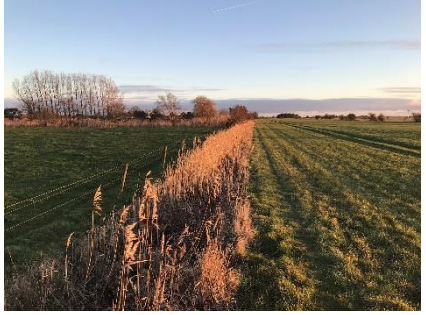
11.80 WC DX105AP

Parameter	Details	Photograph
Channel Form	This watercourse comprised a straight, artificial or heavily modified channel with a trapezoidal cross section.

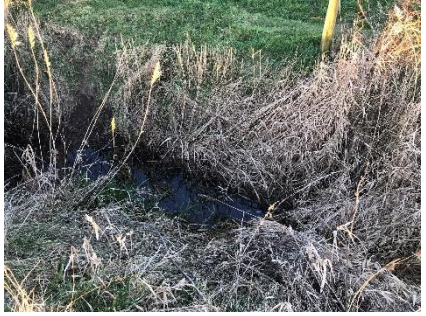
Substrate Conditions	The bed was silty.

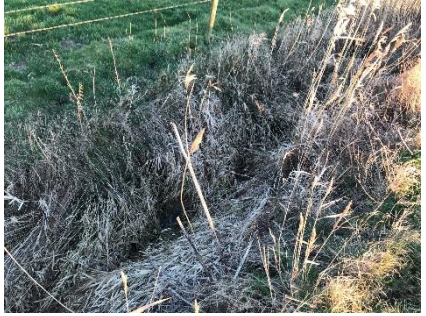
Flow Conditions	The channel had standing water.

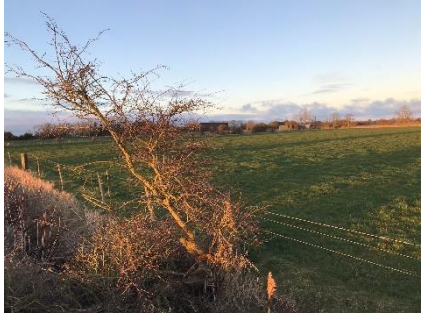
Floodplain Characteristics	The watercourse was artificial or heavily modified and completely disconnected from the adjacent floodplain.

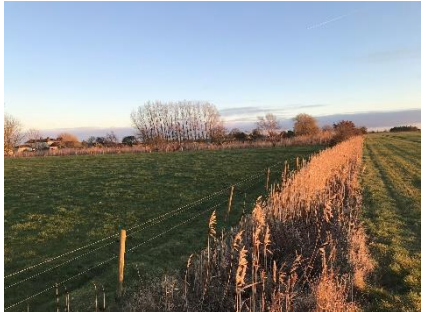
Riparian Zone	The riparian zone comprised agricultural fields.

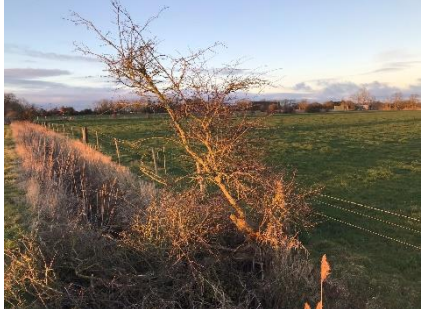
Parameter	Details	Photograph
Modifications	The watercourse is artificial or heavily modified. Adjacent land use is heavily modified for agricultural purposes.

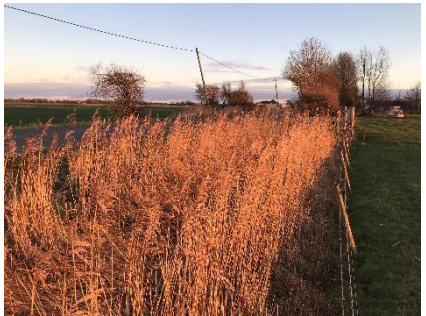
11.81 WC DX106P

Parameter	Details	Photograph
Channel Form	This watercourse comprised a straight, artificial or heavily modified channel with a trapezoidal cross section.

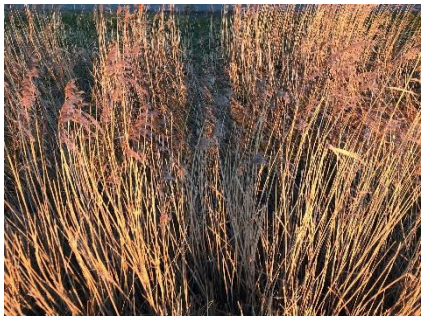
Substrate Conditions	The bed was obscured by vegetation but was assumed to be silty.

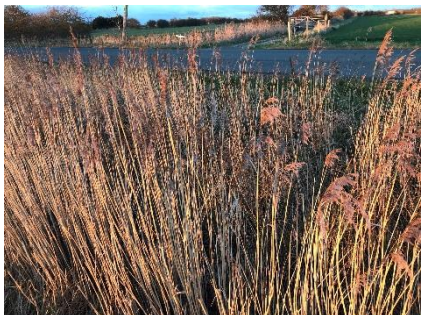
Flow Conditions	Flow conditions were obscured by vegetation, but it was assumed that there would be some standing water.

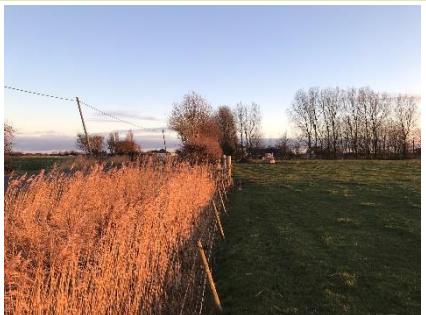
Floodplain Characteristics	The watercourse was artificial or heavily modified and completely disconnected from the adjacent floodplain.

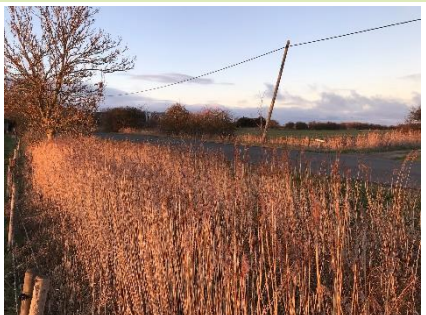
Riparian Zone	The riparian zone comprised agricultural fields. A road ran adjacent to the watercourse.

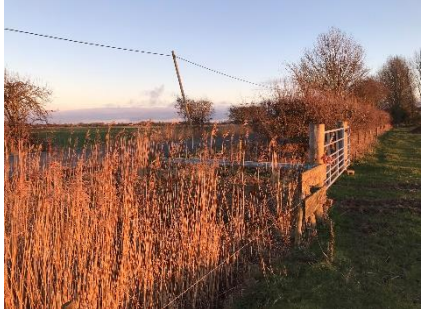
Parameter	Details	Photograph
Modifications	The watercourse is artificial or heavily modified. Adjacent land use is heavily modified for agricultural and transport purposes.

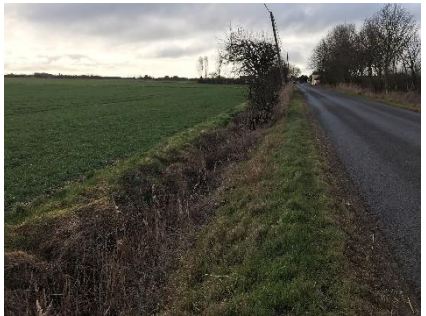
11.82 WC DX107P

Parameter	Details	Photograph
Channel Form	This watercourse comprised a straight, artificial or heavily modified channel with a trapezoidal cross section.

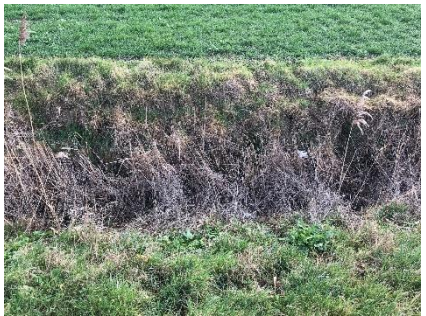
Substrate Conditions	The bed was obscured by vegetation but was assumed to be silty.

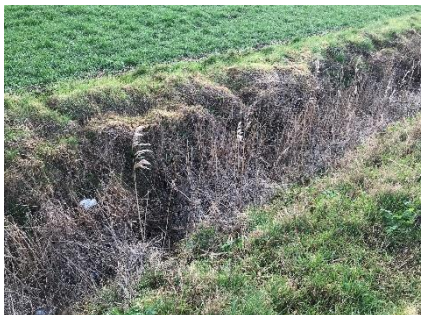
Flow Conditions	Flow conditions were obscured by vegetation, but it was assumed that there would be some standing water.

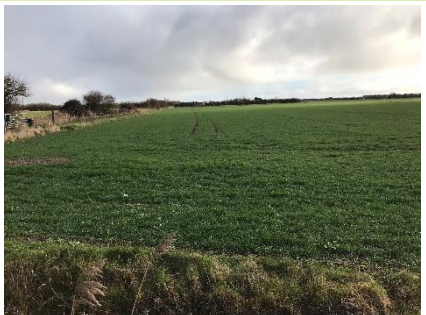
Floodplain Characteristics	The watercourse was artificial or heavily modified and completely disconnected from the adjacent floodplain.

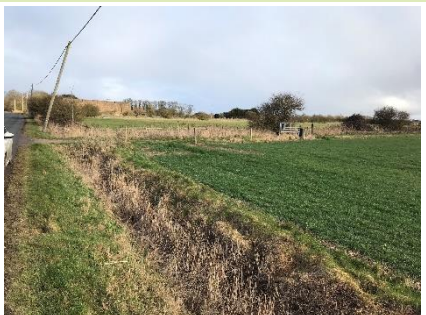
Riparian Zone	The riparian zone comprised agricultural fields. A road ran adjacent to the watercourse.

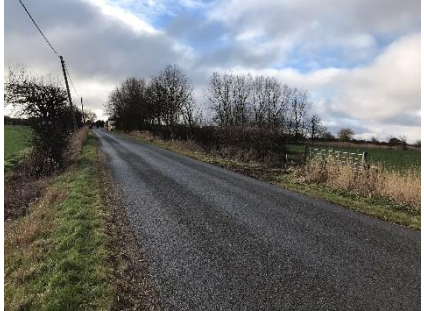
Parameter	Details	Photograph
Modifications	The watercourse is artificial or heavily modified. Adjacent land use is heavily modified for agricultural and transport purposes.

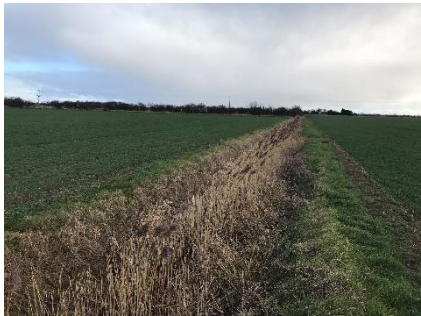
11.83 WC DX108P

Parameter	Details	Photograph
Channel Form	This watercourse comprised a straight, artificial or heavily modified channel with a trapezoidal cross section.

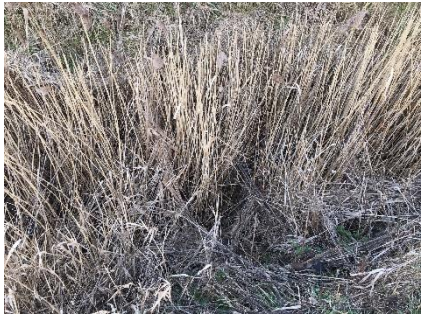
Substrate Conditions	The bed was obscured by vegetation but was assumed to be silty.

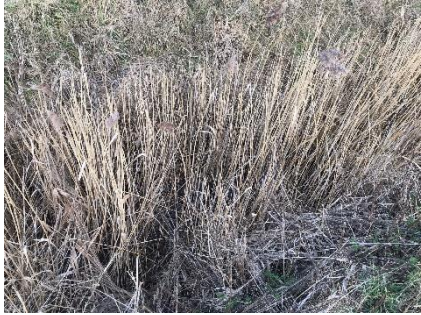
Flow Conditions	Flow conditions were obscured by vegetation, but it was assumed there would be some standing water.

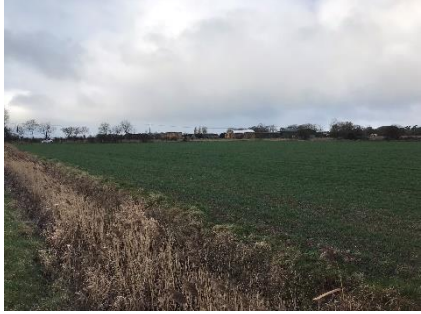
Floodplain Characteristics	The watercourse was artificial or heavily modified and completely disconnected from the adjacent floodplain.

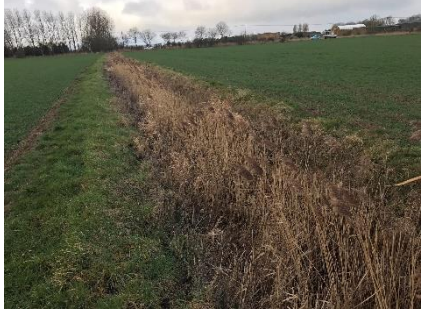
Riparian Zone	The riparian zone comprised agricultural fields.

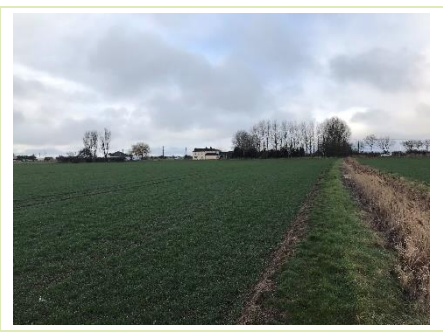
<p>Modifications</p>	<p>The watercourse is artificial or heavily modified. Adjacent land use is heavily modified for agricultural purposes.</p>

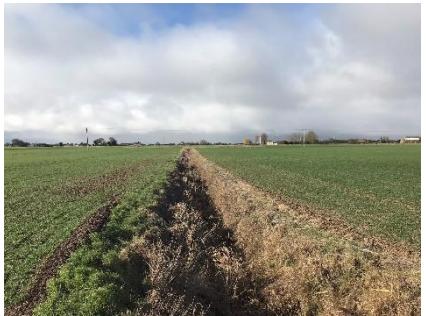
11.84 WC DX109P

Parameter	Details	Photograph
Channel Form	This watercourse comprised a straight, artificial or heavily modified channel with a trapezoidal cross section.

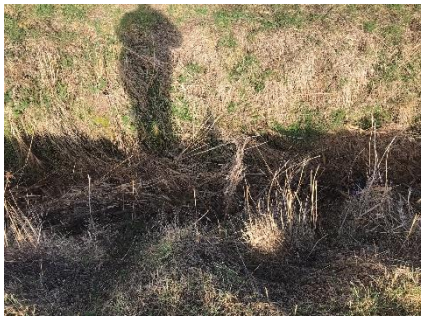
Substrate Conditions	The bed was silty.

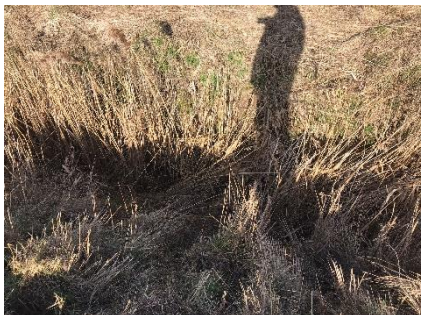
Flow Conditions	The channel had standing water in parts.

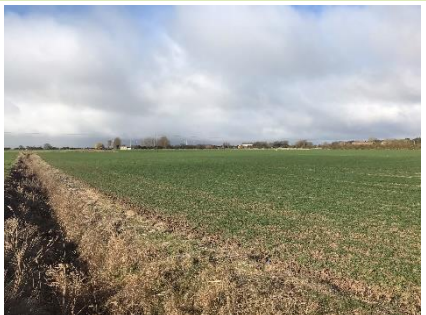
Floodplain Characteristics	The watercourse was artificial or heavily modified and completely disconnected from the adjacent floodplain.

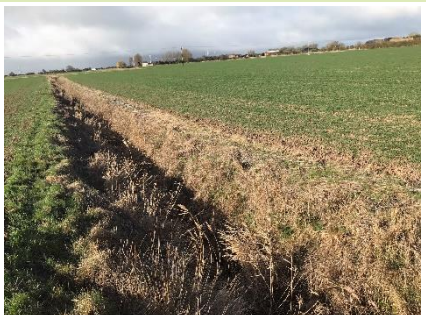
Riparian Zone	The riparian zone comprised agricultural fields.

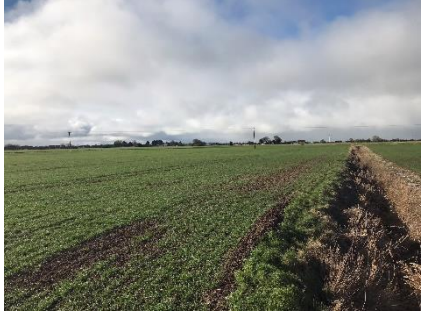
Parameter	Details	Photograph
Modifications	The watercourse is artificial or heavily modified. Adjacent land use is heavily modified for agricultural purposes.

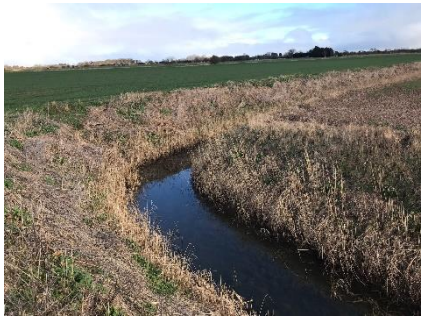
11.85 WC DX110P

Parameter	Details	Photograph
Channel Form	This watercourse comprised a straight, artificial or heavily modified channel with a trapezoidal cross section.

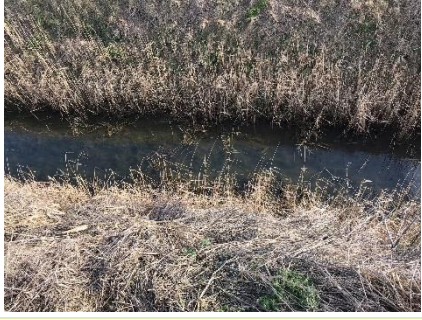
Substrate Conditions	The bed was silty.

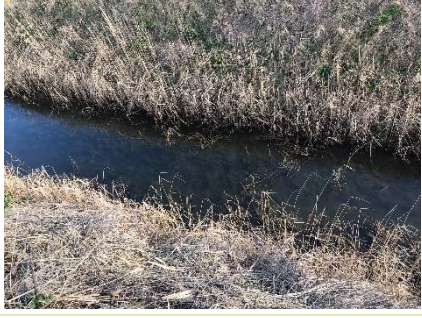
Flow Conditions	The channel had standing water.

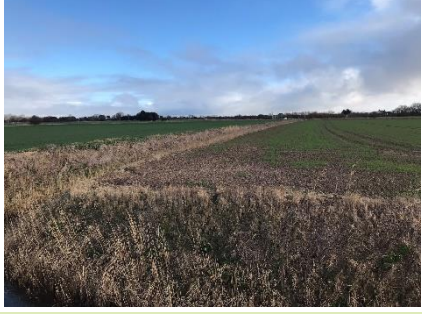
Floodplain Characteristics	The watercourse was artificial or heavily modified and completely disconnected from the adjacent floodplain.

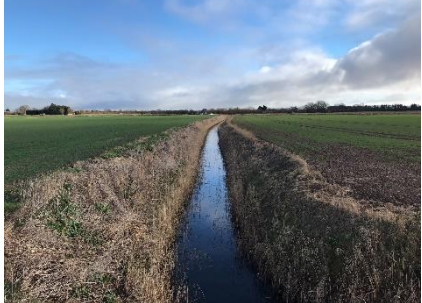
Riparian Zone	The riparian zone comprised agricultural fields.

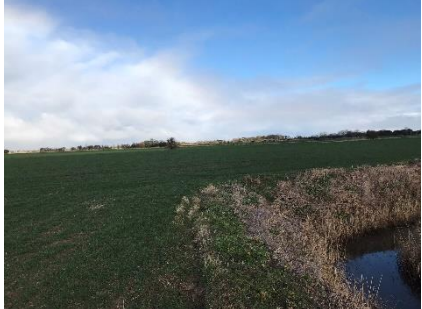
Parameter	Details	Photograph
Modifications	The watercourse is artificial or heavily modified. Adjacent land use is heavily modified for agricultural purposes.

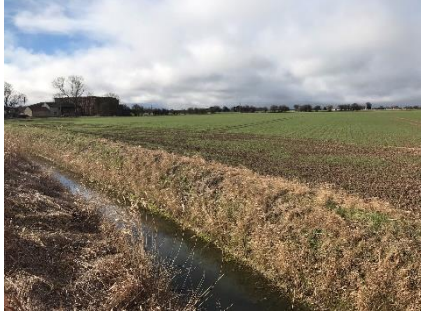
11.86 WC DX011P

Parameter	Details	Photograph
Channel Form	This watercourse comprised a straight, artificial or heavily modified channel with a trapezoidal cross section.

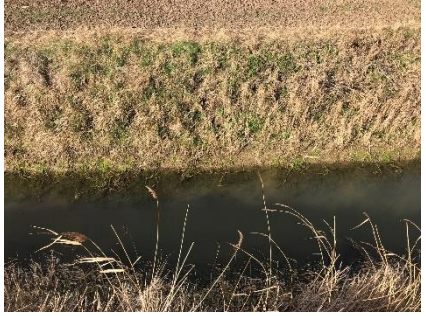
Substrate Conditions	The bed was silty.

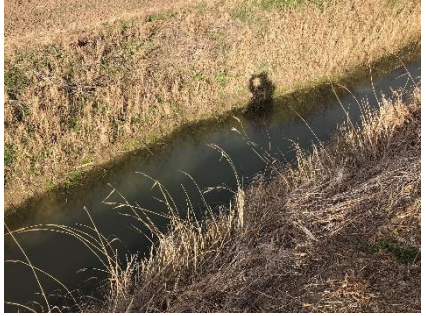
Flow Conditions	The channel had standing water.

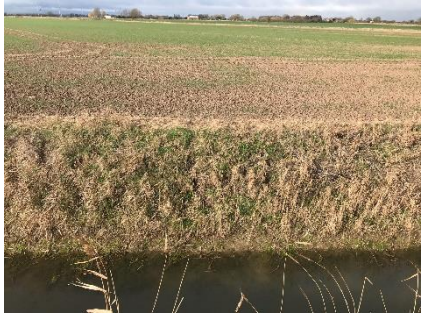
Floodplain Characteristics	The watercourse was artificial or heavily modified and completely disconnected from the adjacent floodplain.

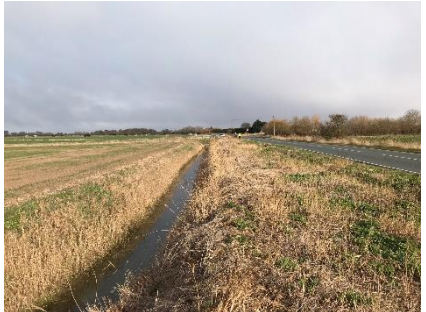
Riparian Zone	The riparian zone comprised agricultural fields, with a road and grass buffer on one side of the watercourse.
