# A47 DUALLING – NORTH TUDDENHAM TO EASTON

APPENDIX 4 to  
STATEMENT OF [REDACTED] of the Berry Hall Estate

# BERRY HALL ESTATE NORFOLK

### **ESTATE BUILDINGS REPORT**

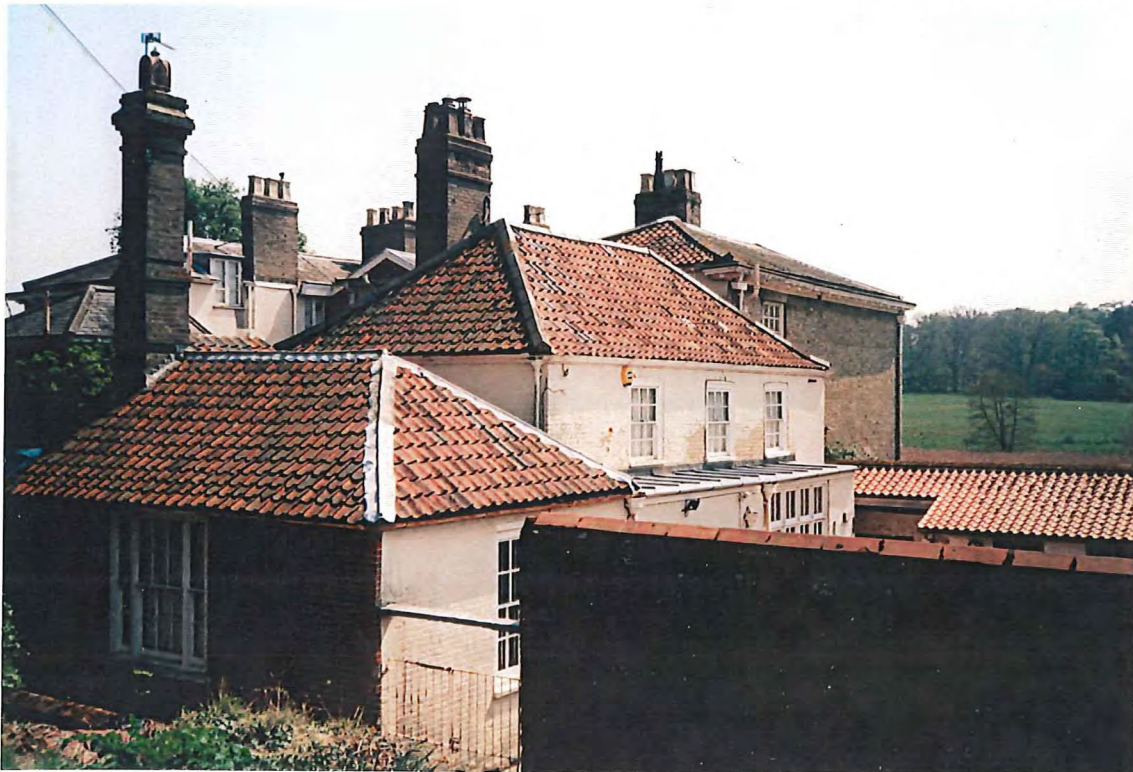
Berry Hall service range seen from the north west with the log store and garden shed to the right

**CONDITION** Generally good

**WORKS REQUIRED** This range of buildings is generally in good order apart from some minor repairs to the brickwork and joinery.

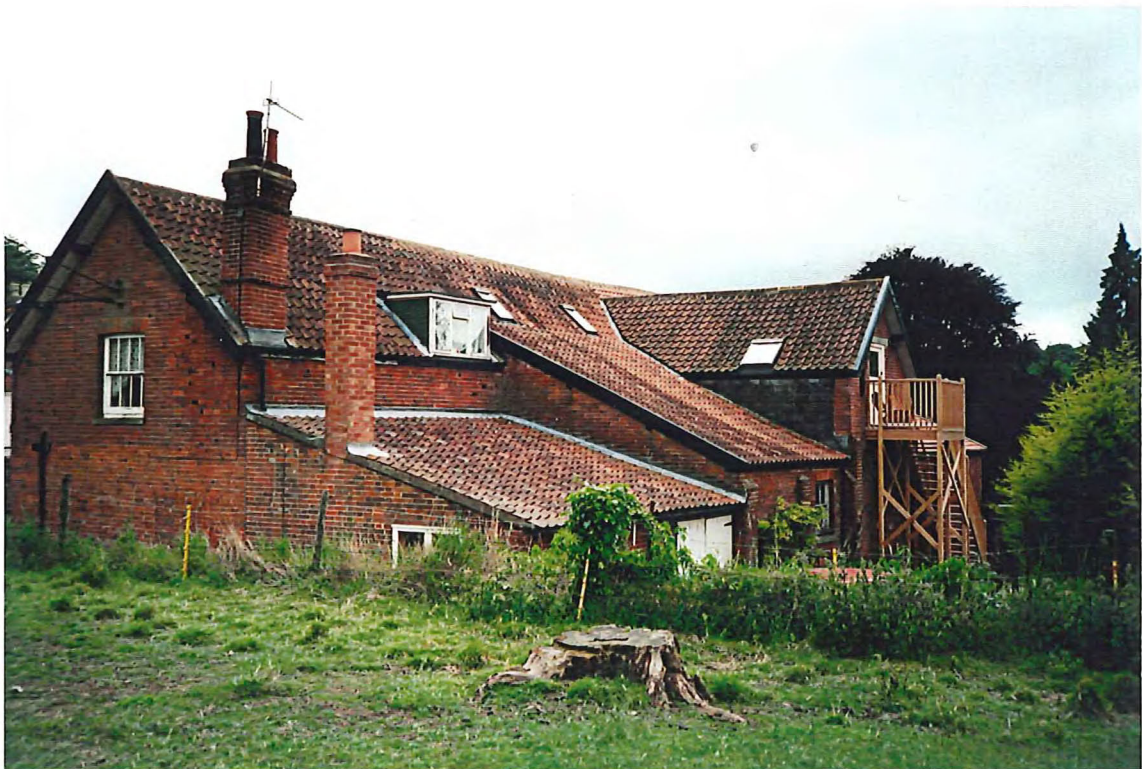
Rosemary Cottage and the stables seen from the north west

**WORKS REQUIRED** This is currently undergoing conversion and appears to be generally sound. However, minor brick work repairs ought to be carried out, joinery painted and rusting rainwater goods redecorated.

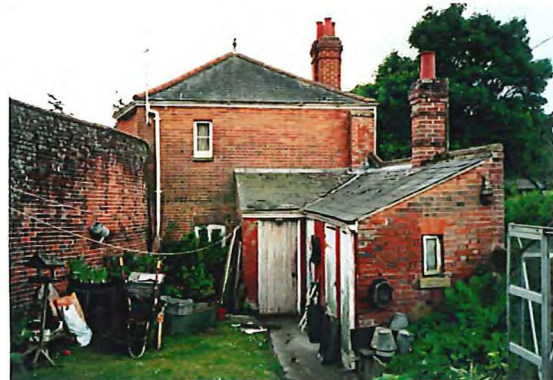
**CONDITION** Generally in good order

The north elevation of Wisteria Cottage

**WORKS REQUIRED** Minor repairs are necessary to the roof and gutters and the open joints to the brickwork on the chimney stacks, and cracks through the south stack, ought to be repaired. Minor repairs are necessary to the joinery which requires redecoration and further minor repairs are necessary to the brickwork of the garden wall to the cottage.

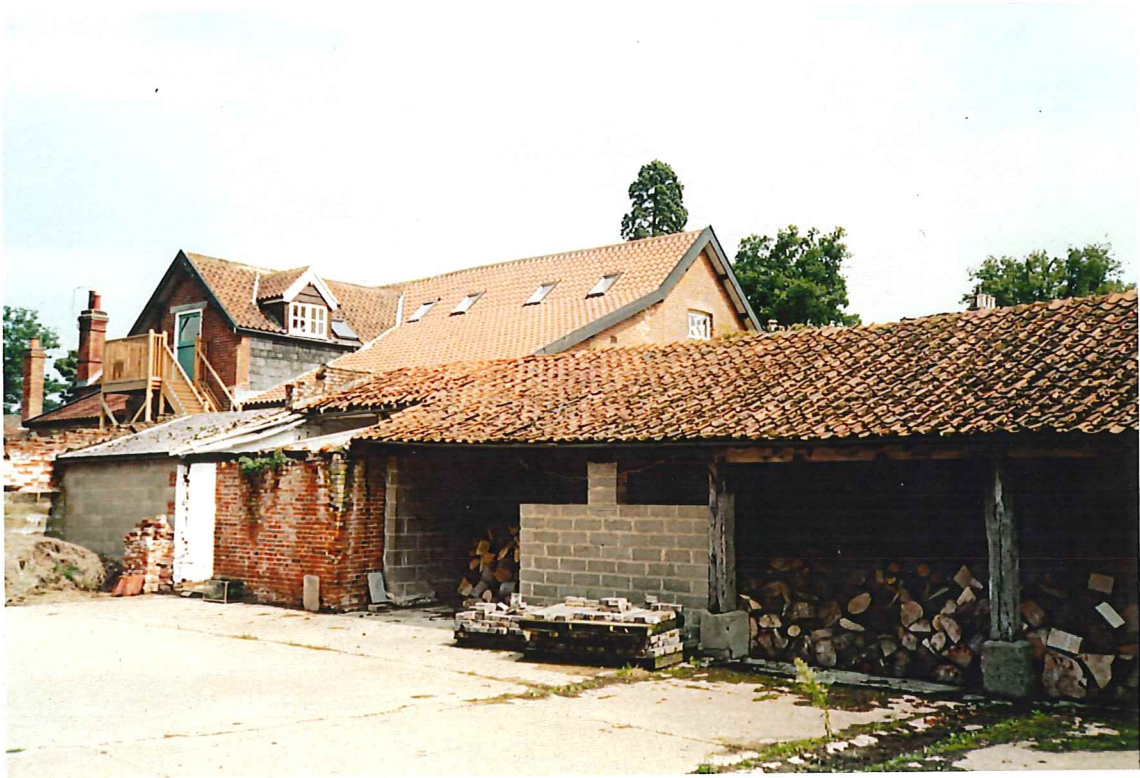
**CONDITION** Generally in a fair condition, though sections of ranges are starting to deteriorate.

Range F and G seen from the west

joints and cracks and the rebedding of loose bricks. The loose timber frame to the southern window should be propped and floors thoroughly cleaned out and all rainwater goods should be regularly cleared and repaired as necessary.

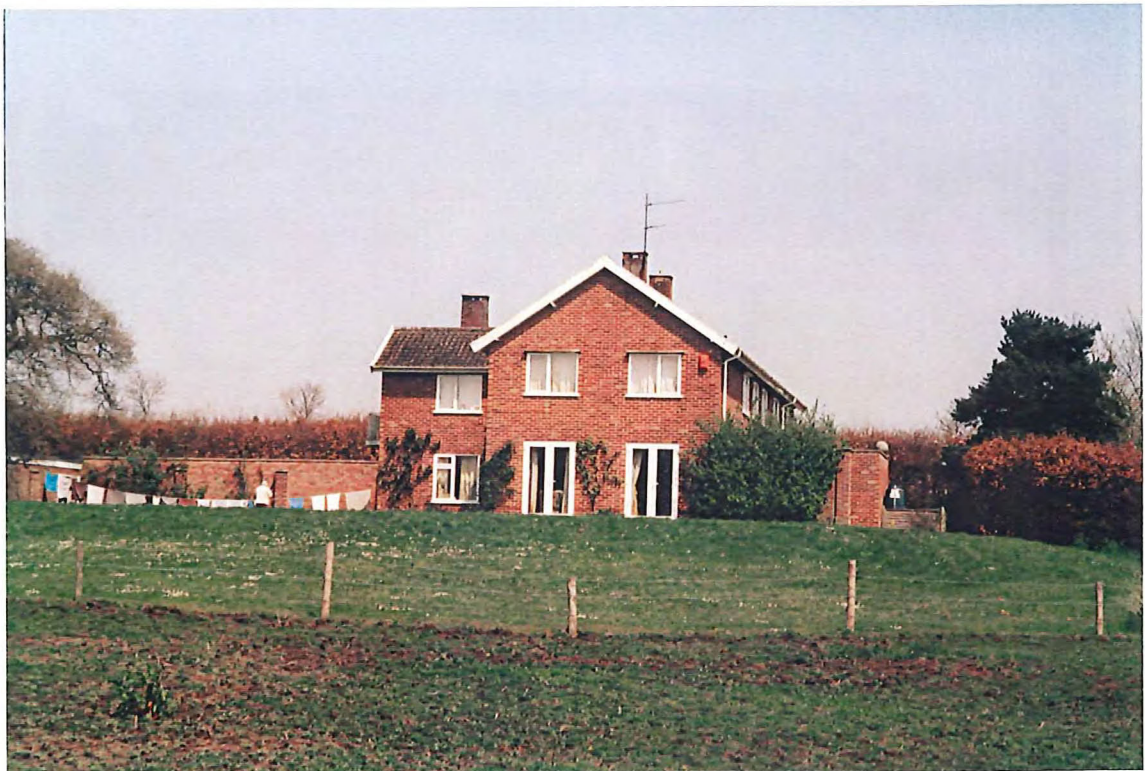
**HERITAGE VALUE** Neutral heritage value

The south elevation of Merrywood House

**WORKS REQUIRED** No immediate works required.
