# A428 Black Cat to Caxton Gibbet improvements

## 9.18 Brook Cottages Technical Note

**9.18 Brook Cottages Technical Note**

<b>Regulation Reference:</b>	Rule 8(1)(k)
<b>Planning Inspectorate Scheme Reference</b>	TR010044
<b>Application Document Reference</b>	TR010044/EXAM/9.18
<b>Author</b>	A428 Black Cat to Caxton Gibbet Improvements Project Team, Highways England

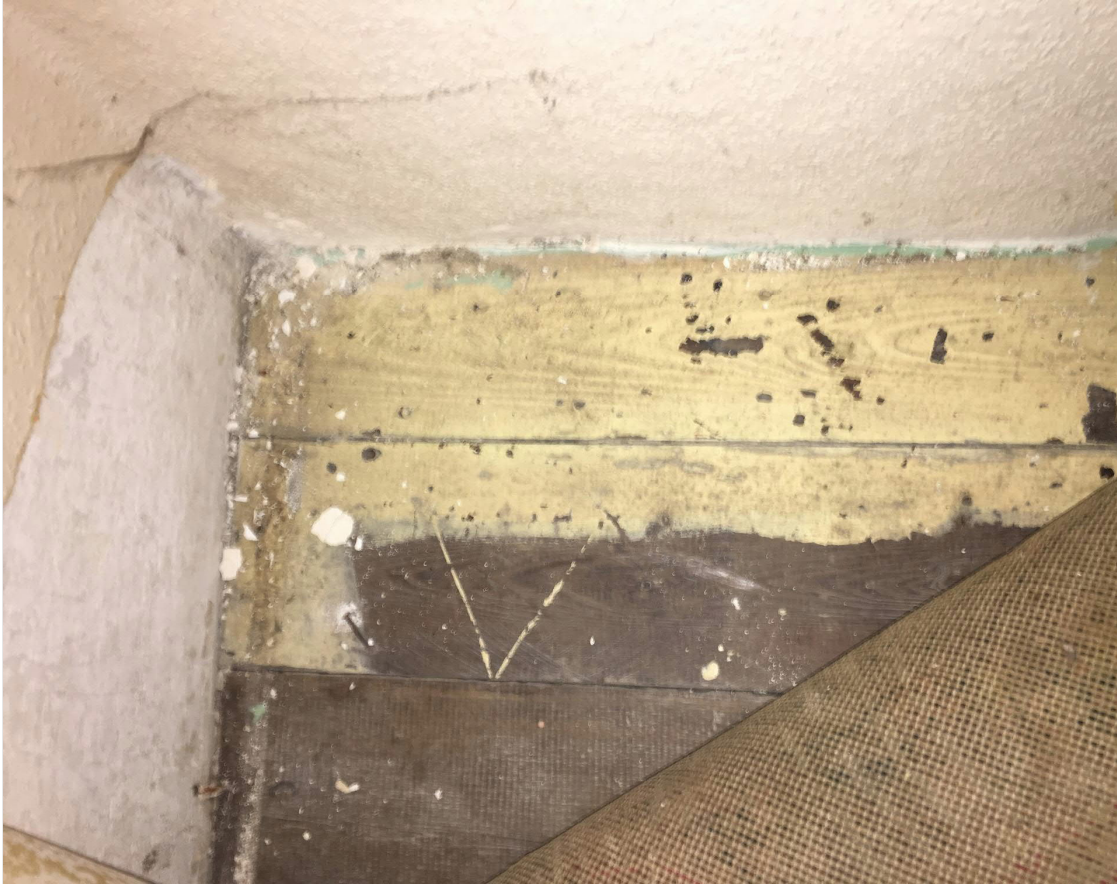
Plate

- 3.1.14 A four-panel door leads into the second bedroom (Plate 25). The arrangement of this matches the first, but without the chimney breast. Lifting the carpet also revealed a wooden floor (Plate 26).

Panel door to second bedroom in No.2
