A417 Missing Link
TR010056

6.4 Environmental Statement
Appendix 13.11 Water Features Survey
(Part 1 of 2)

**6.4 Environmental Statement
Appendix 13.11 Water Features Survey
(Part 1 of 2)**

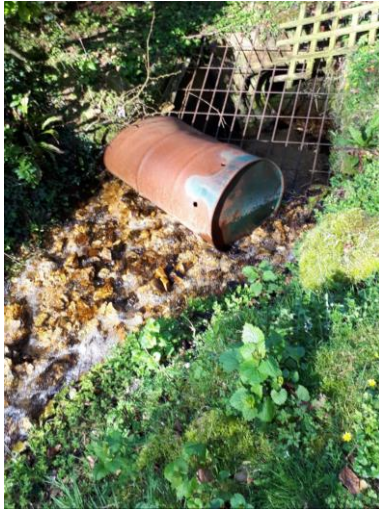
19_looking W DS to culvert under the house_180418

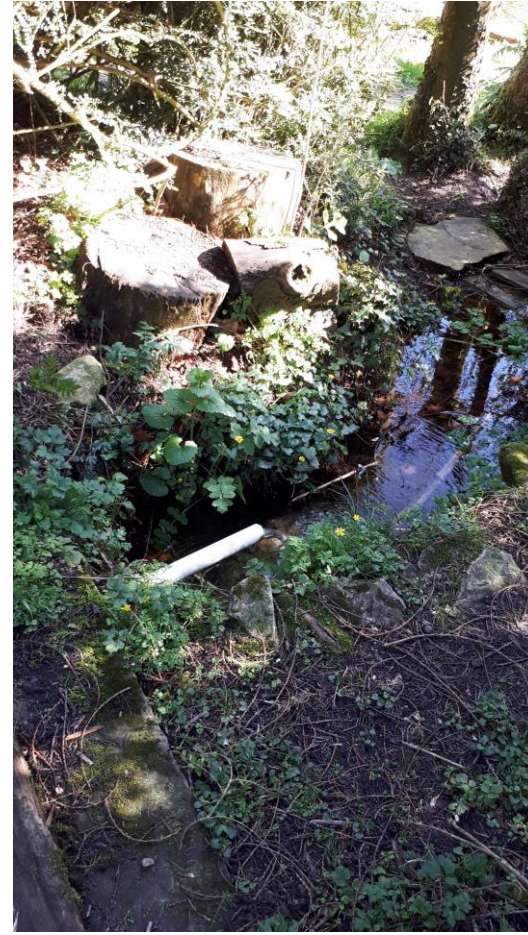
33_looking SE US extent of 31
where it is culverted under the
road_180418

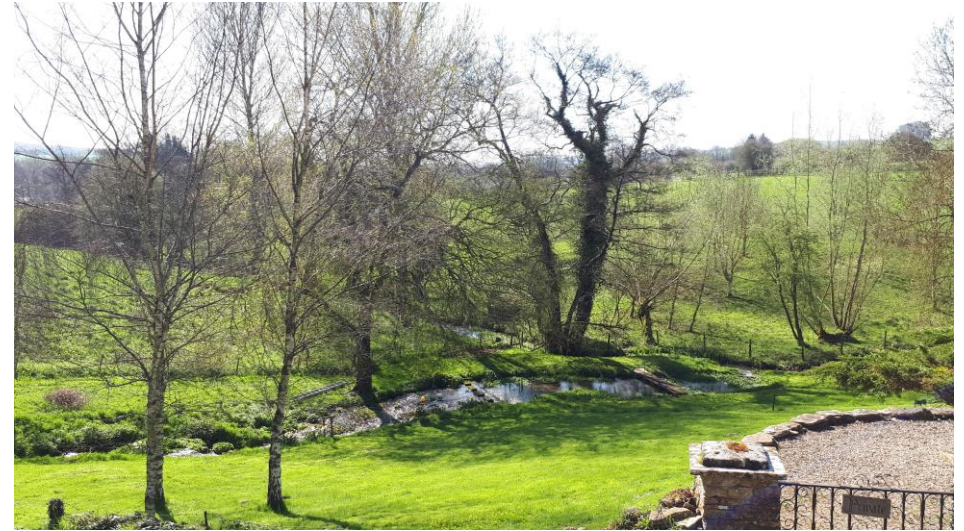
40_US extent outfall looking SE DS of outfall showing conf
with 39_190418

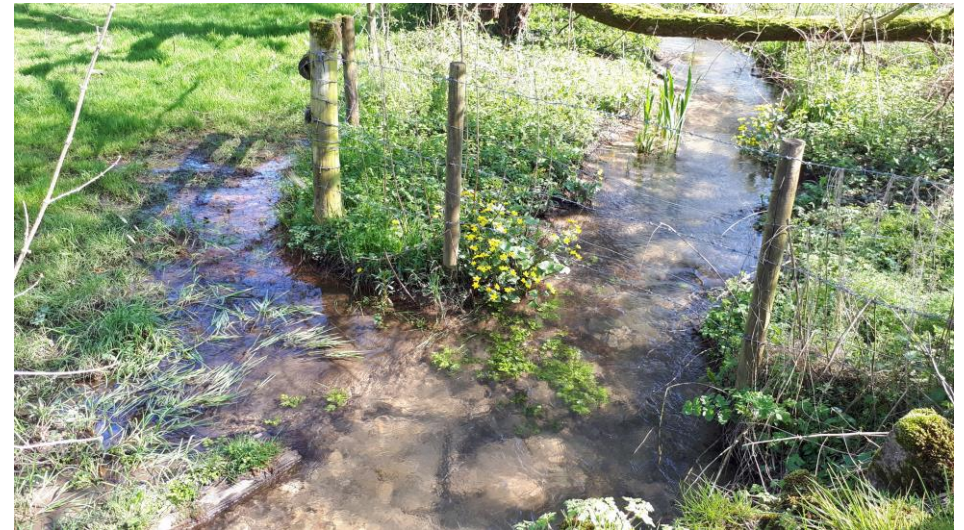
42_looking N US showing pooling and break of R
bank_190418

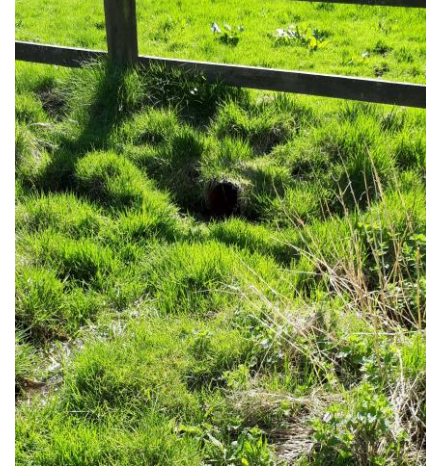
45_looking SE outfall
into area marked as
pond on OS maps

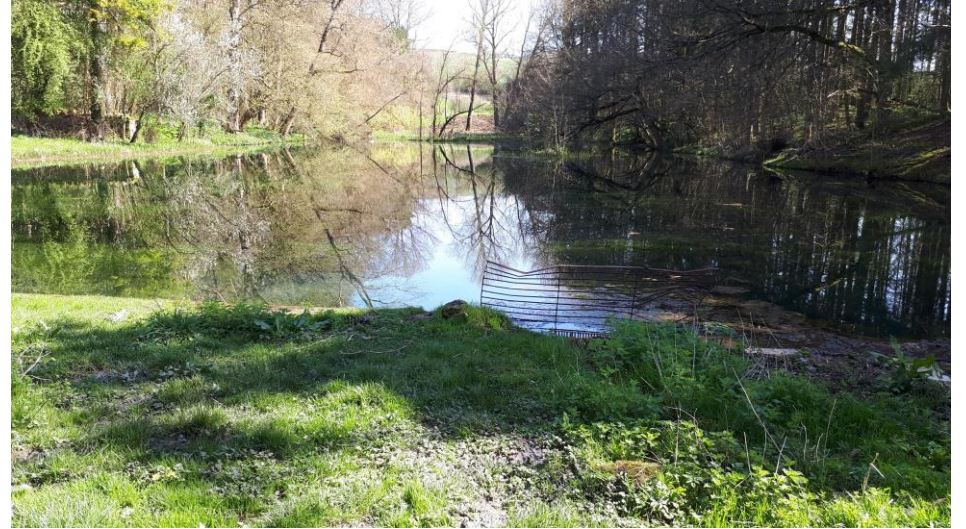
46_looking NE shows culvert_190418

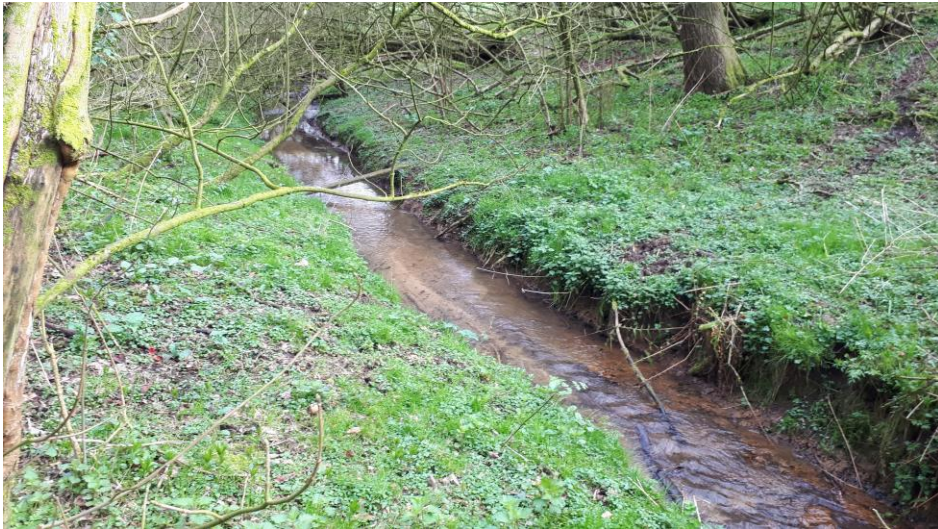
90_Looking W US of watercourse_seepage on banks of
River Churn tributary marked by dogs mercury

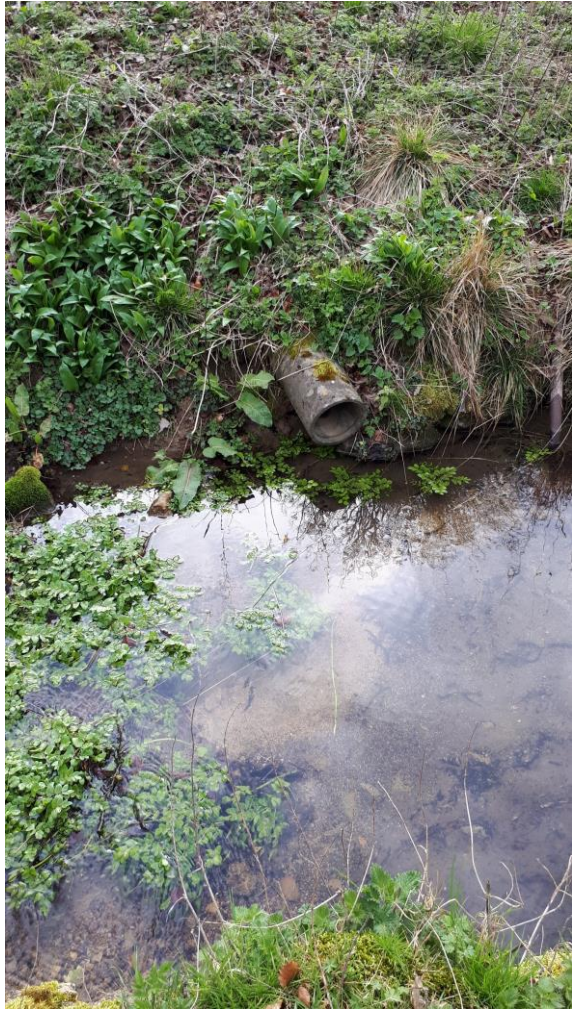
92_looking N US of 91_outfall
likely from road drainage

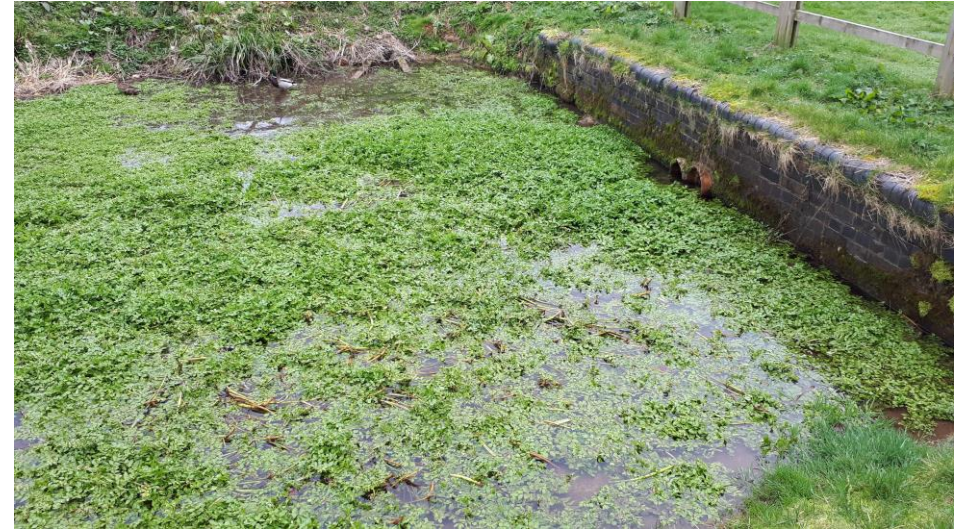
96_looking SE catchpit of flows from NSC

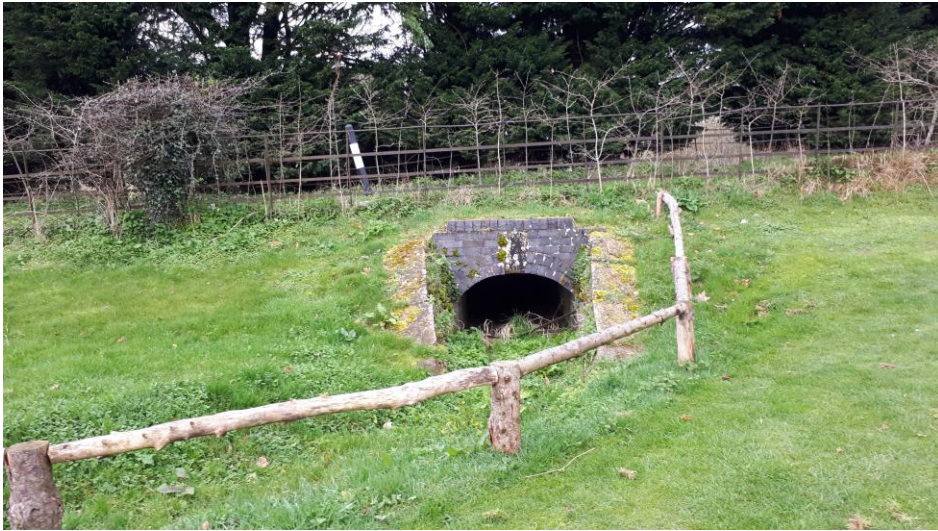
97_looking E US at outfall from national star college

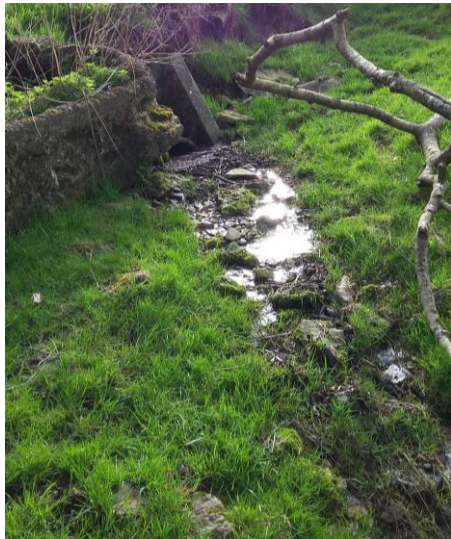
G5_spring_culvert
discharge_looking NW

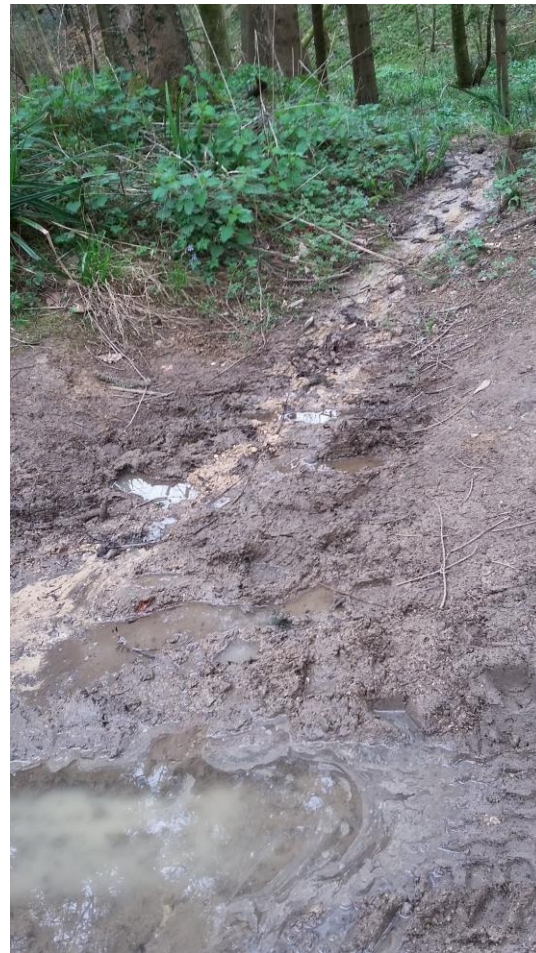
G11_possible seepages onto pathway no spring visible in valley where marked on OS Facing S

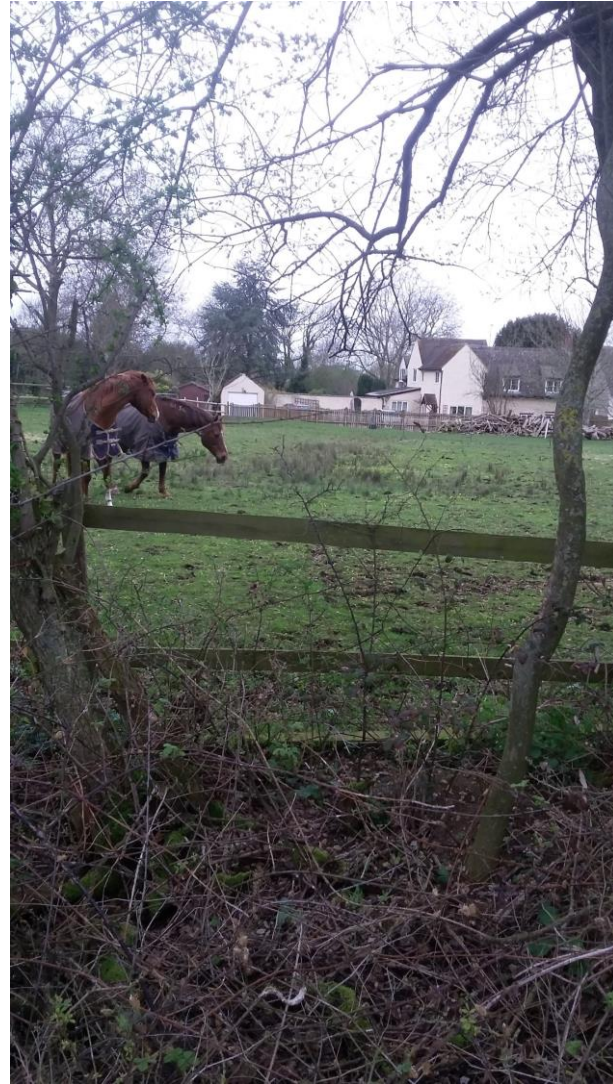
G15_rushes in field viewed from path
Facing W

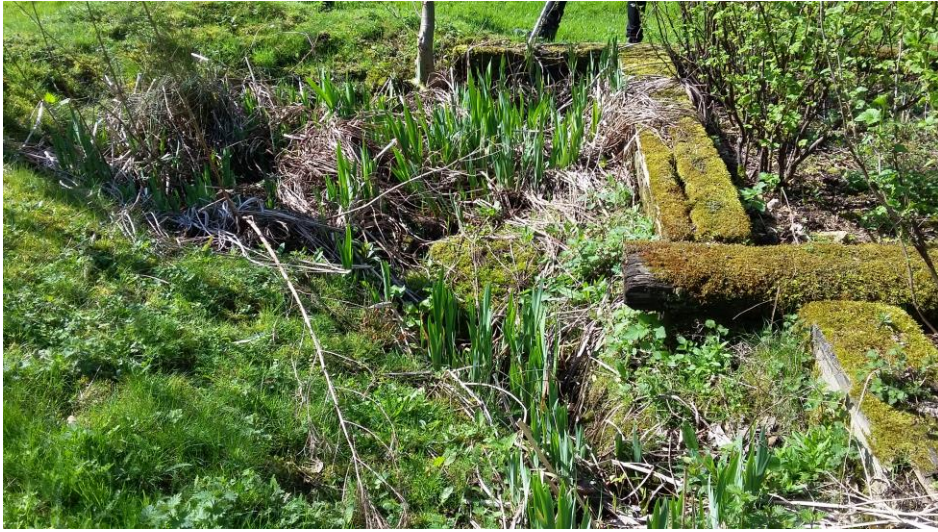
G19_pond with old GI borehole not found facing WSW

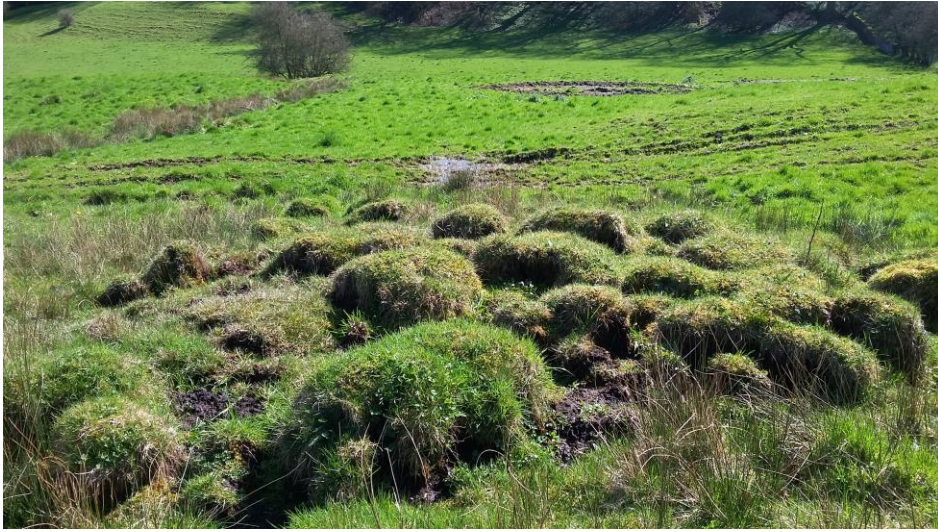
G24_seepage on slope at Bushley Muzzard facing S

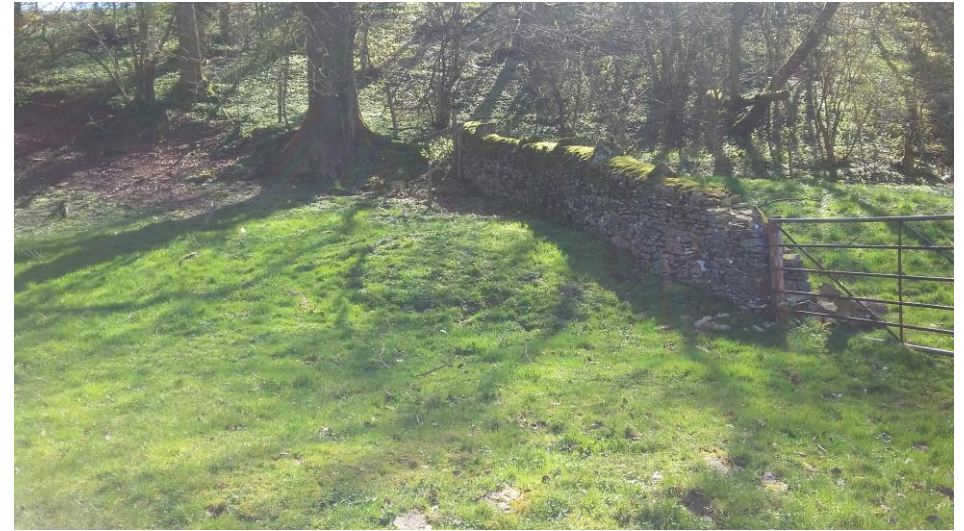
G26_minor seepage on slope facing S

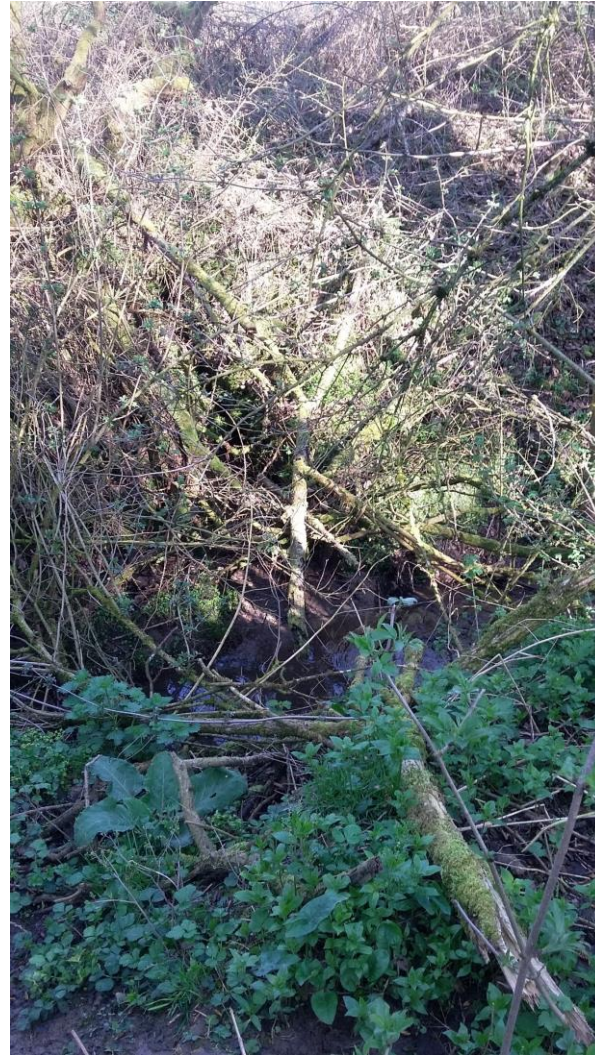
G35_seepage on banks of River Churn trib facing N

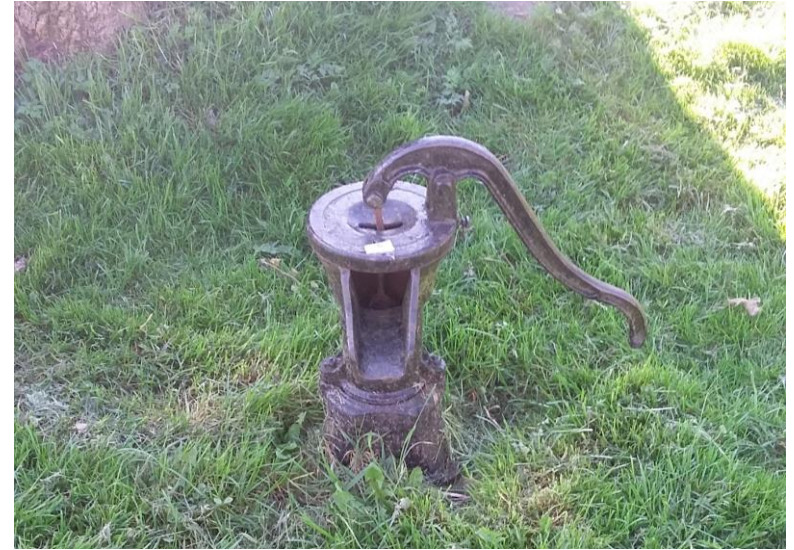
G33_blocked well likely ornamental facing W

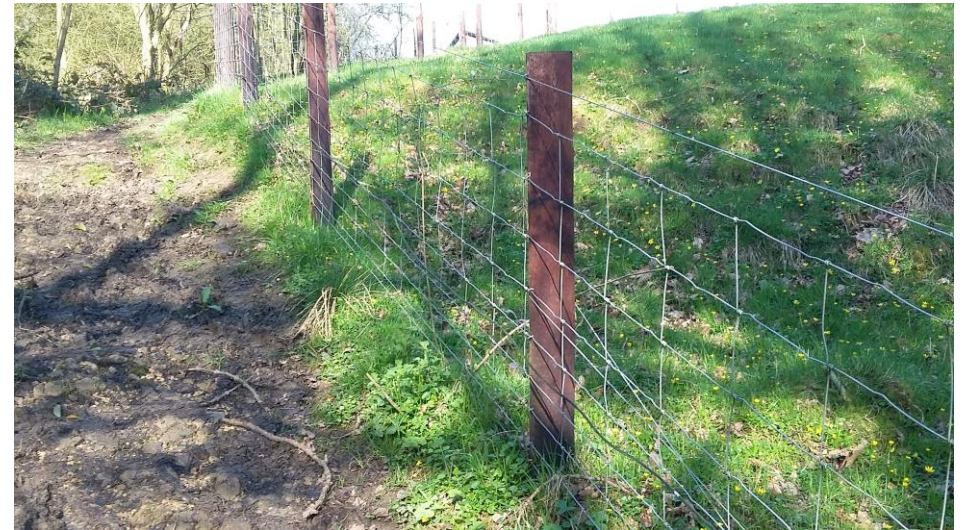
G36_seepage on banks of River Churn trib facing W

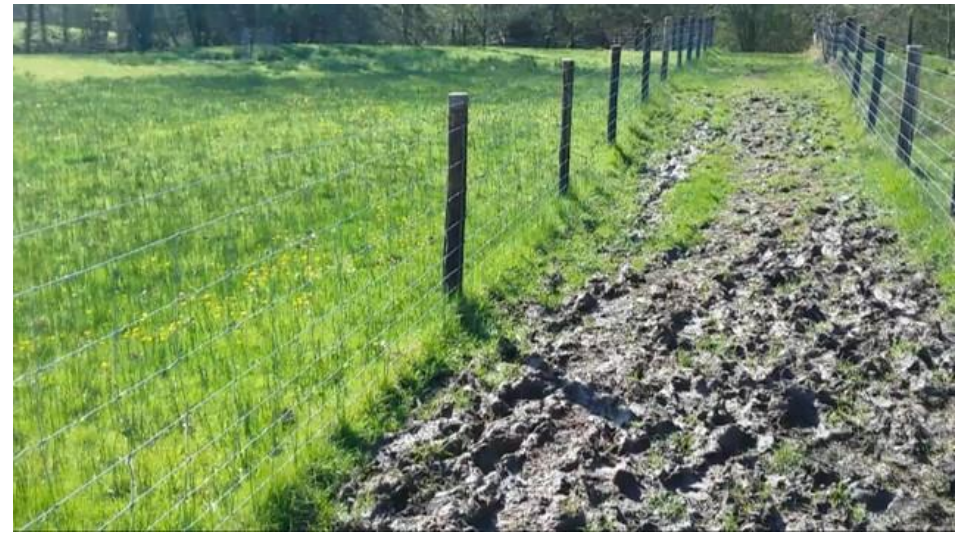
G37_seepage on banks of River Churn trib facing S

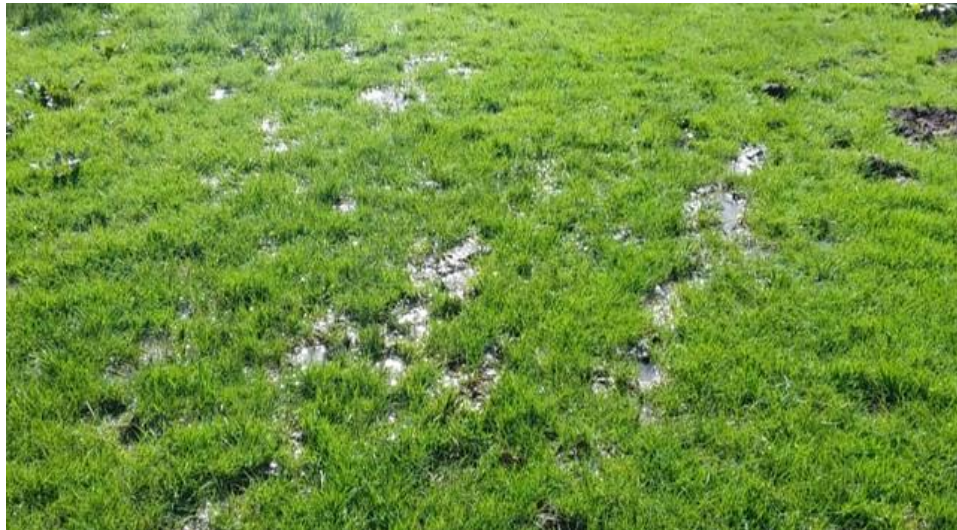
G39_seepage upgradient of River Churn trib starts facing S

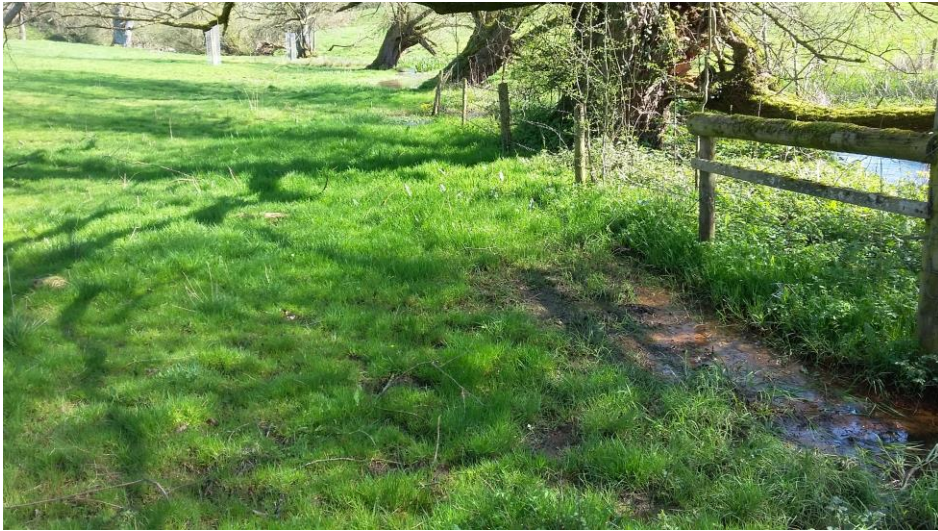
G43_well in Coberley facing E

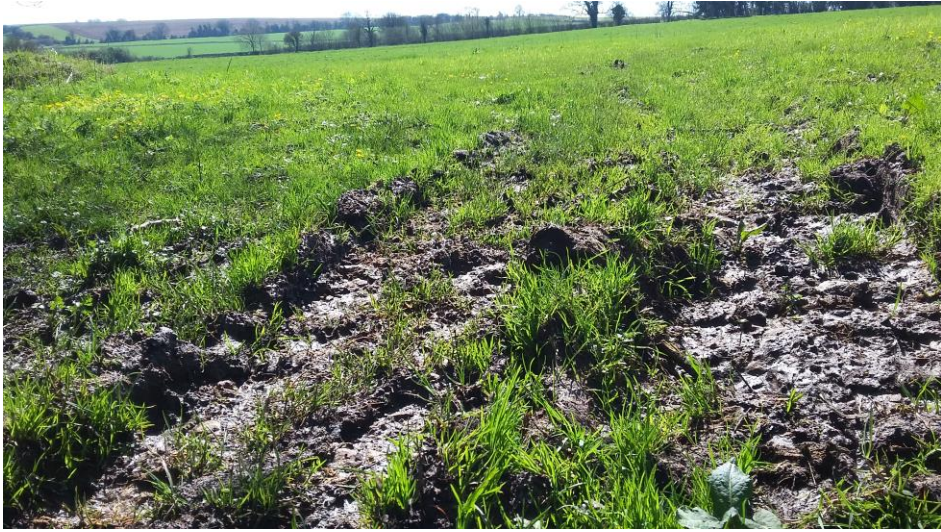
G45_spring as viewed from public access land facing W

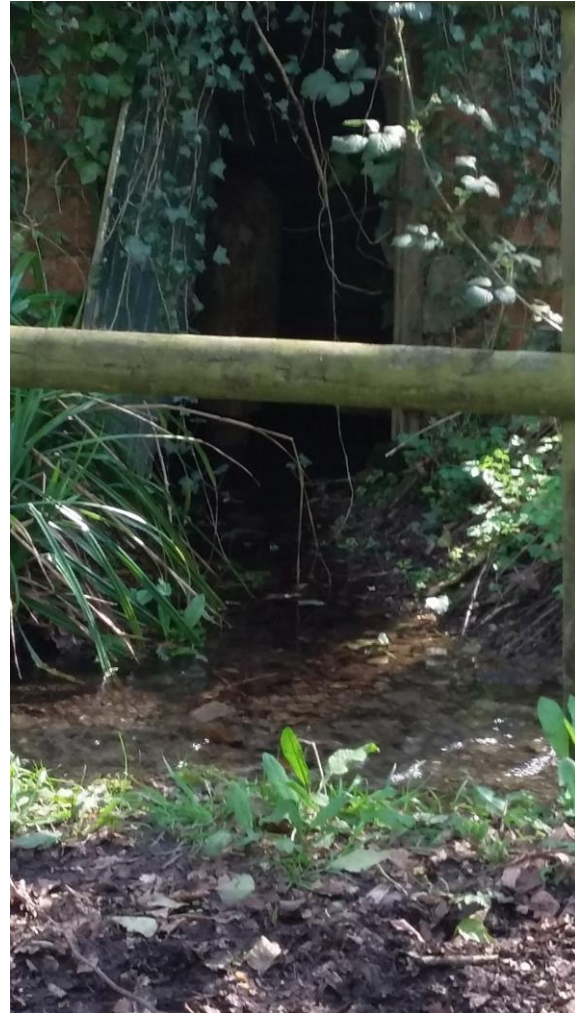
G48_weir and seepage slopes facing S

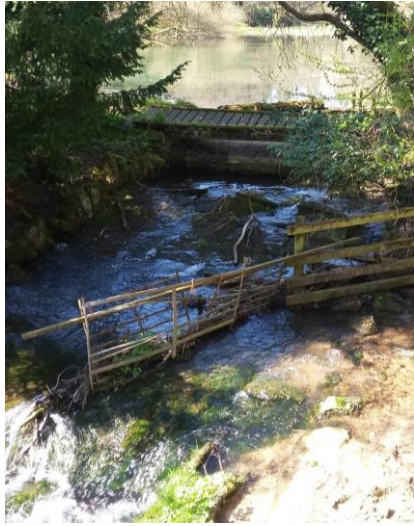
G49_springs and seepage as viewed from road facing S

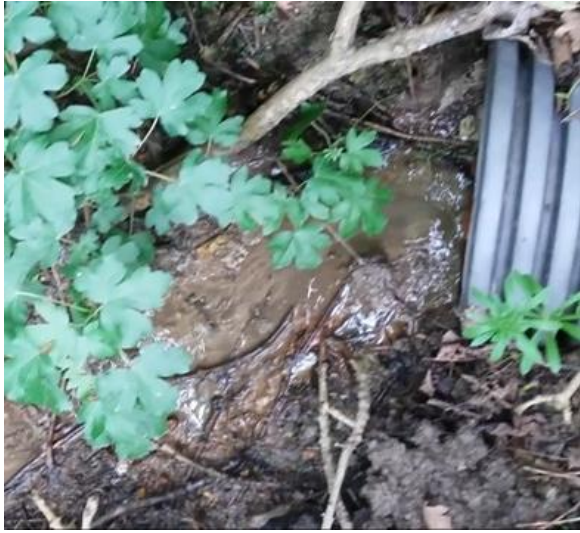
G57_watercourse facing N E

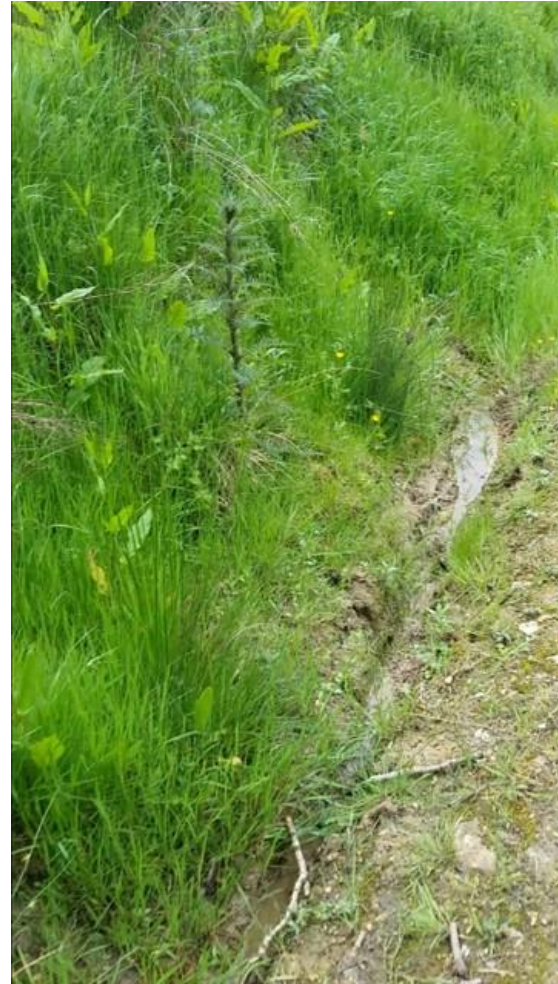
G59_rushes and seepage facing S

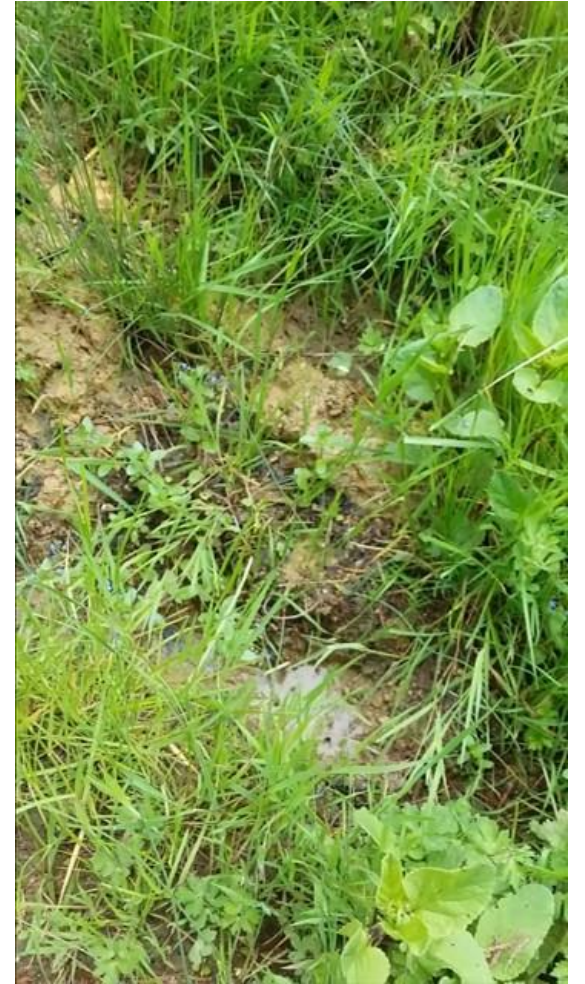
G60_seepages on slope facing S

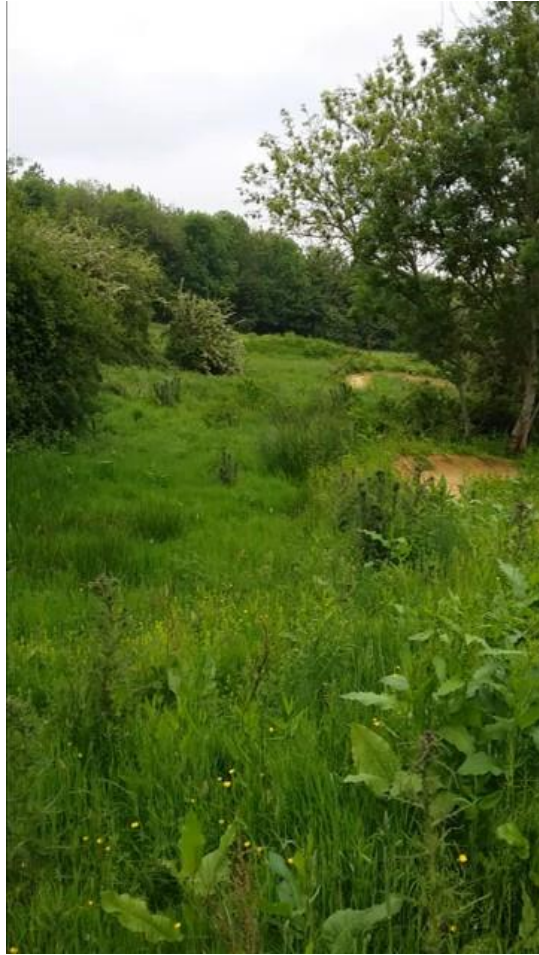
G63_rushes facing S

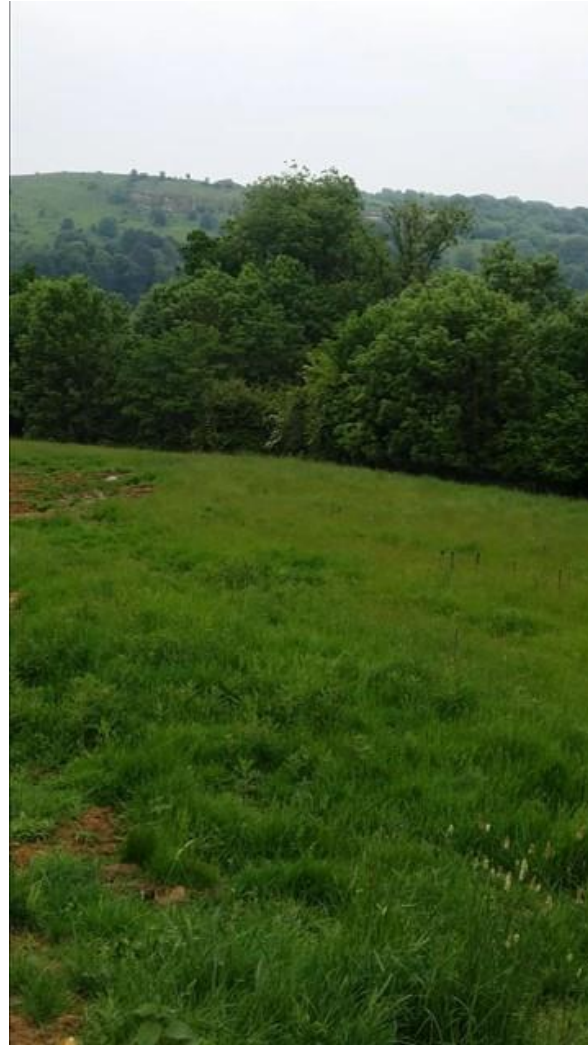
G66_rushes as viewed from path facing SE

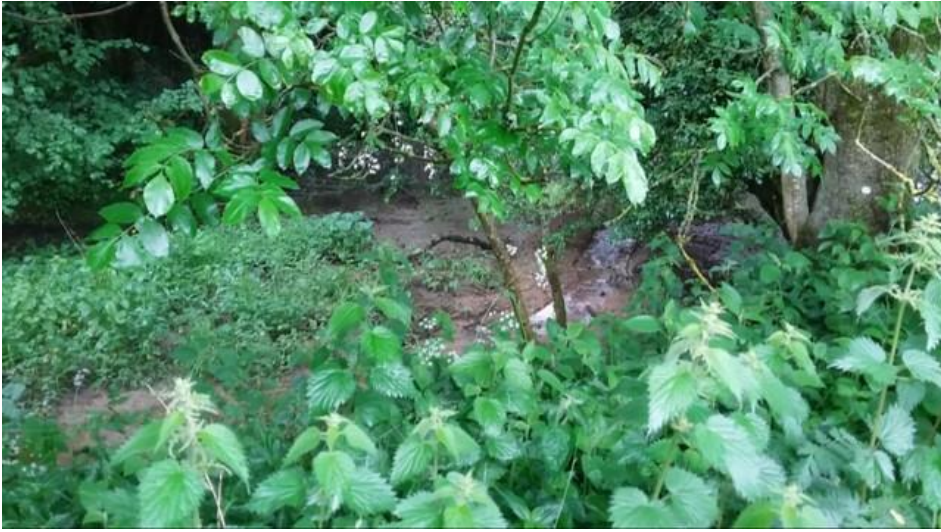
G73_spring that feeds trough and overflows N to watercourse facing SW

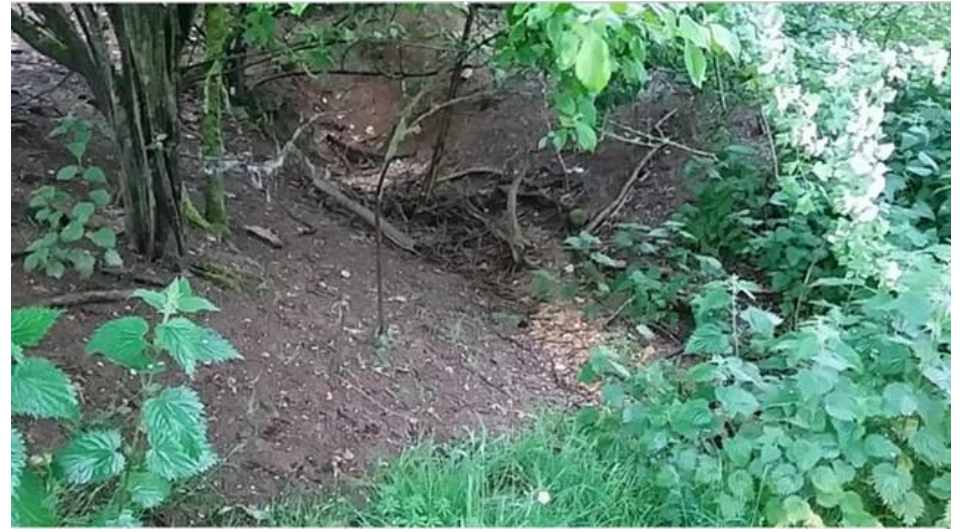
G75_spring fed watercourse and pond facing N

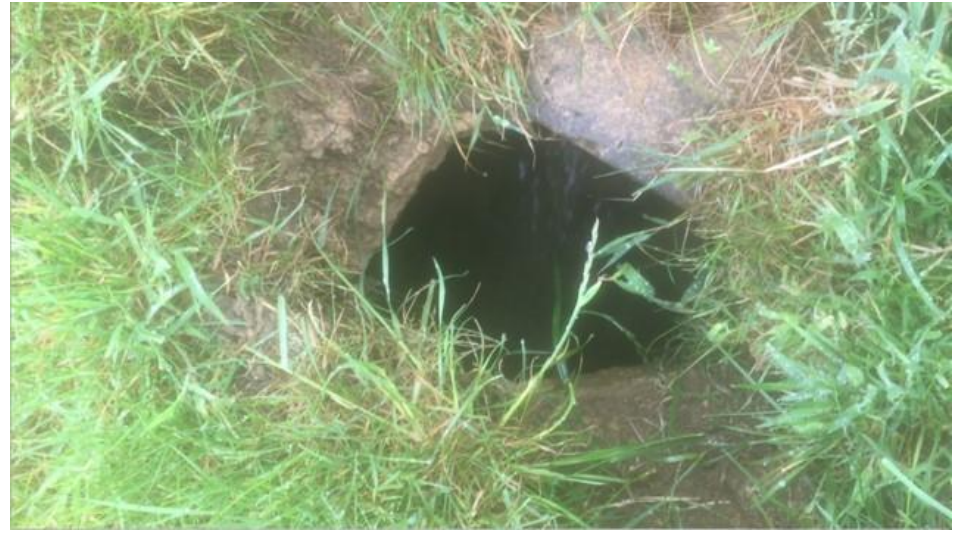
G78_Coldwell Bottom facing W

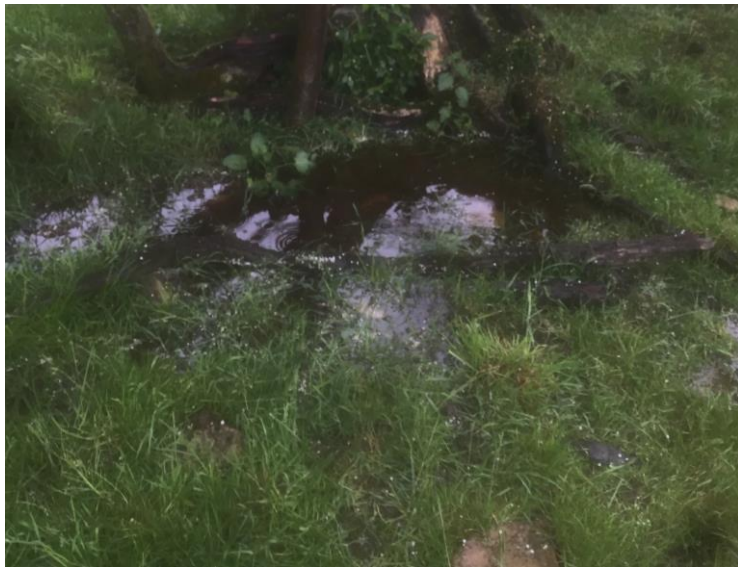
G83_standing water, possibly from seepage facing W

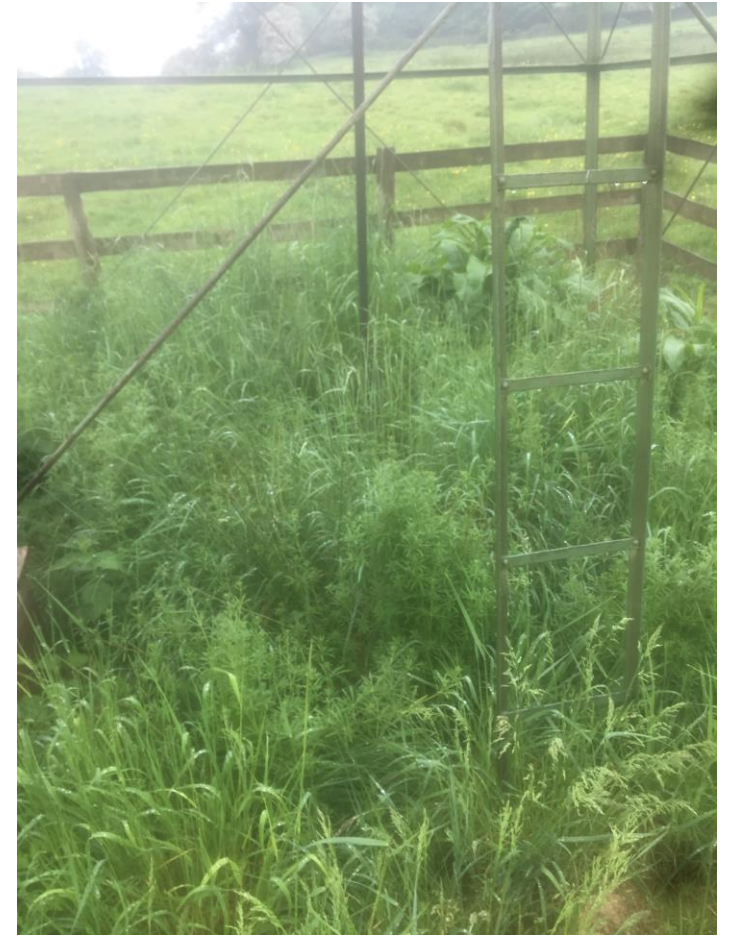
G82_abstraction at Watercombe Farm facing W

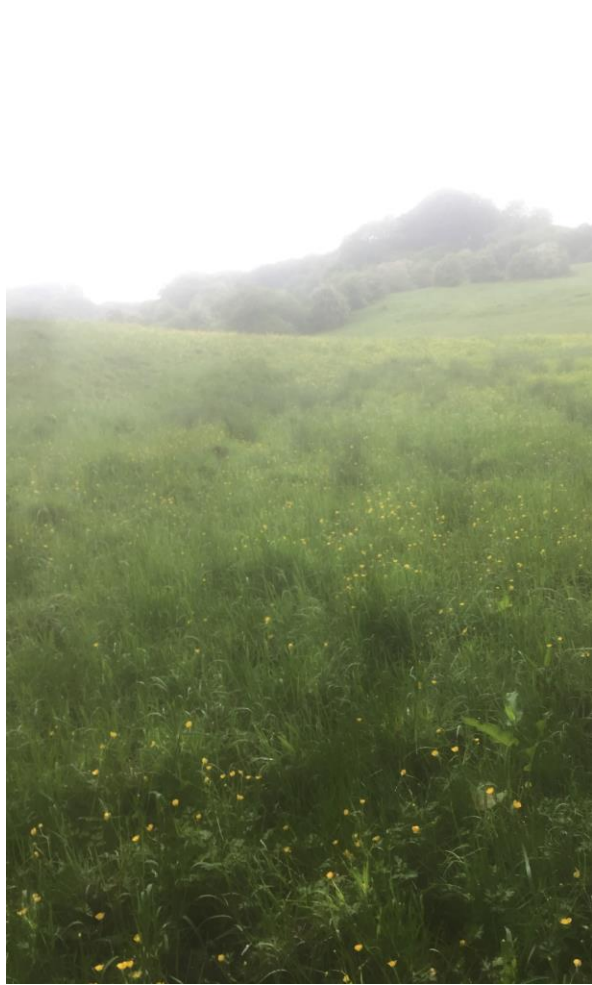
G85_rushes on slope and boggy ground facing W

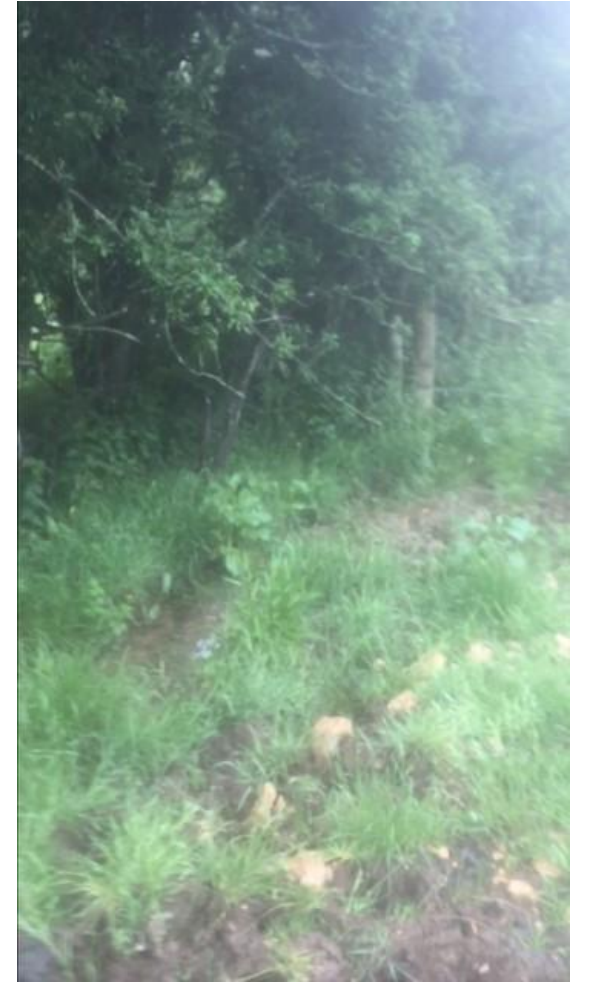
G87_drain facing N

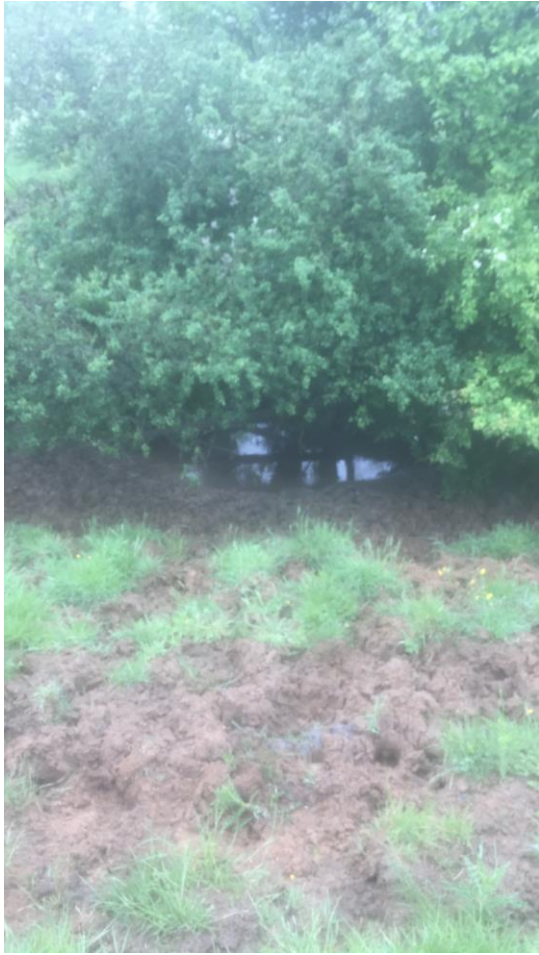
G88_confluence of drains facing N

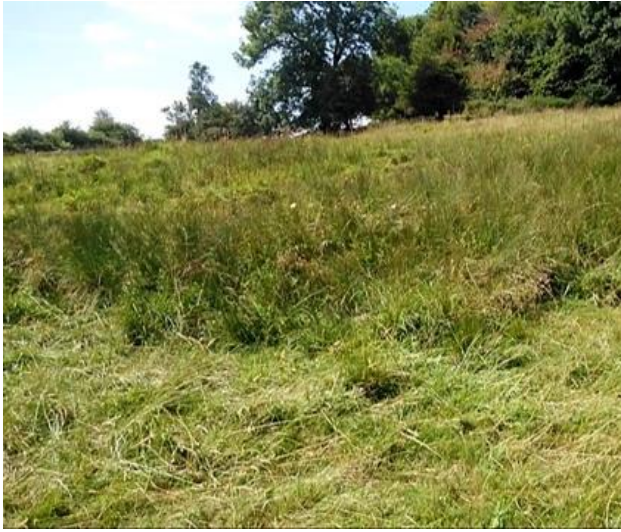
G104_rushes on slope facing W

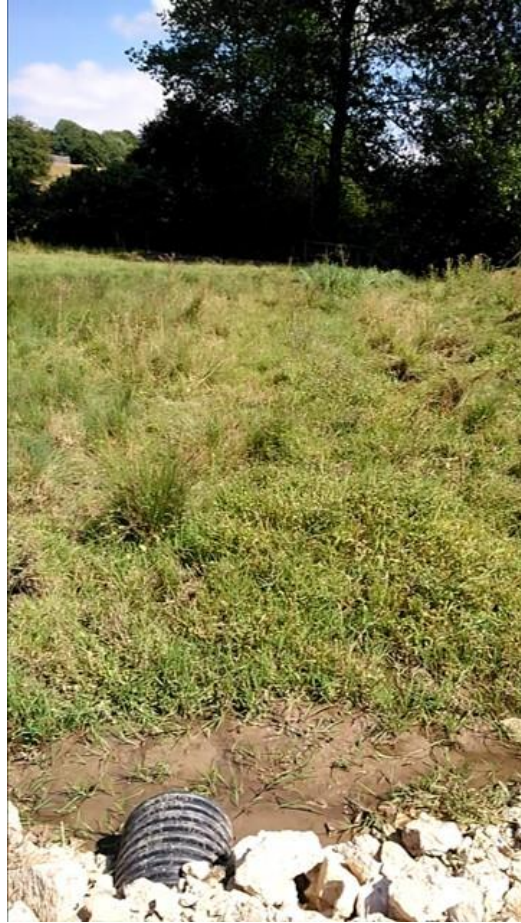
G106_culverted spring fed
watercourse facing W

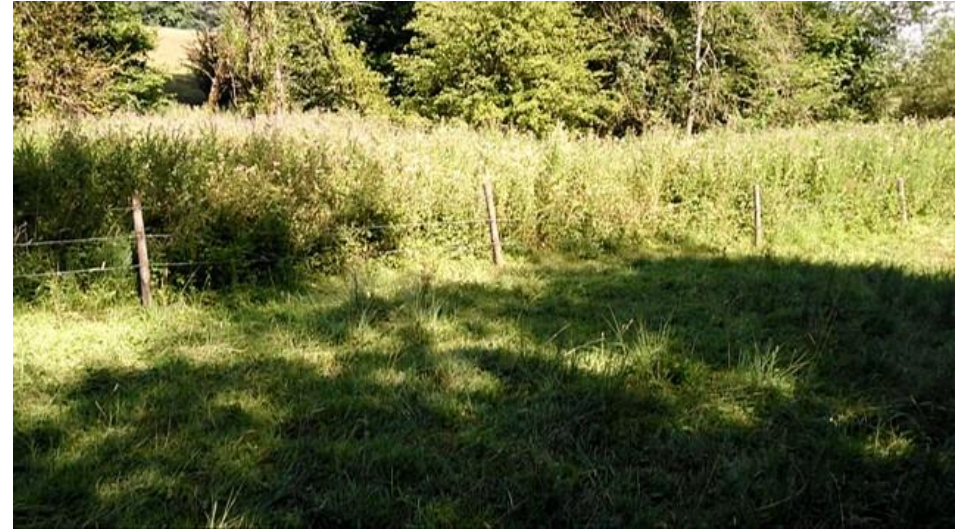
G110	394367 213166	Seepage					23/07/2018 15:20 Seepage area on slope, marked by change in vegetation and slightly damp ground.
G111	394392 213186	Pond					23/07/2018 15:21 Overflow from pond, which is hidden in trees. Overflow shows signs of tufa precipitation.
G112	394457 212566	Seepage					25/07/2018 10:48 Seepage area marked by rushes in field. Rushes are in centre of the screen. Watercourse is dry (bottom of screen).
G113	394437 212704	Spring					25/07/2018 10:57 Spring noted by ground depression with rushes. Dry at time of visit, flowing

G110_seepage on slope facing S

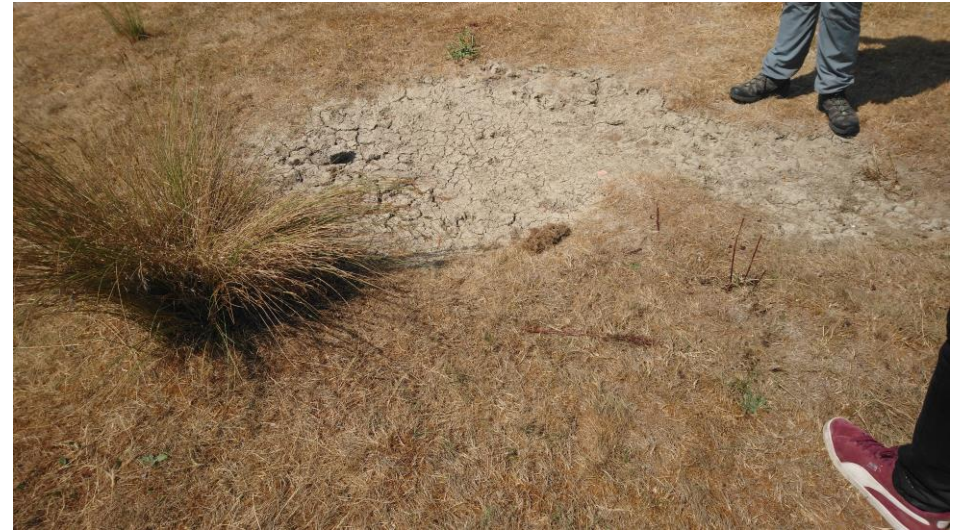
G116	391588 216510	Spring					25/07/2018 13:38 Possible spring, dry, marked by rush and cracked ground. Patches continue along public path to north-east
G117	391658 216494	Lake					25/07/2018 13:42 Dry feature marked by significant depression filled with rushes. Possibly spring fed and dry during summer.
G118	391770 216650	Watercourse					25/07/2018 13:58 Culverted, dry. Likely drains springs towards brook to the west.
G119	392022 216692	Watercourse					25/07/2018 14:05 Watercourse, possibly spring fed. No flow, but damp ground with standing water. Marked as spring fed from springs arising

G116_dry seepage patch

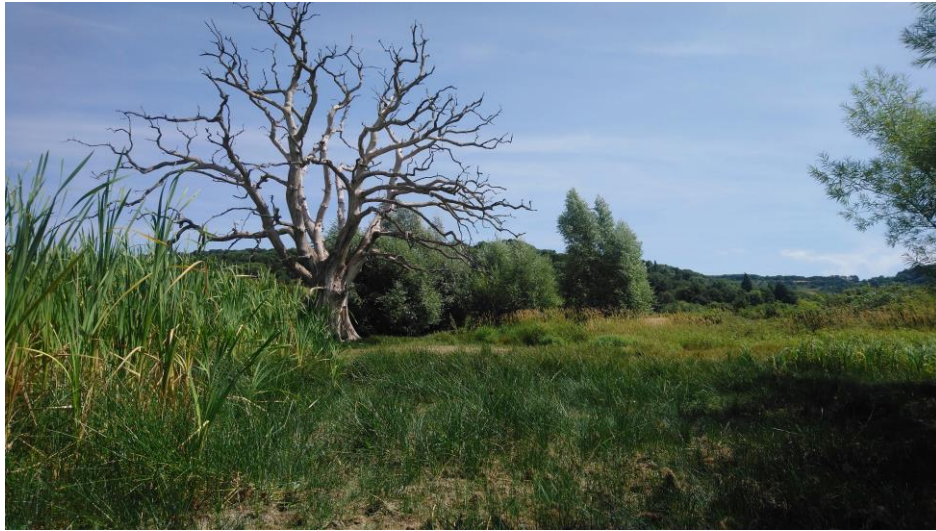
G117_dry seepage area possible pond as aquatic veg in large depression facing E

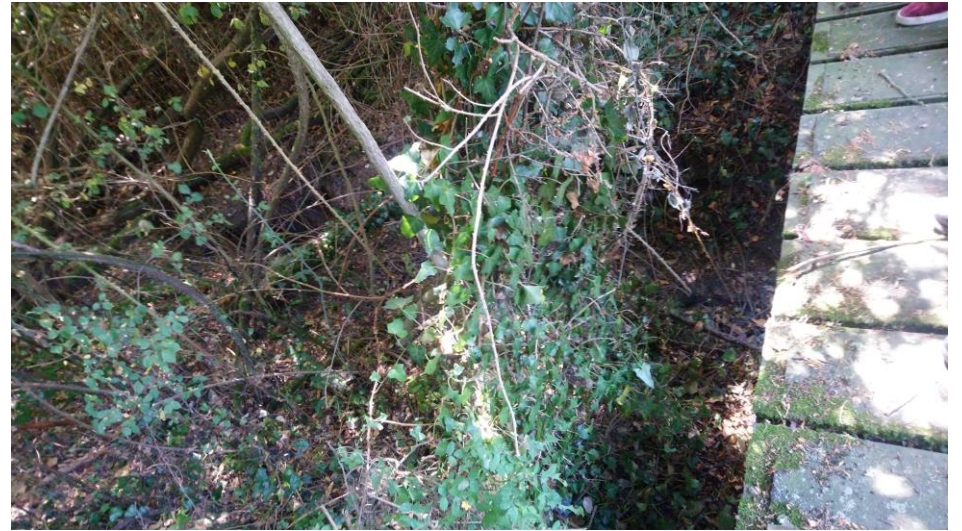
G118_dry watercourse facing W

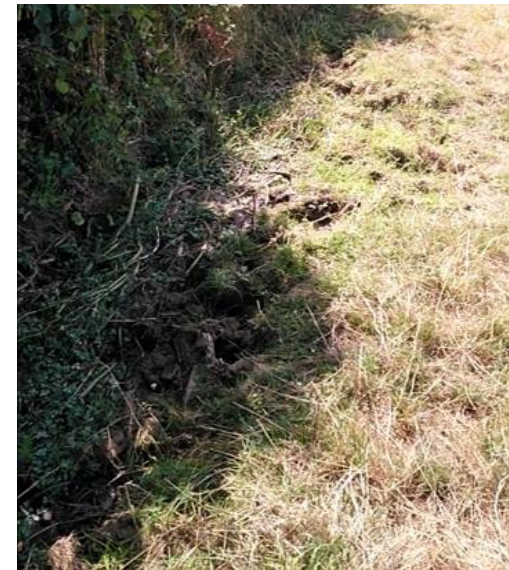
G120_land drain facing E

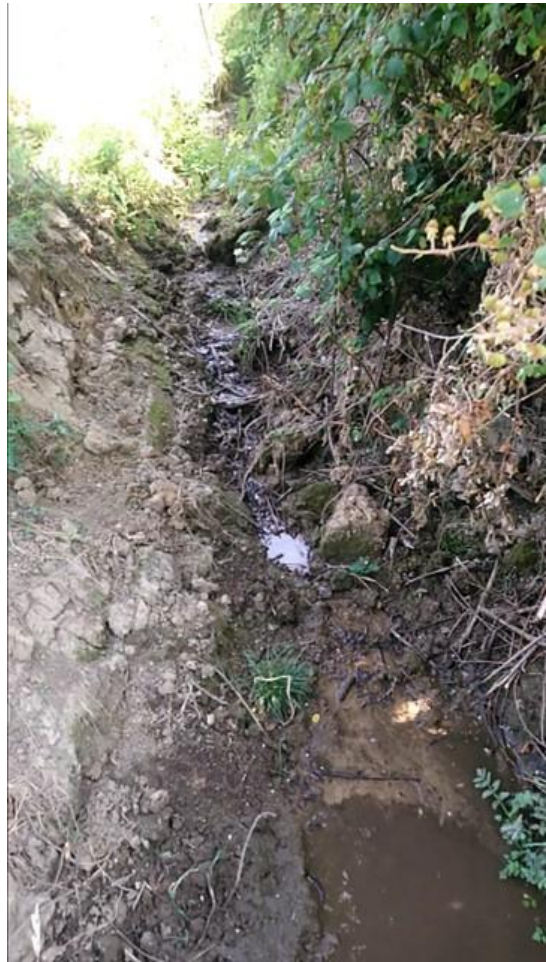
G123_spring fed watercourse
with low flow facing SE
