A417 Missing Link
TR010056

6.4 Environmental Statement
Appendix 13.11 Water Features Survey
(Part 1 of 2)

**6.4 Environmental Statement
Appendix 13.11 Water Features Survey
(Part 1 of 2)**

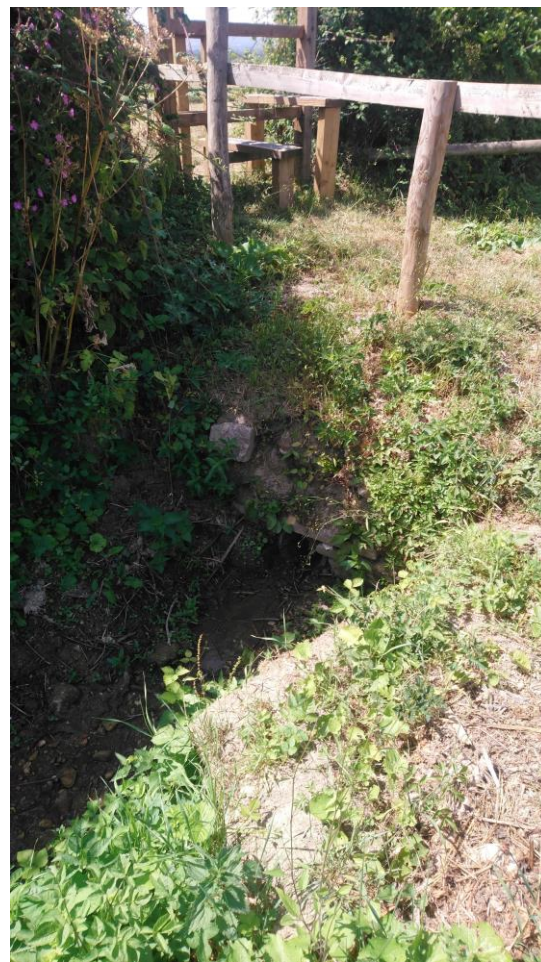
G122_culverted watercourse
facing NW

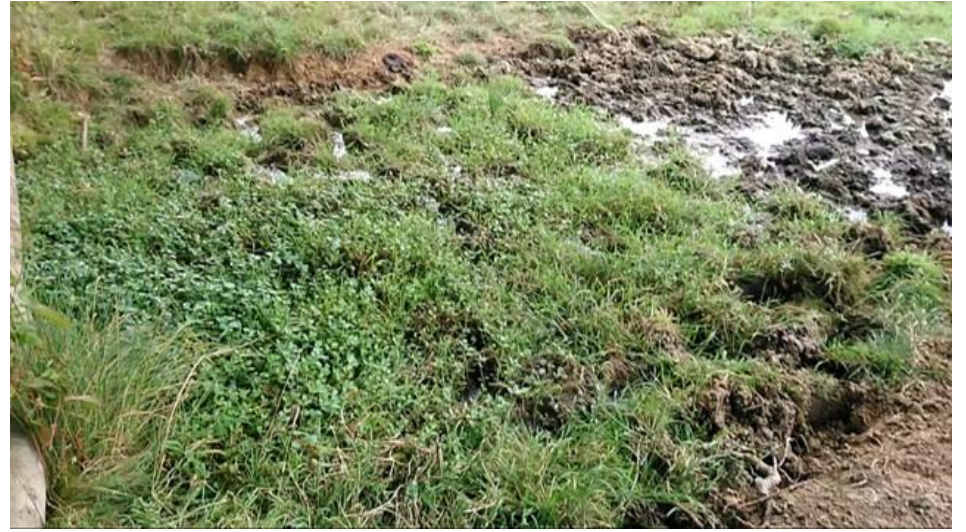
G130_dry watercourse facing E

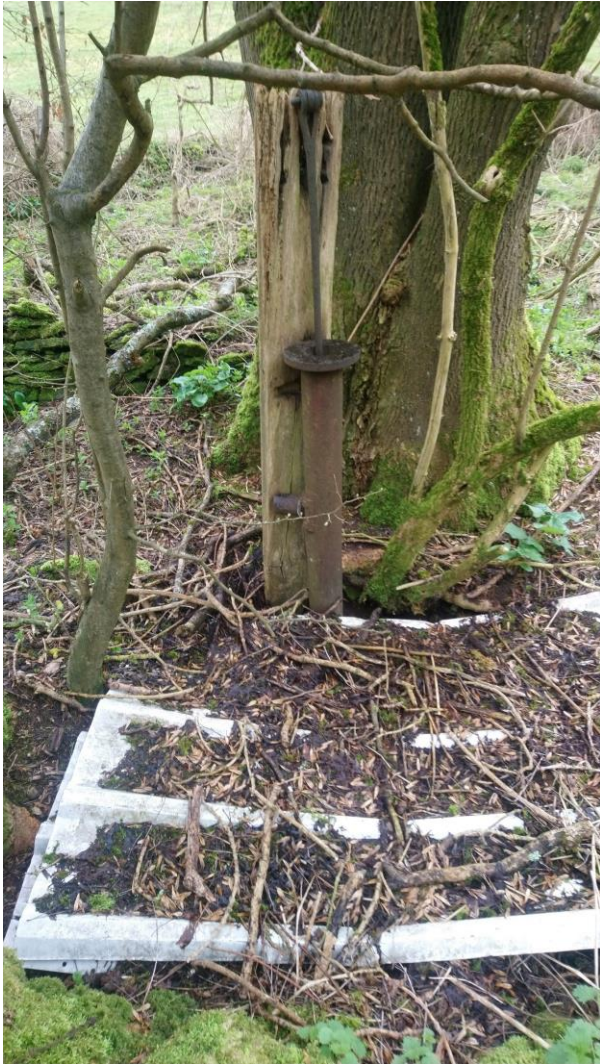
G134	392825 213976	Spring					26/07/2018 15:30 Not found, and not known to owner. Considered a spurious feature. No Photo.
G135	394836 215011	Spring					18/03/2019 14:27 Spring feeding pond. Spring is piped, and pond seeps to ground. Some slight tufa

G135_spring at Stockwell Farm facing N

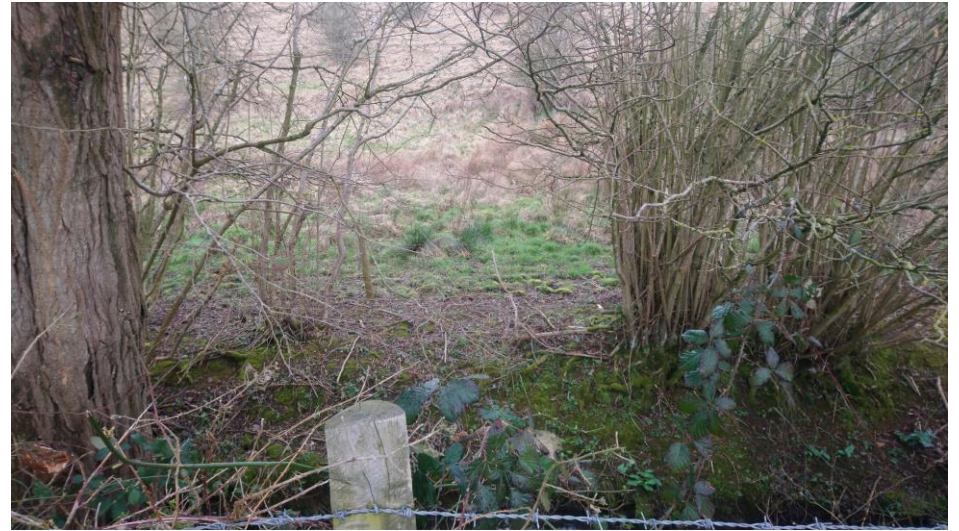
G138 _ facing N pond on L bank at Coldwell Bottom

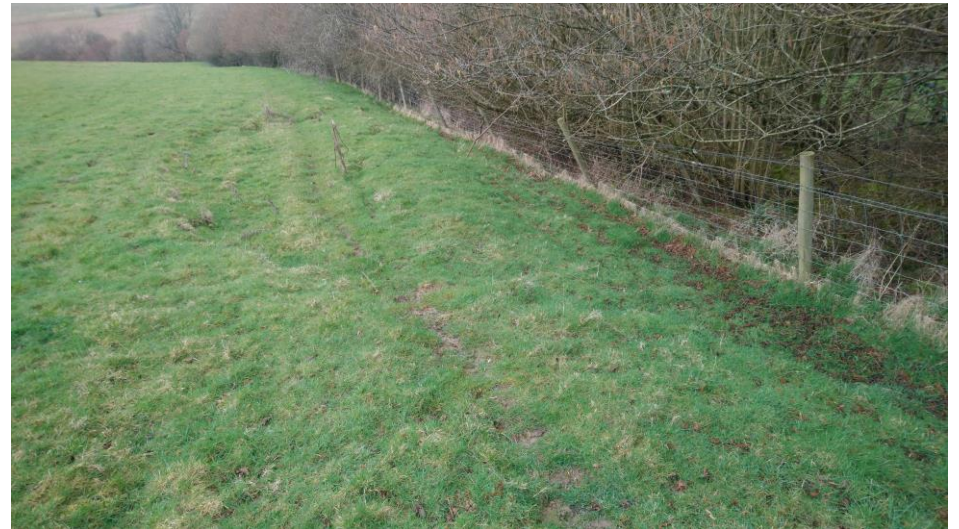
G137 _ possible seepage on L bank at Coldwell Bottom

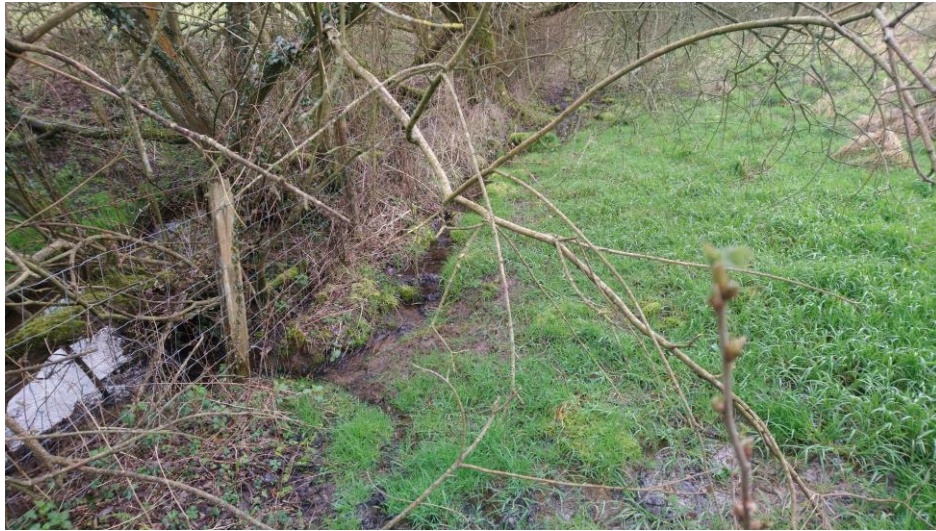
G139 _ facing W sunken ground on R bank at Coldwell Bottom

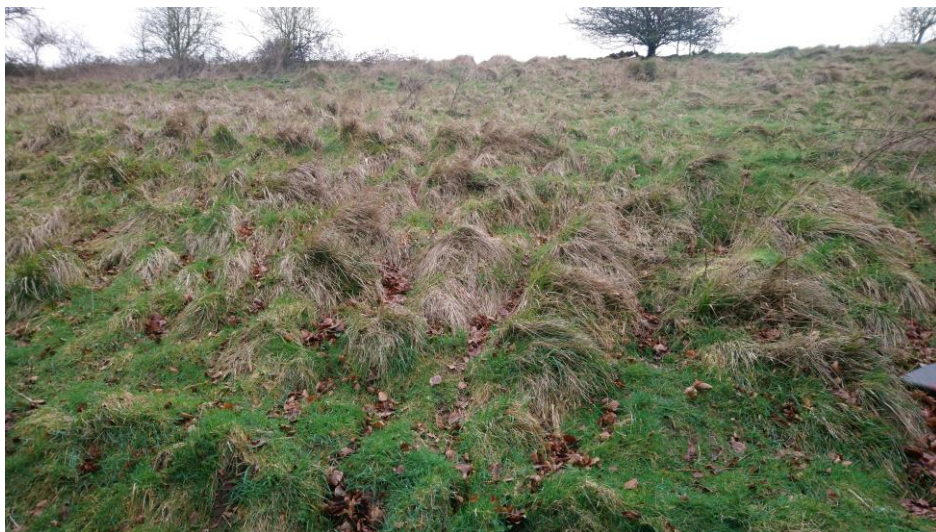
G145 _ raised ground on slopes in Barber Wood S
