A1 in Northumberland: Morpeth to Ellingham

6.7 Environmental Statement – Appendix 11.2 Ground Investigation Report

A1 IN NORTHUMBERLAND: MORPETH TO FELTON SCHEME

Ground Investigation Report

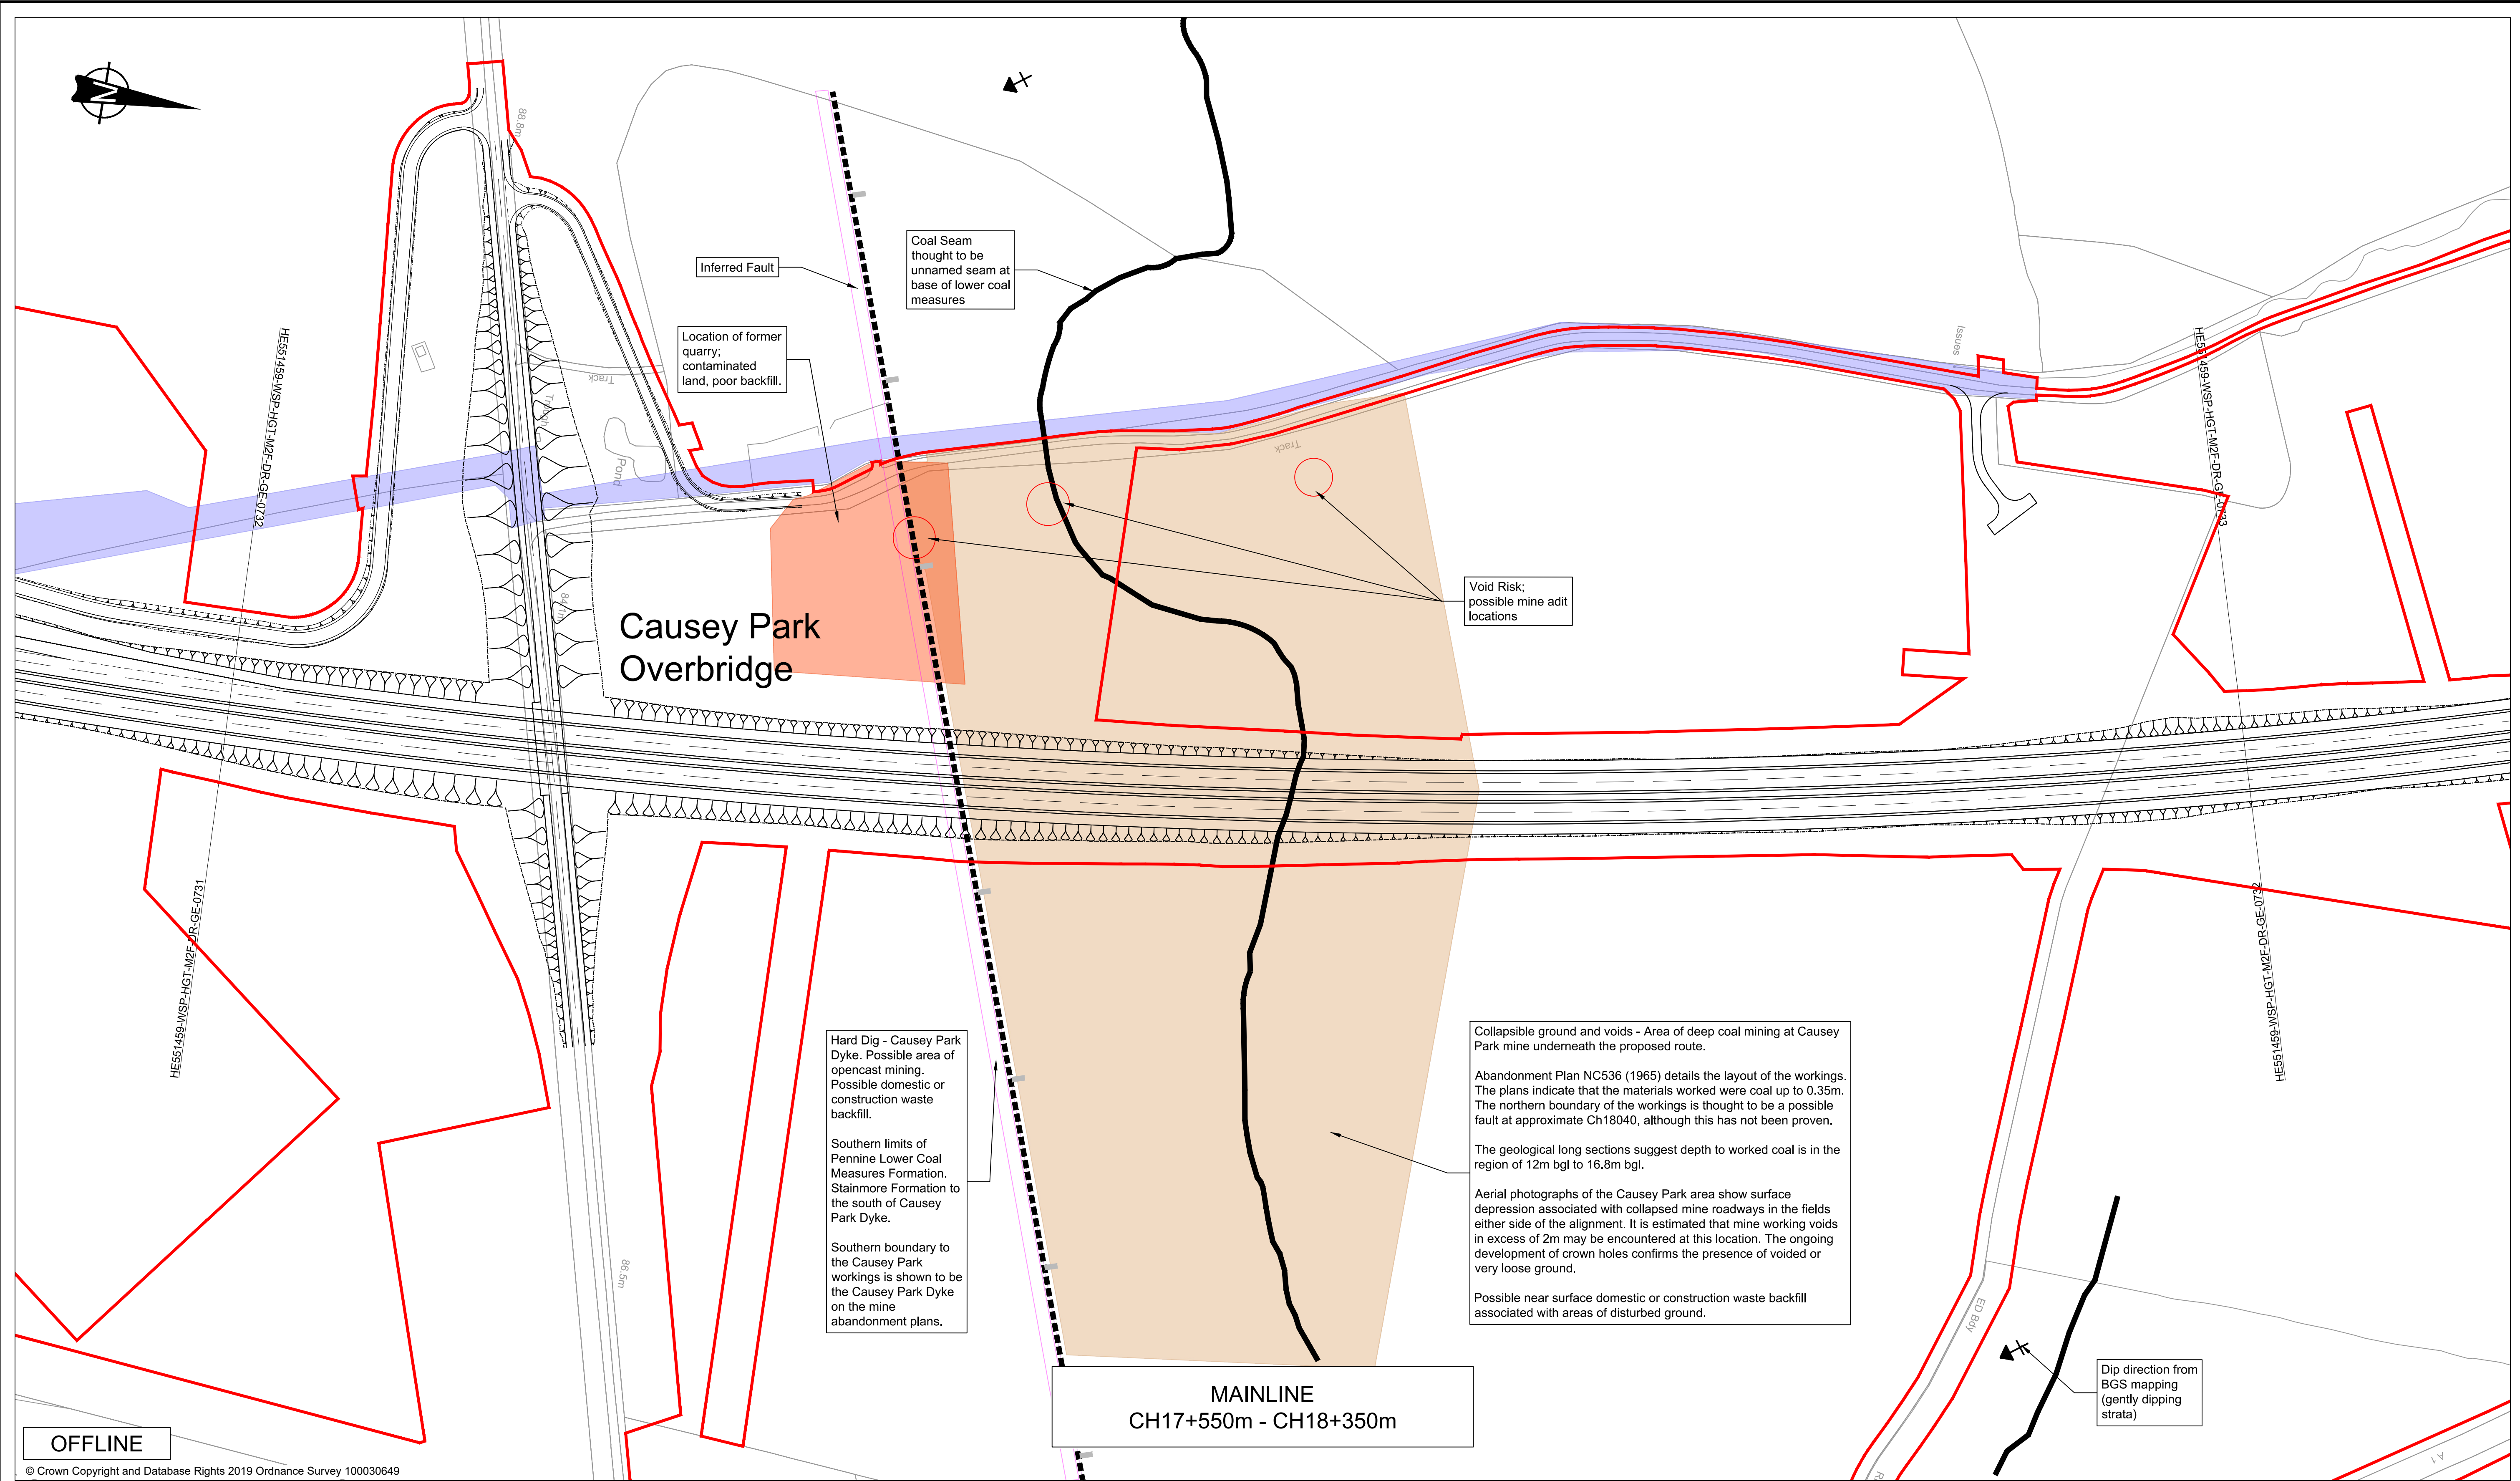
Hard Dig - Causey Park Dyke. Possible area of opencast mining. Possible domestic or construction waste backfill.

Southern limits of Pennine Lower Coal Measures Formation. Stainmore Formation to the south of Causey Park Dyke.

Southern boundary to the Causey Park workings is shown to be the Causey Park Dyke on the mine abandonment plans.

Collapsible ground and voids - Area of deep coal mining at Causey Park mine underneath the proposed route.

Aerial photographs of the Causey Park area show surface depression associated with collapsed mine roadways in the fields either side of the alignment. It is estimated that mine working voids in excess of 2m may be encountered at this location. The ongoing development of crown holes confirms the presence of voided or very loose ground.

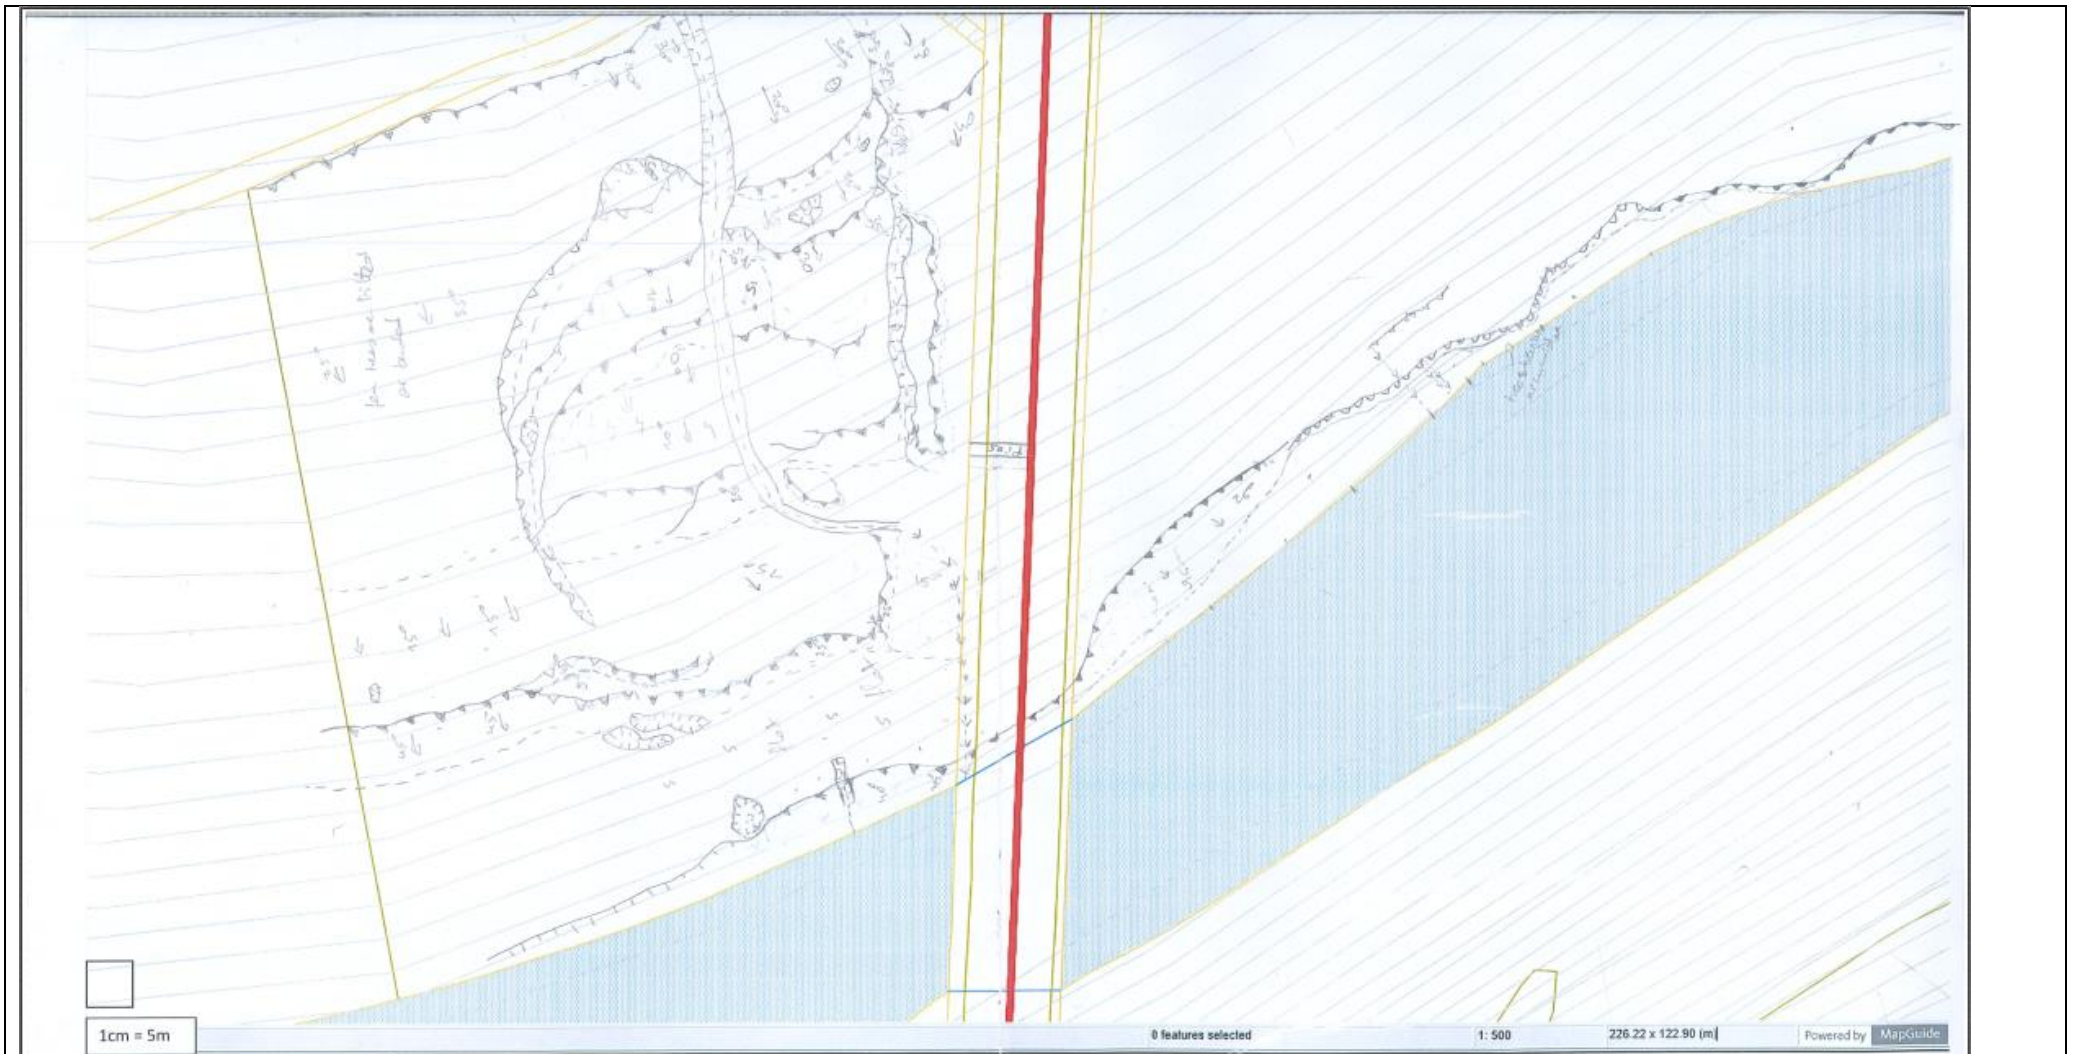
Figure 4 – Geomorphological map of the area to the east of the existing A1 overbridge.

- iii. Measurement of the vertical displacement across the tension cracks in the area illustrated in Figure 3, as shown in Figure 4 would provide a better understanding of the magnitudes of the movements associated with these features.

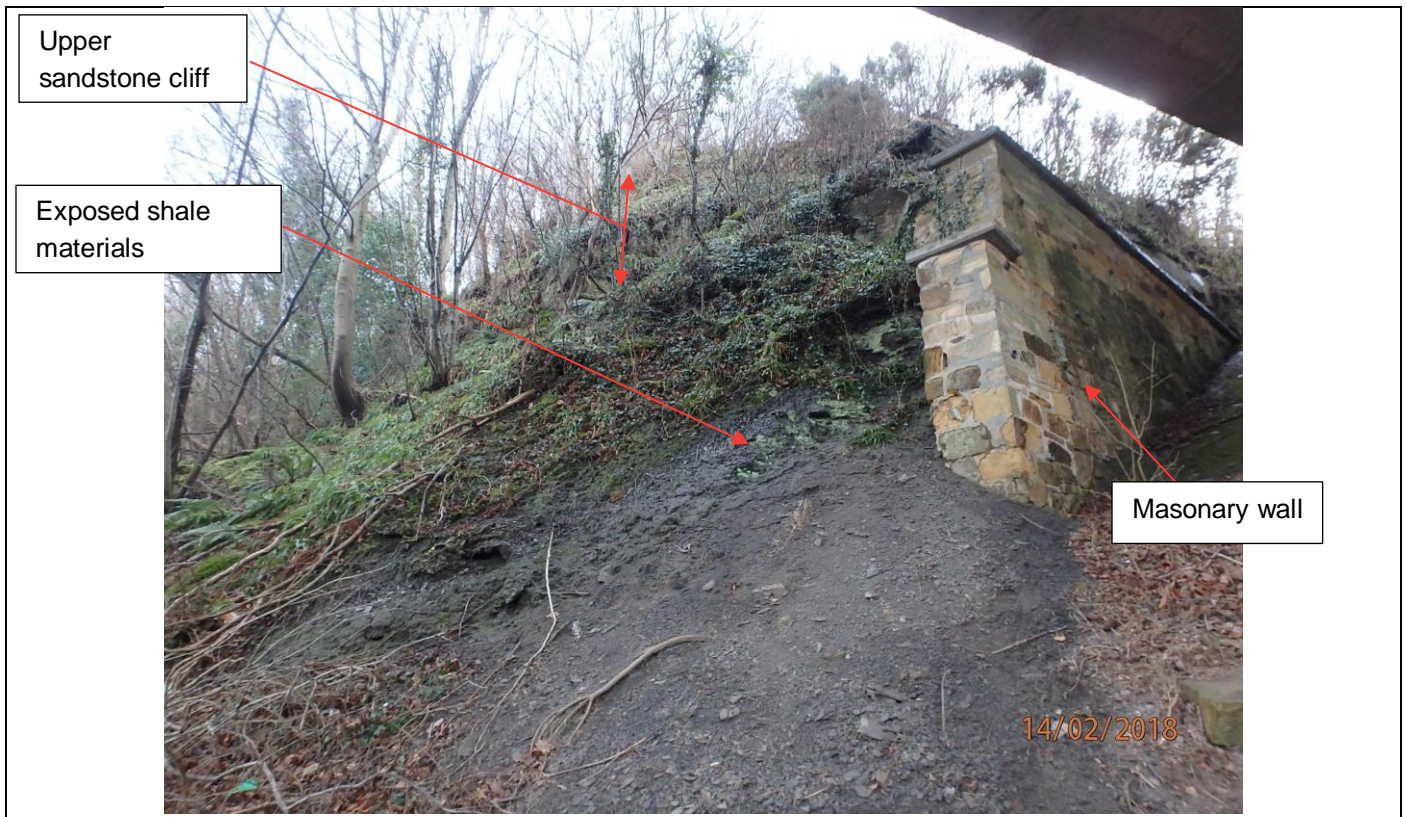
1. A sub-vertical escarpment formed of sandstone. There was limited visual evidence of a significant depth of superficial material overlying this bedrock. The rock cliff face appears to achieve greater relief and more prominent towards the east (**Photograph 1**),

Photograph 1 – View south-east to the sandstone escarpment at the top of the slope.

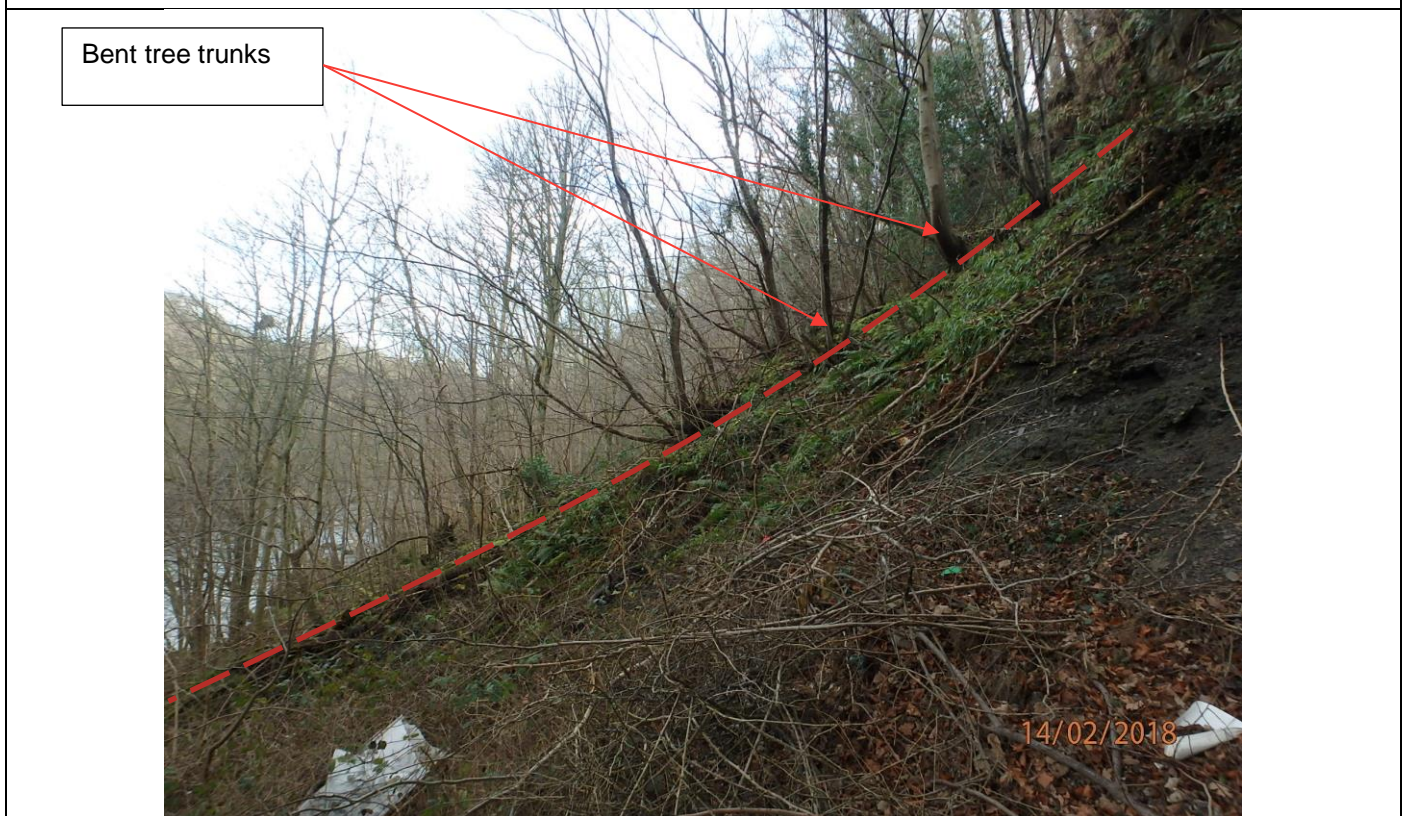
2. Sub horizontal natural benches within the sandstone at the base of the cliffs (**Photograph 1**),
3. A mid-slope geomorphic unit, with a gradient of approx. 28°. This slope unit terminates to the south of the pier of the existing bridge where the gradient levels off to 2 – 4°. The presence of trees with bent trunks on this unit *may imply* that the unlithified 'superficial' material overlying the mudstones *may* have undergone at least creep rates of movement during their lifetime (i.e. the tree trunks may have grown into a curved shape in order to maintain an 'upright' position as the ground surface moved **Photograph 2**).

Photograph 2 – view east of the mid-slope, note the curved trunks of mature trees indicating the movement has been occurring for some time.

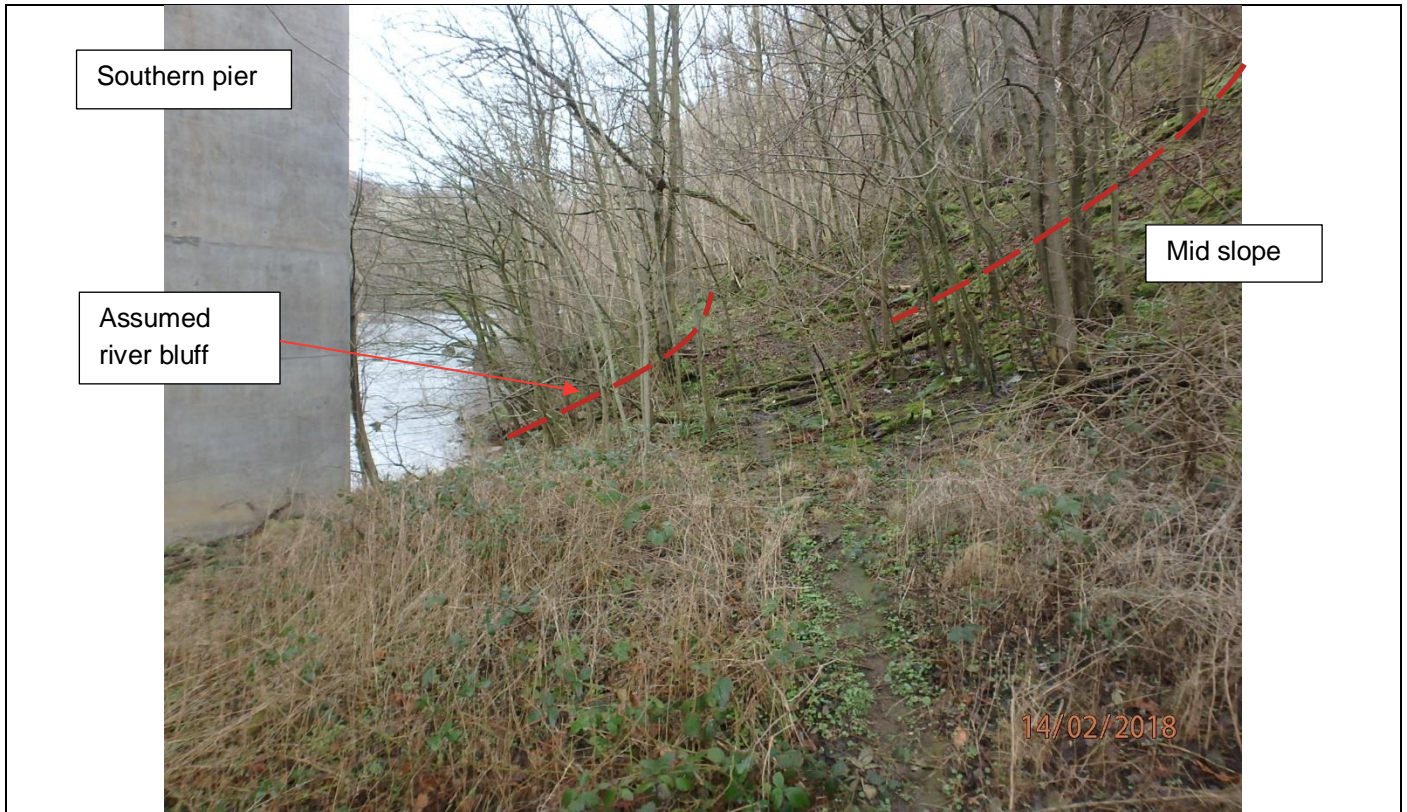
4. Fallen blocks are noted at the base of this slope.
5. Elevation decreases, until the Coquet channel is reached, through a steep slope unit which upon visual inspection appears to be formed of boulders within a clay matrix. This region of the slope was associated with the presence of hydrophilic vegetation. It is possible that this material is colluvium, sourced from the upper slopes and has formed a river bluff (**Photograph 3**).

Photograph 3 – View east from the position of the southern pier of the existing A1 bridge. Note the reducing gradient of the midslope (possible colluvium) and the river cut terrace.

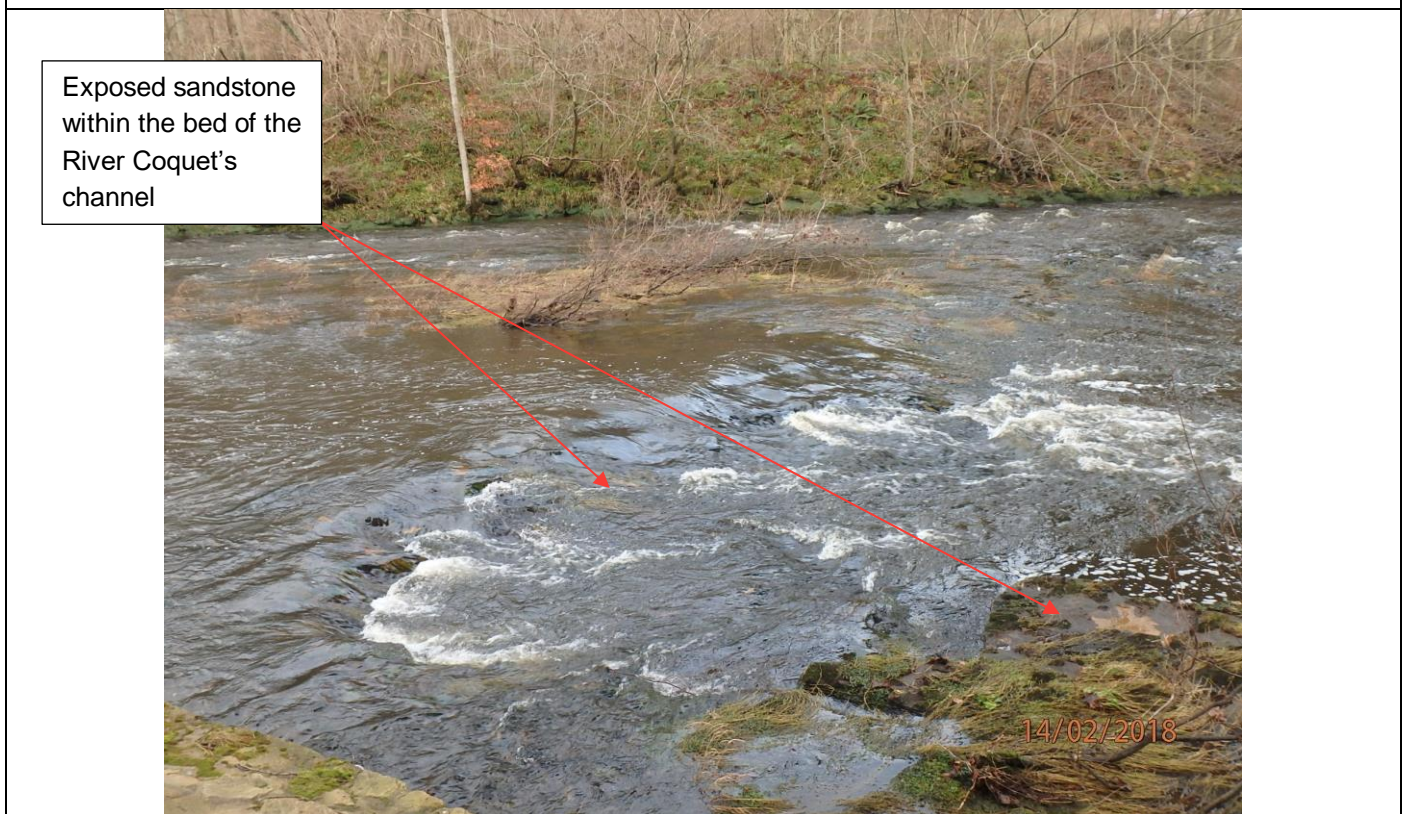
6. Bedrock, which appeared to be sandstone, was noted within the channel of the River Coquet, occasionally forming natural weirs; potentially indicating that this unit is controlling the basal elevation of the valley (**Photograph 4**).

Photograph 4 – Sandstone bedrock exposed within the bed of the River Coquet.

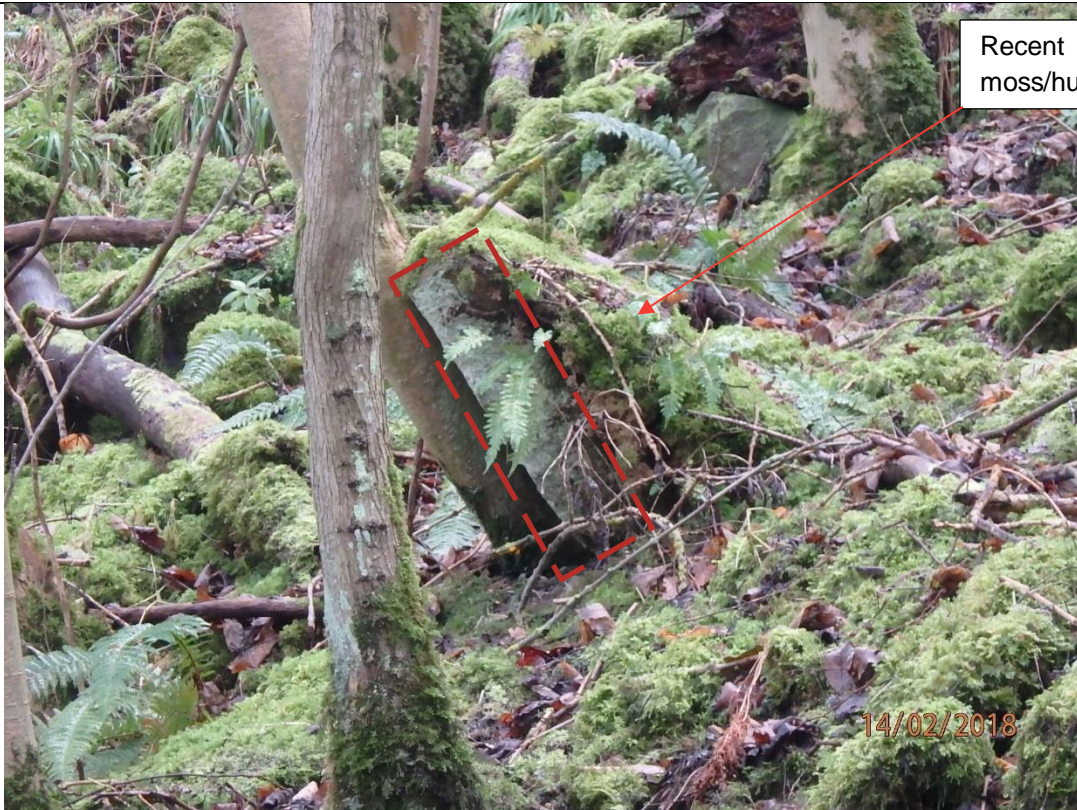
It was noted that fallen blocks, thought to have originated from the cliff face at the top of the slope, had been caught by tree trunks; providing evidence that these failures most likely occurred within the recent past. (**Photograph 5**).

Photograph 5 – Fallen block intercepted by tree trunk. This demonstrates that rock falling has been active within the study area within the recent past.

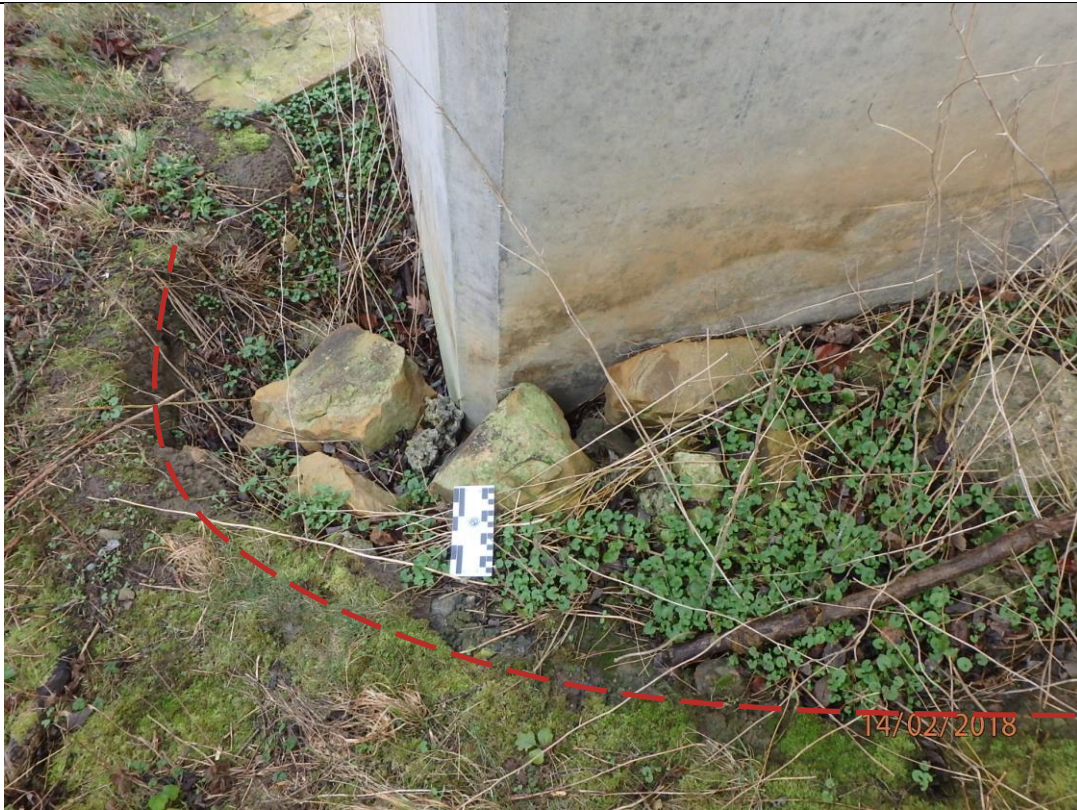
Evidence of scour around the base of the southern pier was observed (**Photograph 6**).

Photograph 6 – Apparent scour around the base and sides of the southern pier of the existing A1 bridge. Note the sandstone blocks which appear to have been intercepted by the structure. The upper divisions on the scale marker are centimetres.

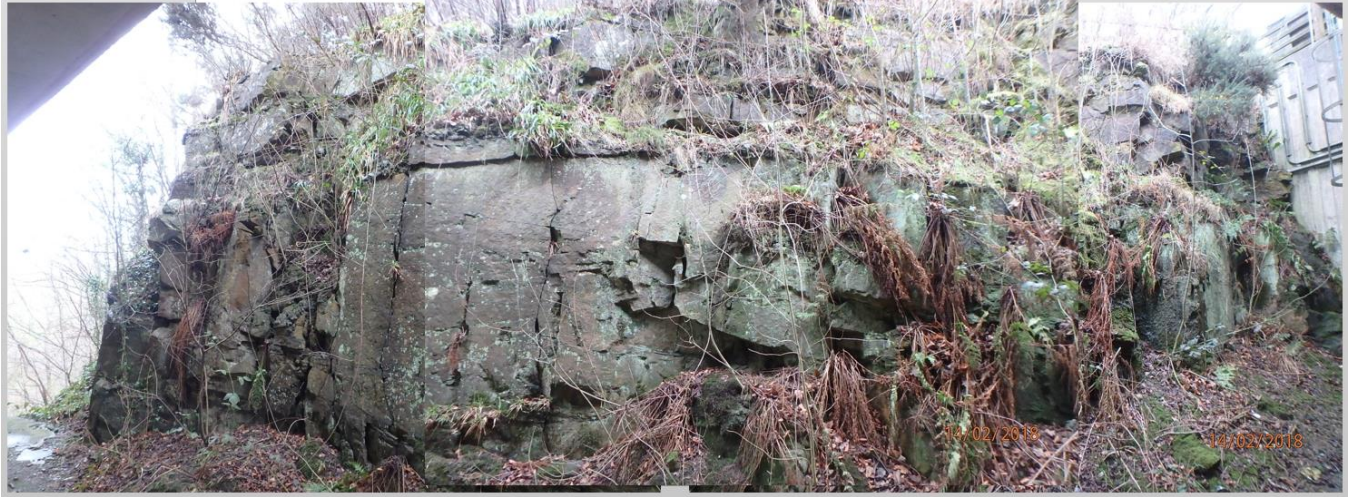
The cutting face presented in **Photograph 7** shows the exposed rock face adjacent to the southern abutment. No scanline assessment of the rockmass was undertaken (**Photograph 7 – eastern exposure**). Within the more massive sandstone units, occasional thin interbeds of siltstone were noted (e.g. **Photograph 8**). From visual observation, the rock was predominantly described as (**Photograph 9 – hand sample**):

Photograph 7 – Panoramic image mosaic of the exposed western rockface on the southern abutment (looking east).

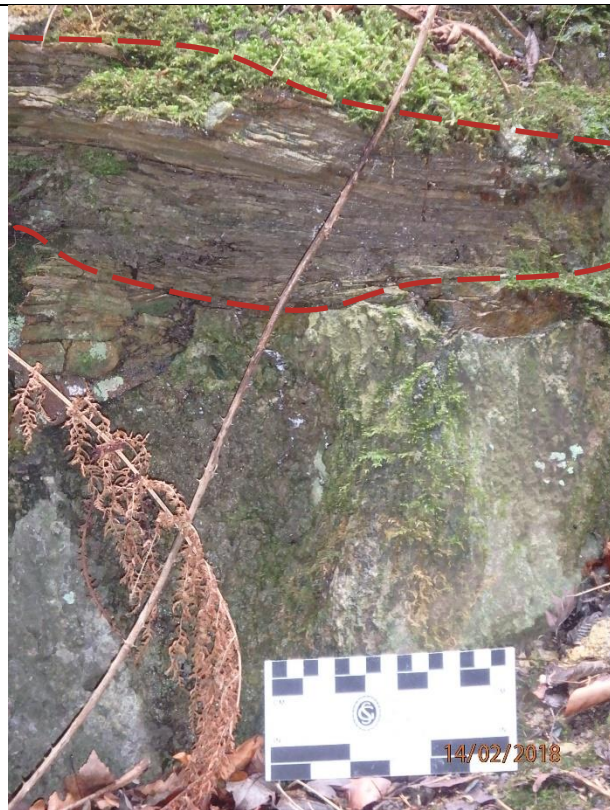
Photograph 8 – Detailed image of the 'silty' material exposed within the rockface pictured in Photograph 7. The upper divisions on the scale marker are centimetres.

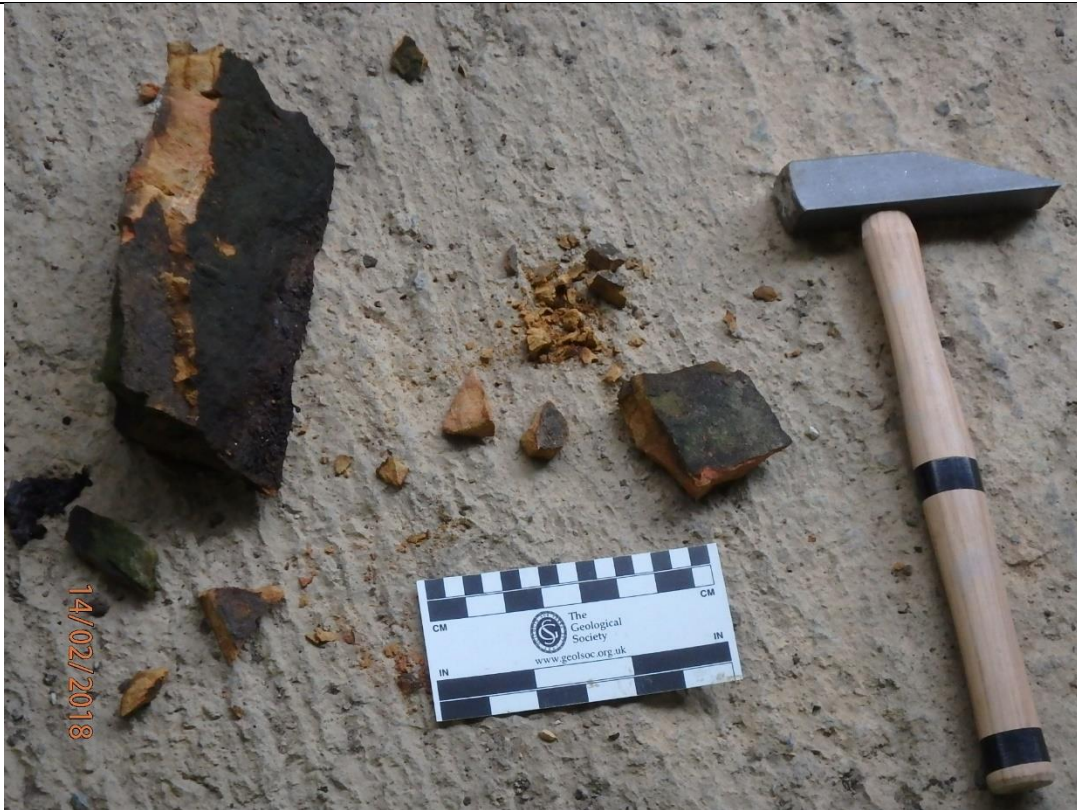
'Medium strong medium to thickly bedded light orangish brown fine SANDSTONE with thin interbeds of thickly laminated siltstones. Weathers to brownish red at surface. [Stainmore Formation]

Photograph 9 – Hand sample of the Sandstone material. This material was obtained from a fallen block away from the exposed rock face.

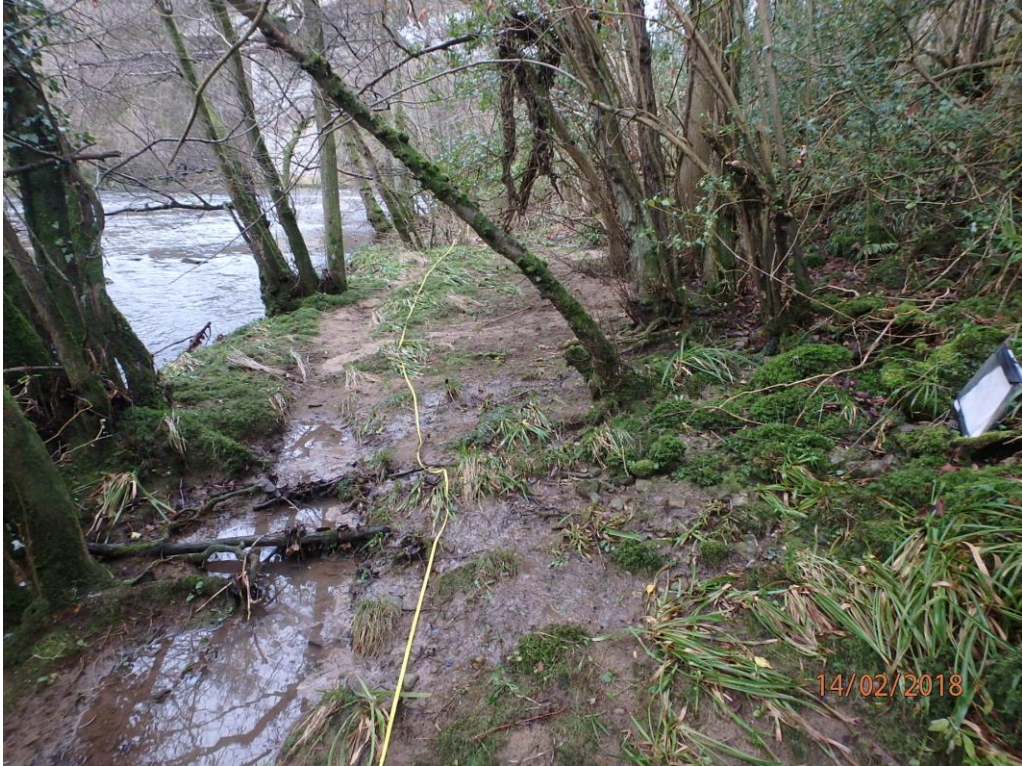
Photograph 13 – View west along one of the alluvial platform adjacent to the River Coquet. A steep slope unit to the right hand side separates the river from it's terrace.

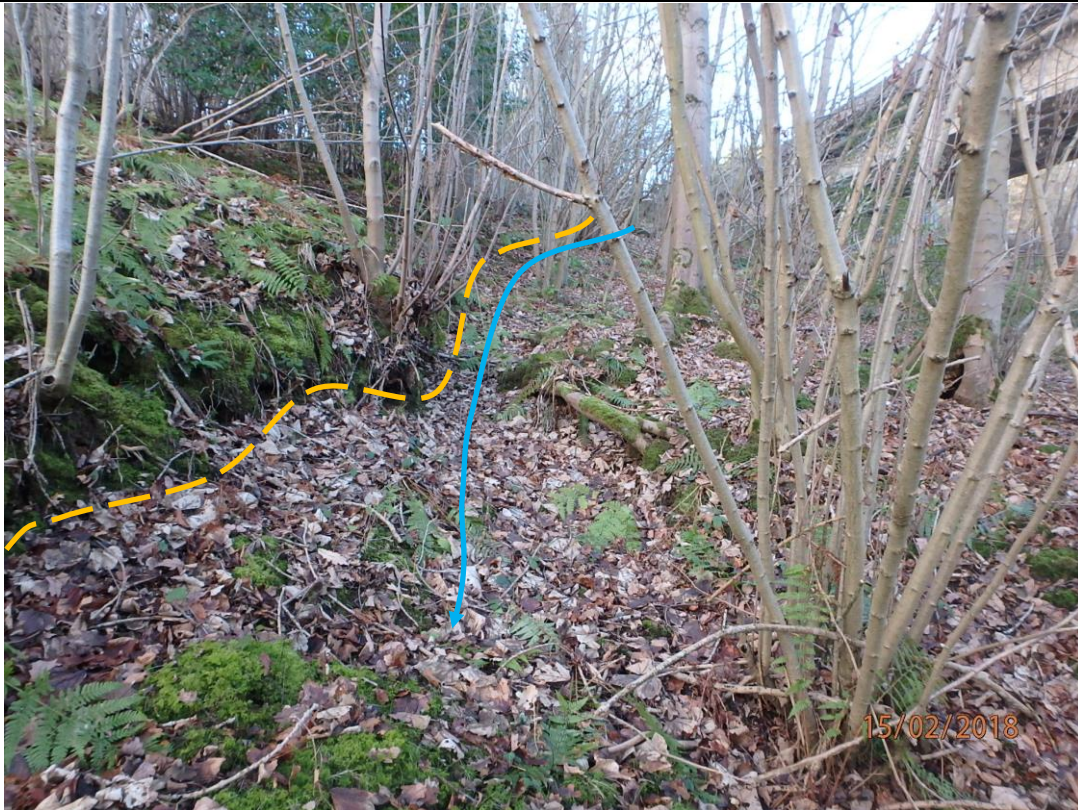
Photograph 20 – Example of the eastern lateral flank of the zone of instability to the west of the existing A1 bridge (yellow line). The lateral extent is marked by the location of a dry drainage channel (blue line).

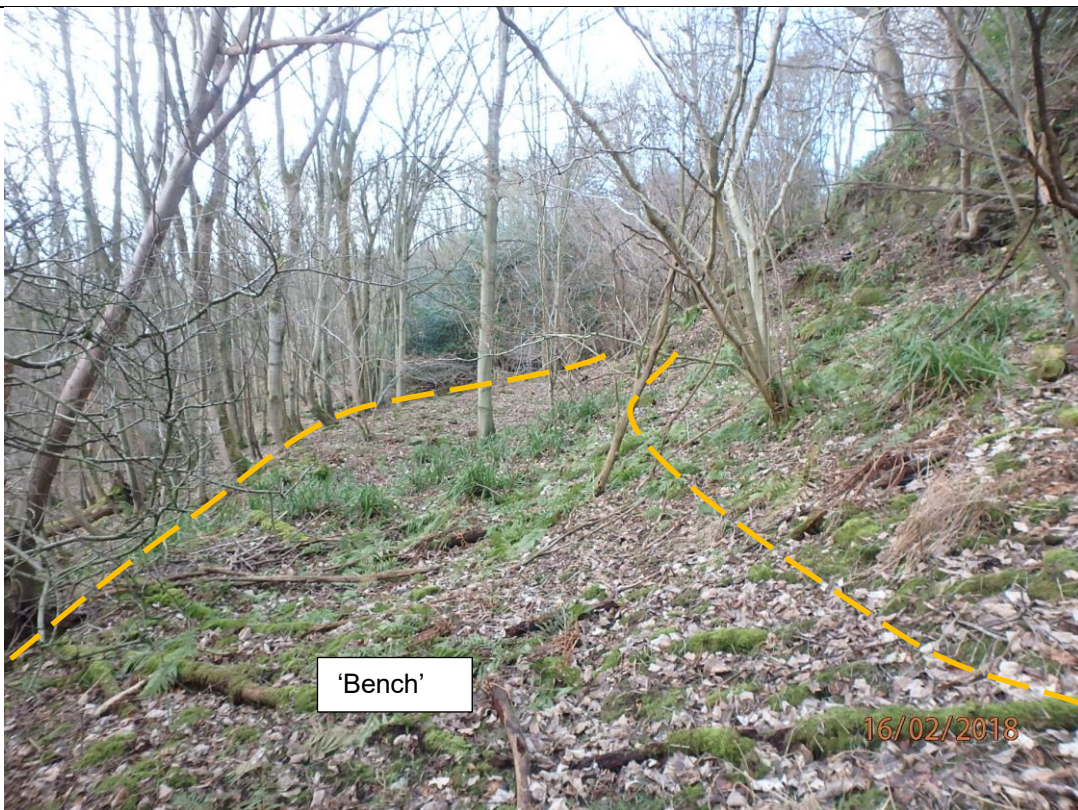
Photograph 21 – View west of the bench structure in the east of the study area. This feature may have been underestimated in scale within previous studies.

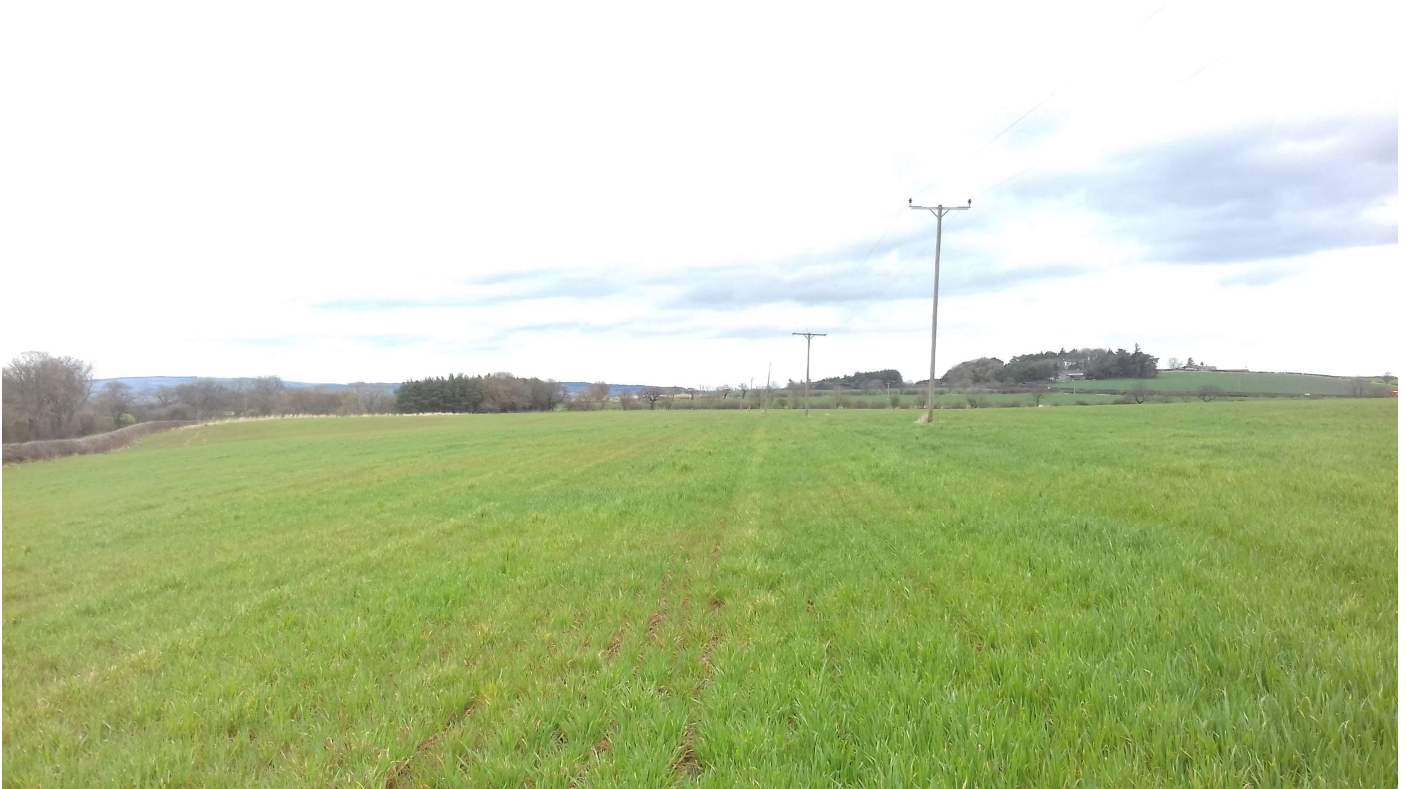
- Opencast mining was located where the concerned field slopes to the west, west of the telegraph poles. Following closure of the works, the area was bull-dozed and infilled. When enquired how the works were infilled Mr Hogg suggested that it was done using excess soil (Figure 1-2;1-3).

Figure 1-2 Looking north from L1. Area of former opencast mining, now infilled.

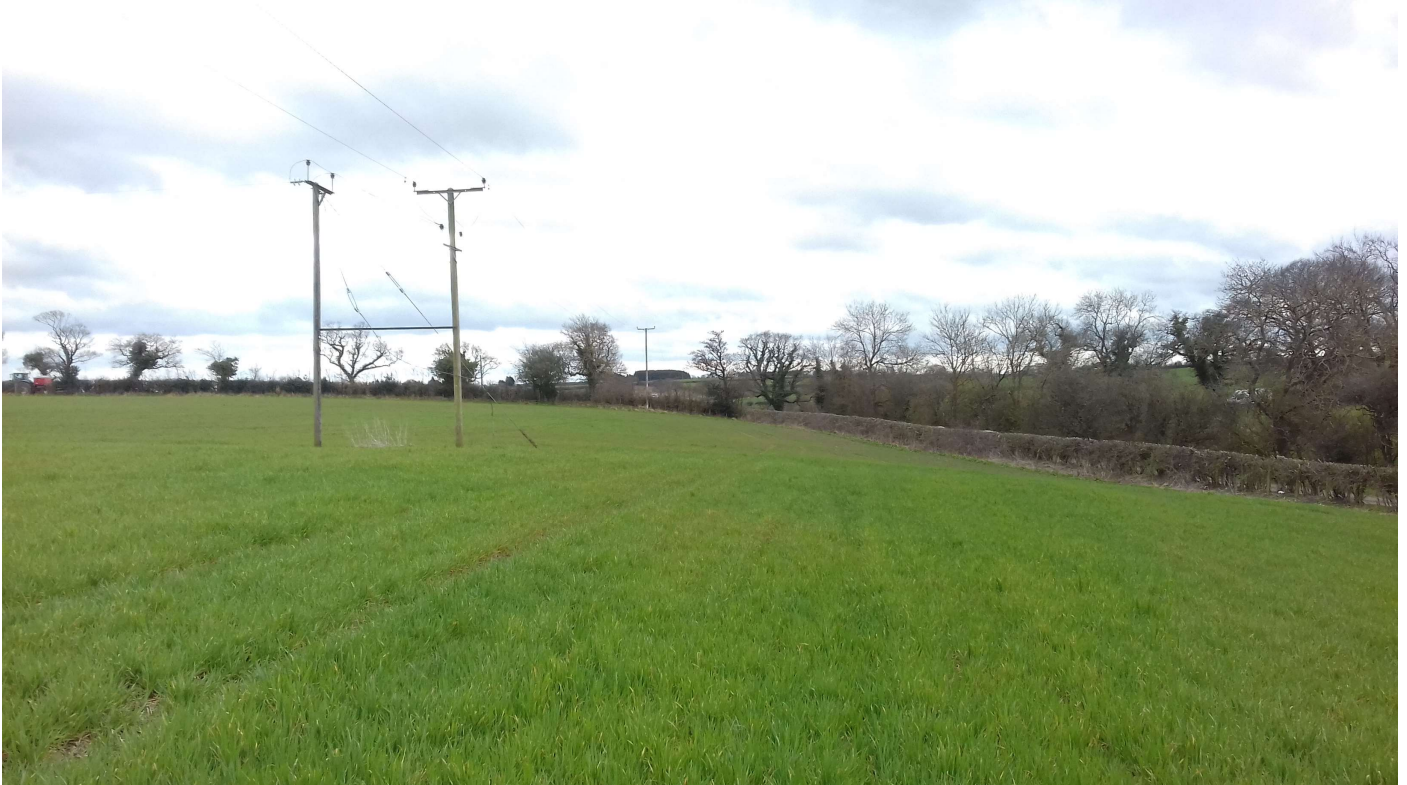
Figure 1-3 Looking south from L1. Area of former opencast mining, now infilled.

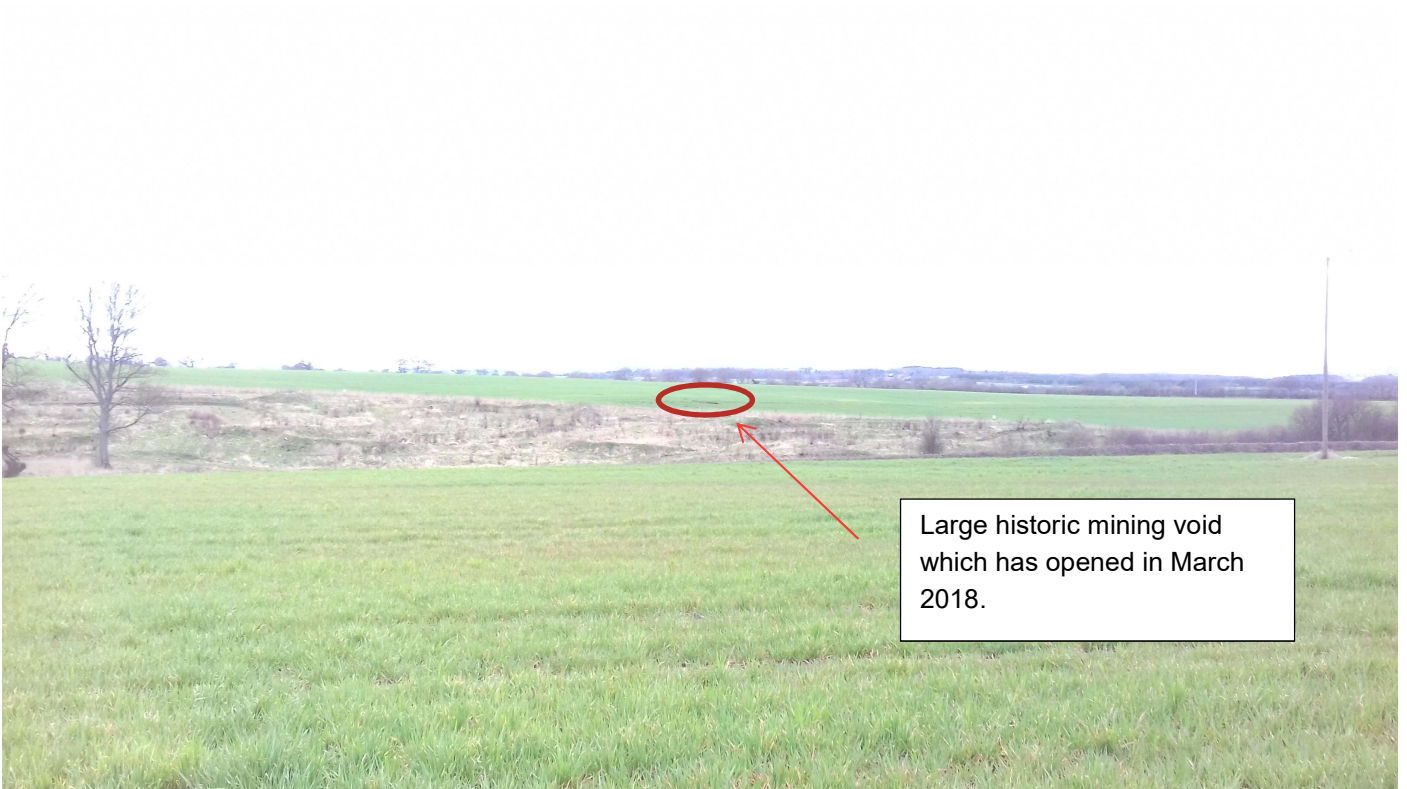
- To the west of the Site area, Mr Hogg pointed out a large void in the far field. This void opened suddenly in March 2018 (Figure 1-4).

Figure 1-4 Looking West from L2

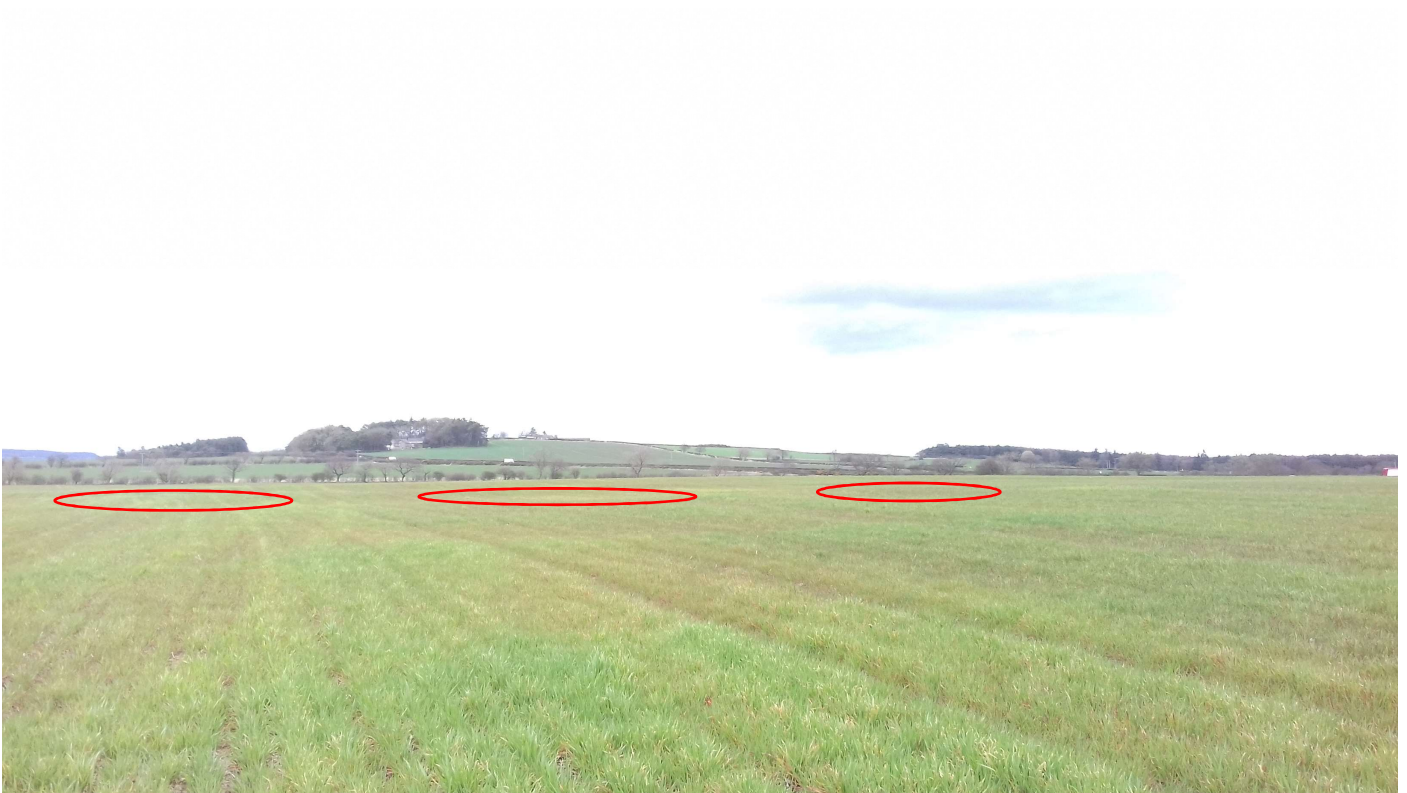
- These voids have since been infilled or left to settle. The voids which were left have only settled a few inches (from what has been seen), which may indicate that the voids are much deeper in this area. No new voids have appeared in the field for the past 5/6 years (Figure 1-5;1-6).

Figure 1-5 Looking north-east from L3. Undulations in the field may indicate locations of possible historic mining voids.
