A1 in Northumberland: Morpeth to Ellingham

6.7 Environmental Statement – Appendix 11.2 Ground Investigation Report

A1 IN NORTHUMBERLAND: MORPETH TO FELTON SCHEME

Ground Investigation Report

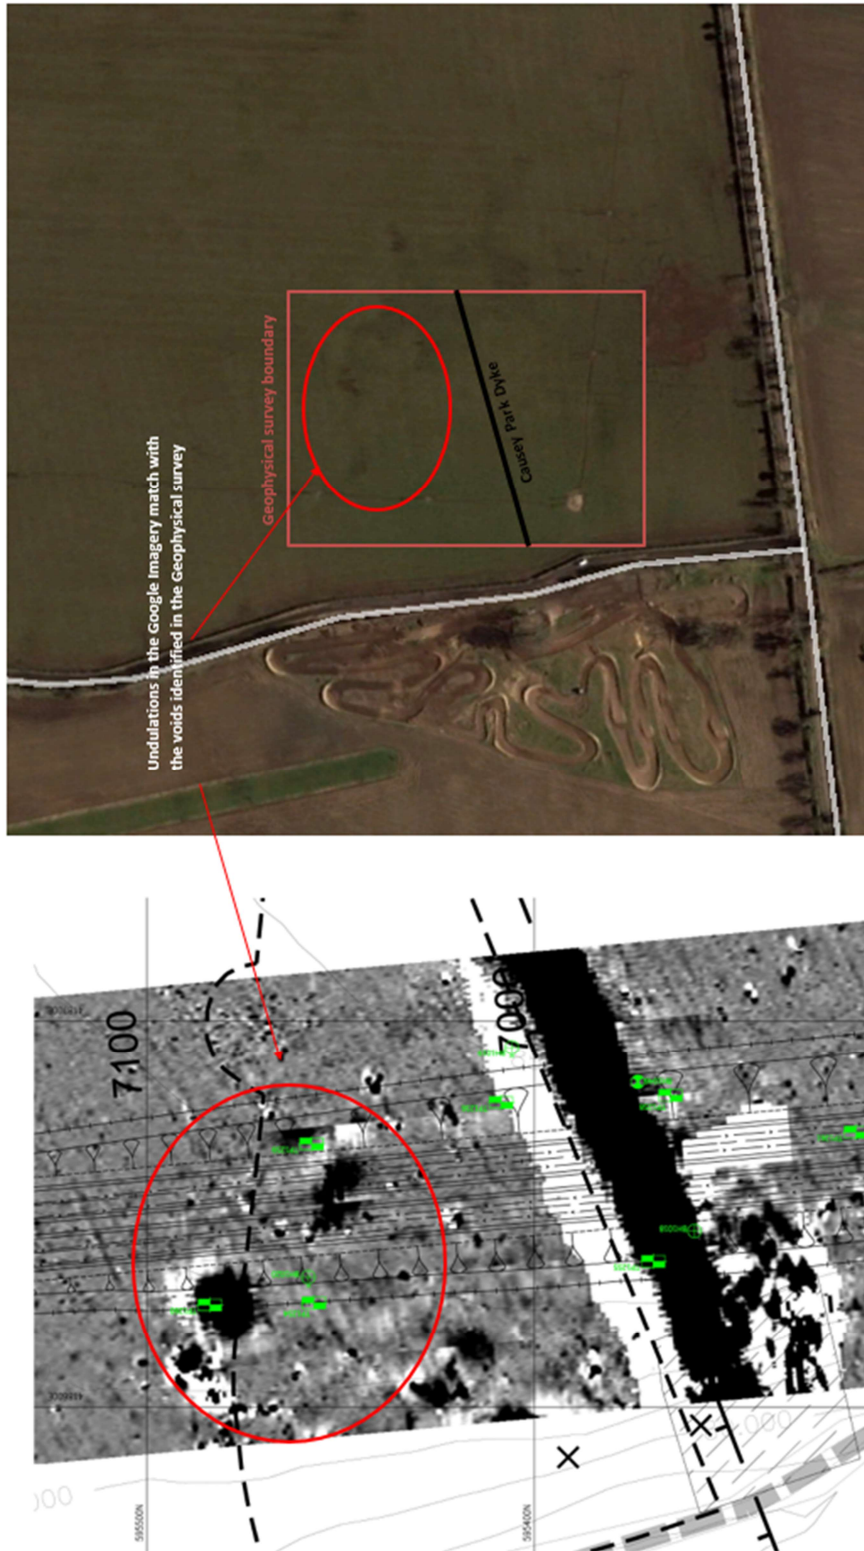
Figure 1-7 below, highlights the Causey Park dyke and mining voids at Causey Park. Some of the undulations visible on Google Map imagery have been identified on the Geophysical survey below.

Figure 1-7 Geophysical Survey. Location of voids. Lang O'Rourke, Preliminary Geotechnical Report. 2006. Google Imagery 2018
