# **A12 Chelmsford to A120 widening scheme**

**TR010060**

## **9.18 Supplementary Riparian Mammal Survey Report**

**Supplementary Riparian Mammal Survey Report**

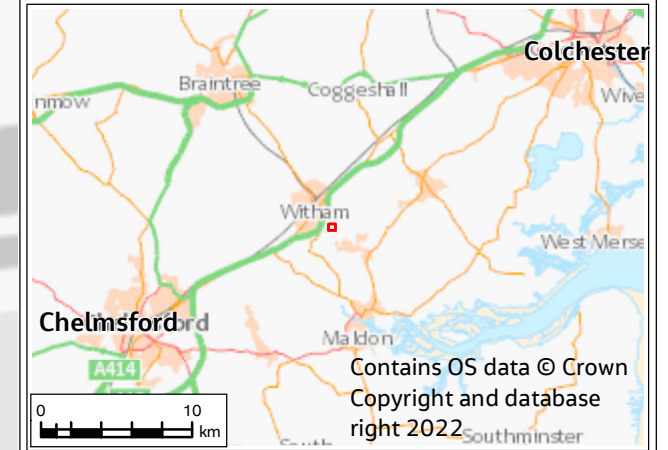
- 6.2.3 Six spraints (fresh and old) and eaten fish scales were found on one particular location along the River Blackwater (TL 83157 13354) which was confirmed as an otter sprainting site through the field camera surveys (C1). This area was also used by the otter to commute to the associated wet ditch to the west of the confirmed sprainting spot. This location is within 130m south-east of the proposed Order Limits.

- f. A confirmed sprainting site at grid reference TL 83157 13354 (Photographs 8 and 9). Five dry otter spraints observed on 20 July 2022 and 1 fresh otter spraint recorded on 23 August 2022 (Photographs 10, 11 and 12). Field cameras recorded otters using the sprainting site
- g. One confirmed otter spraint 5m from potential holt (TL 83264 13617) (Photographs 13 and 14).
- h. Feeding remains (fish scales) on confirmed otter sprainting site (TL 83157 13354)
- i. Four confirmed sightings of otter via field cameras on C1 (Photographs 15 and 16) (TL 83157 13354).
