A46 Newark Bypass

6.3 Environmental Statement

Appendix 8.13 River Physical Habitat Technical Report

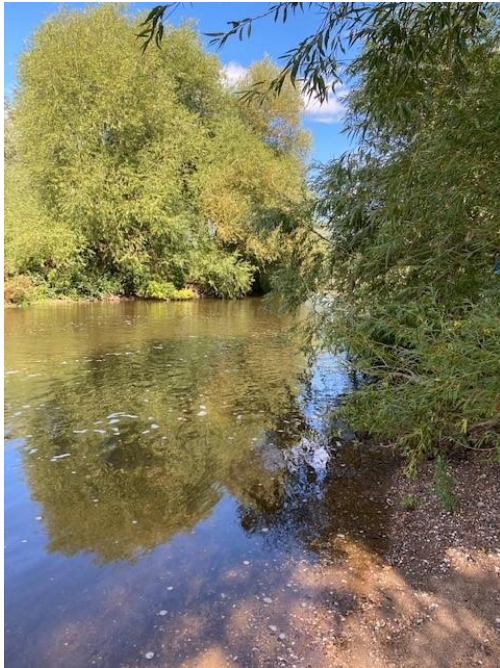
- The channel margin aquatic vegetation extent indicator scores were highest for sub-reach KC1 and KC2 as a greater amount of channel margin vegetation was recorded reflected by the indicator scores of 3 (see Photo 4-5).
- The channel margin aquatic vegetation morphotype richness indicator scores were highest for the sub-reaches KC2 and KC3. Both sub-reaches achieved scores of 3 as emergent linear-leaved, amphibious, and emergent broad-leaved vegetation morphotypes were present within the channel margin.
- The channel margin physical feature extent indicator scores were highest in the sub-reach KC3 as a berm was recorded as extensive along the bank face of modules 4 to 5 as well as a gravel-pebble

Photo 4-5: KC1 module 1 facing downstream

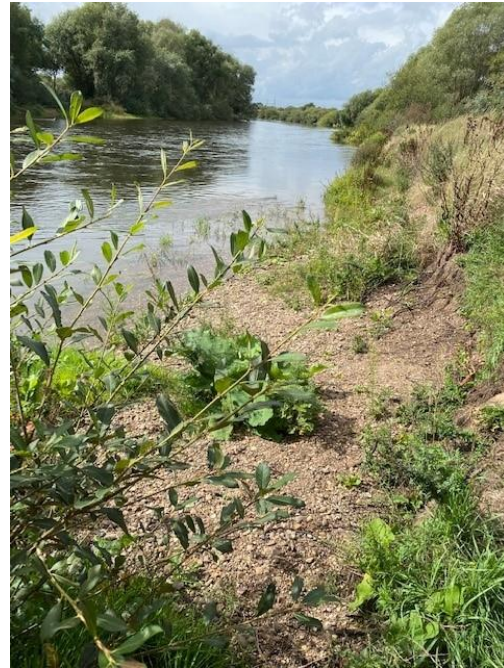
- The channel margin physical feature richness indicator scores were highest for both KC2 and KC3 reflected in the scores of 2. 3 channel margin natural physical features including a berm, gravel-pebble vegetated side bar and an eroding cliff were recorded in KC3. Within sub-reach KC2, a gravel-pebble unvegetated side bar, marginal backwater and a berm were recorded (see Photo 4-6).

Photo 4-6: KC2 module 1 facing downstream

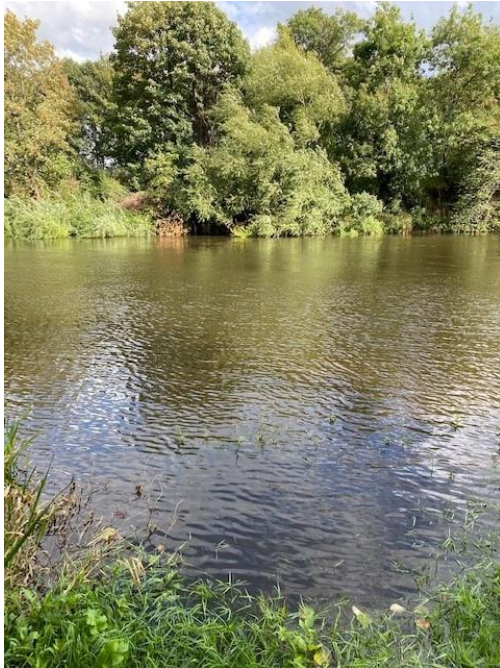
- The channel bed natural features richness indicator score was highest for KC1 with a score of 1. Two natural physical features, an island and unvegetated exposed boulders, were recorded within the channel. No natural physical features were recorded as present or extensive for the sub-reaches KC2 and KC3 (see Photo 4-7).

Photo 4-7: KC1 module 5 downstream

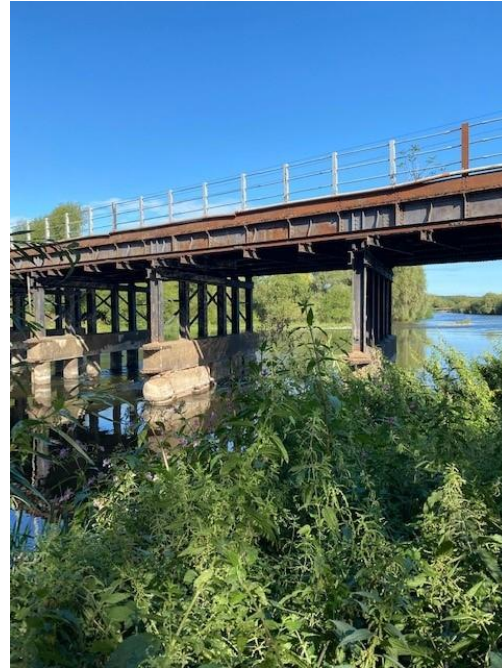
- The channel bed artificial features severity indicator score was lowest for the sub-reach KC1 as six bridge piers in the riverbed were recorded within the channel of module 5 which is where the railway bridge crosses the channel (see Photo 4-8).
- The channel bed NNIPS cover indicator score was lowest for the sub-reach KC1 as Himalayan balsam was recorded within the channel.
- The channel bed filamentous algae extent indicator score was also lowest for the sub-reach KC1 as trace filamentous algae was recorded in module 2.

Photo 4-8: KC3 module 3 midpoint

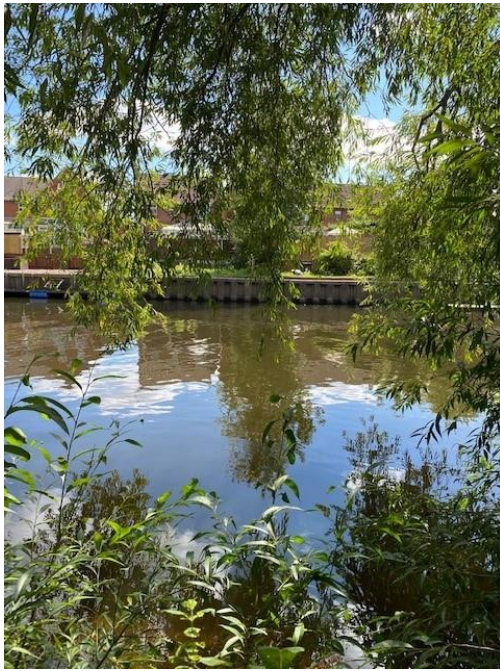
- The bank face tree feature richness indicator scores ranged from 1 to 2 with the sub-reaches MC1 and MC3 both achieving scores of 2. Leaning trees, and trees tree/shrub branches trailing into channel were recorded as well as j-shaped trees which were recorded in MC1 (see Photo 4-11).

Photo 4-11: MC3 module 3 midpoint

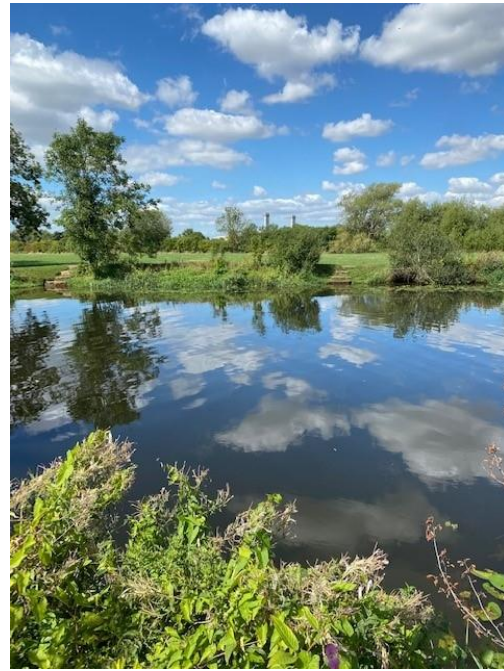
- The bank face artificial profile extent indicator scores ranged from -3 to -4. The sub-reach MC3 was obviously reshaped along the right bank. The sub-reach MC2 was obviously reshaped on both the left and right bank face (see Photo 4-12).

Photo 4-12: MC2 module 2 midpoint

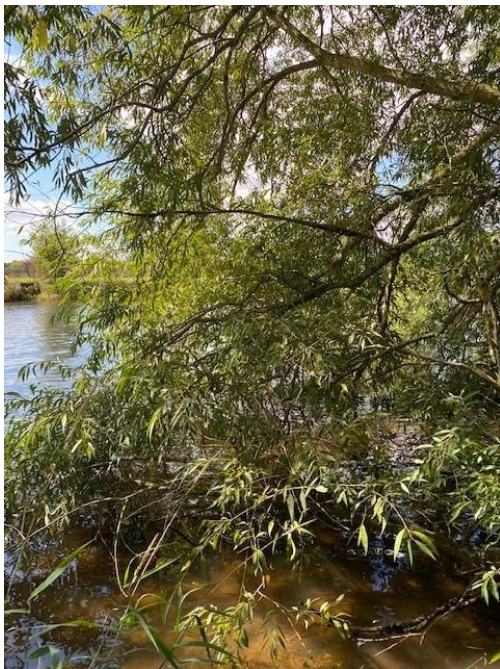
Photo 4-13: MC2 module 4 facing upstream

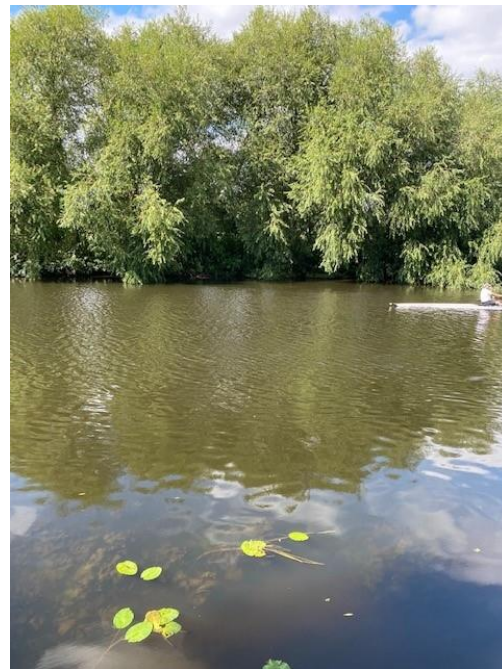
Photo 4-14: MC3 module 5 midpoint

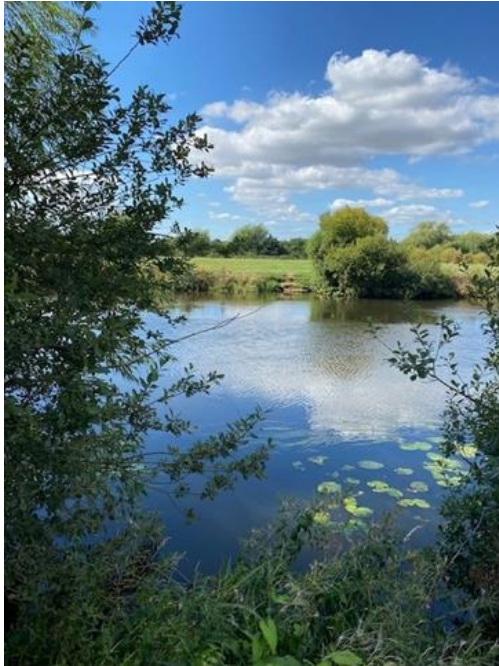
Photo 4-15: MC2 module 3 midpoint

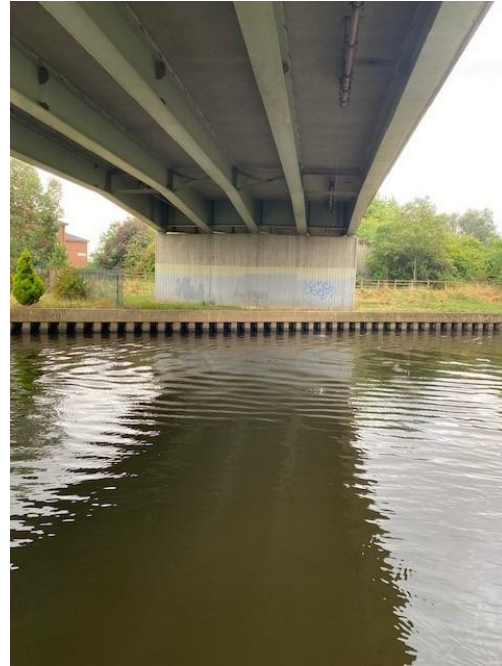
- The channel bed natural features extent indicator scores were all 0 for the 3 sub-reaches (see Photo 4-16). The channel bed natural features richness indicator scores were also 0 for the 3 sub-reaches.

Photo 4-16: MC3 module 2 midpoint

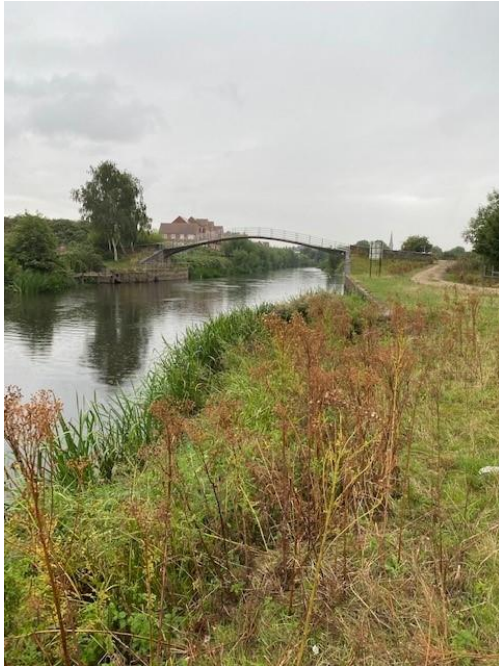
- The bank face natural profile richness indicator scores were 1 for both sub-reaches, as the natural bank profile type steep was recorded in both sub-reaches (Photo 4-19).

Photo 4-19: MC5 module 2 facing upstream

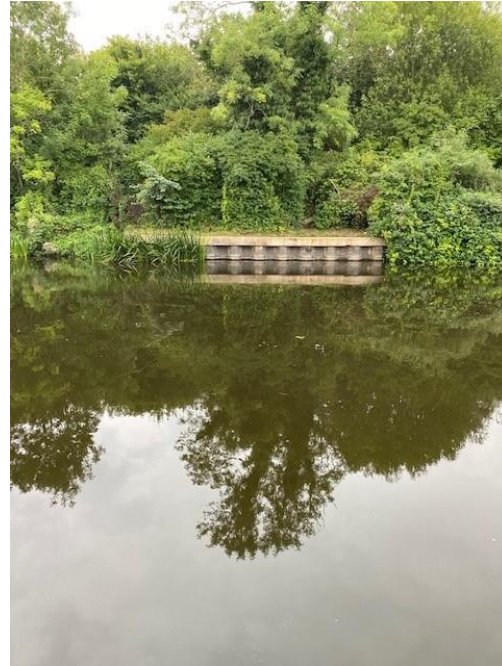
- The bank face artificial profile extent indicator scores were -4 for both sub-reaches as the dominant bank profile was obviously reshaped on the right and left banks (Photo 4-20). The left bank of MC5 module 2 was also poached.
- The bank face reinforcement extent indicator scores dropped from sub-reach MC4 to MC5 from -3 to -4 as there was a greater amount of reinforcement present in MC5.

Photo 4-20: MC4 module 1 midpoint

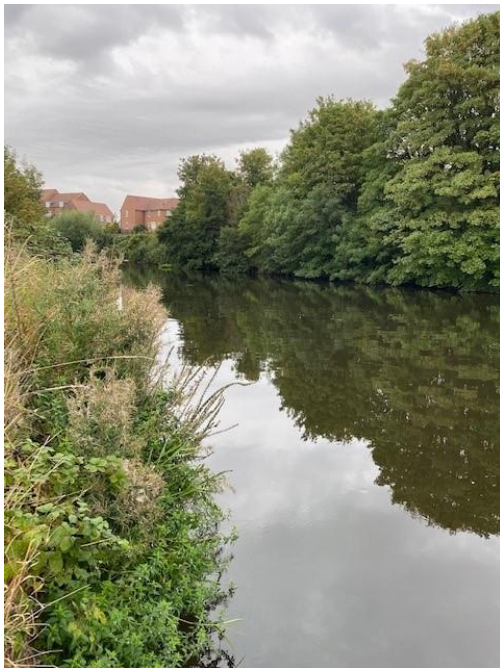
Photo 4-21: MC4 module 1 facing downstream

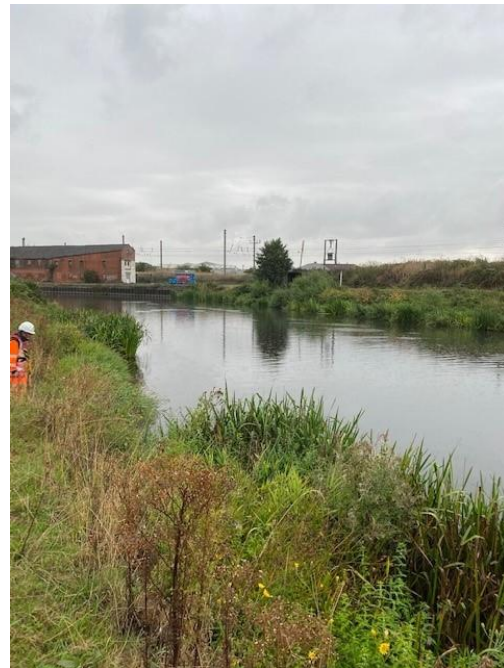
- The channel margin aquatic vegetation morphotype richness indicator scores were marginally different as 3 vegetation types; emergent broad/linear vegetation, and amphibious vegetation were recorded within the sub-reach MC5. Only emergent linear and amphibious vegetation types were observed in sub-reach MC4 (see Photo 4-21).
- The channel margin physical feature extent indicator scores were 1 at both sub-reaches as the total extent of the physical features on the bank face were within the same range as physical features were limited.
- With respect to channel margin physical feature richness, sub-reach MC5 had both a toe and eroding cliff present, whilst a toe feature was observed in sub-reach MC4 (Photo 4-22), leading to a low score of channel margin physical feature richness score of 1 for both sub-reaches.

Photo 4-22: MC5 module 2 facing downstream

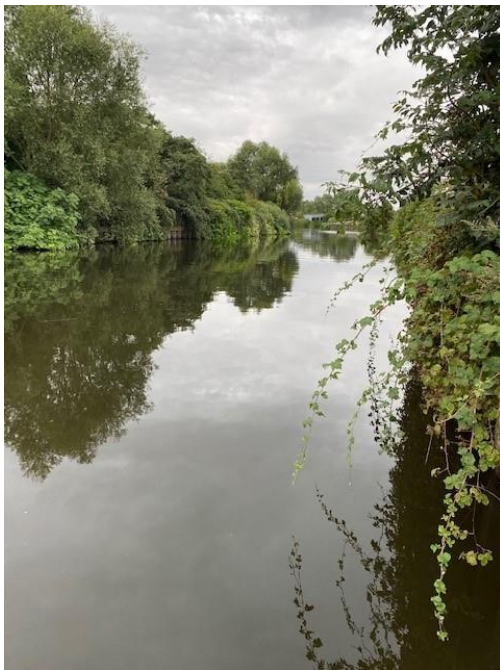
- The channel bed hydraulic features richness indicator score was highest for MC5 with a score of 3 as the freefall, chute, unbroken standing wave, rippled and smooth flow types were recorded in module 5. Only smooth flow type was recorded in MC4 (Photo 4-23).

Photo 4-23: MC4 module 1 facing upstream

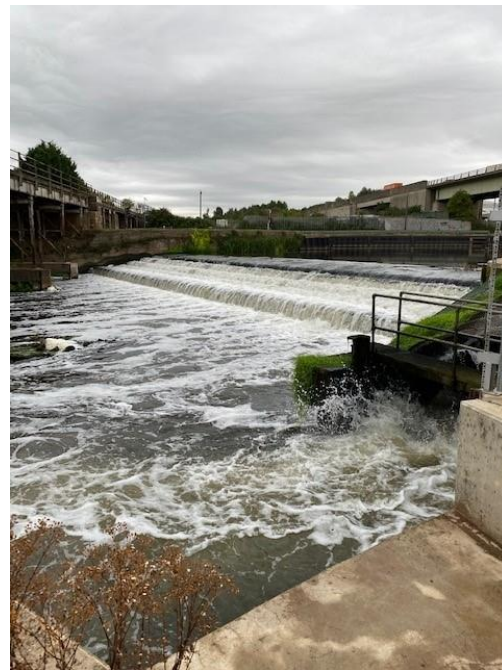
- The channel bed artificial features severity indicator score was lowest for the sub-reach MC5 as a major weir was present and there were eight bridge piers within the channel bed (Photo 4-24).
- The channel bed NNIPS cover indicator score was lowest for the sub-reach MC4 as Nuttall’s waterweed (*Elodea nuttallii*) was recorded within the channel.
- The channel bed filamentous algae extent indicator scores was lowest for the sub-reach MC5 as trace amounts within the channel were recorded.

Photo 4-24: MC5 module 5 midpoint

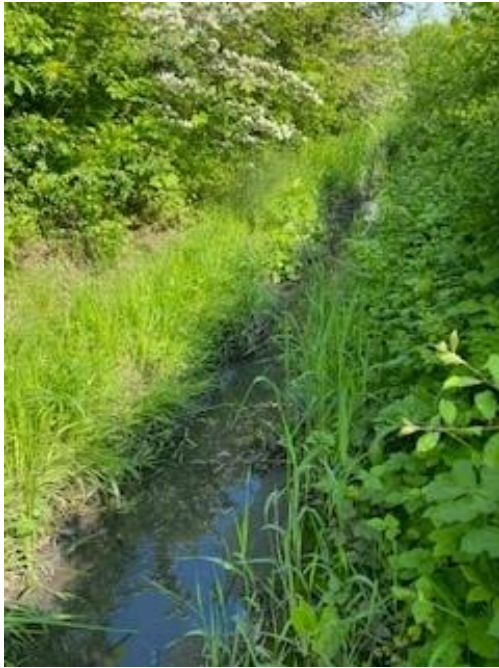
- The bank face riparian vegetation structure indicator scores were consistent for SD2 and SD3. The sub-reach SD1 had a slightly higher diversity of vegetation with an indicator score of 3 reflecting that tall herbs/grasses, scrub/shrubs, saplings/trees and short/creeping herbs/grasses were recorded on both bank faces throughout the sub-reach (see Photo 4-27).

Photo 4-27: SD1 module 1 facing downstream

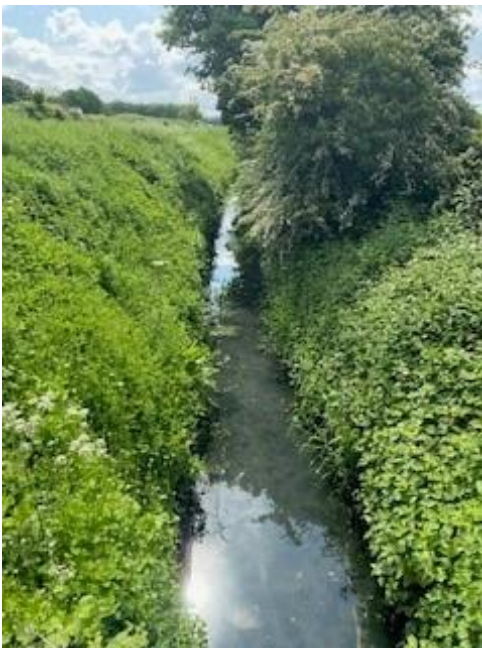
Photo 4-29: SD3 module 5 facing upstream

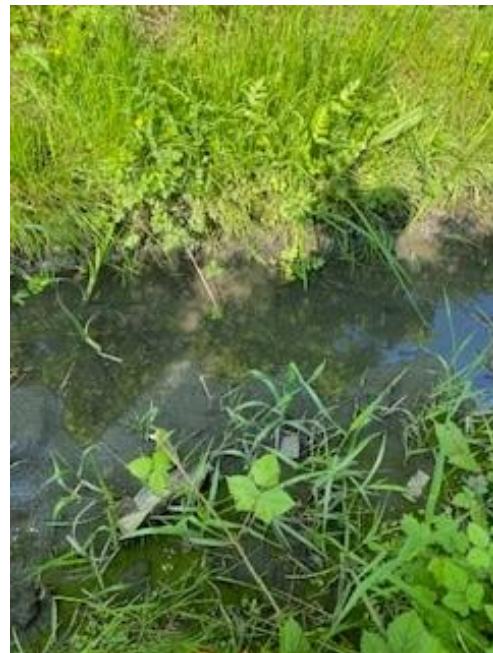
Photo 4-30: SD1 module 1 midpoint

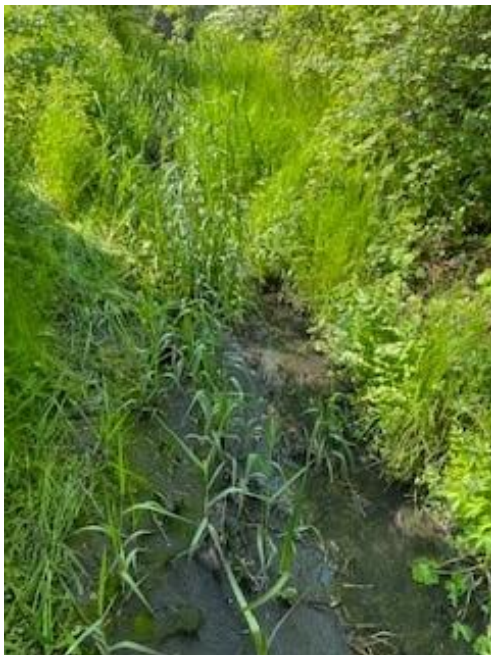
Photo 4-31: SD1 module 1 facing upstream

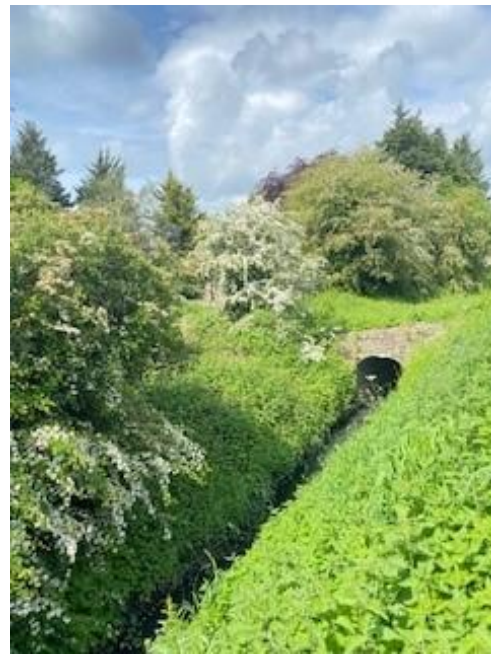
Photo 4-32: SD3 module 4 facing downstream

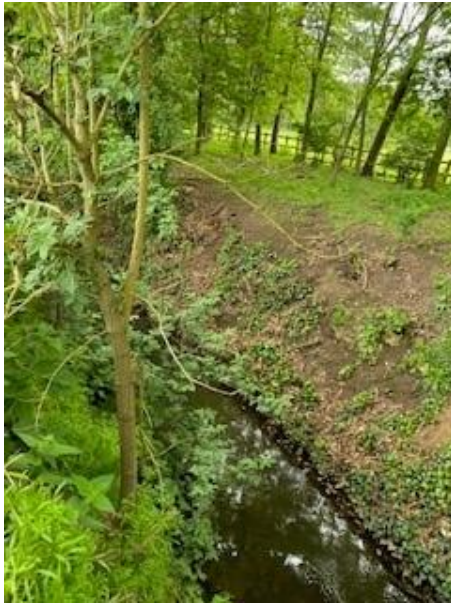
Photo 4-33: F1 module 4 facing upstream

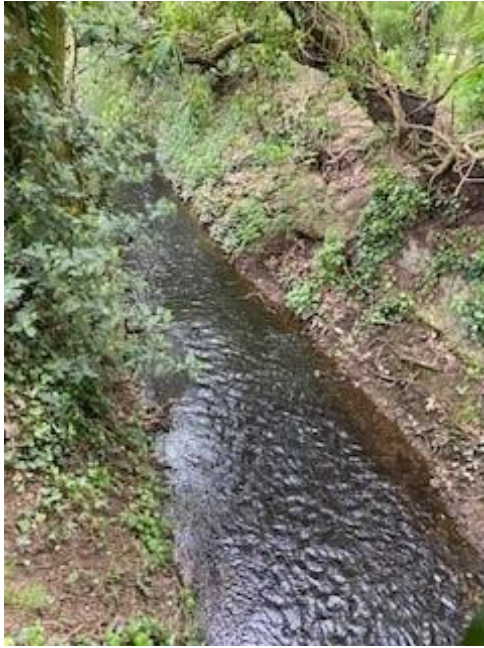
- The bank face riparian vegetation structure indicator score was 2 for sub-reach F1; vegetation types observed included short/creeping herbs/grasses, scrub/shrubs and saplings/trees.
- The bank face tree feature richness indicator score was 1 for the sub-reach F1 as exposed tree roots were observed on the bank face in modules 1 and 5. Leaning trees were also observed on the left bank face of modules 2 and 3 (see Photo 4-34).

Photo 4-34: F1 module 3 facing upstream

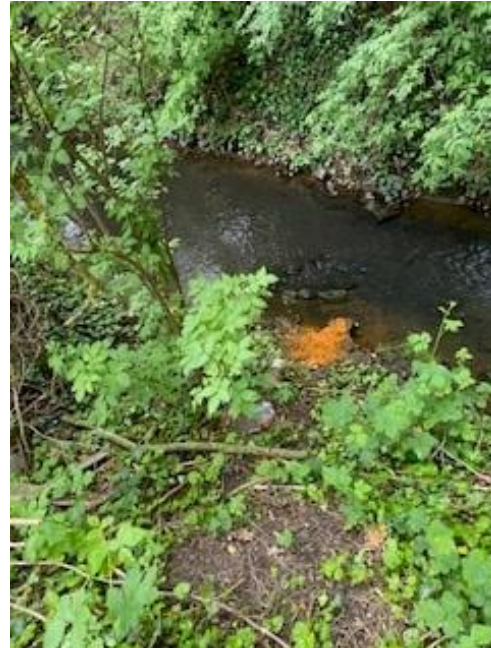
- The bank face natural profile extent was 1 for sub-reach F1 as the natural bank face profile steep was observed as sub-dominant in modules 3 and 4. A gentle bank profile was also observed as sub dominant in module 1 (see Photo 4-35).
- The bank face natural profile richness indicator score for the F1 sub-reach was 2. This was due to gentle and steep bank profiles being observed in the sub-reach.
- The bank face natural bank material richness indicator score was 1 for the sub-reach F1 as only earth was observed as a bank face material in the top and bottom sections.
- The bank face bare sediment extent had an indicator score of 3 for sub-reach F1; unvegetated bare earth was observed in modules 2, 3, 4 and 5.

Photo 4-35: F1 module 1 midpoint

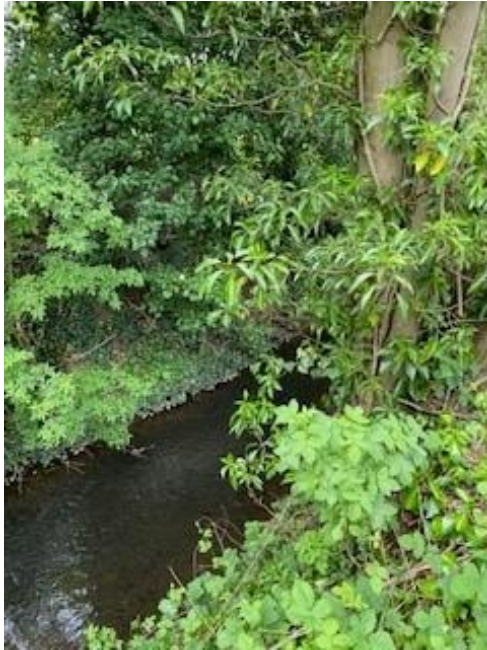
- The channel margin aquatic vegetation extent indicator score for the sub-reach F1 was 2 as amphibious vegetation was recorded in the channel margin throughout the sub-reach. Liverworts, mosses and lichens were also recorded as trace on the right channel margin of module 1 (see Photo 4-36).
- The channel margin aquatic vegetation morphotype richness indicator score was 1 as amphibious vegetation was the only type to be observed in present or extensive coverage within this sub-reach.
- The channel margin physical feature extent had an indicator score of 1 as several features including nest holes, stable cliff, eroding cliff and toe were observed, though each with less than 5% bank coverage.

Photo 4-36: F1 module 1 facing upstream

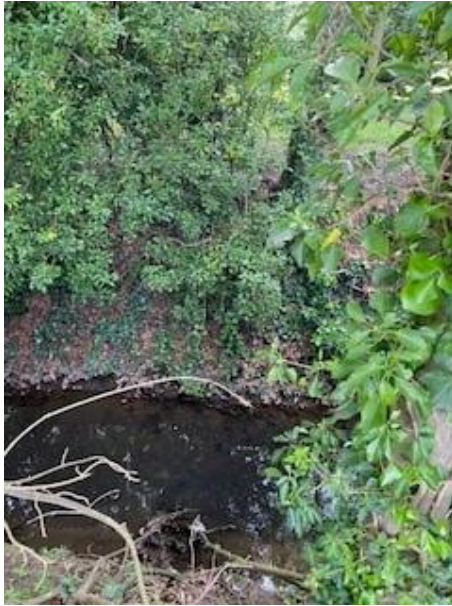
- The channel aquatic morphotype richness indicator score for the F1 sub-reach is 1 as only amphibious vegetation was recorded in the channel area (See Photo 4-37 and Photo 4-38).
- The channel bed tree feature richness indicator score for the sub-reach F1 was 2 as vegetation shading the channel and submerged tree roots were both recorded.
- The channel bed hydraulic features richness indicator score was 1 for the sub-reach F1 as rippled and smooth flow types were observed within the channel.
- The channel bed natural features richness and extent indicator scores were both 0 as none were observed within the sub-reach.
- The channel bed material richness indicator score was 2 as sand and gravel/pebble bed materials were recorded as present and extensive respectively.

Photo 4-37: F1 module 4 midpoint

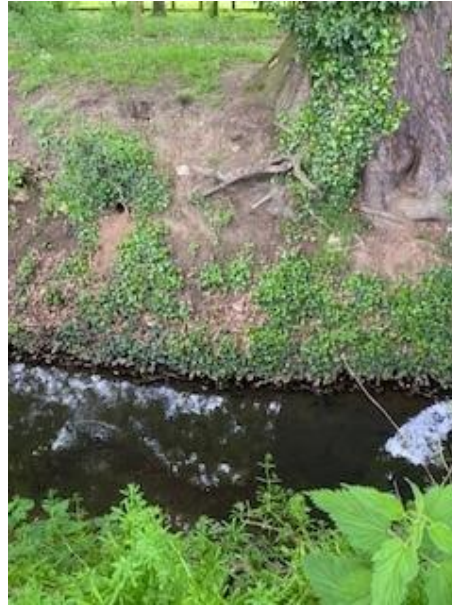
Photo 4-38: F1 module 3 midpoint

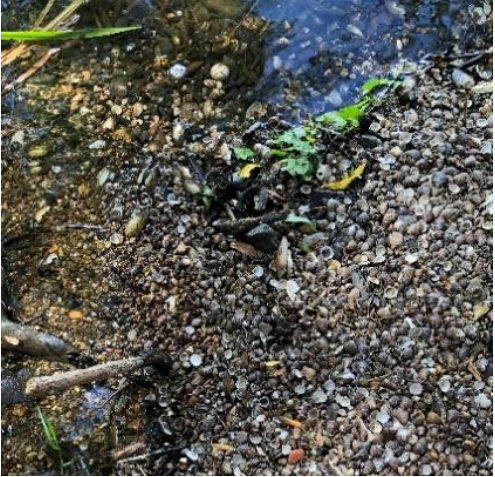
Feature number	Feature type	NGR(s)	Description of ecological significance	Photograph
2	INNS	SK 77170 53643	Huge number of bivalve shells deposited, dominated by Asian clam (<i>Corbicula fluminea</i>).

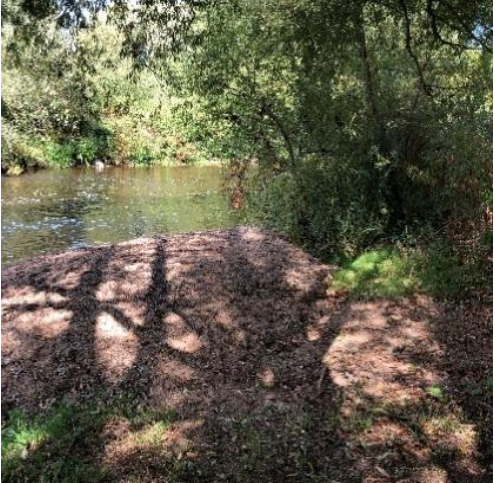
Feature number	Feature type	NGR(s)	Description of ecological significance	Photograph
3	Feature	SK 77170 53648	Several geomorphic and habitat features in the vicinity of the weir, including a marginal backwater, unvegetated side bar (comprised of gravel/pebble and sand), and a bench ¹⁷ higher up the bank.

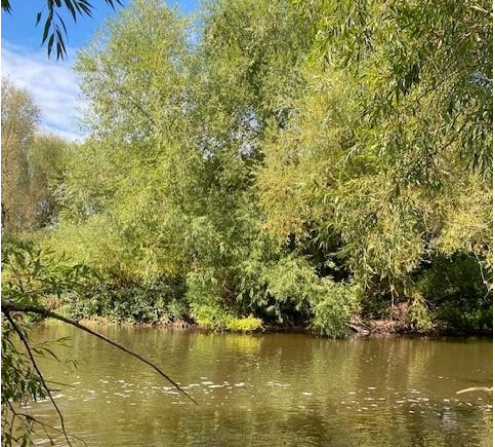
4	Feature	SK 77113 53572 to SK 77110 53773	Mature island, heavily colonised by trees, which may provide marginal cover for fish.

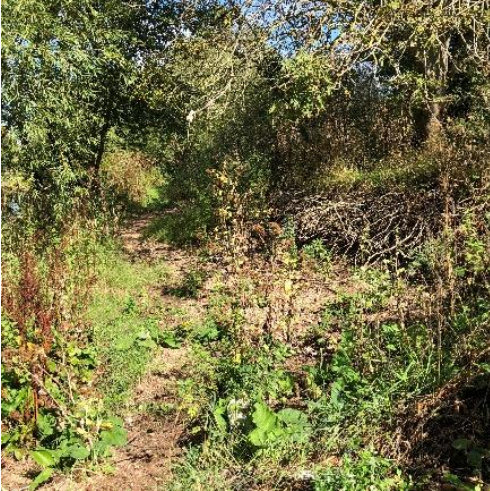
Feature number	Feature type	NGR(s)	Description of ecological significance	Photograph
5	Feature	SK 77181 53655 to SK 77175 53686	The right bank is formed of deposited river material dominated by sand, with some gravel/pebble. The bank includes a large bench and in places forms a composite (stepped) profile.

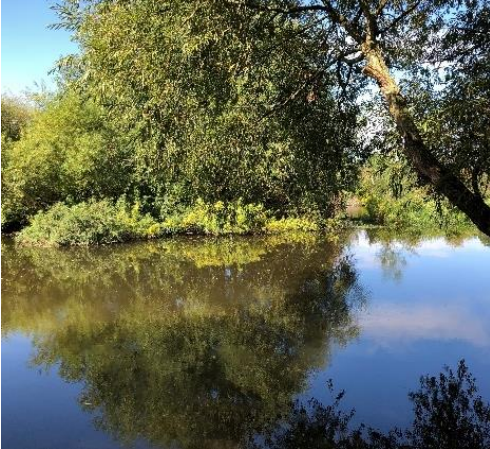
6	Feature	SK 77109 53781	Vegetated mid-channel bar downstream of, and distinct from, larger island feature.

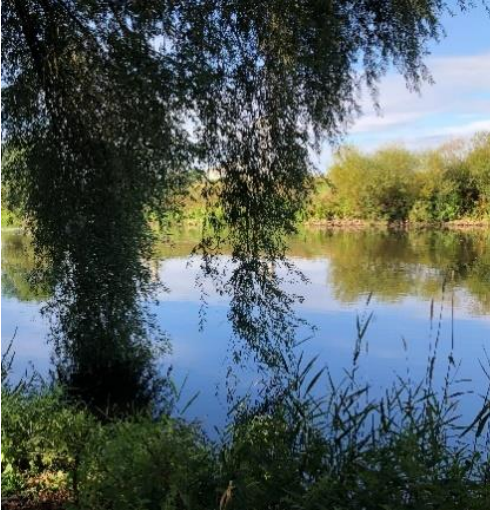
Feature number	Feature type	NGR(s)	Description of ecological significance	Photograph
7	Feature	SK 77138 53830	Large area of slack flow around right bank with some associated tree cover, forming potential resting area for fish.

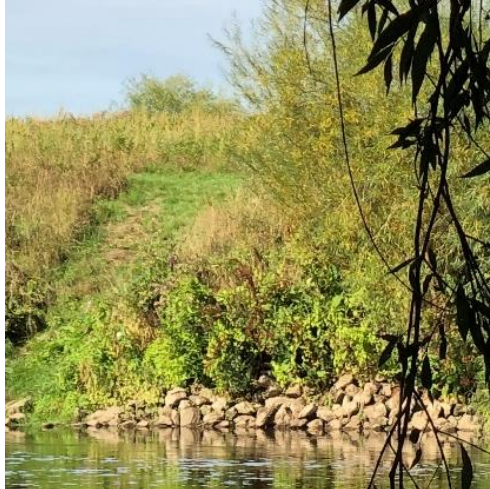
8	Modification	SK 77087 53832	Rip-rap reinforcement along left bank.

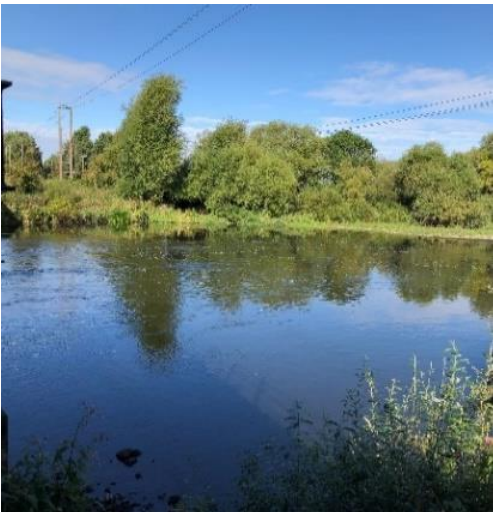
10	Feature	SK 77103 53884	Flow diversity influenced by bridge supports, creating conditions to support a variety of fish species and life stages. Likely to be a pool at this location, as deposited material was visible further downstream.

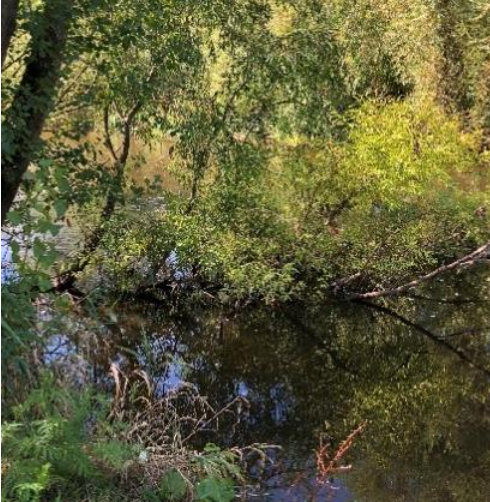
Feature number	Feature type	NGR(s)	Description of ecological significance	Photograph
N/A	Feature	N/A	Trees providing important marginal cover were present, though extensive along the right bank. Some trees, particularly willows, provided additional complexity in the form of submerged roots.

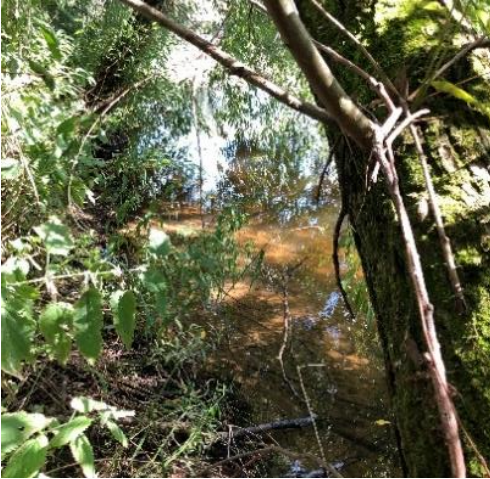
N/A	Feature	N/A	Right bank with semi-natural profile, varying between low and steep angles.

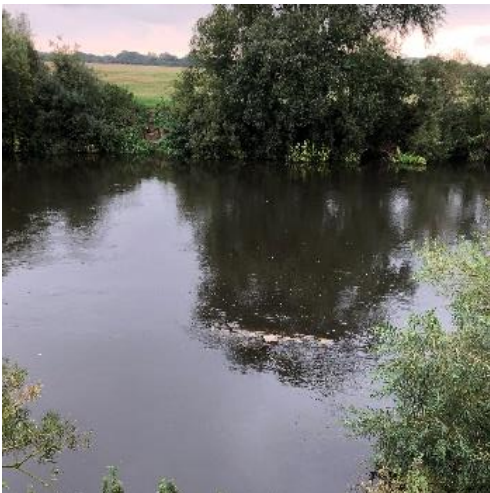
Feature number	Feature type	NGR	Description of ecological significance	Photograph
3	Modification	SK 77073 54642	Groyne in water - partially collapsed.

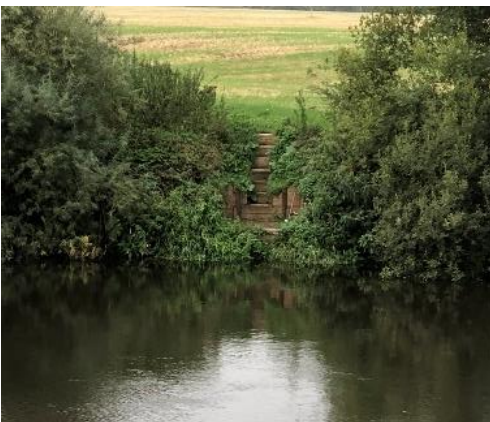
4	Modification	SK 77081 54601	Steps on right bank.

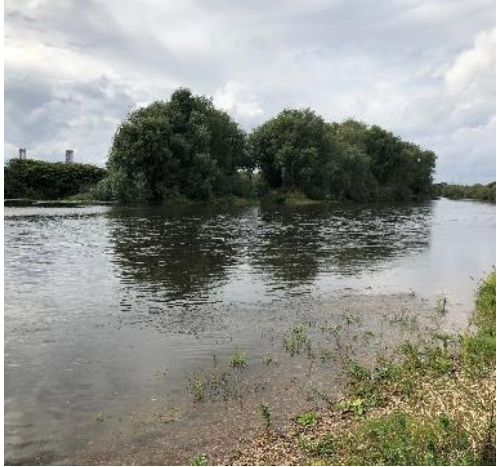
Feature number	Feature type	NGR	Description of ecological significance	Photograph
5	Feature	SK 77190 54613	Area where river activity has created mosaic of bars, backwaters, and side channels.

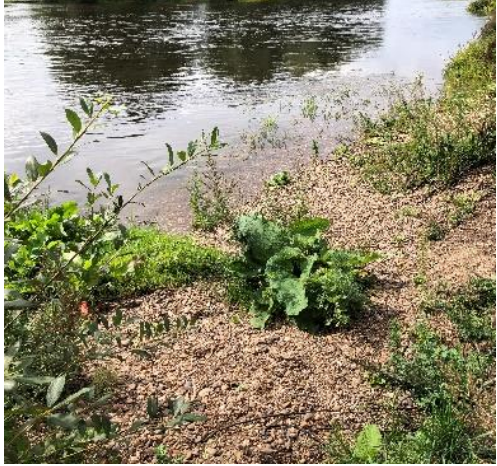
6	Feature	SK 77305 54680	Discrete unvegetated gravel/pebble side bar on left bank, at margin of larger depositional feature (feature 7).

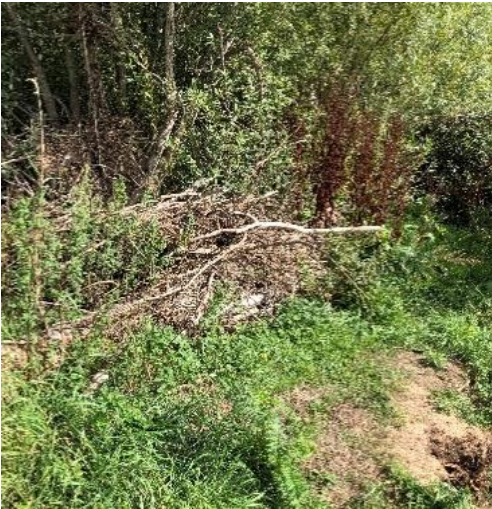
Feature number	Feature type	NGR	Description of ecological significance	Photograph
7	Feature	SK 77353 54857	<p>Large area where fluvial processes have created a mosaic of bars, backwaters, ponds and wetland areas (see some examples below).</p> <p>Example of large wood and organic material deposited on large depositional feature during flooding.</p>

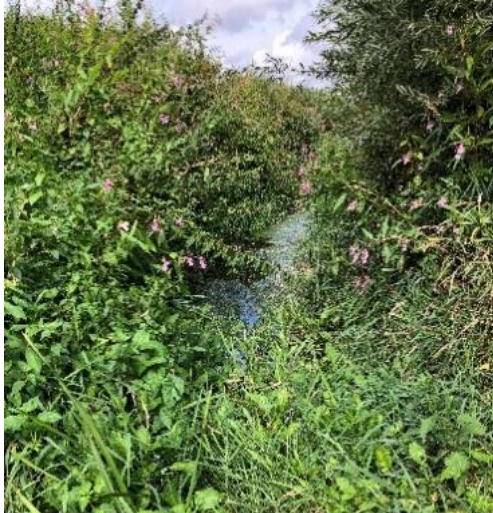
Feature number	Feature type	NGR	Description of ecological significance	Photograph
			Example of pond within the large depositional feature.

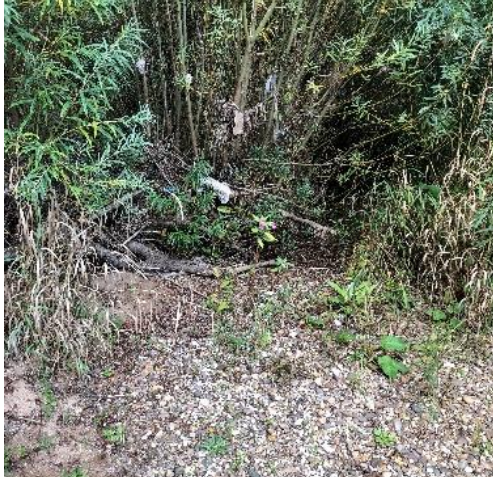
Example of exposed area of riverine sediment (predominantly gravel/pebble) within the large depositional feature.

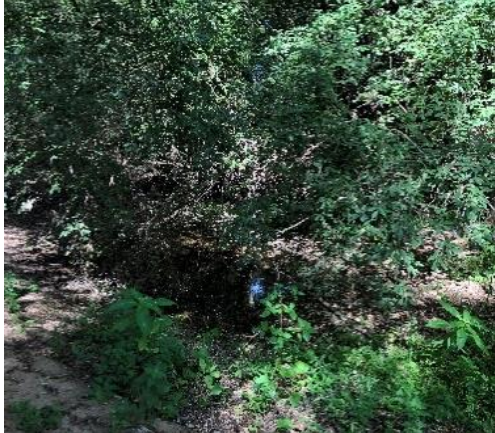
Feature number	Feature type	NGR	Description of ecological significance	Photograph
			<p>Example of pond within the large depositional feature. Photo also shows sandy material which forms much of the larger feature.</p>

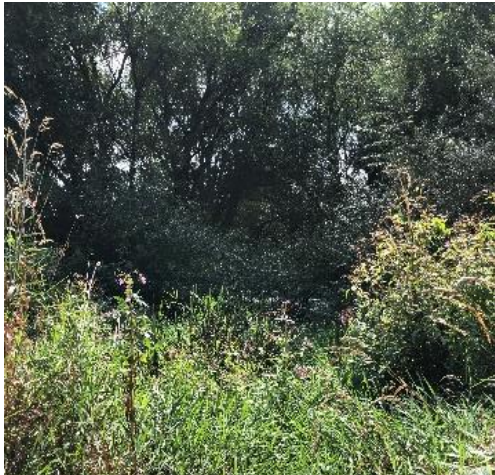
<p>Example of wetland area located within the large depositional feature.</p>

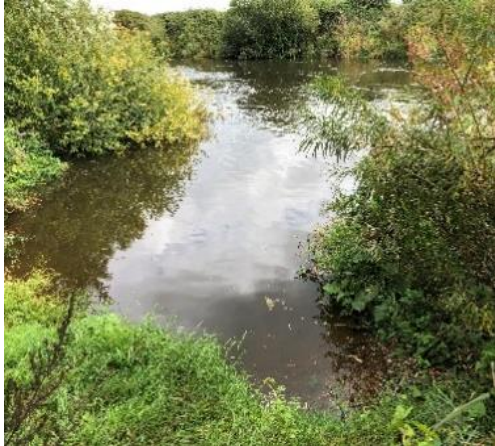
Feature number	Feature type	NGR	Description of ecological significance	Photograph
8	Feature	SK 77341 54683	Small, distinct side bar and backwater feature on left bank, located at edge of large depositional feature (feature 7).

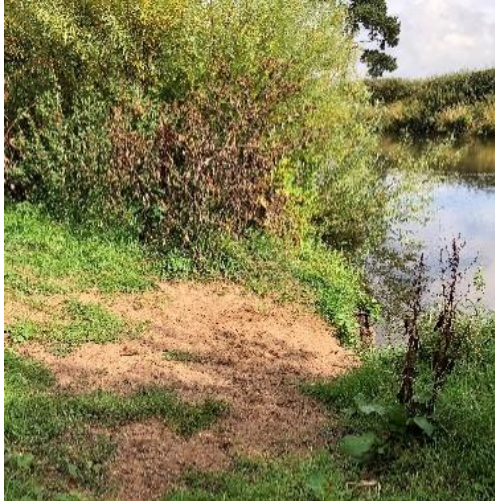
9	Feature	SK 77378 54734	Distinct area of exposed bank, revealing river deposits, including sand and gravel/pebbles, forming part of the larger depositional feature (feature 7) i. Patch may be exposed by recreational activity such as angling rather than natural processes.

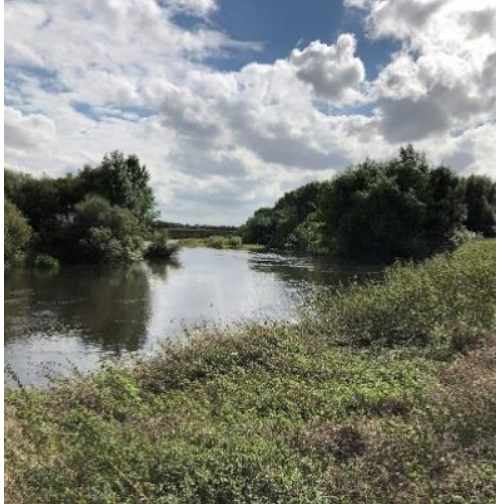
Feature number	Feature type	NGR	Description of ecological significance	Photograph
10	Feature	SK 77368 55056	Large backwater feature, likely to provide important refuge for fish.	N/A
11	Feature	SK 77440 55016	Photo looking upstream towards large in-channel bar which appears largely vegetated at time of survey, potentially indicating stabilisation.

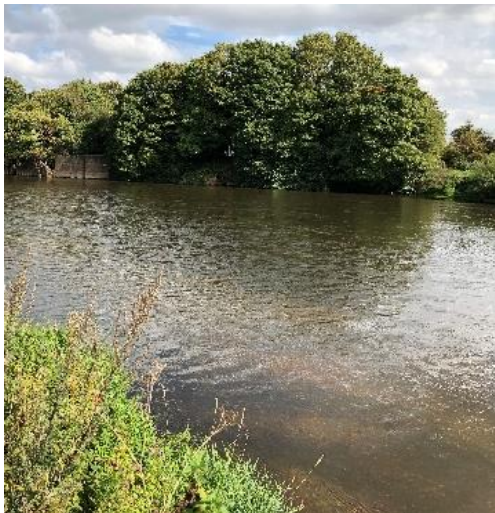
Feature number	Feature type	NGR	Description of ecological significance	Photograph
12	Feature	SK 77579 55367	Very wide section, but shallow and turbulent with clean gravels. Possible fish spawning area.

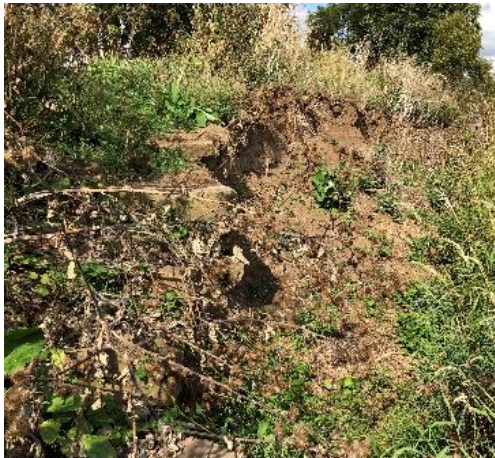
13	Feature/modification	SK 77566 55375	Steps within bank and evidence of bank erosion.

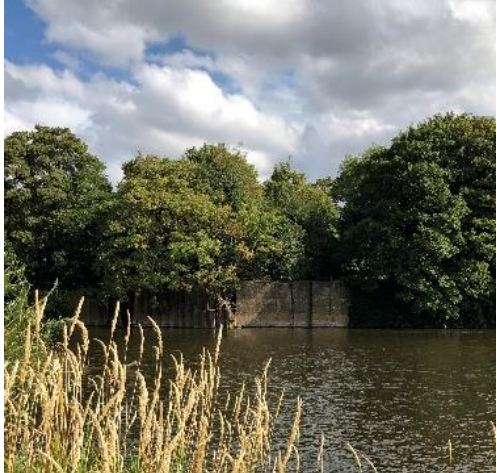
Feature number	Feature type	NGR	Description of ecological significance	Photograph
14	Modification	SK 77639 55362	Approximately 20 metres of reinforcement along right bank including concrete and sheet piling.

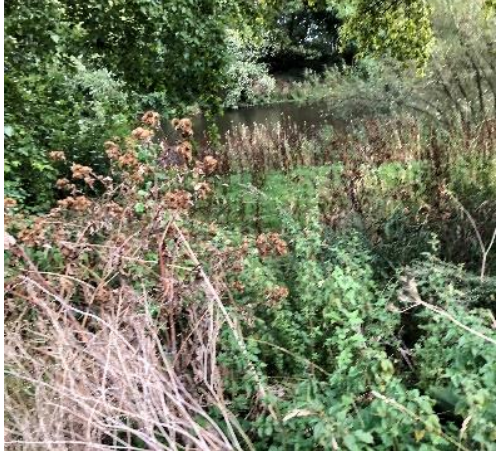
15	Feature	SK 77596 55434	Large berm on left bank.

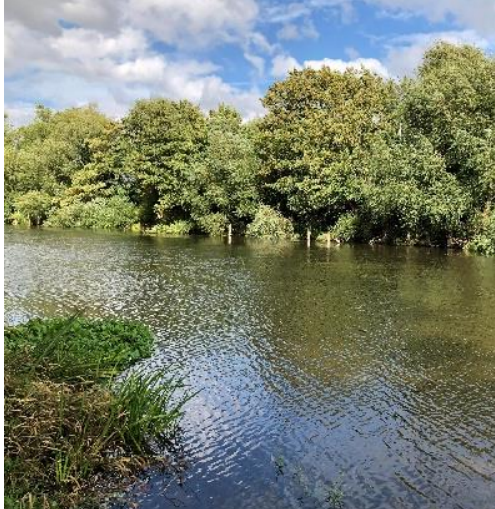
17	Feature/modification	SK 77657 55469 to SK 77637 55651	Right bank rip-rap toe and other failed reinforcements present. Right bank possibly historically resectioned. Completely colonised by trees at the time of survey, with branches overhanging or trailing into the water providing important marginal cover for fish.

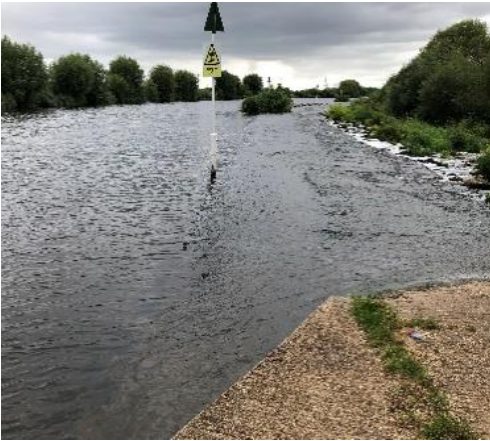
Feature number	Feature type	NGR	Description of ecological significance	Photograph
1	Modification	SK 77187 53631	Top of weir which flows into Kelham side channel.

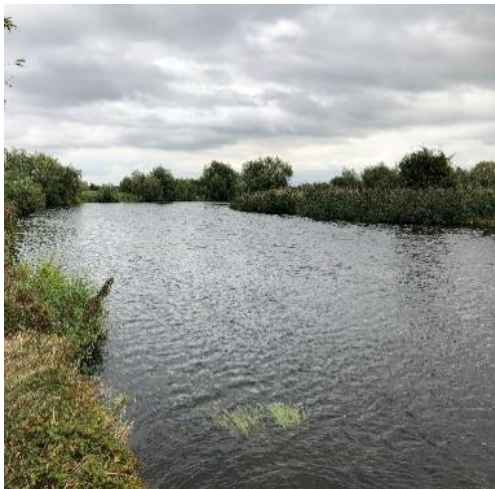
Feature number	Feature type	NGR	Description of ecological significance	Photograph
2	Modification	SK 77194 53634	Left bank reinforced with sheet piling in vicinity of weir (though right bank reed-fringed).

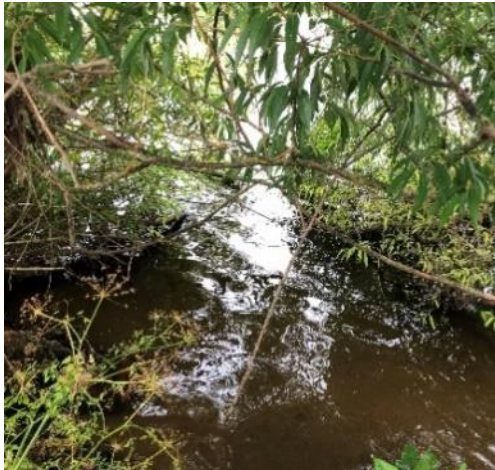
3	Feature	SK 77281 53703	Willows (<i>Salix</i> spp.) fairly abundant and associated with complex bank profiles, tree roots and marginal deadwater areas; potentially providing important habitat for juvenile fish.

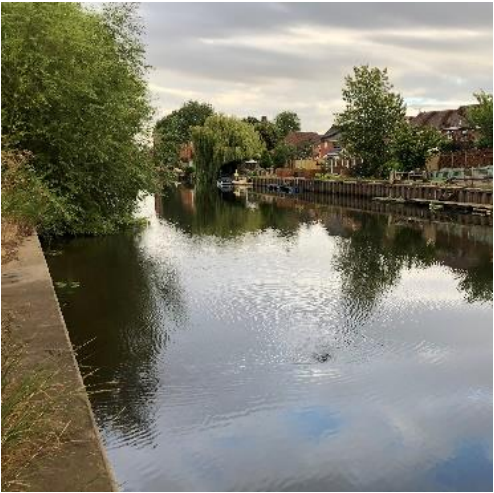
Feature number	Feature type	NGR(s)	Description of ecological significance	Photograph
1	Modification	SK 78089 52858 to SK 78119 52874	Left bank wholly reinforced in vicinity of A46 bridge.

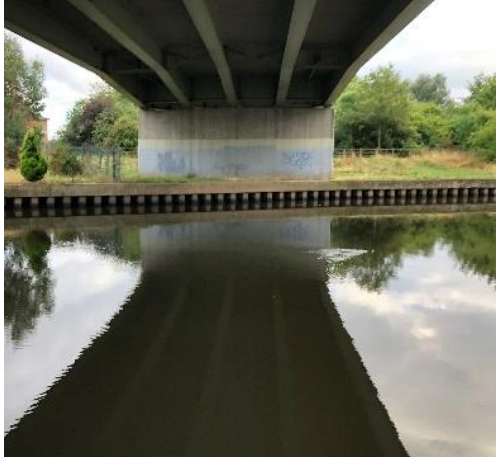
Feature number	Feature type	NGR(s)	Description of ecological significance	Photograph
3	Modification	SK 78104 52866	A46 bridge, associated with reinforced banks and partial concrete bed reinforcement. Shading may provide localised cover for fish.

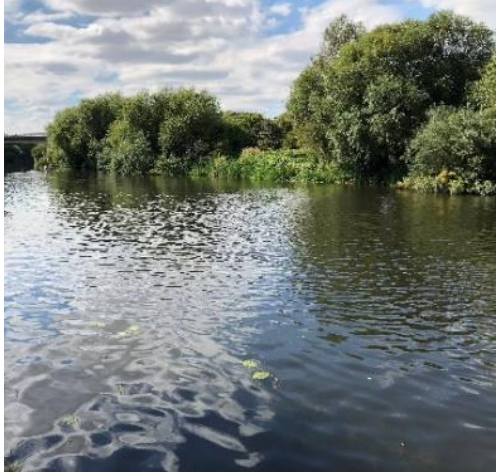
4	Feature	SK 78136 52885 to SK 78274 52964	Bankside linear tree feature providing vegetation, and trailing branches in channel. May provide habitat for fish.

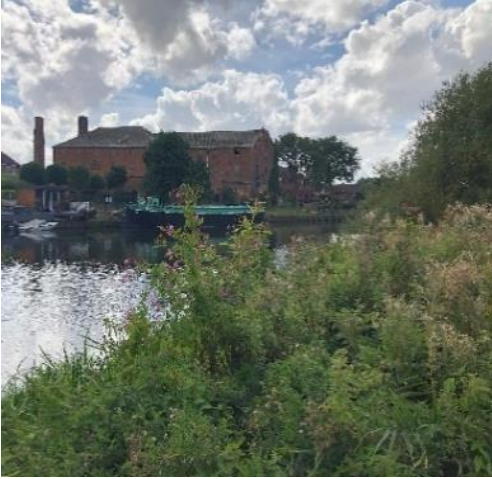
Feature number	Feature type	NGR(s)	Description of ecological significance	Photograph
5	Feature	SK 78365 53023	Confluence of River Trent and Old Trent Dyke. Unsure of specific nature of connection as vegetation too dense to observe. This reach of the Old Trent Dyke was dry at the time of survey with no evidence of being wet (ie, no wetland dependent plant species observed).

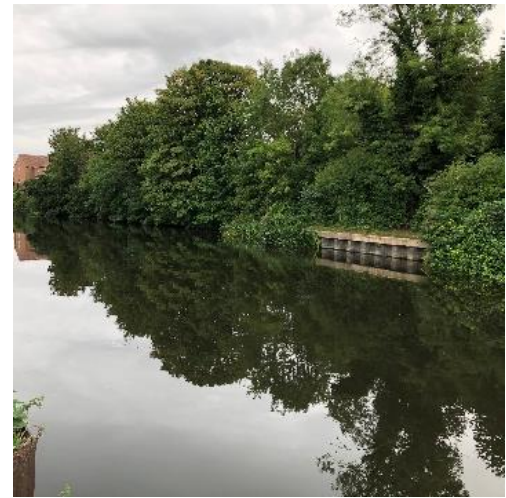
Feature number	Feature type	NGR(s)	Description of ecological significance	Photograph
1	Modification	SK 80012 54674 to SK 80048 54718	Sheet piling along left bank.

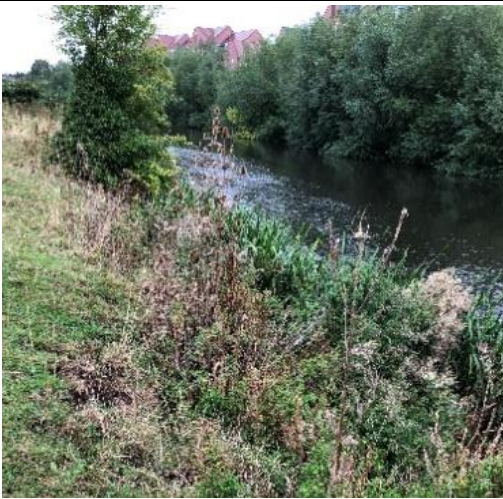
Feature number	Feature type	NGR(s)	Description of ecological significance	Photograph
5	Feature/modification	SK 80118 54836 to SK 80121 55053	Left bank appears to have been poached by livestock; however marginal complexity and macrophyte diversity is relatively high.

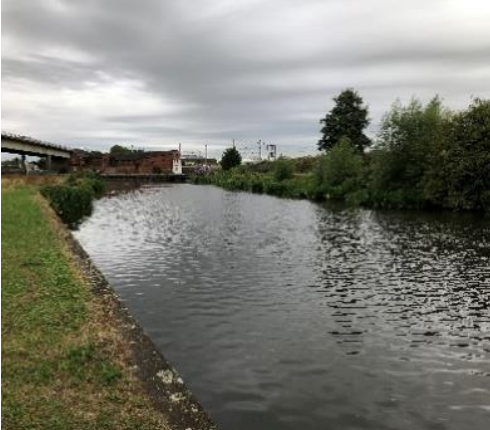
Feature number	Feature type	NGR(s)	Description of ecological significance	Photograph
7	Modification	SK 80123 55061 to SK 80136 55162	Sheet piling along left bank.

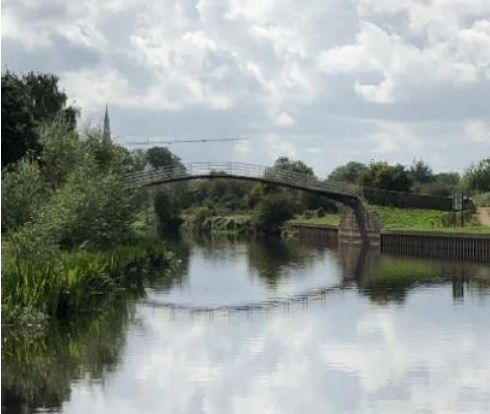
8	Modification	SK 80146 55109	Minor bridge no significant impact on river.

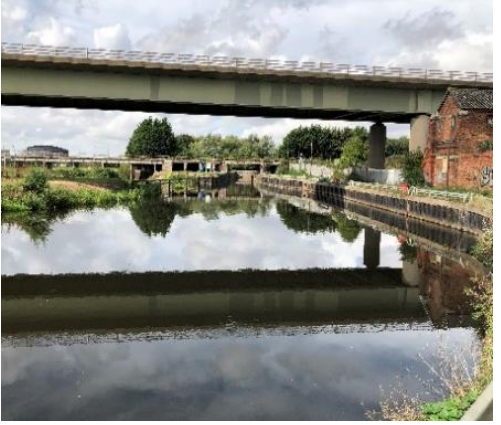
Feature number	Feature type	NGR(s)	Description of ecological significance	Photograph
10	Feature	SK 80174 55302	Higher velocity flows locally present on outside of meander, possibly creating more favourable area locally for rheophilic fish.

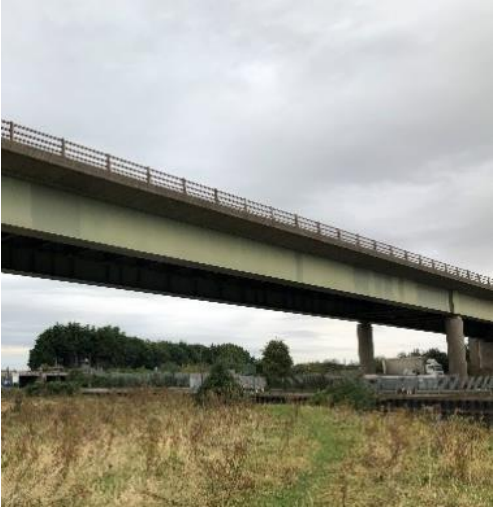
11		SK 80141 55316	A46 road bridge – no supports in river but present on bank top. Approximately 16 metre wide.
